Flood Control Landfill Photos 1991-92: Wickenburg, Cave Creek, Chandler, Northwest Regional & Morristown

Flood Control District of Maricopa County-FCD

Landfills

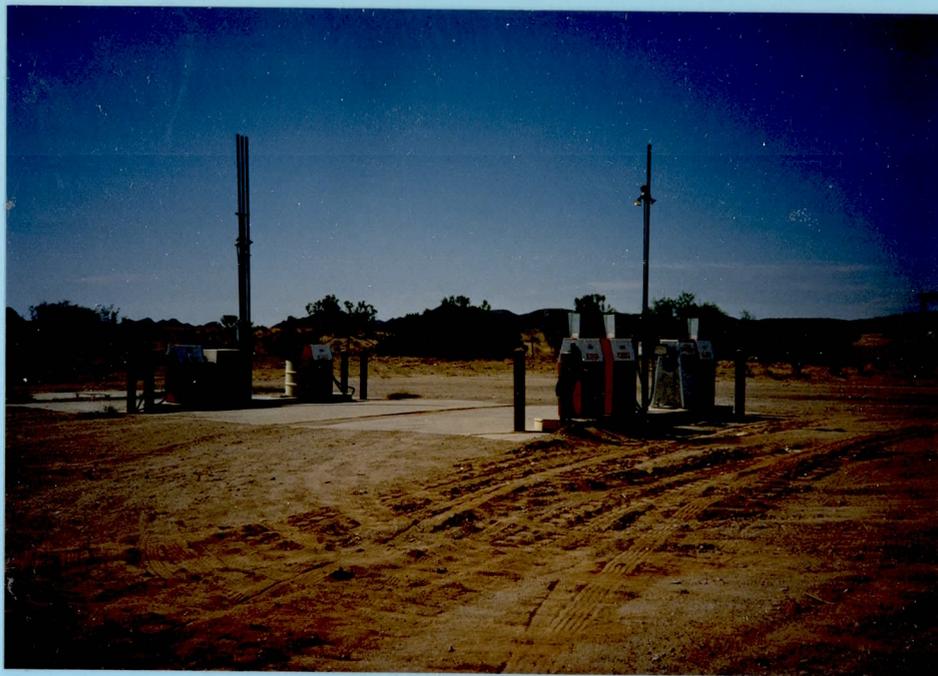
1. gas station adjacent to landfill

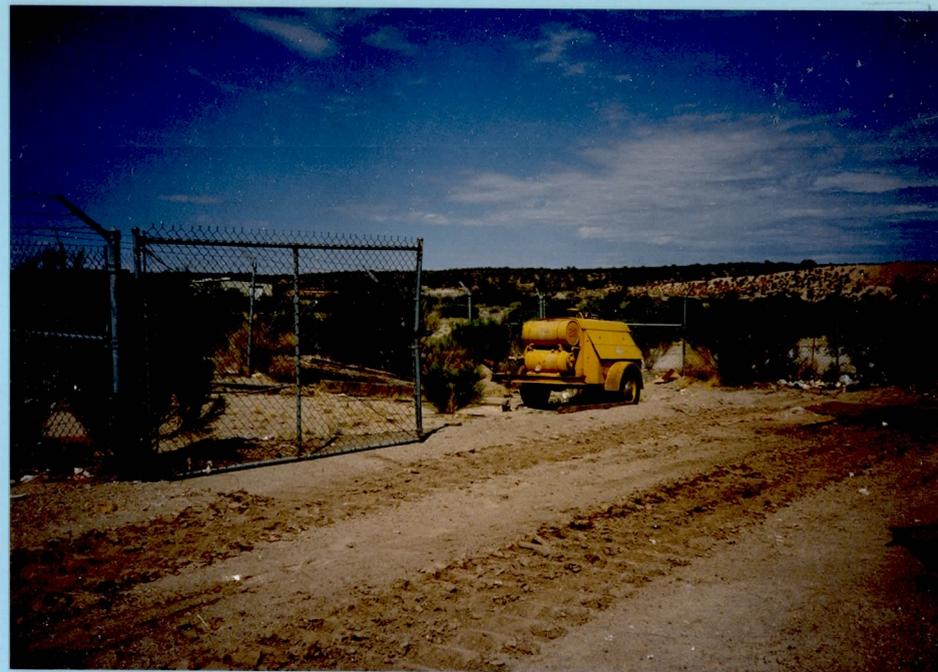
2. scrap metal area - west side

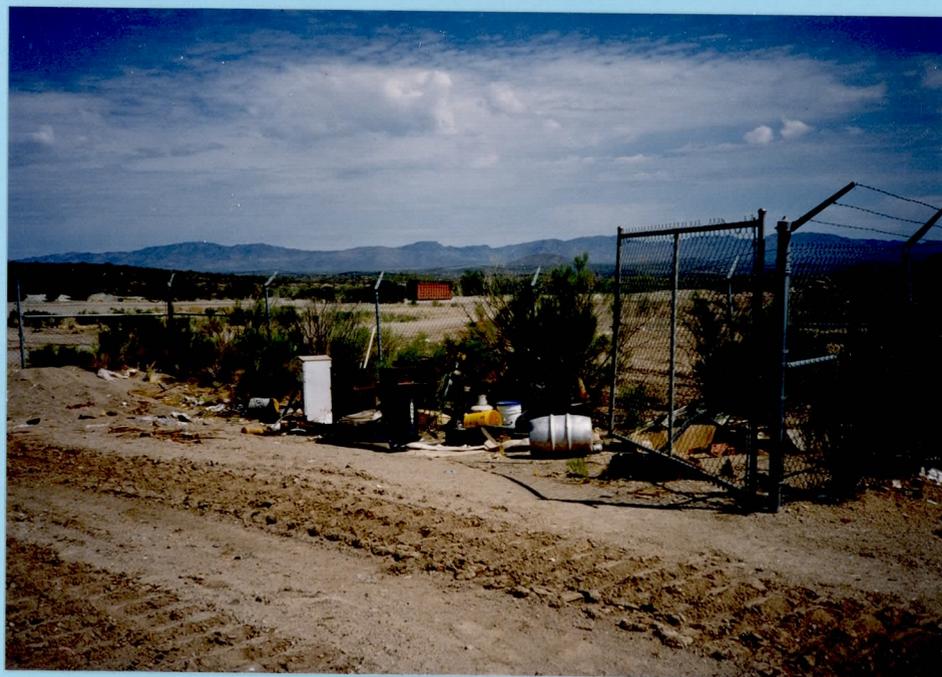
3. scrap metal area - east side

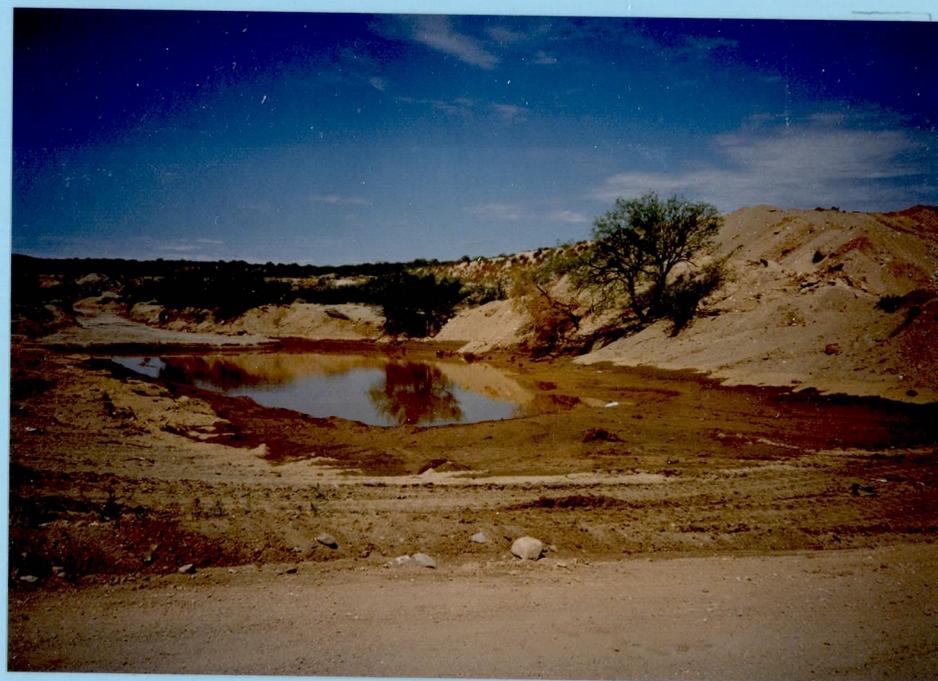
4. Hartman Wash - looking southwest

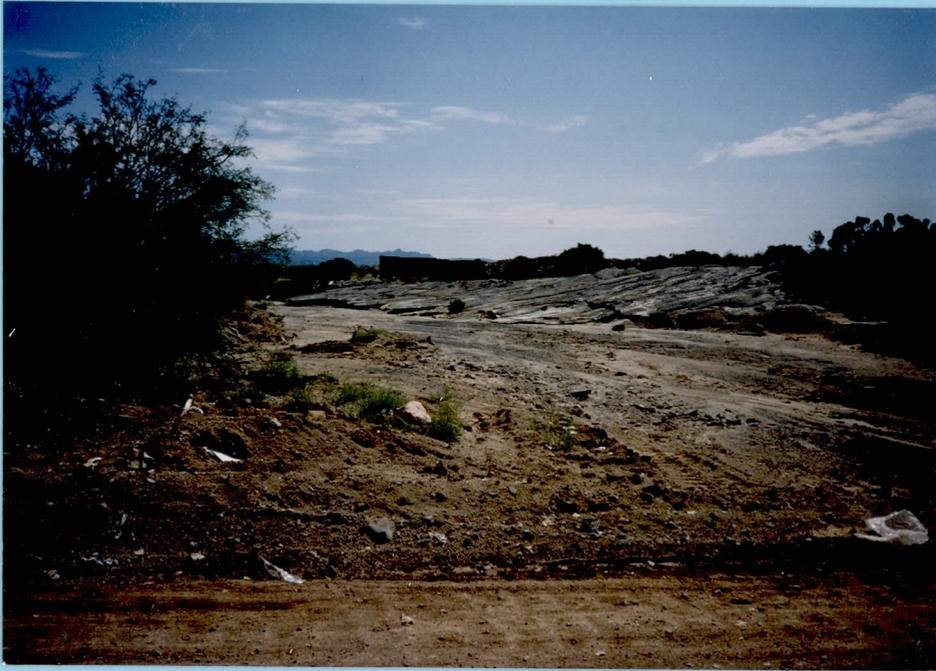
5. Hartman Wash – looking northeast

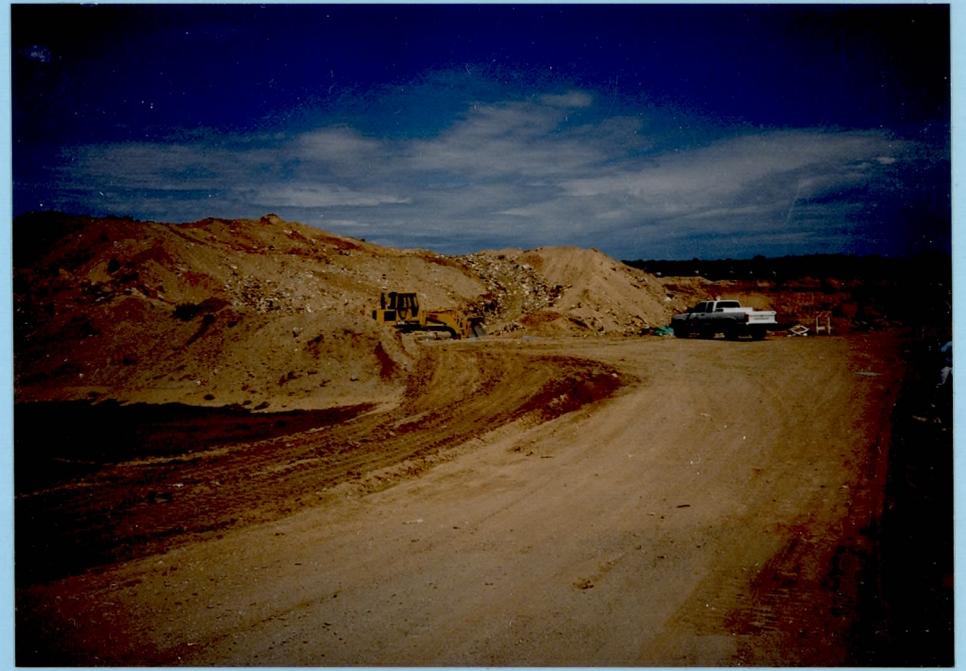
6. active cell adjacent to Hartman Wash

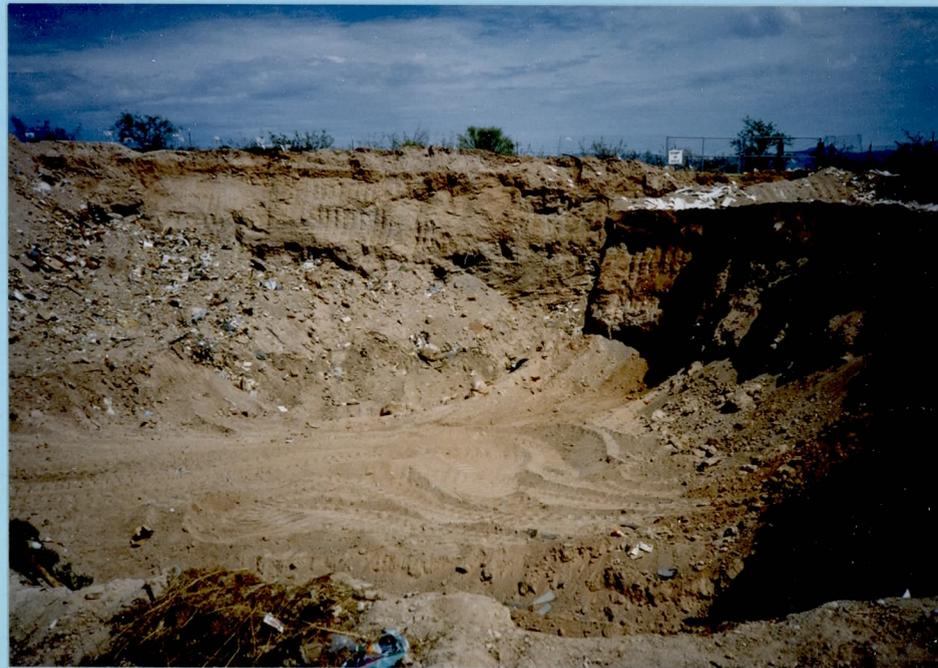
7. active cell – close of photo #6

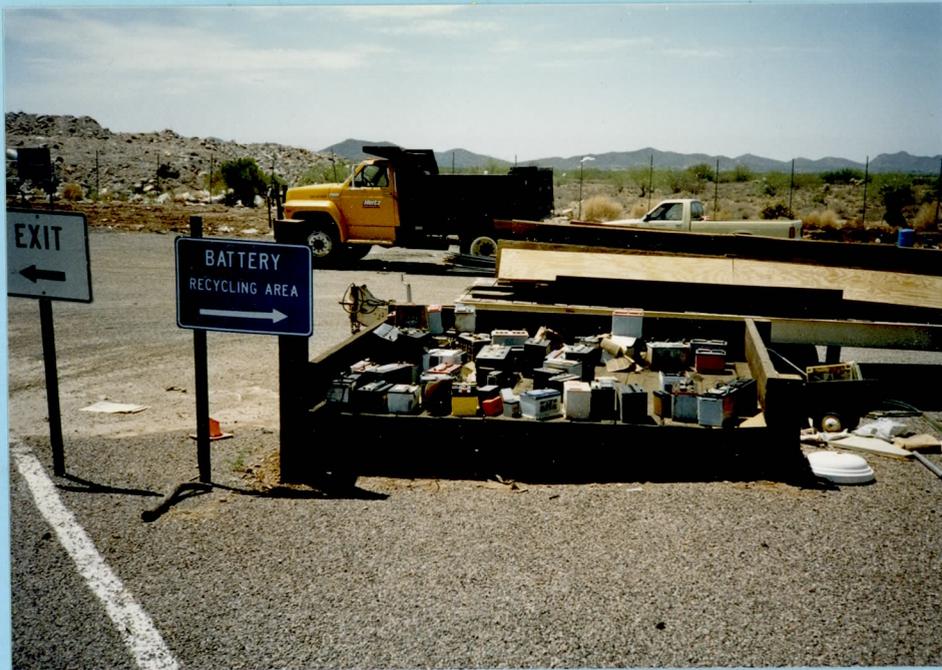
1. Used battery collection area. Underside of collection area is lined.

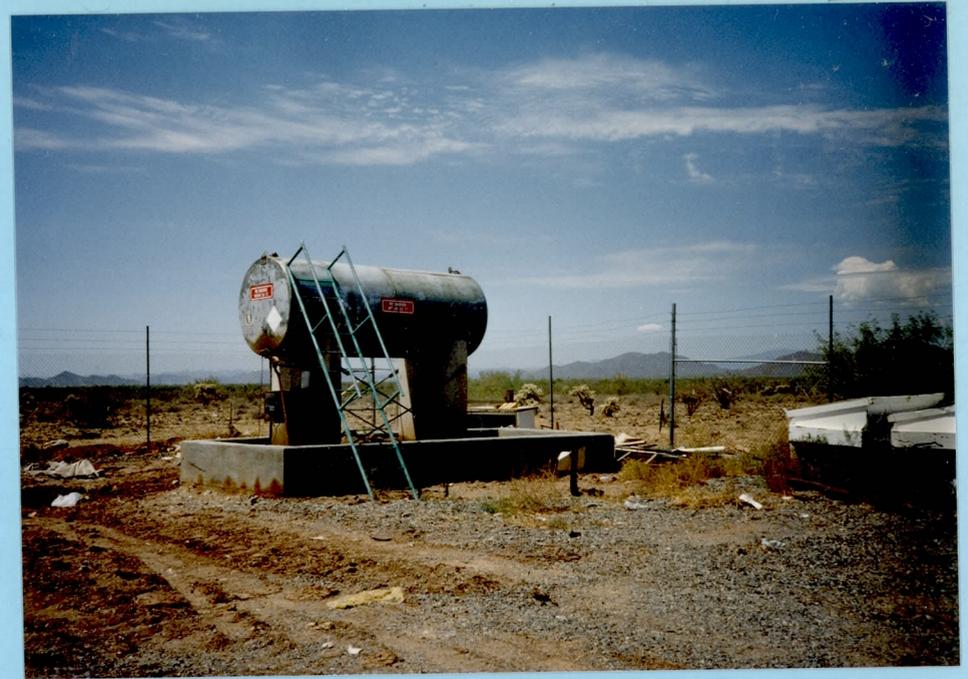
2. Fuel dispensing tank. Note wall containment.

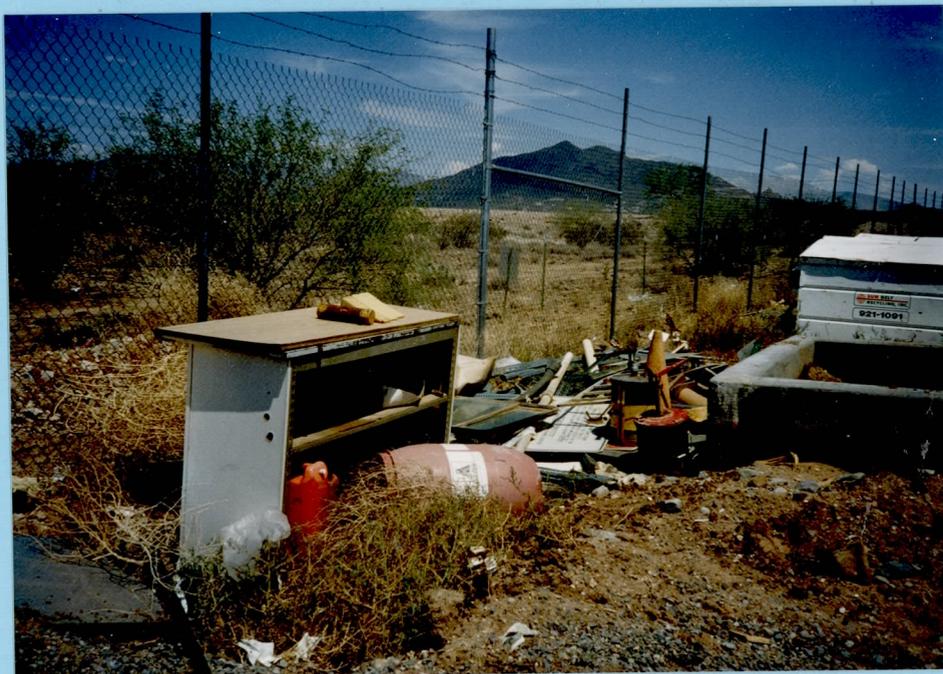
3. Scrap storage area, behind fuel tank.

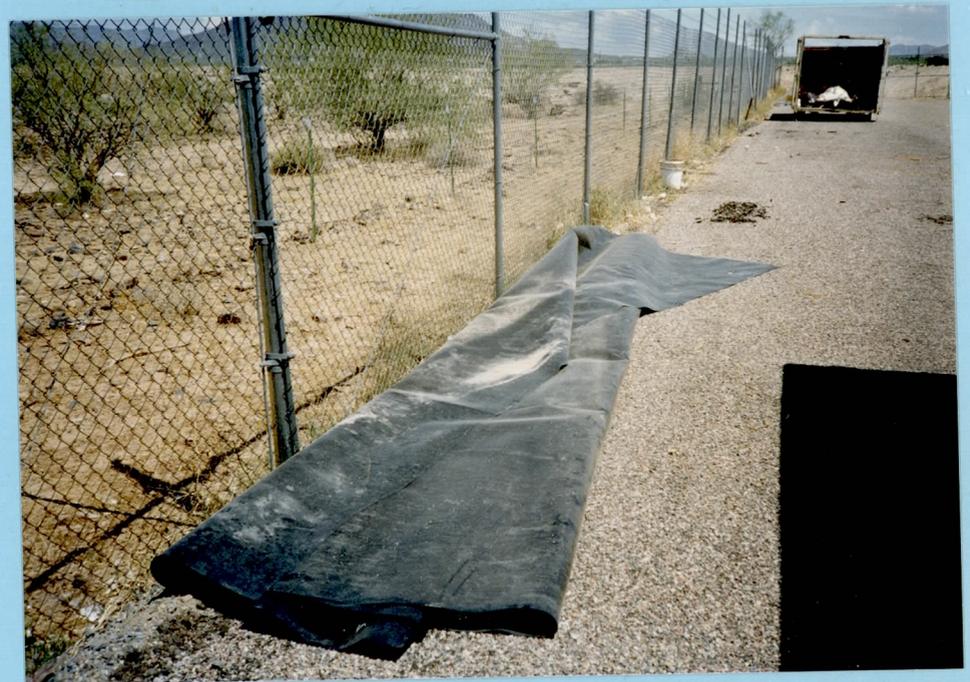
4. Plastic lining used under battery collection area.

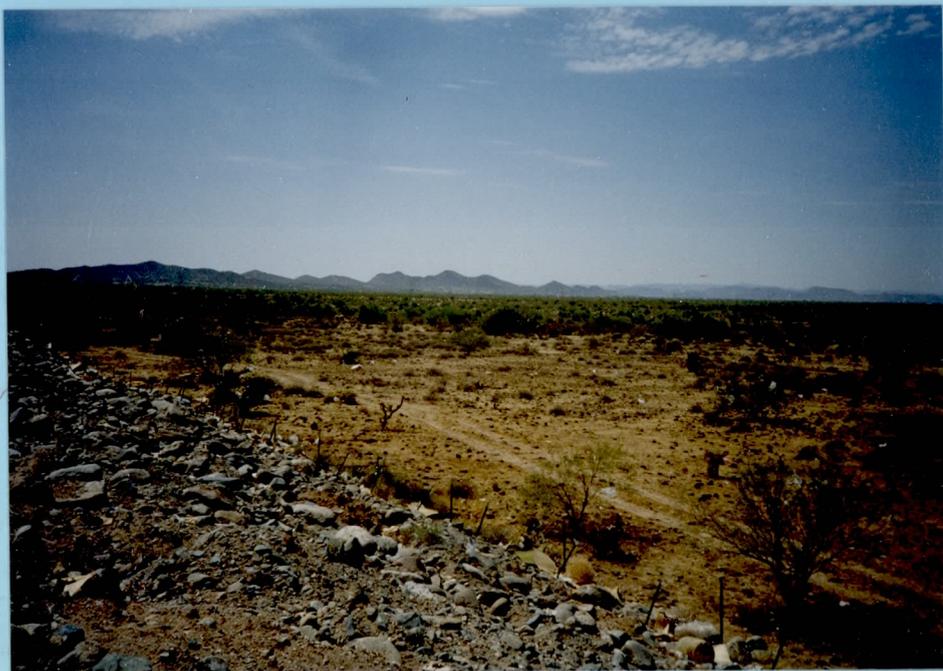
7. Northern boundary berm. Note Cave Creek in background.

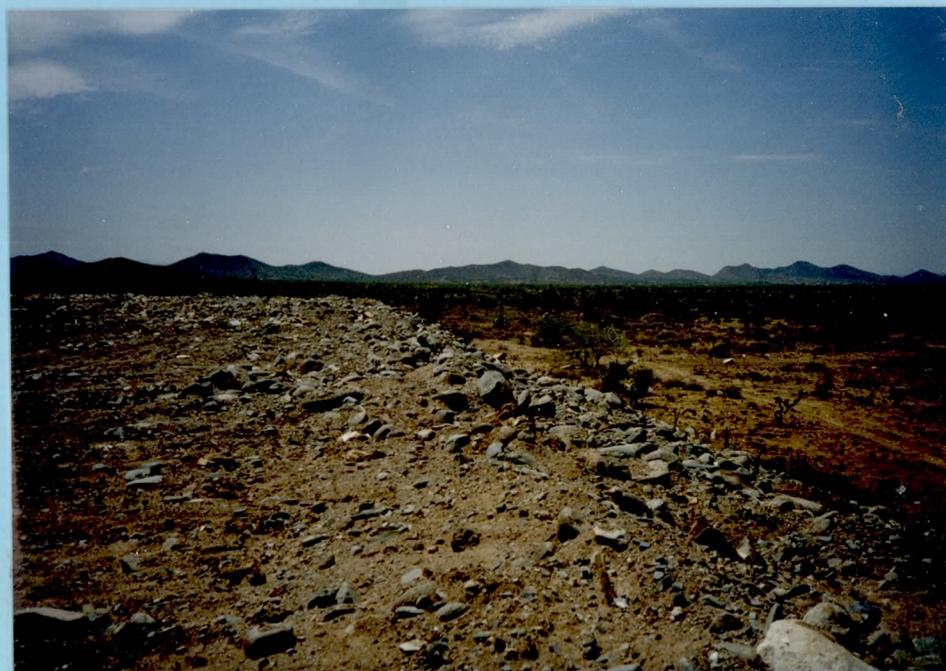
8. Northern boundary berm.

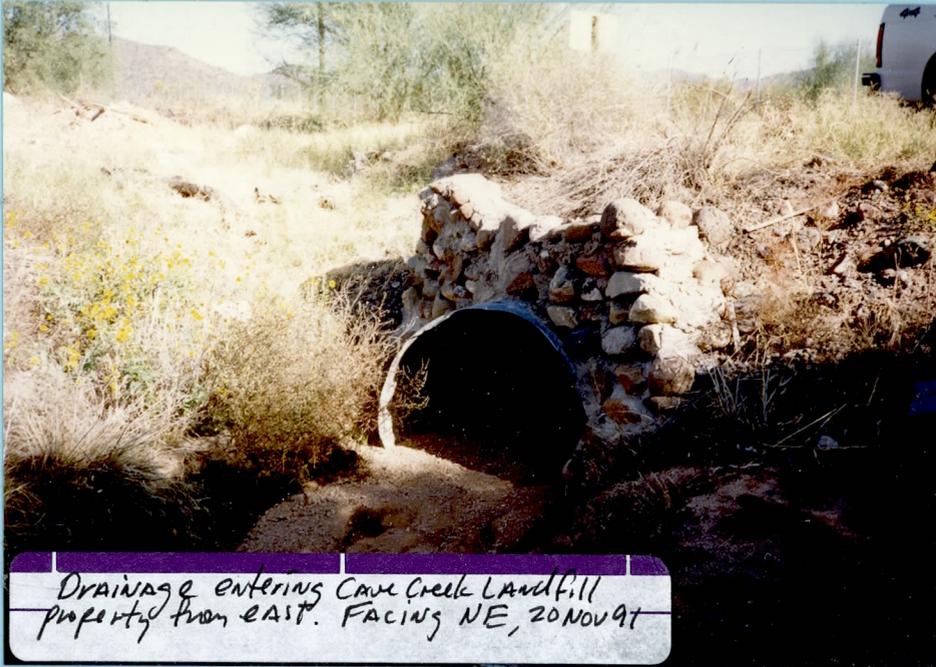
Drainage entering Cave Creek Landfill property from east. Facing NE, 20 Nov 91

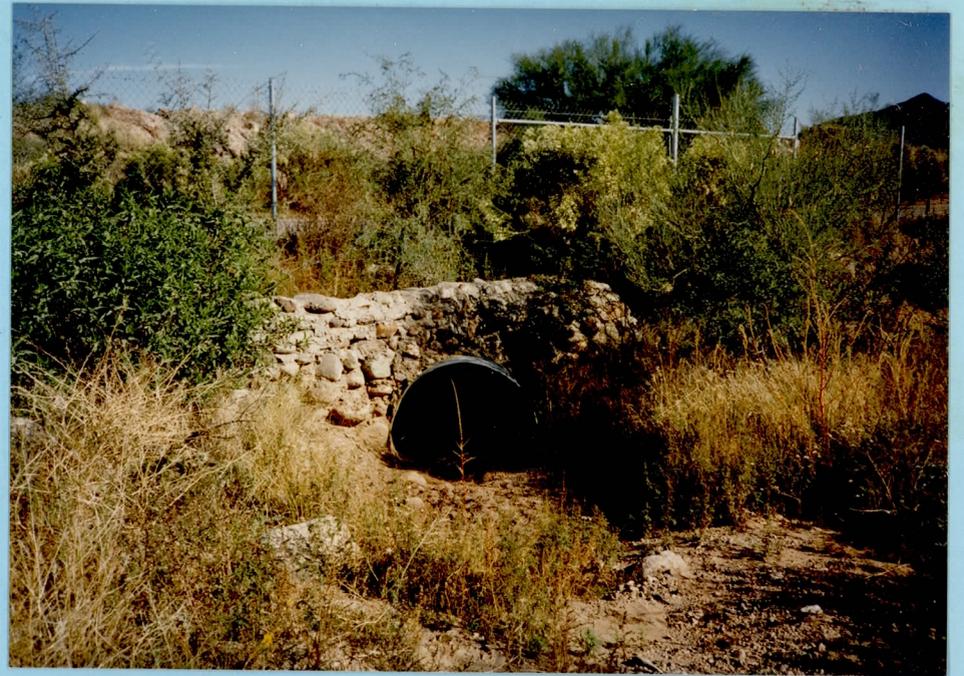
1. off-site drainage into eastern channel, on eastern boundary of closed portion, facing NE

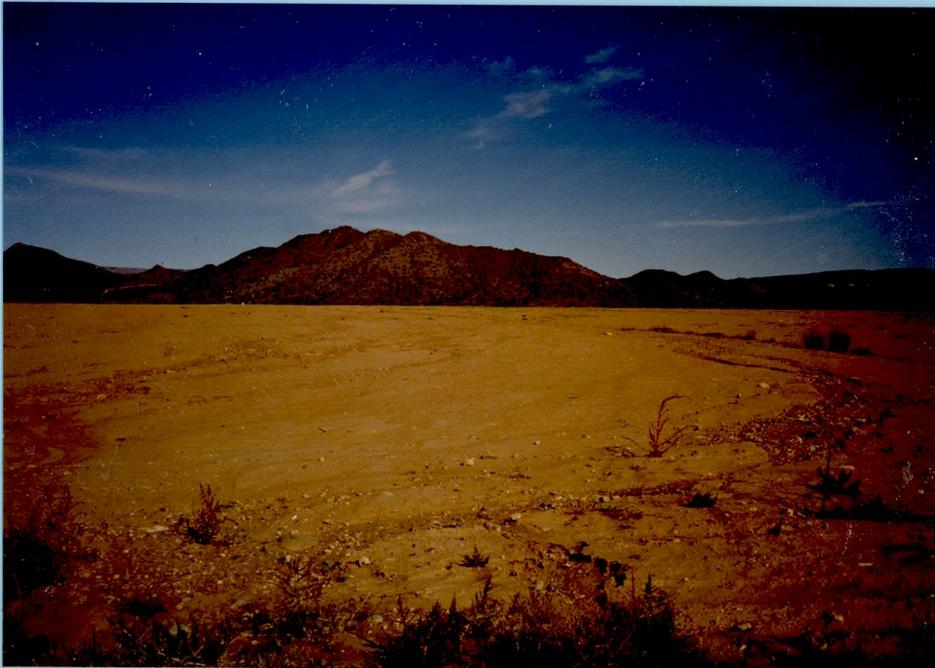
3. top of closed landfill, finished portion

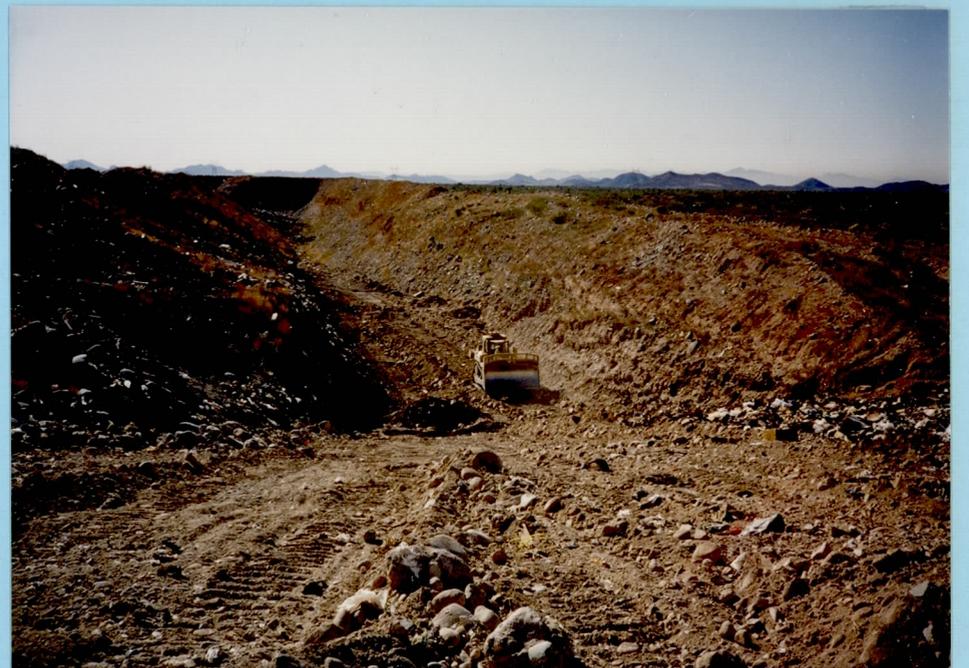
4. active area, facing south

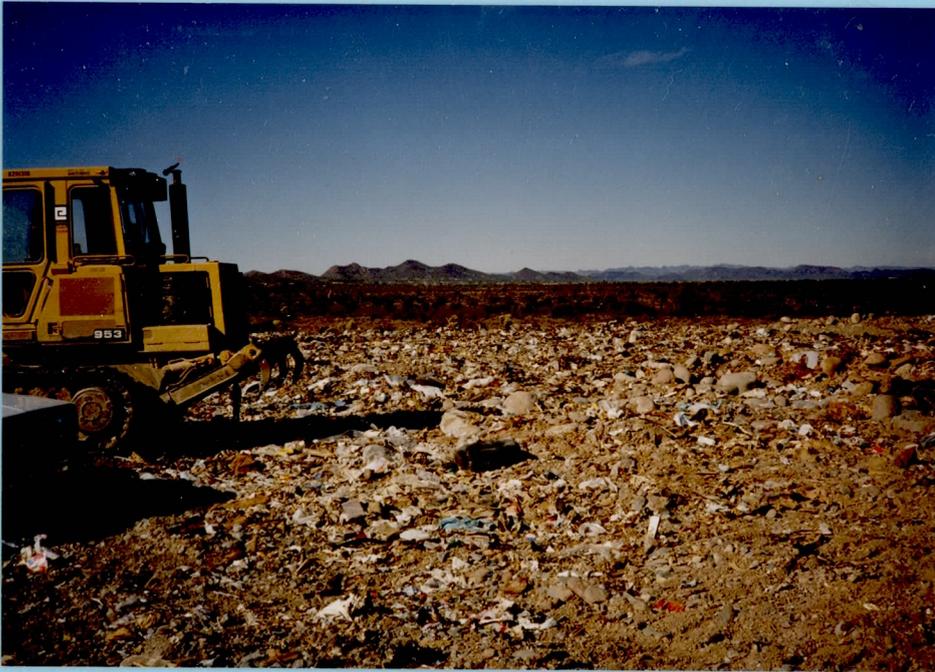
5. area to be covered (6 months), facing west

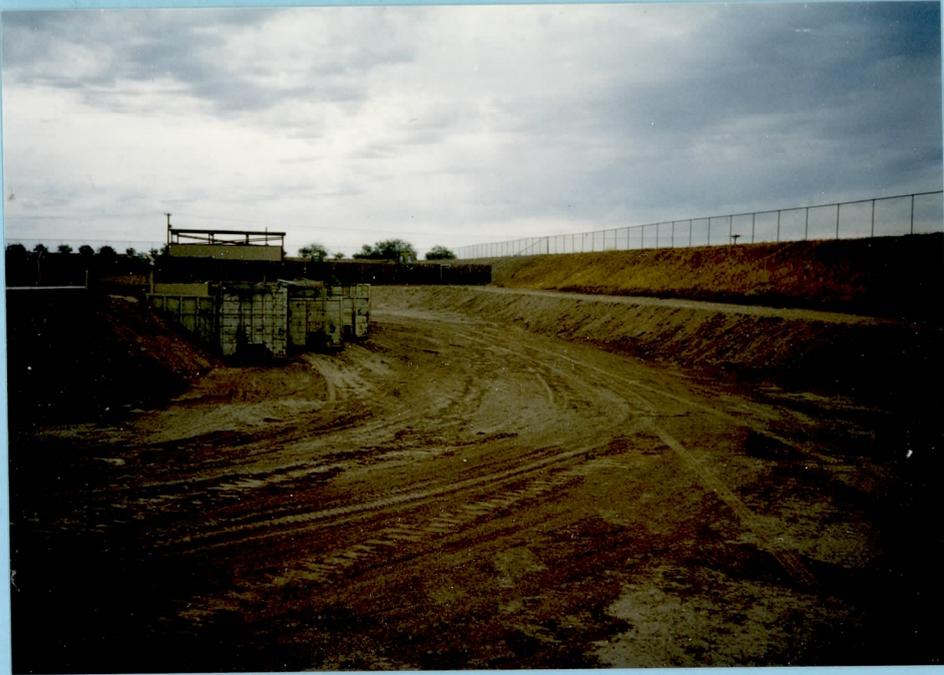
1. Retention basin, south side.

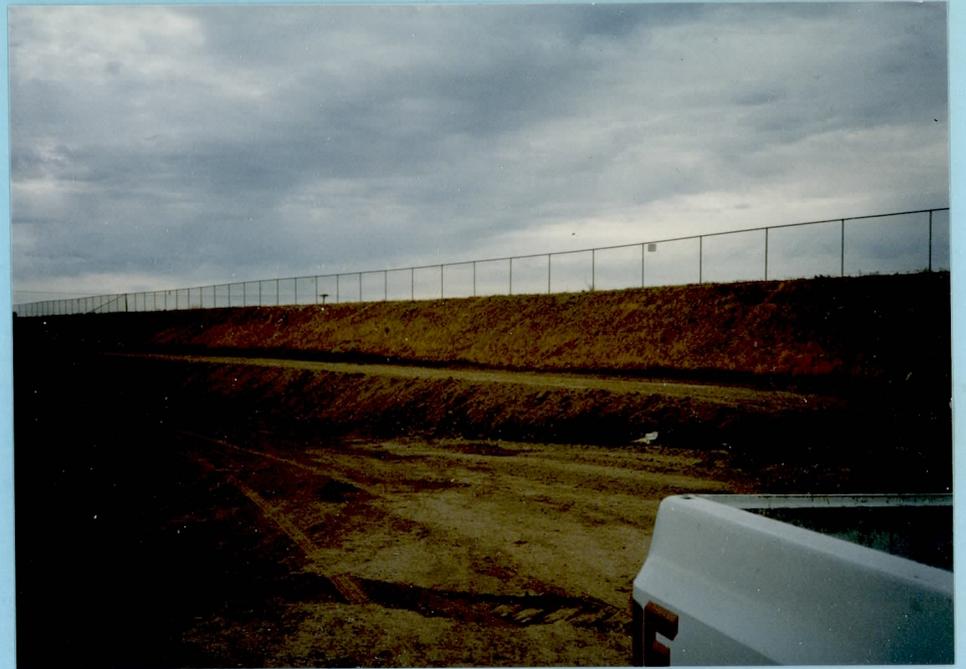
2. Retention basin, north side.

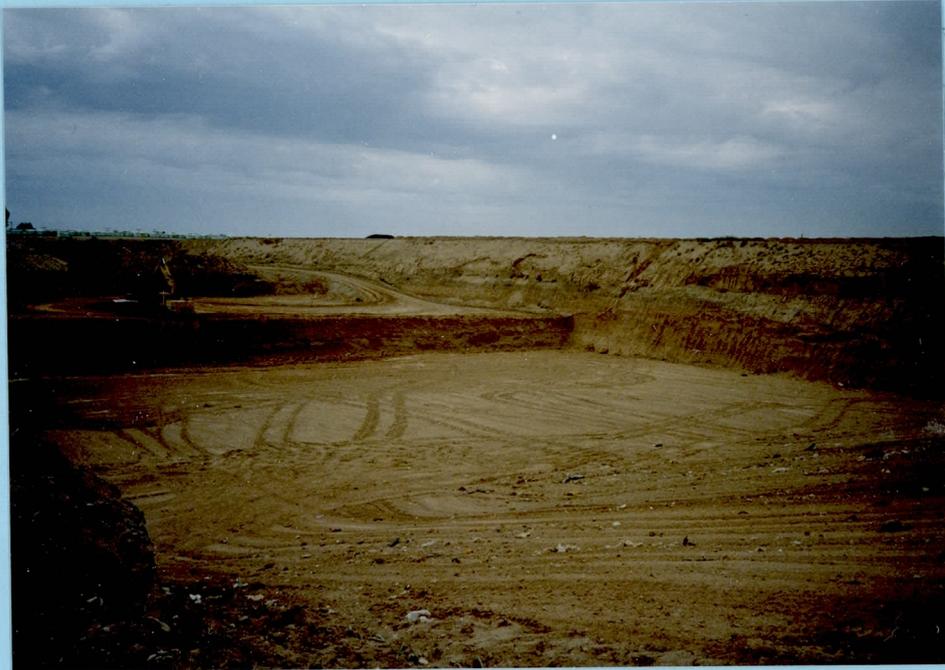
5. Excavation for new cells.

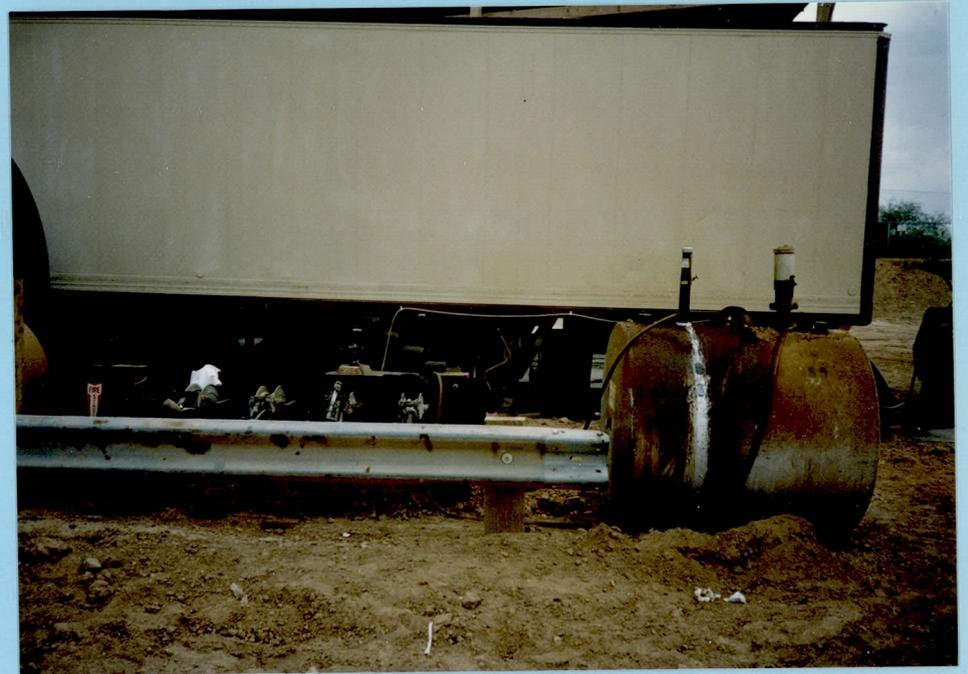
6. Fuel area near entrance.

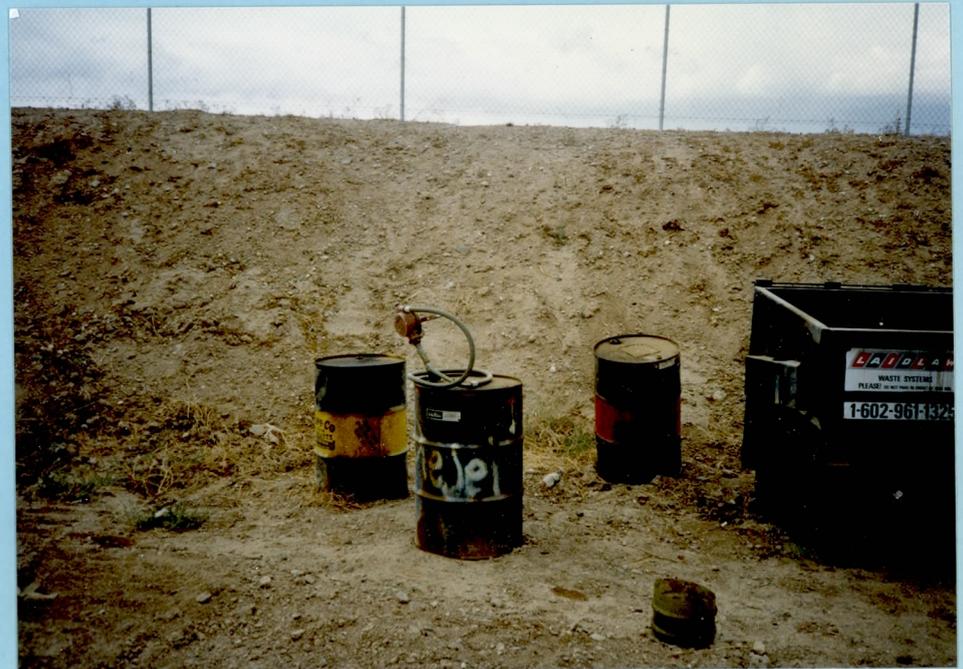
8. Portable fuel tanks.

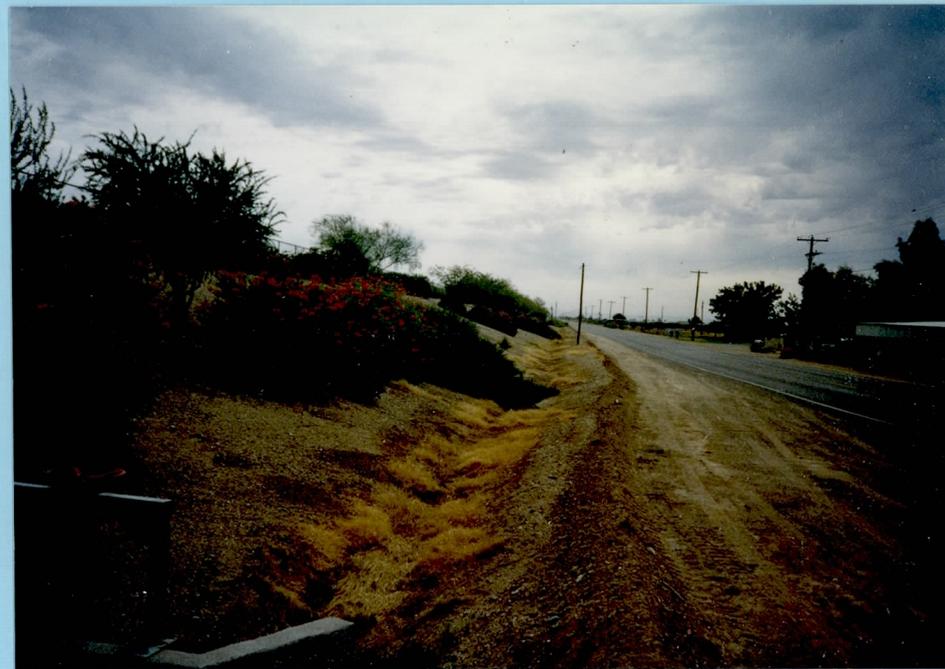
10. Ocotillo Road drainage ditch.

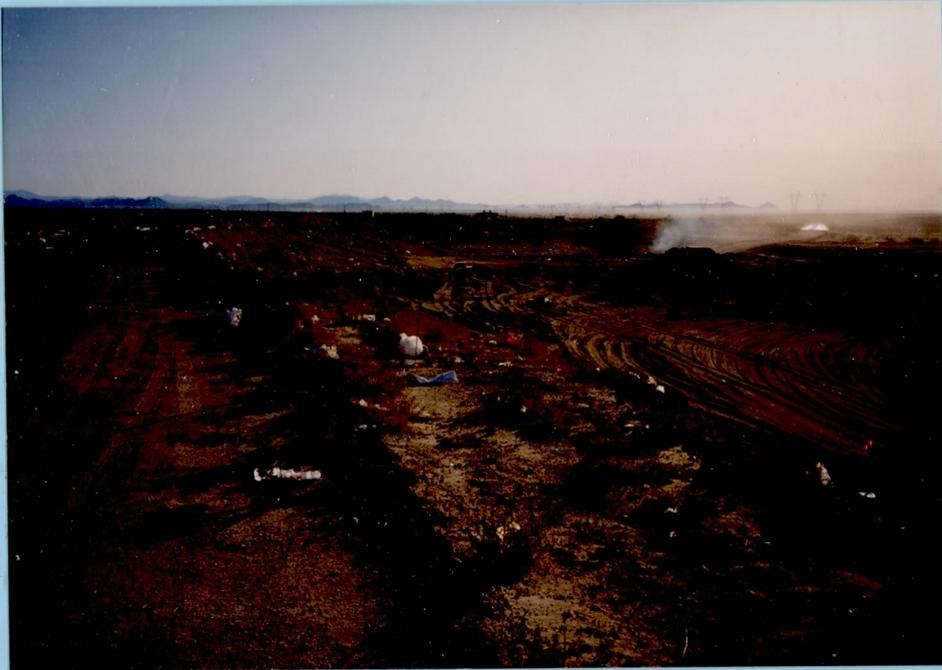
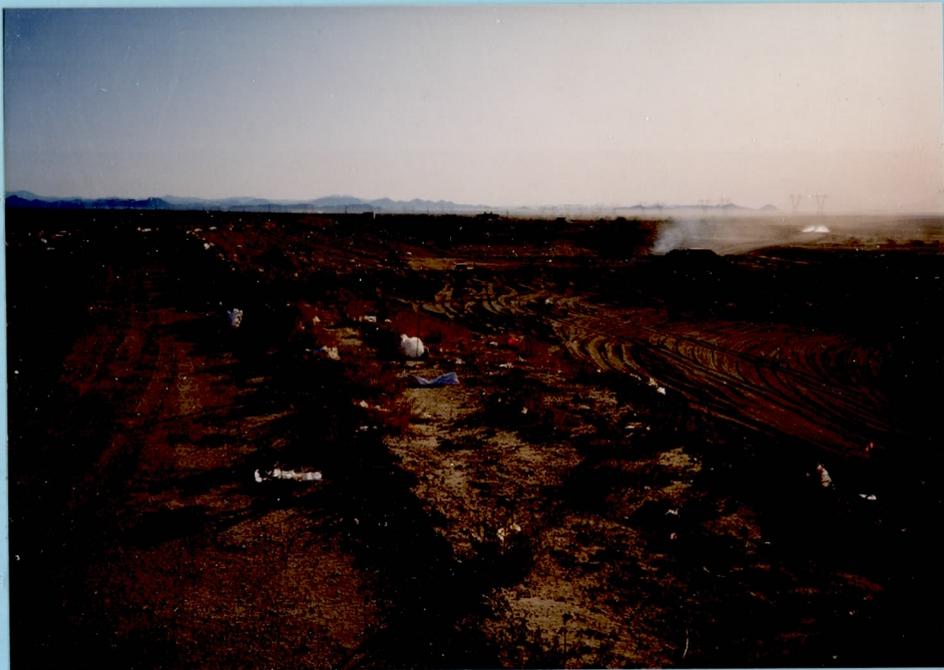
1. top of module facing east

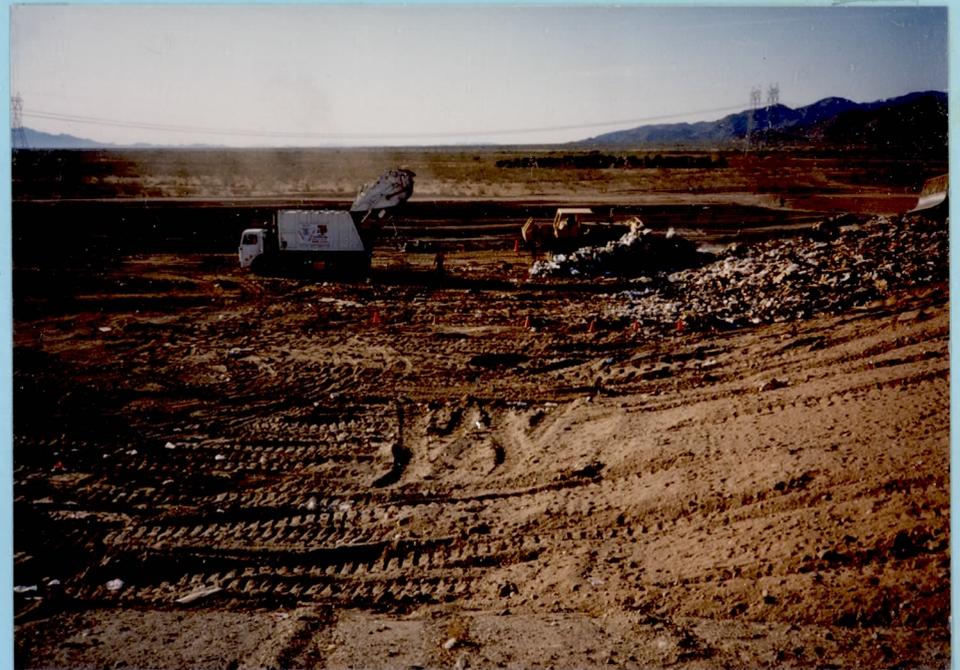
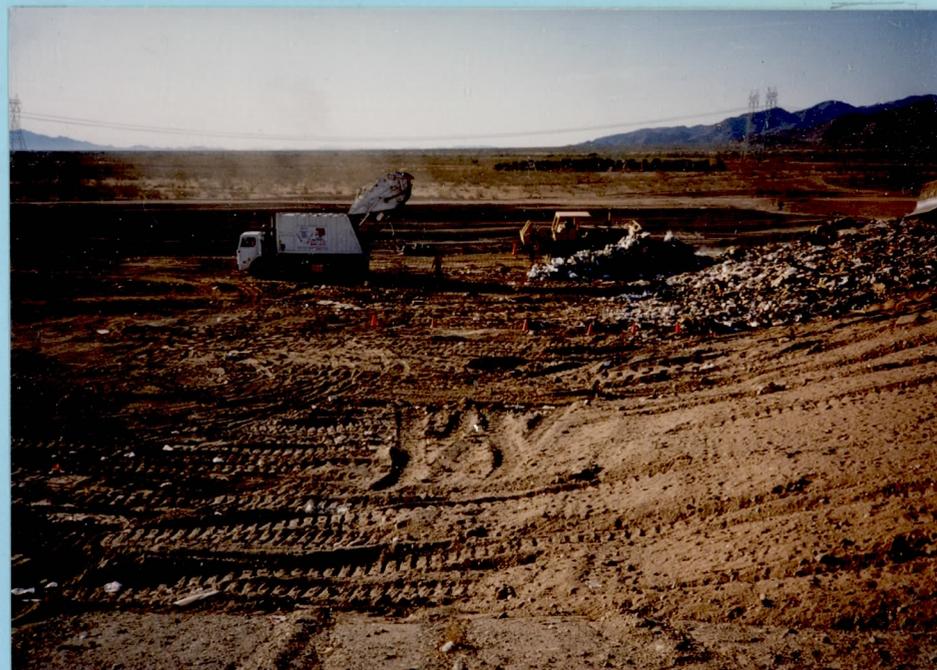
2. the operational area, facing south

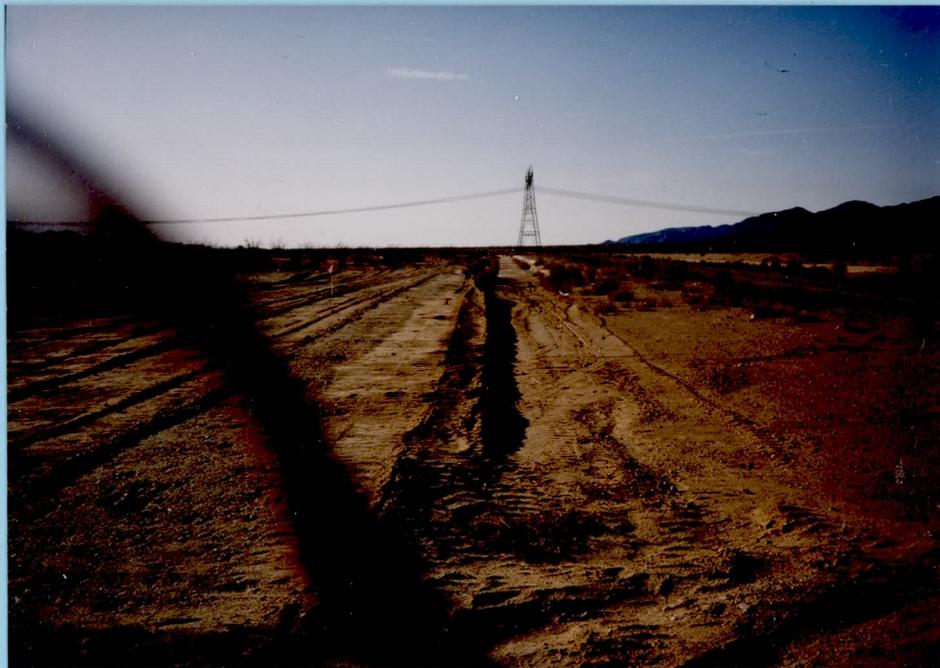
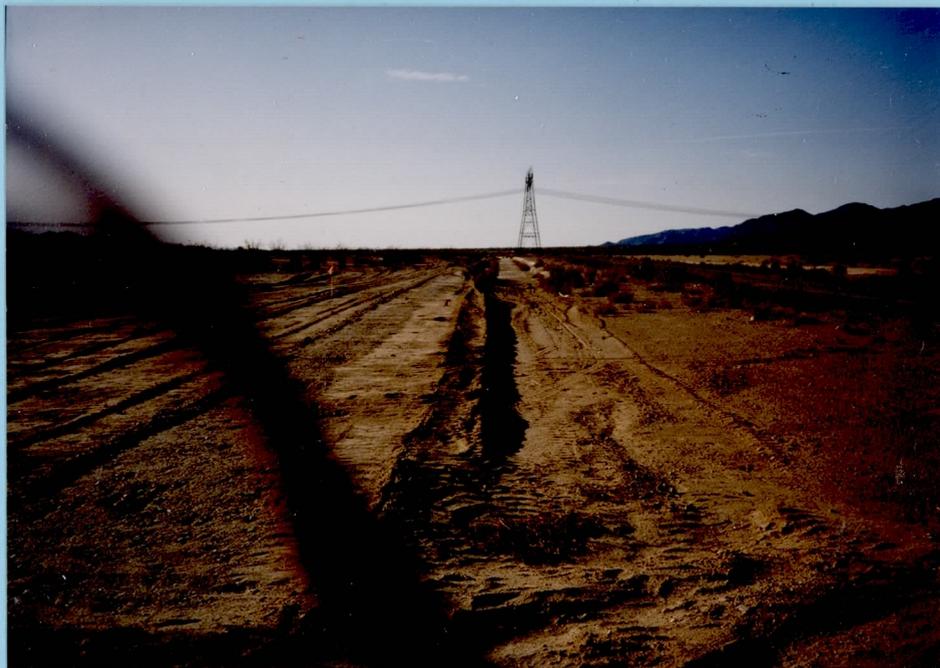
3. on-site drainage, facing south

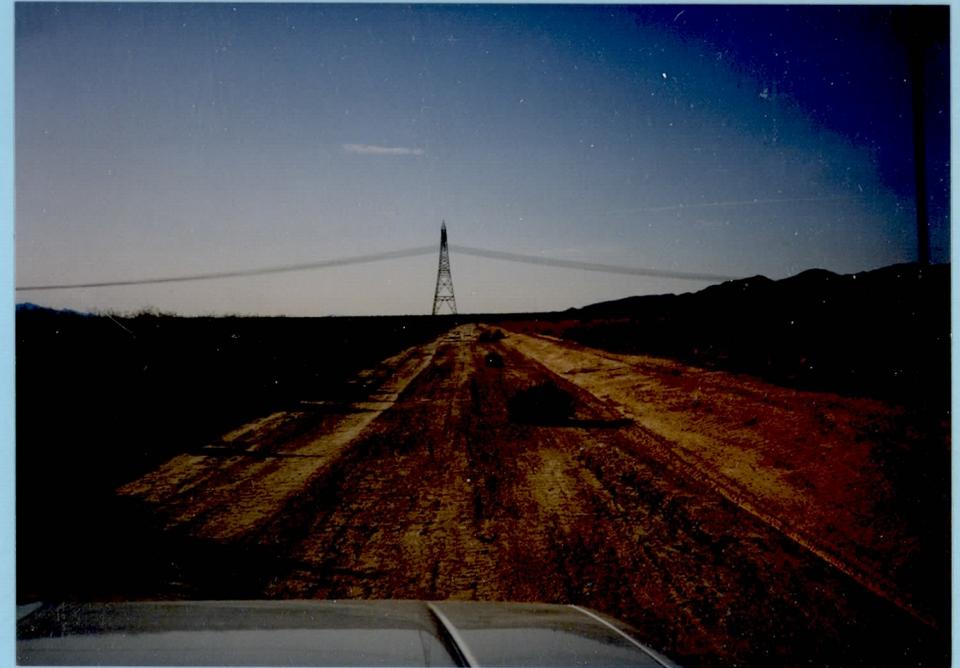
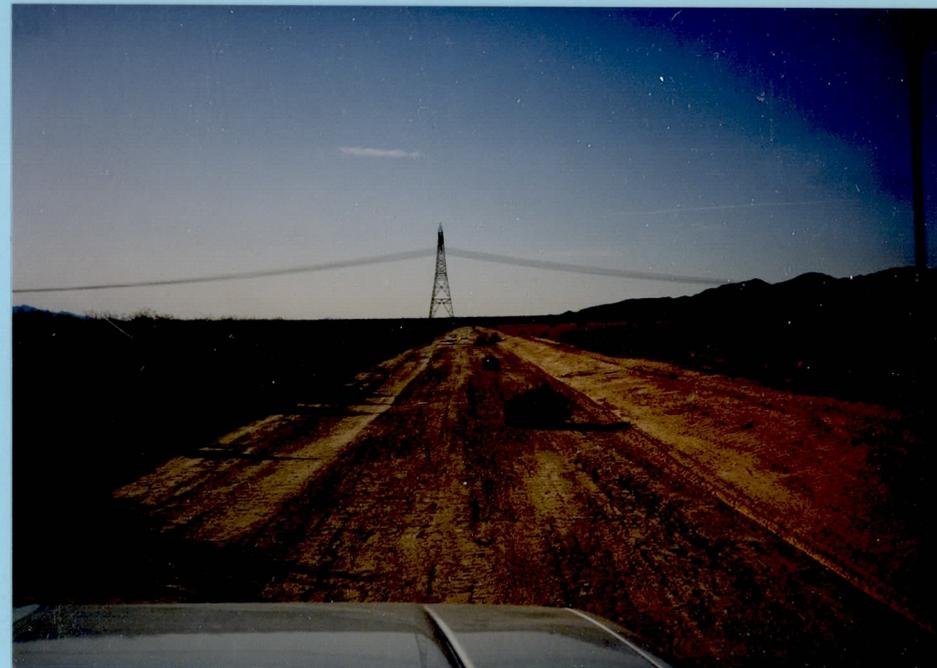
4. off-site drainage, facing south, (parallel to photo #3)

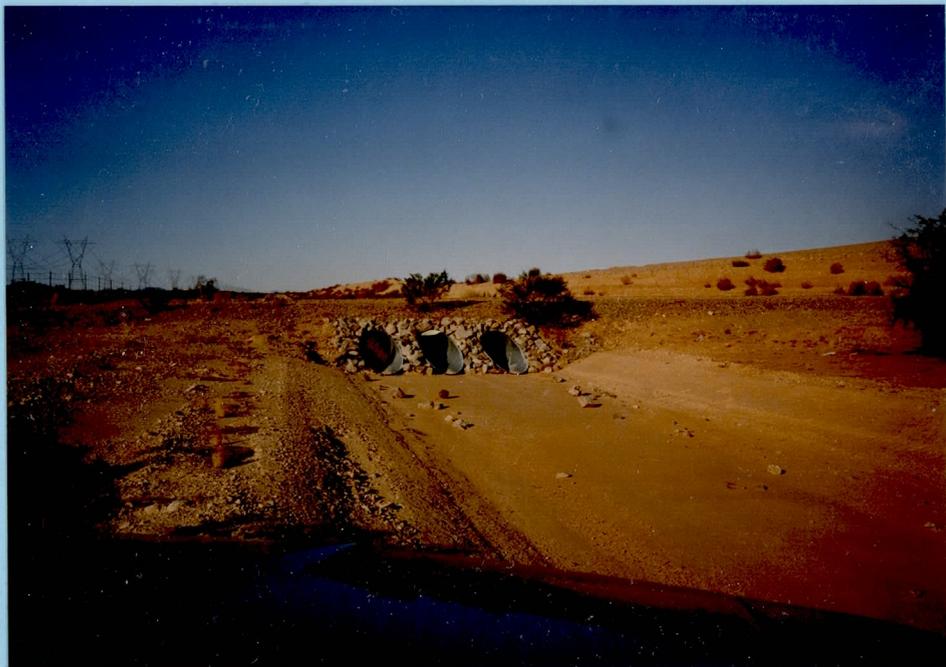
5. pipes at the end of module #1

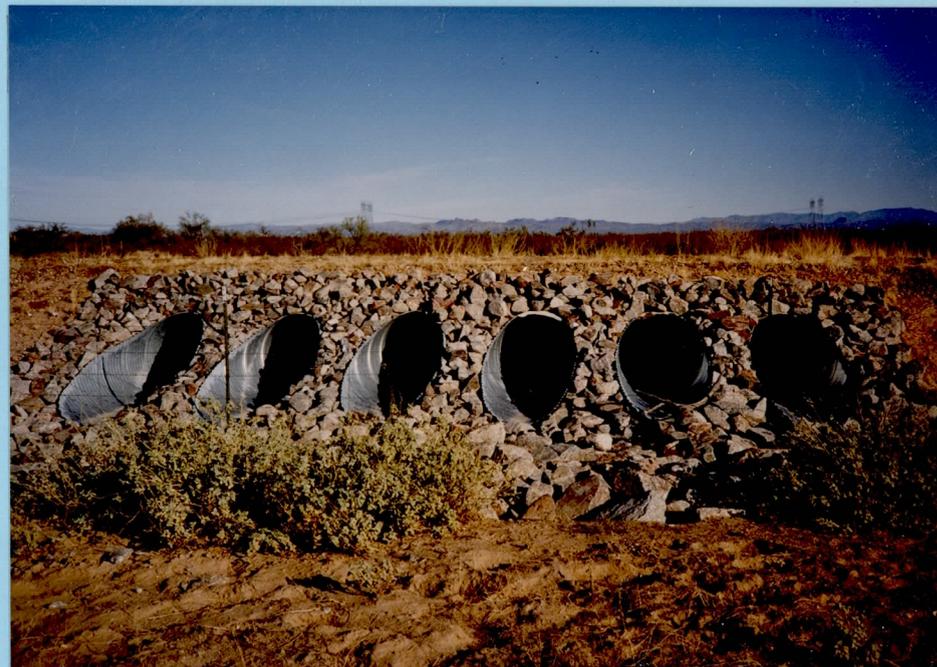
6. Phase 1 area, property outfall that drains (2) west modules

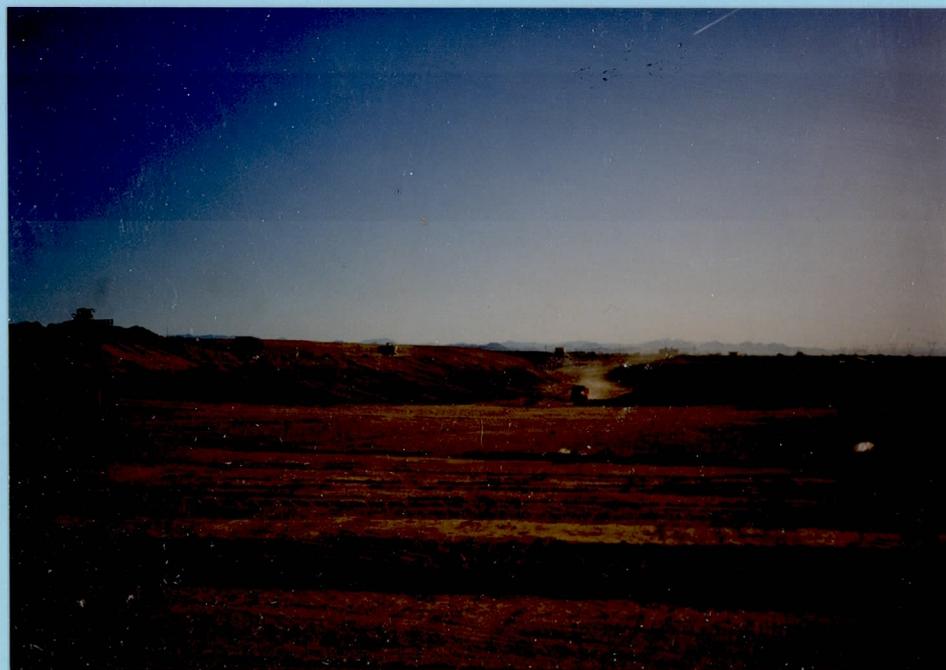
7. active area from the road, facing east

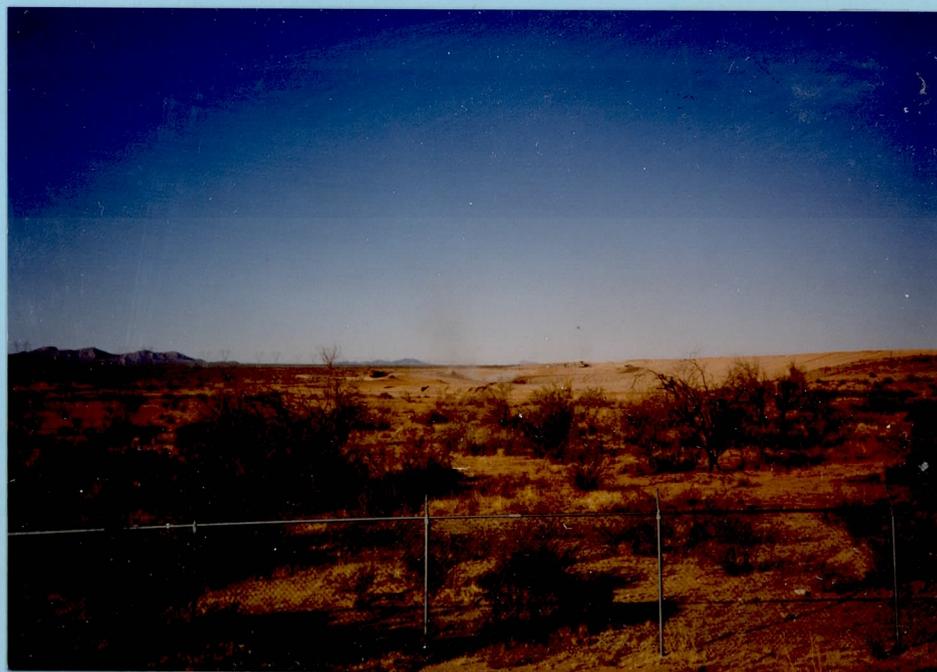
8. east end of active area, facing west
