Flood Control Landfill Photos 1991-92: Wickenburg, Cave Creek, Chandler, Northwest Regional & Morristown

Flood Control District of Maricopa County-FCD

Landfills

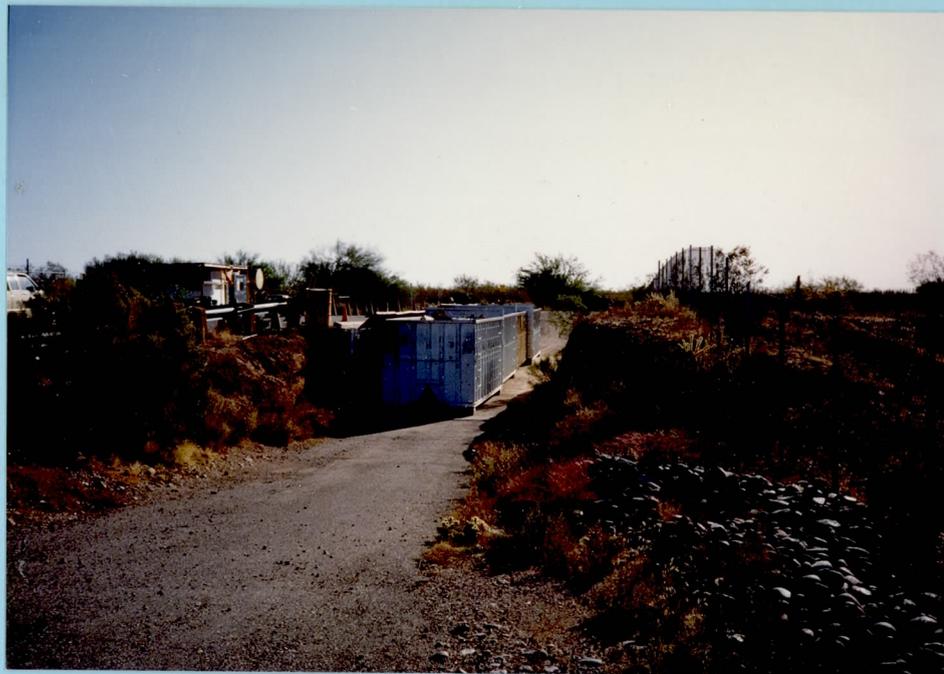
1. inactive landfill and transfer station, facing east

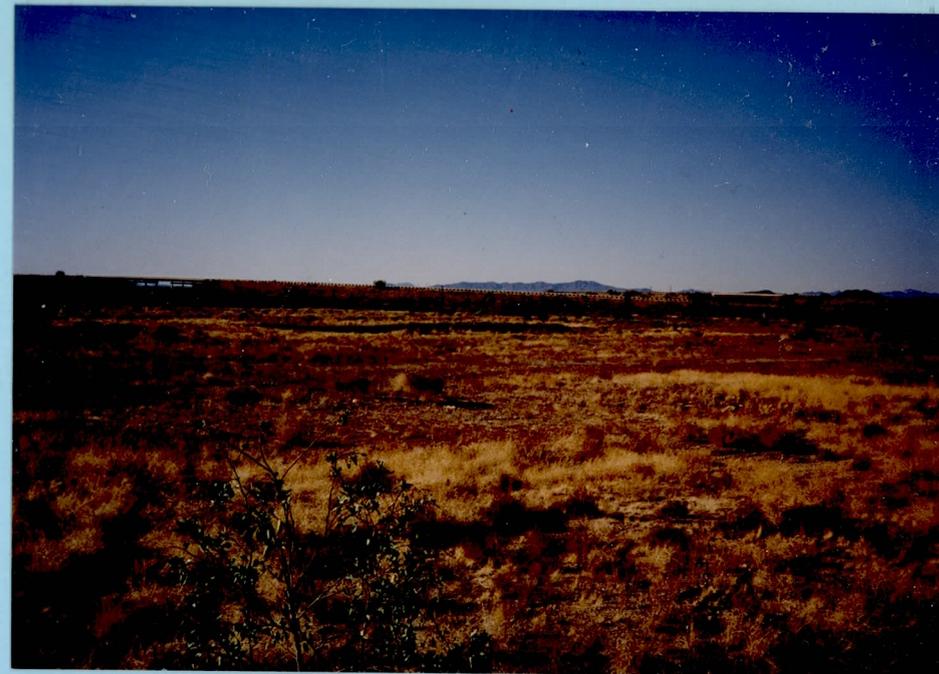
2. inactive landfill, facing ?

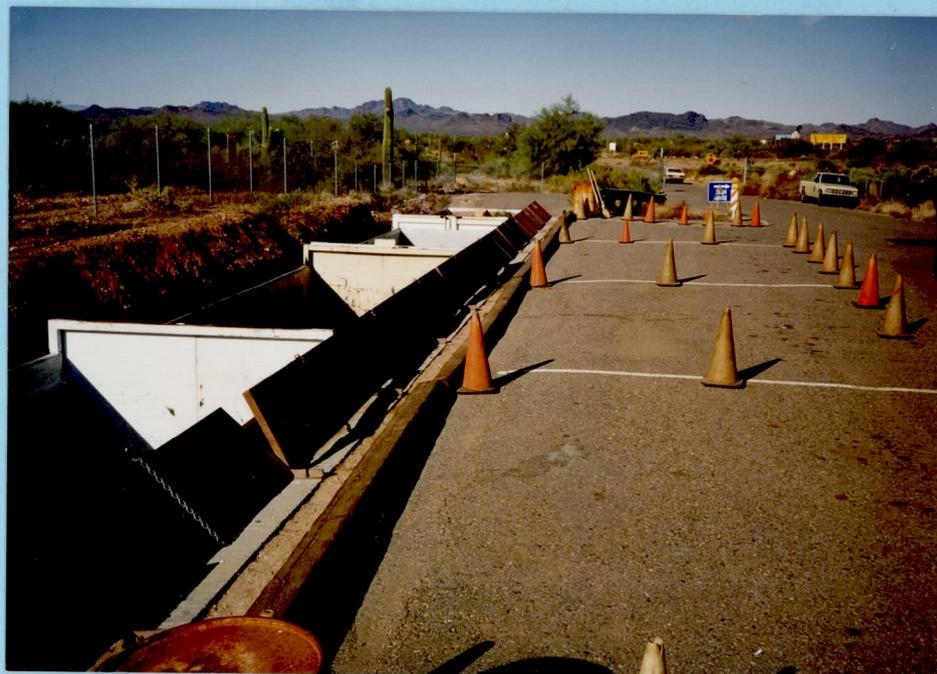
3. transfer station, facing west
