FINAL REPORT TO CONGRESS

**THE STREAMBANK EROSION CONTROL
EVALUATION AND DEMONSTRATION ACT OF 1974
SECTION 32, PUBLIC LAW 93-251**

Appendix E - Missouri River Demonstration Projects

A COMPREHENSIVE SUMMARY REPORT ON TWENTY-EIGHT
STREAMBANK EROSION CONTROL DEMONSTRATION PROJECTS ON
THE MISSOURI RIVER IN THE THREE REACHES: GARRISON DAM
TO LAKE OAHE, FT. RANDALL DAM TO NIOBRARA, AND GAVINS
POINT DAM TO PONCA

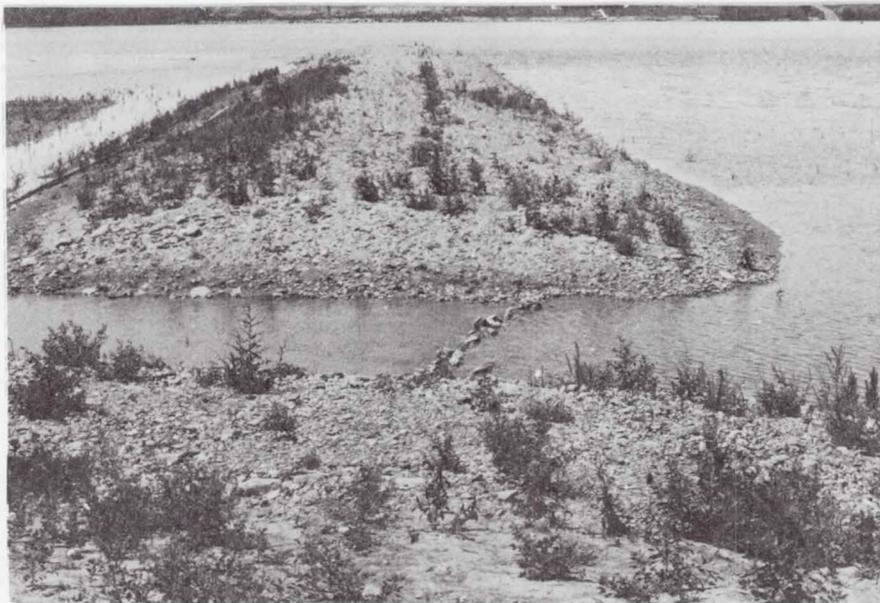
Photo 32. Dike 1320.8, with environmental gap shown in the foreground, approximately 9 months after completion. (Photo taken 18 July 1960)

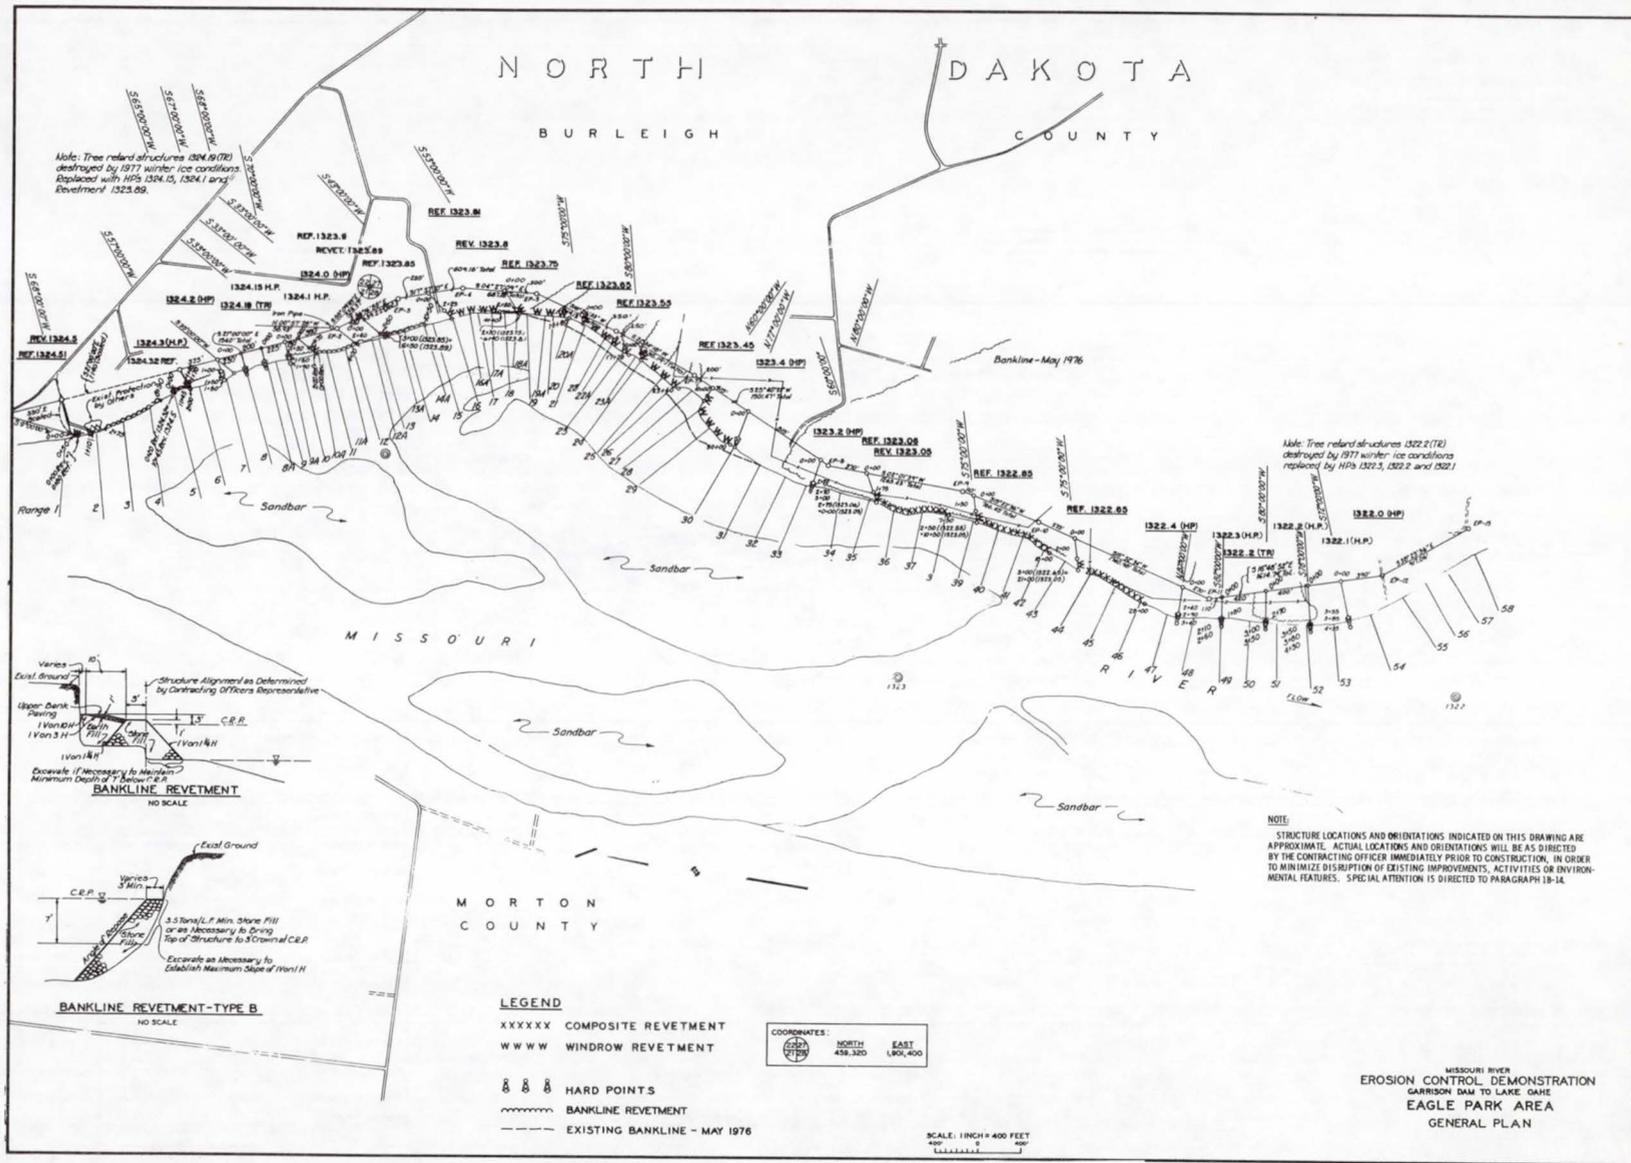
Note: Tree retard structures (1324.0/172) destroyed by 1977 winter ice conditions. Replaced with HPs 1324.15, 1324.1 and Revetment 1323.89.

Note: Tree retard structures (1322.1/72) destroyed by 1977 winter ice conditions replaced by HPs 1322.3, 1322.2 and 1322.1

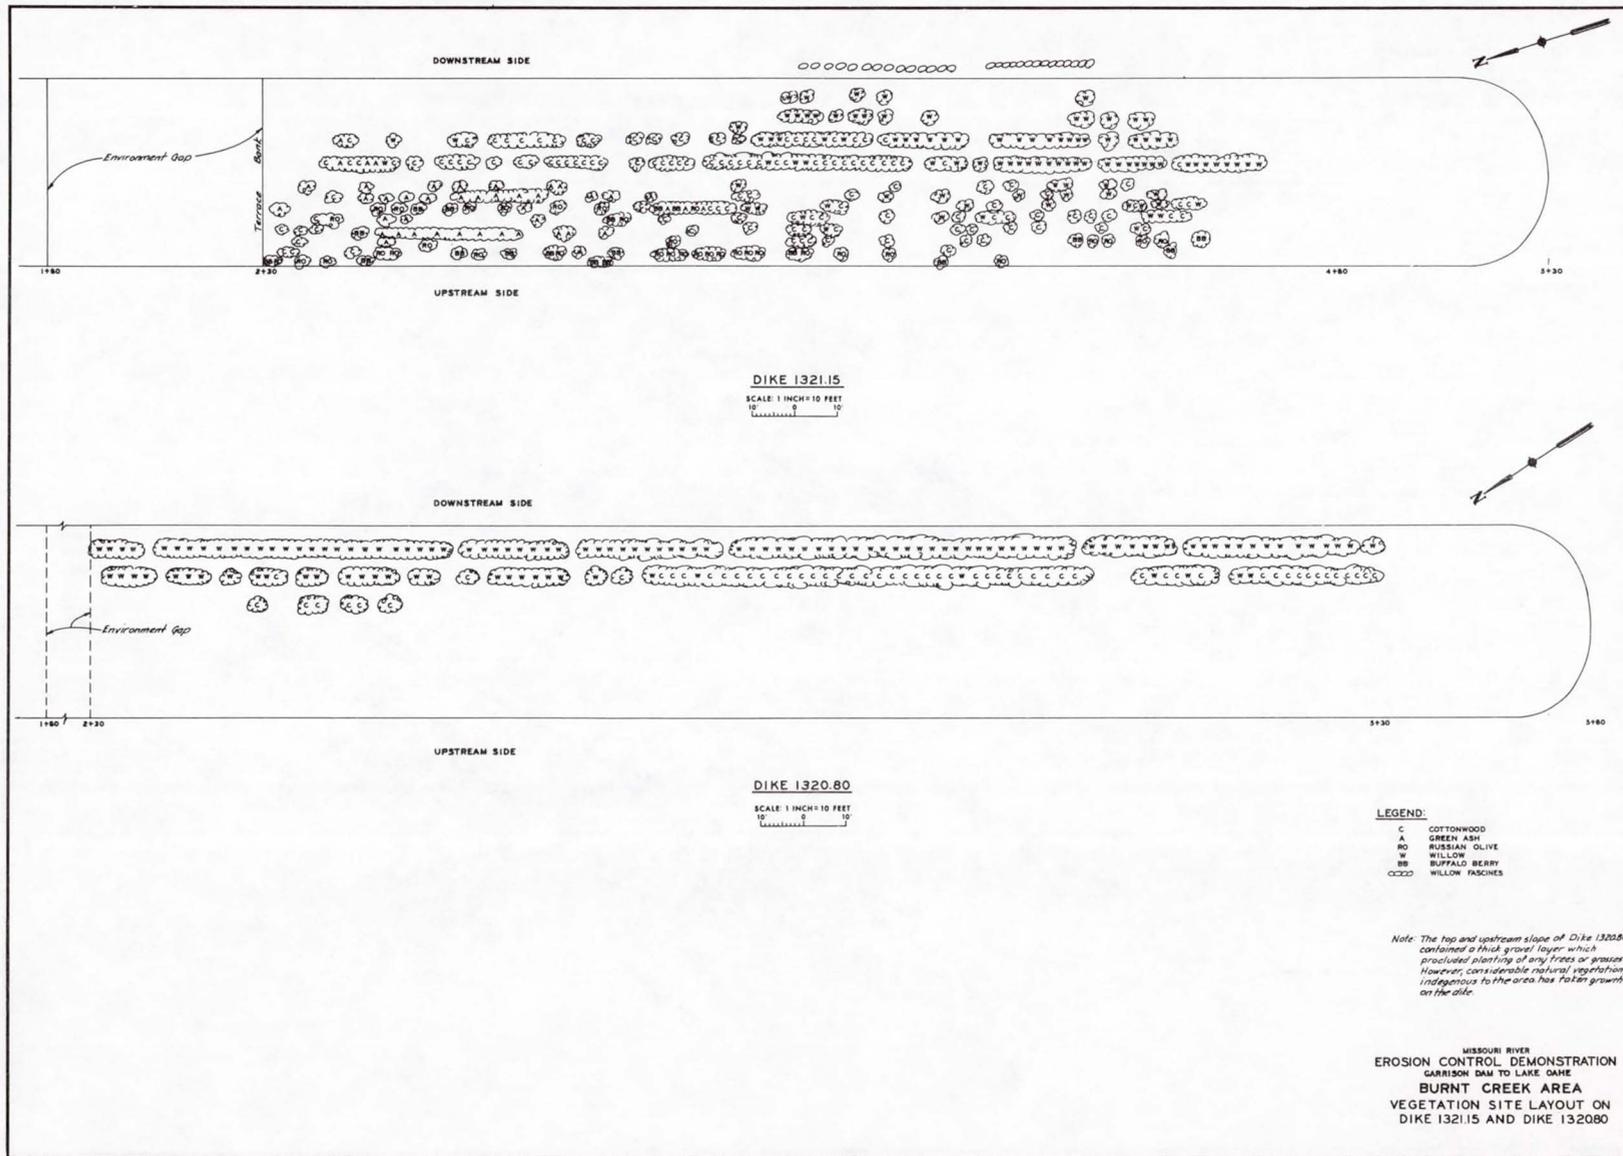
Note: The top and upstream slope of Dike 1320.80 contained a thick grass layer which precluded planting of any trees or grasses. However, considerable natural vegetation, indigenous to the area, has taken ground on the dike.

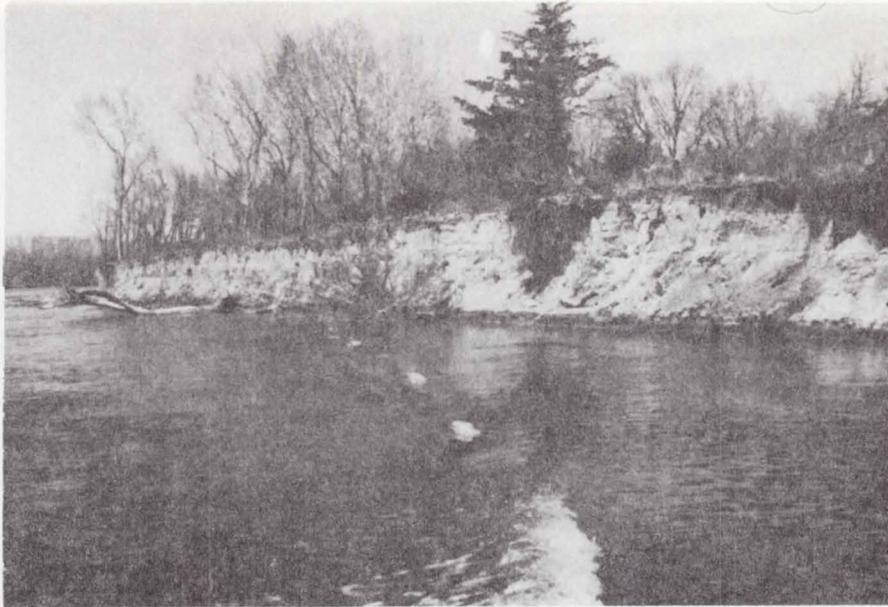
**PHOTO 3. TYPICAL SEVERE EROSION CONDITIONS ALONG
UPSTREAM PORTION OF THE PROJECT AREA.
(Photo Taken 15 April 1980)**

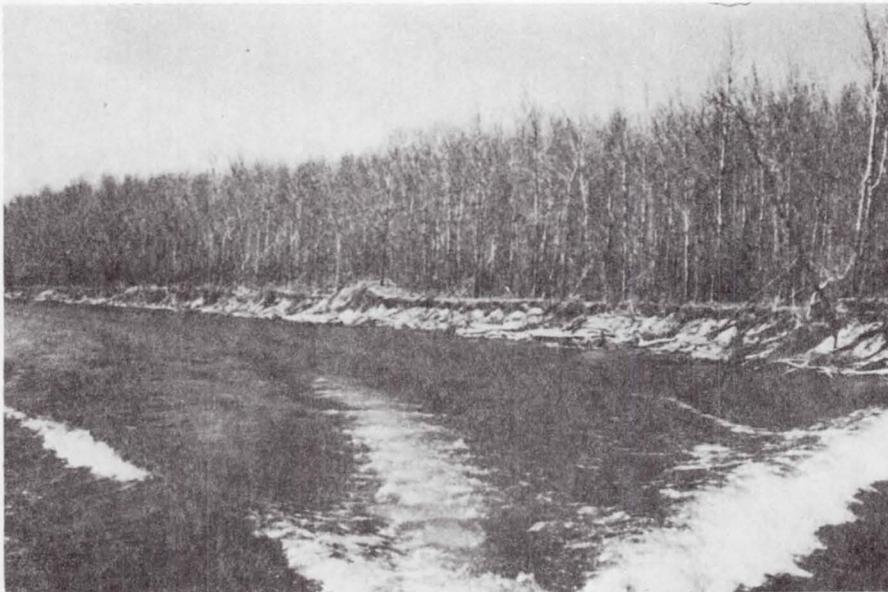
**PHOTO 4. TYPICAL SEVERE EROSION CONDITIONS ALONG THE
DOWNSTREAM PORTION OF THE PROJECT AREA. THIS
BANKLINE WILL CONTAIN HARDPOINTS.
(Photo Taken 15 April 1980)**
