**US Army Corps  
of Engineers**

# FINAL REPORT TO CONGRESS

**THE STREAMBANK EROSION CONTROL  
EVALUATION AND DEMONSTRATION ACT OF 1974  
SECTION 32, PUBLIC LAW 93-251**

## APPENDIX H EVALUATION OF EXISTING PROJECTS

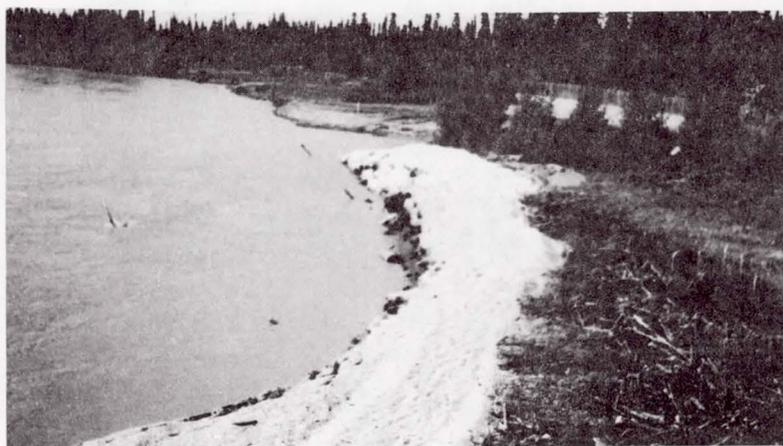
4 June 1979, river discharge is 30,200 cfs, riverbank still frozen, erosion progressing rapidly

Exhibit 3. Ice revetment, Tanana River, Alaska (failure)

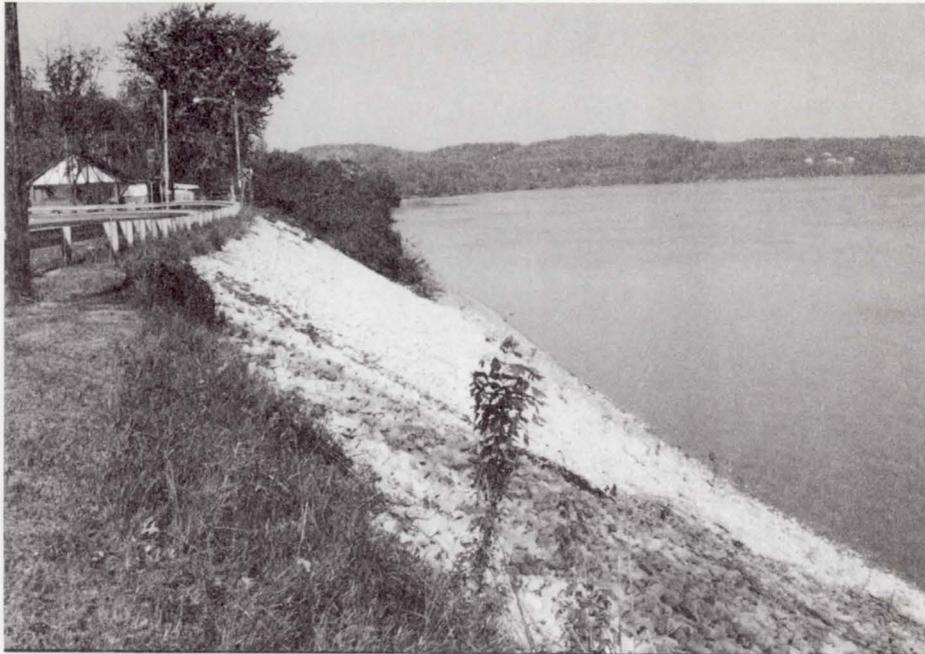
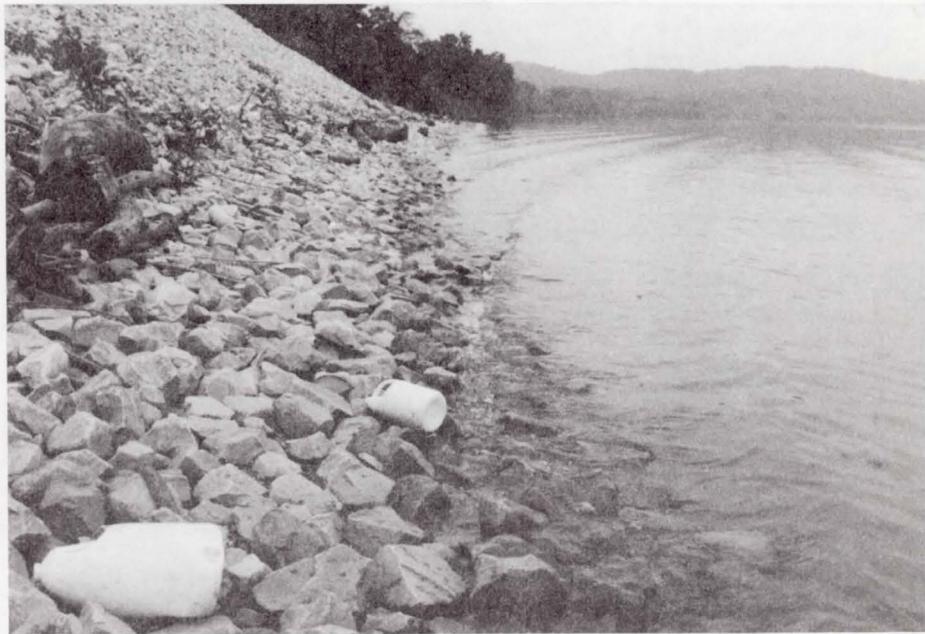
Typical riprap revetment, constructed by the Corps of Engineers  
(successful)

Exhibit 4. Ohio River (left bank) at Cloverport, Kentucky. Downstream  
view shows toe of revetment under wave attack due to passing barge  
traffic (19 June 1978)

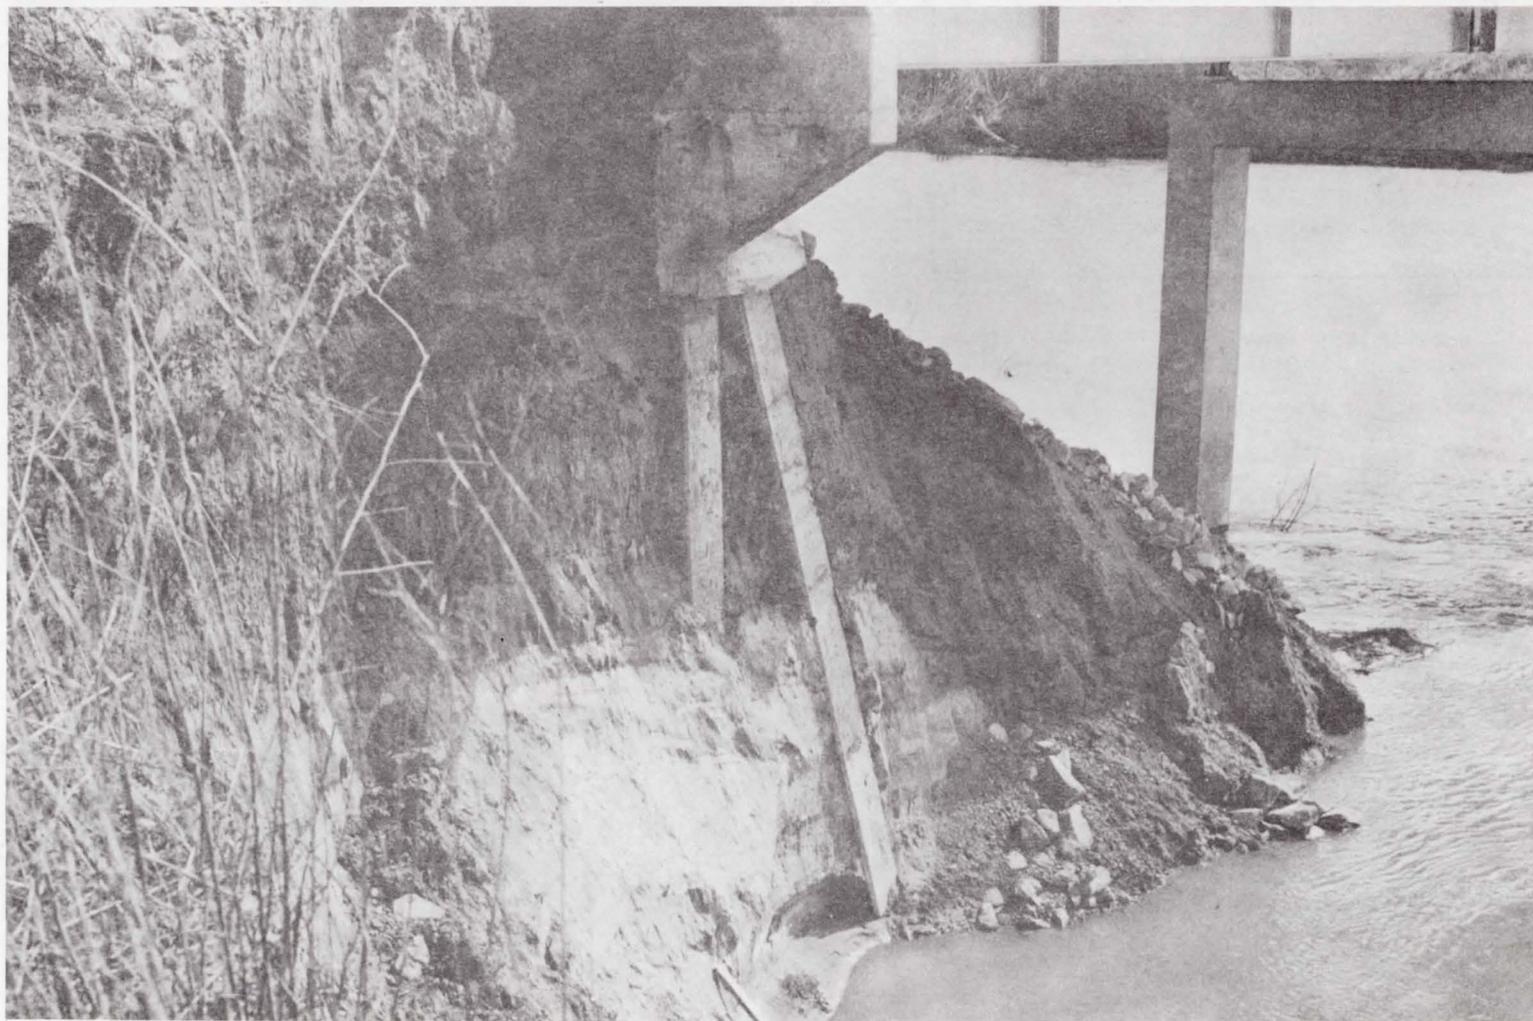
BEFORE CONSTRUCTION (1963)

Scour pocket where active caving was endangering downstream side of west abutment of County Bridge No. 1, Clarks Corner Cutoff, St. Francis Basin Project.

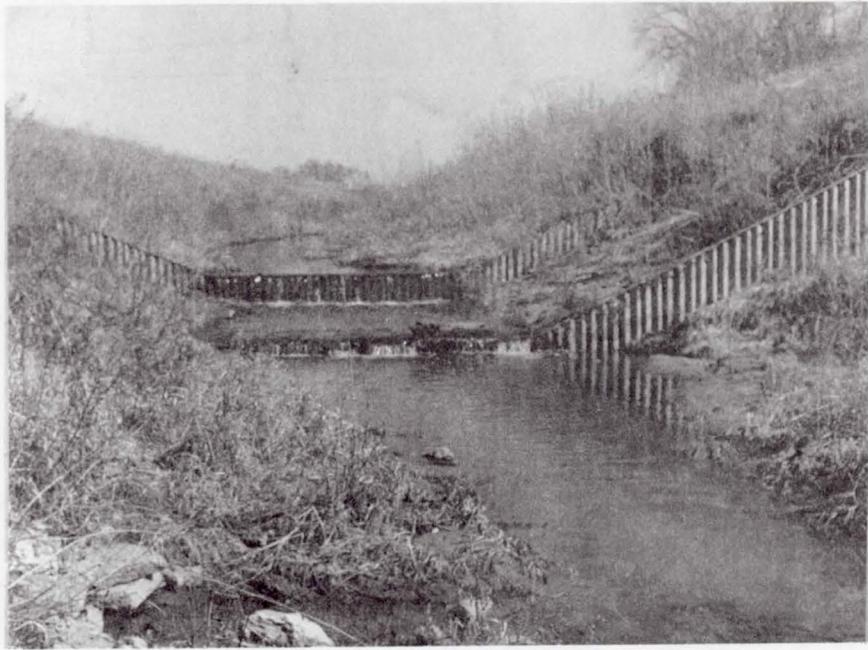
Figure 6. Little Timber Creek at Frankfort, Kansas.  
Ditch check condition as of 10 March 1981.

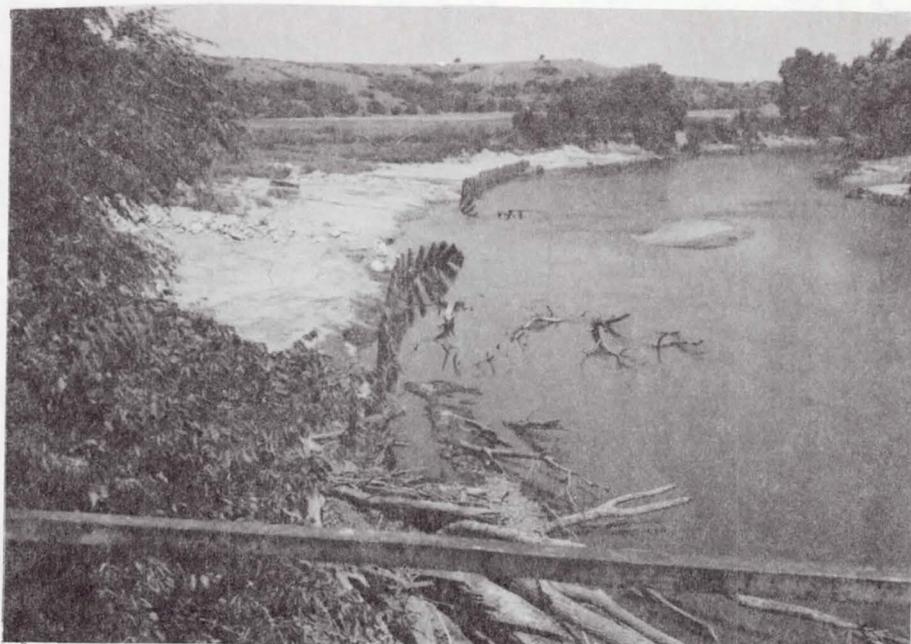
Figure 3. Big Blue River near Marysville, Kans. High flows in July 1978 undermined a section of the fence causing it to fail. This photograph was taken from the Schroyer Bridge (15 August 1978)

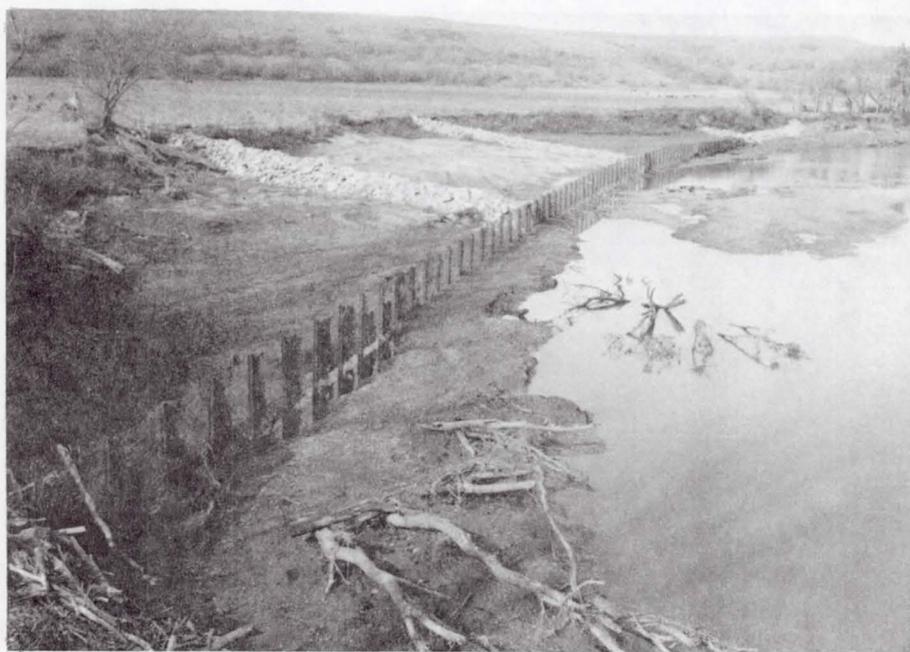
Figure 4. Big Blue River near Marysville, Kans. Upstream view from Schroyer Bridge following high flows in August 1977.

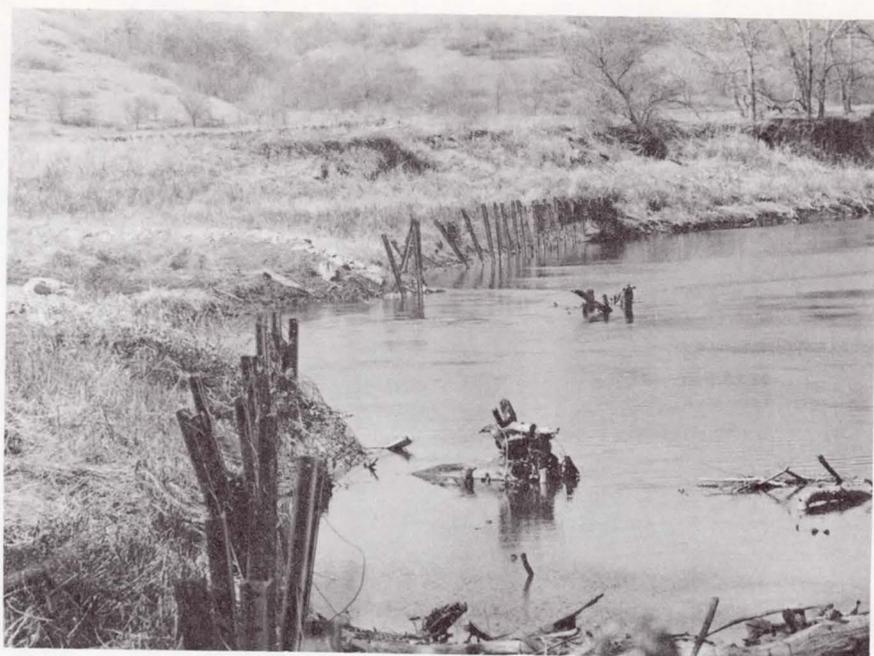
Figure 5. Big Blue River near Marysville, Kans. Condition as of 10 March 1981. View is upstream from former location of the Schroyer Bridge.

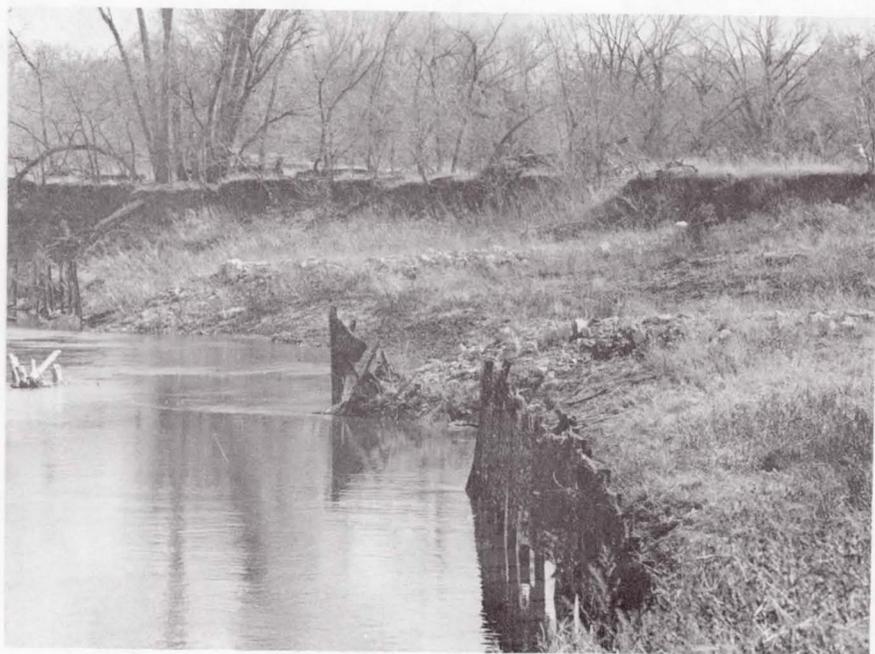
Figure 6. Big Blue River near Marysville, Kans. Condition as of 10 March 1981. View is downstream from upper end of stone fill revetment. Note fill and vegetation.

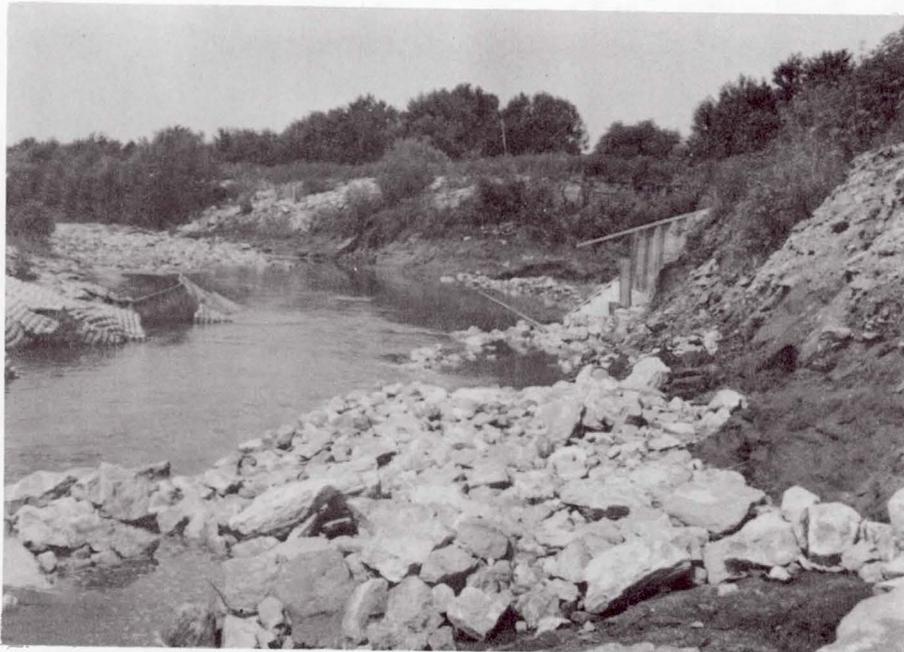
Figure 13. 102 River (East Fork) at Bedford, Iowa. Failure of drop structure at sta 61+60 (March 1979). Note damaged Fabriform mattress in left portion of view.

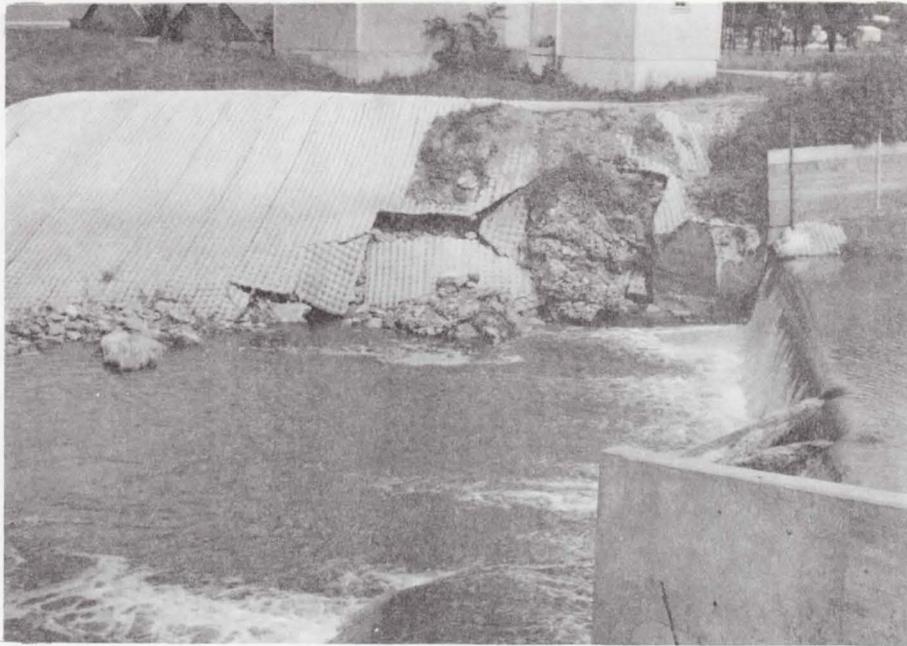
Figure 14. 102 River (East Fork) at Bedford, Iowa. An inspection at the Bedford Water Treatment Plant in March 1979 indicated that a large cavity had formed under the mattress, which collapsed.

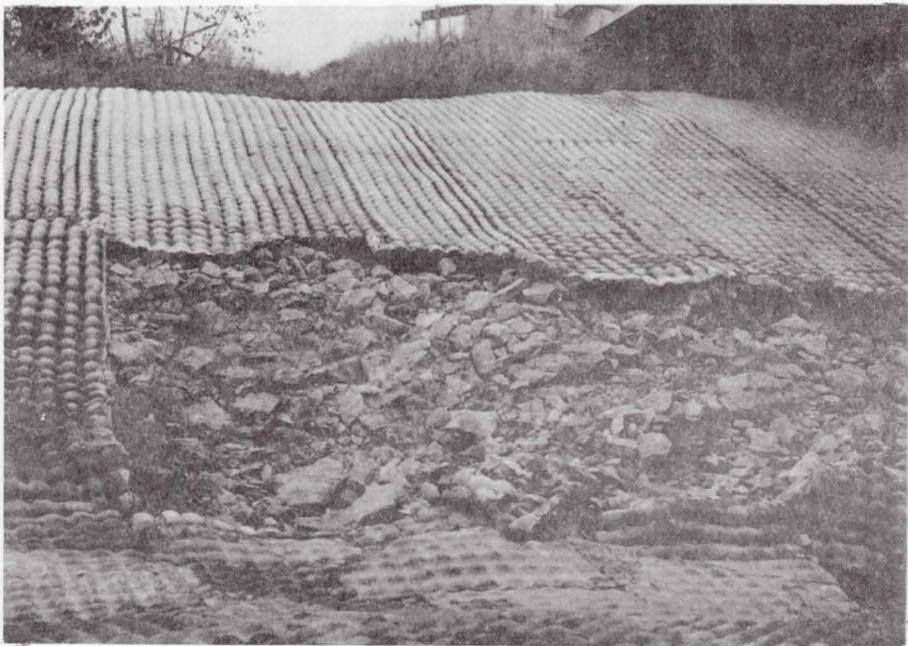
Figure 15. 102 River (East Fork) at Bedford, Iowa. View of damaged Fabriform revetment upstream of the State Street Bridge.

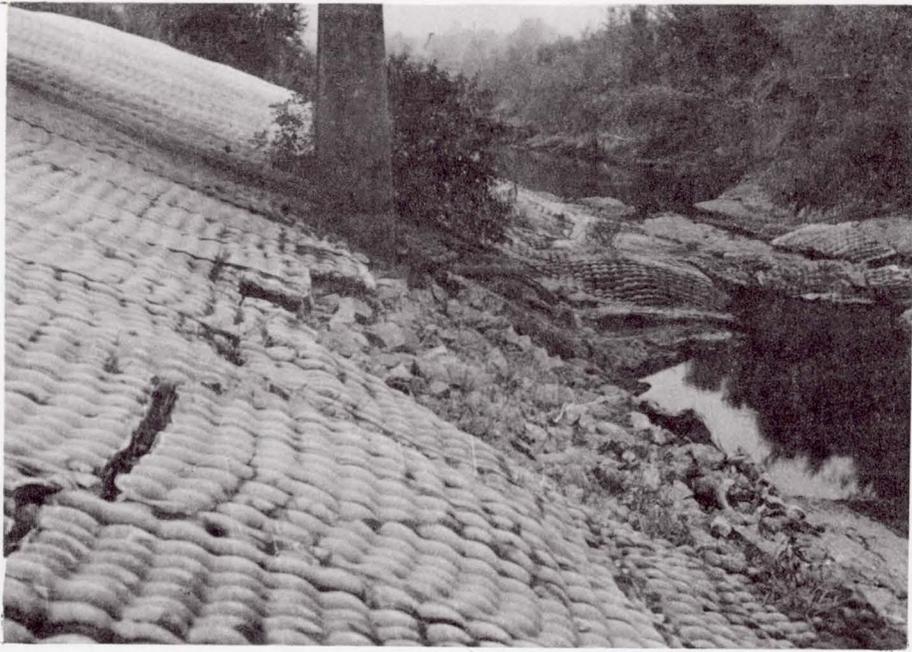
Figure 16. 102 River (East Fork) at Bedford, Iowa. View of damaged Fabriform revetment upstream of the State Street Bridge.

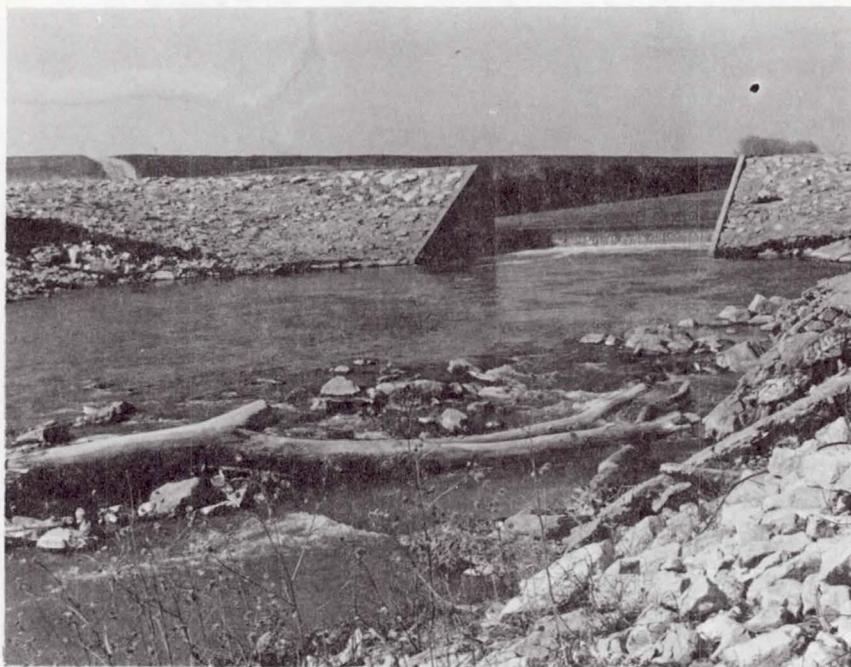
Figure 3. Little Sioux River at Onawa, Iowa. Damage to the stilling basin riprap as a result of high flows in April 1965 required the placement of grouted derrick stone to repair the basin

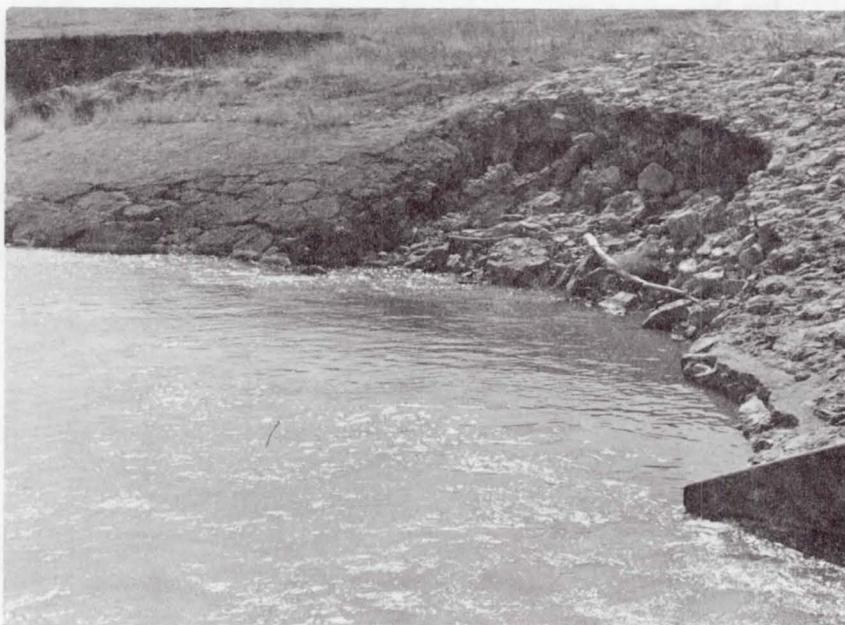
Figure 4. Little Sioux River at Onawa, Iowa. Toe failure of right-bank grouted stone section (20 September 1978)

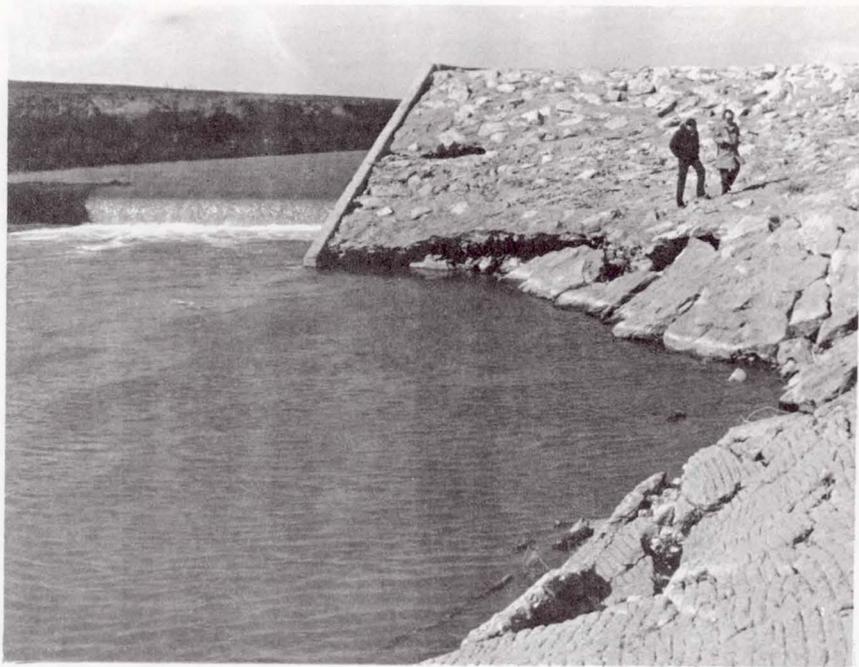
Figure 5. Little Sioux River at Onawa, Iowa. Loss of grout on left-bank mattress

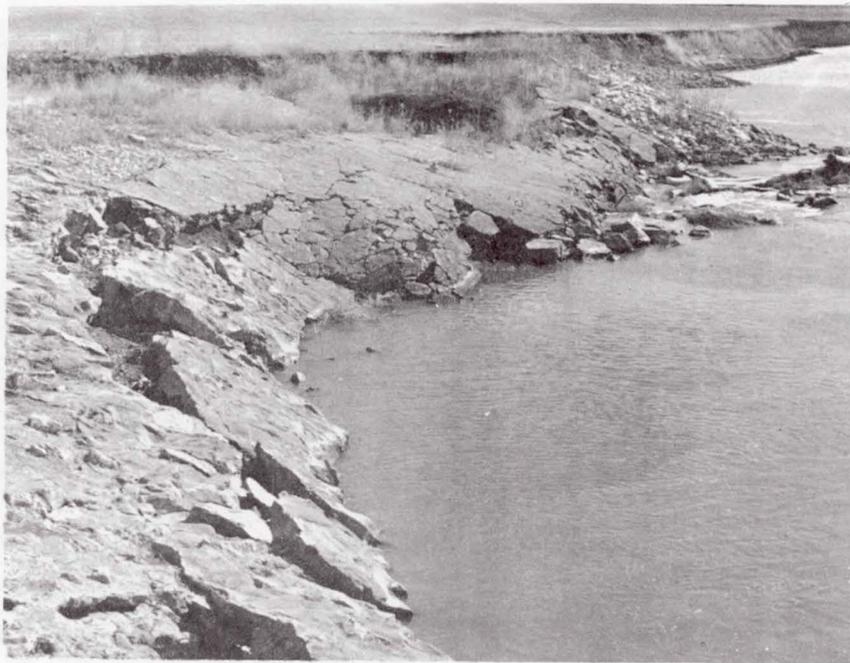
Figure 6. Little Sioux River at Onawa, Iowa. Part of the left-bank mattress failed under its own weight, due to scour under the mattress

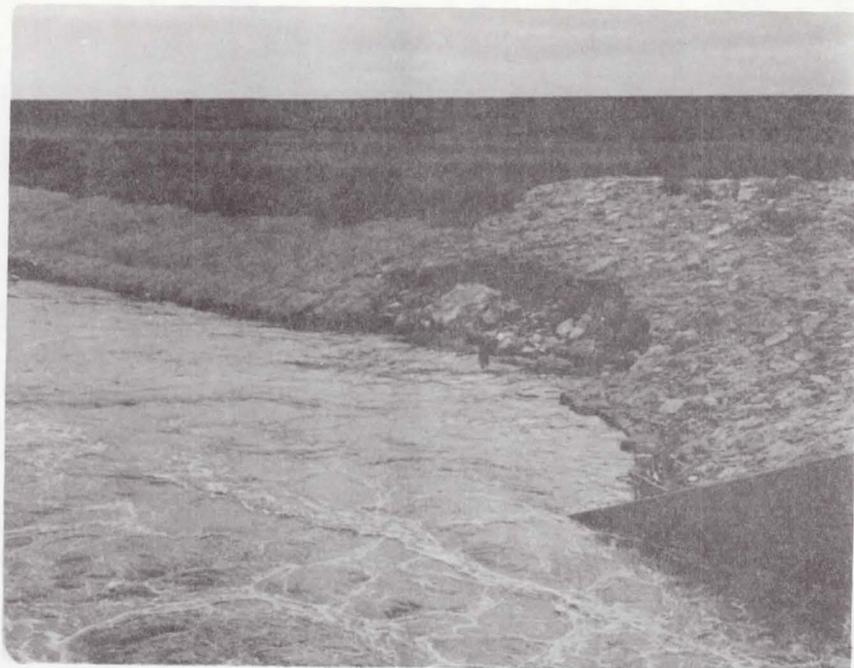
Figure 7. Little Sioux River at Onawa, Iowa. Overbank return flows during March 1979 partially failed the right-bank mattress (July 1979)

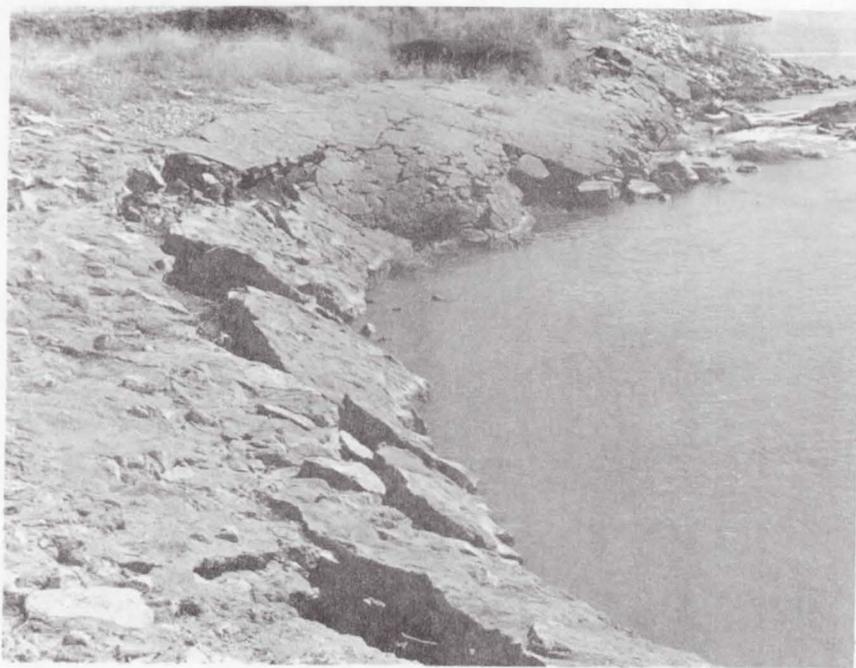
Figure 8. Little Sioux River at Onawa, Iowa. Overbank return flows during March 1979 completely failed the left-bank mattress (July 1979)

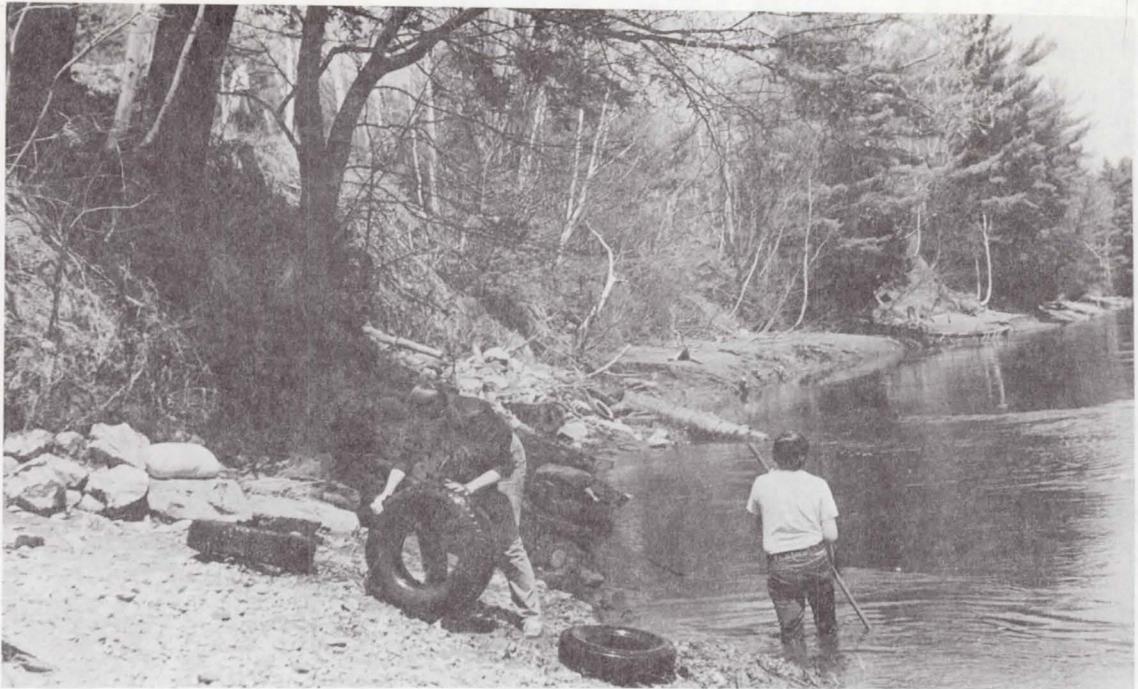
Initiation of used-automobile tire placement in the spring of 1972, Connecticut River at Thetford, Vt. Note eroded bank in background. The Allen residence is located approximately 50 ft landward from the top bank. View is upstream
