**FLOODING IN  
EAST MARICOPA COUNTY**

**AUGUST 1988**

## A REPORT ON THE AUGUST 1988 RAIN

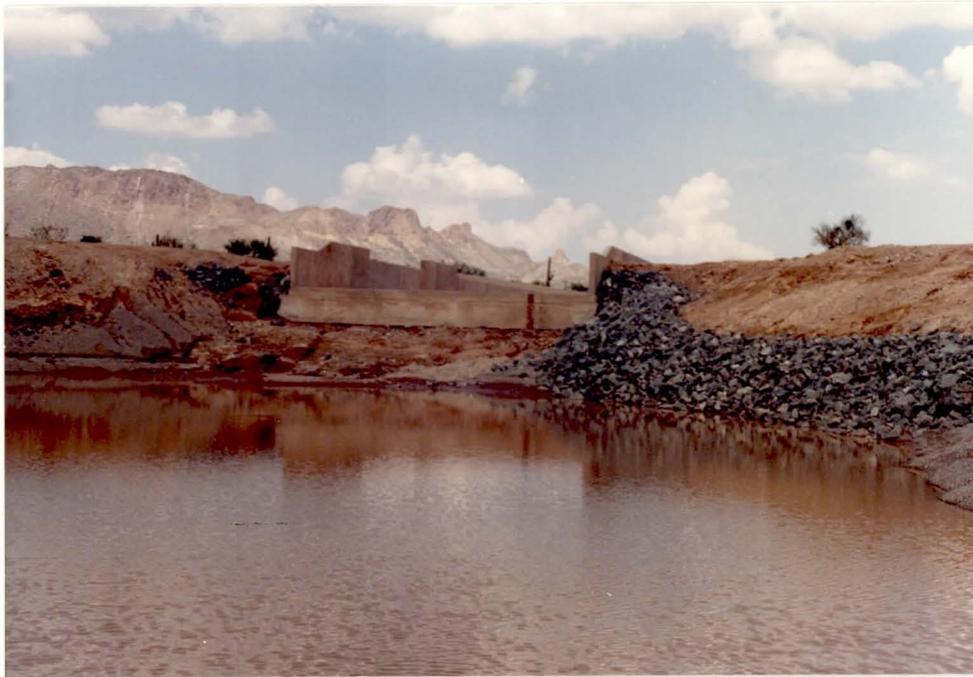
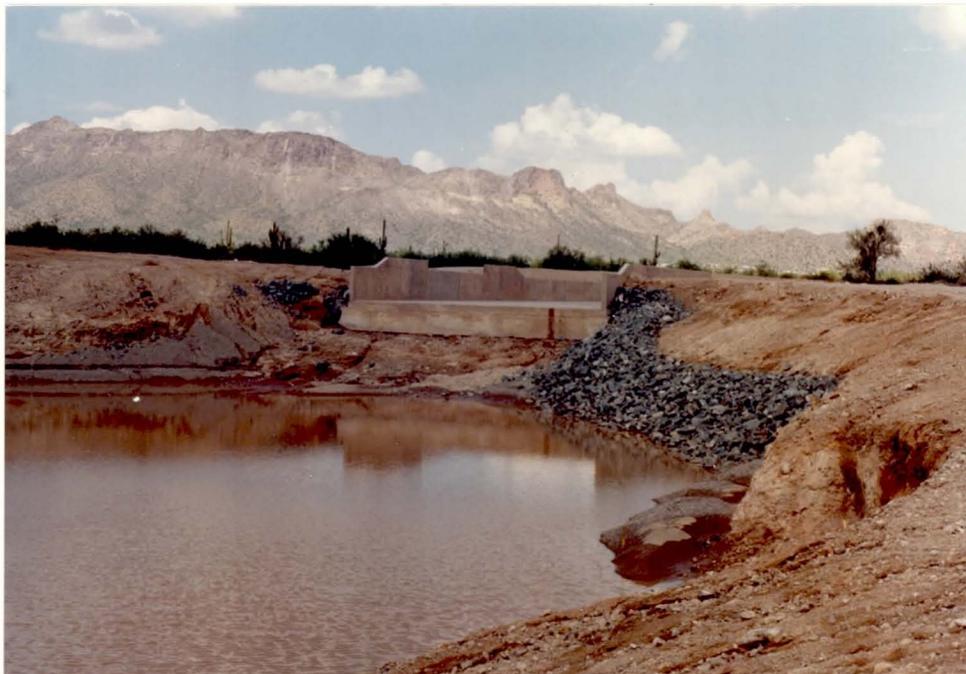
1a. Looking east, Bulldog Floodway at Signal Butte Dam.

1b. Looking east, Bulldog Floodway at Signal Butte Dam.

Pictures 1a and 1b are showing the Bulldog Floodway where it receives the discharges from Apache Junction Dam into the Signal Butte Dam (East of Meridian Dr. north of Brown Rd). This structure, as part of the Buckhorn-Mesa flood retarding structures, is still under construction and is expected to be completed soon. As it shows, there is approximately one foot of water ponding at this point. But, there is no ponding at Signal Butte Dam. The ponding area in the pictures is designed to be covered by riprap construction as part of Bulldog Floodway construction.

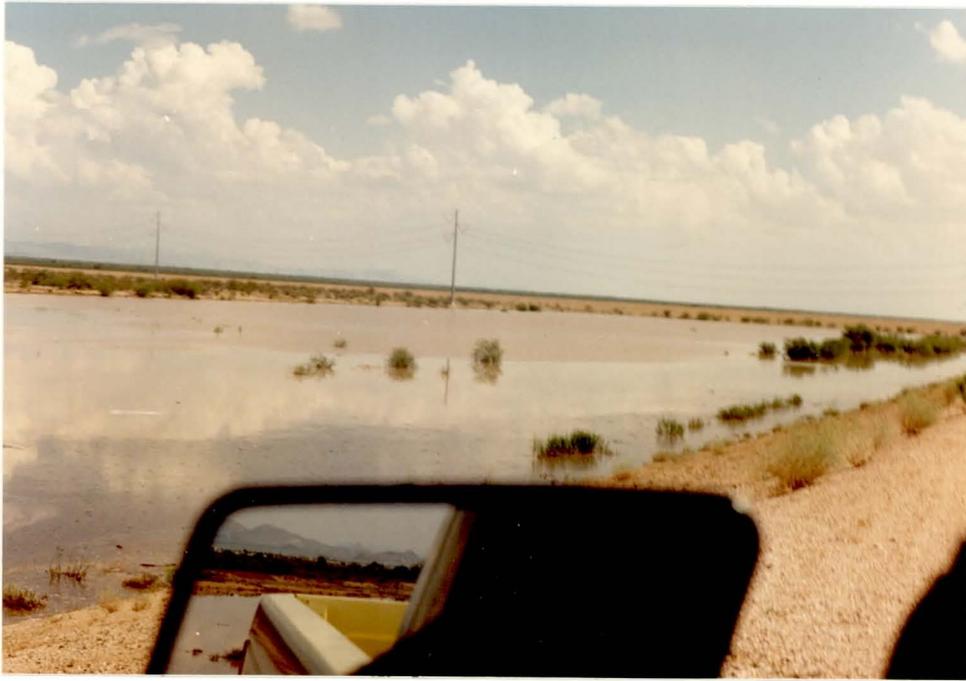
3a. Vinyard Rd. dam, 4.50 feet of water is stored.

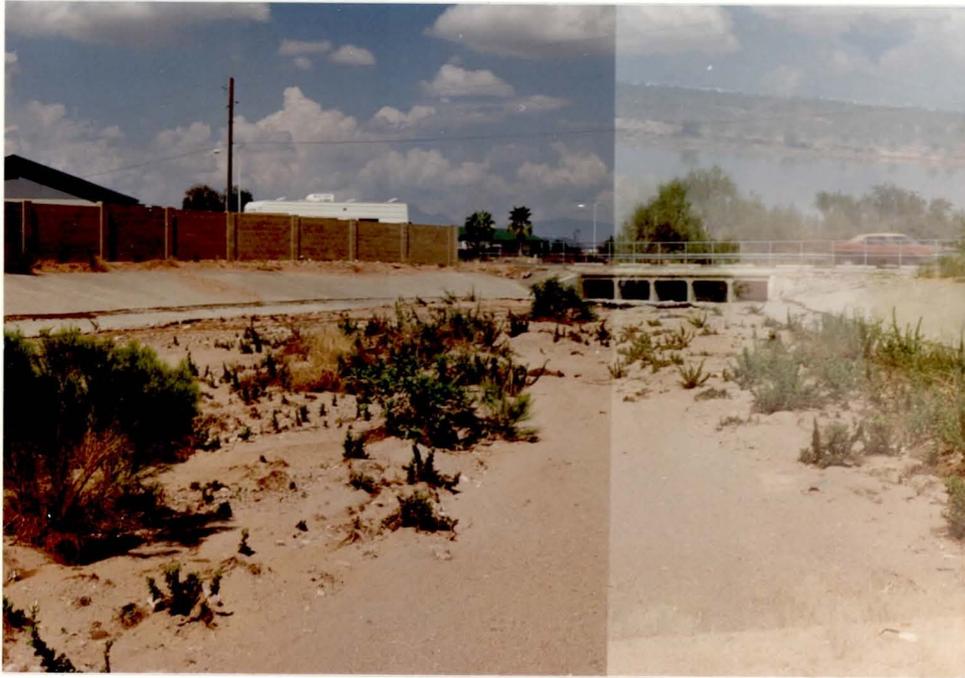
2. Looking east, Ironwood Rd. ditch, crossing Ironwood road north of 16th Avenue. The depth of water from the water marks is approximately 1.5 feet.

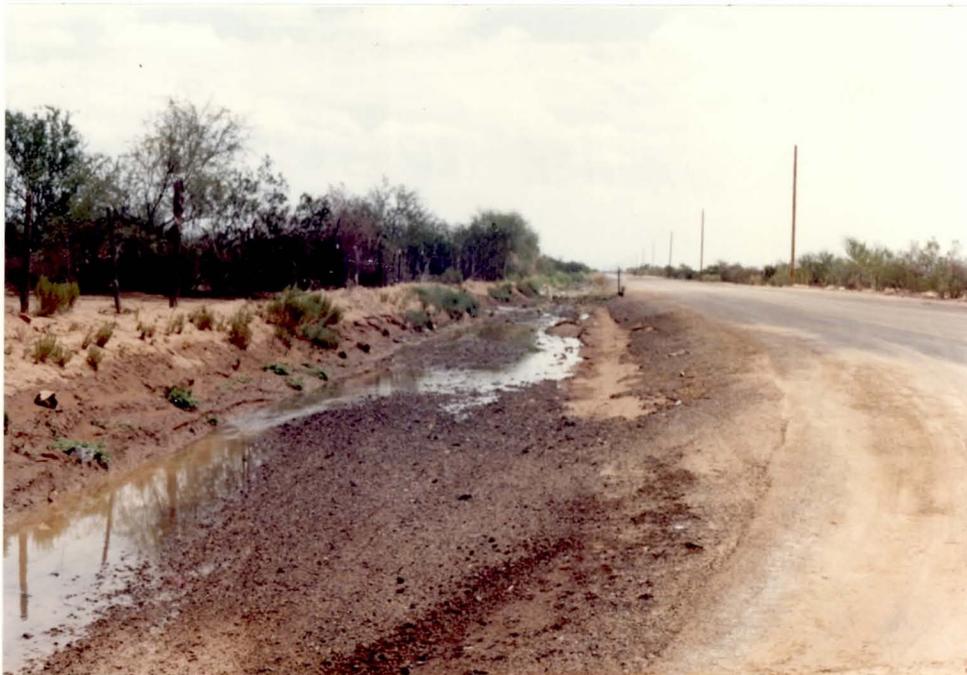
- 4a. Warner Rd. ditch, looking east at Warner Rd. and Sossaman Rd. intersection. The water mark shows at approximately 2 feet deep. (See vicinity map)

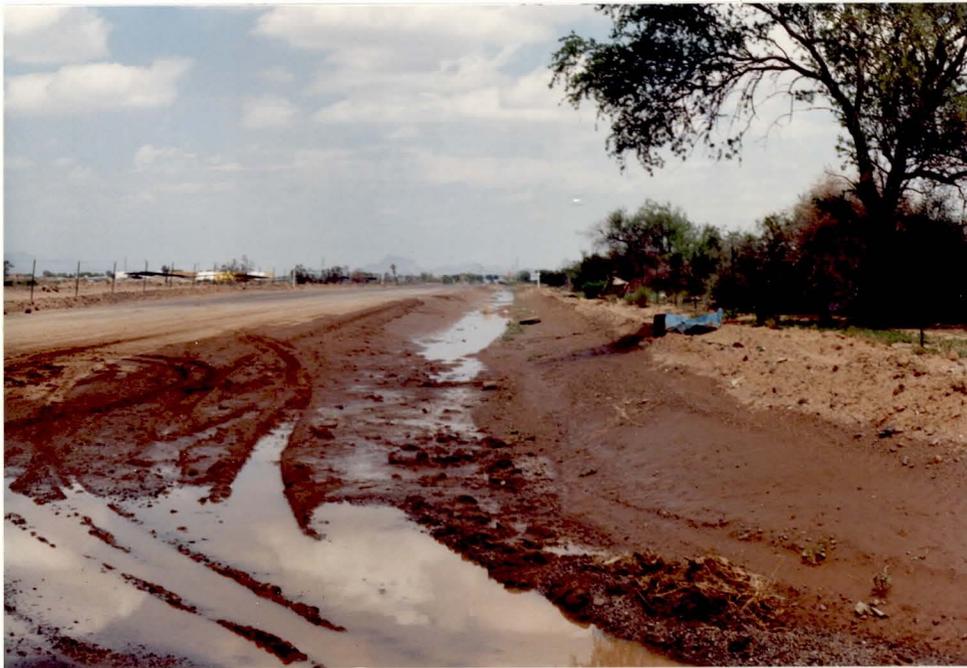
4b. Sossaman Rd. ditch, looking north at Warner Rd. and Sossaman Rd. intersection. The water mark shows approximately 3.50 feet deep. (See vicinity map)

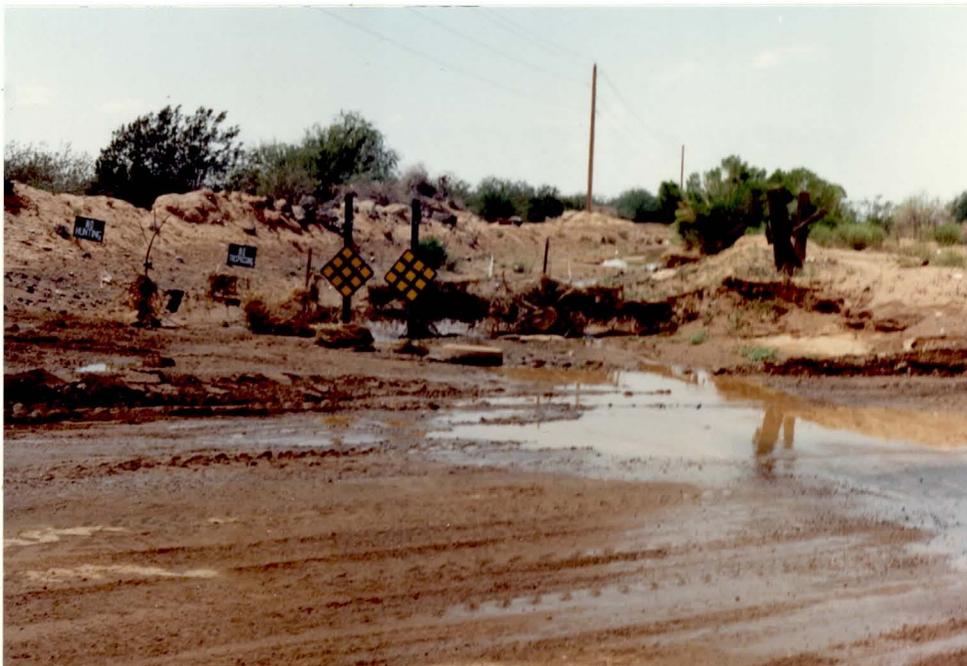
4c. Combine Sossaman/Warner Rd. ditch, looking west at Warner Rd. and Sossaman Rd. intersection. The water surface elevation is marked at approximately 4 feet deep. (See vicinity map)

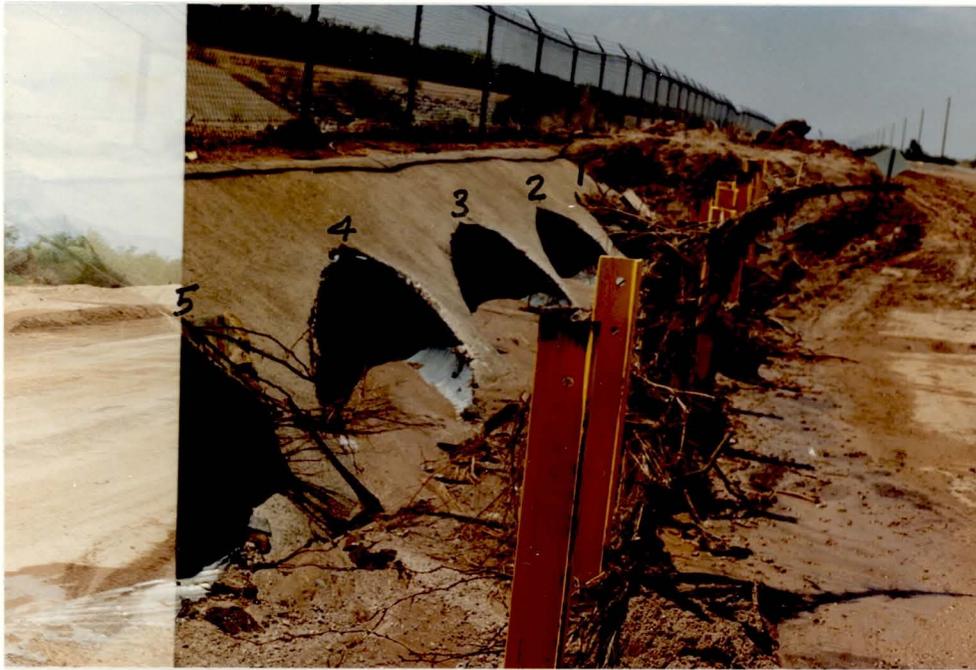
5a. Elliot Rd. looking west, one of the two pipe inlets which collects the discharges coming from the north of Elliot Rd. and directs them west along Elliot Rd. Pipe #1 in the picture is blocked by an engine.

Elliot Rd and Ellsworth St. intersection had the worse flooding condition. GM has constructed a very high berm along Elliot Rd. and Ellsworth St. which discharges flows from the north of Elliot Rd. which is designed to be collected into a ditch on the south side of Elliot Rd. and directed westerly to the intersection and then cross Ellsworth St. in different locations for continuing in a southwesterly direction. There was no rain in this area of the county, based on our discussion with the residents. However, the residents were complaining about flooding problems that they are getting from runoffs crossing Ellsworth St. There was evidence of the carport being under a few inches of water. (See vicinity map)

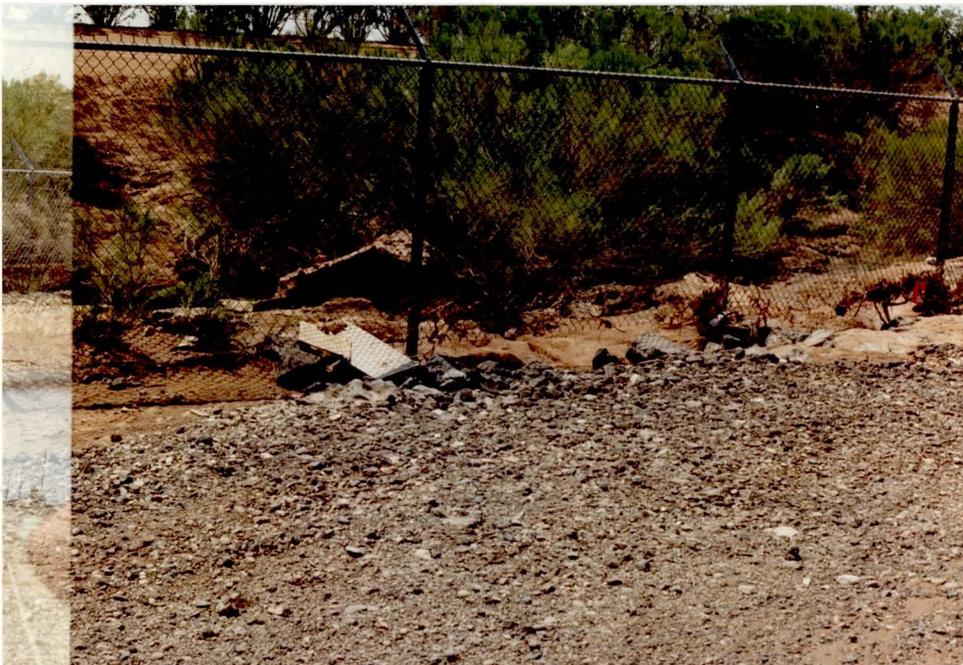
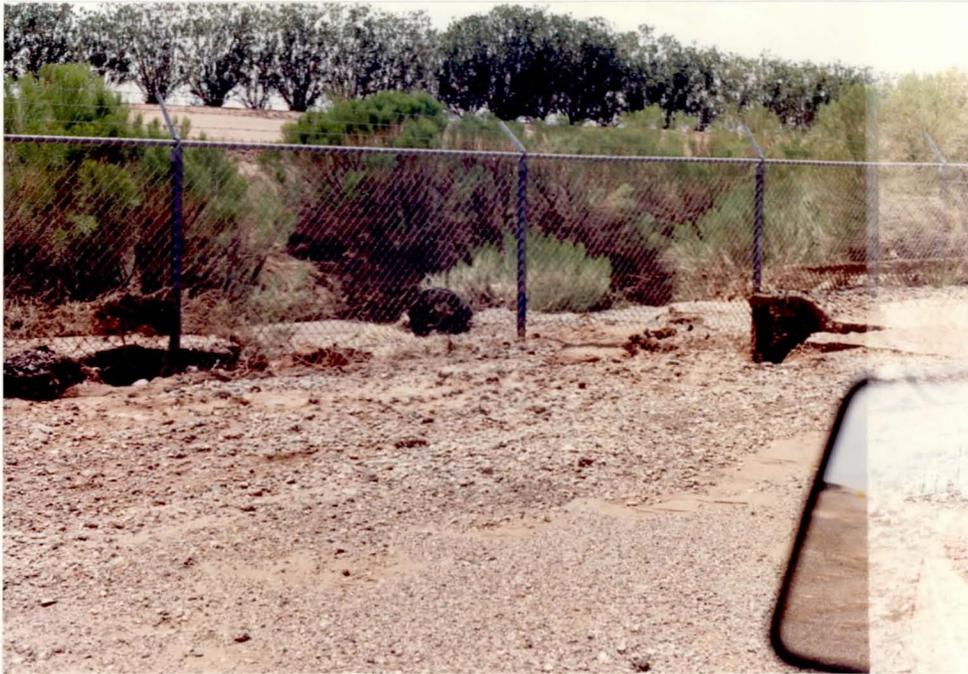
5b. Debris along the south side of Elliot Rd.

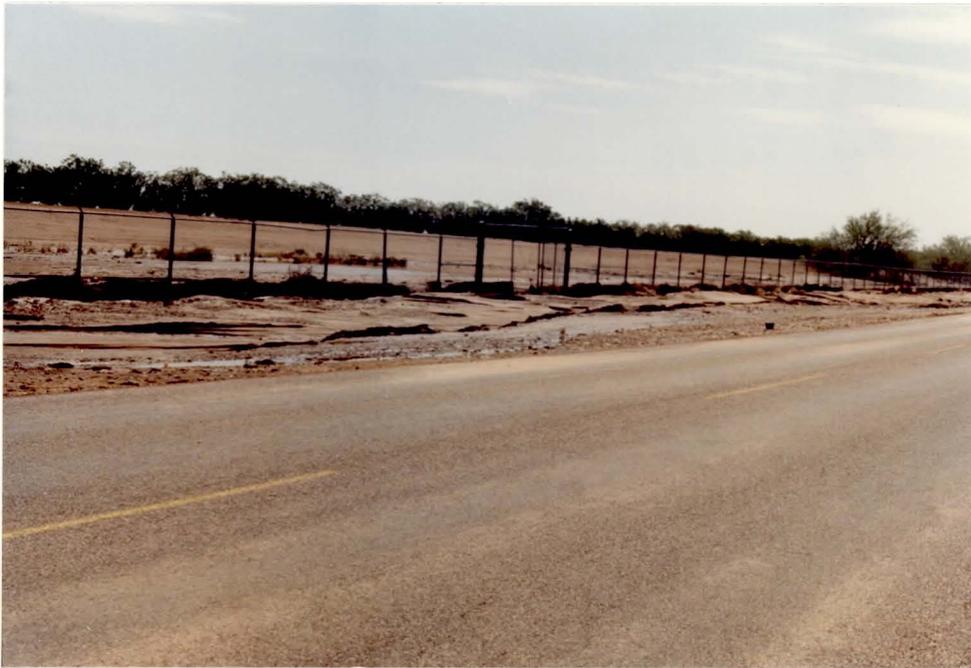
5c. Looking south, Scours and debris along east side of Ellsworth Street, south of Elliot Rd. and Ellsworth Street intersection.

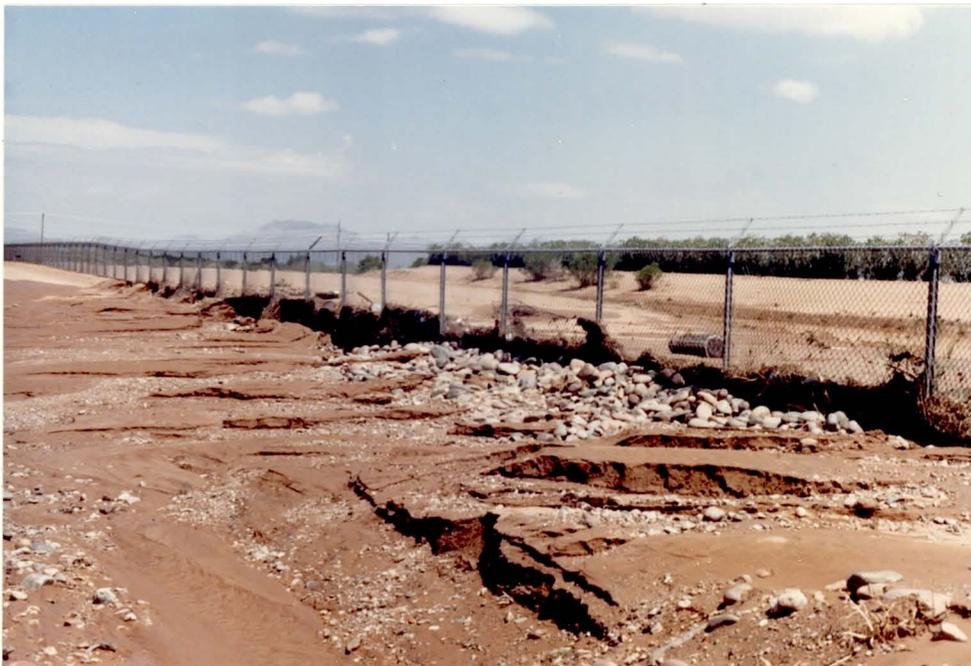
5d. Looking north, Scours and debris along east side of Ellsworth St., and south of Elliot Rd. & Ellsworth St. intersection (south of 5c).
