FLOOD CONTROL
DISTRICT OF
MARICOPA COUNTY

FLOOD REPORT

OCTOBER 14, 1988 STORM

PRELIMINARY FLOOD REPORT FROM THE STORM OF OCTOBER 14, 1988

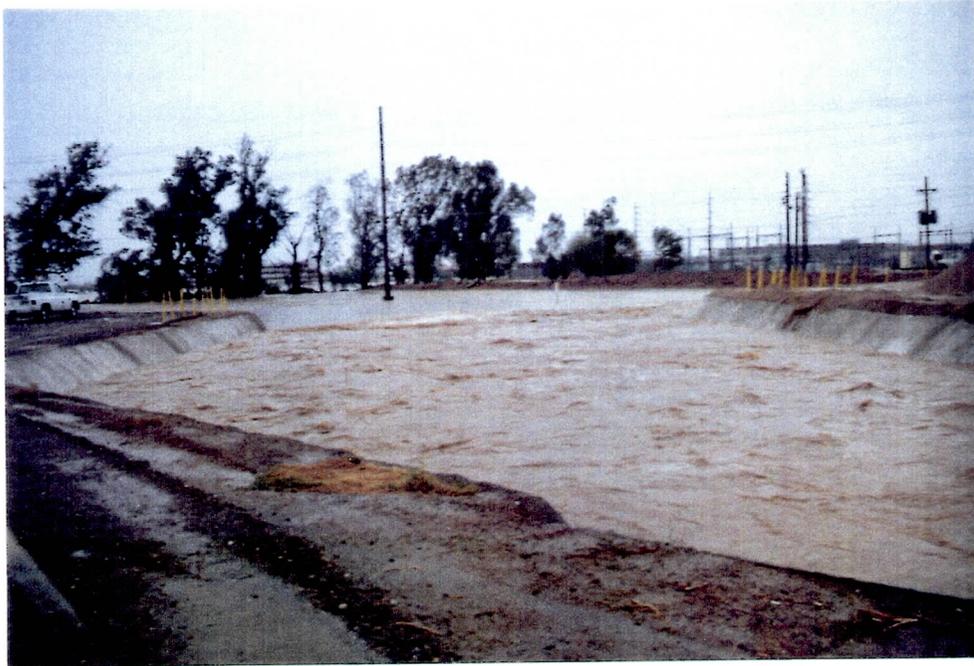
Flows from Cave Creek into the Arizona Canal reached a maximum discharge of 900 cfs according to SRP. Figure 6 shows a view of Cave Creek at its confluence with the Arizona Canal. Of this discharge, SRP measured, using a propeller meter, 690 cfs spilling over Spillway #8 of the Arizona Canal directly south of the Cave Creek confluence during peak flows. Figure 7 shows flows passing over Spillway #8, heading south. The flows from Cave Creek, along with other local inflows into the Arizona Canal, caused the Arizona Canal to start overtopping. Upon consultation with the Maricopa County Flood Control District and receiving permission to breach the Arizona Canal into the ACDC, SRP breached the Arizona Canal between 51st and 59th Avenues allowing water in the canal to flow directly into the ACDC. Maximum flows into the ACDC from this breach was estimated to be 200 cfs by SRP officials. Water levels in the Arizona Canal were lowered about 4 inches about an hour after breaching. Figures 8 and 9 show the breaching of the Arizona Canal. Figures 10 and 11 show the water running down the embankment of the ACDC and the erosion caused by the breach. The maximum flow in the

Figure 6: Cave Creek at the confluence of the Arizona Canal looking south.
($Q=900$ cfs)

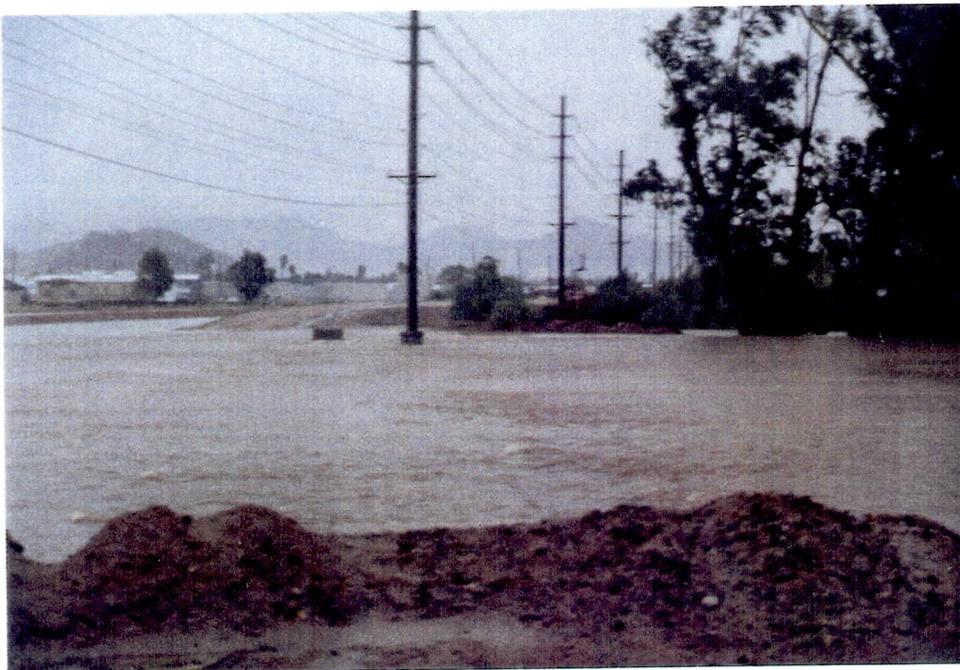
Figure 7: Flood waters from Cave Creek passing over Spillway #8 of the
Arizona Canal. ($Q=690$ cfs)

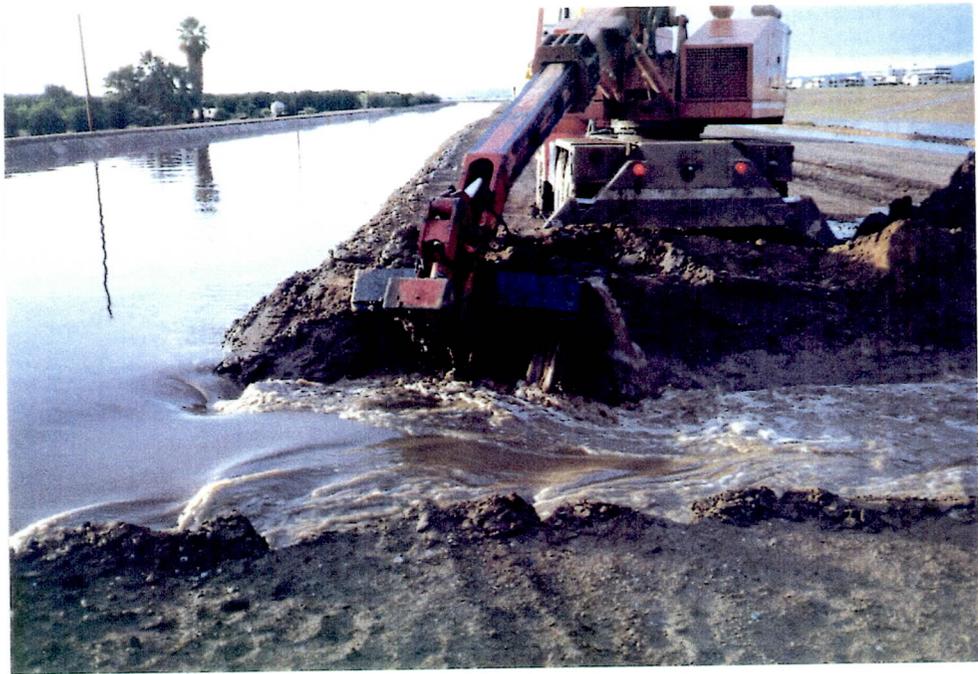
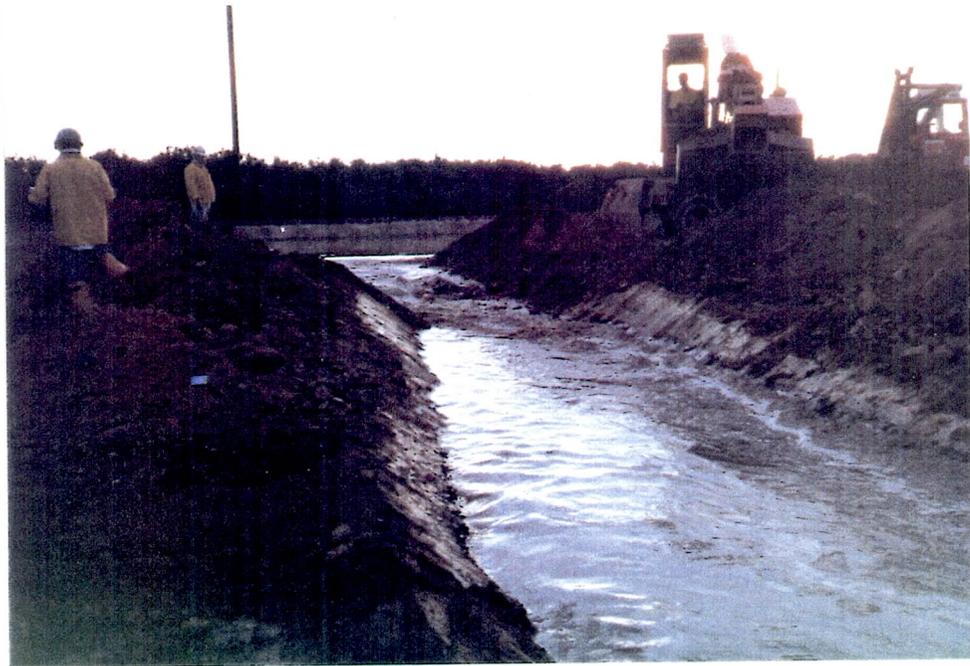
Figure 8 & 9: Breaching of the Arizona Canal between 51st and 59th Avenues. Maximum flow was estimated at 200 cfs.

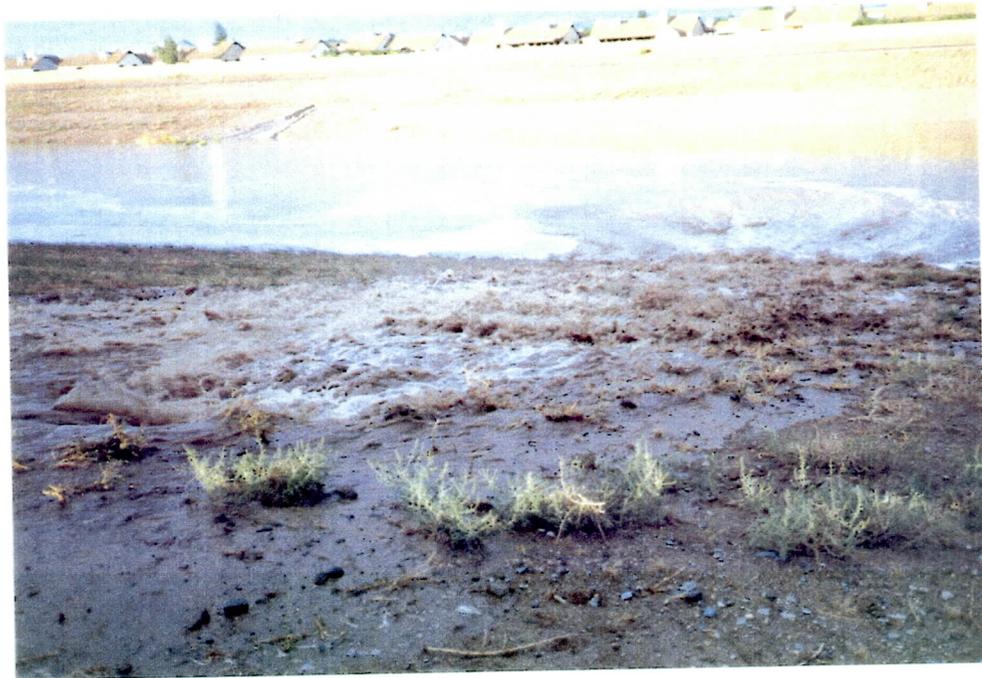
Figure 10: Breach water of Arizona Canal flowing down south embankment of ACDC (Arizona Canal Diversion Channel).

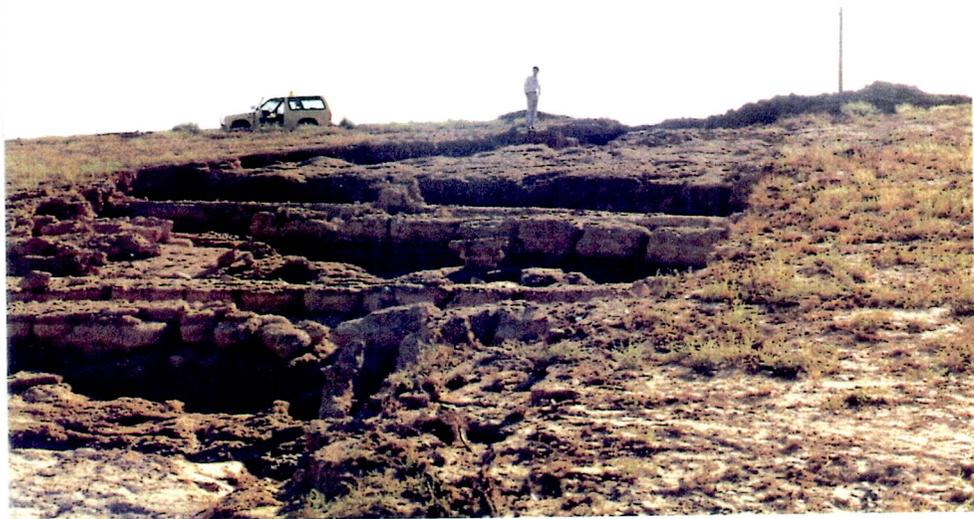
Figure 11: Erosion of ACDC caused by breach waters from Arizona Canal.

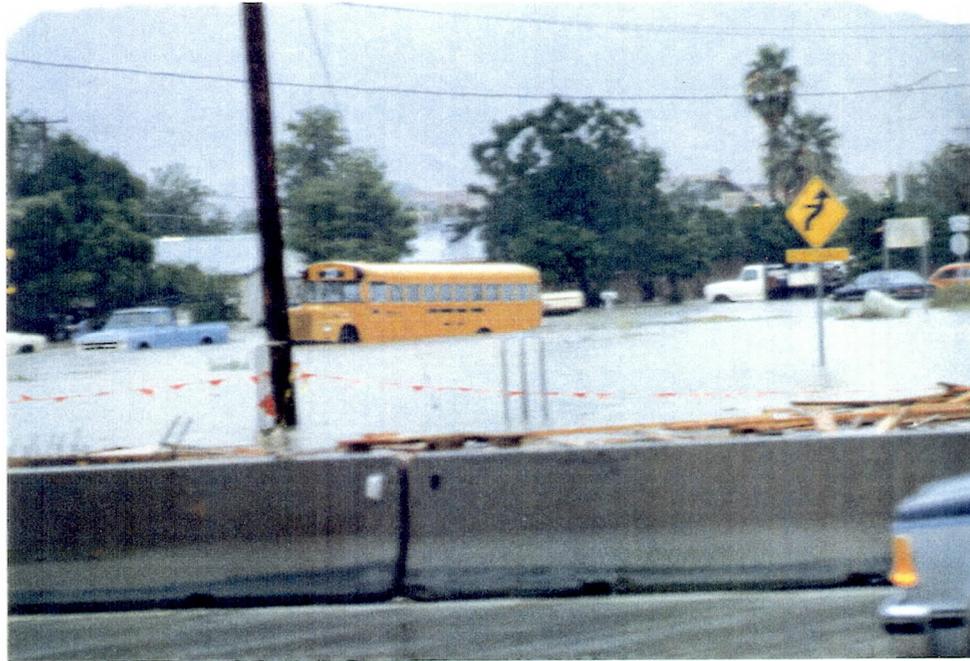
Figure 12: Flooding at 19th Avenue and Hatcher, Phoenix.

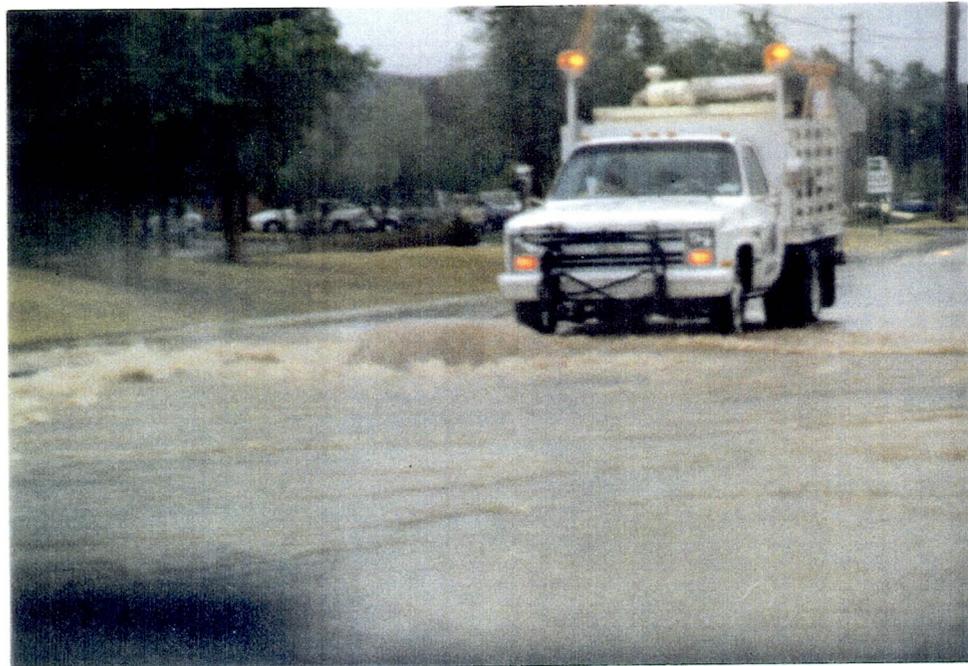
Figure 13: Storm sewer surcharge causing flooding at 23rd Avenue and Alice.

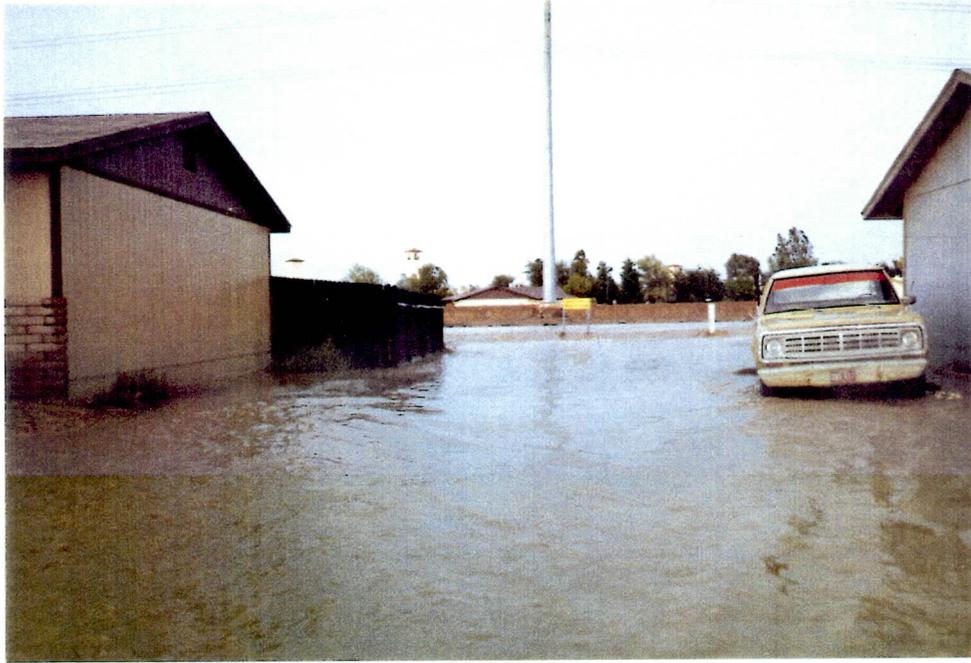
The Arizona Canal overtopped its south bank several hundred yards east of 43rd Avenue giving cause for the mechanical breaching of the canal mentioned previously. Figure 14 shows the main area of overtopping and the flooding caused as a result. The subdivision west of 39th Avenue was flooded, with water halfway up the lawns of the houses, but there was no flood damage to the houses. Grading within the subdivision directed the flood water west toward 43rd Avenue.

Figure 14: Arizona Canal overtopping it's south banks several hundred yards east of 43rd Avenue
