Bridge Scour Investigation
and Design of Corrective Measures

Work Order No. 80407
Maricopa County Department of Transportation

FINAL REPORT

Structure Number 9145
Indian School Road Bridge over the Agua Fria River

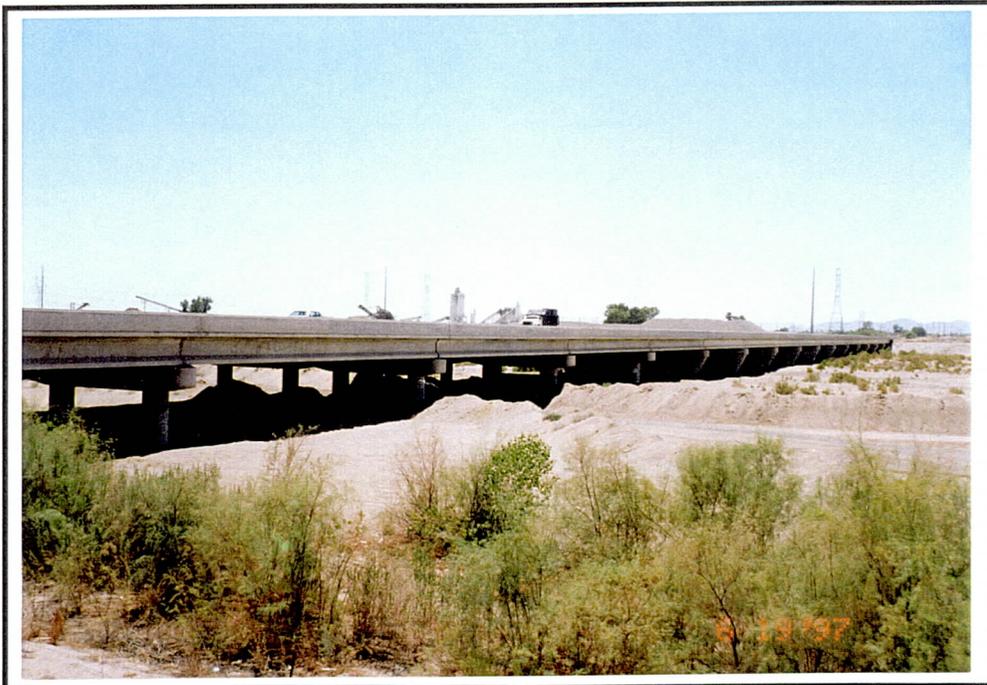
7. A local gravel mining operation has a haul road crossing under the bridge to transport material between processing facilities on both sides of Indian School Road. The haul road is depressed under one of the spans in the newer section of drilled shaft piers.

Westward view of structure from upstream bank.
Note: Drilled shaft piers in foreground and solid piers on spread footings in background. Sand and gravel haul road under bridge.

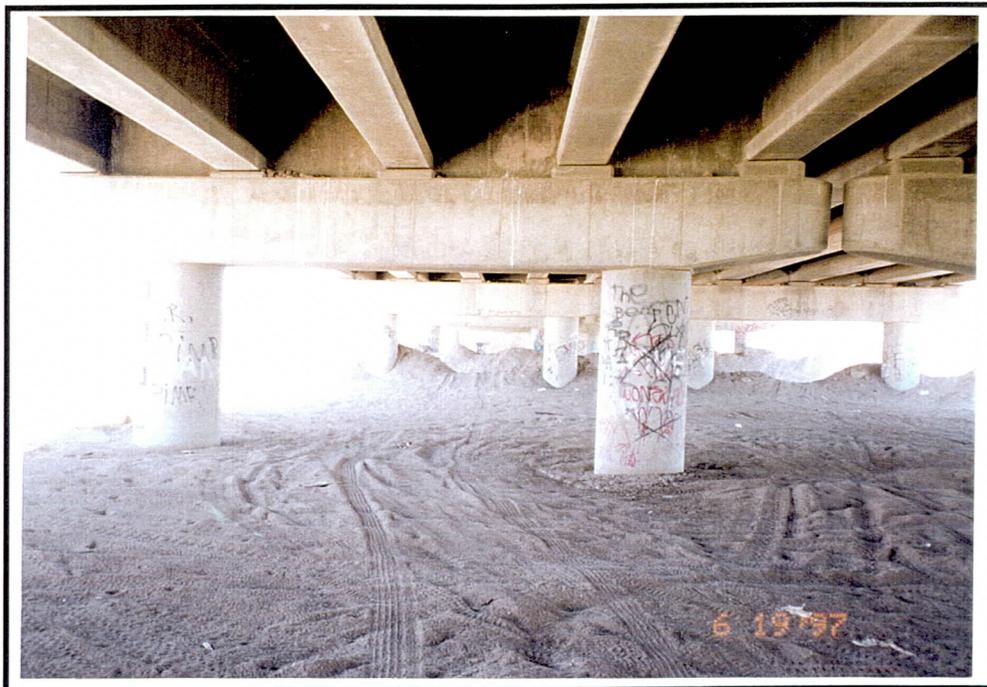
Westward view under bridge of sandy channel bottom in drilled shaft pier section.

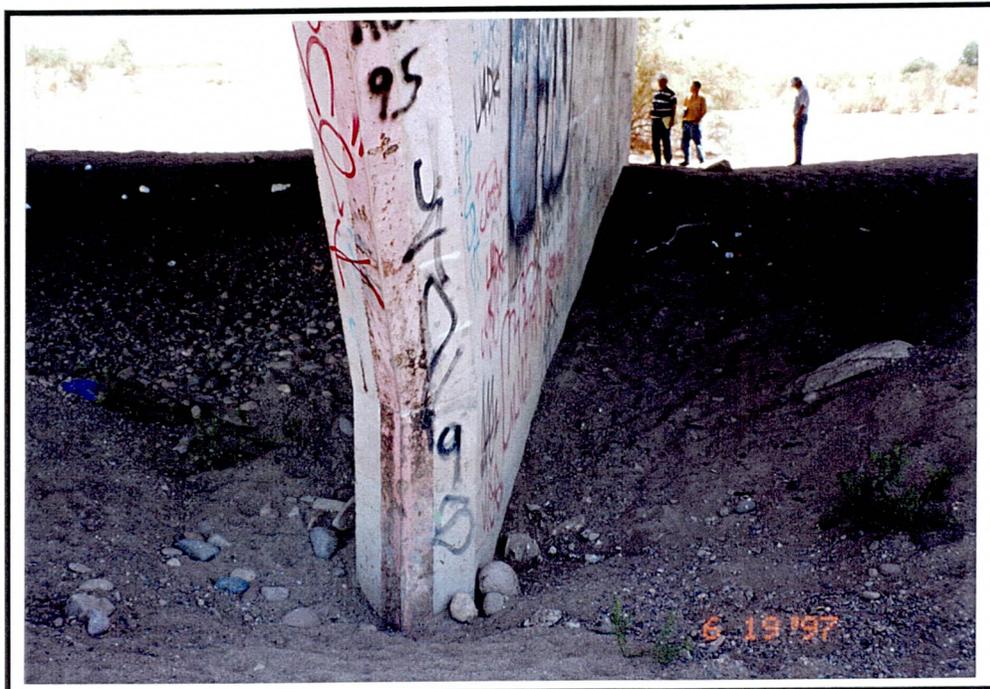
Cannon determined that the bridge is scour critical due to local scour depths below the shallow spread footings at the piers. The 5 drilled shaft piers and the abutments are not scour critical.

Scour at nose of solid pier.

Alternative No. 2 is the recommended scour countermeasure.

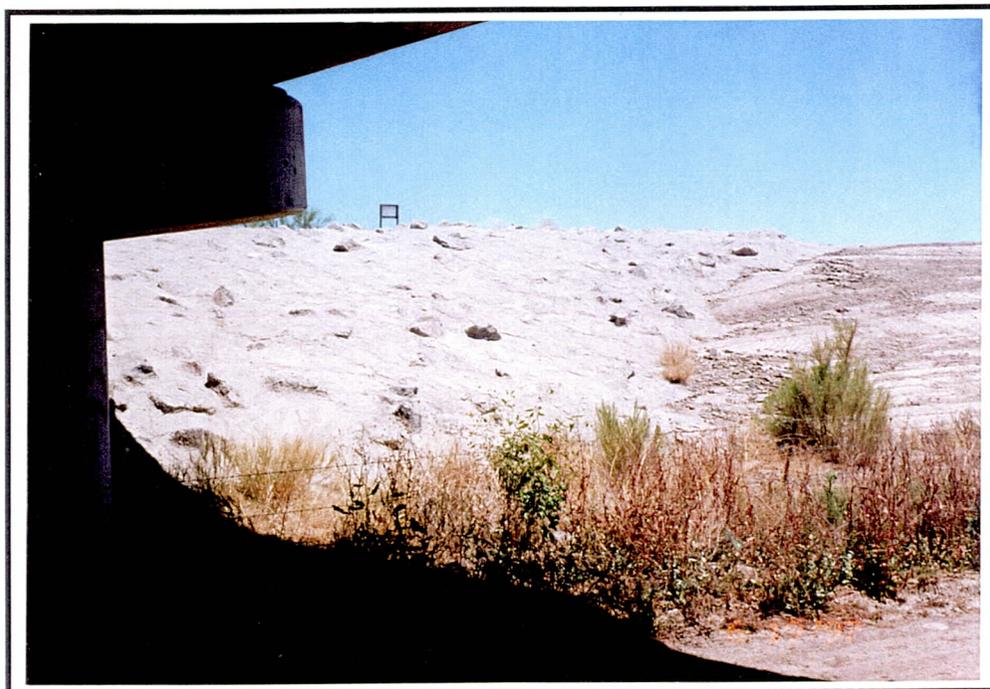
1. Both banks are in sound condition, each consisting of a soil-cement section.
2. There is no visible evidence of a broken grade-control structure.
3. The channel bed material appears to be well suited for soil cement.

East bank, at downstream face, showing transition interface between grouted riprap and soil cement.

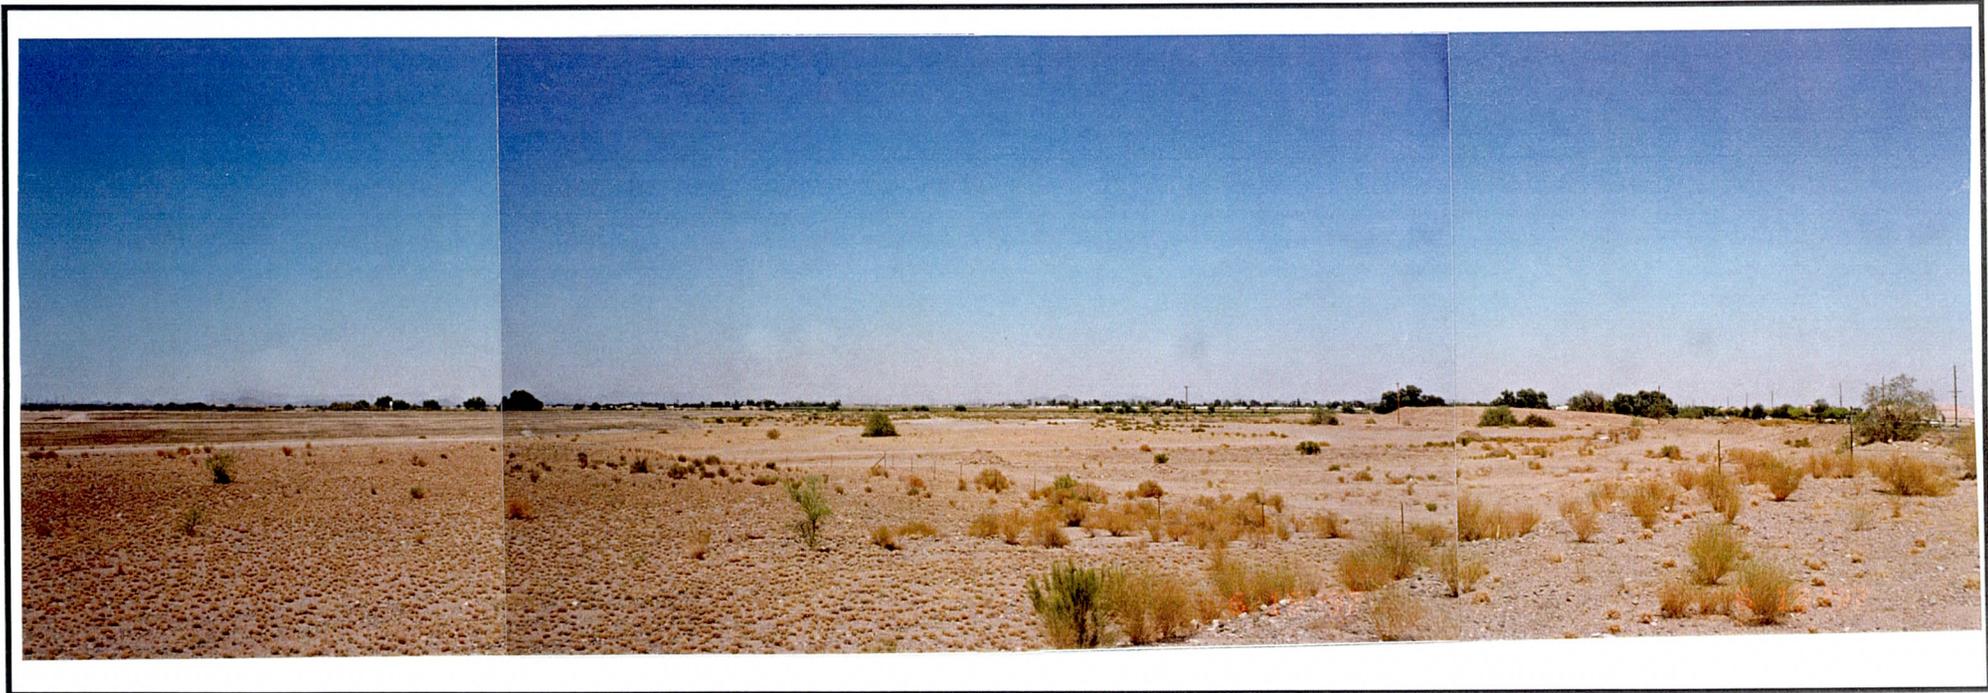
6. There is a large area on the east upstream over bank that would be suitable for material storage, processing of soil cement, and contractor staging. This area appears to have been previously used for similar operations.

Northward view of deflector dikes on east bank upstream from bridge.
This area would be a good potential location to store and process material for
compliance to US Corps Engineers 404 requirements.
