WILLIAMS FIELD RD BRIDGE OVER EMF

BRIDGE SCOUR EVALUATIONS

Williams Field Road Bridge over the East Maricopa Floodway

**HYDRAULIC ANALYSIS FOR THE
WILLIAMS FIELD ROAD BRIDGE
OVER THE EAST MARICOPA FLOODWAY**

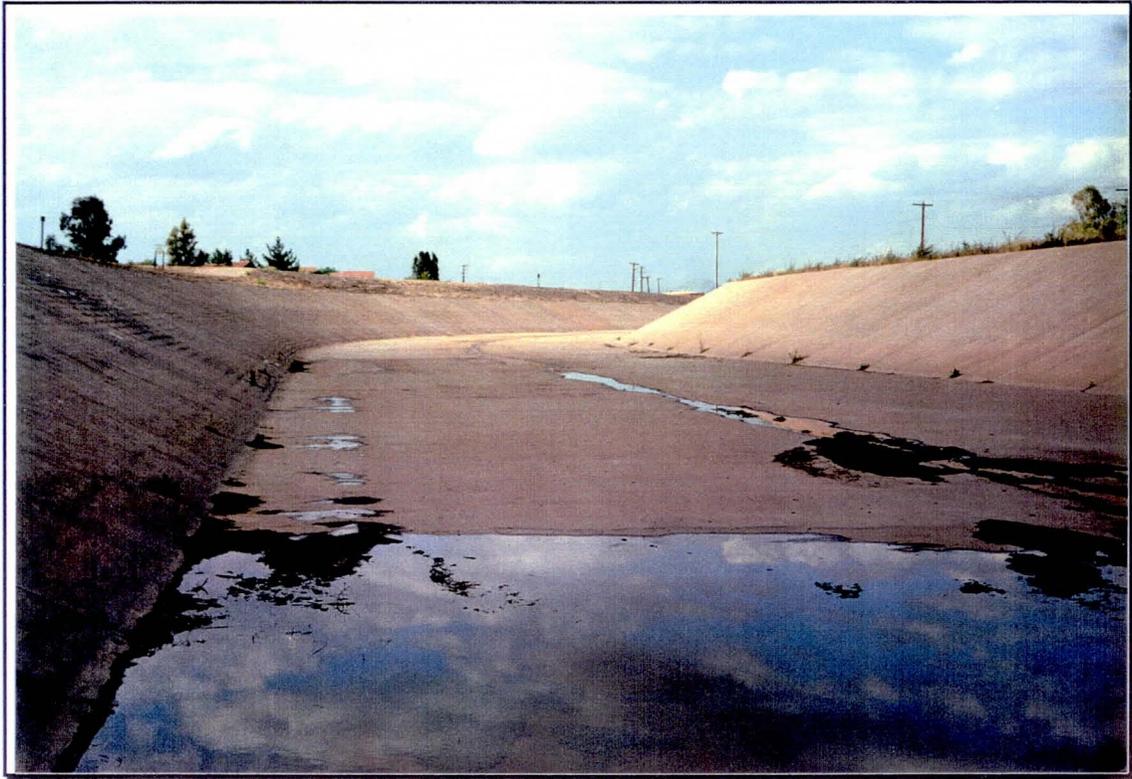
Looking upstream.

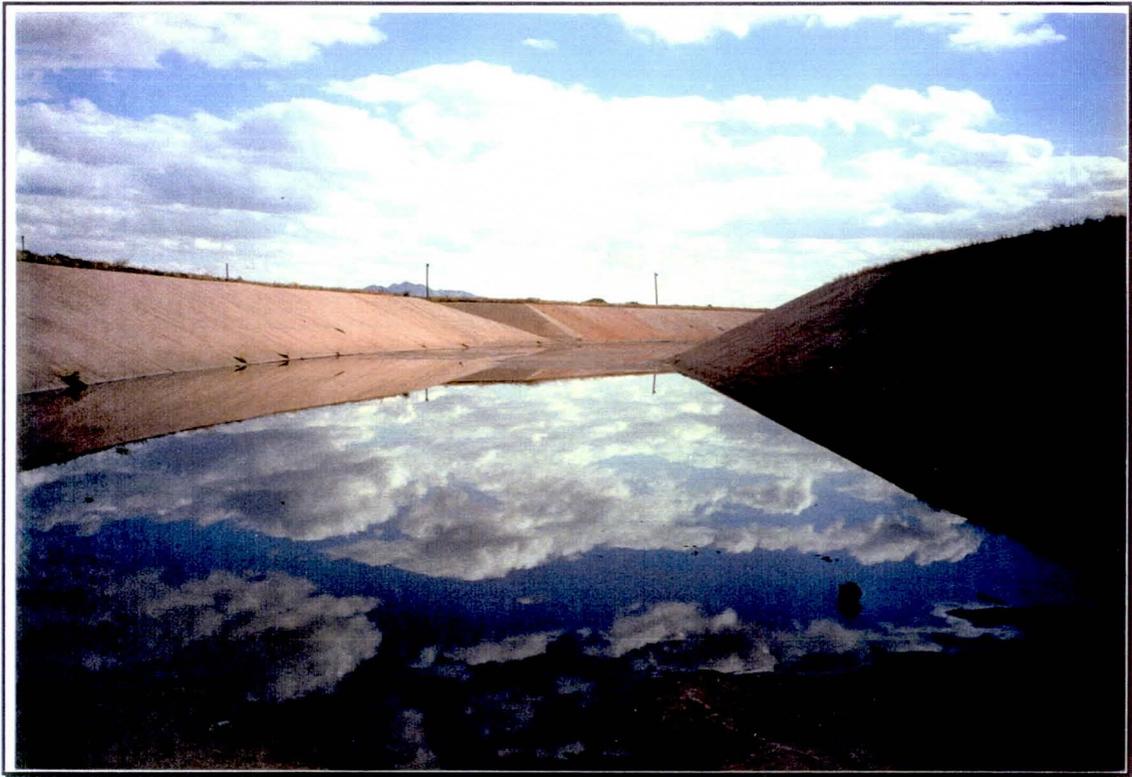
Looking downstream.

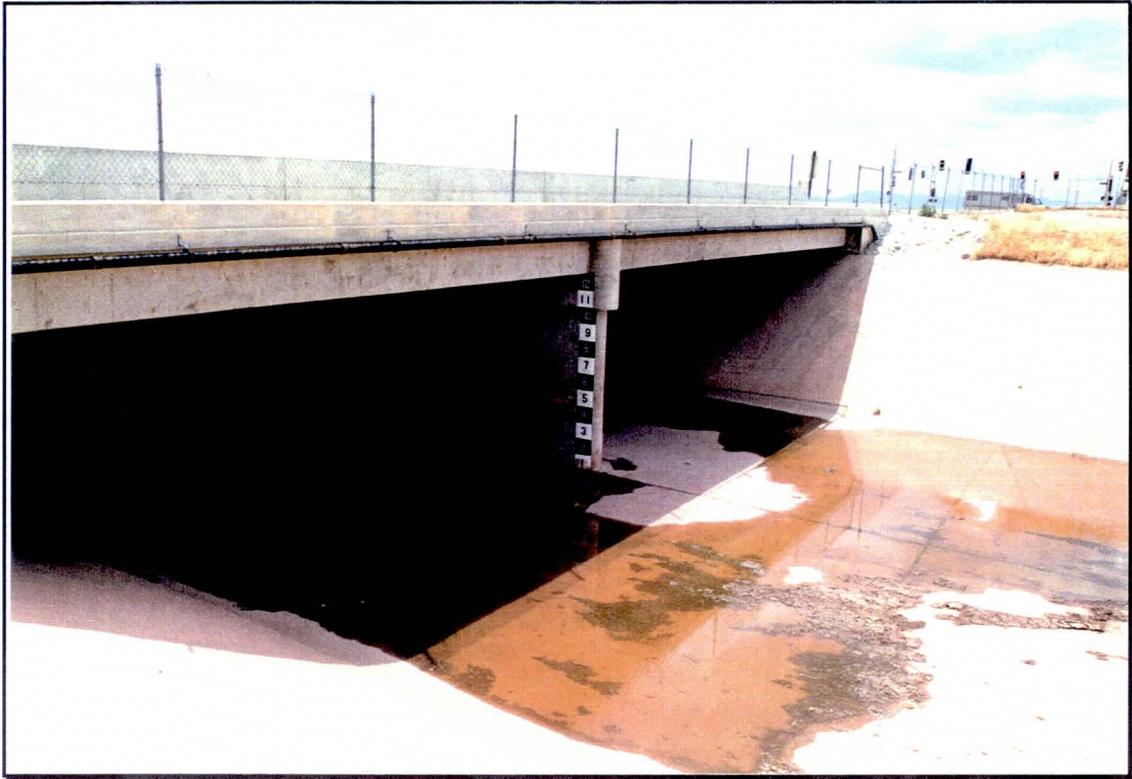
channel lining extends up and down stream. The bridge is in excellent condition. No cracks, corrosion, or other deficiencies of structural members are visible. There are no visible cracks on the barrier or approach slabs.

Upstream face looking West.

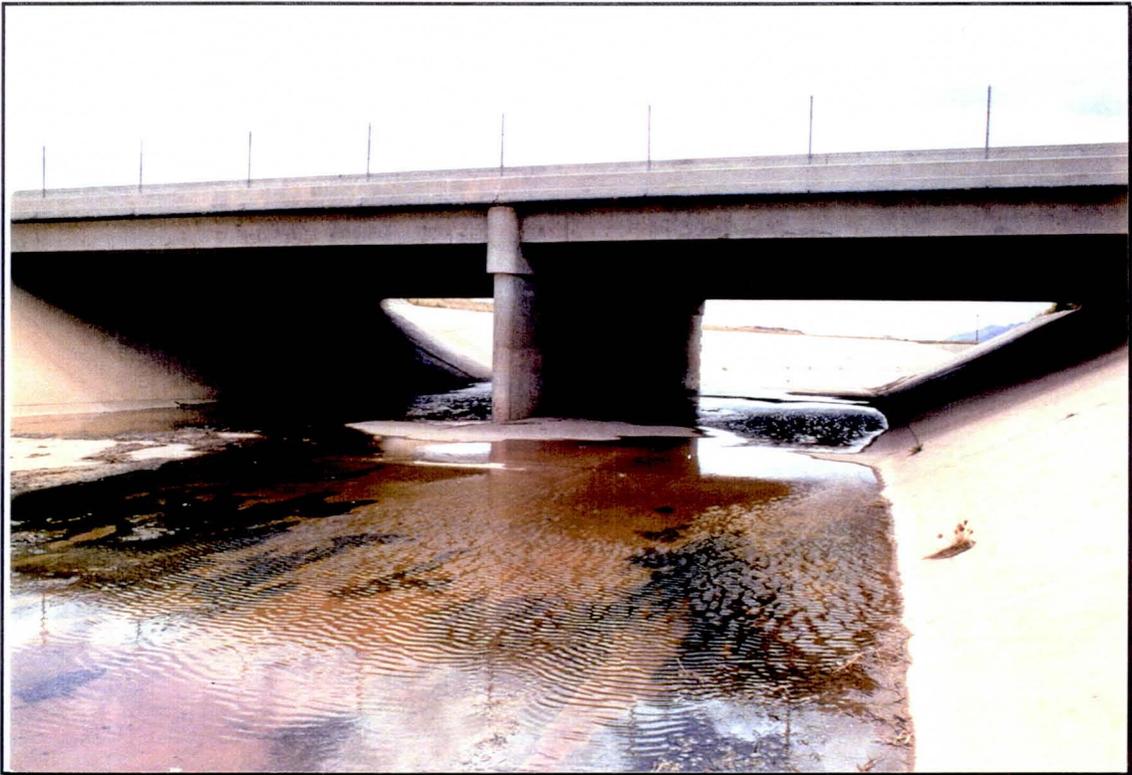
Looking downstream at subject bridge.
