Tres Rio North Levee Final Construction Report

**NATIONAL FLOOD INSURANCE PROGRAM, LEVEE SYSTEM
EVALUATION REPORT (NLSE) FOR TRES RIOS NORTH LEVEE,
MARICOPA COUNTY, ARIZONA**

Date: 25 September 2012
PGT
Project No.: 345-PGT-TO2
Subject: Final Construction Report for the Tres Rios Environmental Restoration Project Phases 1A and 1B, North Levee, Maricopa County, Phoenix, Arizona

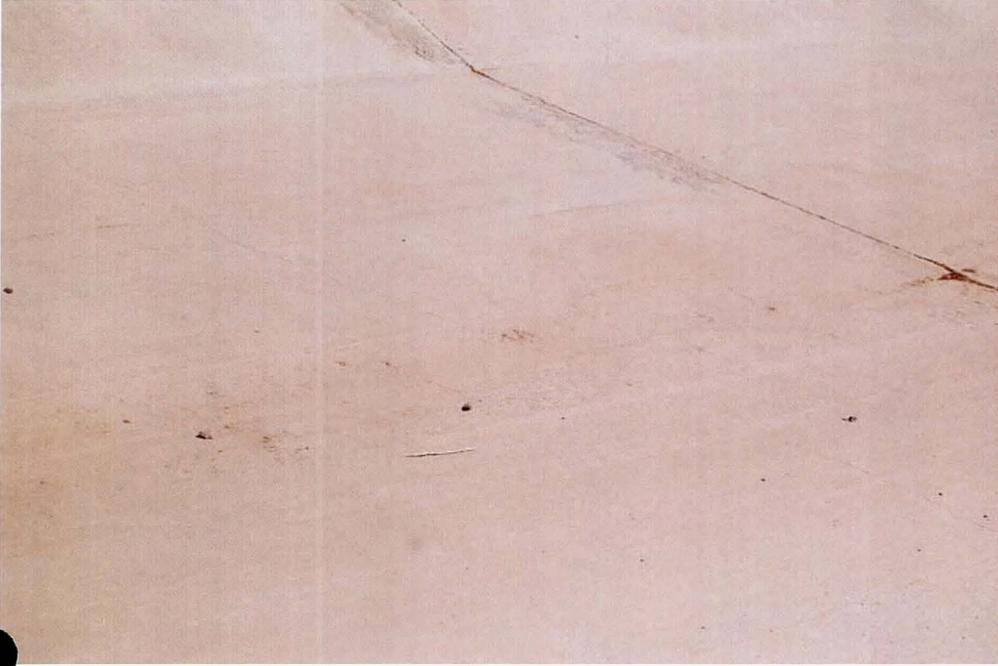
Photo No: 1253
		Location: Tres Rios Levee Station 208+50, Phase 1A
		Description: Looking northeast at transverse cracking and resealed joints in Concrete Irrigation Channel (typical).

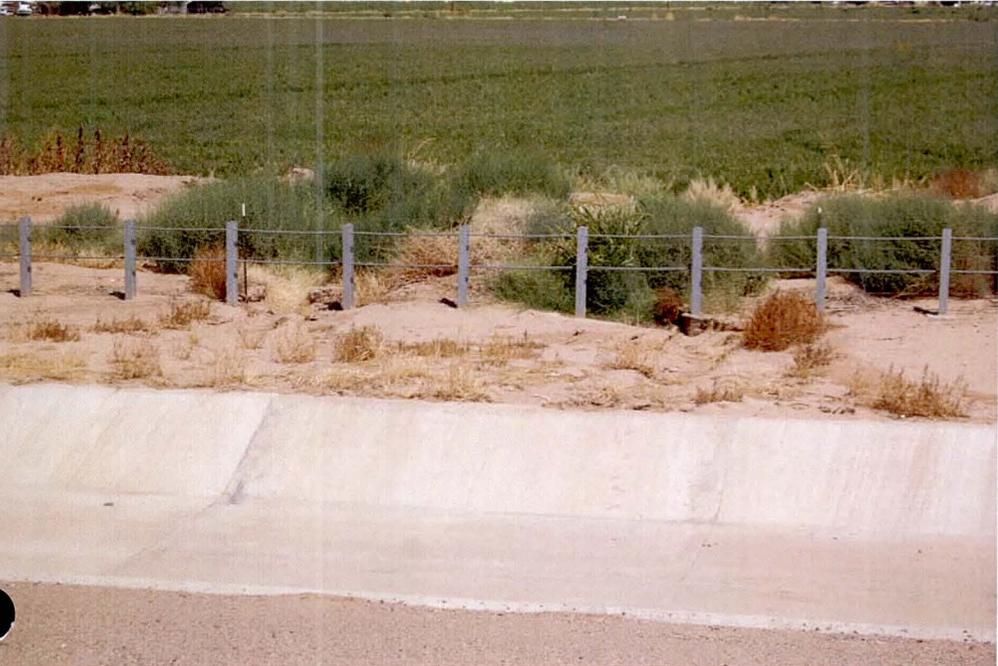
Photo No: 1279
		Location: Tres Rios Levee Station 202+50, Phase 1A
		Description: Looking north at erosion caused by farmland irrigation (typical).

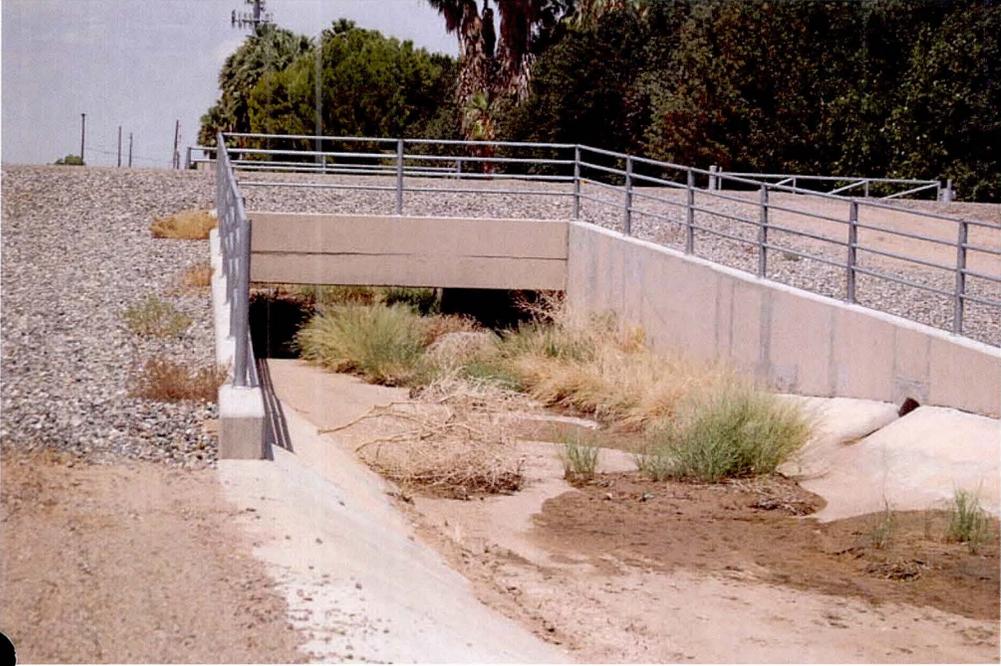
Photo No: 1343
		Location: Tres Rios Levee Station 170+50, Phase 1A
		Description: Looking northwest at 113 th Ave. box culvert obstructed by silt and vegetation.

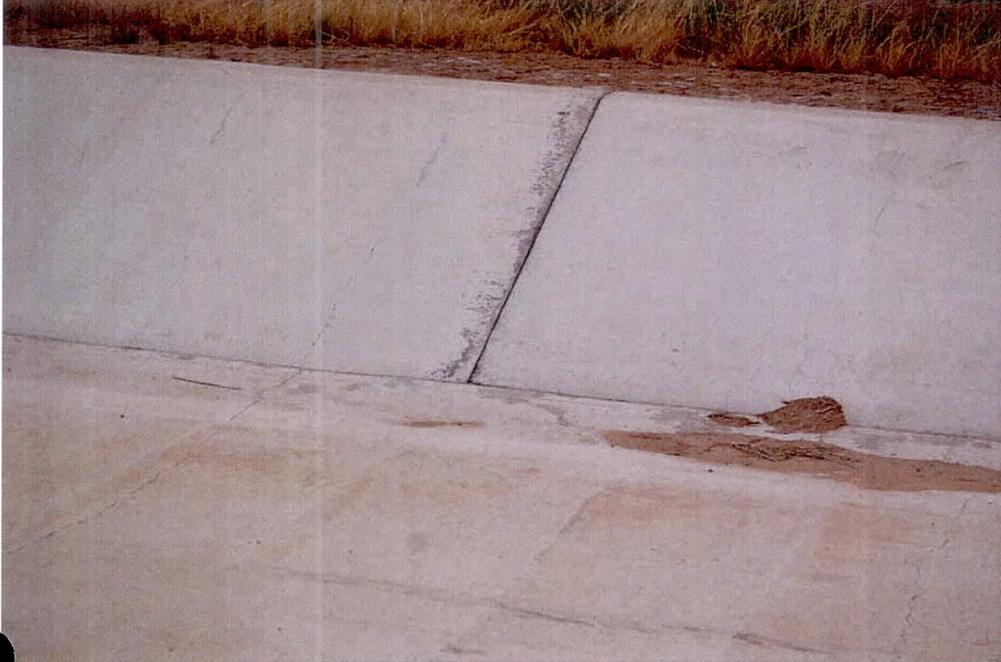
Photo No: 1509
		Location: Tres Rios Levee Station 147+00, Phase 1B
		Description: Looking north at cracks in Concrete Irrigation Channel (typical).

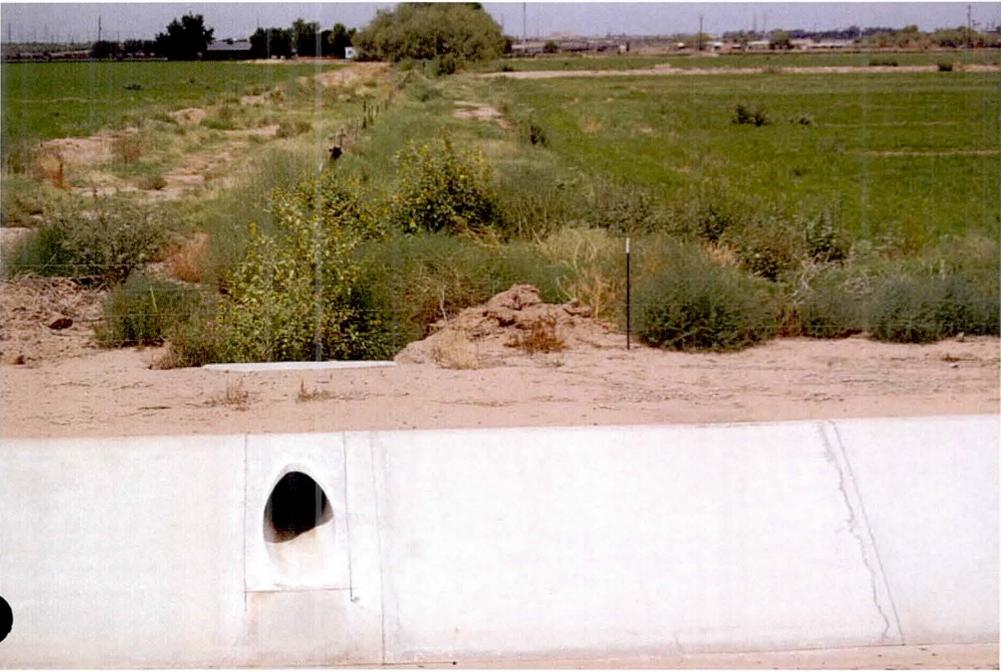
Photo No: 1517
		Location: Tres Rios Levee Station 141+10, Phase 1B
		Description: Looking north at 117 th Ave. side drain obstructed with vegetation (typical). Pipe side drain is not constructed as shown on plans.

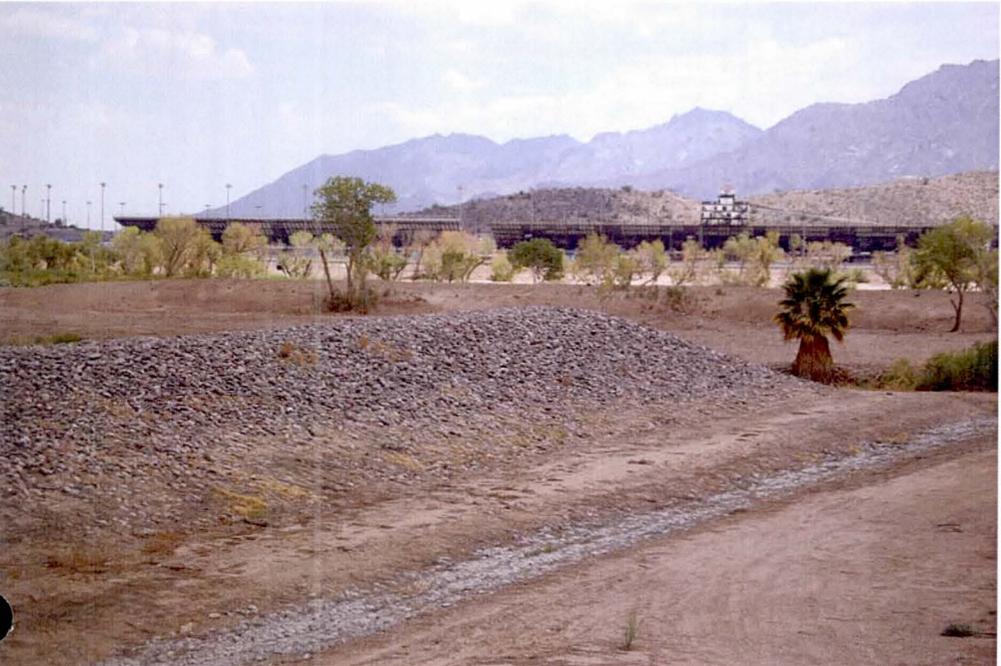
Photo No: 1539
		Location: Tres Rios Levee Station 140+00, Phase 1B
		Description: Looking southeast at West 117 th Ave. Guide Dike. Soil was observed covering the gabion mattress along the toe of dike.

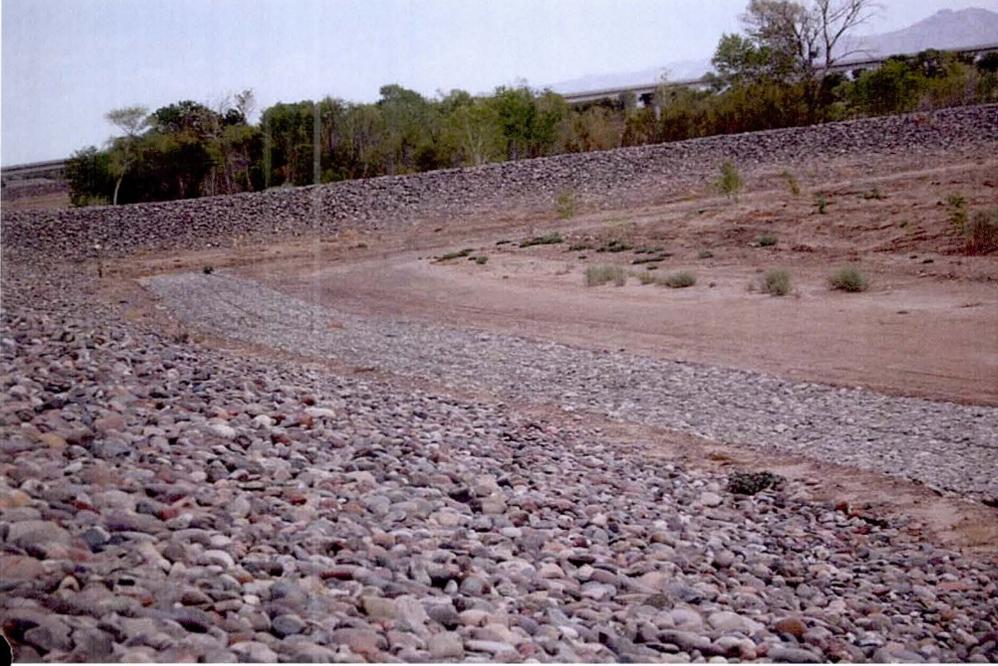
Photo No: 1586
		Location: Tres Rios Levee Station 122+00, Phase 1B
		Description: Looking southeast at East 119 th Ave. Guide Dike. Soil was observed covering the gabion mattress along the toe of dike.

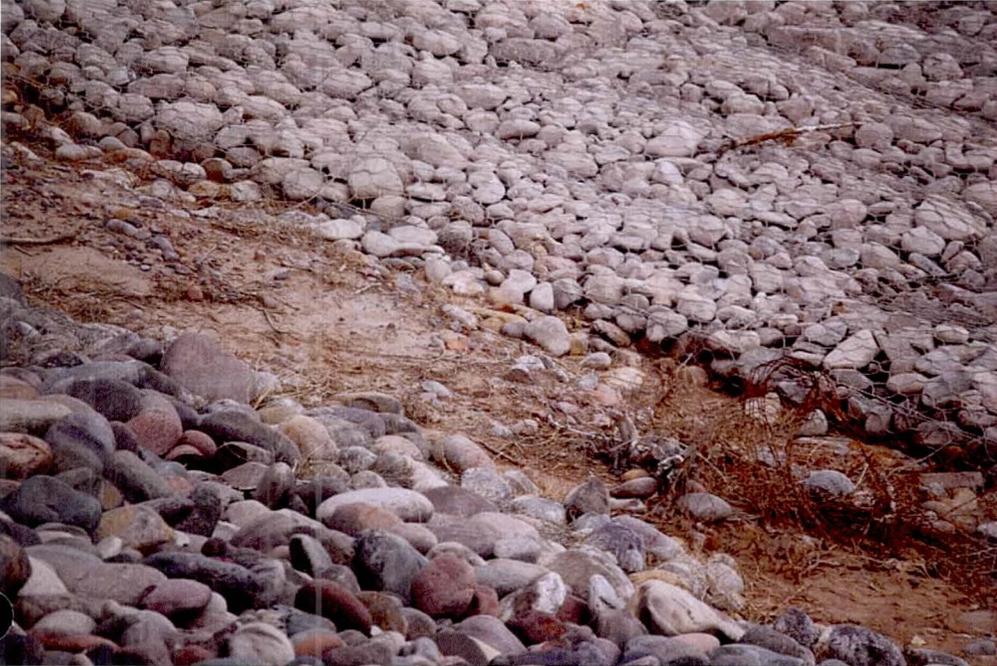
Photo No: 1594
		Location: Tres Rios Levee Station 121+50, Phase 1B
		Description: Looking southeast at levee toe. Soil was observed covering portions of the gabion mattress along the toe of levee.

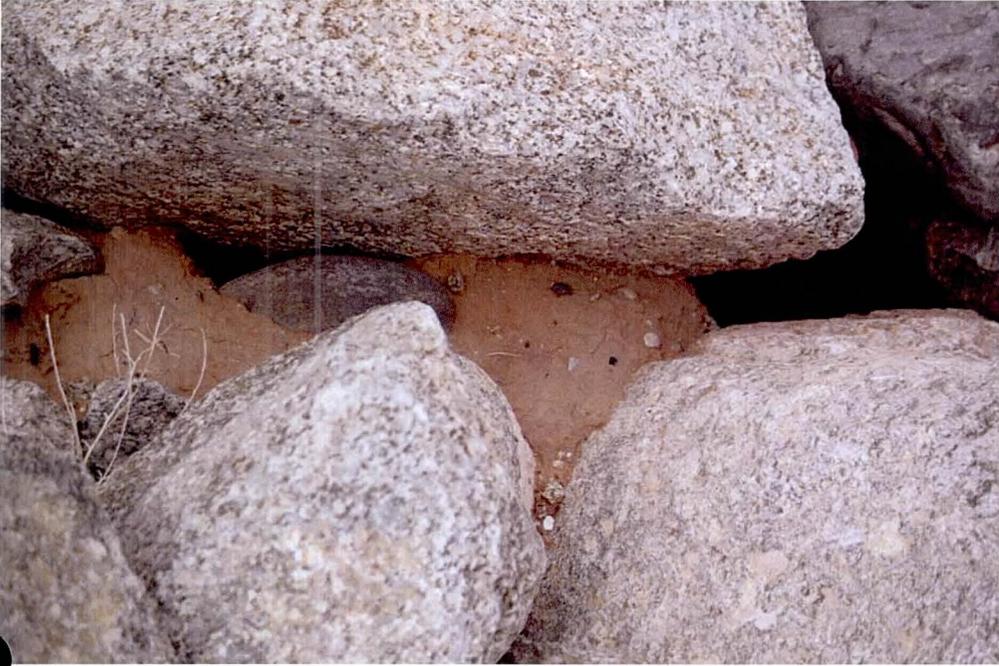
Photo No: 1602
		Location: Tres Rios Levee Station 119+80, Phase 1B
		Description: Looking at West 119 th Ave. Guide Dike. Soil was observed in between riprap voids of the guide dike.

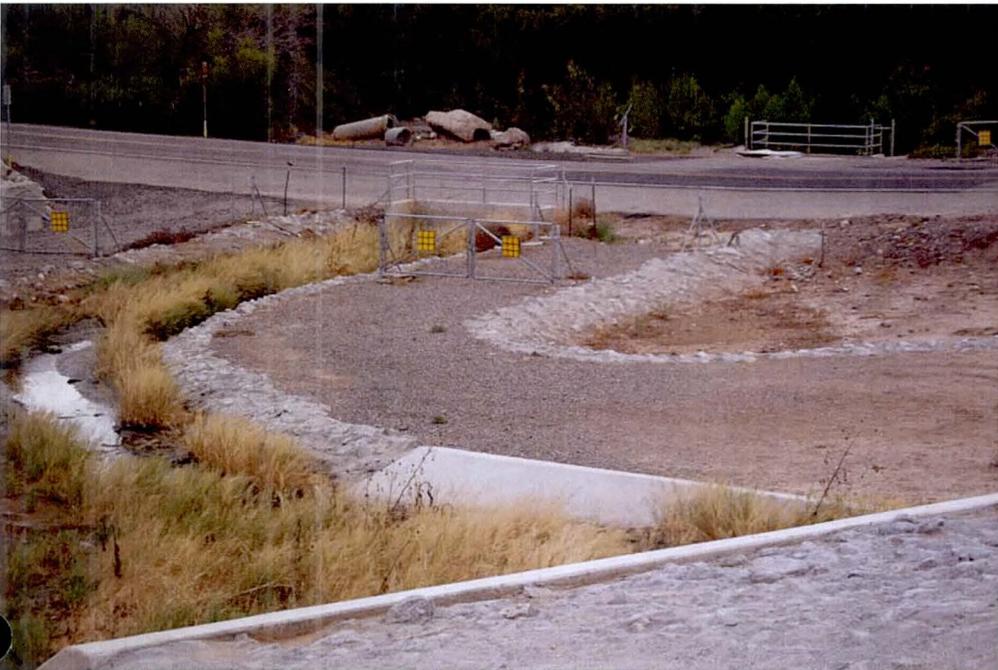
Photo No: 1649
		Location: Tres Rios Levee Station 103+50, Phase 1B
		Description: Looking southwest at Diversion Channel, single 48" RCP structure under El Mirage Rd, and gates. The single RCP is not as designed in plans (4-RCP). Signs of recent construction activity were observed in this area. Grouted riprap protection was observed.

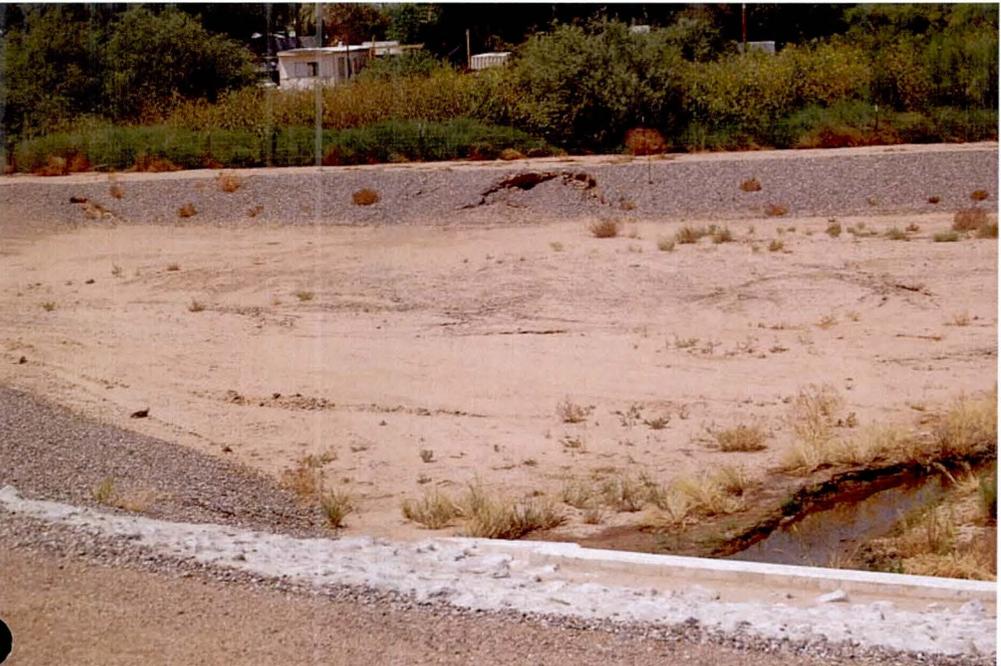
Photo No: 1685
		Location: Tres Rios Levee Station 105+00, Phase 1B
		Description: Looking north at two small slippages in the south facing slope of the 8.5-Ac-Ft Catch Basin near El Mirage Rd. Dense vegetation on the farmland side was observed.

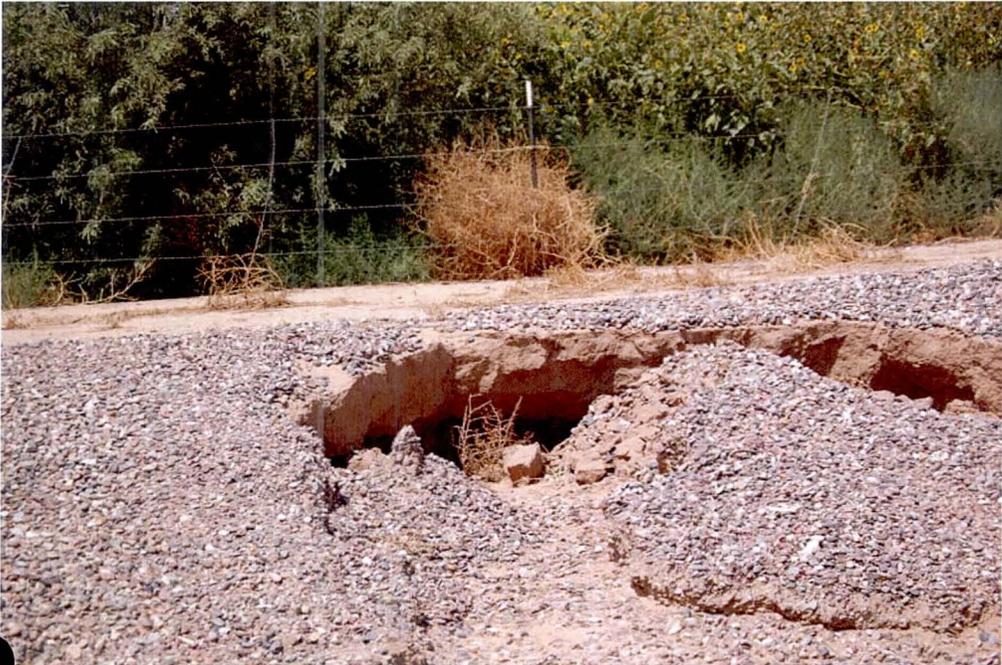
Photo No: 1699
		Location: Tres Rios Levee Station 105+00, Phase 1B
		Description: Looking north at close up view of slope slippage in the northwest corner of 8.5 Ac-Ft Catch Basin near El Mirage Rd. Rodent activity was observed in the slope slippage. Dense vegetation on the farmland side was observed.

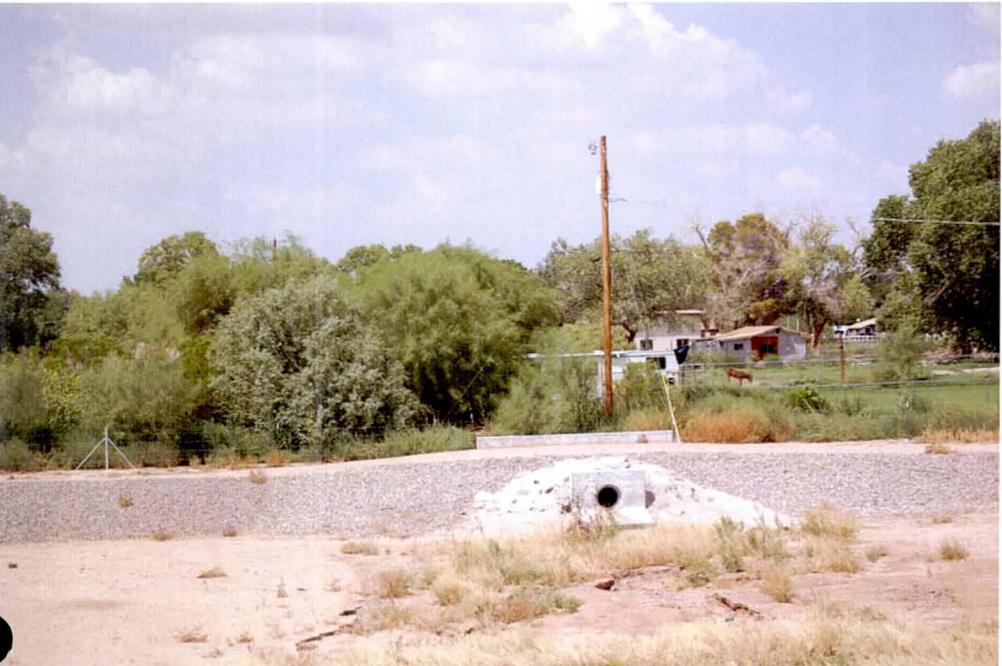
Photo No: 1687
		Location: Tres Rios Levee Station 105+500, Phase 1B
		Description: Looking north at the 8.5 Ac-Ft Catch Basin near El Mirage Rd. A single RCP and power pole guide wire were observed and are not shown on the plans.
