# DREAMY DRAW DAM

## DAM, OUTLET WORKS AND SPILLWAY

PERIODIC INSPECTION

REPORT NO. 3

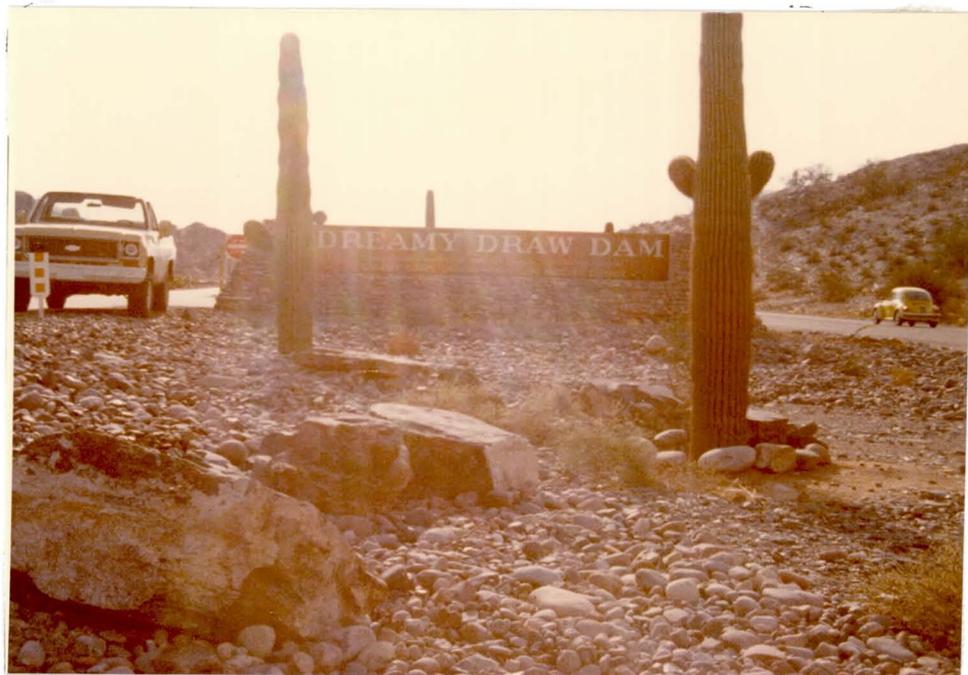
Photo 1 - Entrance to project showing project sign.

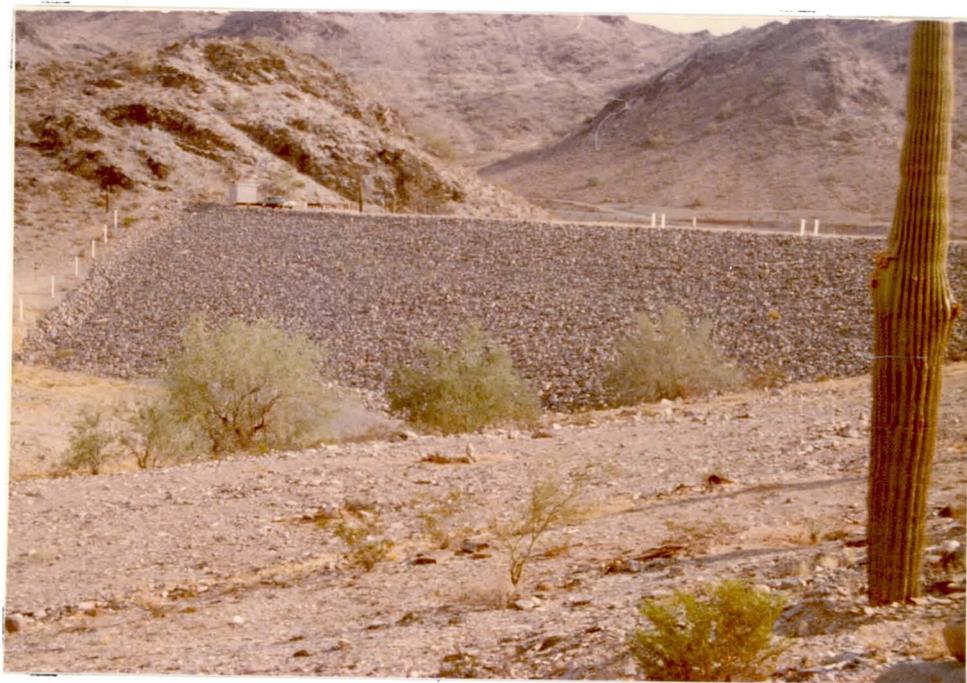
(3) Upstream and downstream slopes - There was no erosion or evidence of burrowing animals on the upstream slope. The riprap on the slope was sound and durable with no signs of deterioration, nor was there any vegetation on the slope. Since the last inspection the freshly applied topsoil on the downstream slope has produced its first covering

Photo 2 - Upstream slope of dam from saddle dike.

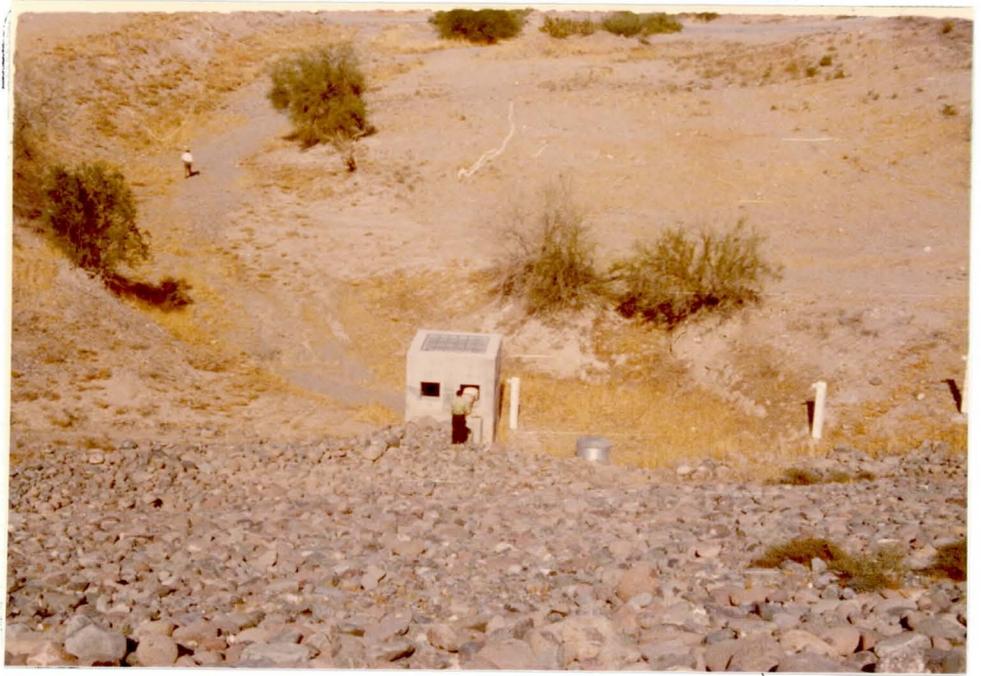
Photo 3 - Reservoir, intake structure and upstream slope of dam from crest.

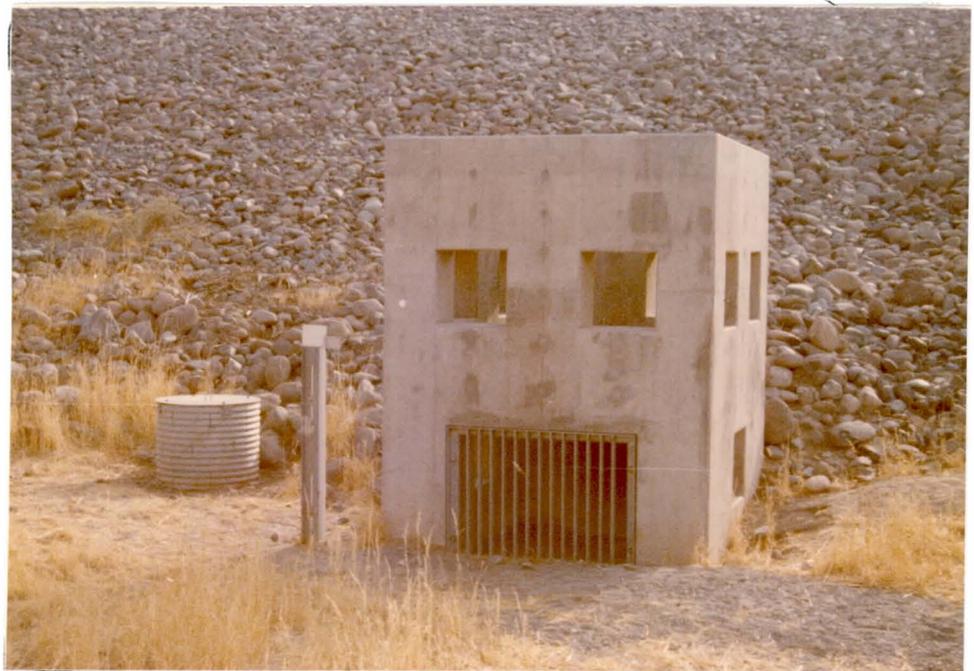
(2) Intake structure - Concrete in the structure was in good condition with no evidence of reactive aggregate and only minor cracking. There was no debris in the vicinity of the structure.

Photo 4 - Intake structure and upstream slope of dam.

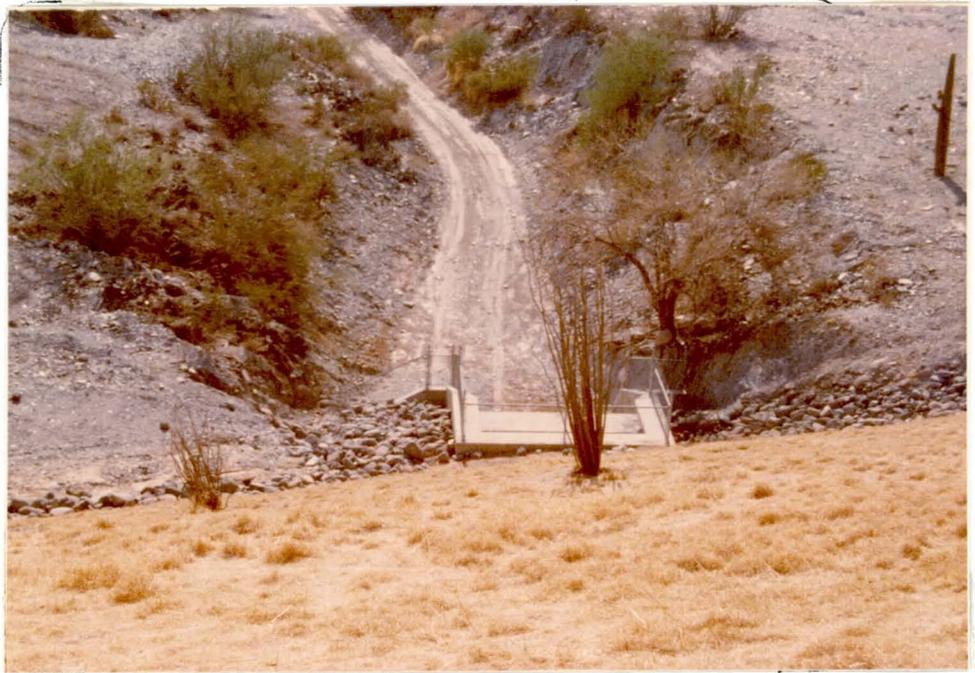
of grass which is now dormant. Several gullies about 1 foot wide and 0.5 feet deep have scoured the emerging turf on the downstream slope from the crest to the toe of the slope. These gullies, about 12 inches apart, form small groups that are about 100 feet apart.

a. The erosion on the downstream slope of the dam is not significant since a stable layer of slope protection was placed on the slope during construction and prior to the addition of the 18-inch layer of topsoil.

Photo 5 - Outlet works outlet channel, outlet structure and downstream slope of dam from crest.

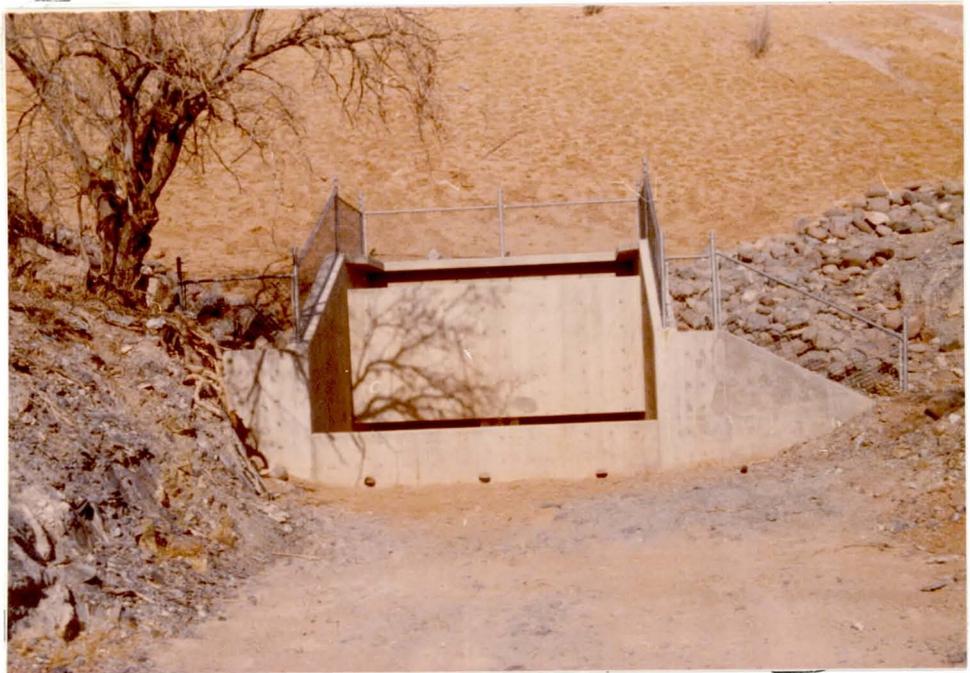
(4) Outlet structure. The concrete was in good condition with no evidence of reactive aggregate or structural distress. Cracking was minor. Two 6-inch drains under the downstream toe of the embankment terminate at the upstream wall of the stilling basin where they are closed by automatic flap gates. Both gates appeared to be in good operating condition.

Photo 6 - Outlet structure and downstream slope of dam.

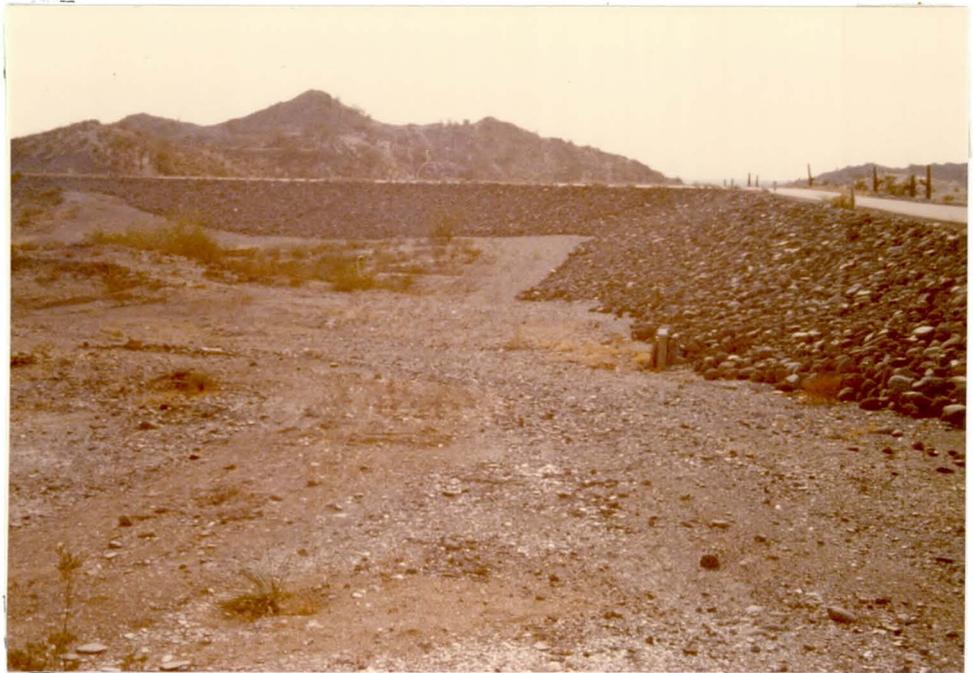
(3) Upstream and downstream slopes - The riprap on the upstream slope was sound and in place. No vegetation was observed on the slope. The condition of the downstream slope was stable.

Photo 7 - Upstream slope of saddle dike from right abutment of dike.

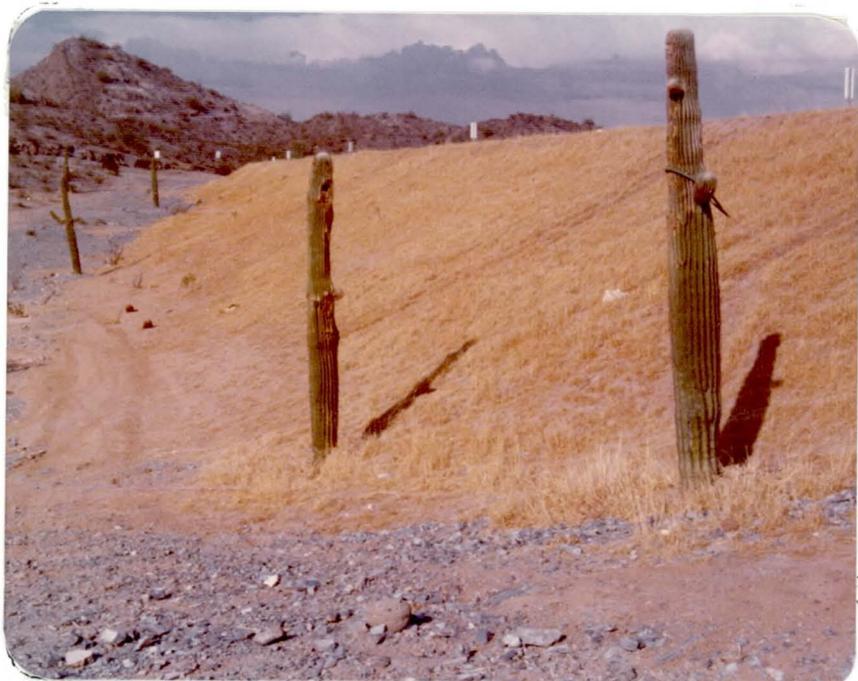
Photo 8 - Downstream slope of saddle dike from left abutment showing new grass now dormant.

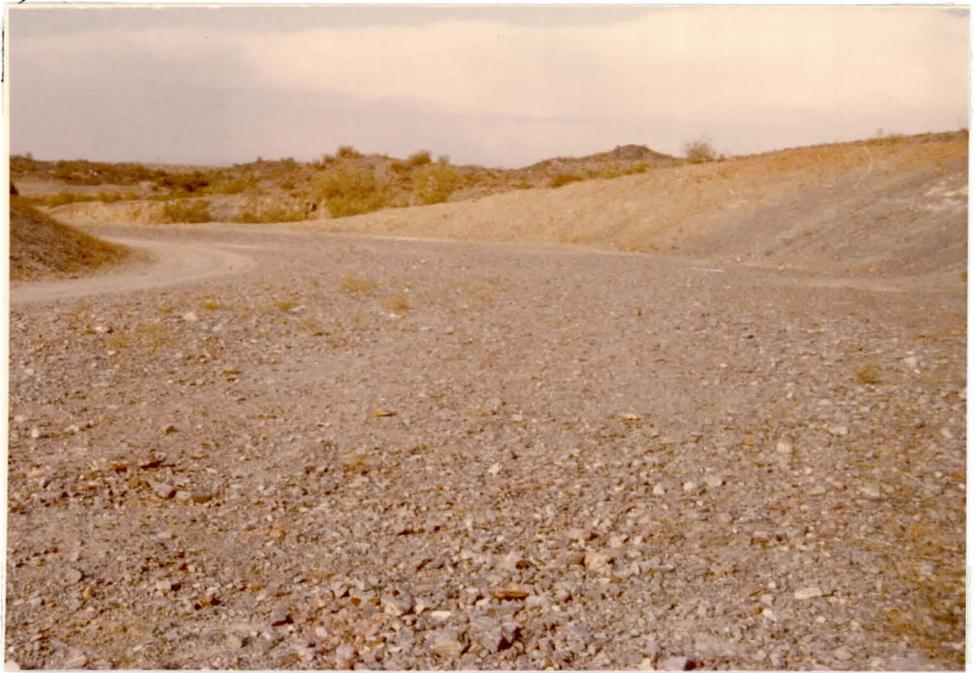
(1) Approach channel - There was some ravelling of the left excavated slope due to flow over the top of the slope from the natural waterways.

Photo 9 - Spillway approach channel looking upstream from sill.

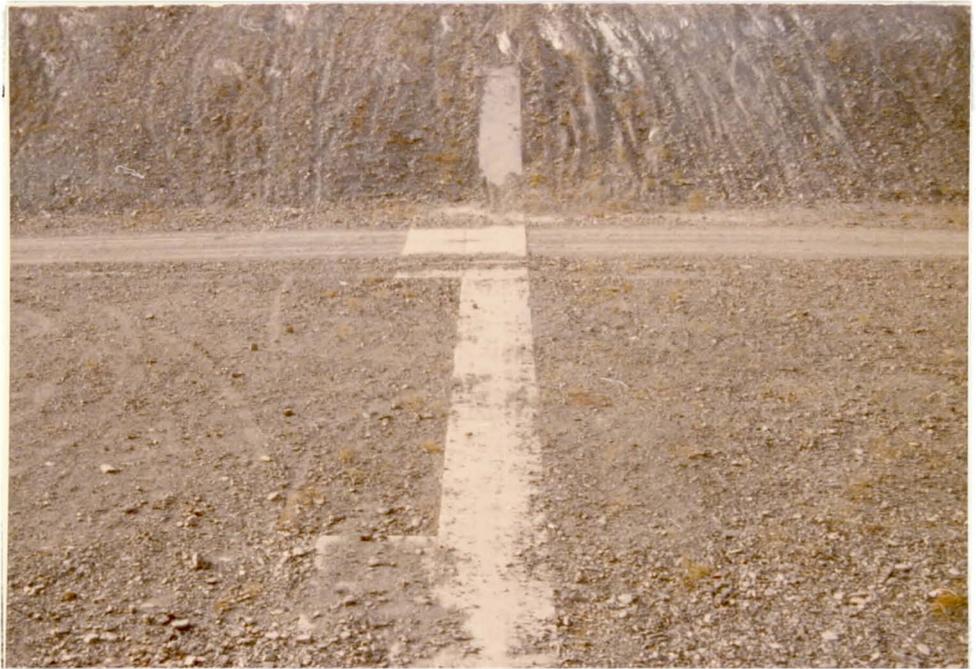
(2) Control section. Concrete in the sill had only minor shrinkage cracking, and there was no sign of reactive aggregate. There was no erosion or ravelling of the excavated slopes above the sill.

Photo 10 - Spillway sill looking west.

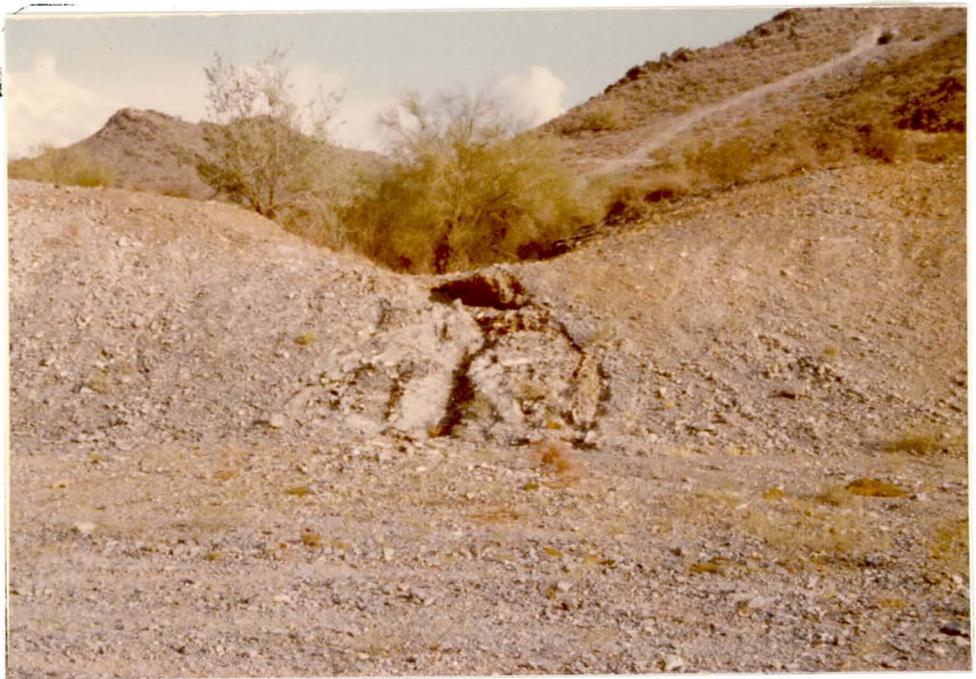
(3) Outlet channel - Excavation for the spillway intersected three gullies 3 to 5 feet deep which drain down the left excavated slope into the channel. Flow from these gullies has caused considerable erosion of the slope since the last inspection. These gullies have a maximum depth of 3 feet. The right excavated slope was not eroding. The channel was clean and unobstructed.

b. The erosion along the left bank of the spillway channel could cause excessive deposition of alluvium in the spillway channel. This could result in partial blocking of the spillway channel.

Photo 11 - Erosion of left side slope of the spillway outlet channel at a gulley drain.

e. Construction of road along the south side of the spillway has amplified the drainage and erosion problems reported during the last inspection. The roadway provided greater runoff and concentrates the

flows into the gullies which were eroding the left side of the spillway. The gully erosion should be arrested by some means. The problem was brought to the attention of the county representative at the site.

a. Install grouted stone flumes with adequate cutoff walls at each of the three gullies draining down the left bank of the spillway channel.

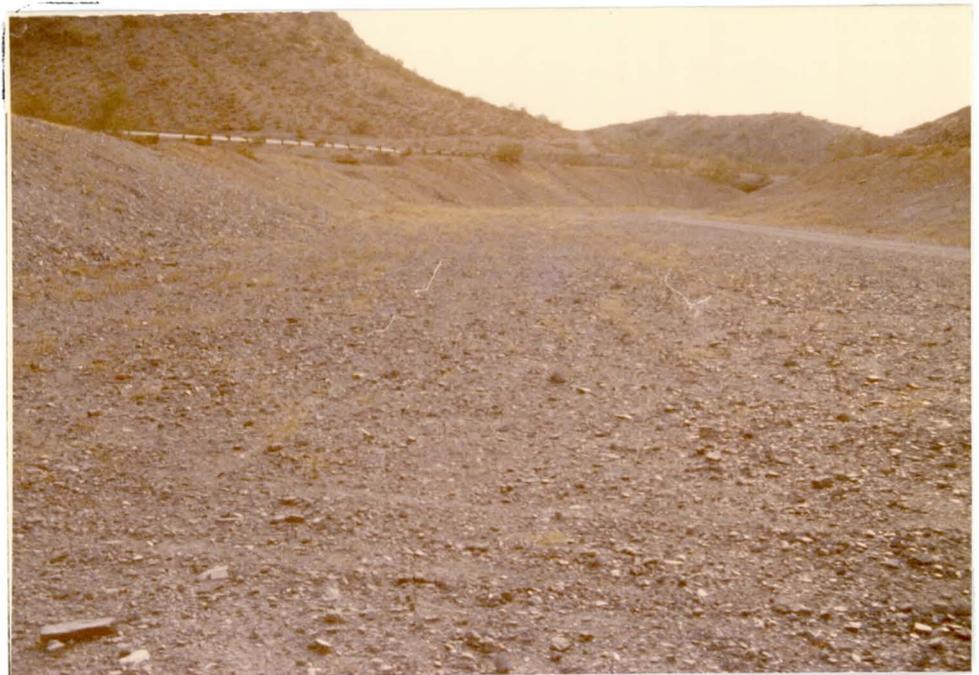
Photo 12 - Spillway outlet channel looking downstream from sill.
