**FINAL GEOTECHNICAL INVESTIGATION
SUPPLEMENTAL INVESTIGATION OF TRANSVERSE CRACKS
BUCKEYE FLOOD RETARDING STRUCTURE NO. 1
FLOOD CONTROL DISTRICT OF MARICOPA COUNTY
CONTRACT FCD 2003C014
WORK ASSIGNMENT NO. 2**

**JANUARY 7, 2005
AMEC JOB NO. 4-117-001021**

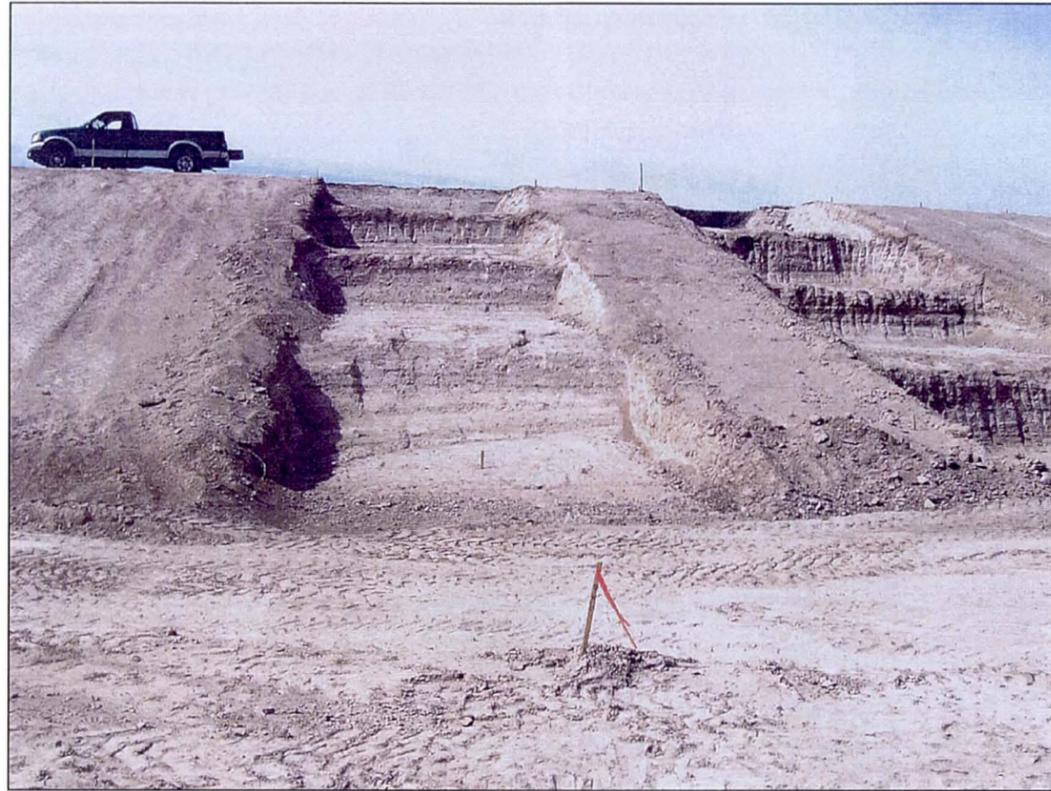
VIEW OF ZONE 1.

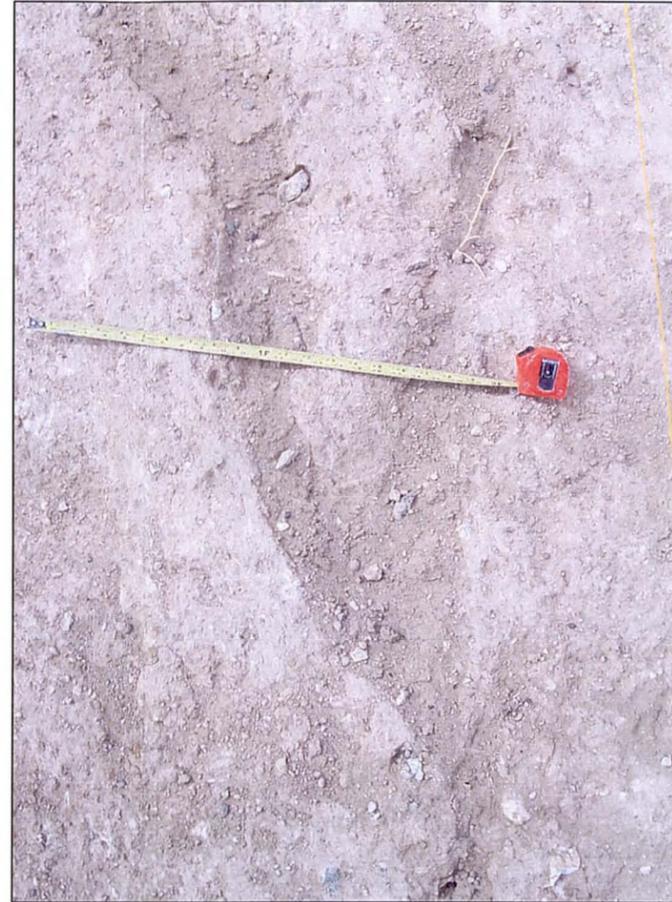
VIEW OF FILLED CRACKS IN ZONE 1 AT NOTE 19.

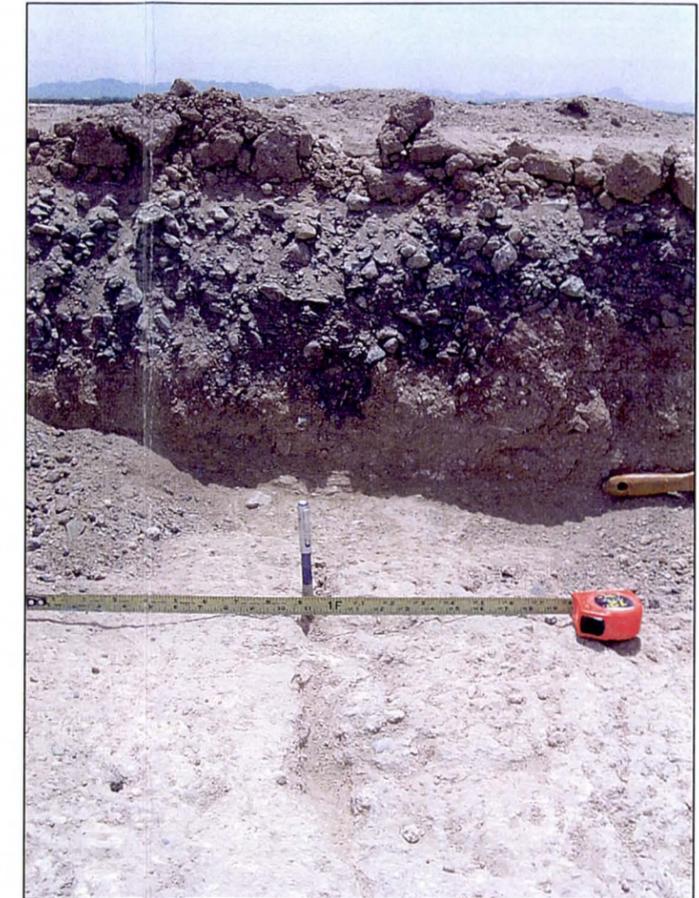
VIEW OF CRACK AS IT APPROACHES THE CENTER DRAIN.
(PENCIL MARKS THE CRACK LOCATION AND CRACK DOES NOT PROPAGATE INTO THE DRAIN).

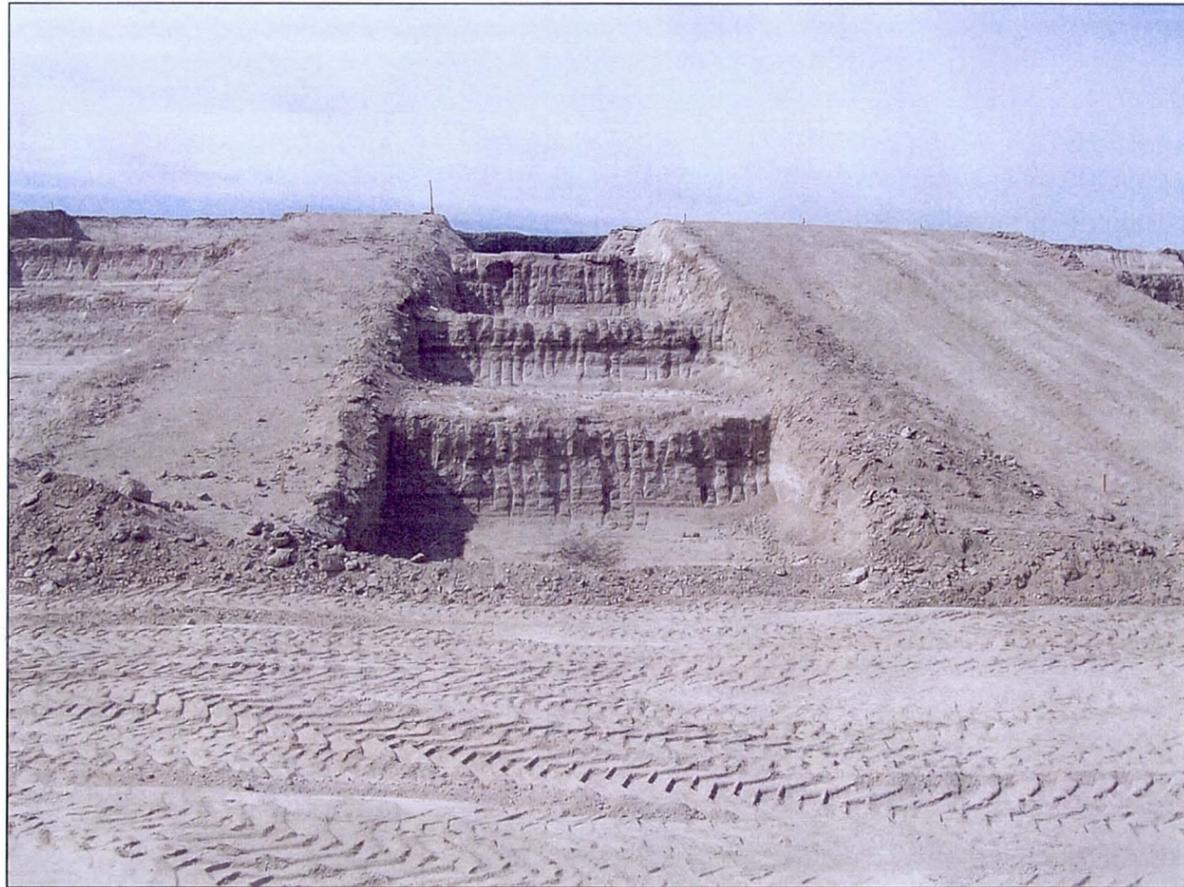
VIEW OF ZONE 2.

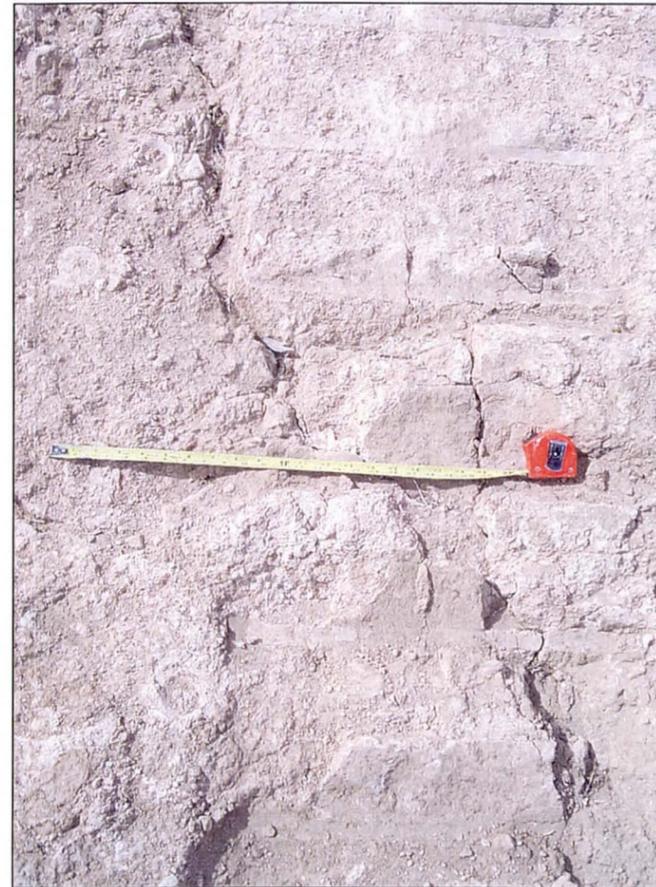
VIEW OF CRACK AT NOTE 23.

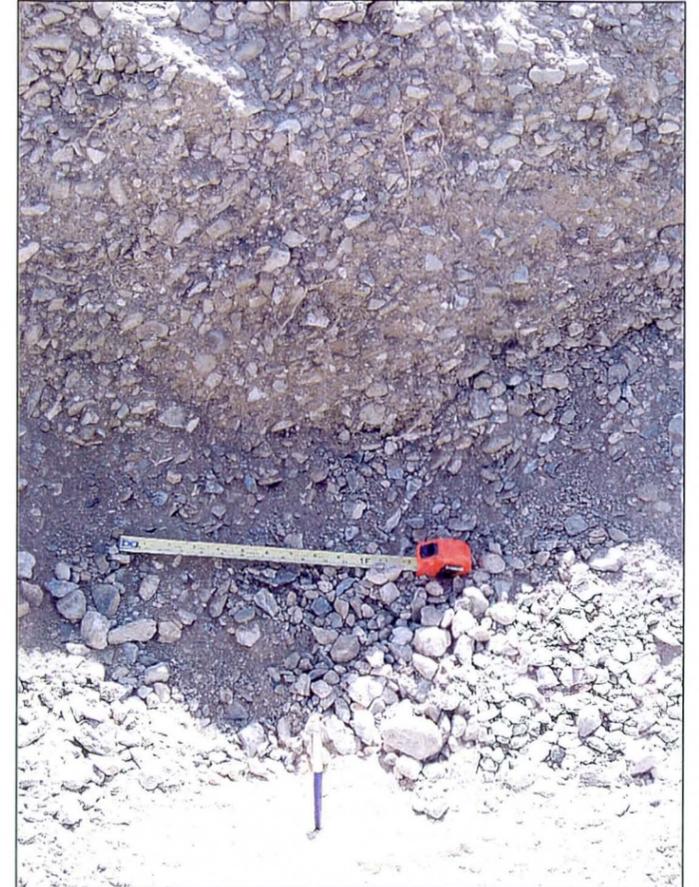
VIEW OF CRACK (INDICATED BY PEN) AS IT APPROACHES THE CENTER DRAIN (CRACK IS NOT PRESENT IN DRAIN MATERIAL).

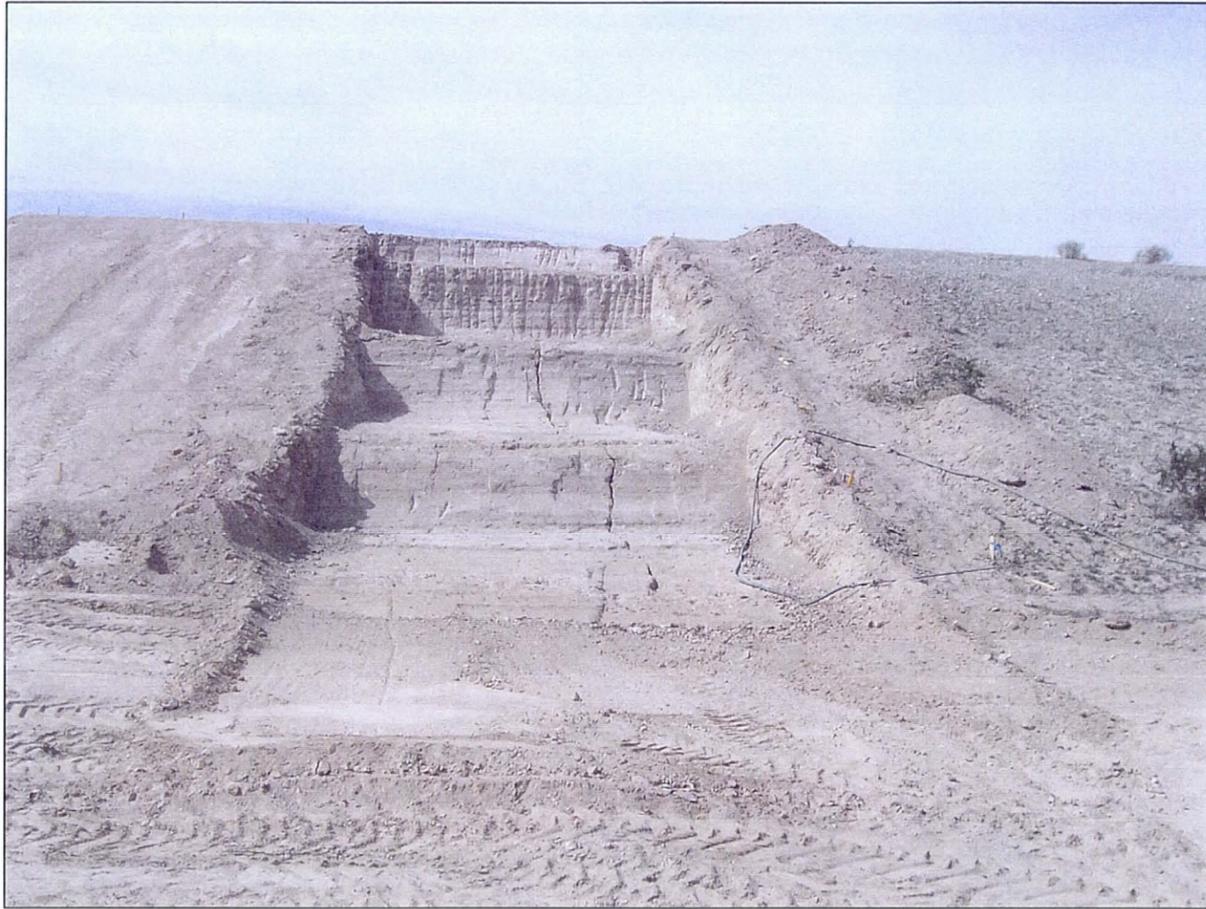
VIEW OF ZONE 3.

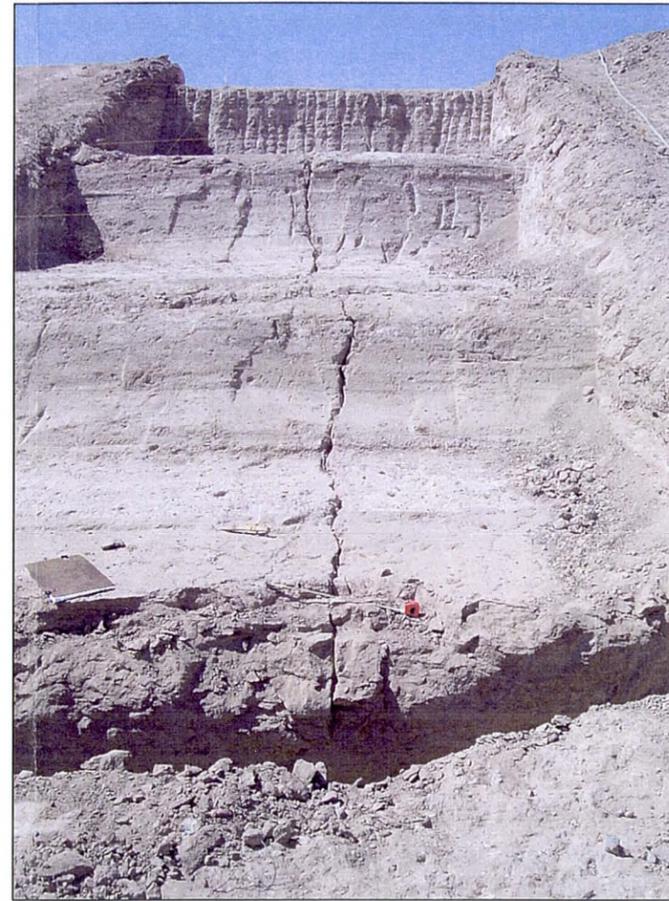
VIEW OF TT-Z3 AND CRACK IN ZONE 3 (CRACK DOES NOT PROPAGATE INTO FOUNDATION).

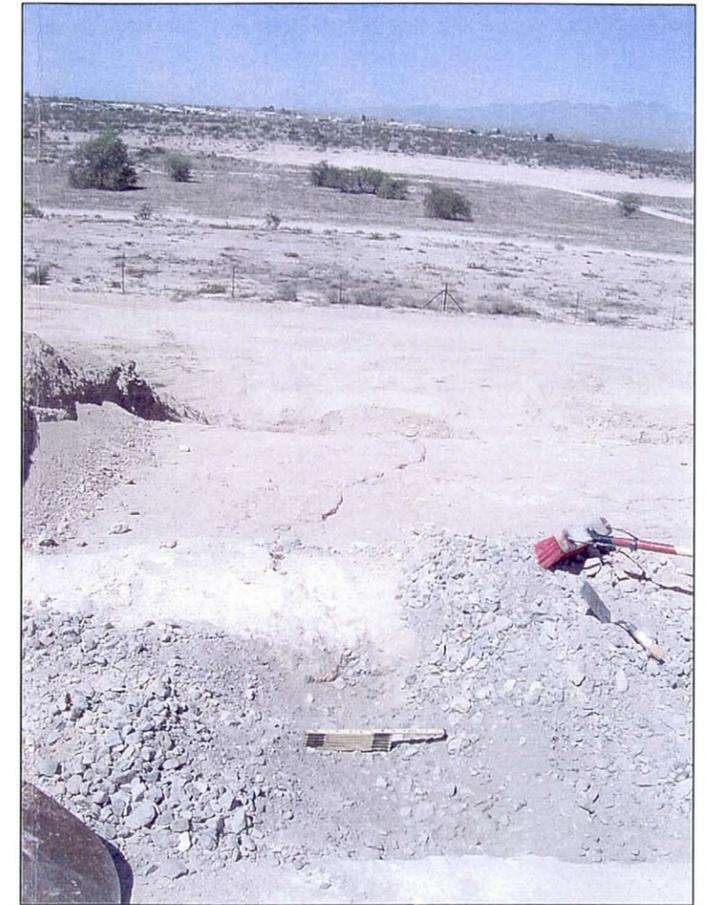
VIEW OF CRACK IN ZONE 3 AS IT APPROACHES THE CENTER DRAIN (CRACK IS NOT PRESENT IN DRAIN MATERIAL).

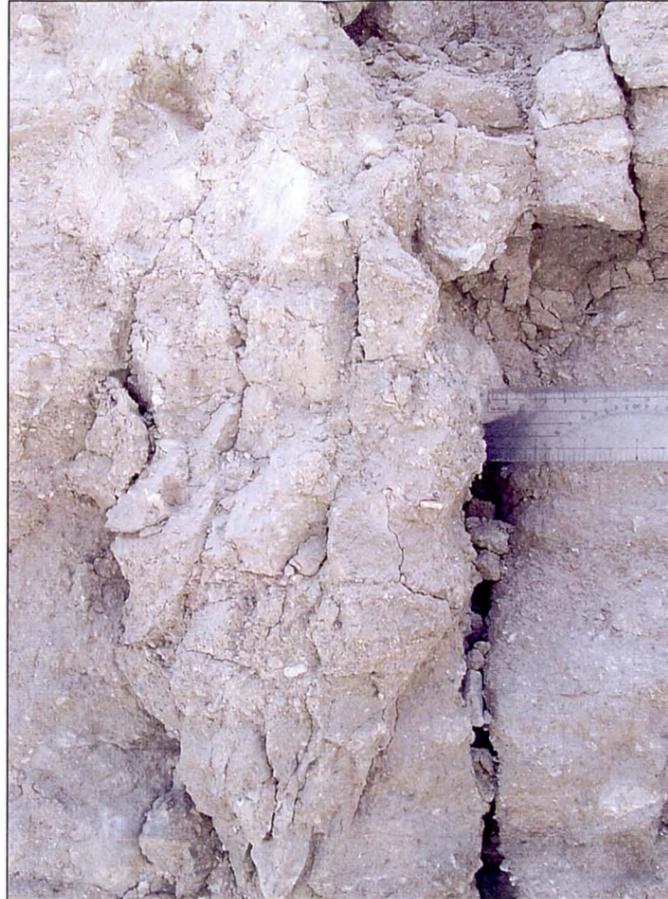
VIEW OF CRACK IN DOWNSTREAM WALL IN ZONE 2. THE DEPTH IS ABOUT 5-FEET BELOW THE CREST OF THE DAM

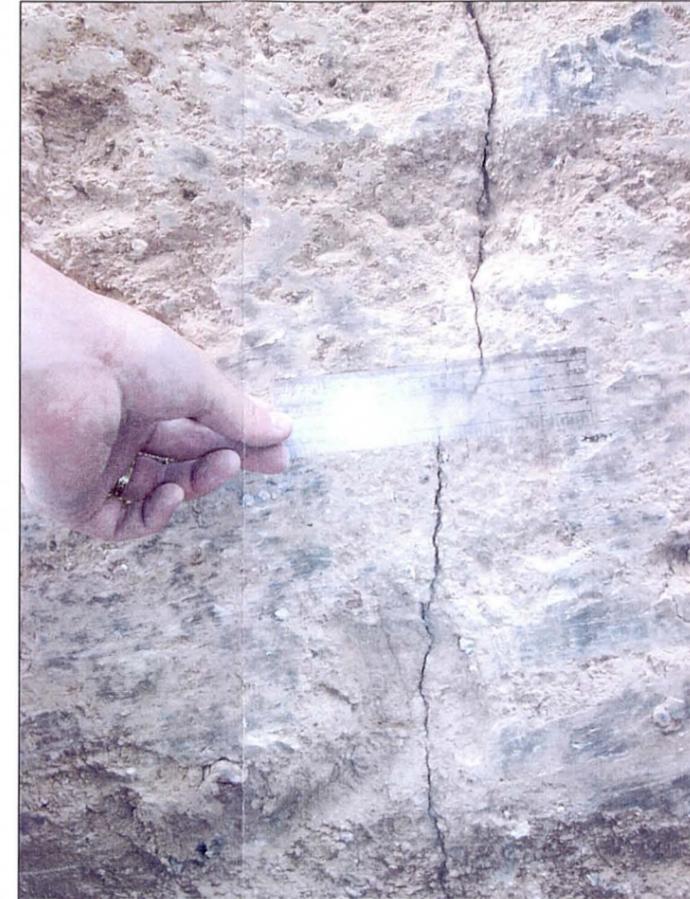
VIEW OF CRACK IN UPSTREAM WALL IN ZONE 3. THE DEPTH IS ABOUT 7-FEET BELOW THE CREST OF THE DAM

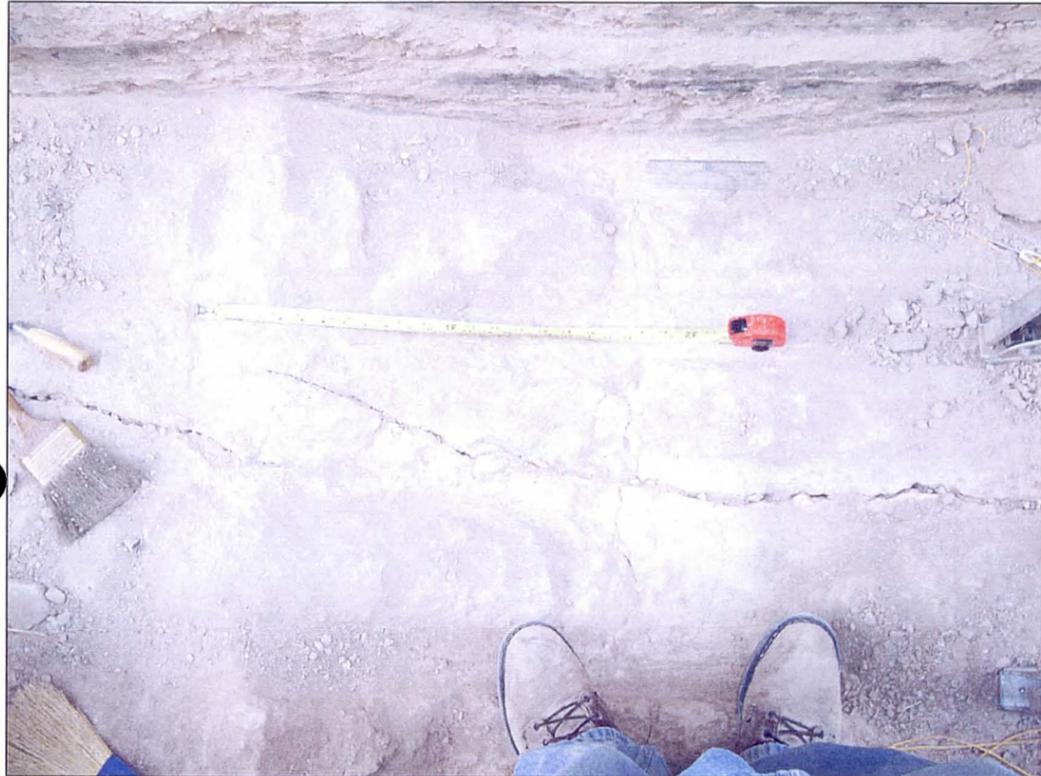
VIEW OF TRENCH BOTTOM (UPSTREAM WALL AT TOP OF PHOTO) AT ZONE 3. NOTE LARGE LONGITUDINAL CRACK AND INTERSECTING TRANSVERSE CRACKS.

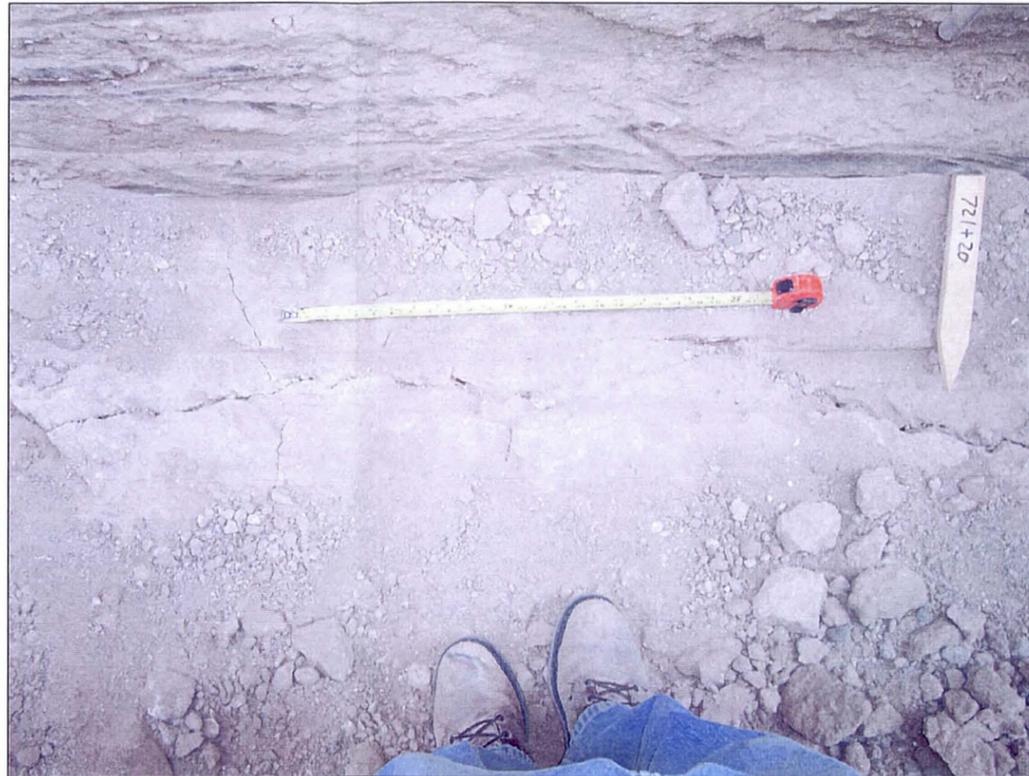
VIEW OF LONGITUDINAL CRACK IN VICINITY OF STATION 721+20 (UPSTREAM WALL IS AT TOP OF PHOTO). NOTE INTERSECTING TRANSVERSE CRACKS.

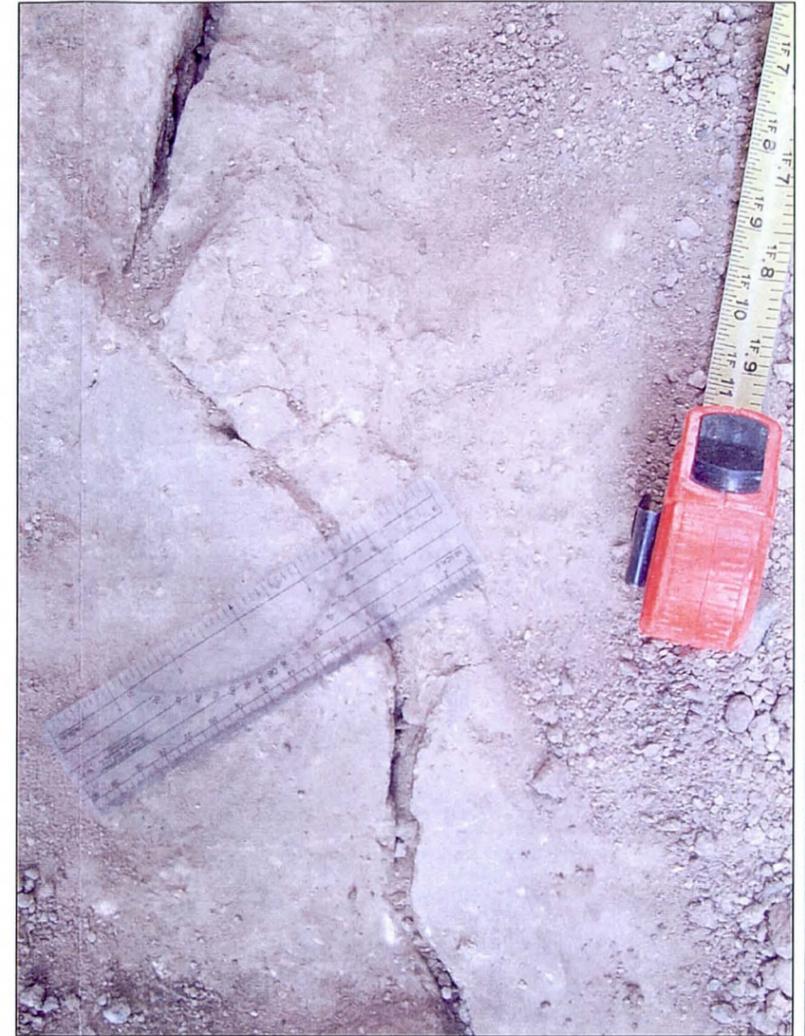
CLOSE-UP VIEW OF LONGITUDINAL CRACK IN THE VICINITY OF ZONE 1.
