**RODGER CREEK  
EROSION HAZARD STUDY**

# Memorandum

**DATE:** September 18, 2001  
**TO:** Joe Tram, P.E./ FCDMC  
**FROM:** Jon Fuller, P.E.  
**RE:** FCD #2000CO13 – Task Order #3  
Rodger Creek Erosion Hazard Study  
**CC:** Tim Murphy, P.E./ FCDMC

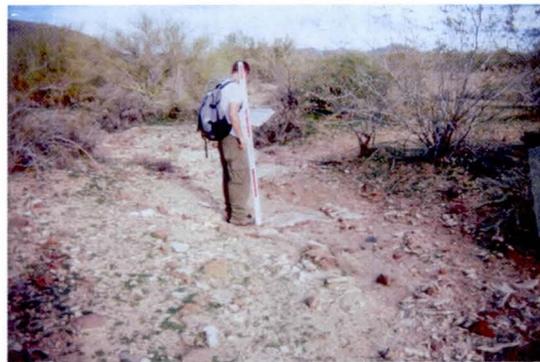
Figure 3. Laminar caliche exposed in bed of Rodger Creek, Reach 1.

- Caliche. Laminate carbonate-rich soil layers (a.k.a. “caliche”) were observed in the bed of Rodger Creek in Reach 1 (Figure 3). Caliche is also exposed in cut banks where the main channel intersects the margins of older geomorphic surfaces in Reaches 3 and 5 (Figures 20 and 21; Table 3). While the caliche layers themselves are more resistant to erosion than the non carbonate-cemented soil layers, field data suggest that the carbonate layers have been eroded by recent stream flows, including overhanging layers and exposed roots. The carbonate layers erode primarily by undercutting the non-cemented underlying layers (cantilever failures), but also by direct shear and impact forces on the carbonate layers themselves (Figure 22). Locations of caliche outcrops observed in the field are shown on Figures 23a to 23d.

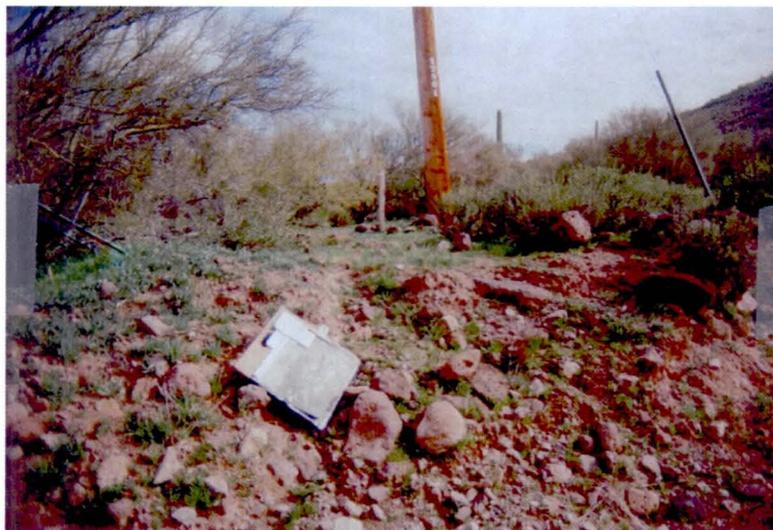
- Floodplain Soils. The soil materials underlying the natural floodplains adjacent to the main channels appear to be comprised of erosive, unconsolidated sand and gravel. A roadcut exposing portions of the soil profile is shown in Figure 19.

Figure 19. Exposed floodplain soil profile at road cut.

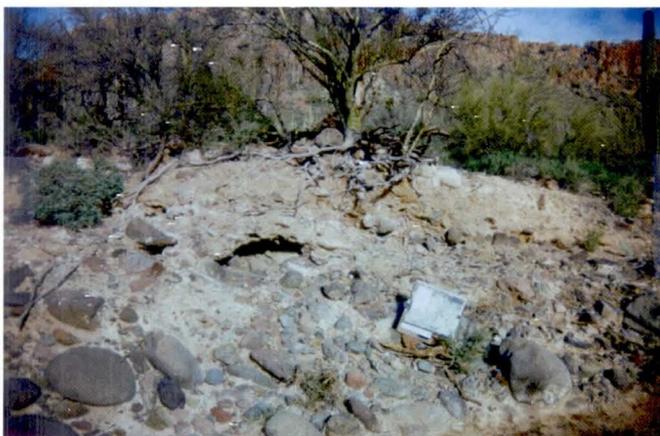
Figure 20. Exposed caliche cutbank on right bank in Reach 3. Note exposed palo verde roots indicating active lateral erosion.

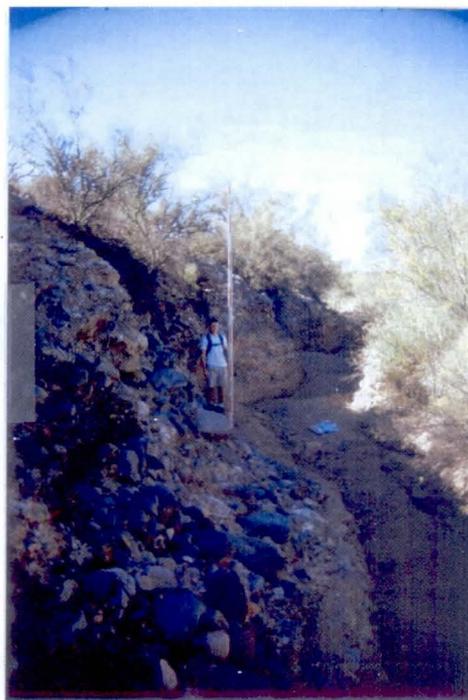
Figure 21. Caliche bank in Reach 5 created by Rodger Creek eroding into old terrace.

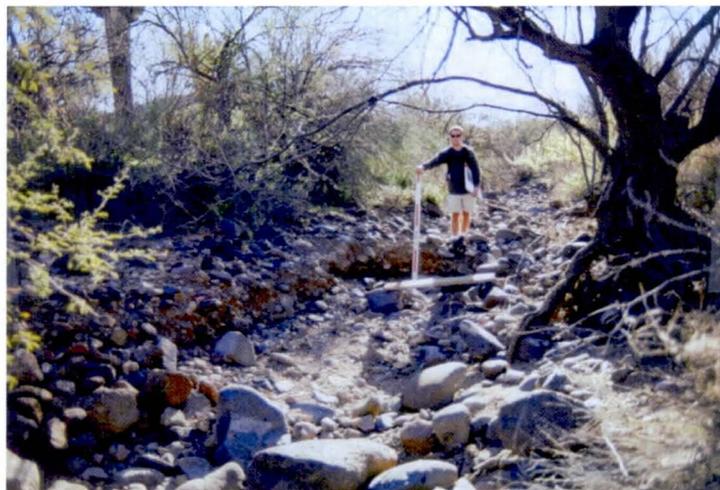
- **Long-term scour.** No evidence of extensive and significant historical long-term degradation on Rodger Creek was observed in the field. Field evidence of long-term scour typically includes undercut bank vegetation, leaning or fallen bank vegetation, high or multiple terraces, abundant cut banks, headcutting, armoring, perched channels, and excessive erosion at structures. The only feature of this type observed was a headcut in Reach 4 (Figure 26), the upstream expansion of which is ultimately limited by the presence of bedrock approximately 2400 feet upstream. However, the New River Road culvert is located between the headcut and the upstream bedrock. The hypothesis of no significant long-term scour is supported by the comparison of longitudinal stream profiles from 1964 and 1997 discussed later in this memorandum (Figure 45).

Figure 26. View upstream at 2' deep headcut in Reach 4. Note also exposed roots on left bank (photo right).

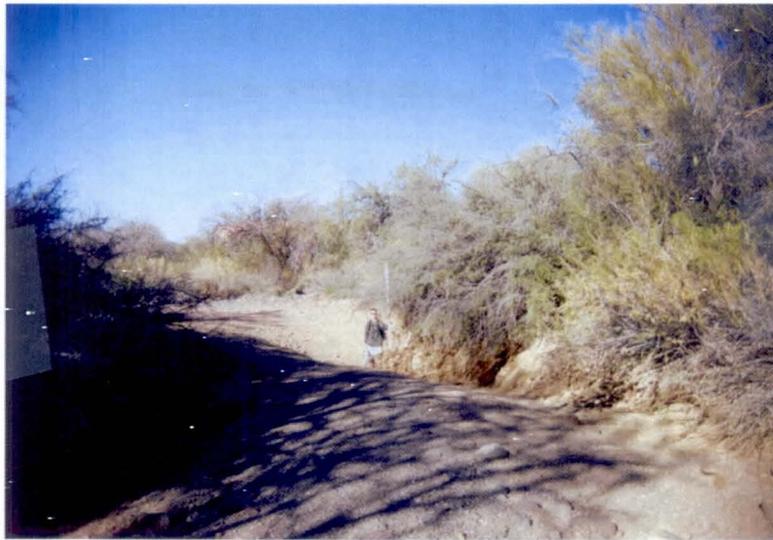
- Local scour. Scour holes up to three feet deep were observed at some channel bends or where natural obstructions such as trees, boulders, or bedrock partially block the main channel (Figure 27). The size of the observed scour holes indicates a moderate potential for severe local scour, especially at bends or obstructions in the creek. The scour holes are created when cross currents erode sediment from the inside of the bend and then deposit the sediment on the outside of the bend when the velocity decreases. Alternately, turbulence created by the obstructions in the creek also contribute to sediment scour adjacent to the obstruction. The size of the scour holes also reflects the moderate flood velocities and peaks that occur in the wash.

Figure 27. Scour hole approximately 3' deep in Reach 4.

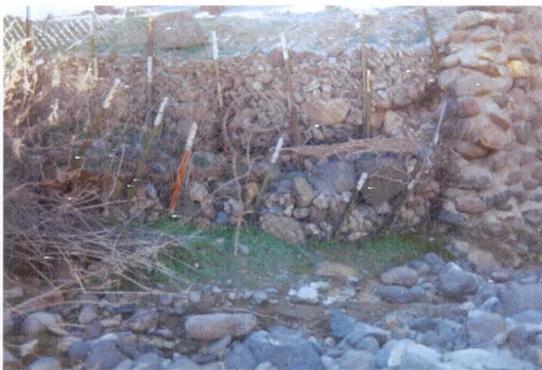
Figure 29. Bank protection on left bank just upstream of New River Road culvert. Culvert abutment is visible at extreme right of photo.

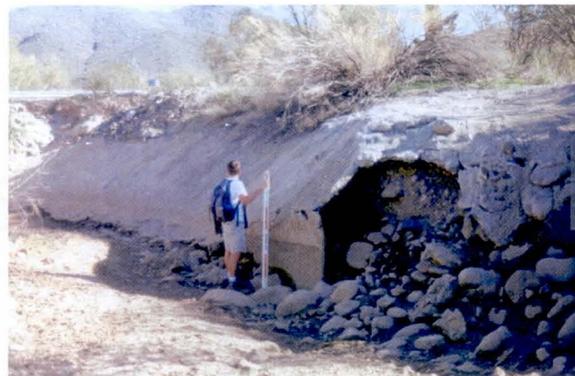
side of the bridge, providing a degree of bank protection (Figure 29). Downstream of the culvert, wire-reinforced concrete protects the left bank. Apparently recent flow has severely undermined the concrete protection (Figure 30).

Figure 30. Undermined concrete bank protection on left bank downstream of New River Road culvert.

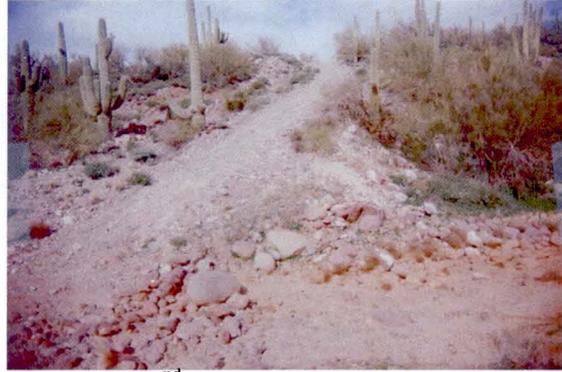
Figure 32. 22<sup>nd</sup> Street road crossing, view at right bank. Road fill interrupts existing floodplain.

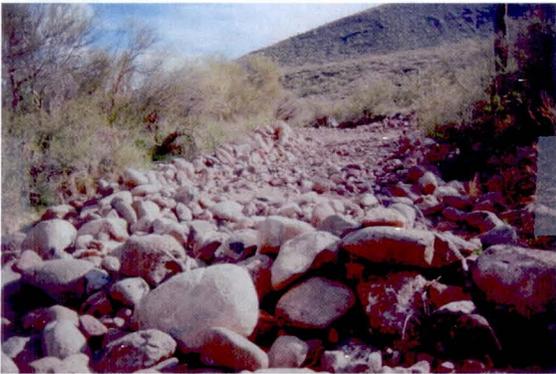
Figure 33. Disturbance of creek bed downstream of 20<sup>th</sup> Street road crossing, view upstream.

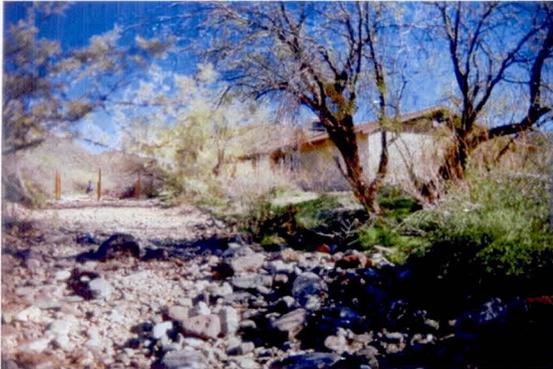
Figure 37. Home built partially in floodway of Rodger Creek downstream of New River Road, view upstream. Note Abandoned bridge pilings in creek bed.

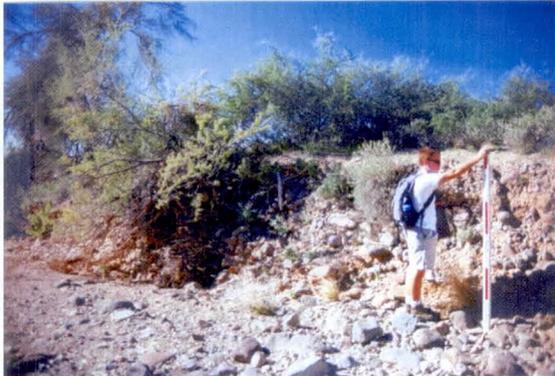
Figure 39. Cut bank in Reach 5.

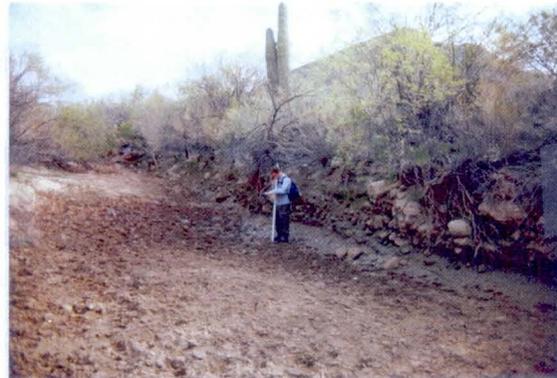
Figure 40. Cutbank in Reach 3.

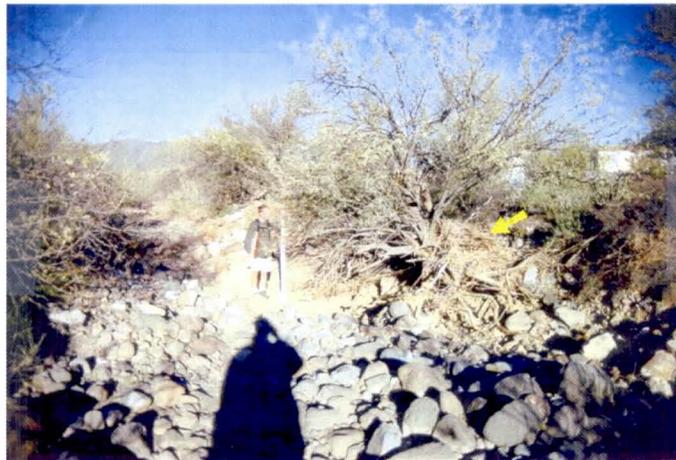
- **Flood High Water Marks.** Flotsam observed along the banks of the main channel in Reach 4 indicates that at least one flood has recently filled the channels and inundated portions of the floodplain. The depth of flow as indicated by the flotsam was approximately 4 to 5 feet deep in the channel (Figure 44).

Figure 44. Flotsam observed slightly above bank level in Reach 4. View downstream.
