**SUBJECT:        ADDENDUM # 1 TO PHASE I ENVIRONMENTAL SITE ASSESSMENT AT  
                     THE DYSART DRAINAGE CHANNEL, ASSIGNMENT FCD-037, MARICOPA  
                     COUNTY, ARIZONA**

**SUBJECT:        ADDENDUM # 3 TO PHASE I ENVIRONMENTAL SITE ASSESSMENT AT THE DYSART DRAINAGE CHANNEL, ASSIGNMENT FCD-037, MARICOPA COUNTY, ARIZONA**

**SUBJECT:        ADDENDUM # 2 TO PHASE I ENVIRONMENTAL SITE ASSESSMENT AT  
 THE DYSART DRAINAGE CHANNEL, ASSIGNMENT FCD-037, MARICOPA  
 COUNTY, ARIZONA**

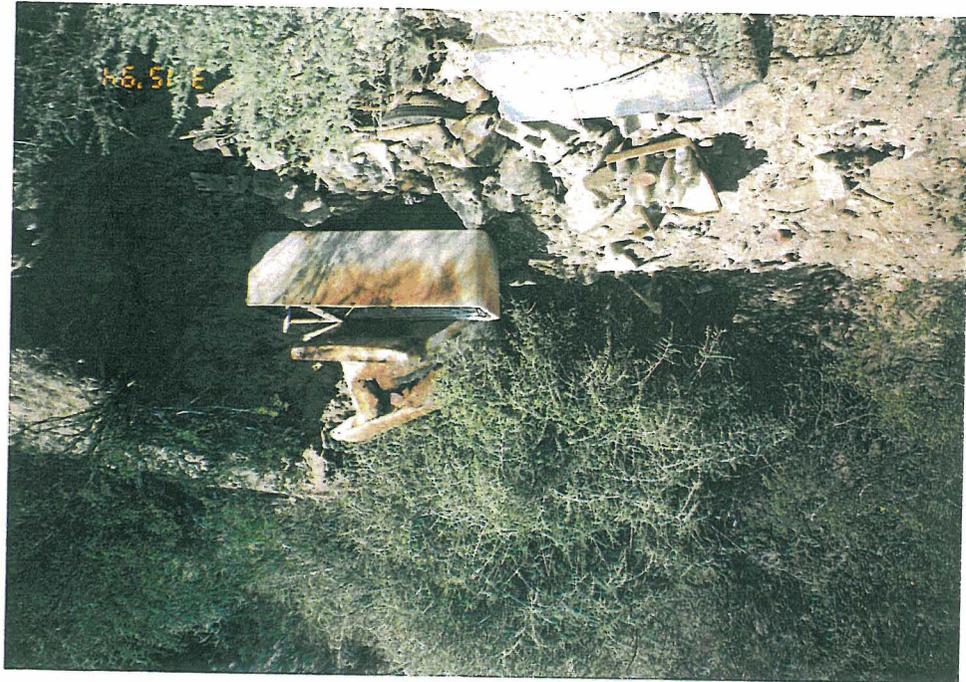
The dumped materials visually appeared to be non-hazardous in nature. In addition to paper trash, the debris included an old camper shell north of the channel near the Agua Fria outfall; a couch, some auto parts, and a few piles of tree cuttings north of the channel between El Mirage and Dysart Roads; and a large pile of dirt and concrete rubble located on the Luke School yard. The dirt pile was approximately 50 to 100 cubic yards in volume.

The origin of the large pile of dirt and concrete rubble on the Luke School yard was not determined. However, visual observations suggest that part of the pile may be made up of sediment previously dredged from the channel. If this is the case, this sediment would be expected to exhibit residues of pesticides and/or herbicides from agricultural runoff into the channel. The previous Phase I assessment included sampling and analysis to screen for elevated pesticide and herbicide concentrations in sediment still in-place in the channel. The only detected compounds were observed at very low levels, well below the applicable Health-Based Guidance Levels established by ADEQ. Although CEC/WRA cannot say conclusively that this pile does not contain hazardous substances, no evidence was observed to suggest that disturbance of the pile is likely to present a problem.

**PHOTOGRAPH 1**  
Soil piles on adjacent Luke School property.

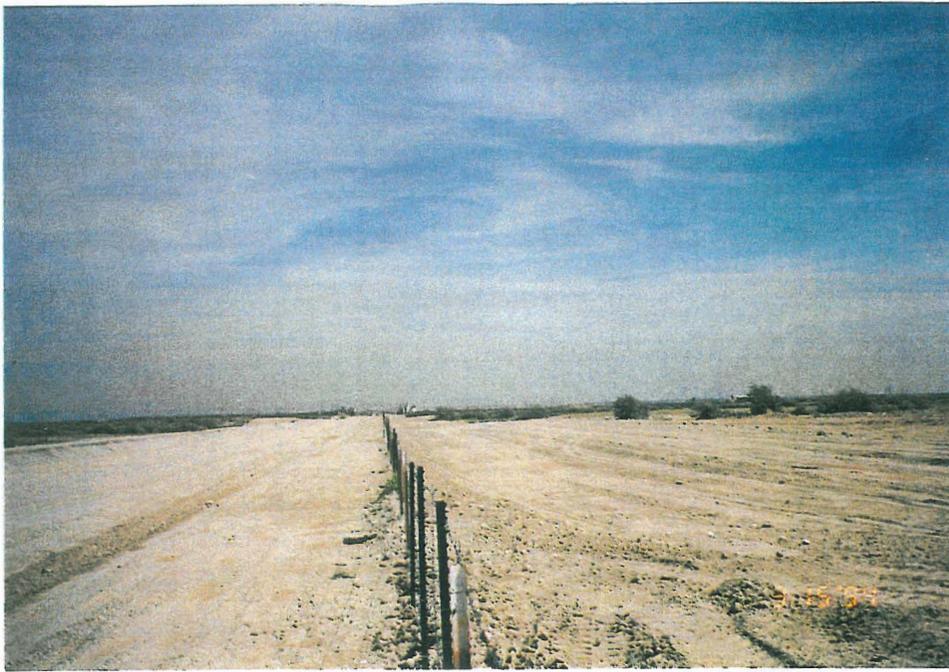
**PHOTOGRAPH 3**  
Graded area of subject property to south of channel, between Dysart and El Mirage Roads.

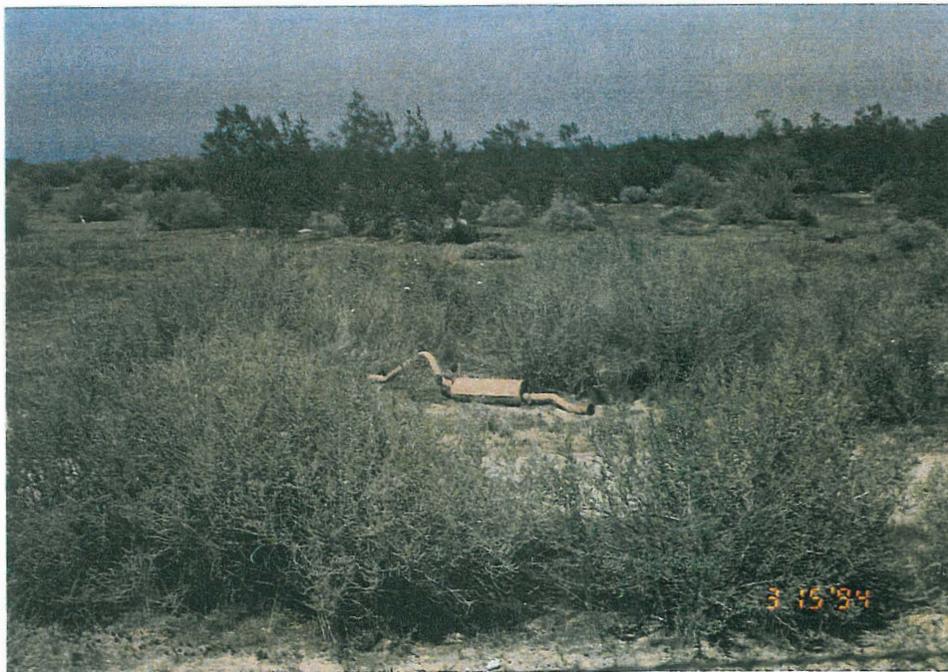
**PHOTOGRAPH 4**  
View of typical native desert with isolated dumping on subject property.

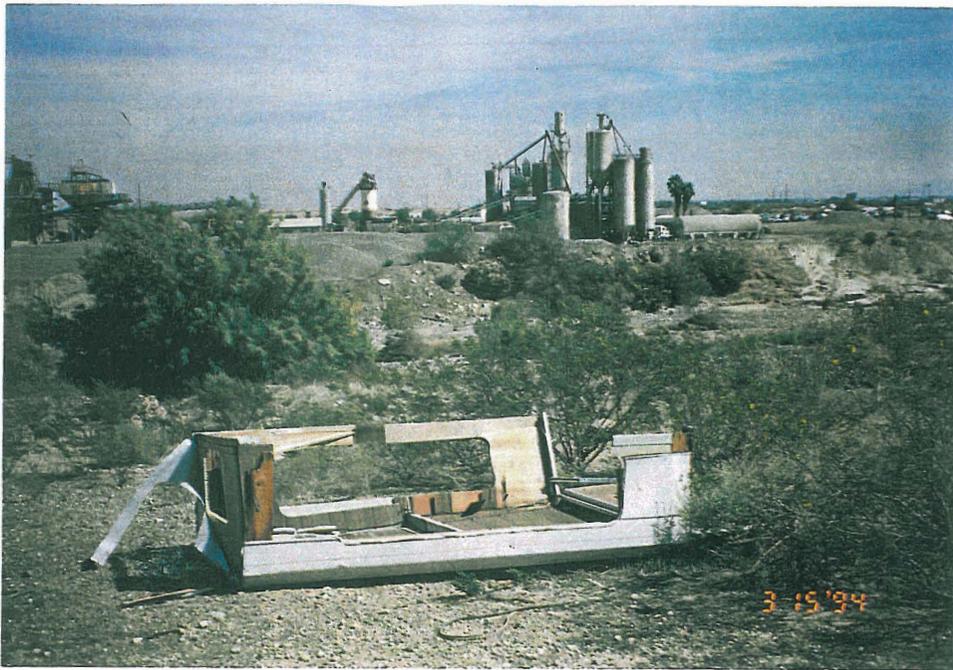
**PHOTOGRAPH 5**

Camper shell on subject property near Agua Fria outfall. Concrete plant off-site in background.

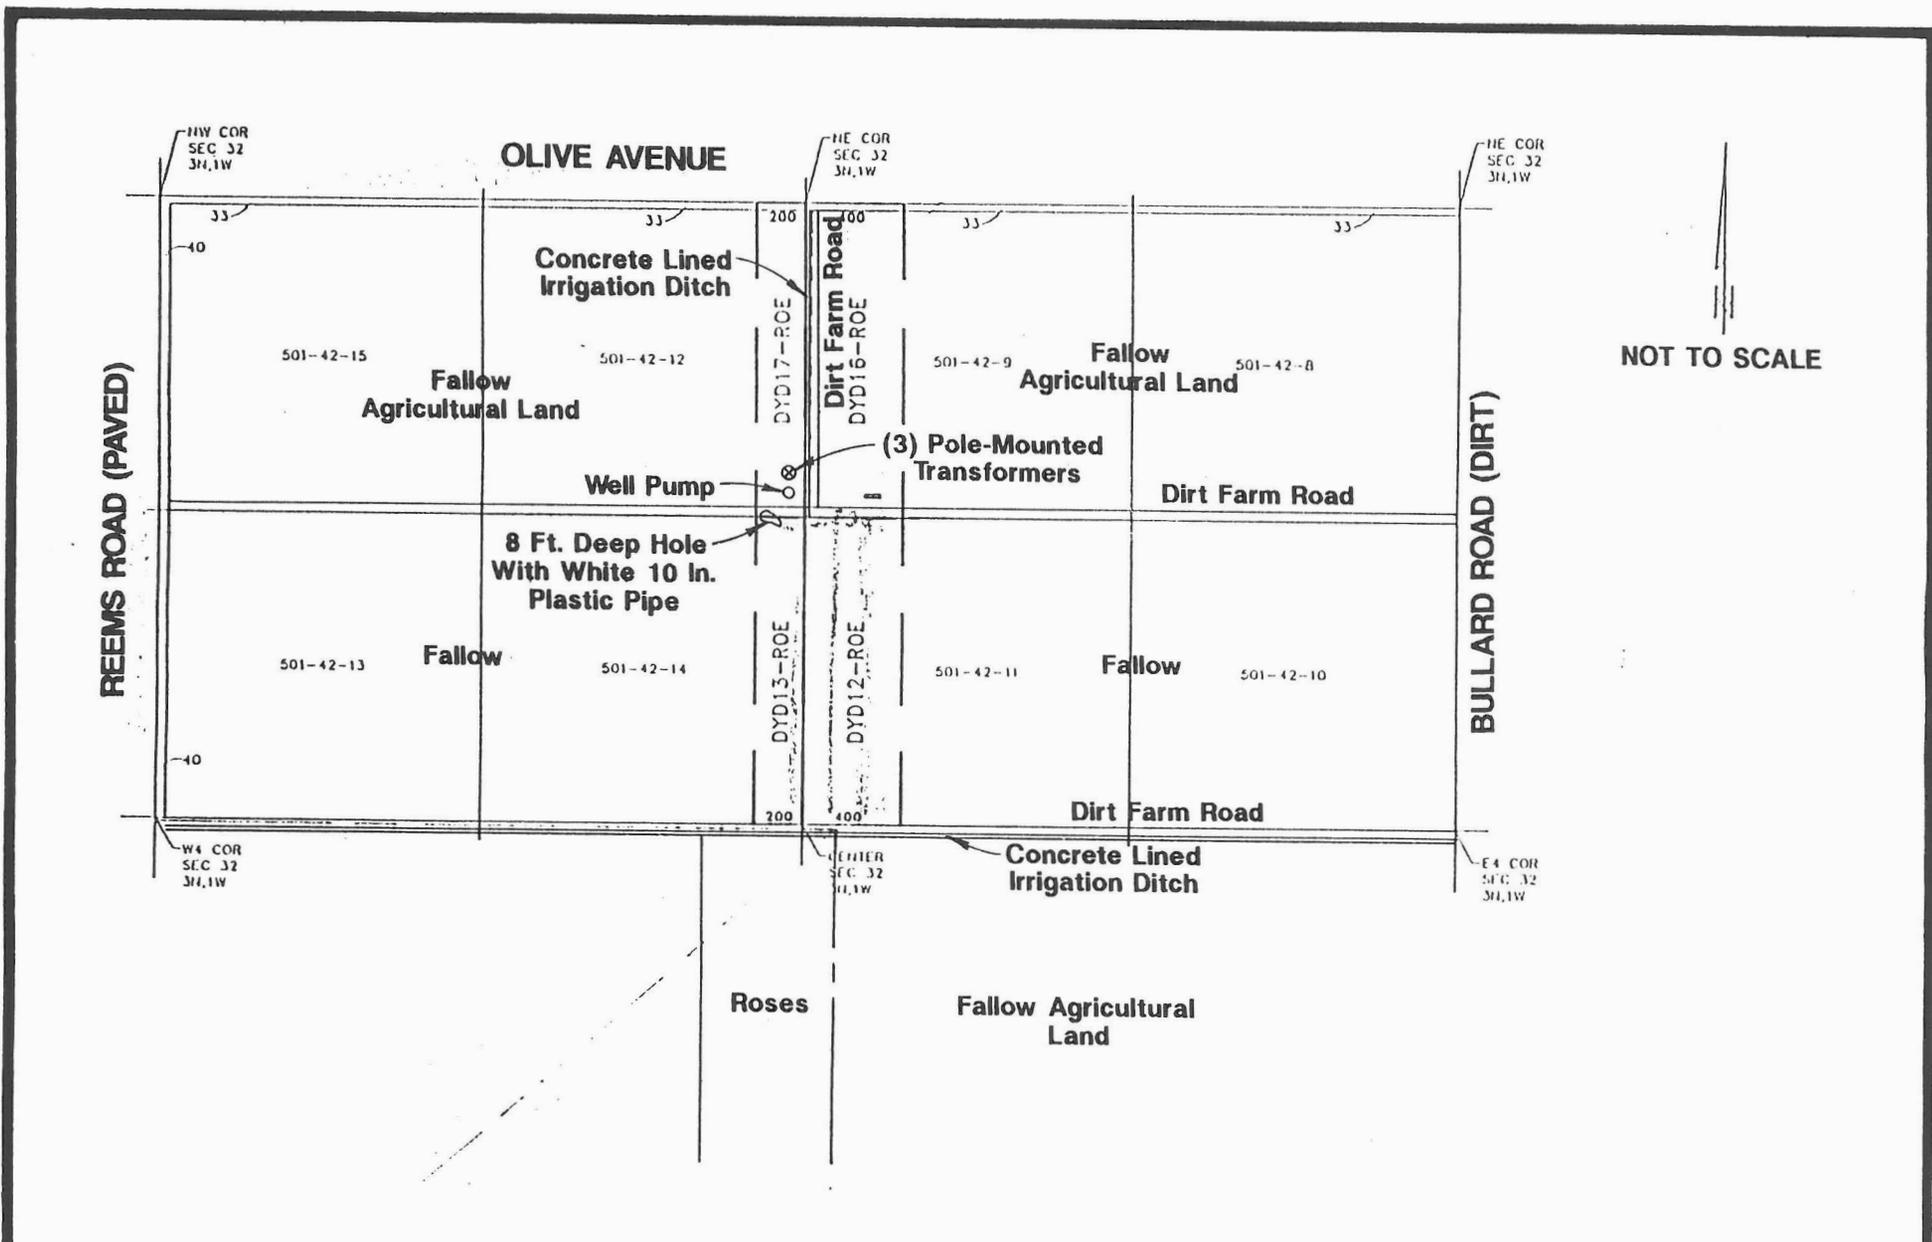
**FIGURE 2**

CEC/WRA personnel visited the subject property on January 24, 1994. The site visit was conducted to confirm aspects of the records review, and to visually identify features suggesting the potential presence of hazardous substances on the subject property, or the potential for migration of hazardous substances from adjacent properties onto the subject property. Relevant observations are shown on Figure 2.

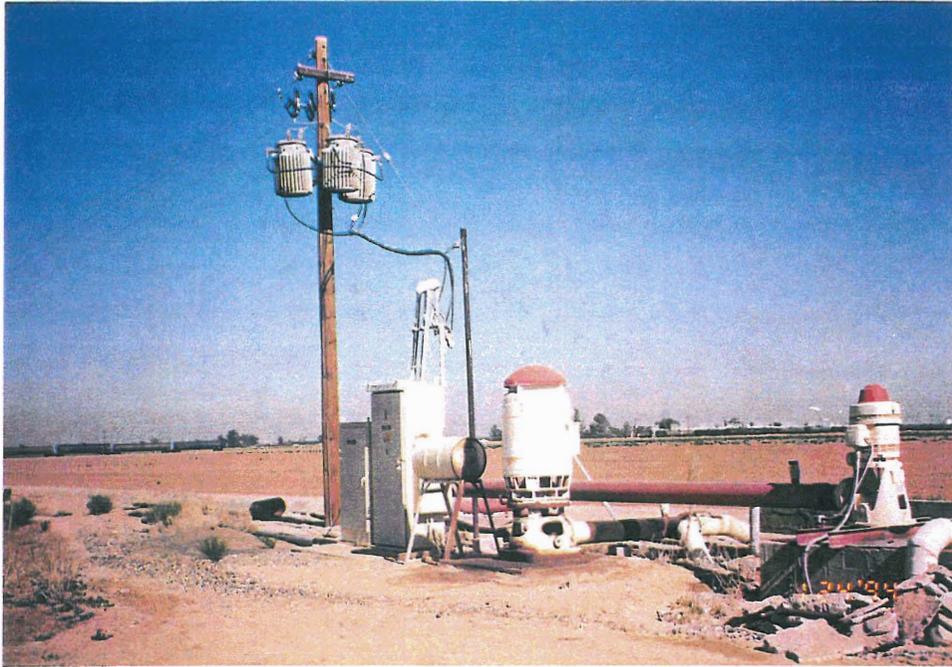
**Photograph #5**  
Well, pump, and pole-mounted transformers on adjacent property to the west.

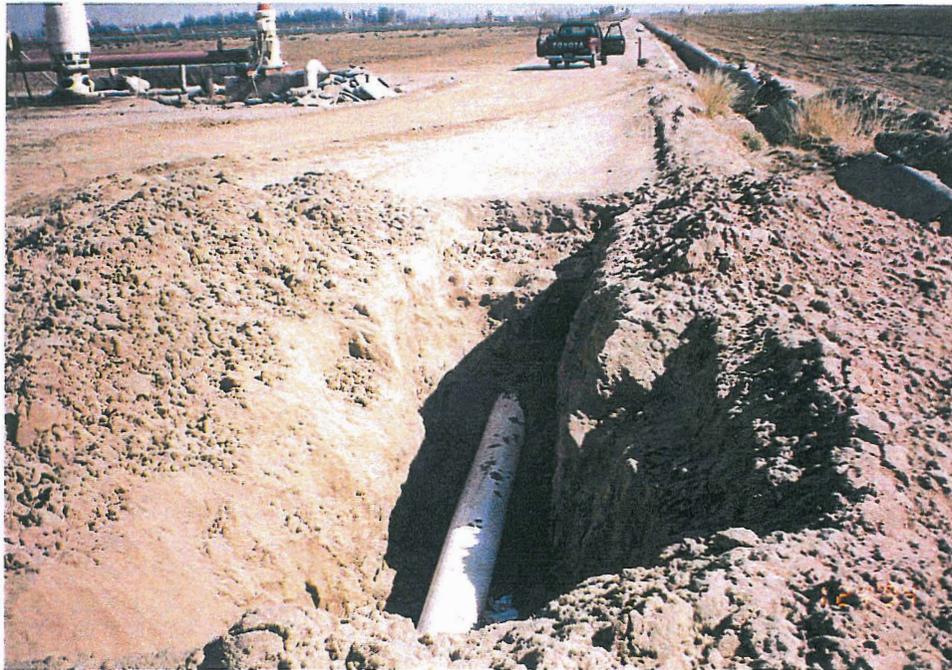
A water line appeared to run along the southern side of the field road crossing the property from east to west. In one area near the center of the site, a hole approximately 8 feet deep had been excavated and a 10" white plastic pipe was exposed. Further to the east along the same road, two stationary pumps were present with canvas hoses to feed the irrigation ditch. The pumps were aligned with the plastic pipe observed in the hole. Along the same alignment was a small welded steel device which appeared to be either a gate support or a traffic barricade. Adjacent to the structure was a 6" diameter galvanized steel pipe protruding approximately 3" from the ground, with a conical steel cap. Although CEC/WRA could not conclusively determine the purpose of the pipe, which is shown in photograph # 8, it appeared to be a foot valve or other type of relief valve.

CEC/WRA did not observe significant evidence to suggest the presence of petroleum or hazardous substances on the subject property. One unidentified pipe was observed near the center of the site. If the District's plans for the property involve excavation of this area, CEC/WRA recommends that the pipe be identified prior to excavation.

**Photograph #6**  
Hole and plastic pipe near the center of the subject site.

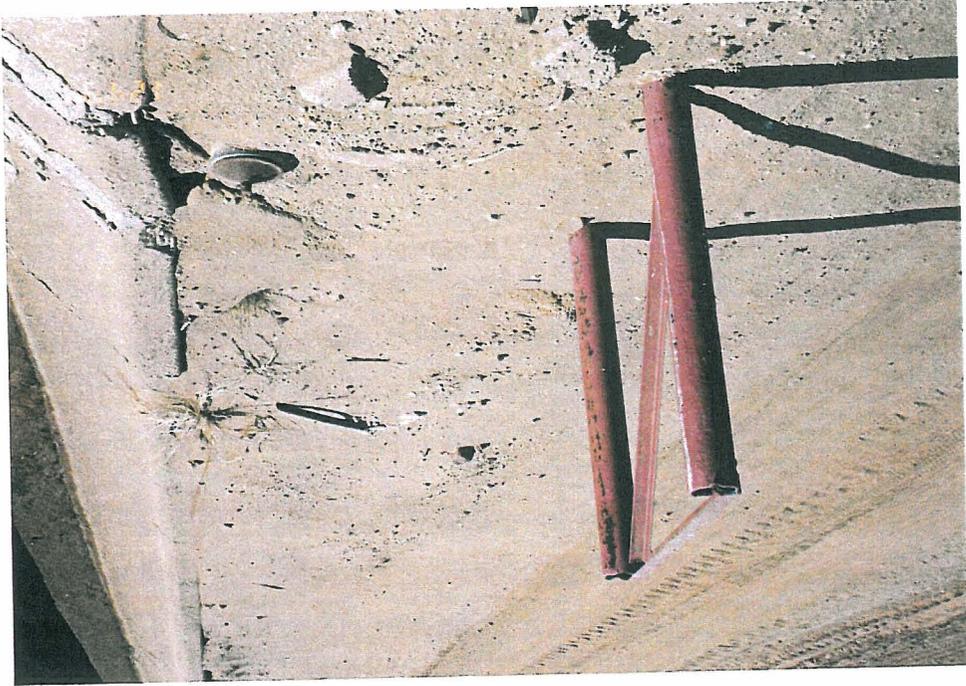
**Photograph #8**  
Traffic barrier and six-inch pipe near the center of the subject site.

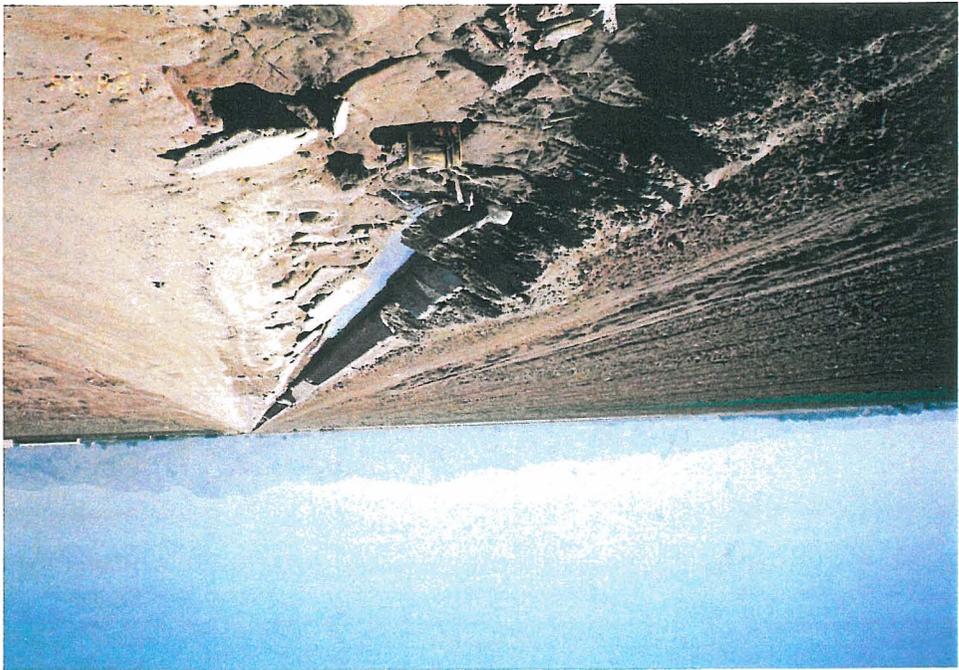
At the time of the site visit, the subject property consisted of fallow agricultural land. The property was crossed by typical dirt field-access roads and shallow, concrete-lined irrigation ditches, which were in poor repair. The ditches contained small amounts of debris that visually appeared to be non-hazardous in nature. The debris included paper trash, a plastic bucket, concrete rubble, old pipes and wood, and some articles of clothing.

**Photograph #7**  
Debris near the center of the subject site.

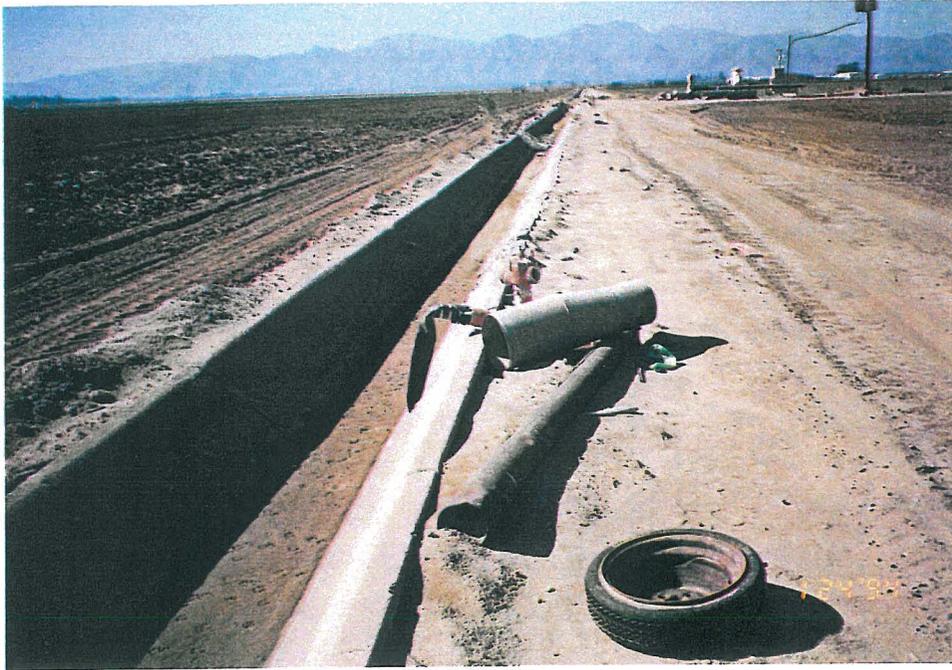
**Photograph #9**  
Debris and irrigation pump near the center of the subject site.
