PHASE I ENVIRONMENTAL
SITE ASSESSMENT

BULLARD WASH CORRIDOR
I-10 TO GOODYEAR AIRPORT
GOODYEAR, ARIZONA

JOB NO. 2183JK144

October 14, 2003

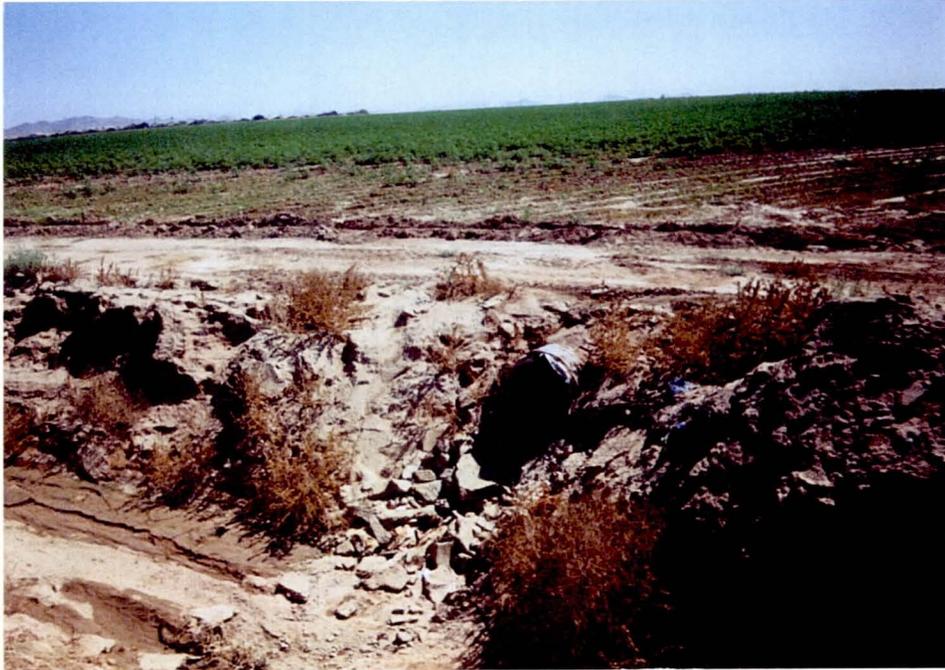
Picture No. 3 - An irrigation pipe along the side of the wash.

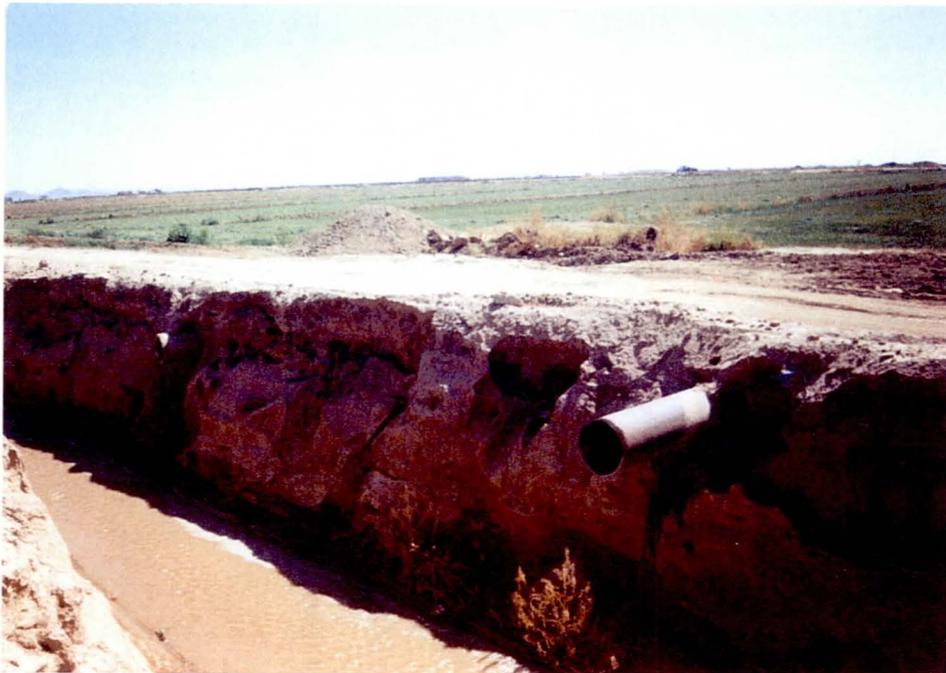
Picture No. 8 - Exposed piping along the side of the wash.

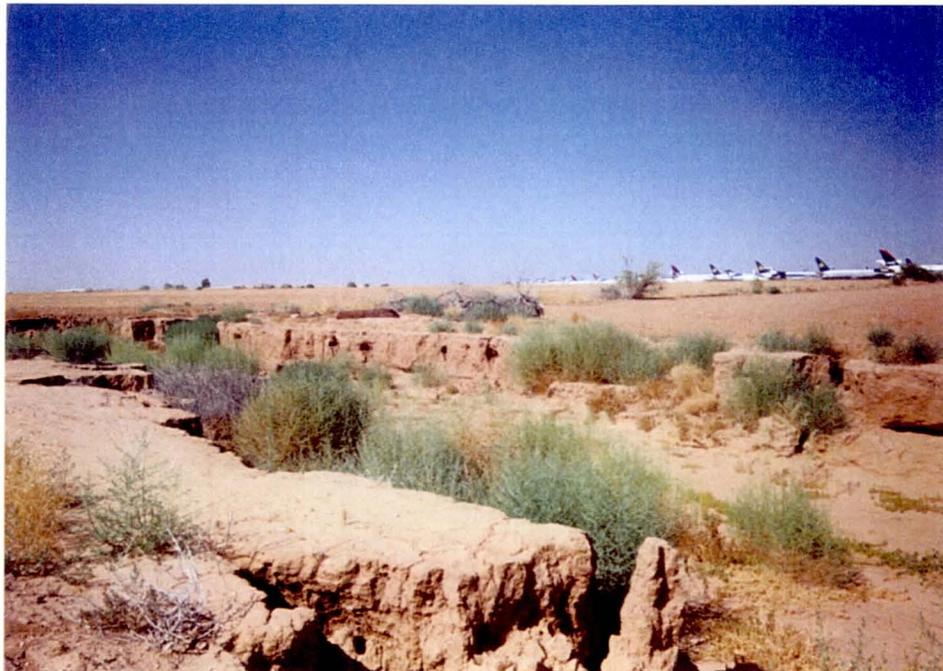
Picture No. 18 - An area of surface soil erosion along the north end of the retention basin.

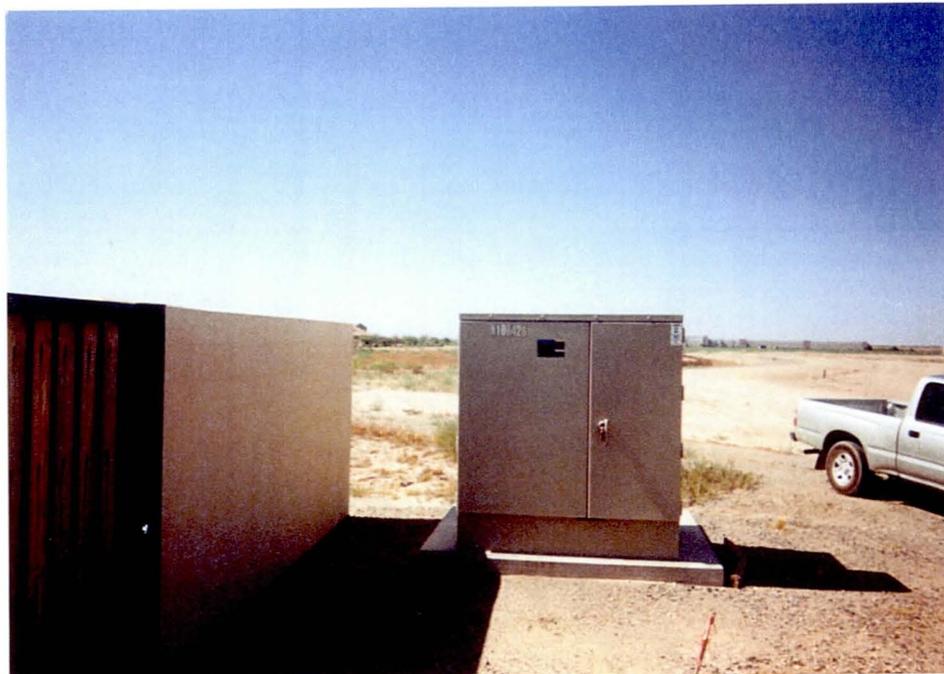
WT observed one pad-mounted transformer and two pole-mounted transformers belonging to APS on the Property (Appendix B, Picture 20). These units were in good condition with no indications of leakage. According to Ms. Gay C. of APS, the pad-mounted transformer does not contain PCBs and the PCB-content of the two pole-mounted transformers is unknown.

- 6.2.6 One pad-mounted transformer and two pole-mounted transformers were located on the Property. The pad-mounted transformer is reported to be non-PCB and the PCB content of the two pole-mounted transformers are unknown. These three transformers appeared to be in good condition with no indications of leakage. These transformers do not currently represent a potential impact to the Property.

Picture No. 20 - A pad-mounted transformer next to the City of Goodyear lift station.

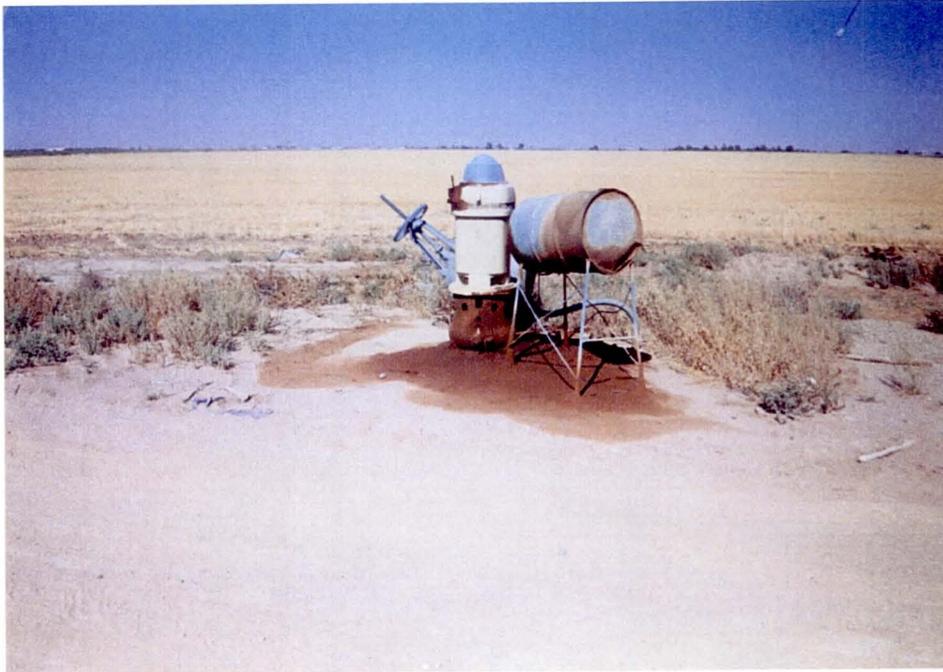
A 55-gallon drum of gear oil was attached to the pump motor at the north end of the tailwater pond (Appendix B, Picture 21). Soil staining was observed around the base of the pump and beneath the drum.

- 6.2.1 Soil staining was observed next to a tailwater pond pump at the northeast end of the tailwater pond. This staining appeared to be from a 55-gallon drum of gear oil used for lubrication of the pump. This staining represents a minimal impact to the Property and is typical for this type of water pump.

Picture No. 21 - A gear oil drum and associated soil staining next to a groundwater well.

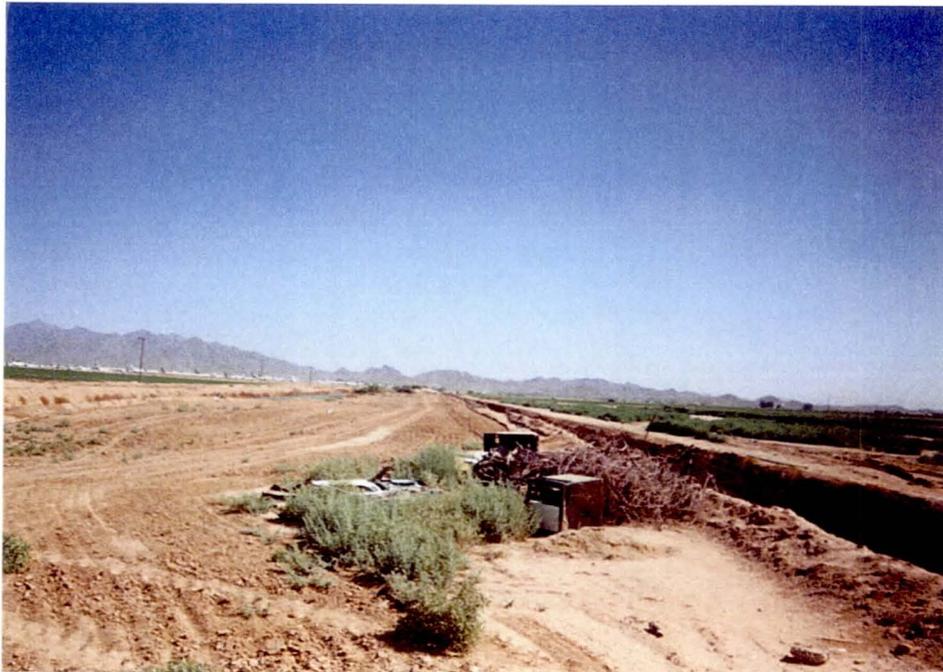
A discarded stove, freezer, car door and landscape debris were observed at the northwest corner of the tailwater pond (Appendix B, Picture 22). A pile of vegetative debris was along the west side of the tailwater pond (Appendix B, Picture 23). Vegetative debris and a discarded stove were along the north side of the retention basin (Appendix B, Picture 24). Scattered household debris and an empty 5-gallon bucket of paint were along the west side of the retention basin (Appendix B, Picture 25). Concrete debris was along the sides of Bullard Wash south of Yuma Road (Appendix B, Picture 26). This debris may have been placed as rip rap or it may have resulted from the break-out of a concrete canal. No staining or evidence of disposal of hazardous material was observed in these areas.

- 6.2.5 Discarded appliances, landscape debris and vegetative debris were observed at locations along the Bullard Wash alignment. No staining or evidence of hazardous chemicals were observed at these locations. These materials do not represent a potential environmental impact to the Property, however, they should be properly disposed of at an approved landfill facility.

Picture No. 22 - Discarded appliances and landscape debris.

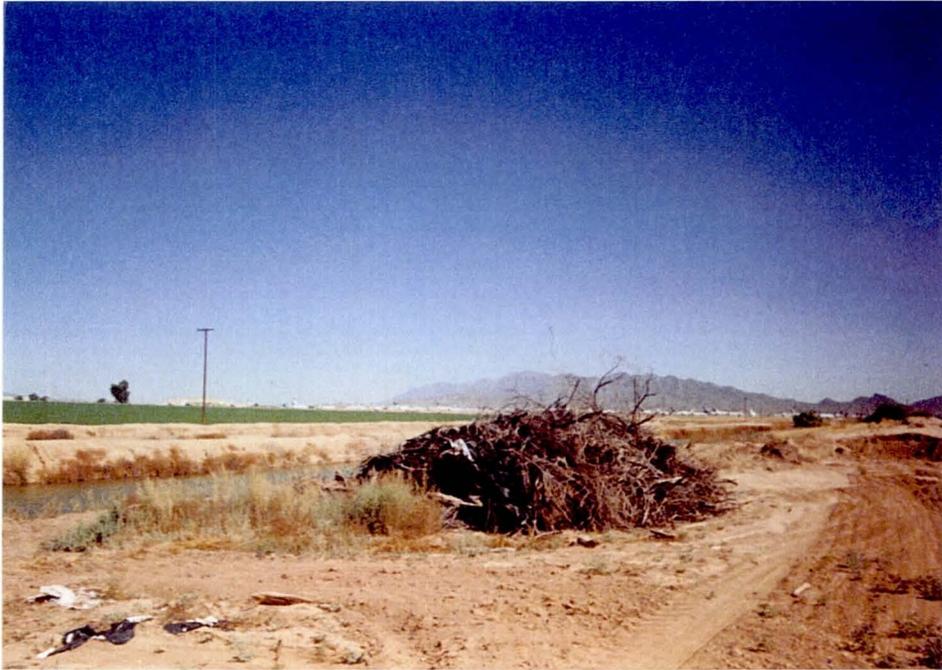
Picture No. 23 - Vegetation debris along the west side of the tailwater pond.

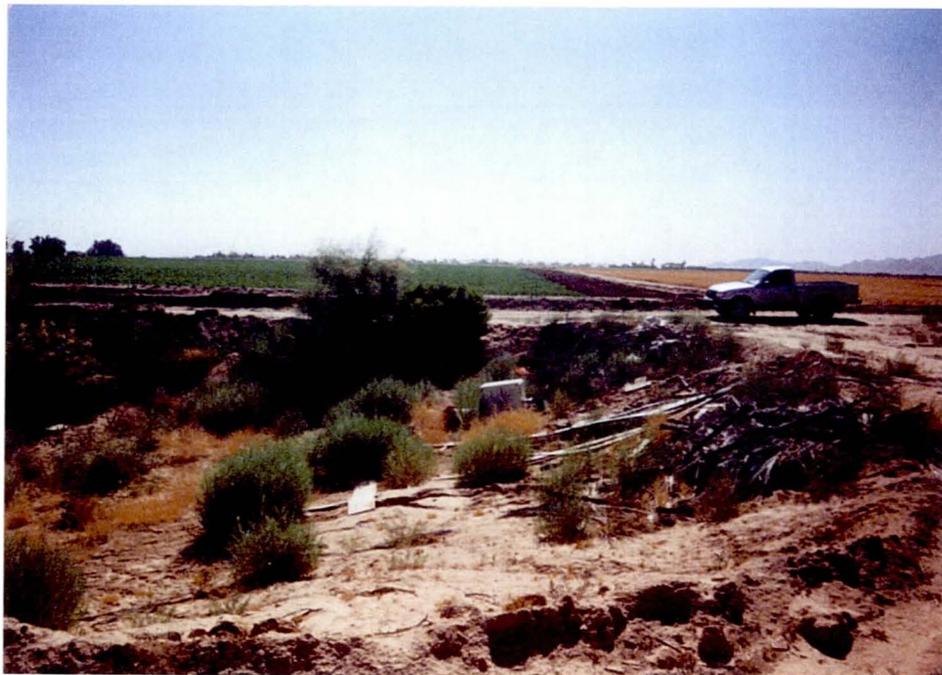
Picture No. 24 - Discarded debris at the north end of the retention basin.

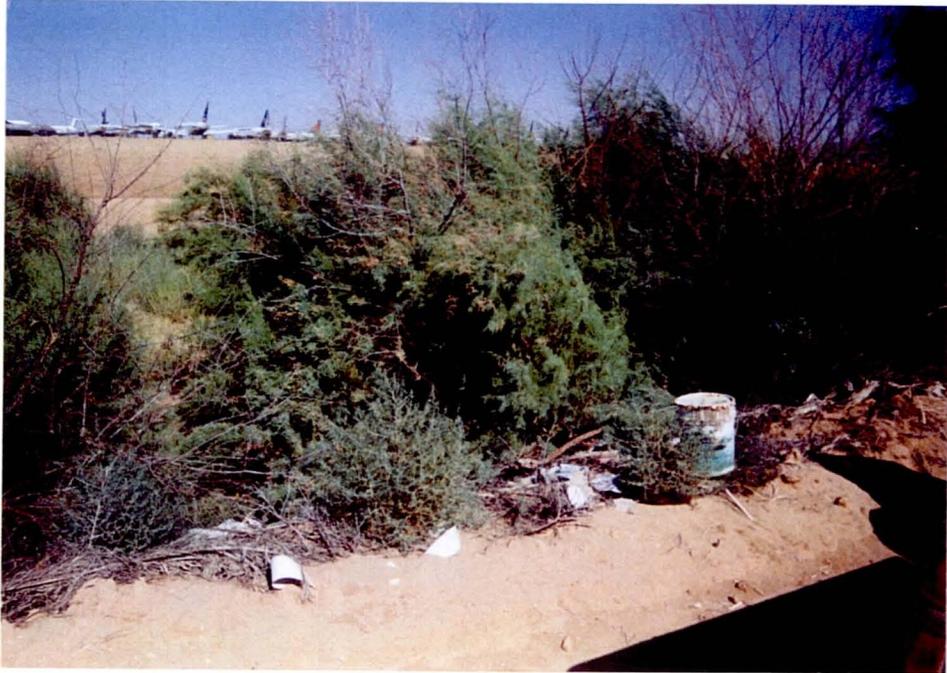
Picture No. 25 - Discarded household debris and an empty 5-gallon bucket along the west side of the retention basin.

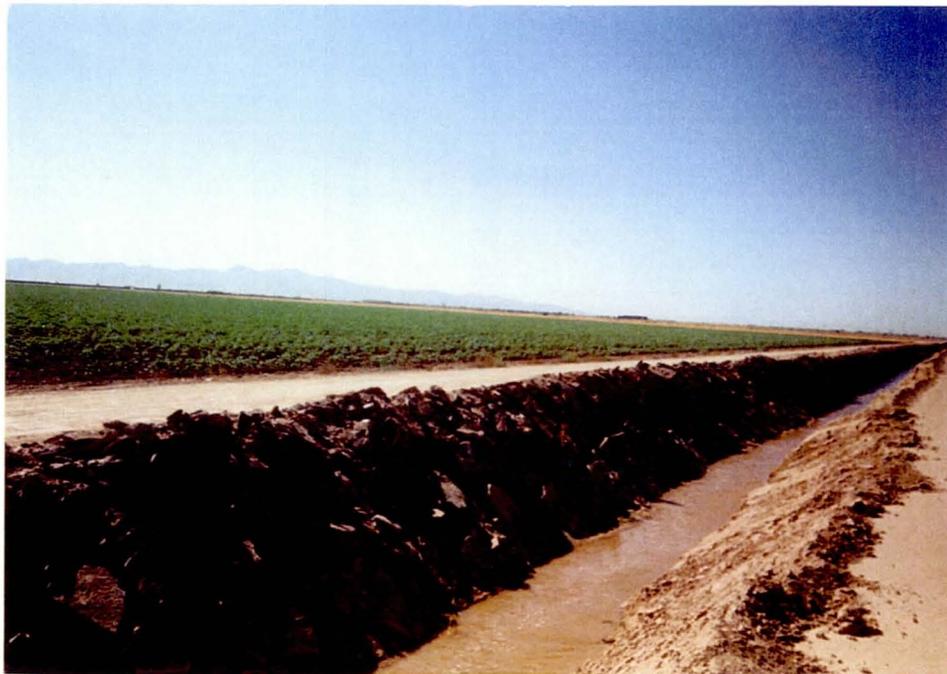
Picture No. 26 - Concrete debris along the sides of the wash.
