Queen Creek, Arizona

Survey Report
for Run off
and Waterflow
Retardation
and
Soil Erosion
Prevention
in the Interest of
Flood Control

Photographic Supplement

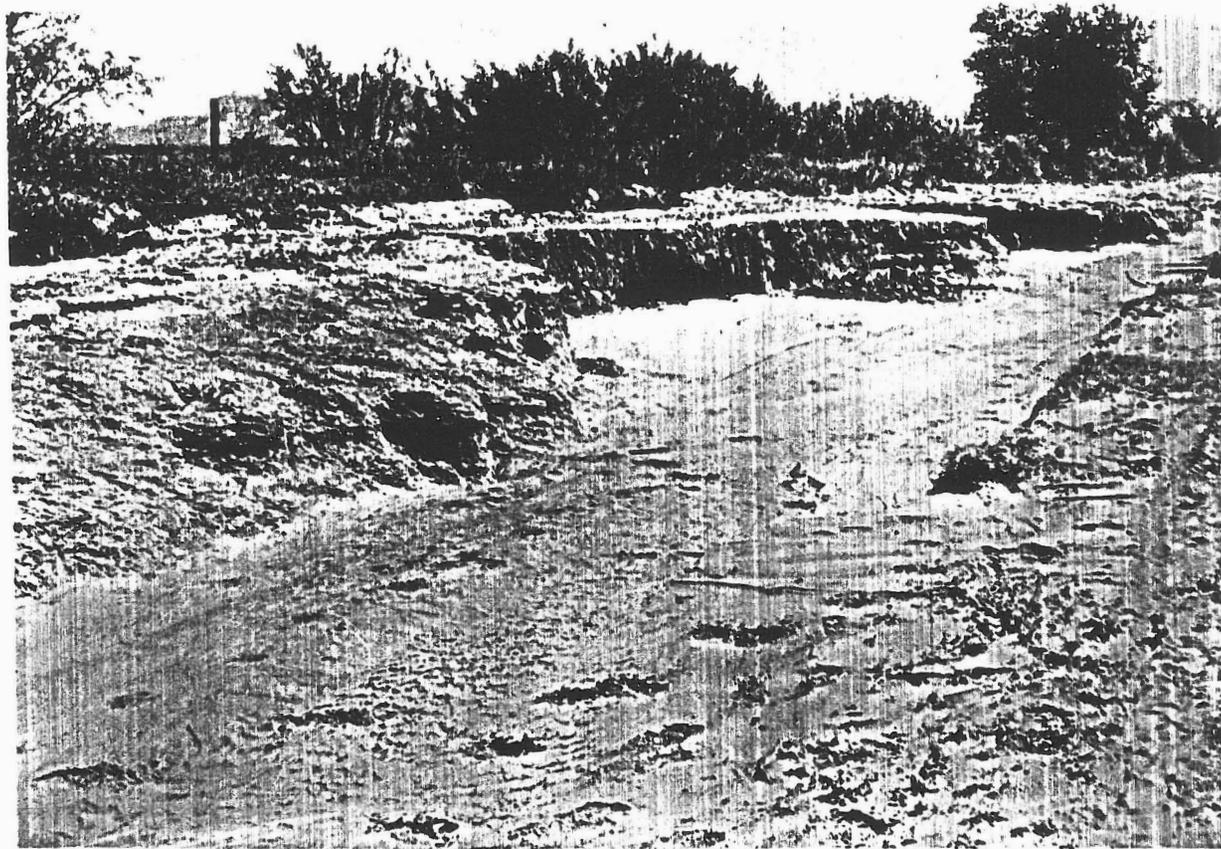
FIGURE 1. A COUNTY ROAD, 2 MILES NORTHEAST OF HIGLEY, BADLY DAMAGED BY THE SEVERE FLOOD OF SEPTEMBER 8-11, 1933.

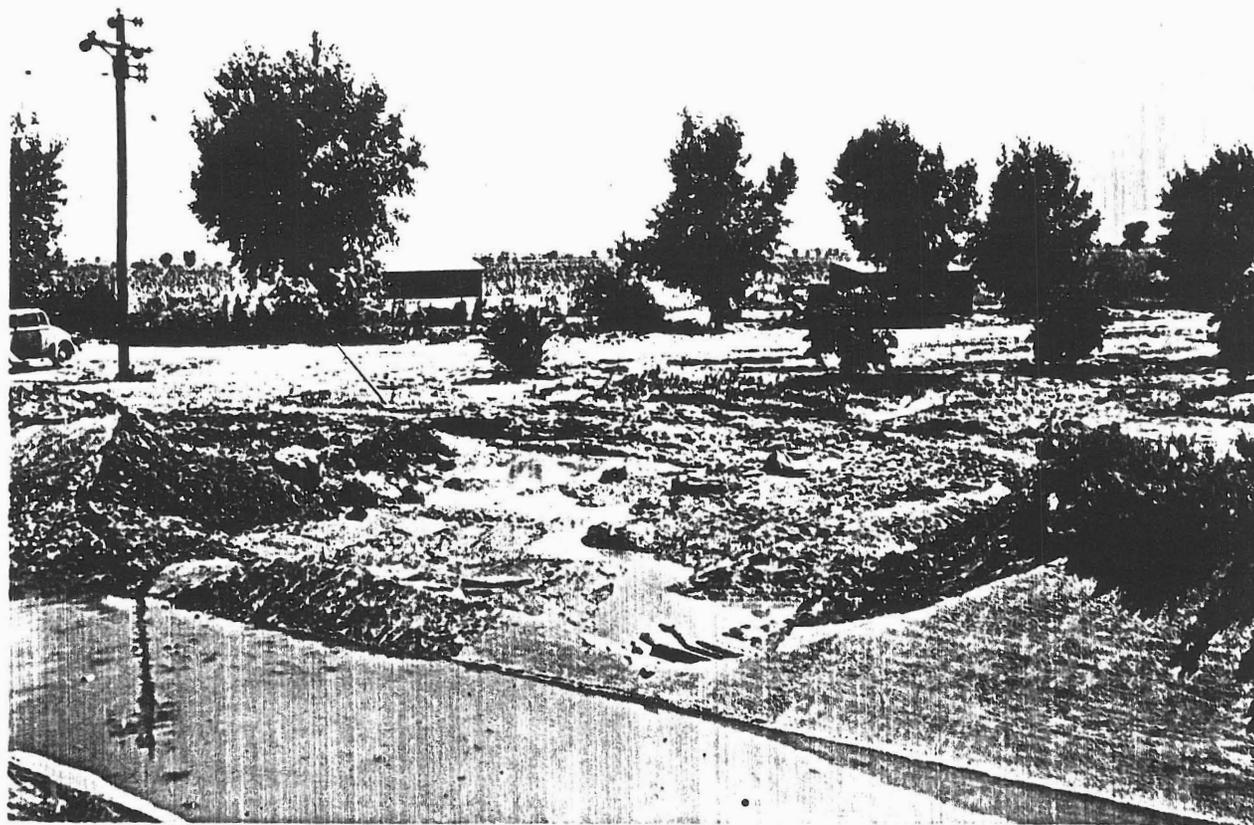
FIGURE 2. DAMAGES TO THE ROOSEVELT IRRIGATION CANAL (FOREGROUND), CITRUS ORCHARD, AND ROAD (BACKGROUND) CAUSED BY THE HEAVY FLOOD OF JULY 1936.

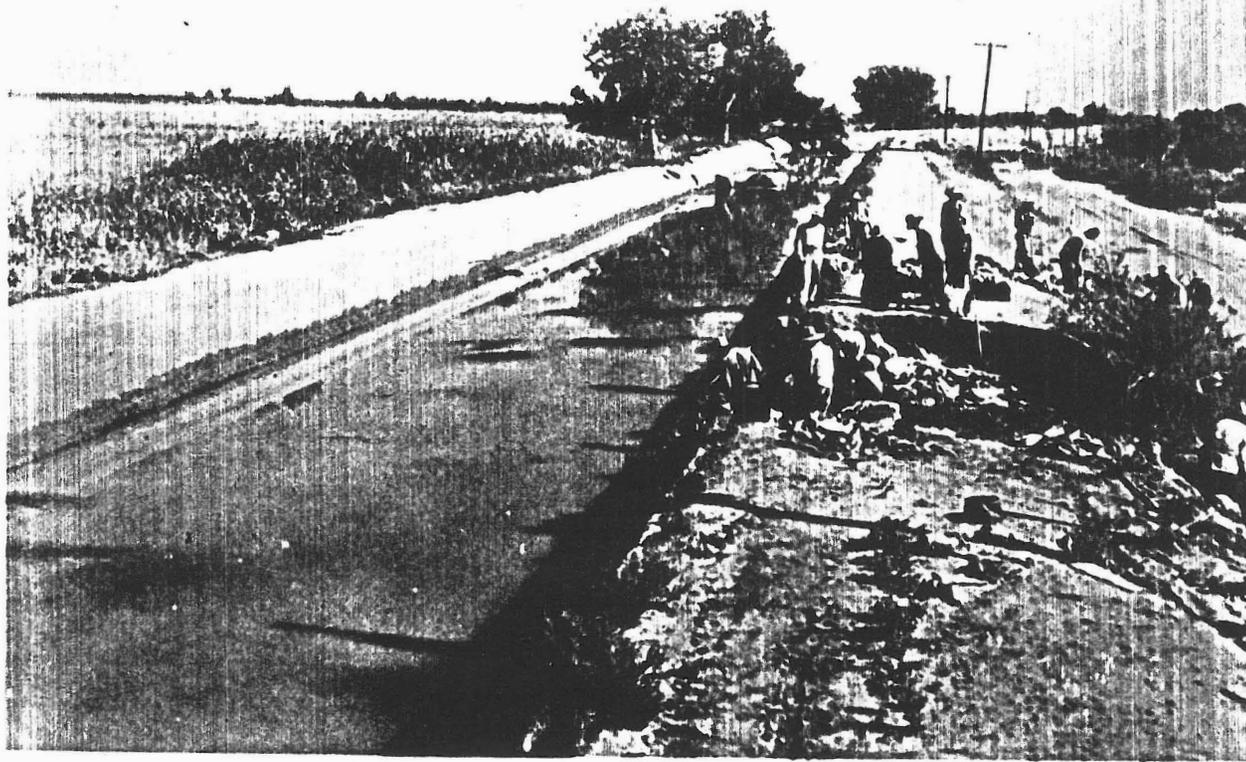
FIGURE 3. DAMAGE TO EASTERN CANAL BELOW LATERAL 6.5 DURING FLOOD OF JULY 1936.

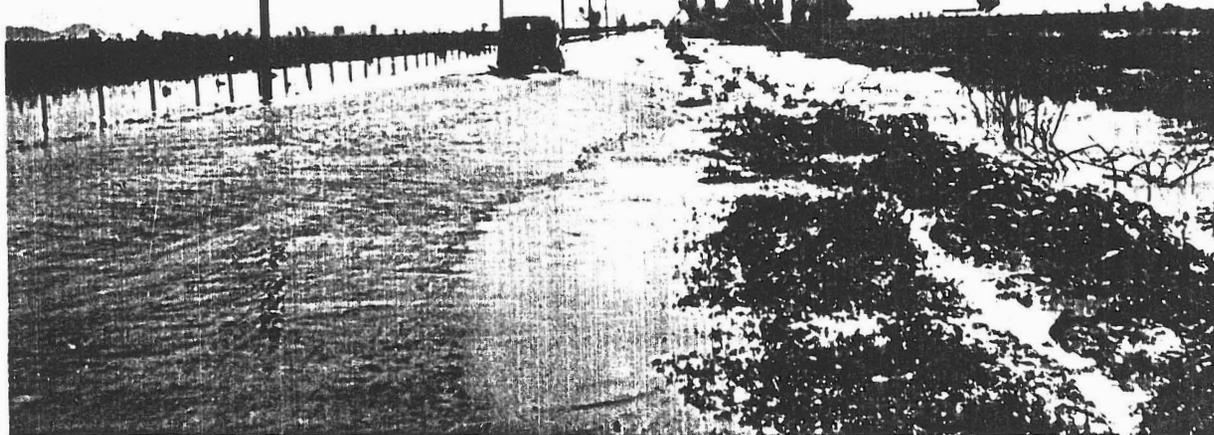
FIGURE 4. ROAD AND ADJACENT FARM LAND UNDER WATER, MARCH 1941. NOTE DAMAGE
PHONE LINE ON RIGHT. PICTURE TAKEN ON ROAD BETWEEN SECTIONS 3 AND 4, TOWNSH
2 SOUTH, RANGE 6 EAST.

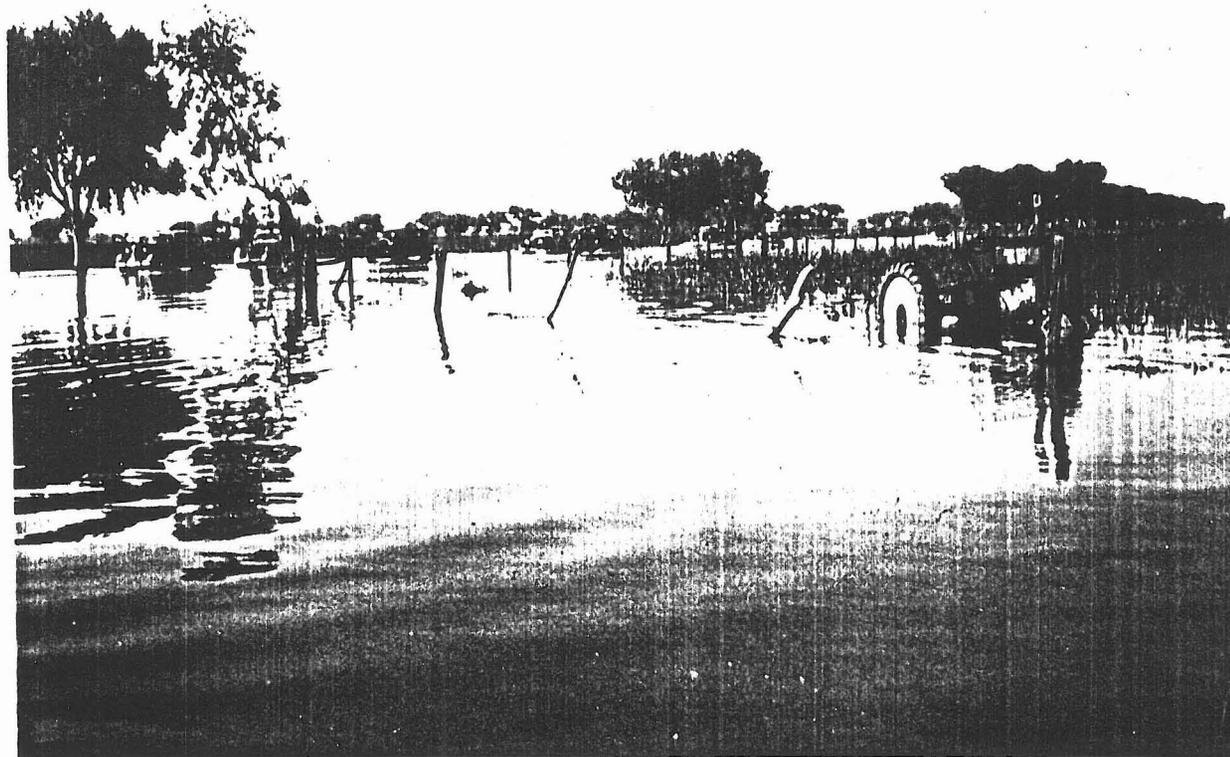
FIGURE 5. FLOODWATERS POURING OVER PHOENIX-TUCSON HIGHWAY SOUTH OF CHANDLER, ARIZONA DURING FLOOD OF MARCH 1941. TRAFFIC WAS BLOCKED FOR ONE DAY. TRACTOR WAS LOCATED IN SW CORNER OF SECTION 22, TOWNSHIP 2 SOUTH, RANGE 5 EAST.

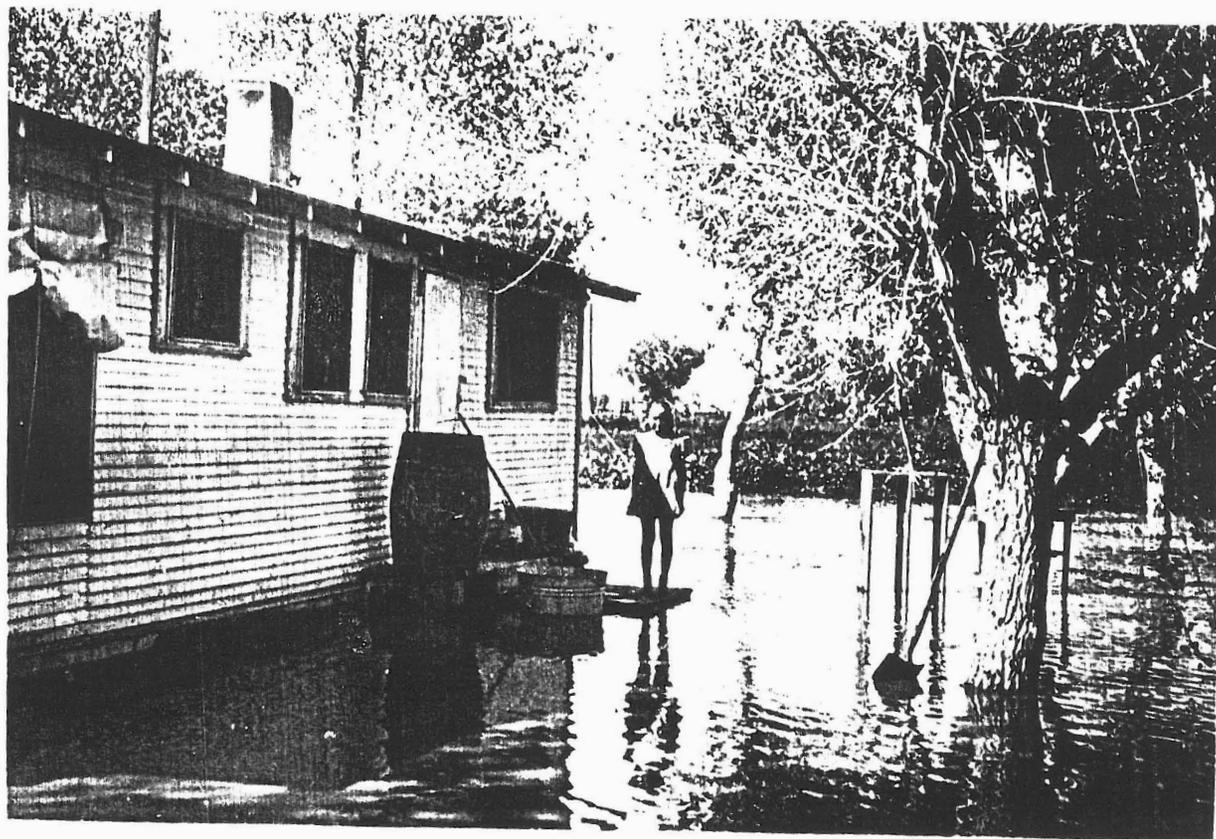
FIGURE 6. FARMHOUSE AND CROPLAND DAMAGED BY FLOOD OF MARCH 1941. SOUTHWEST
CORNER OF SECTION 6, TOWNSHIP 2 SOUTH, RANGE 6 EAST.

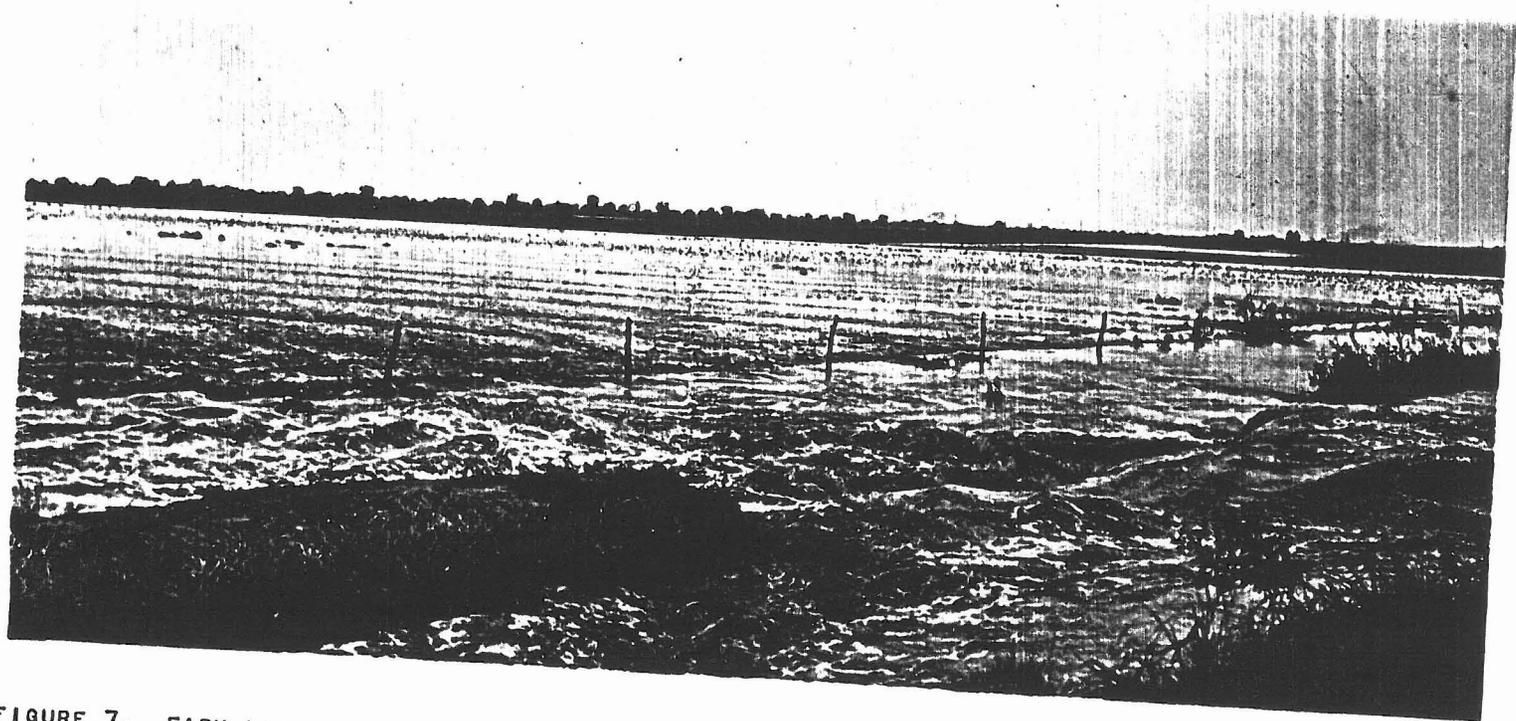
FIGURE 7. FARM LAND INUNDATED BY FLOOD OF SEPTEMBER 1946 IMMEDIATELY BELOW BREAK IN ROOSEVELT WATER CONSERVATION DISTRICT CANAL. W $\frac{1}{2}$ SECTION 36, TOWNSHIP 2 SOUTH, RANGE 6 EAST.

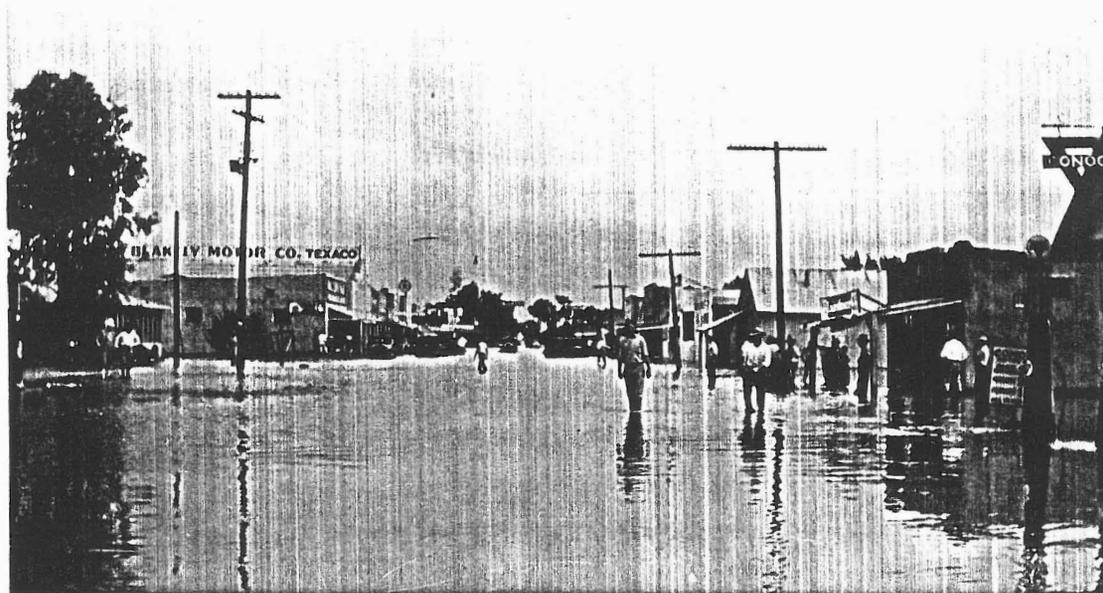
FIGURE 7A FLOODWATERS IN THE TOWN OF GILBERT, SEPTEMBER 1933, QUEEN CREEK
WATERSHED, ARIZONA.

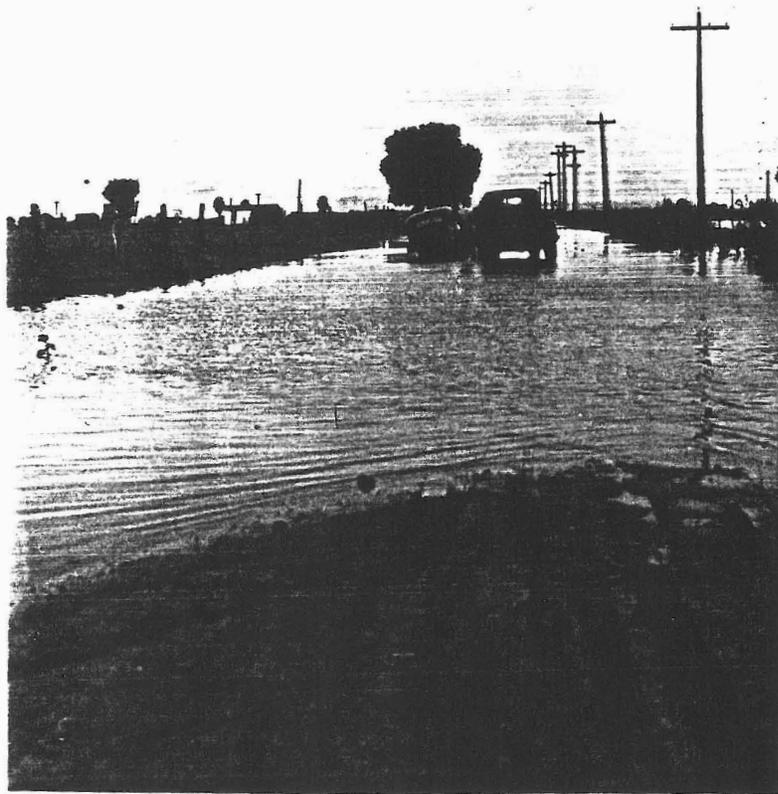
FIGURE 8. CROPLAND DAMAGED AND TRAFFIC BLOCKED DURING FLOOD OF SEPTEMBER 1946 BETWEEN SECTIONS 20 AND 21, TOWNSHIP 1 SOUTH, RANGE 6 EAST.

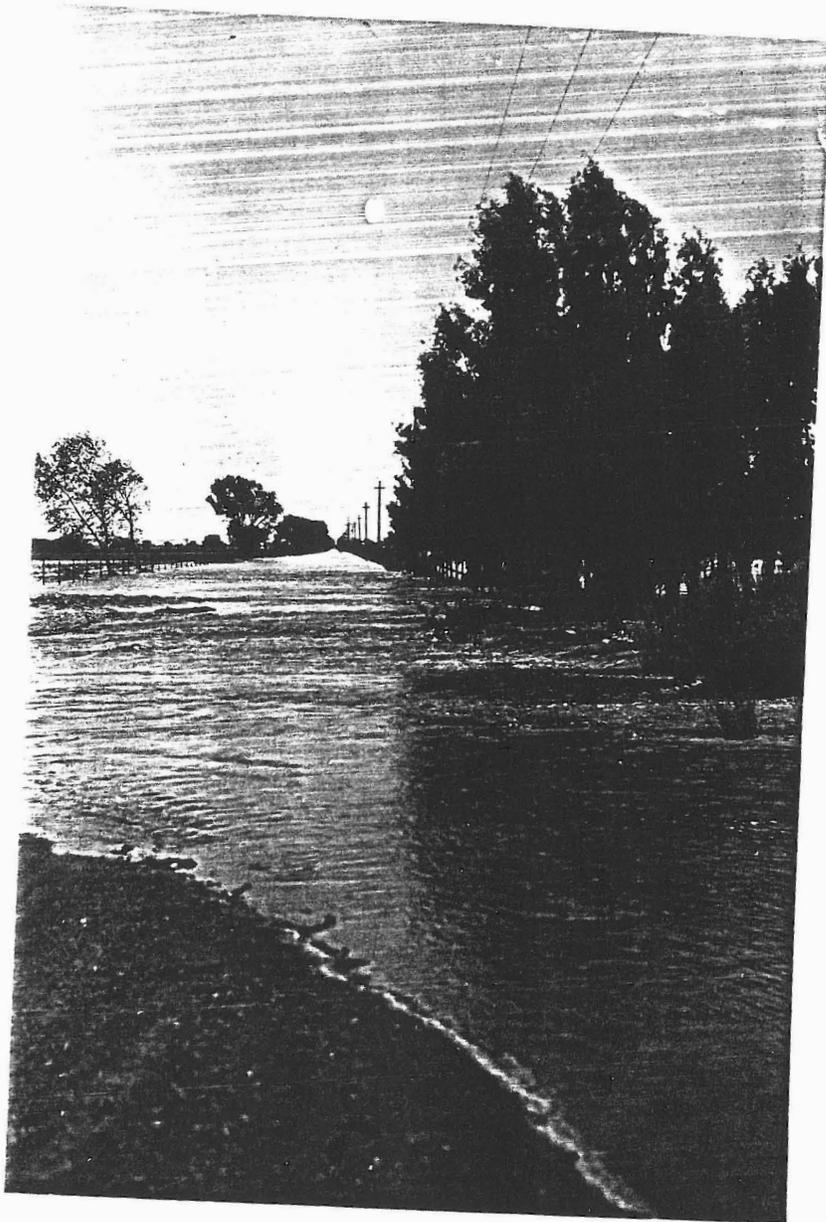
FIGURE 9. CROPLAND AND ROAD DAMAGE BY FLOOD OF SEP-
TEMBER 1946 NORTH OF RAILROAD BETWEEN SECTIONS 35-36,
TOWNSHIP 1 SOUTH, RANGE 6 EAST.

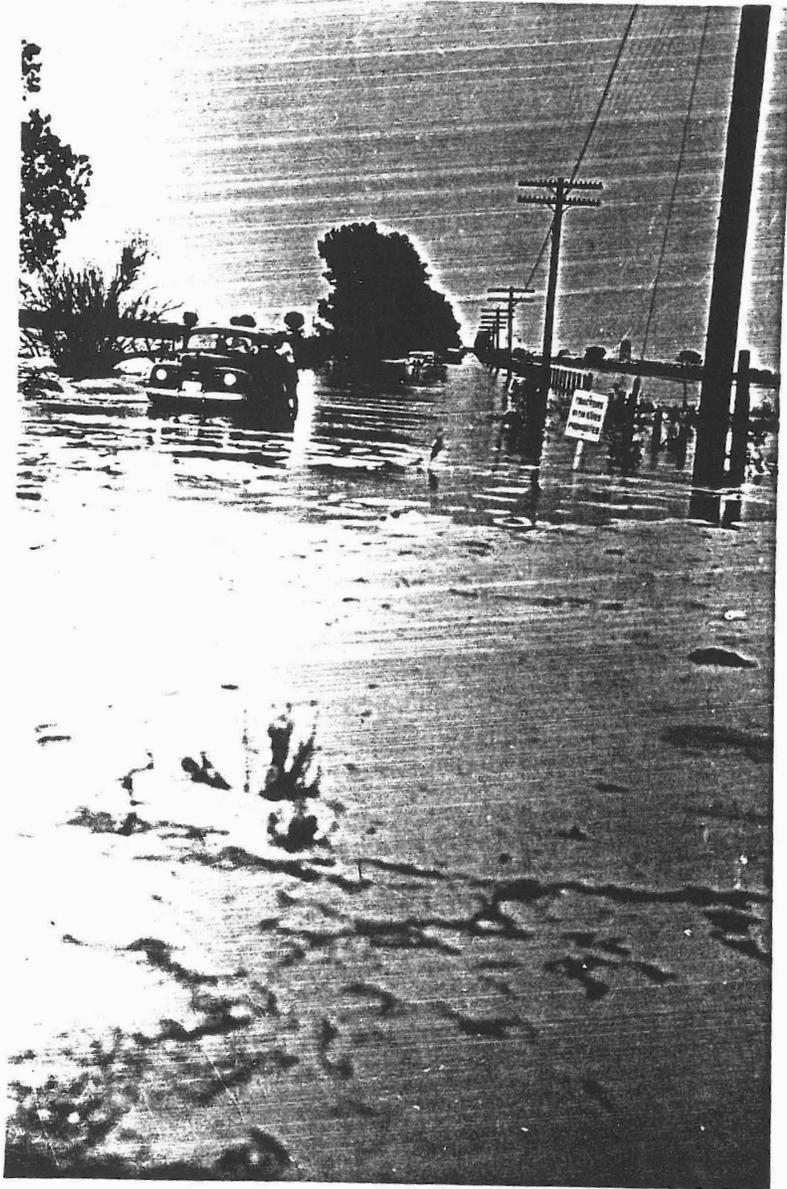
FIGURE 10. LOOKING EAST ALONG HIGHWAY TOWARD WILLIAMS
FIELD ARMY AIRBASE AT A POINT JUST EAST OF RAILROAD
CROSSING DURING FLOOD OF SEPTEMBER 1946 ($\frac{1}{2}$ MILE EAST
OF HIGLEY). ROAD WAS BLOCKED FOR ABOUT 48 HOURS.

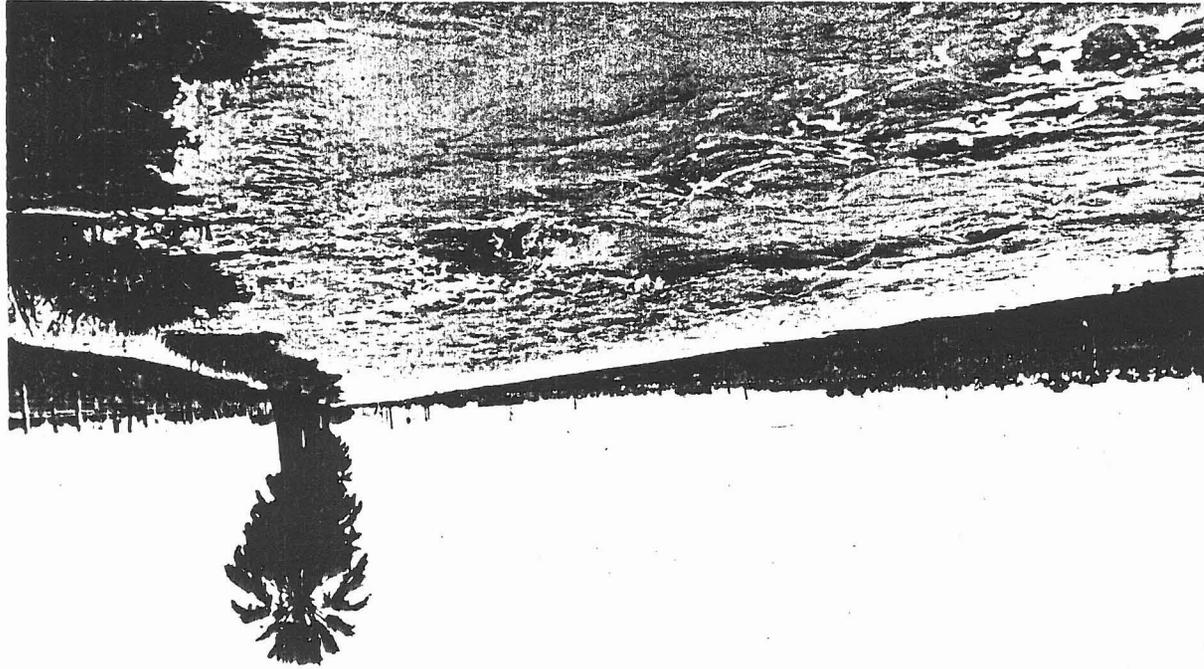
FIGURE 10A FLOODWATERS FLOWING DOWN ROAD AND SPREADING OUT ON FARM TO RIGHT OF ROAD WHERE ROAD INTERCEPTS THE RAILROAD ABOUT 1/2 MILE BELOW. ALL WATERS CAME FROM SUPERSTITION AREA DURING FLOOD OF SEPTEMBER 1946. PICTURE TAKEN LOOKING WEST AT SOUTHEAST CORNER OF SECTION 17, TOWNSHIP 1 SOUTH, RANGE 6 EAST.

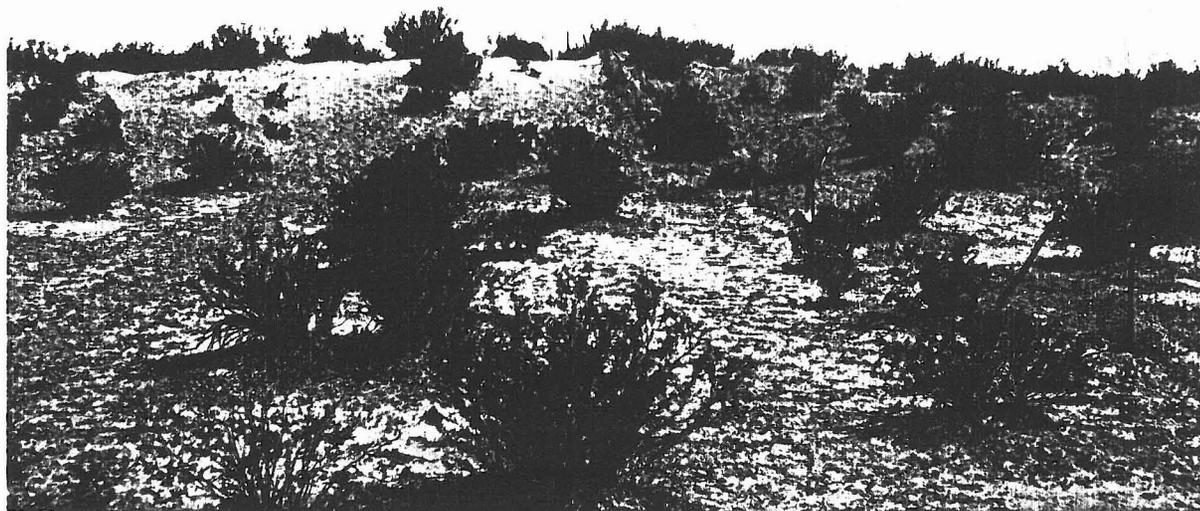
FIGURE 11. AREA NORTH OF QUEEN CREEK CHANNEL, 1946. SECTION 3, TOWNSHIP 2 SOUTH, RANGE 7 EAST. LOWER SUPERSTITION (PLAINS) AREA. ANNUAL VEGETATION TO THE LEFT OF THE FENCE HAS BEEN COMPLETELY UTILIZED, ALLOWING NO LITTER TO FORM ON THE GROUND. RANGE MAINTAINED IN THIS CONDITION IS NOT IN THE INTEREST OF FLOOD CONTROL. PROTECTION OF THE AREA TO THE RIGHT OF THE FENCE FROM GRAZING HAS RESULTED IN AN IMPROVEMENT IN THE VEGETATIVE COVER.

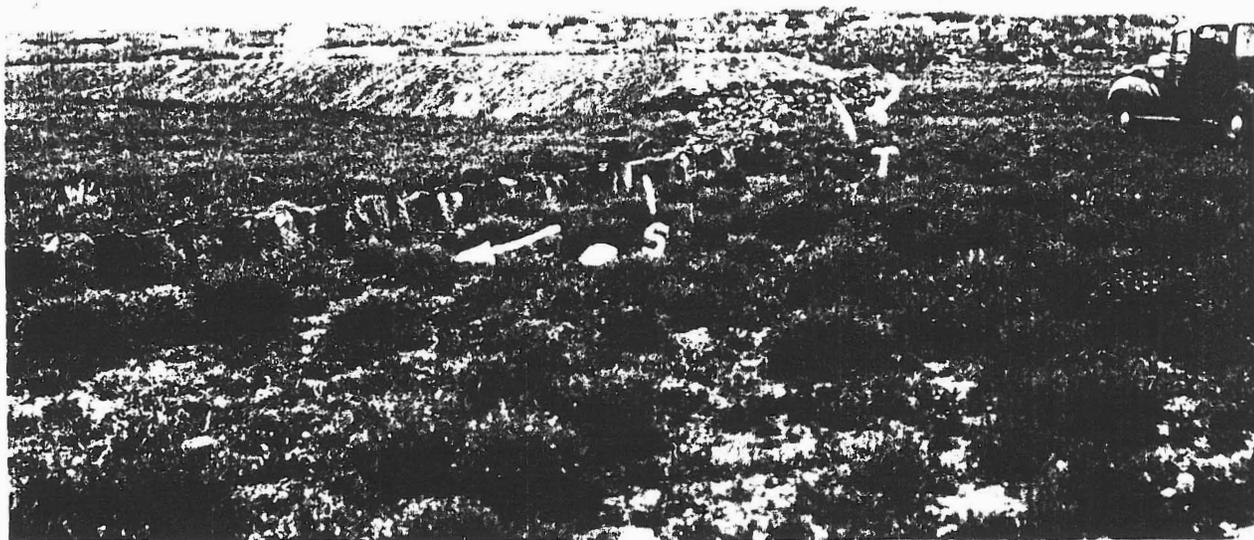
FIGURE 12. EARTHEN DIVERSION DAM (D) WITH WELL-KEYED ROCK SPREADERS (S). UPSTREAM FACE OF ONE OF THE TWO ATTACHED SPREADERS IS SHOWN. THE FACE ROCKS OF SPREADERS (UPSTREAM SIDE) ARE SET WELL IN THE GROUND, WITH THEIR TOPS ON GRADE LINE. NOTE THE HEAVY ROCK THIMBLE (T) AT END OF DAM. ARROWS SHOW DIRECTION OF FLOW OF WATER DIVERTED FROM CHANNEL.

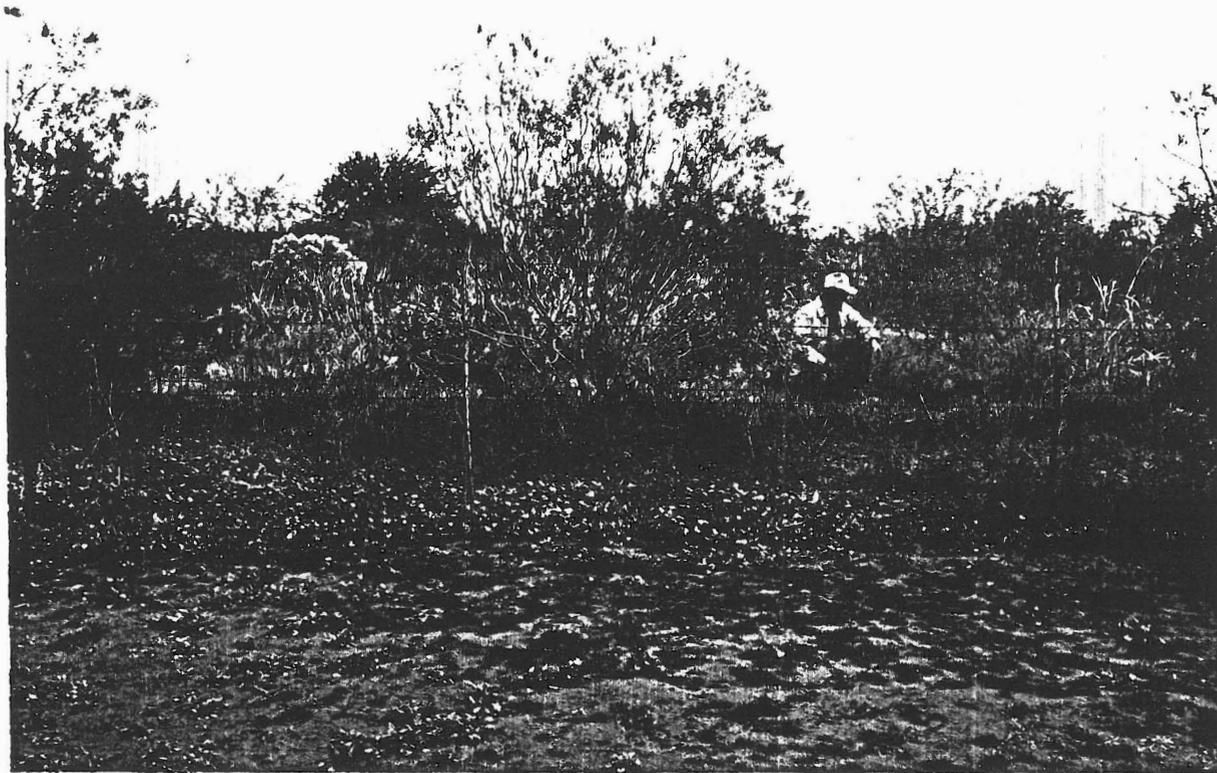
FIGURE 14. AREA INSIDE THE FENCE WAS SEEDED TO GRASS IN 1937 AND HAS BEEN PROTECTED FROM GRAZING. AN EARTH DIKE DIVERTS RUN-OFF ONTO THE AREA. PERENNIAL GRASS IN THE AREA HAS SURVIVED SEVERAL PROLONGED DROUGHTS SINCE IT WAS ESTABLISHED. SECTION 3, TOWNSHIP 1 SOUTH, RANGE 8 EAST. PICTURE TAKEN IN NOVEMBER 1946.

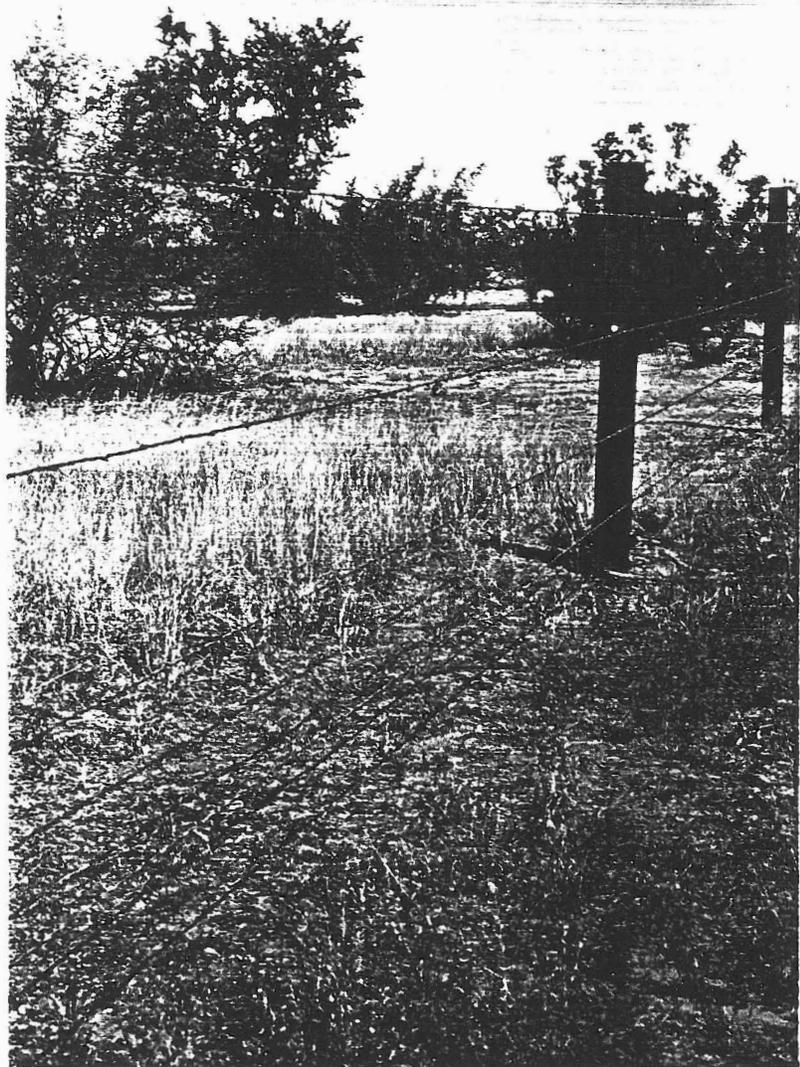
FIGURE 15. AREA WITHIN AIRFIELD BOUNDARY FENCE HAS BEEN PROTECTED FROM GRAZING FOR ABOUT THREE YEARS. GRASS IS LARGELY SIX WEEKS GRAMA. SECTION 15, TOWNSHIP 2 SOUTH, RANGE 8 EAST. PICTURE TAKEN AUGUST 1946.
