**ADOBE
DAM/DESERT
HILLS**

AREA DRAINAGE MASTER PLAN

**Sedimentation Engineering and
Geomorphology Evaluation**

September 2003

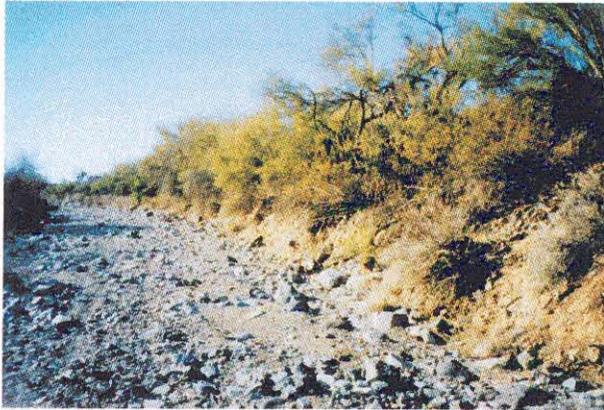
Figure 2-1. Evidence of recent minor (~1 ft.) long-term degradation on Apache Wash. Note unvegetated, oversteepened toe of right bank and incipient bed armoring.

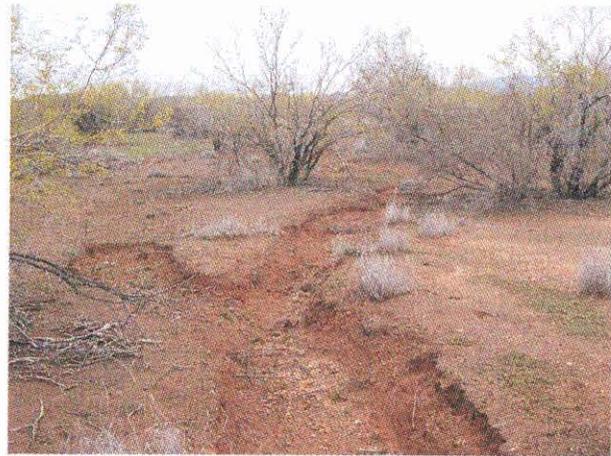
Figure 2-4. Upstream limit of minor headcut incision on CAP Wash West Branch at transition to non-incised reach.

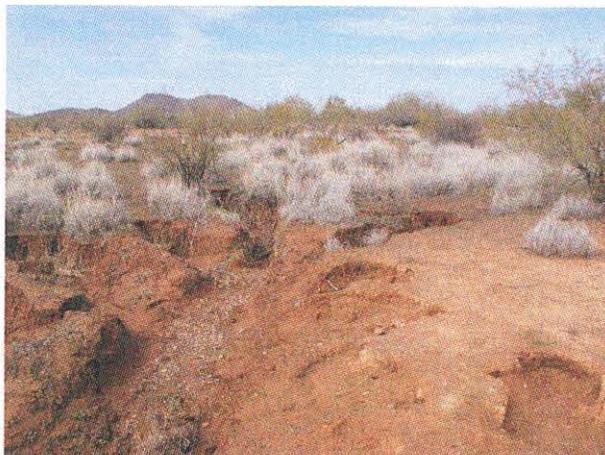
Figure 2-3. Minor headcutting upstream of CAP ponding area on CAP Wash West Branch.

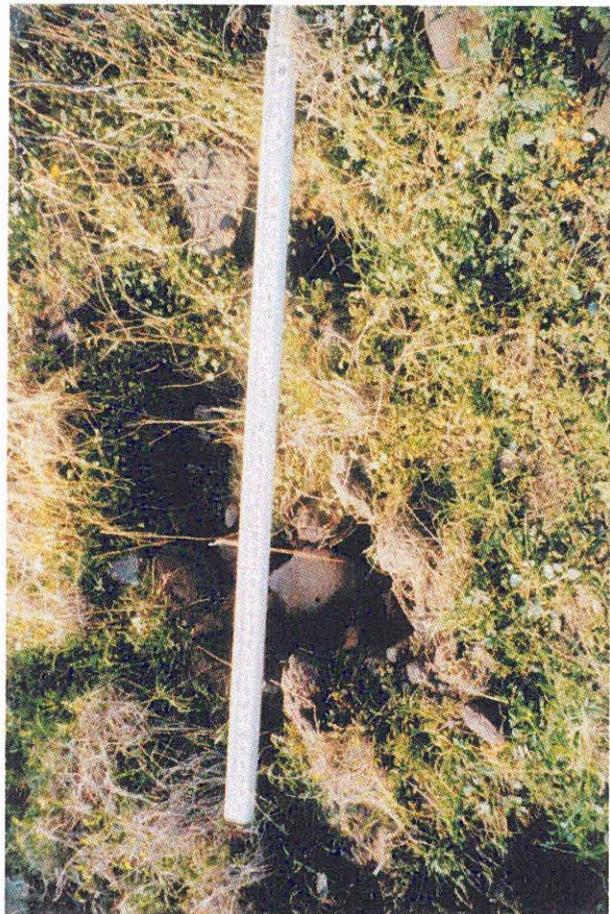
Figure 2-5. Cobbles buried by fine-grained alluvium in non-incised Buchanan Wash headwater reaches upstream of the CAP.

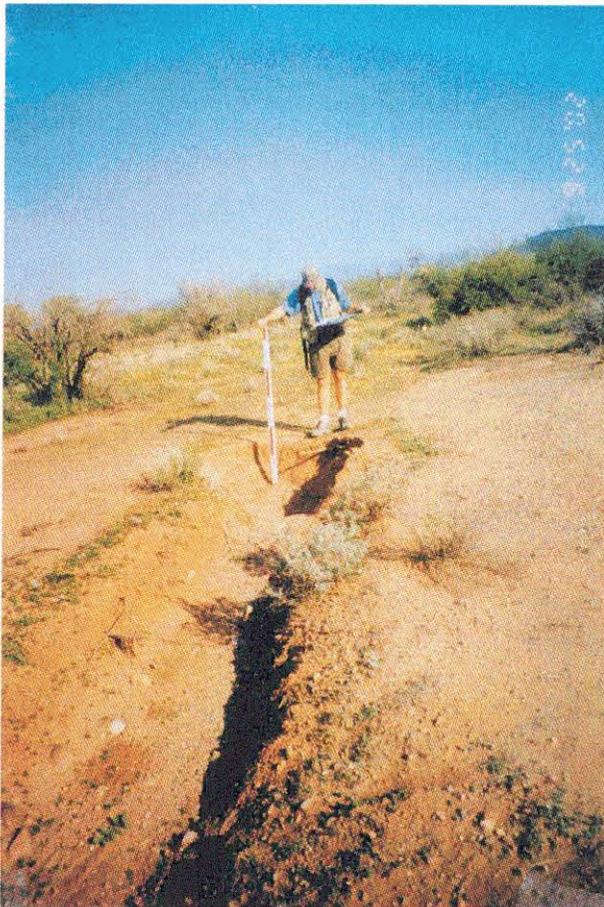
Figure 2-6. Small headcut on Buchanan Wash between stock ponds & non-incised reach.

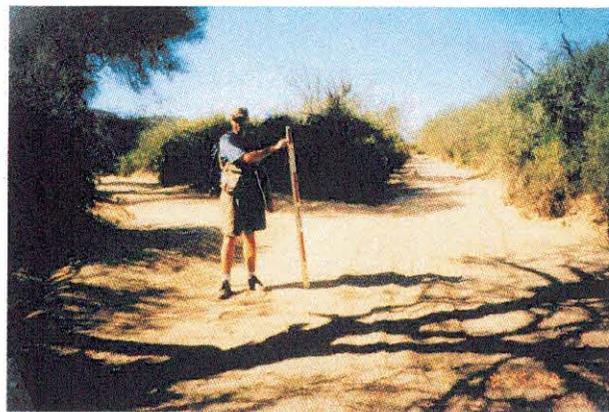
Figure 2-7. Hanging tributary on Buchanan Wash upstream of CAP & downstream of stock ponds.

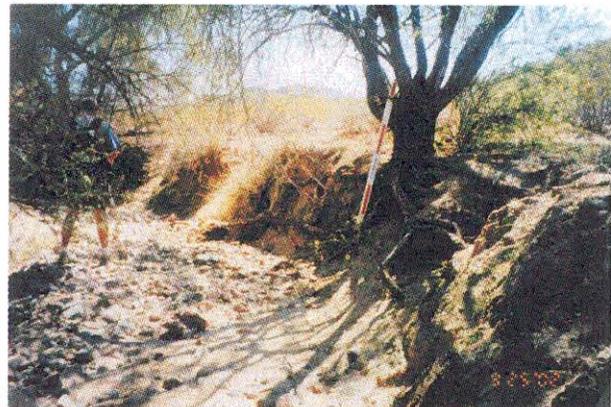
Figure 2-8. Long-term degradation (~3 ft) and resulting lateral erosion on Buchanan Wash between stock ponds and CAP.

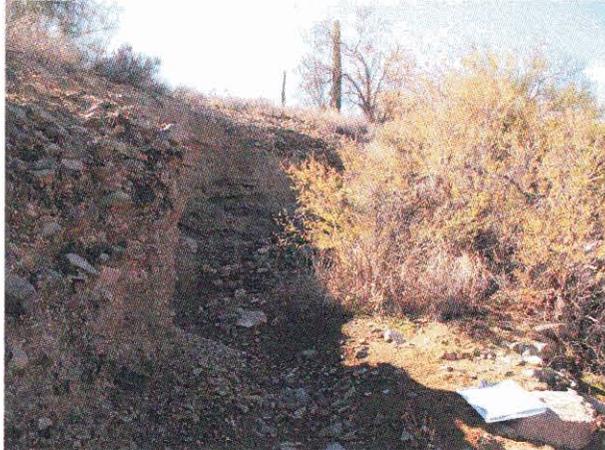
Figure 2-9. High cut bank in moderately cohesive material on Apache Wash West Fork Tributary 1.

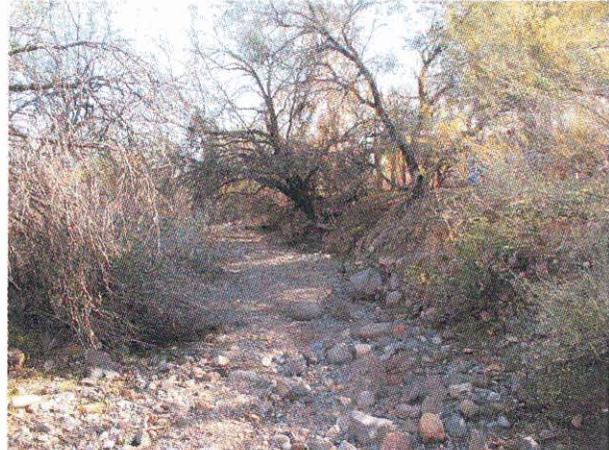
Figure 2-12. Exposed roots and leaning bank vegetation with cut banks on King Well Wash.

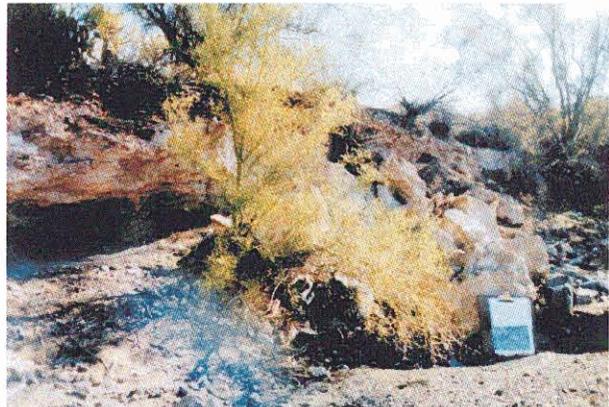
Figure 2-13. Erosion by block failure erosion in caliche-cemented bank.

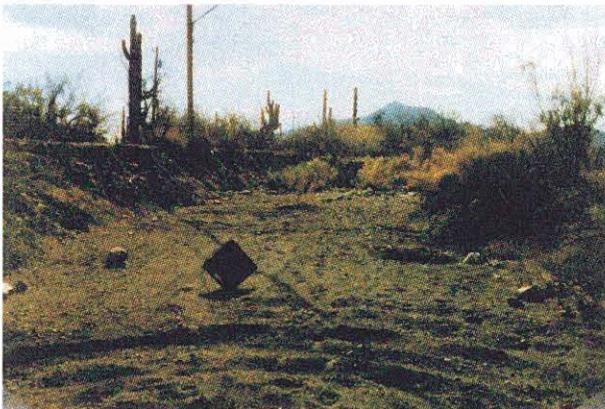
Figure 2-11. Active cutbank in older terrace on Skunk Creek. Note saguaro cacti near top of bank.

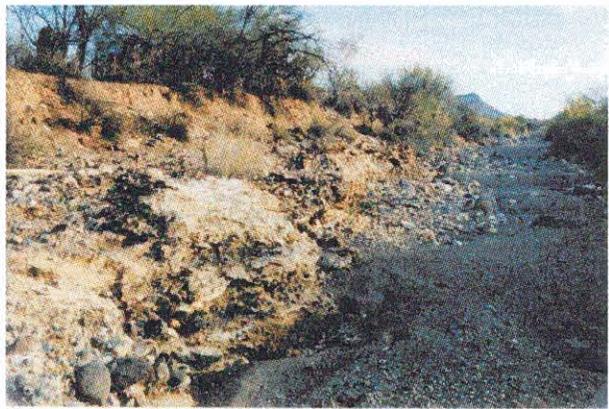
Figure 2-14. Cemented caliche layer providing toe protection for overlying erodible fine-grained alluvium on Upper Skunk Creek.

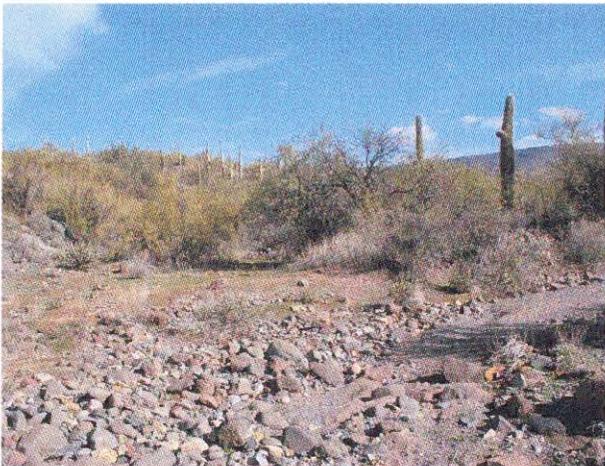
Figure 2-16. Avulsive low floodplain on King Well Wash. Low floodplains subject to more frequent inundation are prone to avulsions.

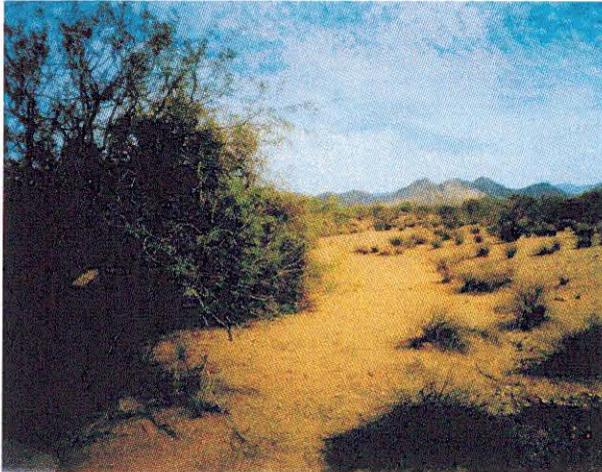
Figure 2-19. Proto-avulsive channel in right overbank of Desert Hills Wash. Note that the avulsive channel forms well outside the swath of dense riparian vegetation lining the channel banks.

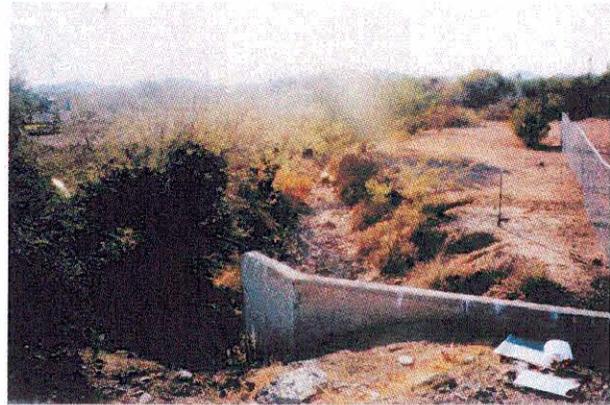
Figure 2-20. Impact of bank vegetation on bank stability from partially graded site on Desert Hills Wash Tributary 6.

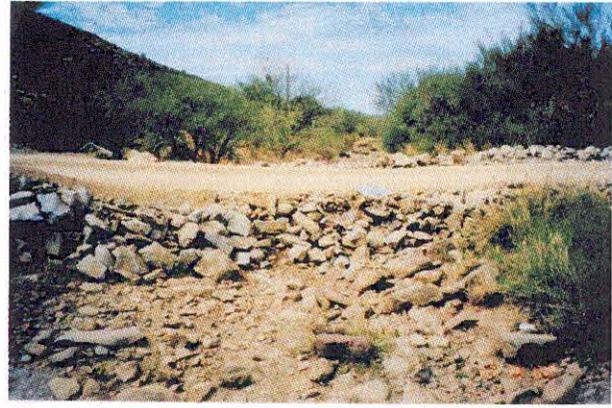
Figure 2-26. Raised dip section with no culvert at unpaved crossing on Cline Creek Tributary C8. Small floods will destroy crossing.

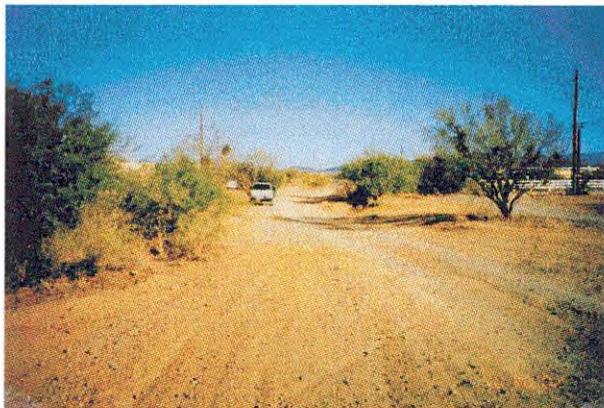
Figure 2-24. Dip crossing of Desert Lake Wash East Fork with high skew angle resulting in flow in road.

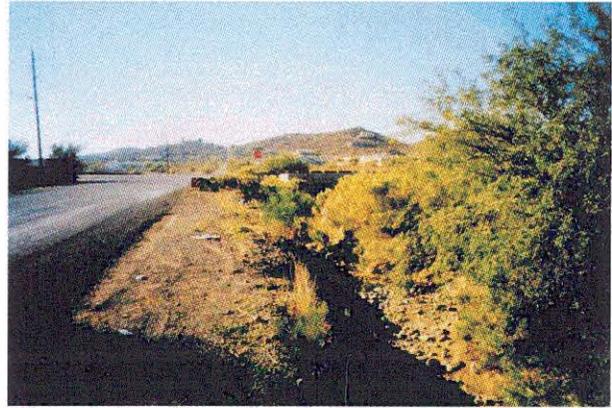
Figure 2-27. Channel realigned for road construction on Desert Lake Wash East Fork.

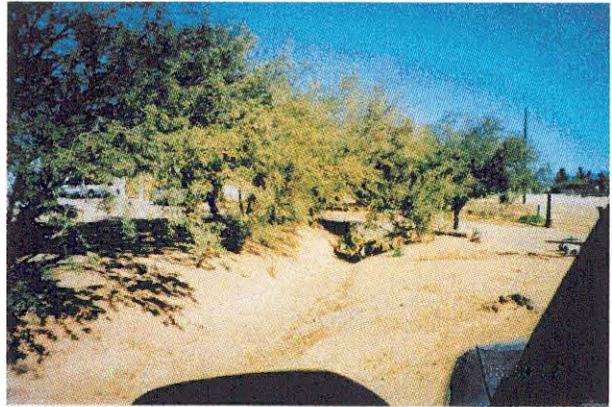
Figure 2-28. Driveway culvert limits stream capacity on Desert Lake Wash East Fork. Drainage plans must accommodate resident access.

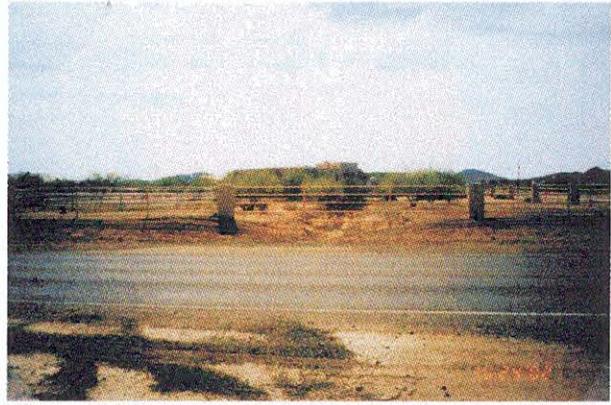
- **Road Surface Deposition.** If the dip section significantly widens the natural channel cross section, the flow velocity in the dip section will decrease and induce sediment deposition. If deposition occurs in the roadway, it may not only be a traffic hazard, but may also create a backwater condition in the upstream channel that increases flood elevations.

Figure 2-32. Desert Lake Wash geometry modified by road construction and development. Wide shallow dip section induces sediment deposition and causes upstream backwater inundation.

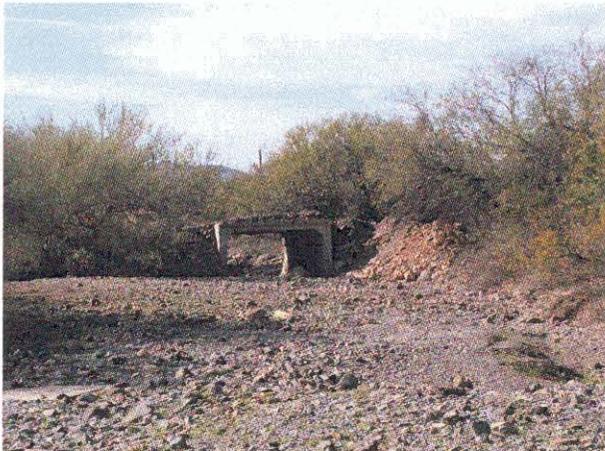
Figure 2-30. Failed box culvert crossing at private road on King Well Wash. Crossing is too narrow and doesn't address erosion by flanking.

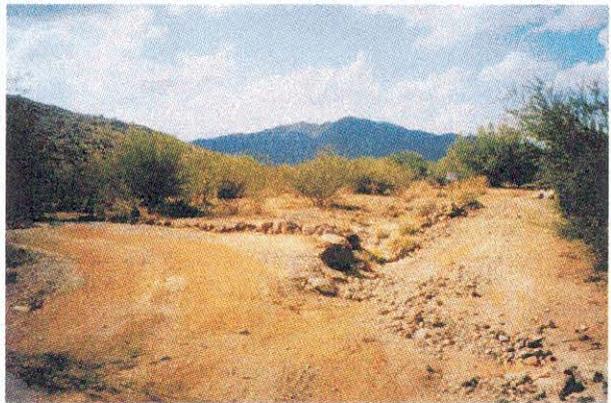
Figure 2-33. Channel and floodplain disturbed by driveway and lot grading on Cline Creek Tributary X4a.

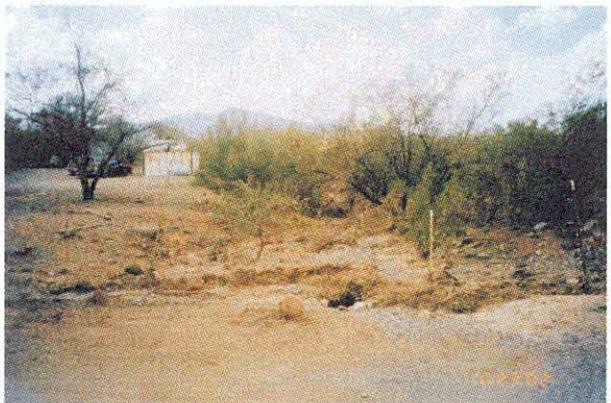
Figure 2-34. Fence obstructing main channel at unpaved dip crossing on Cline Creek Tributary X5. Fence captures debris and causes deposition.

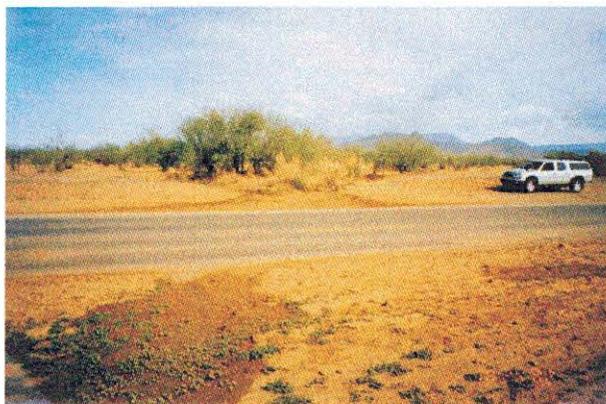
Figure 2-35. Ponding and sediment deposition at overwidened dip section on Desert Lake Wash.

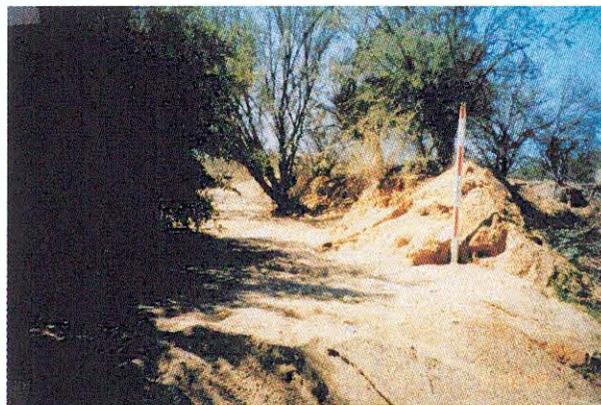
- **Stock Ponds.** Stock ponds that capture the low flow channel also capture and store the majority of the sediment load. Therefore, deltaic deposition occurs upstream of the stock pond at the inlet. If flow is released from a stock pond, it is typically deprived of sediment resulting in long-term degradation and increased lateral erosion. However, since most stock ponds are not designed to release flow except through an emergency spillway, overflows tend to have high peaks that cause significant scour. Furthermore, if stock ponds are breached or removed as development occurs around them, a pulse of fine grained sediment into the reaches immediately downstream should be expected that may reduce channel capacity, induce overbank flooding, initiate channel avulsions, or clog drainage crossing structures. Finally, failure from overtopping has occurred at least once (Skunk Tank) in the study area. Catastrophic breaches of stock tanks could cause peak flows to exceed regulatory discharges and flood homes outside or above the regulatory floodplain. Stock ponds exist through the non-urbanized portion of the study area.

Figure 2-39. Incision and lateral erosion near stock pond breach on Buchanan Wash. Long-term degradation due to sediment trapped by pond.

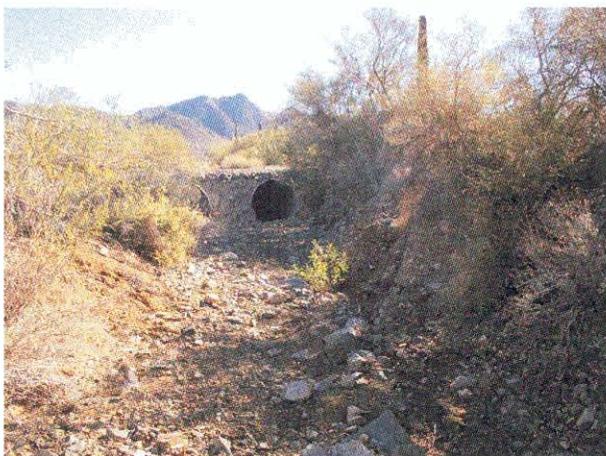
- **Undersized Culverts.** Undersized culverts create backwater that induces upstream sediment deposition and downstream scour. If overtopping occurs, flow can be diverted to adjacent watersheds via the raised right-of-way. Several undersized culverts were observed in the study area, particularly on private roads.

Figure 2-37. Undersized culvert relative to channel capacity on Apache Wash West Fork. Expect upstream sediment deposition.

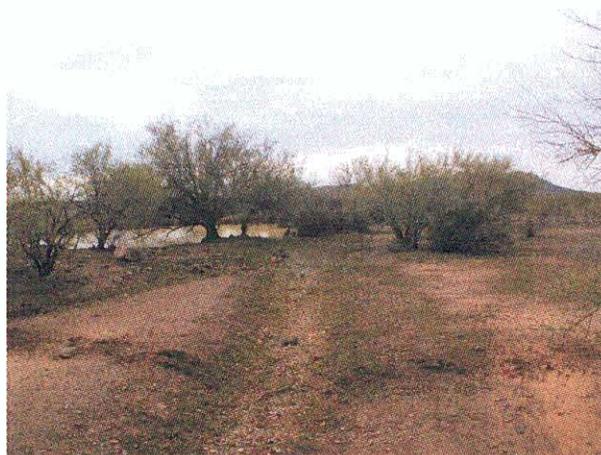
Figure 2-40. Sediment deposition upstream of stock pond on CAP Wash West Branch.

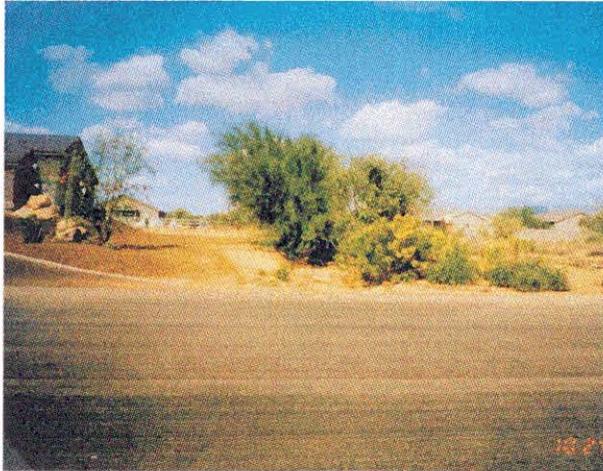
Figure 2-41. Recent development in floodplain elevated on fill along Desert Lake Wash.

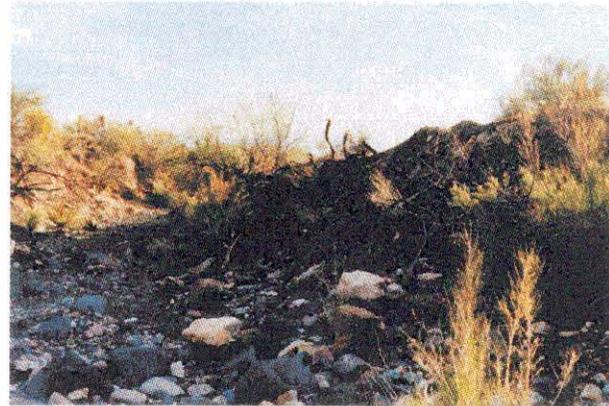
Figure 2-44. Dumped fill in Upper Skunk Creek.

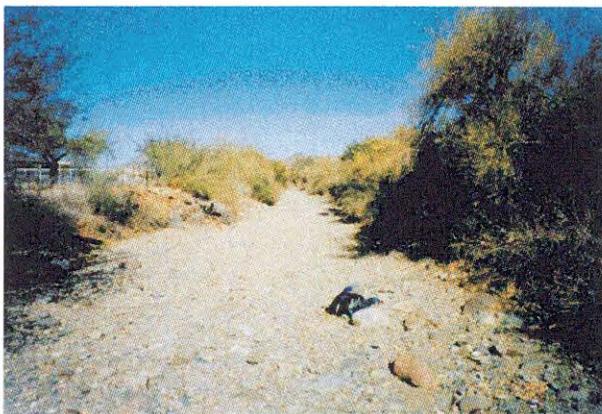
Figure 2-43. Dumped fill material in Apache Wash channel. Bank vegetation removed by local residents.

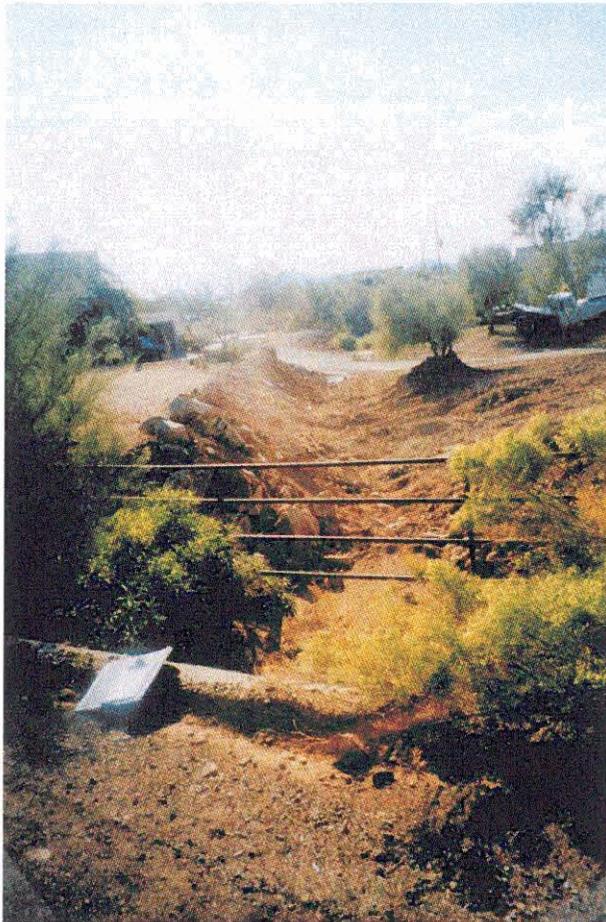
Figure 2-45. Dumped fill in main channel of Desert Lake Wash near headwaters.

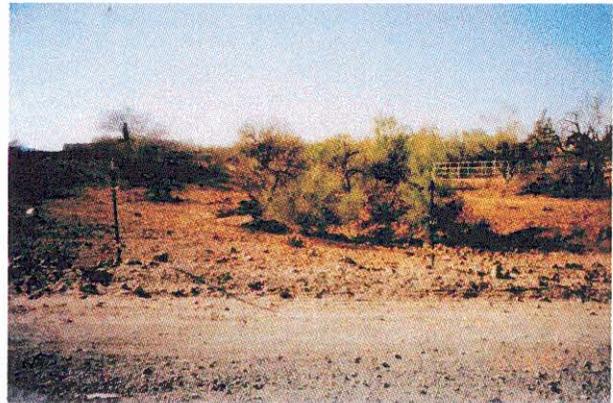
Figure 2-47. Impact of grazing on floodplain and channel vegetation on Desert Hills Wash Tributary 6.

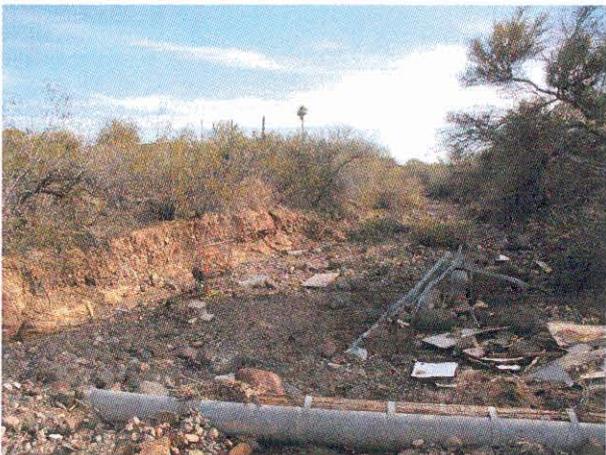
Figure 2-46. Dumped trash in King Well Wash.

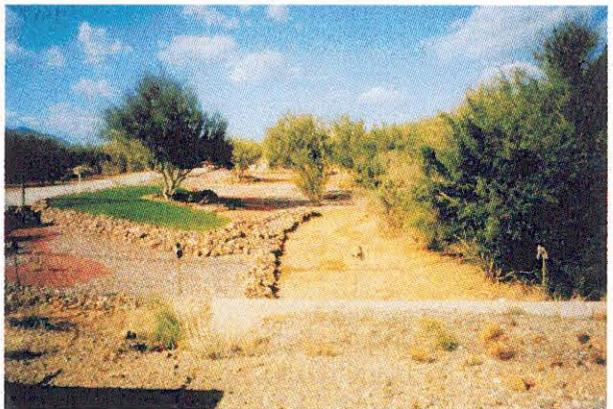
Figure 2-49. Landscaping in channel of Desert Lake Wash.

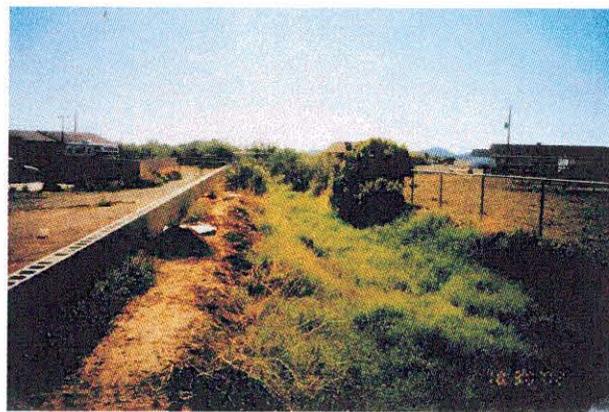
Figure 2-51. Fences, walls, realignment, and irrigation impacts on Desert Lake Wash East Fork.

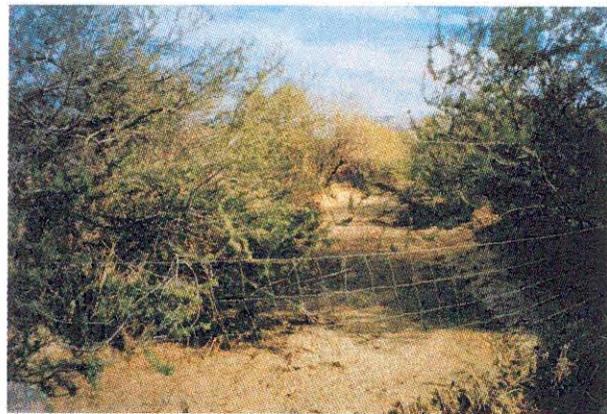
Figure 2-52. Hog wire fence in channel of Skunk Creek Tributary 12.
