**PHASE I PRELIMINARY SITE ASSESSMENT
FLOOD CONTROL DISTRICT
OF MARICOPA COUNTY
CAVE CREEK WASH AND DETENTION BASIN
CAVE CREEK, ARIZONA
CONTRACT NO. FCD 90-70**

WTEC JOB NO. FCD002

PHASE I PRELIMINARY SITE ASSESSMENT

CAVE CREEK PROPERTY
BETWEEN UNION HILLS DRIVE AND BEARDSLEY ROAD
CAVE CREEK, ARIZONA

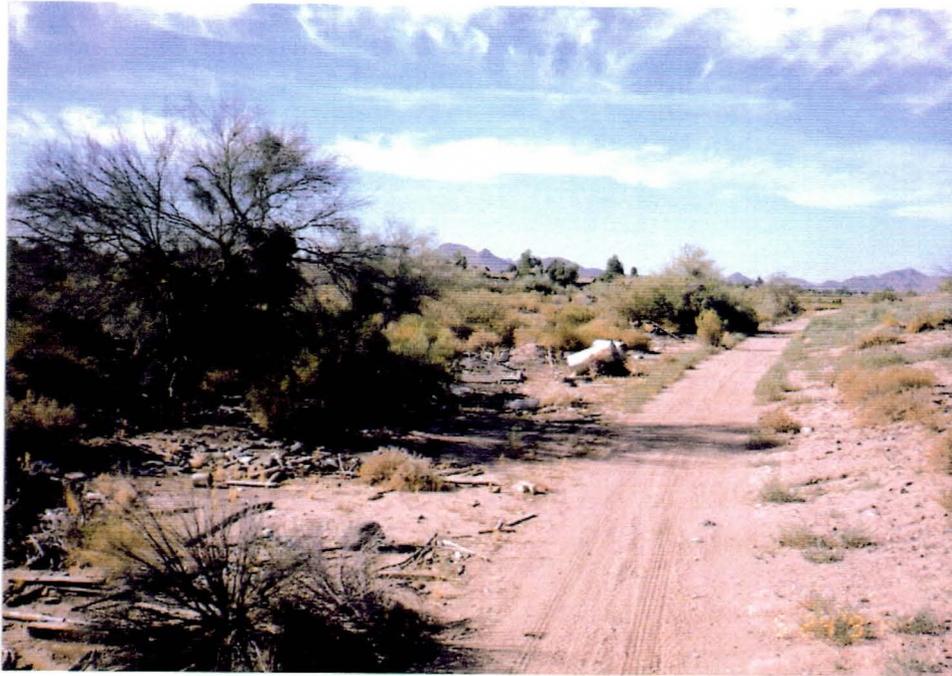
Photograph No. 5
Debris Located on North Portion of Subject Property

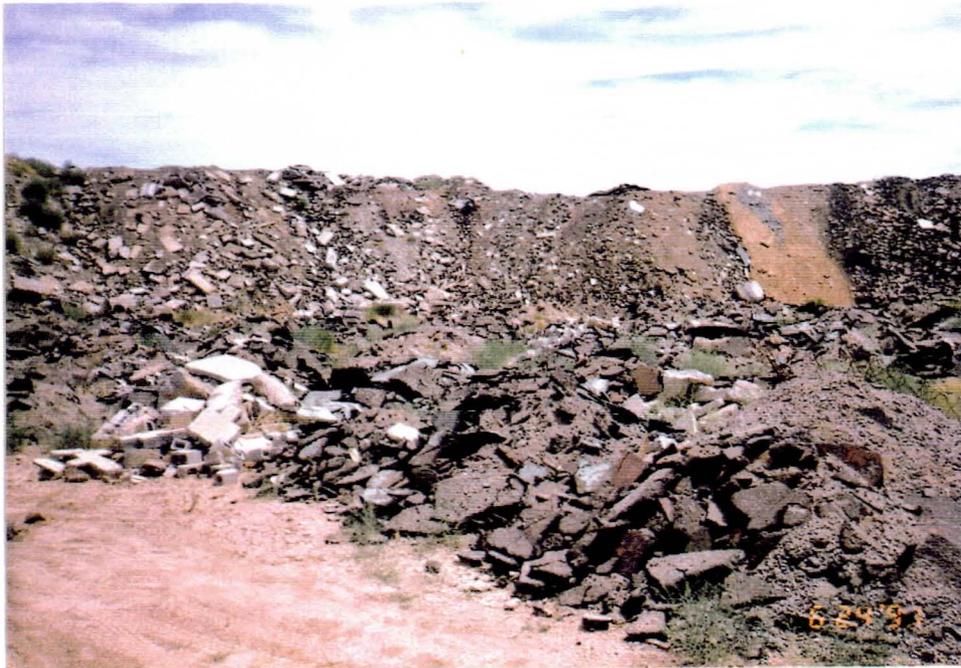
Approximately, 6 to 8 cubic feet of discolored soil with a petroleum type odor was noted in the northwest portion of the potential detention basins. In addition, rubble containing large quantities of concrete and asphalt were observed in this area. It is WTEC's opinion that uncontrolled dumping of materials has occurred in this area for an extended period of time.

Photograph No. 11
Northwest Portion of Potential Detention Basin Area
Showing Construction Debris and Soil Containing Potentially Regulated Substances

Based on these findings, it is recommended dumping activities on the property be further evaluated. There is the potential that some of these activities require regulatory approval. Further, the soils exhibiting petroleum type odors should be sampled and analyzed to determine if they contain regulated quantities of petroleum hydrocarbons. Should these soils be found to be a regulated substance, the area used for dumping should be assessed to determine the extent of contaminated materials on the property.

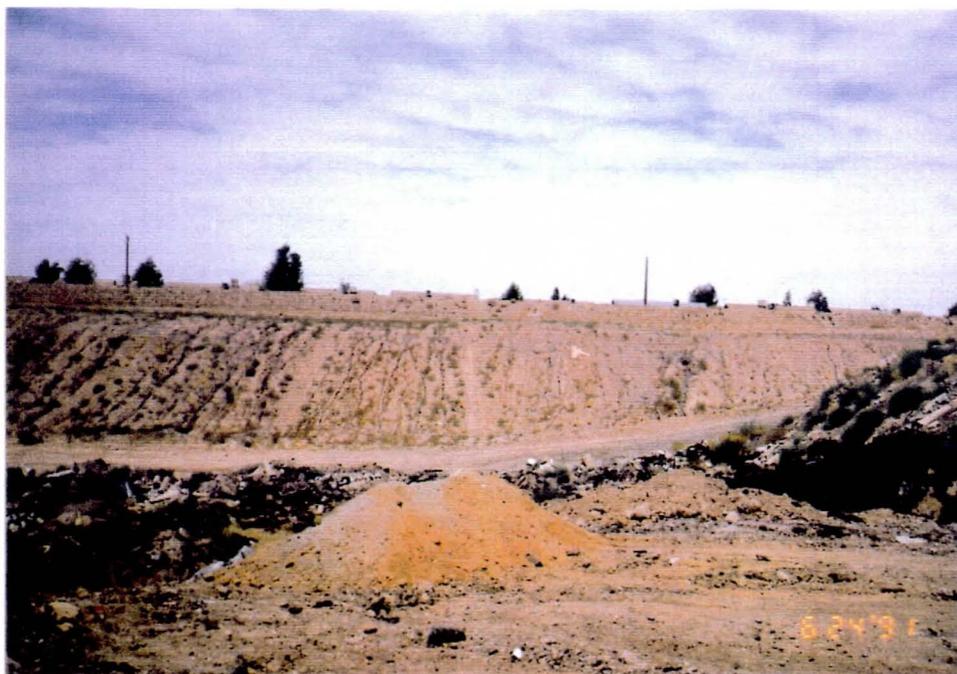
Photograph No. 12
Northwest Portion of Potential Detention Basin Area
Showing Soil Containing Potentially Regulated Substances

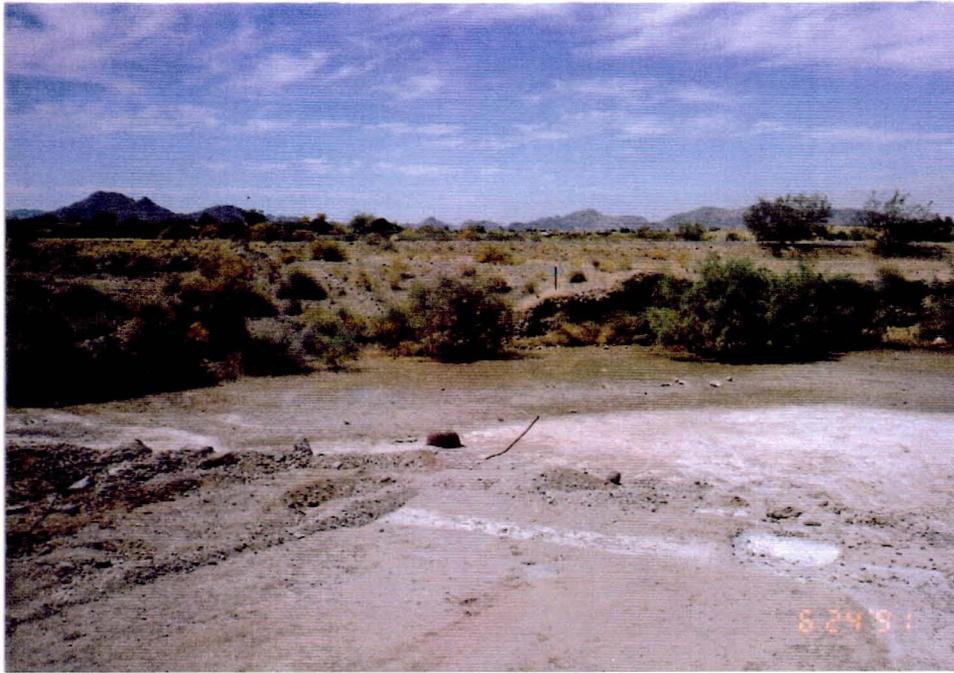
Photograph No. 13
Stagnant Water in Area of Potential Detention Basin Area

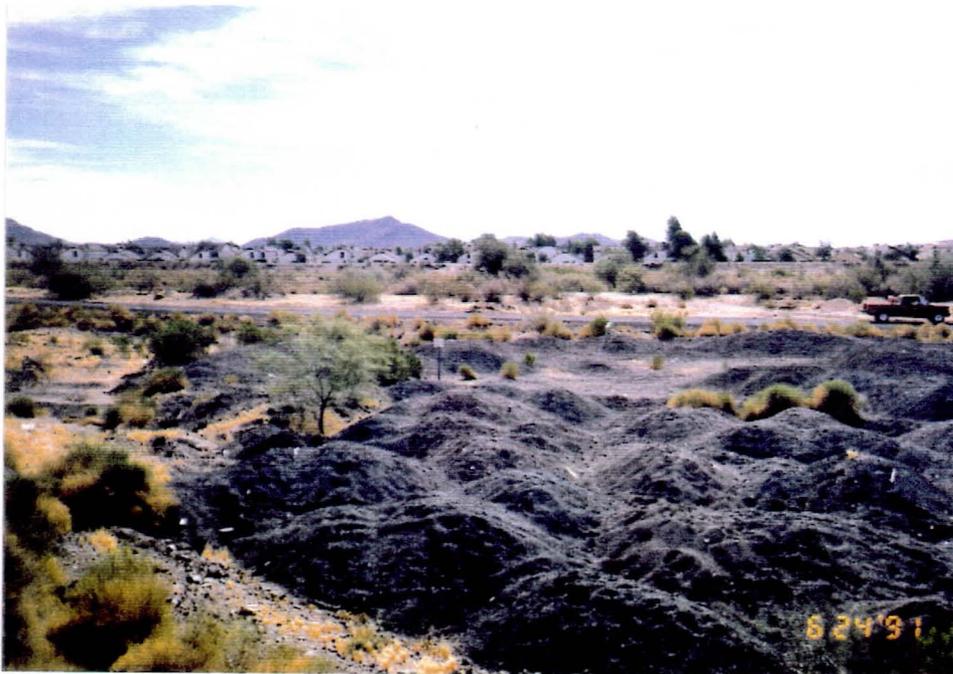
Photograph No. 14
Crushed Rock Pile Located Immediately South of Potential Detention Basin Area

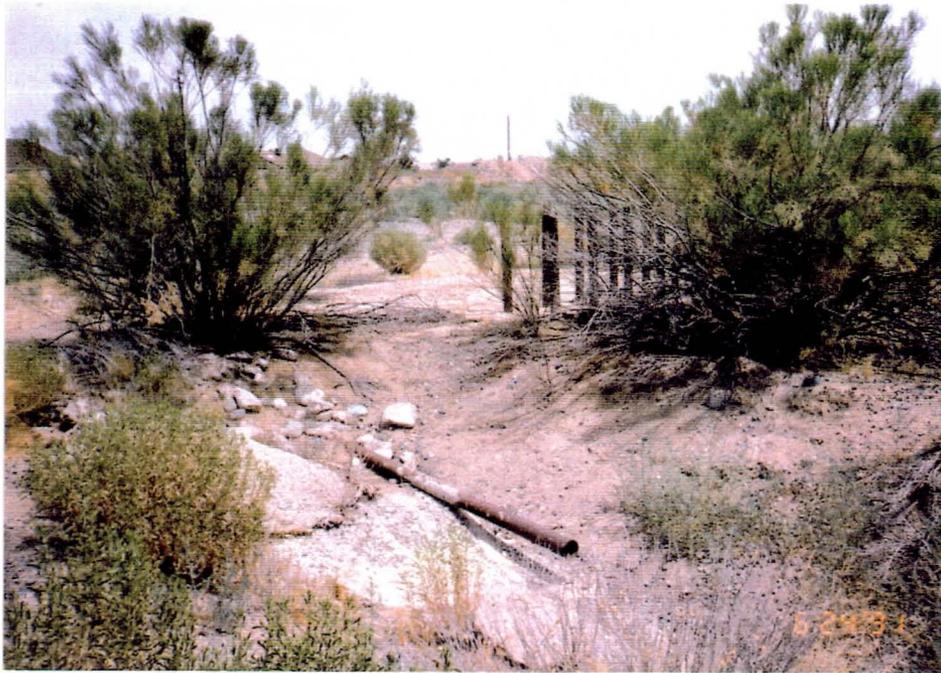
A metal pipe, 4 inches in diameter, extending into the ground was observed on the south portion of the subject property. Sixteen 3-inch pipes set in a concrete pad were also observed in this vicinity. WTEC was unable to determine the purpose of these pipes.

Photograph No. 15
Pipe Existing from Ground that is Located on South Portion of Subject Property
