**FINAL GEOTECHNICAL ENGINEERING REPORT**

**REHABILITATION OF THE OLD US 80 BRIDGE  
AT THE GILA RIVER  
MARICOPA COUNTY, ARIZONA**

**TERRACON PROJECT NO. 65055196  
JANUARY 26, 2007**

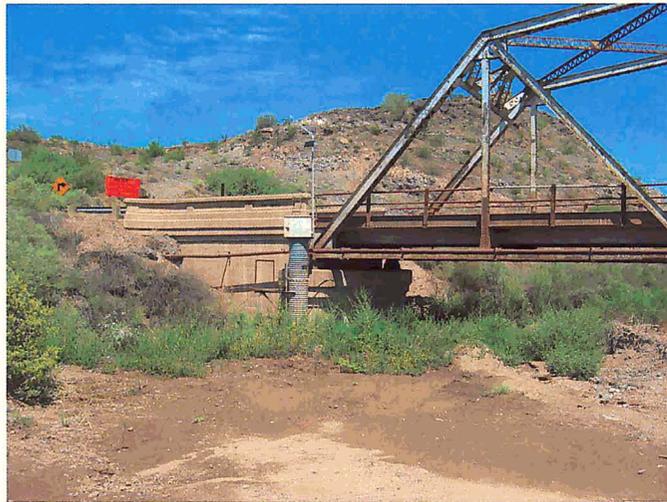
**Photo #1** View looking north at the west abutment Pier 10 of bridge and the presence of an irrigation canal at the abutment.

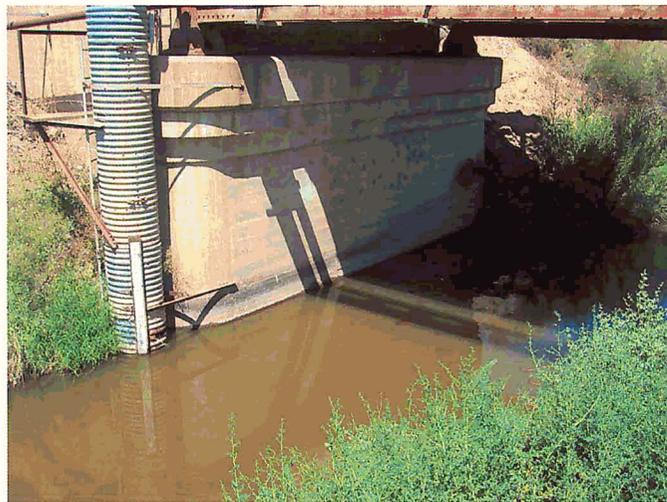
**Photo #2** Close-up view of irrigation canal at the west abutment of the bridge

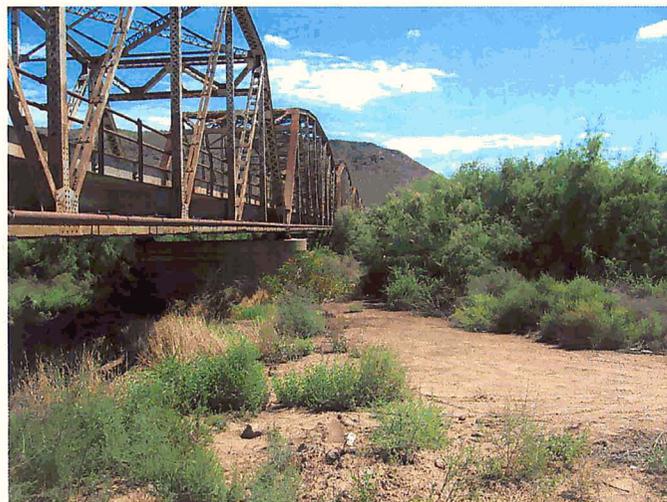
**Photo #3** View looking east on the downstream (south) side of bridge at rough access road for Piers 5 through 9.

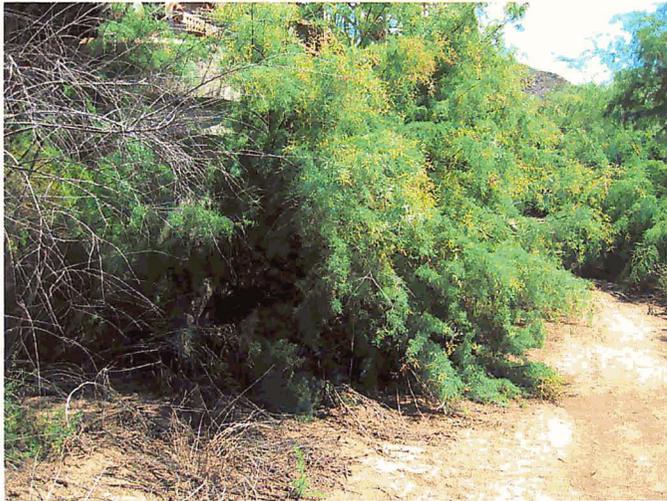
**Photo #4** View of rough access road on downstream side of bridge

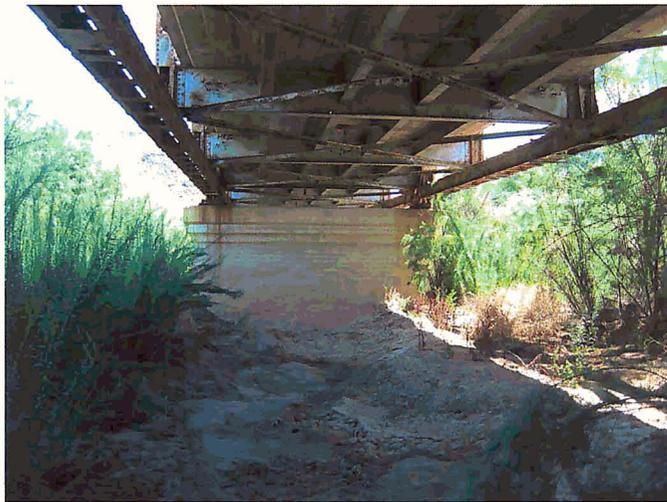
**Photo #5** View looking east at underside of bridge showing access for the upstream side from the downstream access road

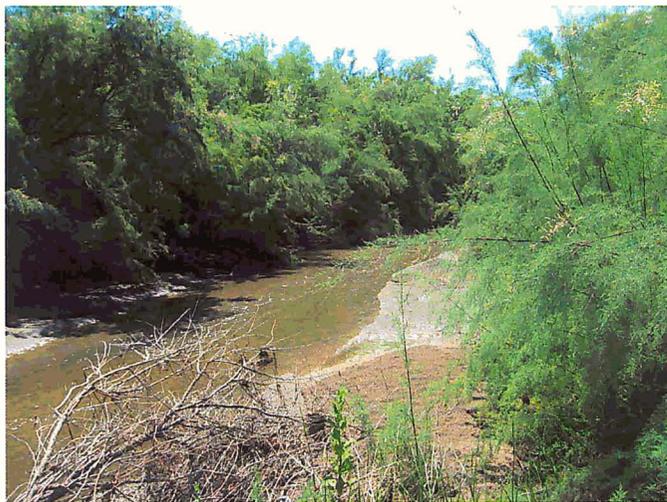
**Photo #6** View of the current Gila River flow channel located between Piers 4 and 5.

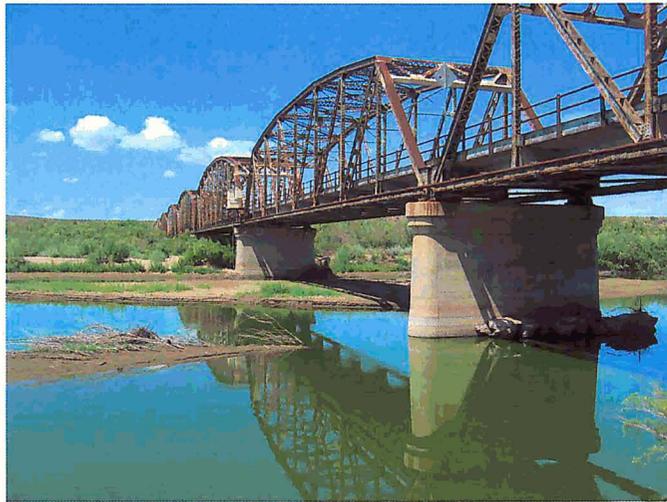
Pier 2 at the east end of the bridge is located in an area of standing water. An existing sand bar divides the standing water into two distinct channels, the western portion of which extended to the eastern side of Pier 3. The standing water is an estimated two to three feet in depth at the location of Pier 2. Evidence of previous scour protection repairs (installation of jet grouted concrete piers) was observed above the level of the standing water at Pier 2.

**Photo #7** View looking northwest at Pier 2 and the standing water surrounding that pier. Boring will be drilled from deck.

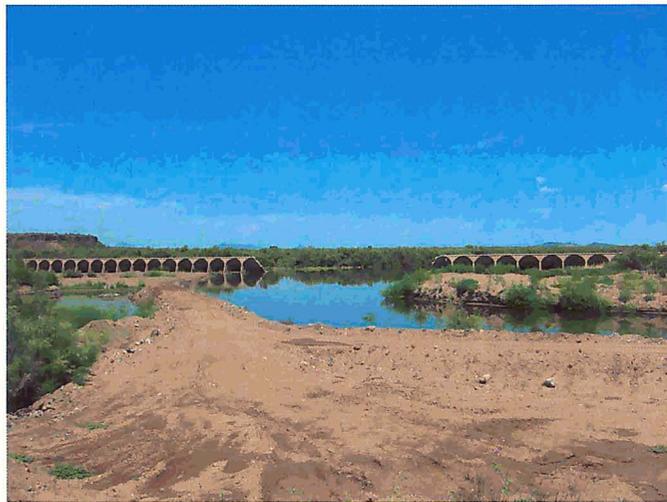
**Photo #8** View of Paloma Irrigation & Drainage District access road that allowed access to Piers 3 and 4.

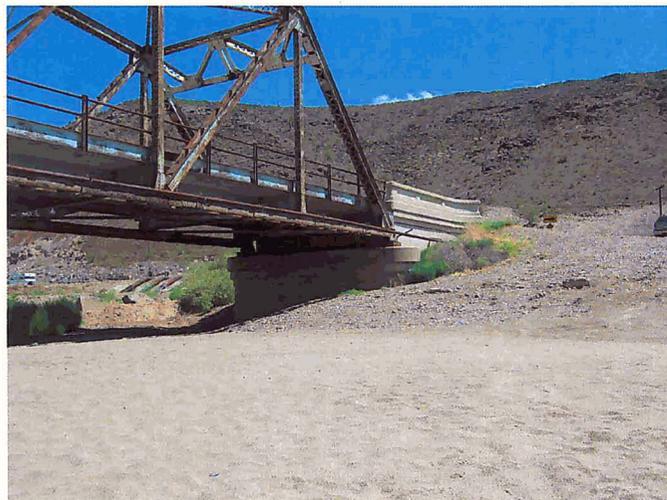
**Photo #9** View of the east abutment of bridge Pier 1, and the access from the highway to the south side of the structure.
