CAPital idea

Steel sheets may route crack away from canal

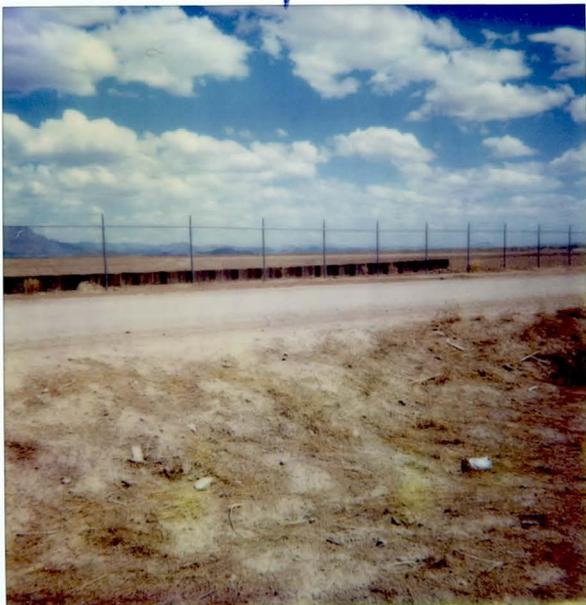
Point # 1, Looking 180°
from fissure. (Eastward)
Toward Powerline Dam.
In foreground, piling of CAP

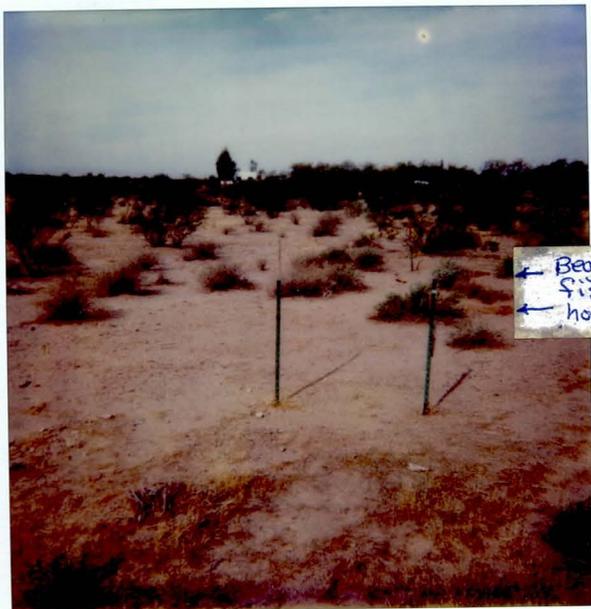
Point #1

← Beginning of fissure
← holes 2' deep

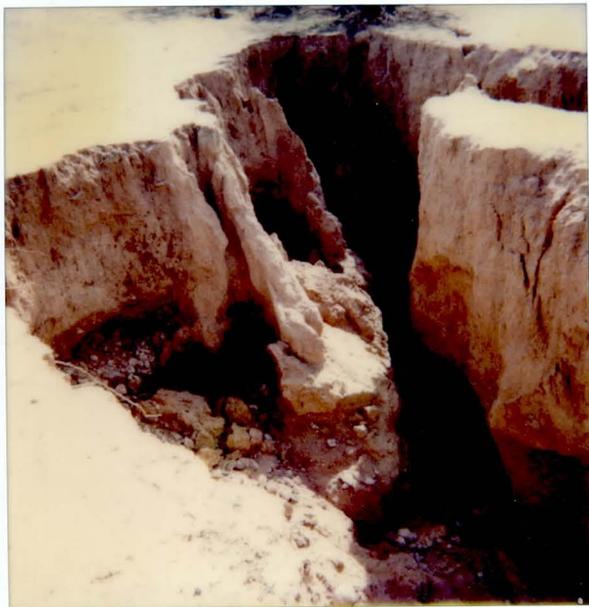
10-4-85
Point #6, turned 180°

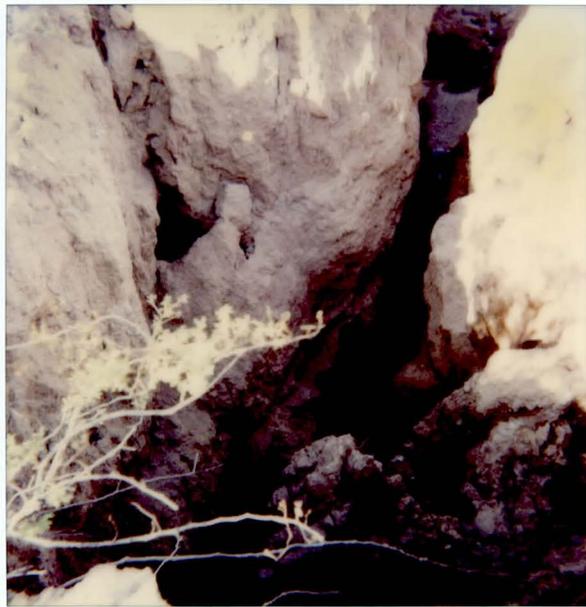
10-4-85
Point #6, looking down.
About 18' deep.

Point #6 appeared to be the deepest point, about 18' deep.
Also, there are ~~two~~ holes in the vicinity of point
#1 which do not show up in the photo, about 8' deep.

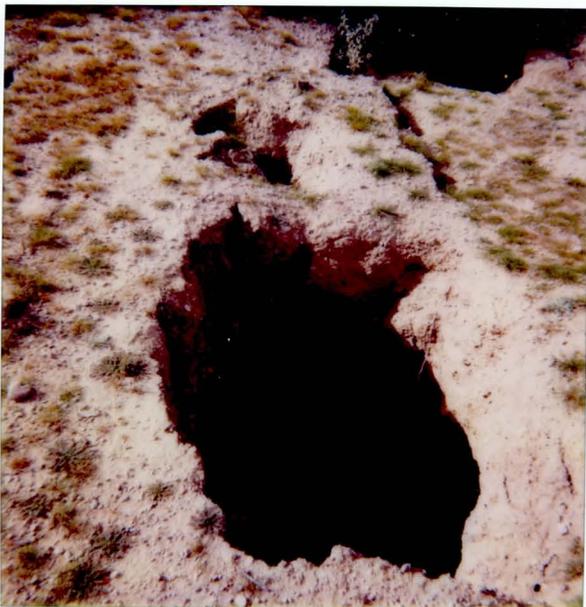
1-2-86
Pt 4, looking
down. \approx 8' deep.

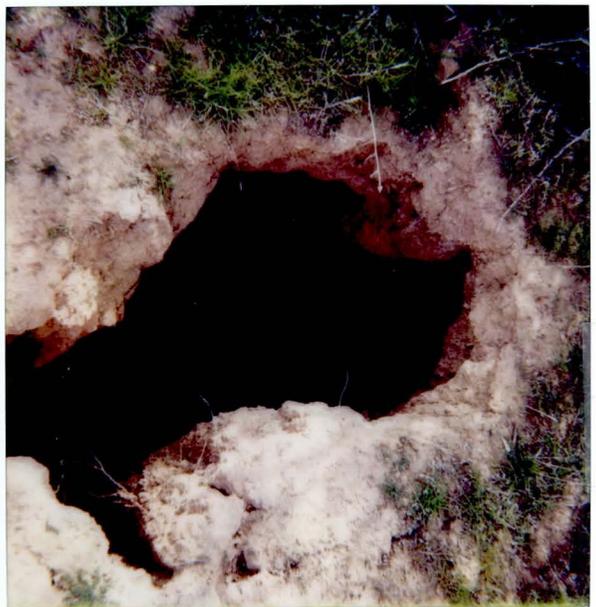
1-2-86
Pt 5+70
 \approx 15' deep

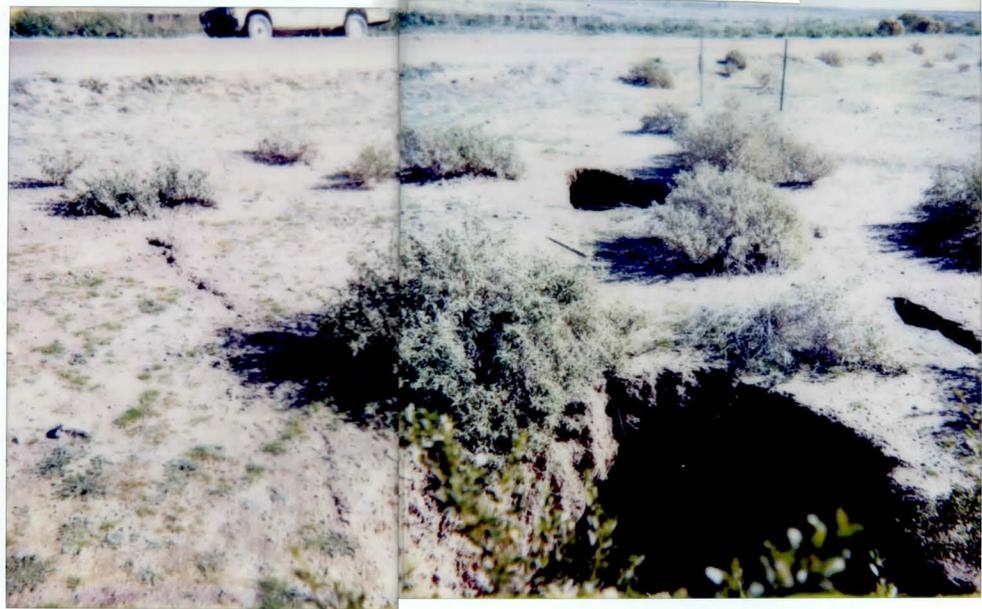
PE # 1

FISSURE CONTINUES
ONTO PRIVATE PROPERTY
