Flood Control District
of
Maricopa County
July 24, 1992

Storm Damage
Report

802.070

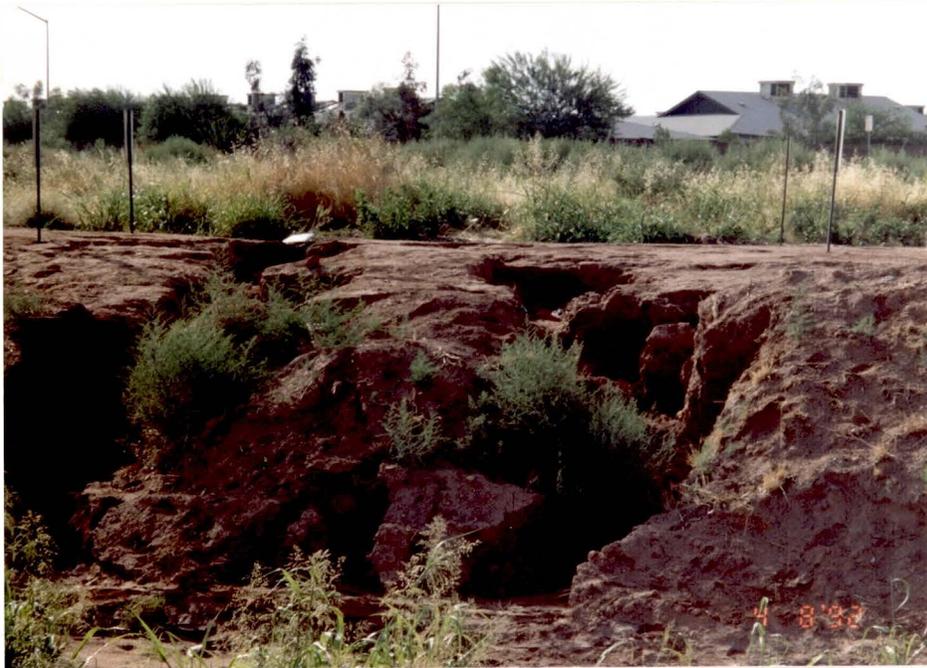
Sossaman Road Drain: South of Baseline Road the problems are the result of the golf course east of the drain directing their runoff water into the drain. The outlets they have created in the block wall allows the run off water into Sossaman Drain via the unprotected slope. In addition, the sheet flows south of the wall are not directed into spillways. From station 5+00 to station 44+88 a total of 10 areas need to be repaired. Approximately 100 feet north of Baseline Road on the east bank, an area 39' long by 32' wide was eroded as a result of water entering the drain from a drainage ditch the parallels Baseline Road.

Approximately 100 feet north of Baseline Road on the east bank, an eroded area caused by runoff water from a drainage ditch that parallels Baseline Road.

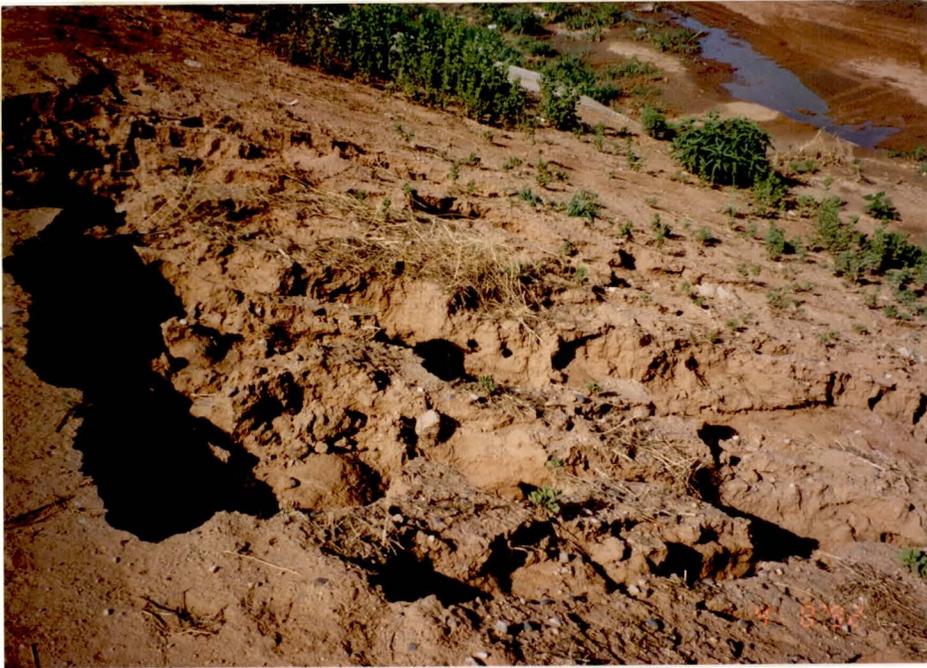
East bank, station 44+88. Damage from runoff water directed through block wall at golf course.

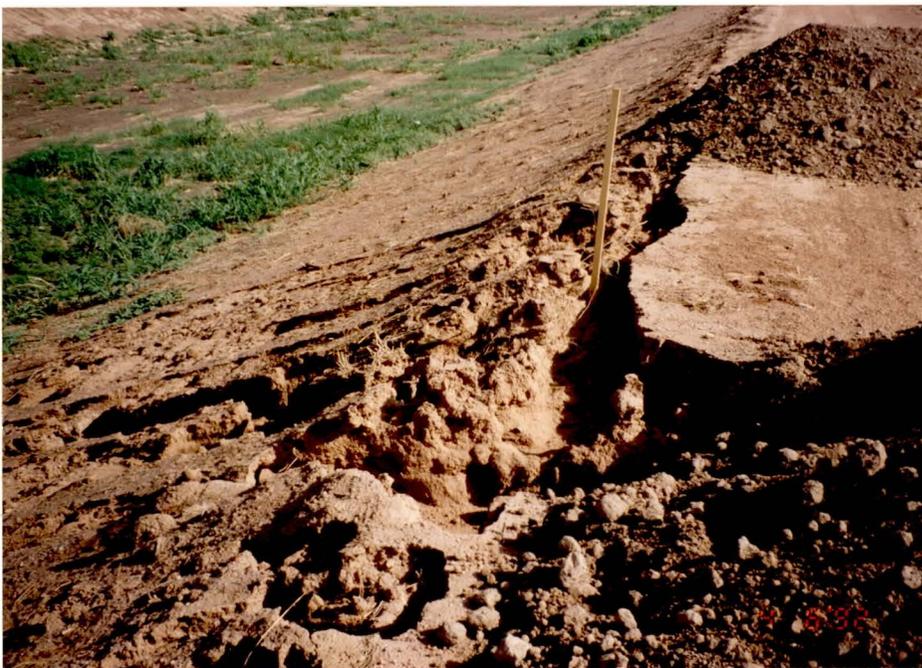
East bank, station 15+00. The result of sheet flow entering the drain from a vacant field to the east.

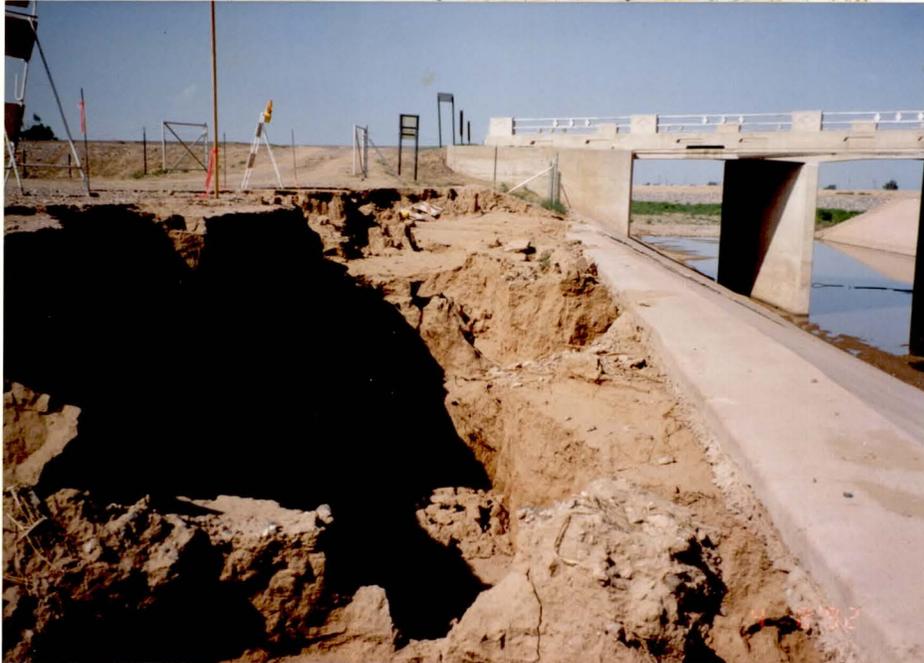
East Maricopa Floodway: The damage done to the EMF occurred in Reaches 3 and 4 with the most severe occurring south of Williams Field Road on the south bank, station 550+00. It appears that runoff water in the drainage ditch east of Power Road inundated a culvert and sheeted into the floodway. This resulted in the liner being undermined, lifted and buckled. The center of the liner in this section was lifted 4 inches. Because the material behind the liner has been eroded away, the top portion of the liner has dropped 8 inches. On the east bank at stations 560+00, 575+00 and 585+00 sheet flows entering the floodway caused severe erosion to the slope.

South of Williams Field Road, south bank at station 550+00. Section of liner that has been undermined from runoff water entering the floodway.

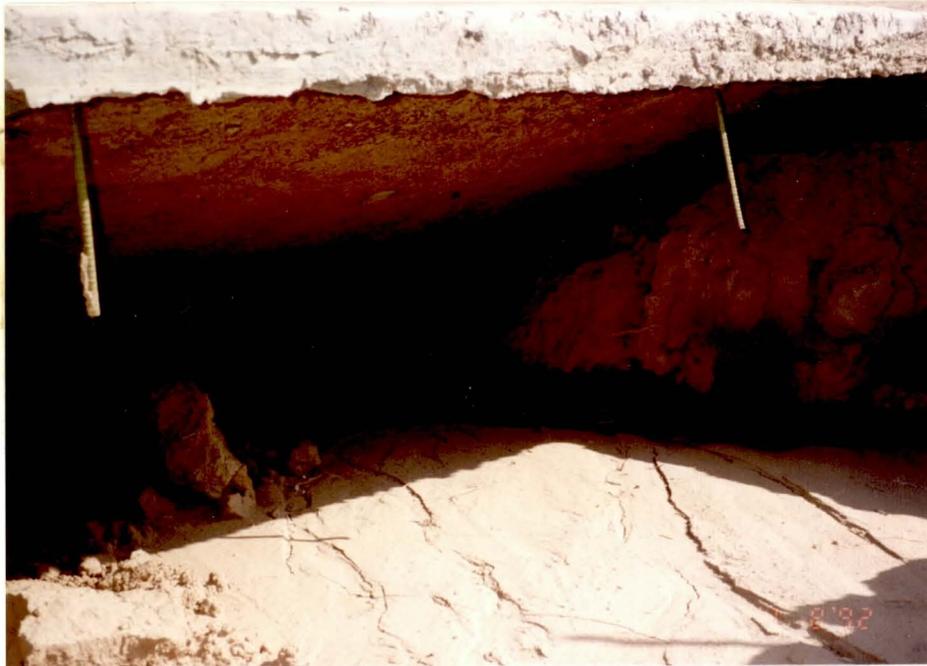
Shows the severity of the voids beneath the lined section

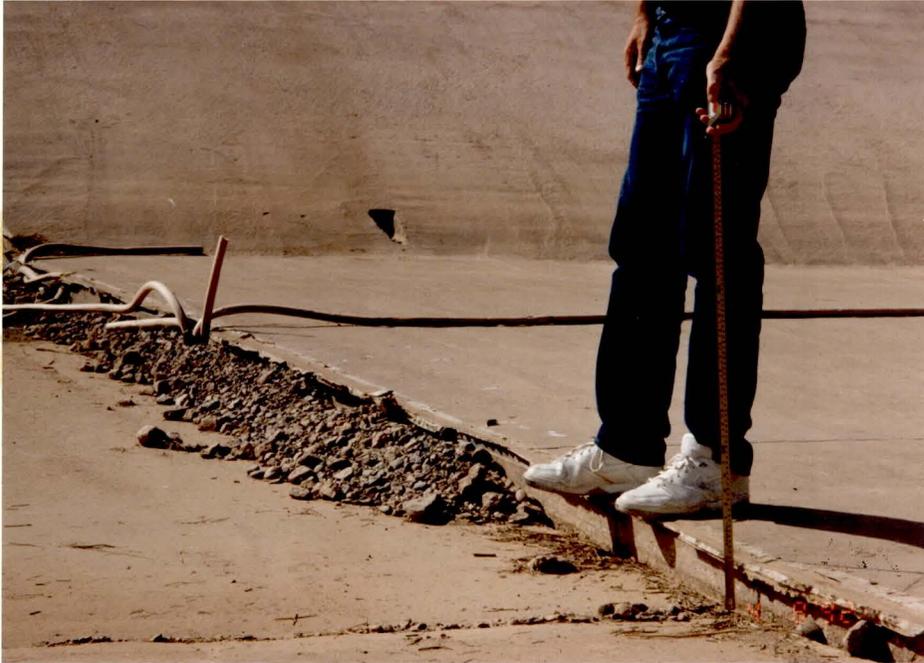
The liner at station 550-00 has been lifted 6 inches at the invert, (above) and has dropped 8 inches at the top of the slope, (bottom).

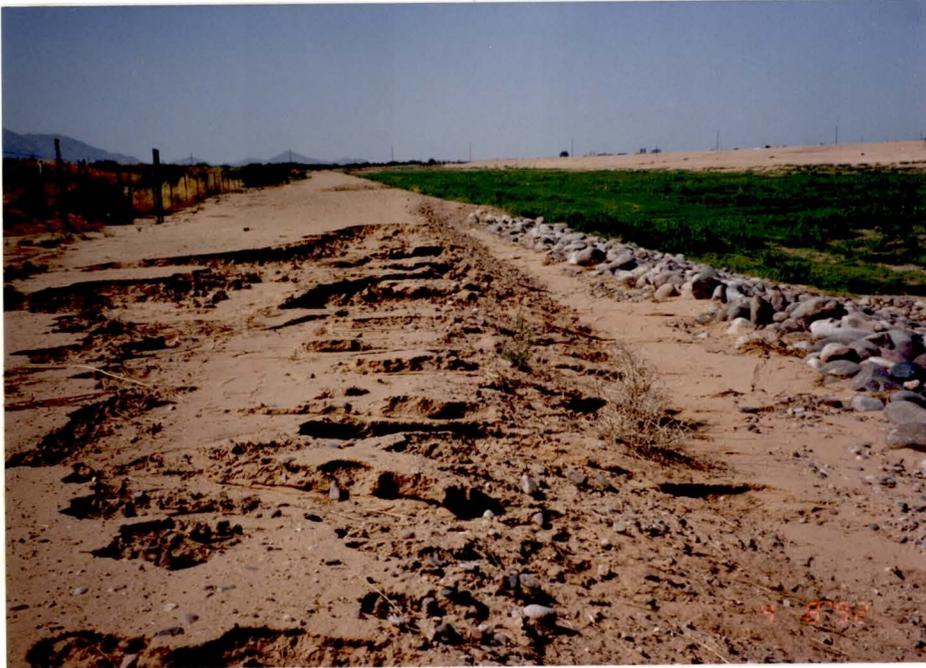
At station 560+00, east bank, sheet flow across access road and bar ditch. (above)

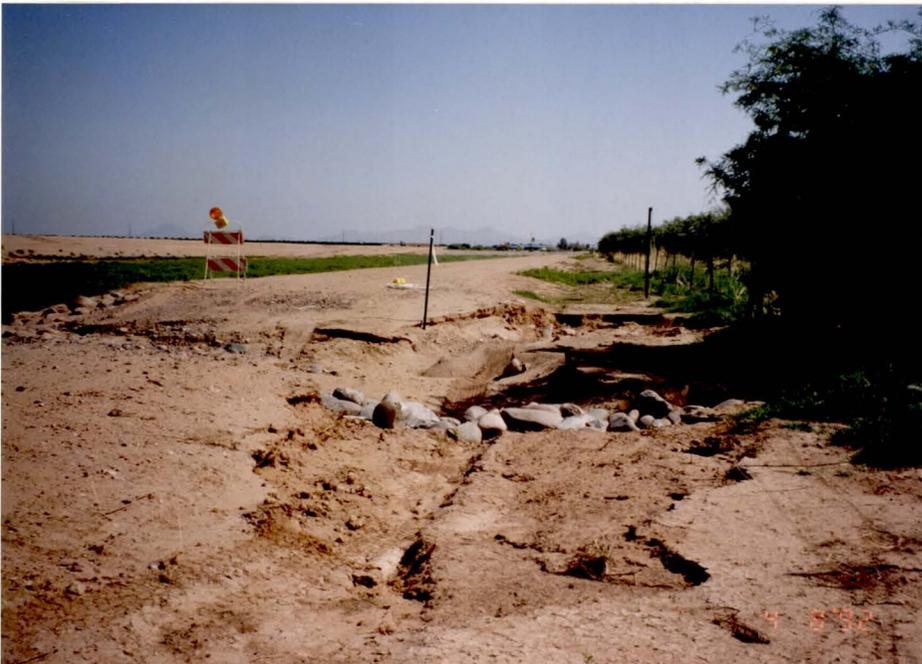
At station 575+00, east bank, erosion and piping at riprap chute. (below)

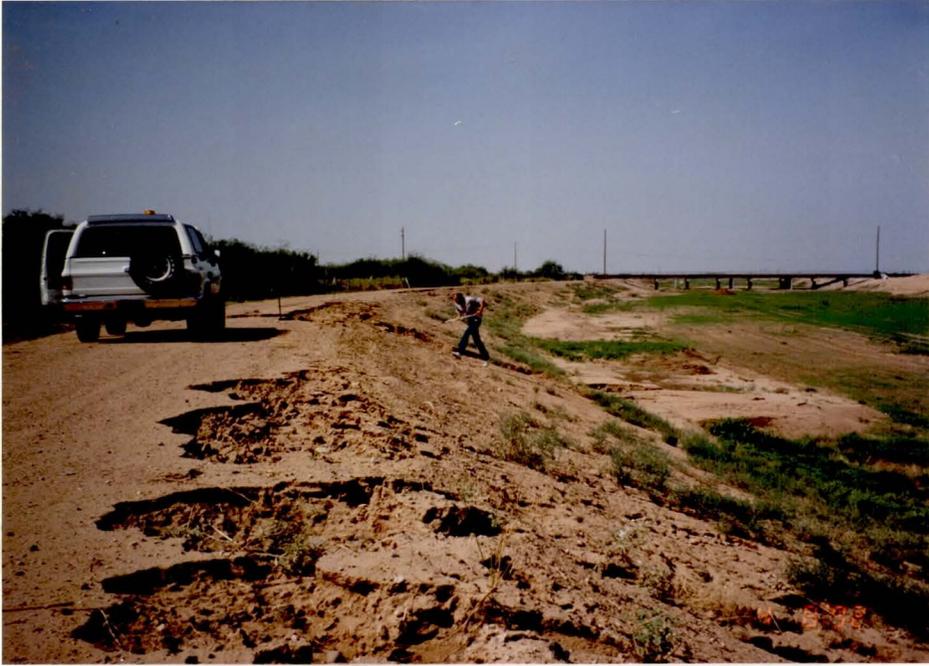
At station 585+00, east bank. Sheet flow down the unprotected bank. (above)

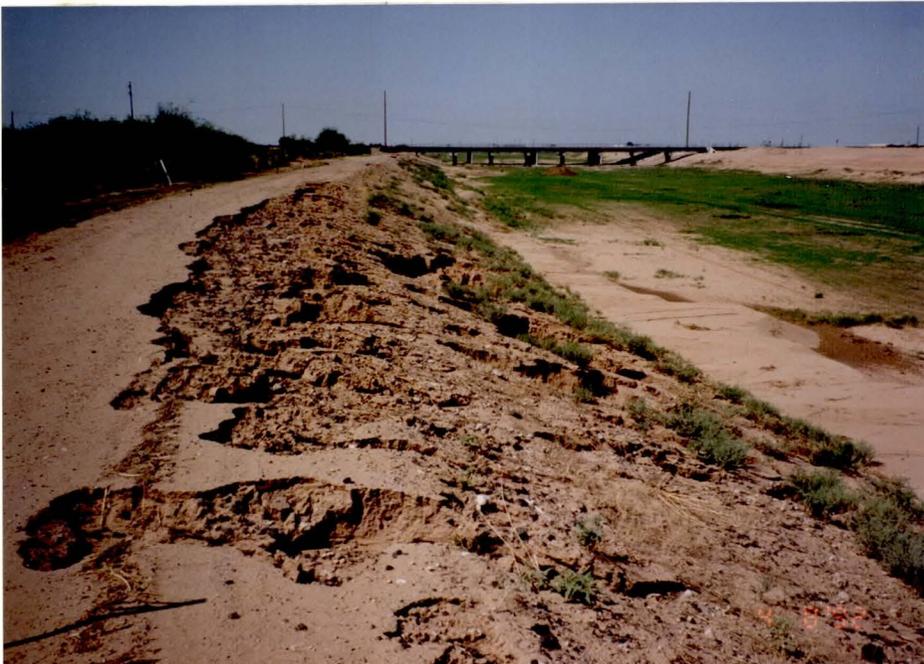
At station 590+00, east bank. Erosion to the access road and bank caused by sheet flow. (below)

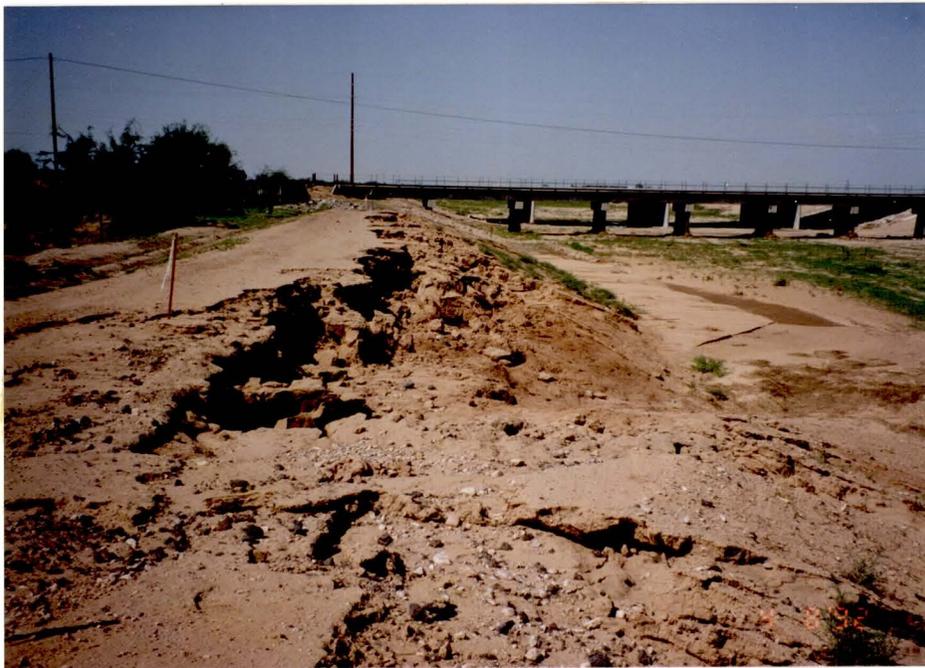
Damage to the access road, embankment and ramp into the floodway just north of Rittenhouse Road, east bank.

On the east bank north of Rittenhouse Road, in an area approximately 300 feet long, extensive erosion damage occurred. The access ramp into the floodway will need to be rebuilt, the entire slope in that area needs to be addressed and the upstream slope of the levee should be armored. At station 670+00 and station 680+00 on the east bank, inlet chutes were undermined and need repair. On the east bank at station 810+00 piping from the east side of the levee into the floodway needs to be repaired. In reach 3 the gravel mulch chutes on the west bank have been damaged and need repair. On the west bank, south of Hunt Highway a major piping area will need to be excavated and repaired.

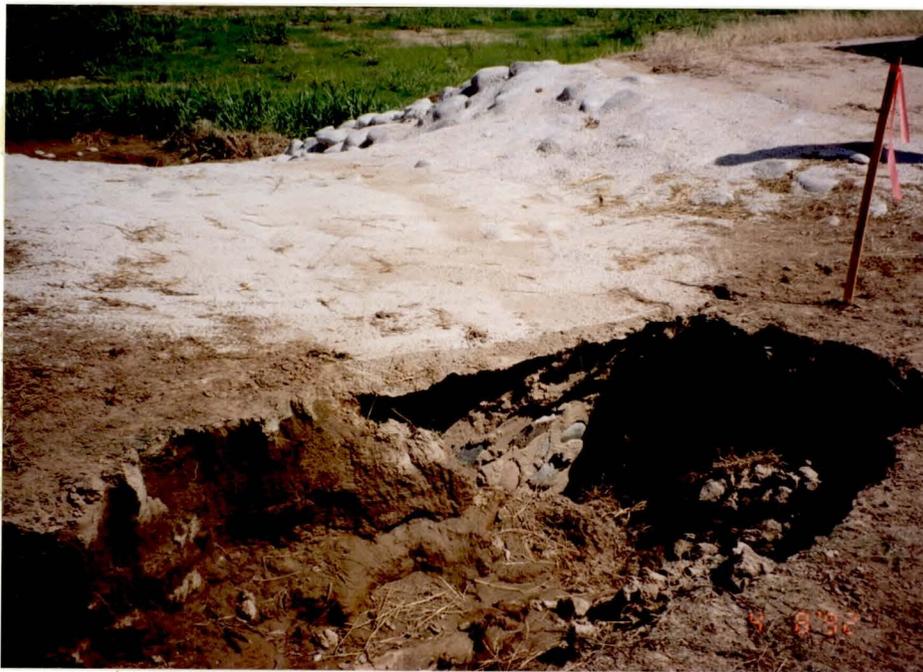
Station 670+00, east bank. Piping and blow out of grouted riprap chute.

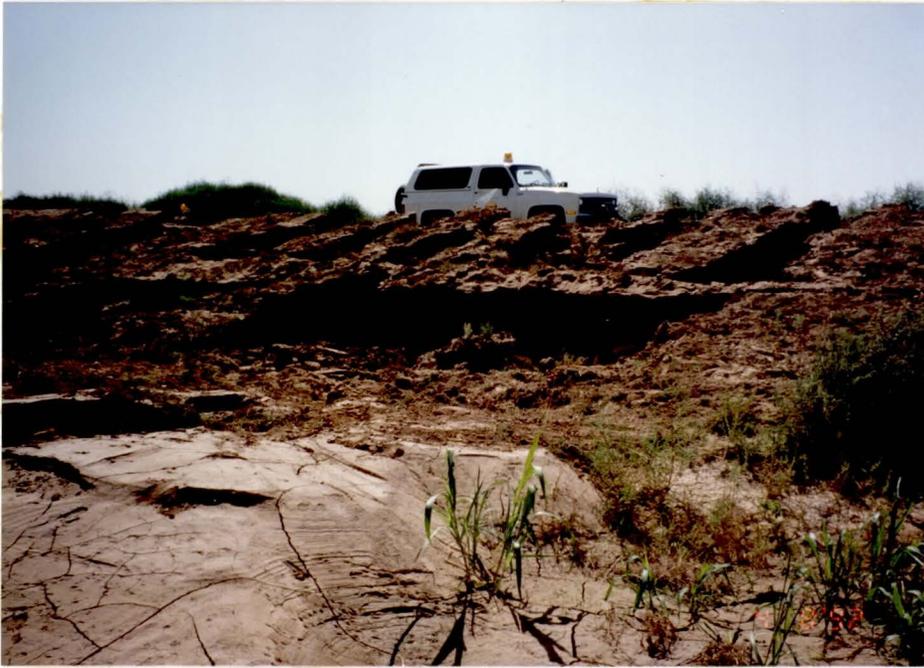
At station 810+00, east bank. Damage to access road and embankment caused by sheet flow and piping.

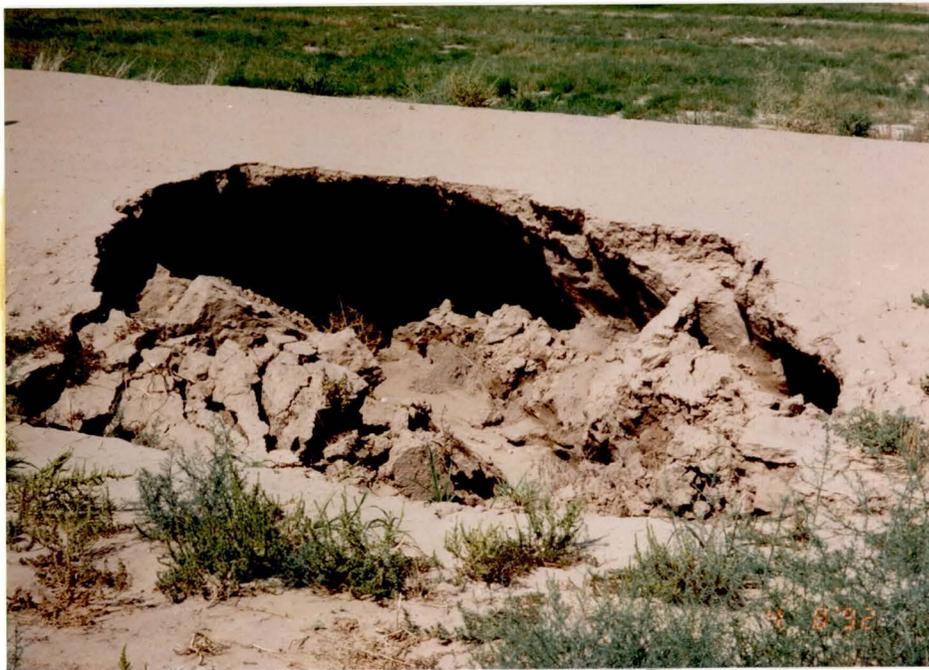
At station 810-00, east bank. Blow out from bar ditch to floodway. (above)

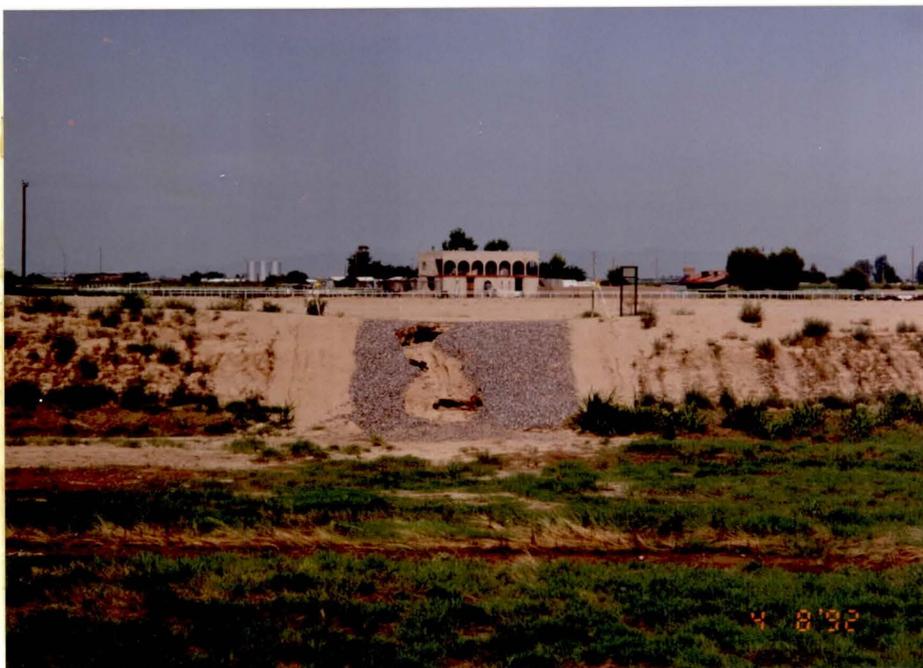
At station 857-00, west bank. Damage to gravel mulch chute. (below)

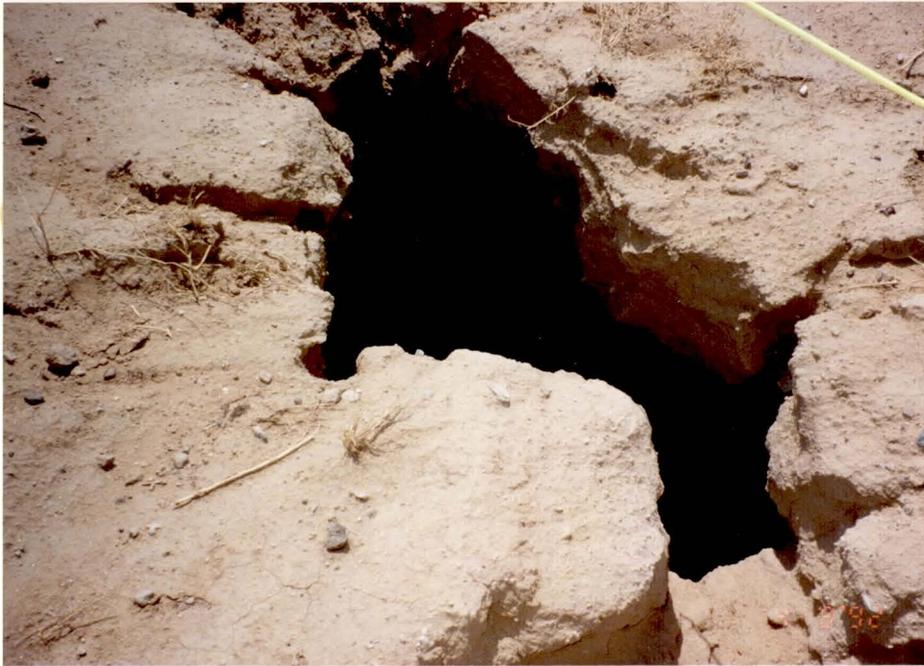
Approximately 200 feet south of Hunt Highway, west bank. Piping from the access road to the floodway.

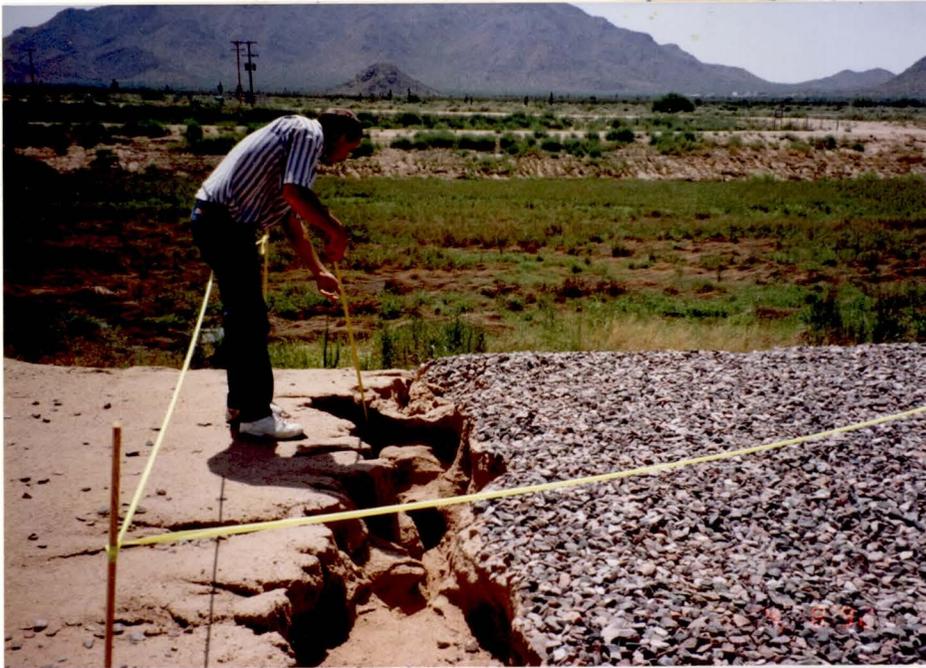
Approximately 300 feet south of Hunt Highway, west bank. Piping and erosion damage to a gravel mulch chute.

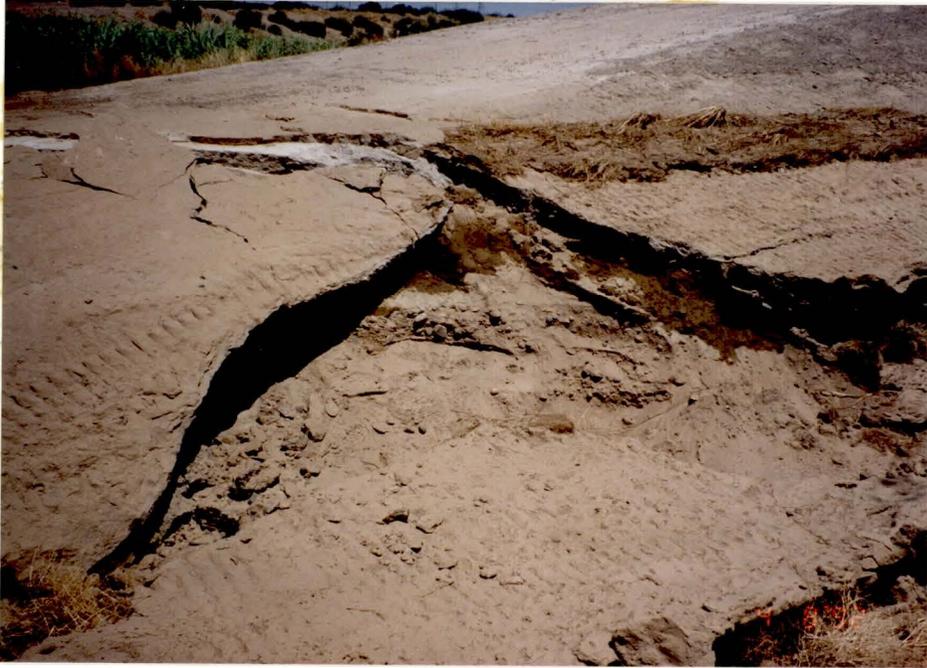
Agua Fria River: The damage was restricted to the north levee of the West Papago Channel. This channel is located north of I-10 on the east bank of the Agua Fria River. At station 30+35, (west end of the levee) the flows from the channel have undermined the toe of the levee approximately 8 feet causing the soil cement to break and give way.

Damage to the south bank of the north levee, of the West Papago Drainage channel of the Agua Fria River. Soil cement has been broken off and eroded away.

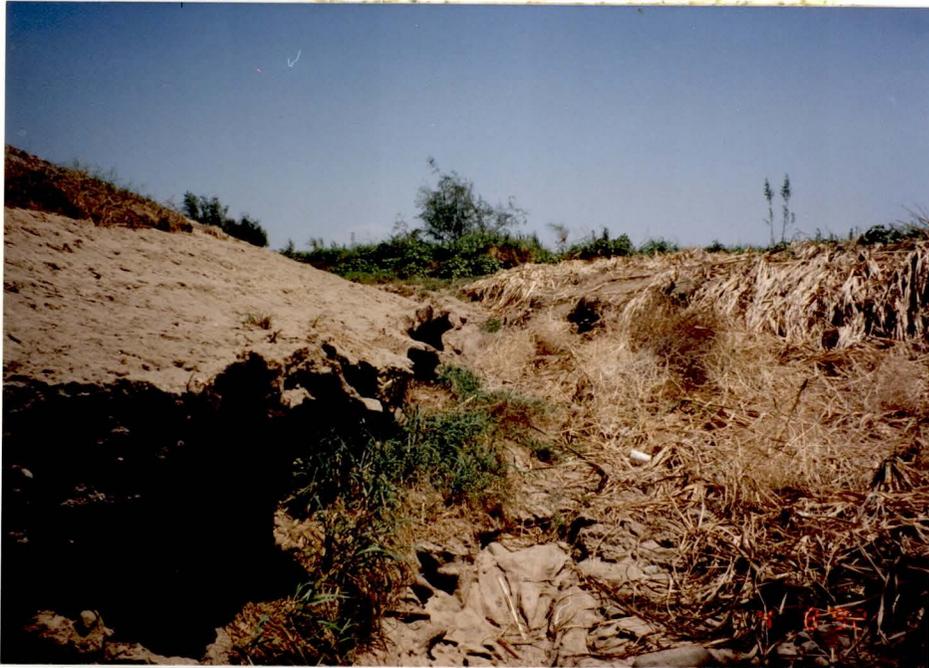
The west end of the southern slope being undercut.

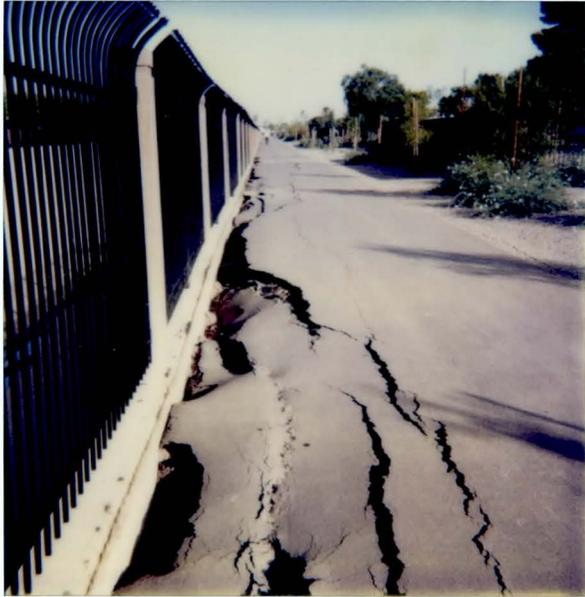
720 - 730

ACDC: The most severe damage occurred in Reach 3 between stations 595+00 and 770+00. On the north bank: At station 770+00 a large portion of the granite landscaping had been eroded and washed away. From station 720+00 to station 730+00 the entire area settled resulting in the cracking and buckling of the asphalt maintenance road, voids adjacent the channel wall, the maintenance road becoming separated from the channel wall and the apparent 4 inch rotation of the channel wall. At station 670+00 the landscaped area suffered serious erosion that will require the importation of fill material and granite. The concrete chute at station 660+00 has been undermined. This entire reach suffered minor erosion on the north bank that will also require attention.

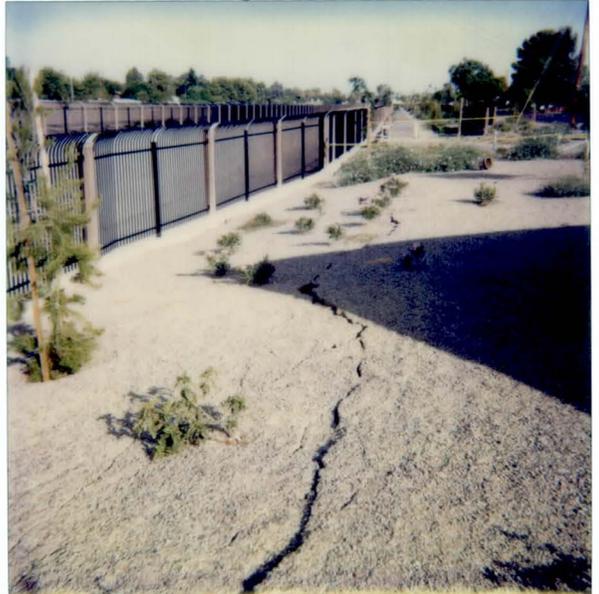
720 - 730

Damage in Reach 3 of the Arizona Canal Diversion
Channel, station 720 to station 740, north bank.
