**Flood Control
District of
Maricopa County**

**CANDIDATE ASSESSMENT REPORT
Upper Camelback Walk Wash
Flood Control Project
FCD Contract 98-24
Assignment No. 3**

Revised
March 12, 2001

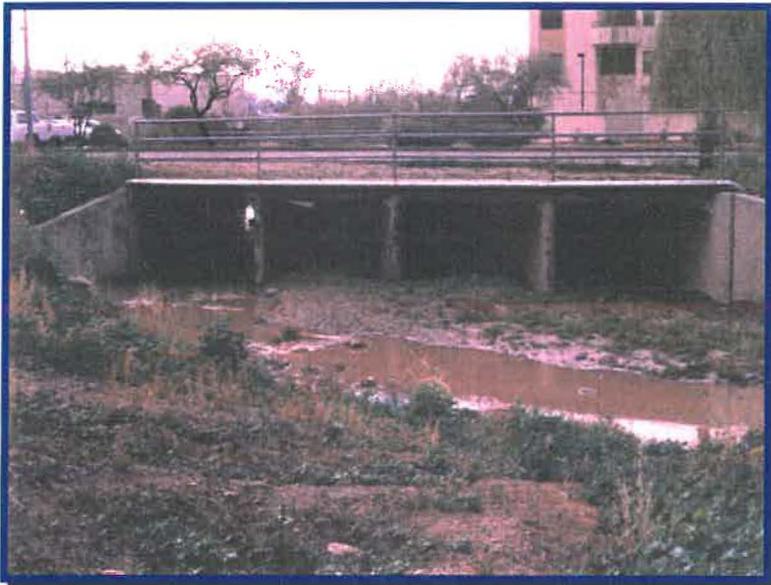
Pic 1.5:

4 Barrel Box Culverts
Crossing 92nd Street at the
upstream end with wing
walls.

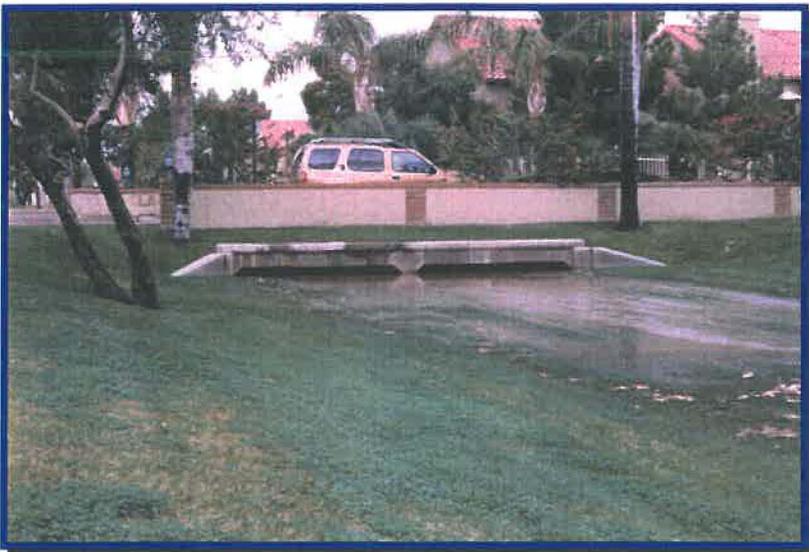
Pic 1.9:

Looking upstream at the
grass-lined trapezoidal
channel and 2-barrel box
culvert crossing the
entrance to La Contessa.
Channel invert has been
raised approximately 1-
foot blocking discharge
from box culvert

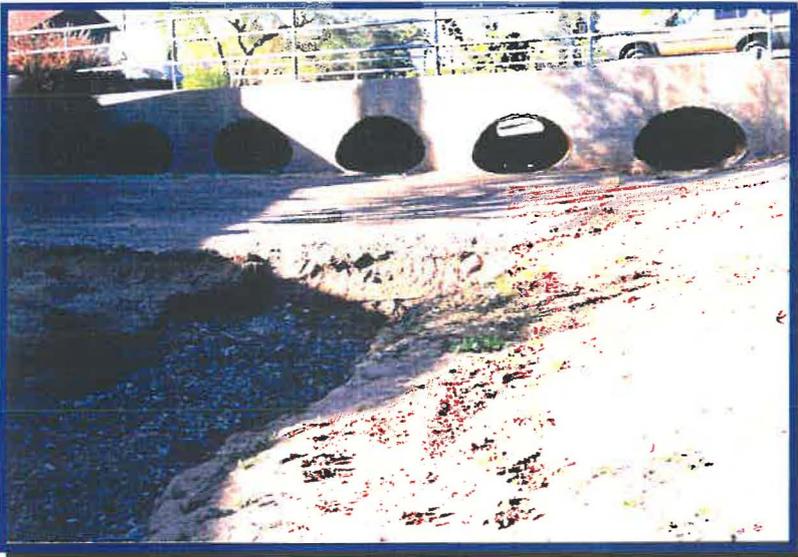
Pic 1.19A:

Looking upstream at the channel and the 5-barrel elliptical pipes crossing Laurel Lane. The channel bottom has eroded approximately 200-feet downstream.

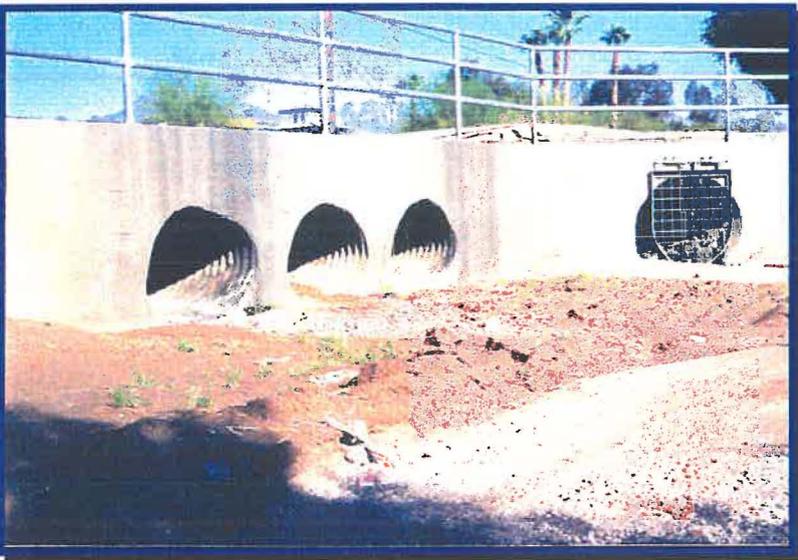
Pic 1.20:

Looking upstream at the 3-CMP pipes and 48"-RGRCP pipe with grate crossing Cactus Road located on the south side of Cactus. 3-CMP pipes are discharging flows north of Cactus as shown in Pic 3.6. The 48"-RGRCP pipe is a storm drain system originating north of Sweetwater Avenue within the 94th Street alignment.

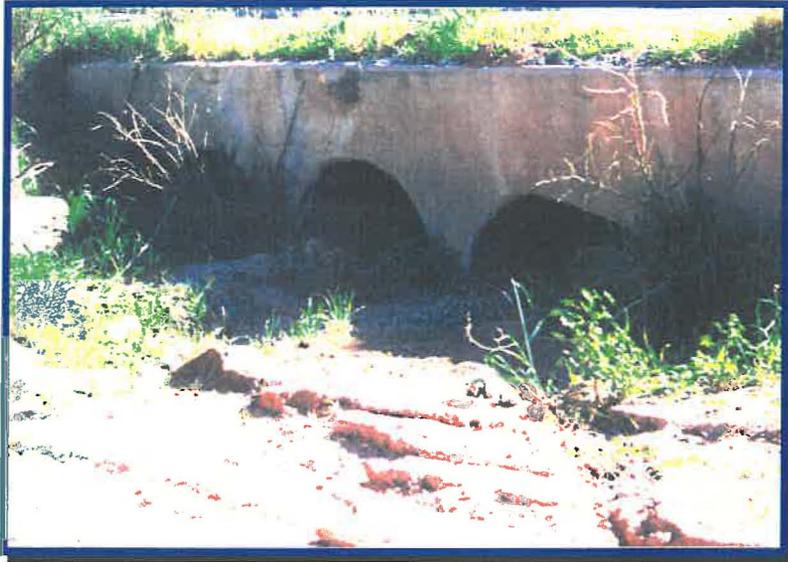
Pic 1.21:

Looking downstream at the 3-CMP pipes crossing Cactus Road located on the north side of Cactus. It is unclear where flows are originating from to this structure.

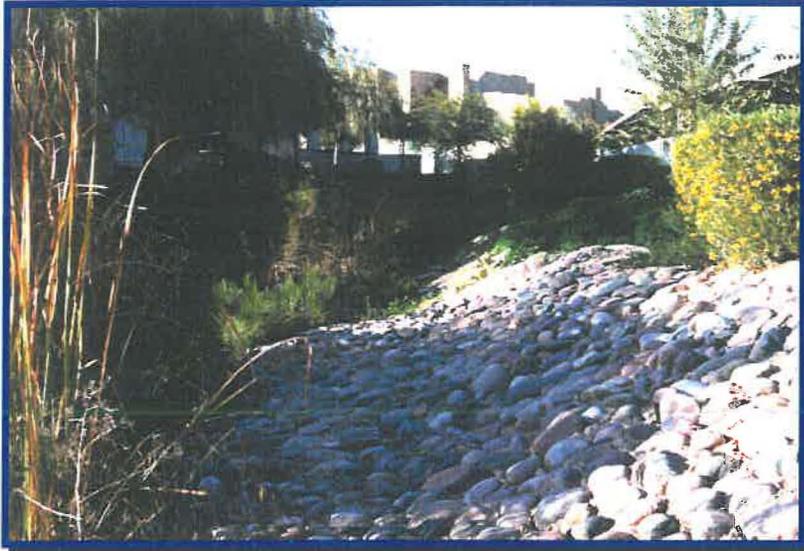
Pic 1A.1:

Looking upstream at the earthen channel (Wash-1A) with rip-rap along the east bank. The channel upstream is covered with dense brush.

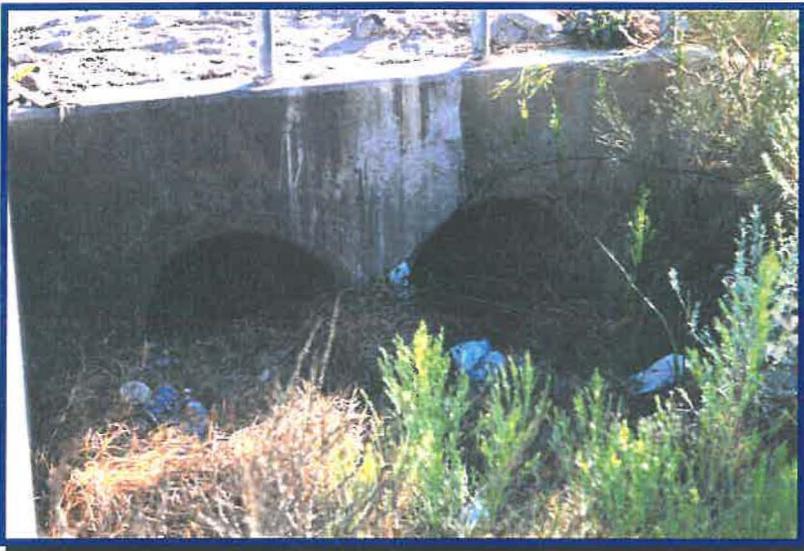
Pic 1A.2:

Looking upstream at the 2-barrel RCP pipes crossing Desert Cove. The pipes are partially covered with brush obstructing flow.

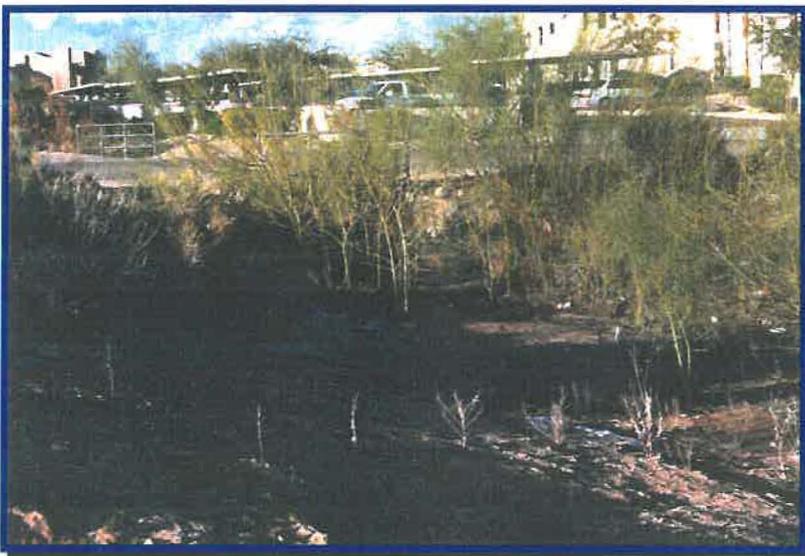
Pic 1A.3:

Looking downstream at the unimproved earthen channel (Wash-1A) covered with brush.

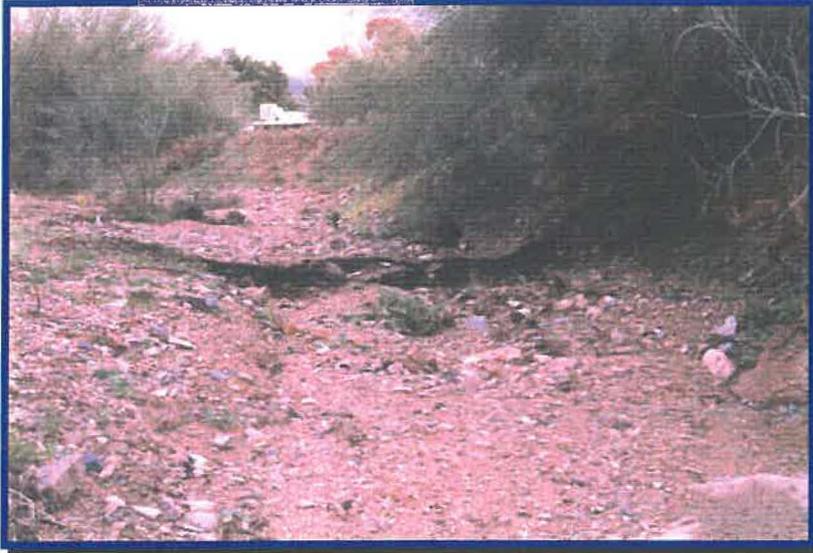
Pic 2.7:

Looking upstream at the unimproved wash (Wash-2). It is also, apparent the erosion that has taken place at the channel bottom

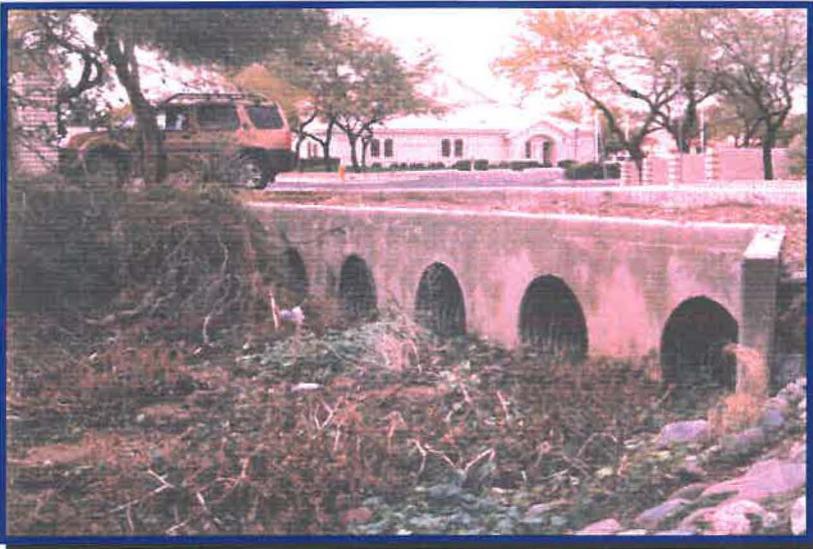
Pic 2.8:

Looking upstream at the 6-barrel CMP pipe crossing Oak Drive west of 96th Street. The discharge culverts are obscured with debris especially west most pipe compared to the upstream end as shown in Pic 1.25.

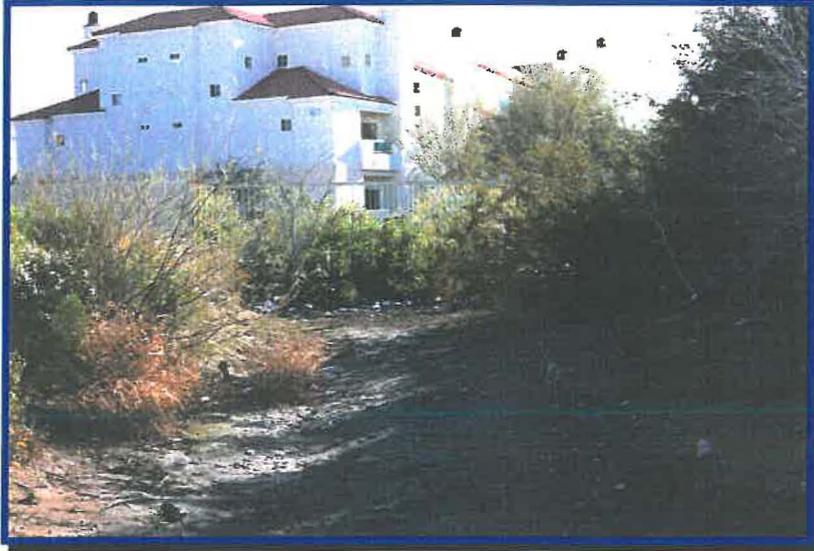
Pic 2A.8:

Looking downstream at the unimproved channel south of Redfield Road and west of 96th Street outletting flows to the apartment complex through the wall opening.

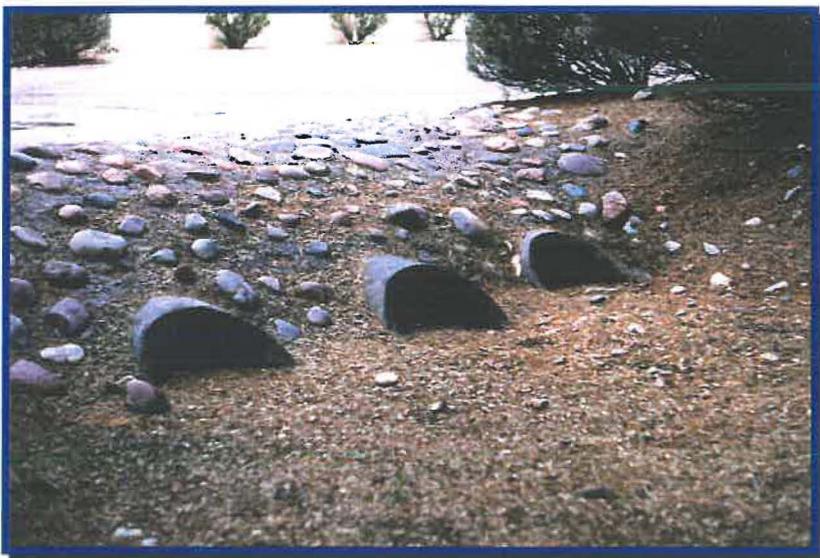
Pic 2C.9:

Looking downstream at the 3-pipes crossing Windrose Drive. The pipes appear to be partially blocked with debris.

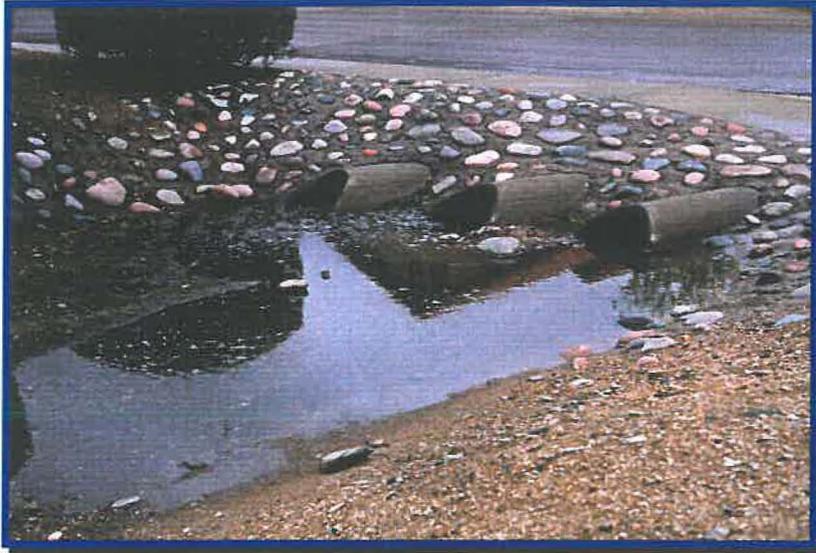
Pic 2C.10:

Looking upstream at the 3-pipes crossing Windrose Drive (downstream of Pic 2C.9). Stagnant storm water just downstream of the pipes.
