Report of the Flooding in Laveen Storm of July 28, 1999

Afshin Ahouraiyan, Flood Control District of Maricopa County

Report on the flooding in Laveen
Storm of July 28, 1999
Afshin Ahouraiyan, Engineering Division

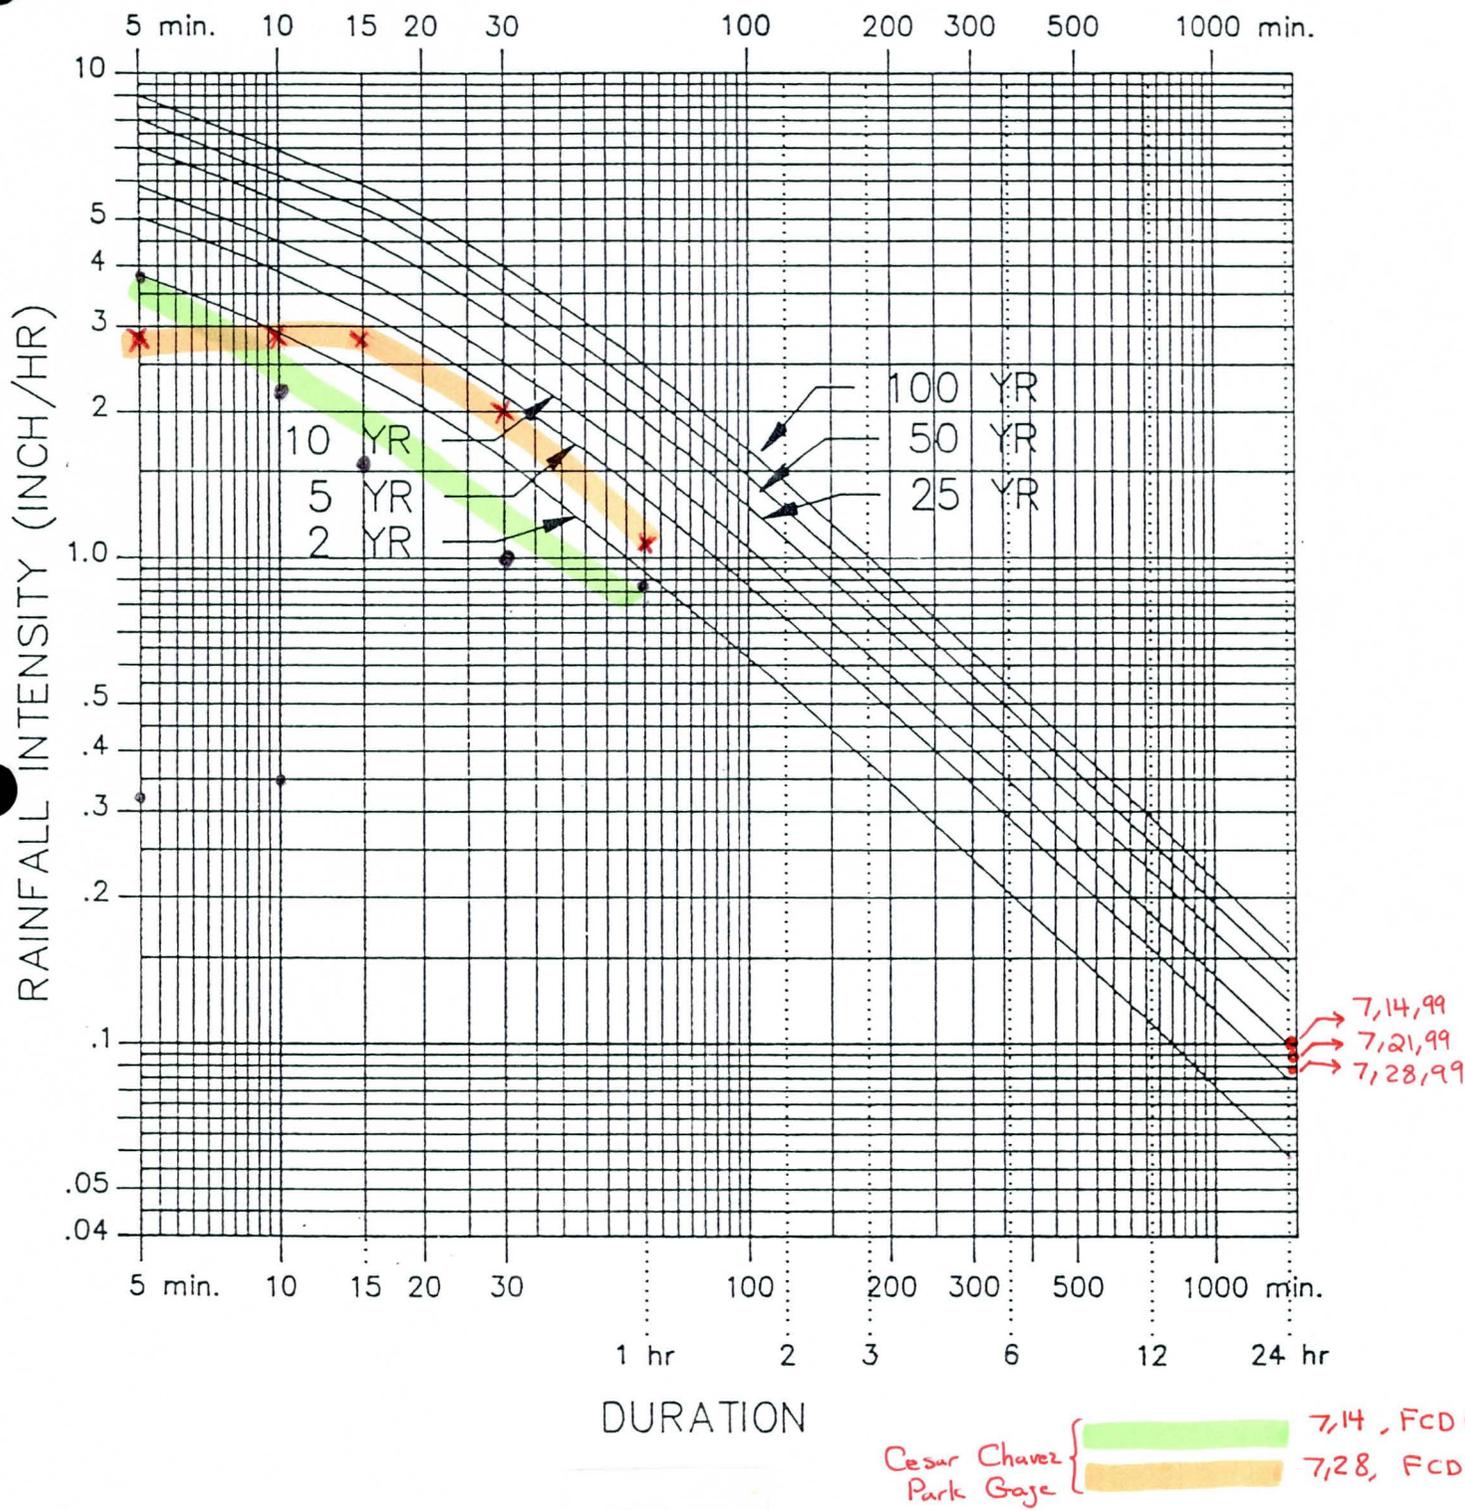
Figure 3
 Rainfall Intensity-Duration-Frequency Relation
 (Phoenix Metro Area)

A frequency chart for these storms is shown in Figure 3.

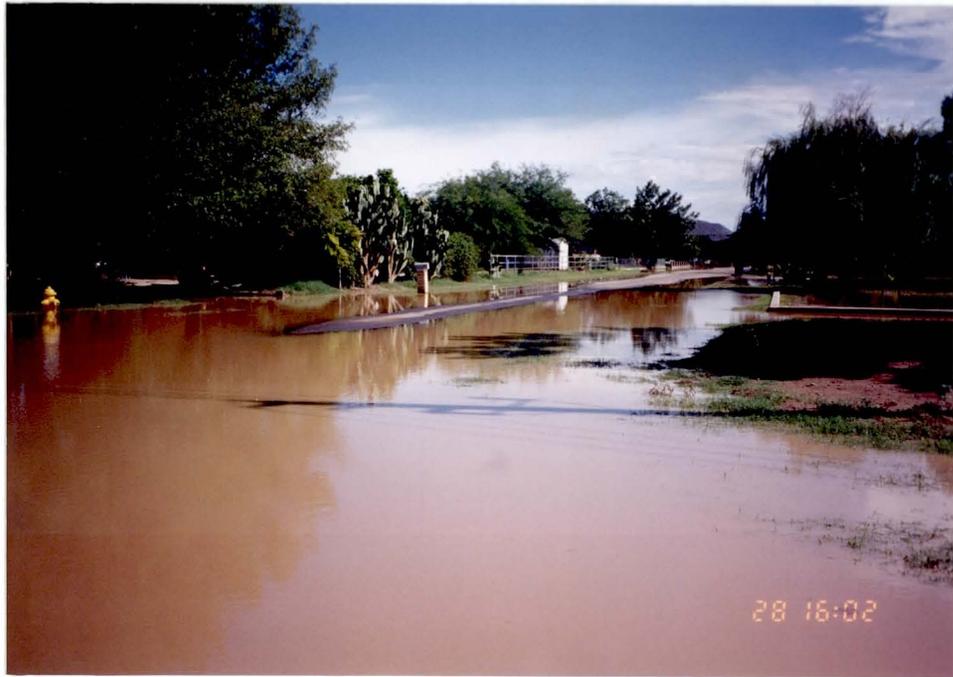
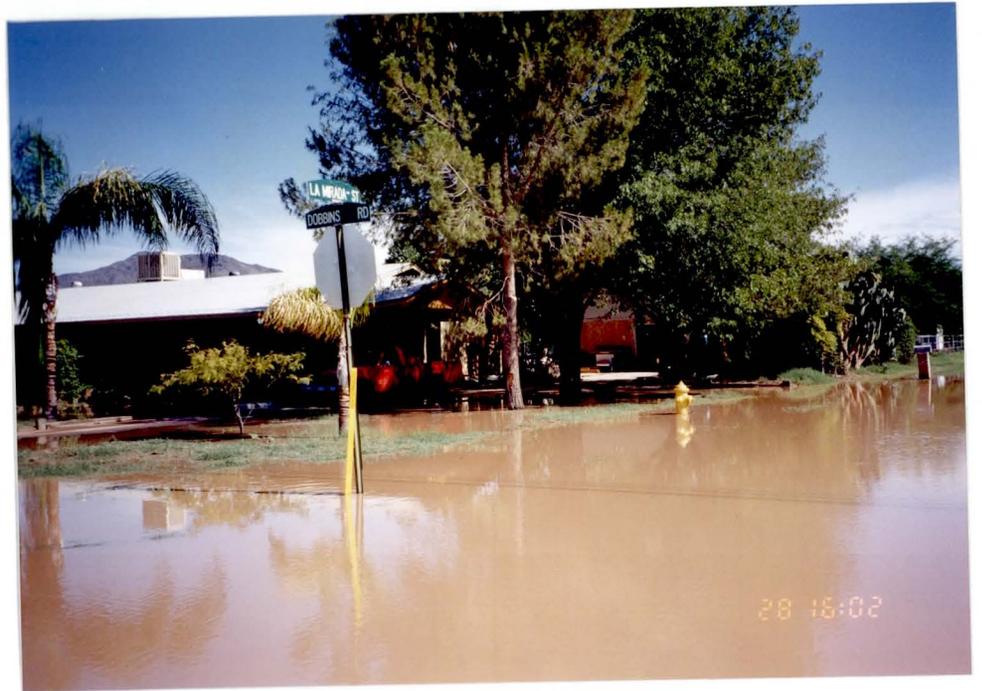
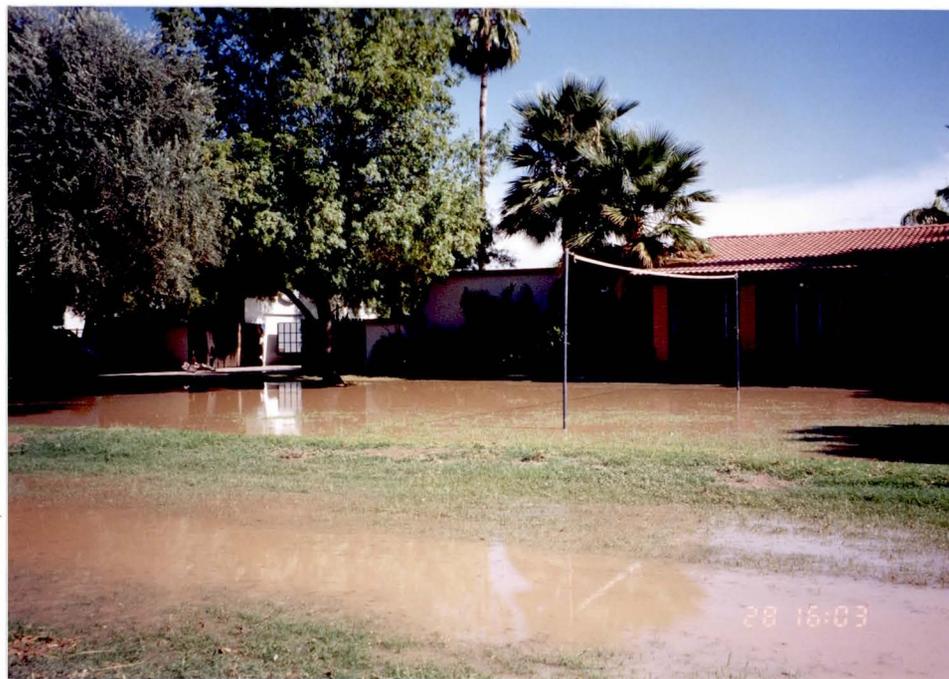
- 1- Photos of flooding were taken at Dobbins Road and La Mirada Drive. Based on conversations with Bob Ruiz at 9202 S. La Mirada Street and Judy Schoenberger of 9222 S. La Mirada Street, the flooding of this neighborhood has occurred for the past three storms of July 28, 1999, July 21, 1999, July 14, 1999. Their property flooded for all these events and they are tired of having to deal with the floodwaters getting to their properties. (Photos 1, 2, 3)

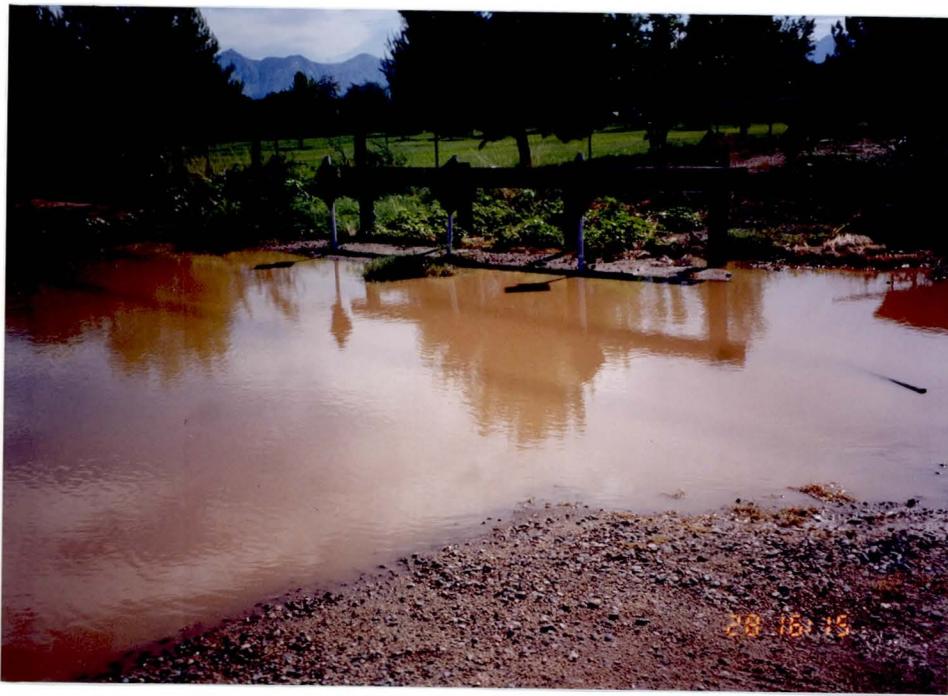
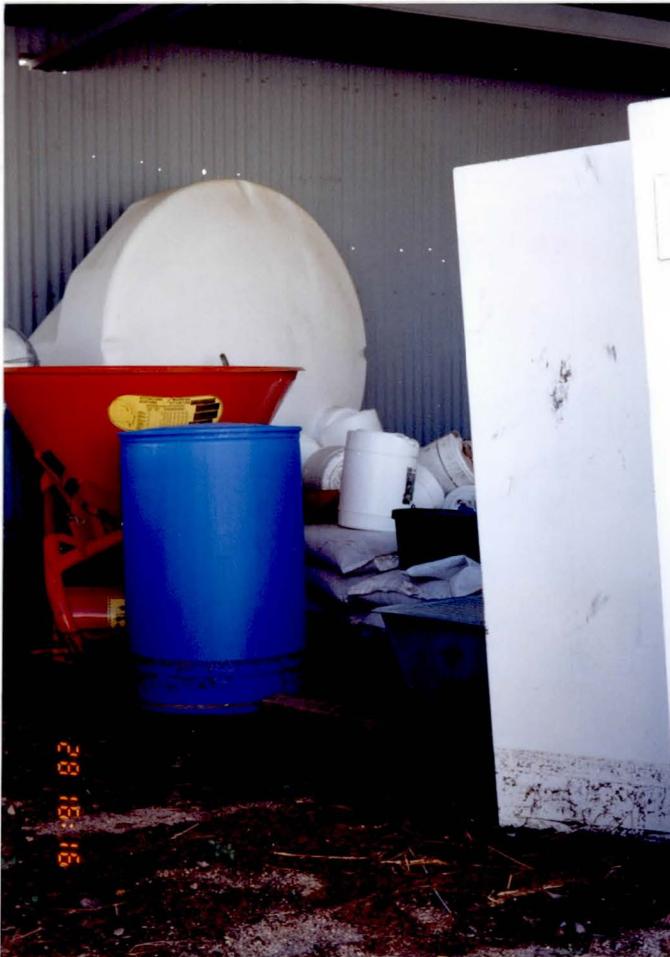
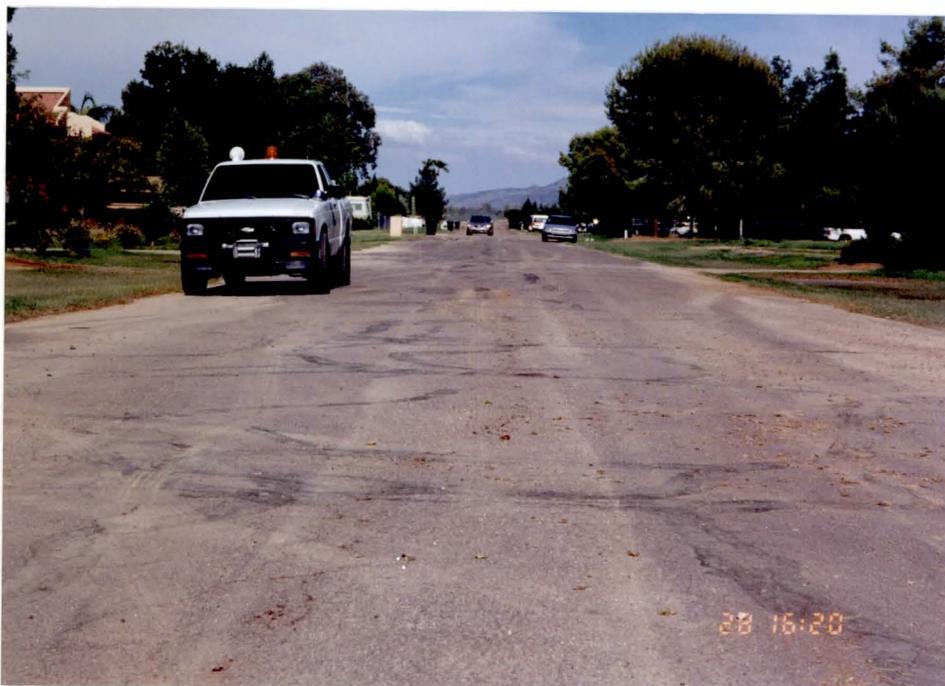
- 2- Next sign of flooding was in the neighborhood immediately to the west of 47th Avenue. Floodwaters had crossed over 47th Avenue and flowed westward along Piedmont and Redfield Roads and Olney Avenue. At the west end of Piedmont Road, discussions with neighbors indicated that the floodwaters were due to the breach in the tail water ditch on the East Side of 47th Avenue. Photos of high water marks were taken at Mr. Vernon St. John's residence (4842 W. Piedmont). The high water marks were from all the storms that had occurred recently. The flows pond at the end of Piedmont Road behind a Salt River Project (SRP) ditch that is used to water the residential fields. (Photos 4, 5, 6)

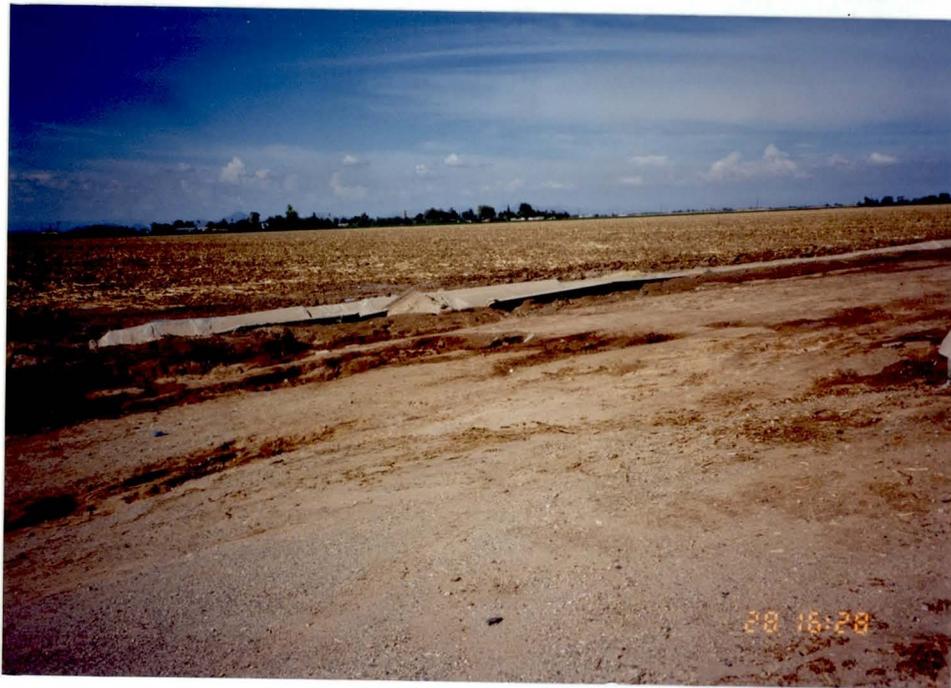
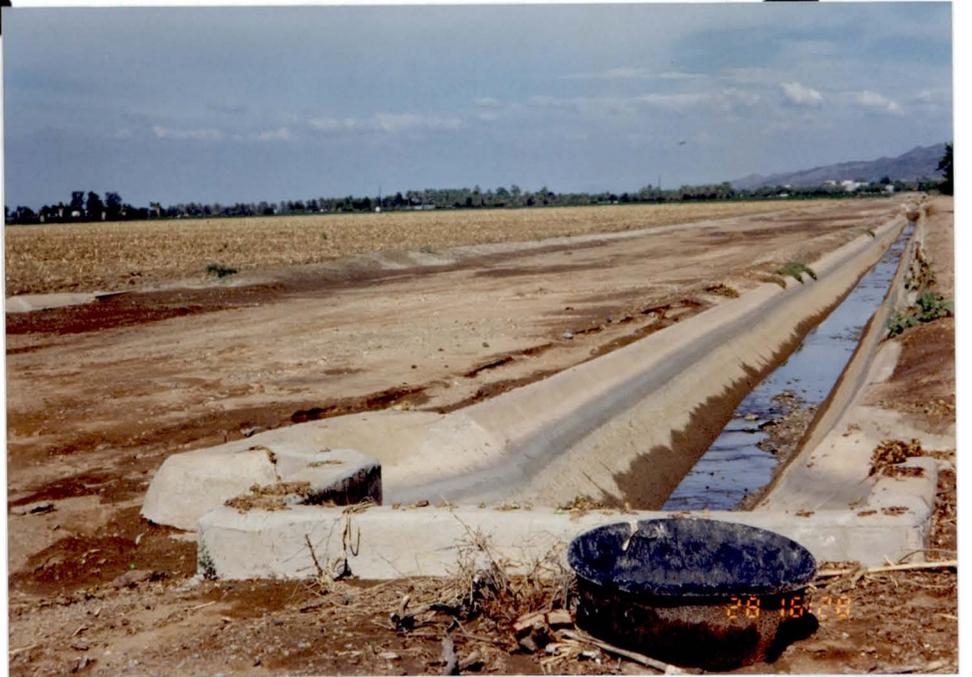
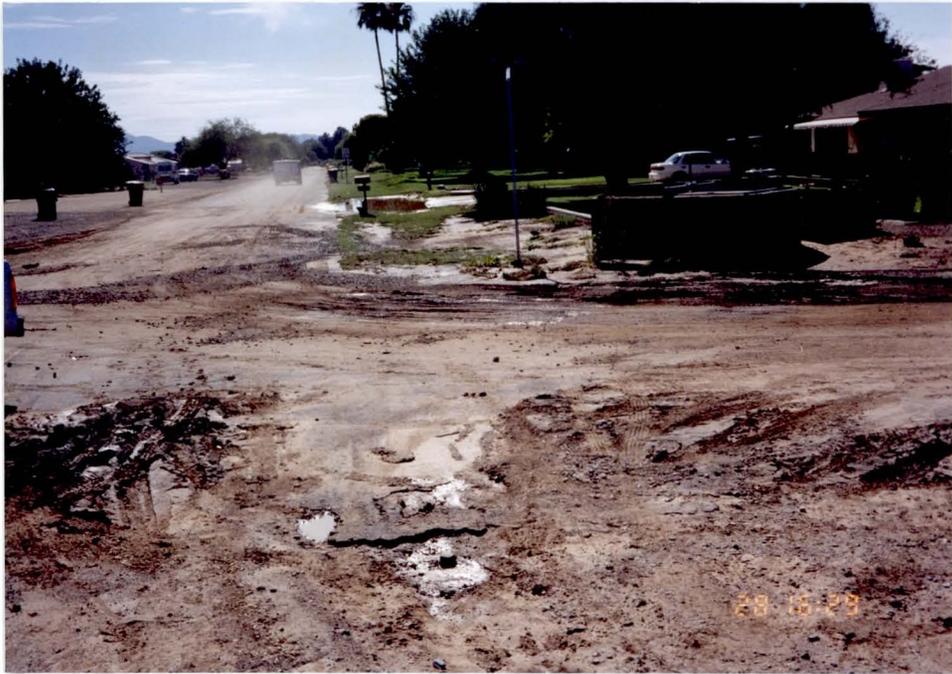
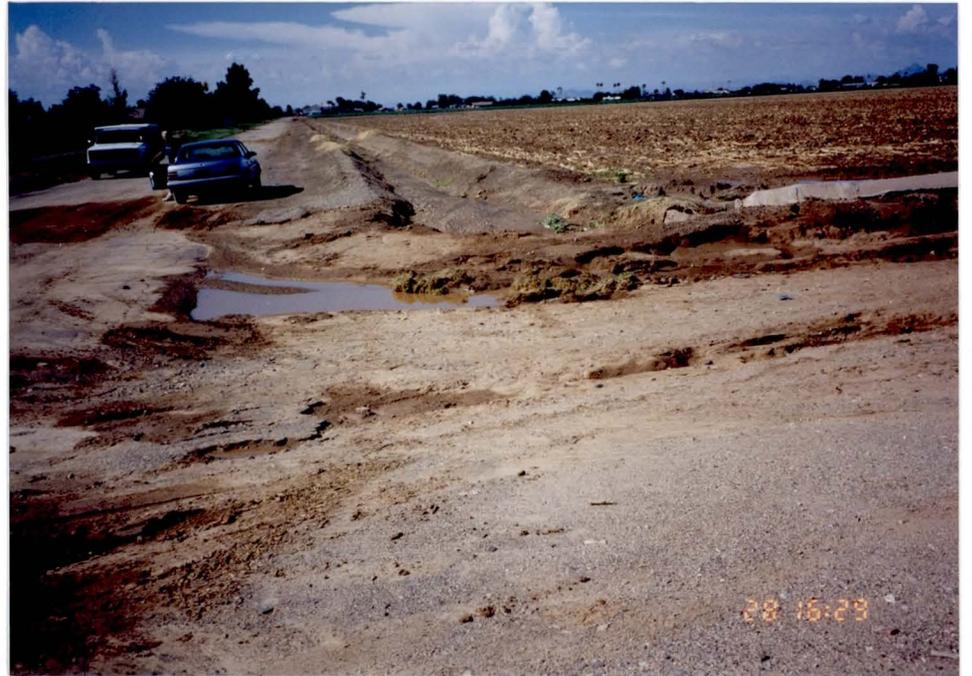
- 3- There were signs of erosion and undercutting by the intersection of 47th Avenue and Olney Avenue. The photos taken at this location clearly shows the high water marks and limits of ponding of the intersection. According to Mr. Cecil Miller (who called the District regarding the flooding of the area) the SRP's ditch located on the south side of the east extension of Olney at 47th Avenue is used as a delivery ditch. The flows within the ditch overtop its banks and cause the flooding. The water then makes its way to the tail water ditch on the east side of 47th Avenue and since the ditch is not kept up by the farmers any more, the ditch is breached sending the flows towards the neighborhood roads. (Photos 7, 8, 9, 10)

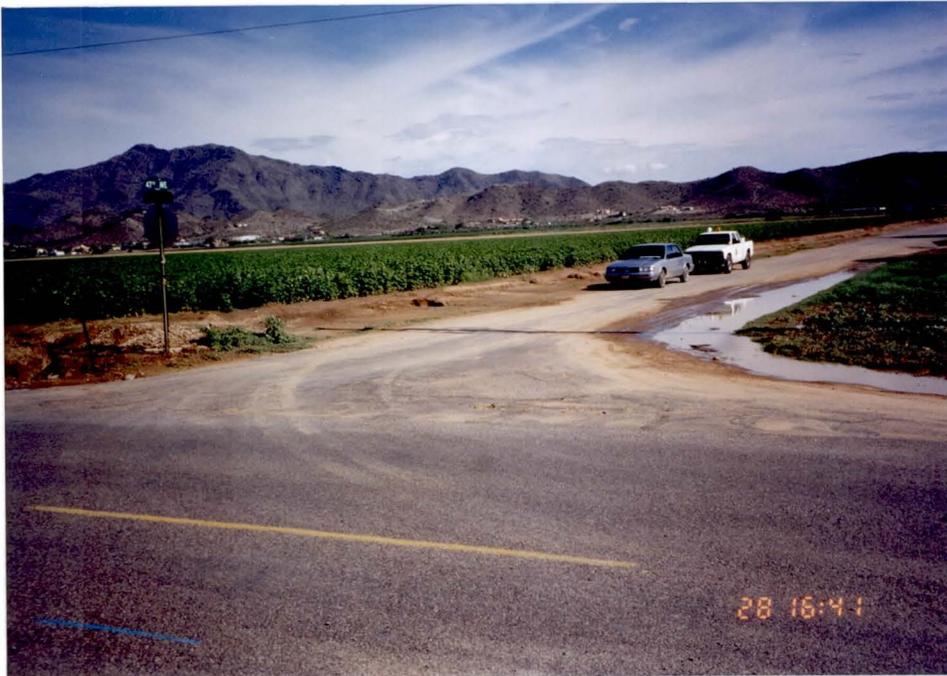
8/2/99 ENG AFA
Photo ①

- 4- Mr. Frank Grimes of 4701 W. Dobbins Road (SW corner of 47th Avenue and Dobbins) discussed what he believes is the cause of the flooding at this location. The SRP's water delivery ditch on the South side of Dobbins Road is connected to a SRP ditch that is on the North side of the road. Since the SRP ditch on the North side carries water in it at all time, due to back water effects the water carried in the smaller ditch on the south side overtops its banks, sending flows down 47th Avenue and west

on Dobbins Road. This is the cause of flooding of the neighborhood of La Mirada and eventually the school site. (Photo 11)

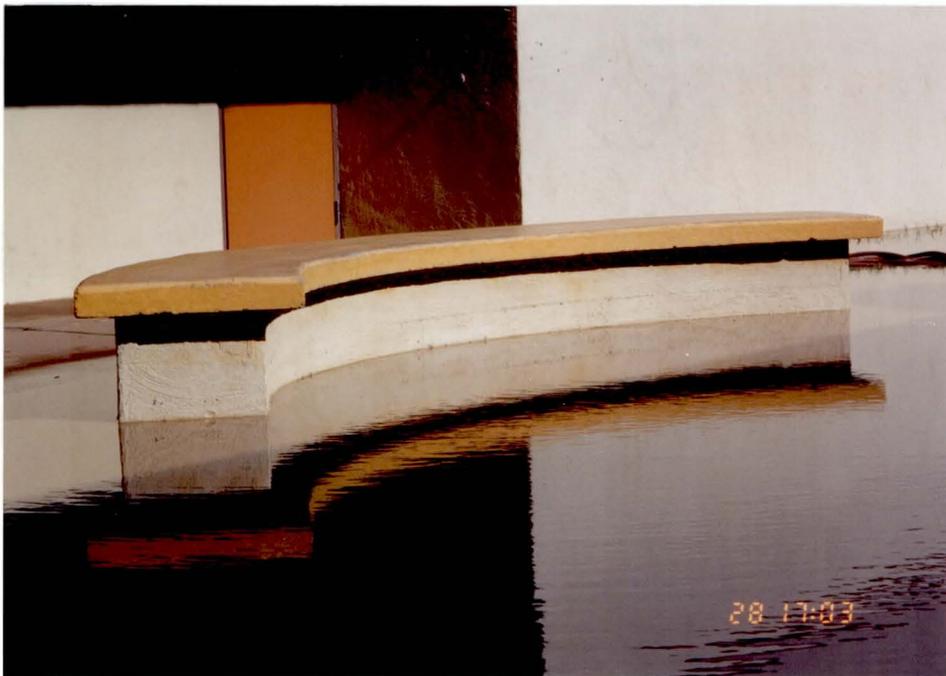
Photo 12 8/2/99 ENG AFA

- 5- The Laveen Elementary School was also hit for the third time. Twenty classrooms were flooded, and the school has to repair the rooms before the start of the school. Picture of the high water mark clearly shows the limit of the flooding within the school area. Mrs. Linda Krapu, one of the 5th grade teachers was able to show us some of the flooded areas within the school. (Photo 12)
- 6- Mr. George Anderson residing at the corner of 47th Avenue and Redfield Road recorded the following precipitation at his residence. The explanation of the problem was the same as the others, the flows travelling south from 47th Avenue turns into their street and flooding the road and homes in the neighborhood. His precipitation readings were as follow;
