# Bridge Evaluation Study Ash Avenue Bridge (Salt River Crossing)

**City of Tempe**  
**Project 876191B**  
**Maricopa County, Arizona**

BRIDGE EVALUATION STUDY

May 4, 1990

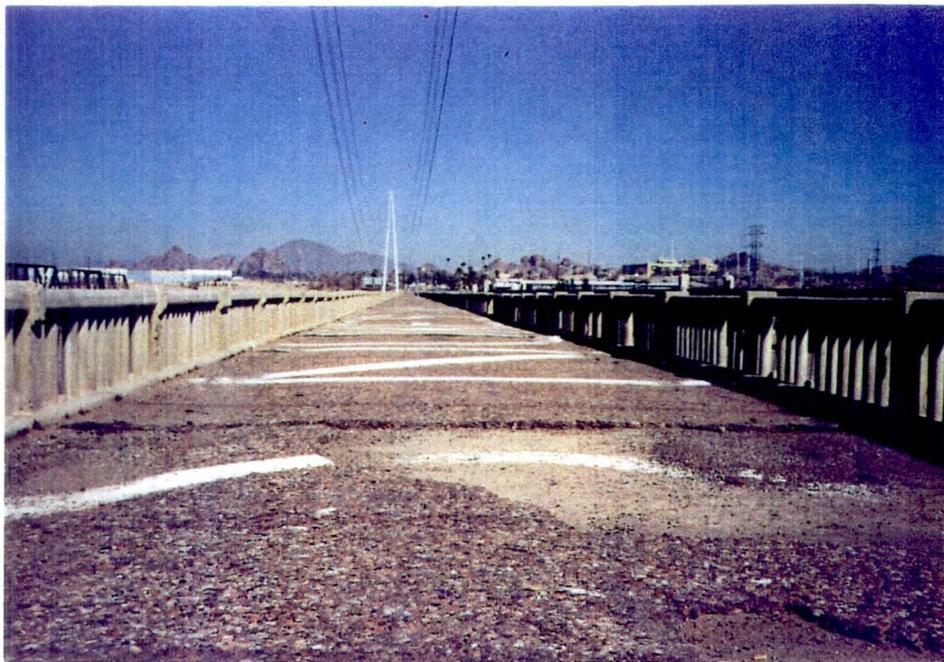
BRIDGE DECK, LOOKING NORTH

- NOTE: Missing parapet railing
- NOTE: Missing pavement
- NOTE: "Sagging" of parapet railing

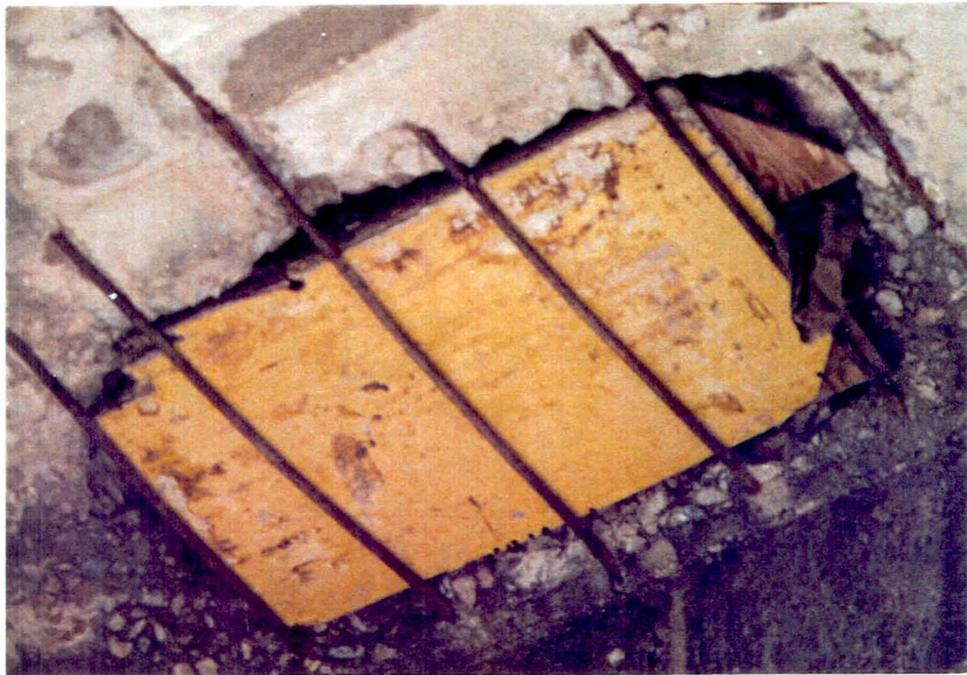
SPAN No. 1, SPANDREL BAY No. 3

- NOTE: Exposed deck reinforcing

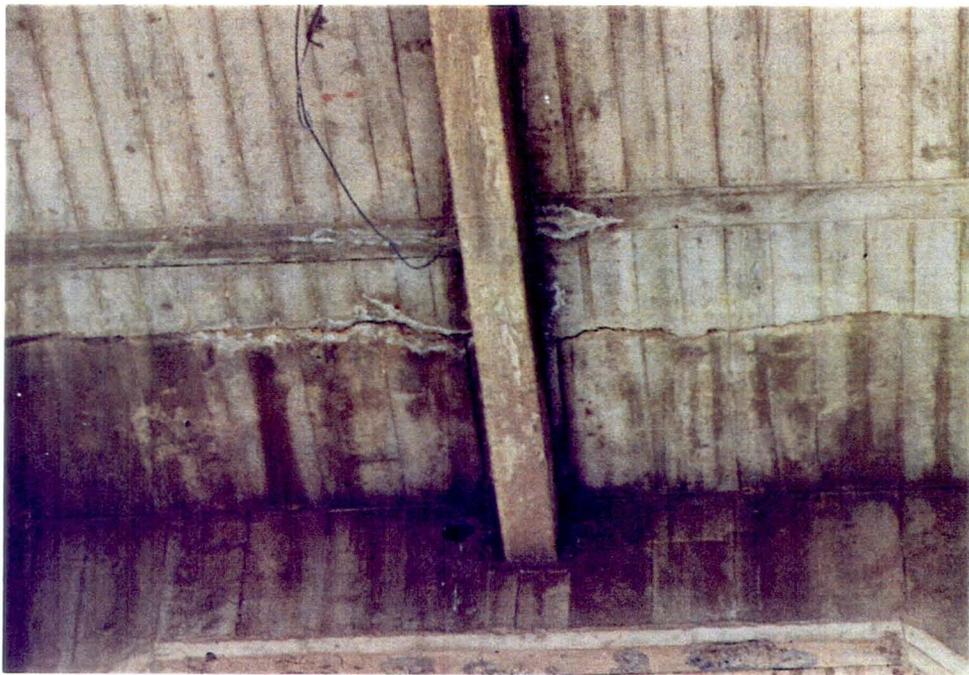
SPAN No. 4, SPANDREL BAY No. 1

NOTE: Transverse crack in deck

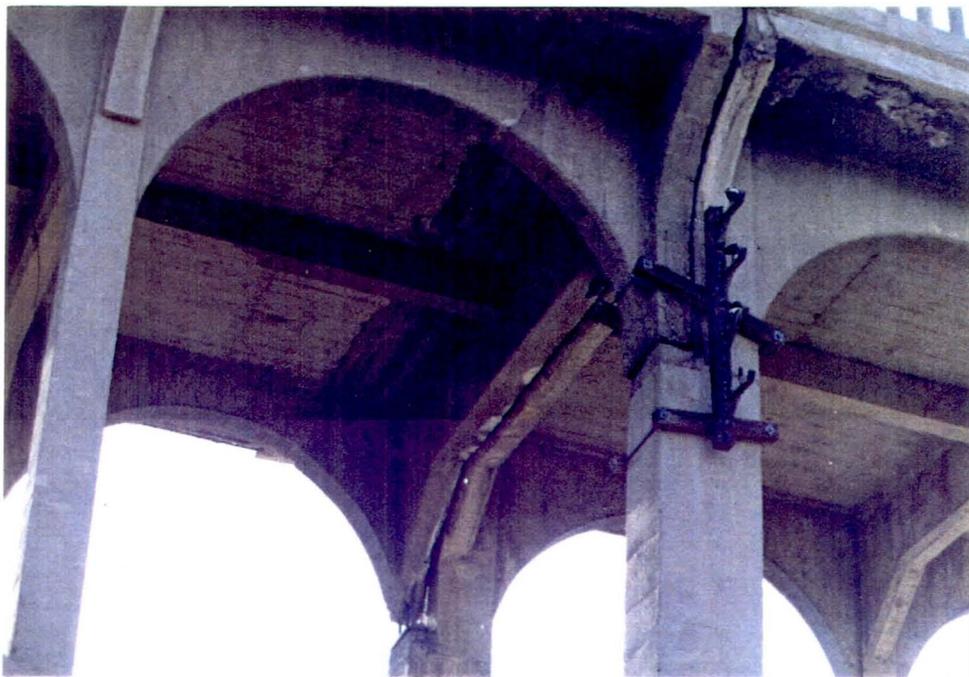
SPAN No. 4, SOUTH OF PIER No. 4

NOTE: Crack across deck continuing through  
spandrel arches

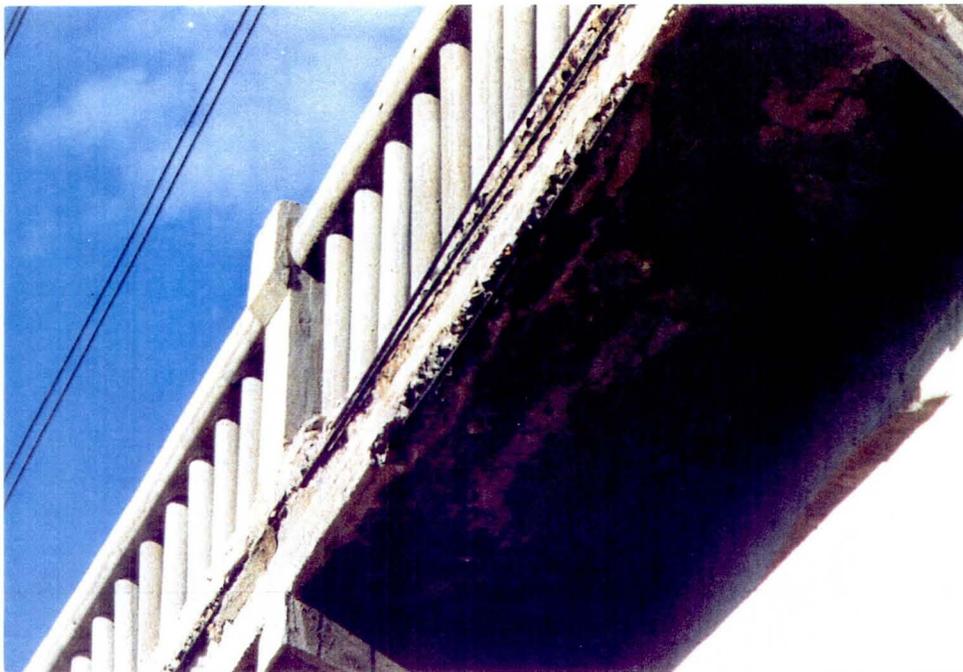
SPAN No. 3, SPANDREL BAY No. 4  
WEST SIDE

NOTE: Exposed reinforcing steel  
NOTE: Delamination and spalling concrete

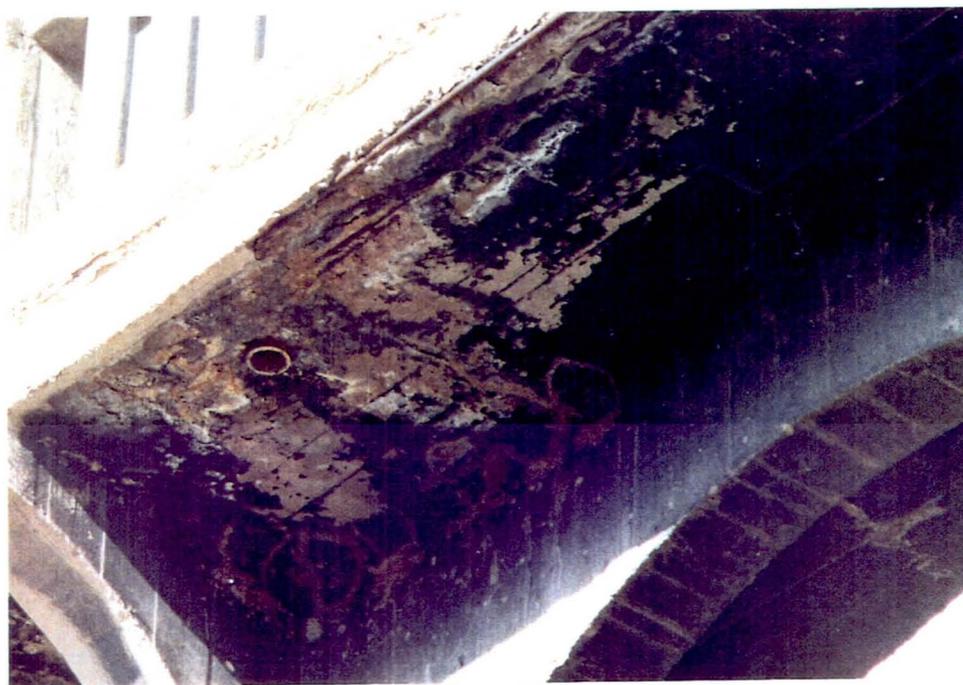
SPAN No. 4, SPANDREL BAY No. 7

The section of the concrete deck between the arch ribs is in fair condition. The section of the concrete deck supported between the arch rib and the curb beam is in poor condition. Since the concrete deck is covered with an asphalt wearing surface, only the bottom side of the concrete deck could be visually reviewed. The underside of the deck has transverse cracks throughout the bridge exhibiting leaching and efflorescence. Between the pier and the first spandrel on each side of Pier Nos. 1, 2, 3, and 4, transverse cracks extend the full width of the deck, and in several instances extend down the spandrel arches. There are several locations where the reinforcing steel is exposed. The underside of the deck between the arch rib and the curb beam is severely cracked, spalled, and delaminated and exhibiting efflorescence with exposed reinforcing steel. The underside of the deck in Span Nos. 4, 7, 8, and 9 is darkened and could have been exposed to fire.

NOTE: Delamination and spalling concrete  
NOTE: Efflorescence  
NOTE: Darkened area (may have been exposed to  
fire)

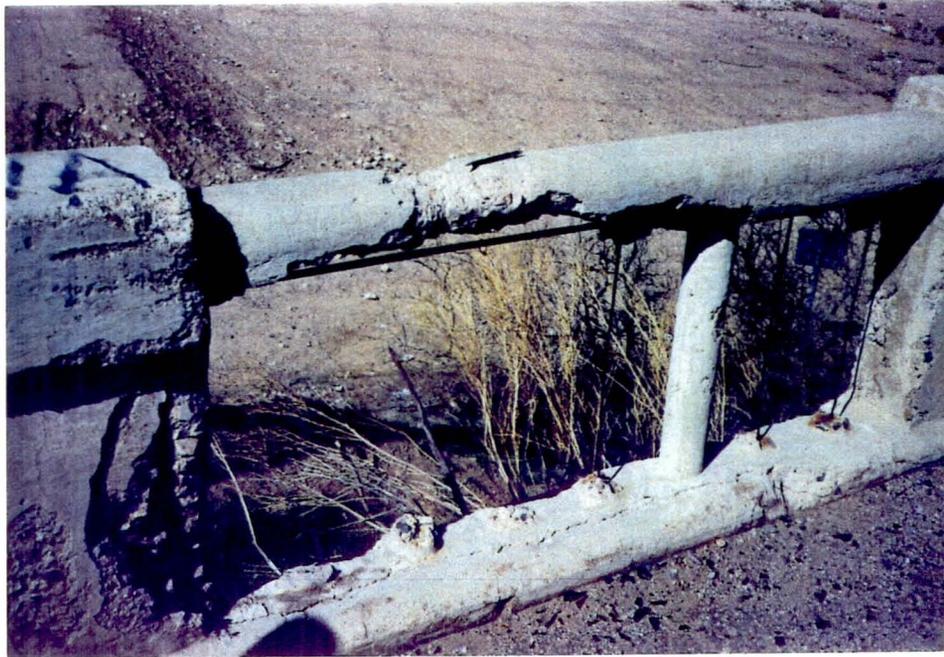
PARAPET POST AND RAILING AT SOUTH END

NOTE: Missing parapet rails

NOTE: Delamination and spalling of parapet post

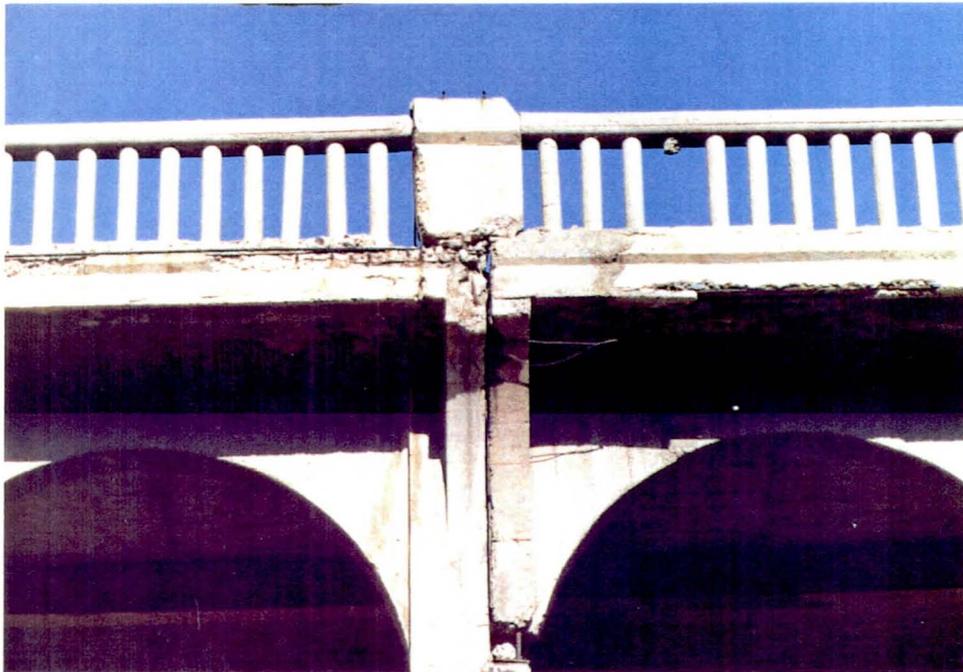
BRACKETS, PARAPET, AND EXPANSION JOINT - PIER No. 4

NOTE: Exposed reinforcing steel at base of railing and parapet post

NOTE: Exposed reinforcing steel at base of bracket and spandrel arch at spandrel column

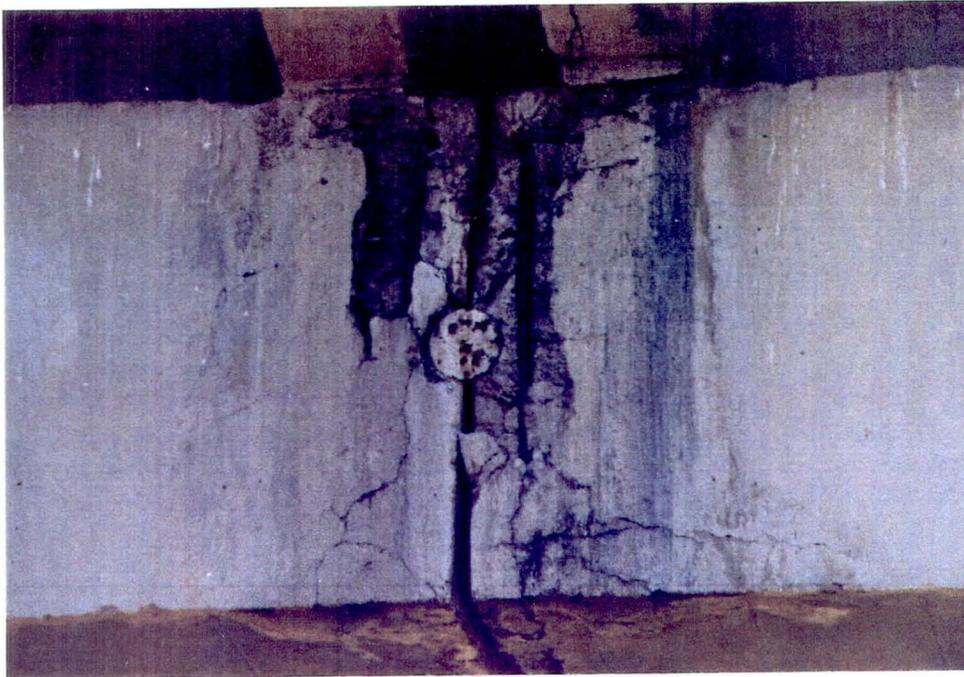
SPAN No. 1, EAST CROWN HINGE

- NOTE: Exposed crown hinge pin
- NOTE: Exposed reinforcing steel
- NOTE: Fractures in arch rib near hinge pin

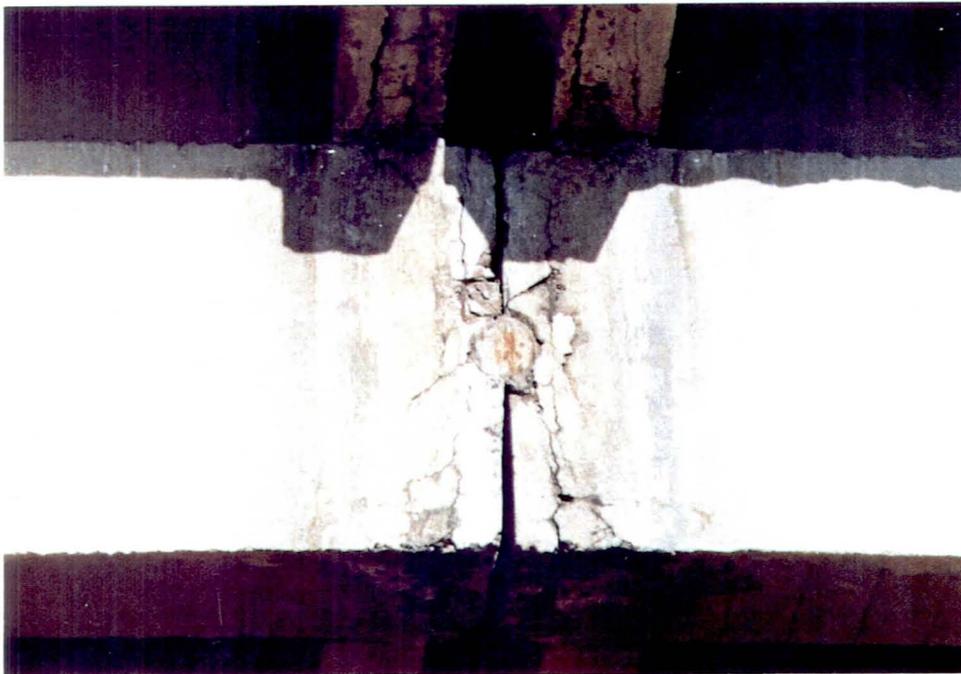
SPAN No. 1, WEST CROWN HINGE

- NOTE: Cracks around hinge

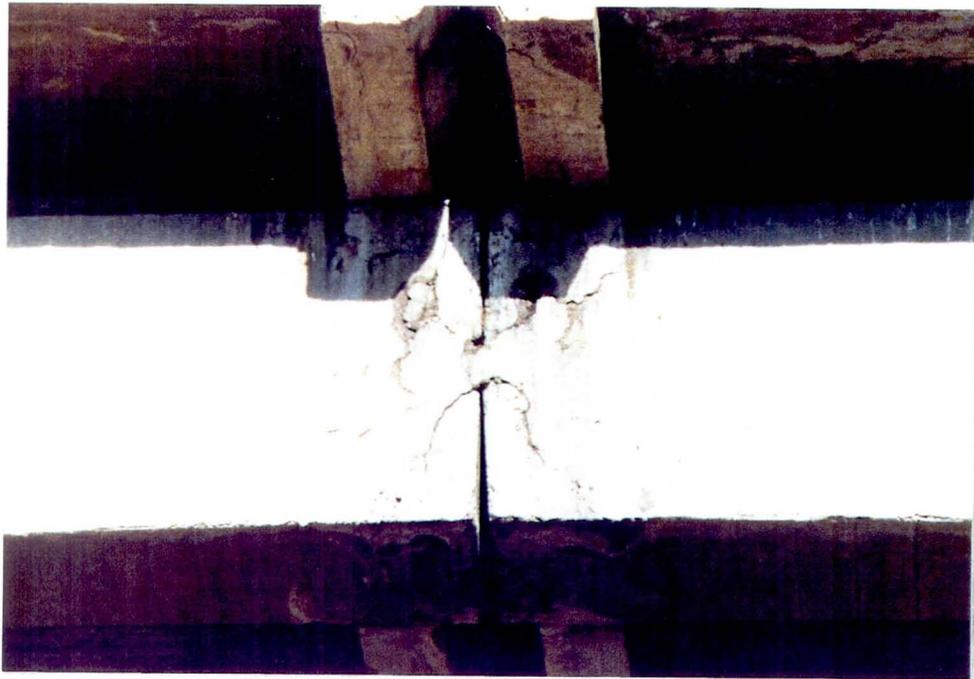
SPAN No. 5, WEST CROWN HINGE

NOTE: Cracks around hinge

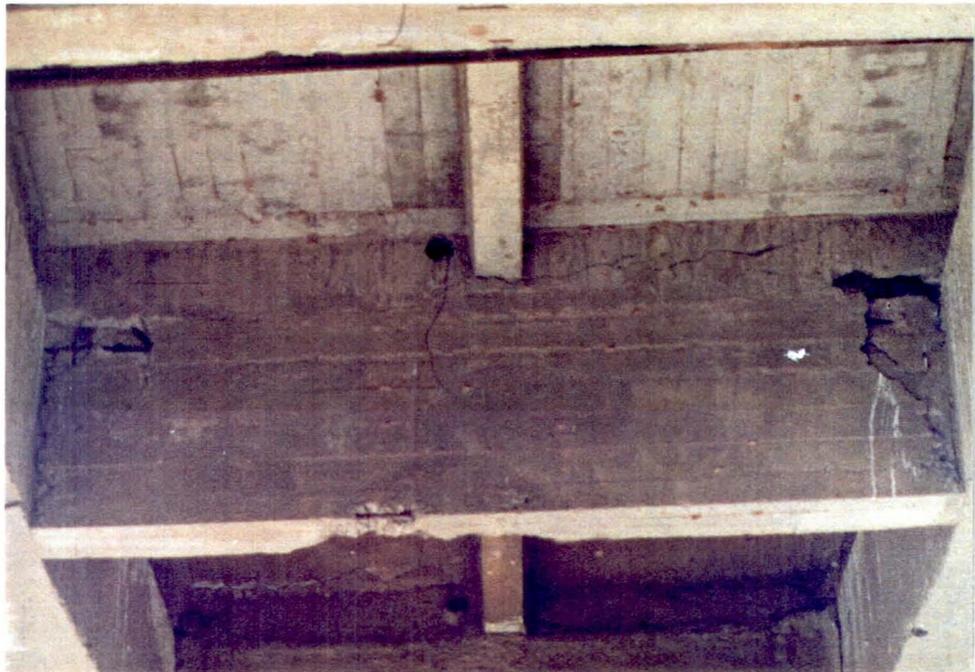
SPAN No. 10, TRANSVERSE FLOOR BEAM No. 9

NOTE: Cracks at the ends of the floorbeam

NOTE: Exposed reinforcing steel at the bottom  
of the floorbeam

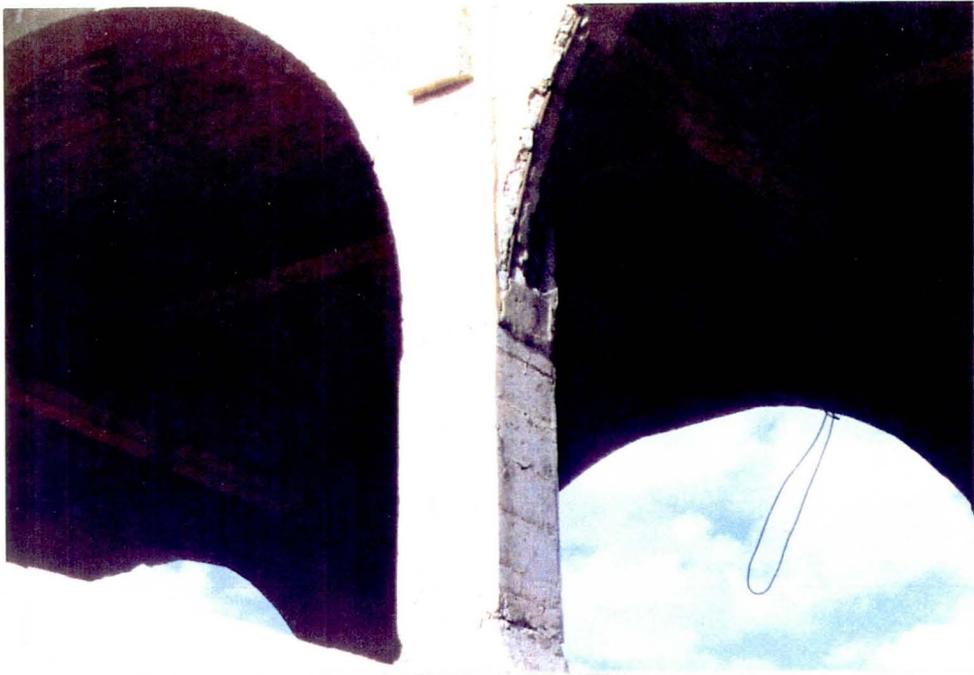
SPAN No. 10, SPANDREL BAY No. 2

NOTE: Exposed reinforcing steel in spandrel arch

NOTE: Horizontal cracks at spandrel arches

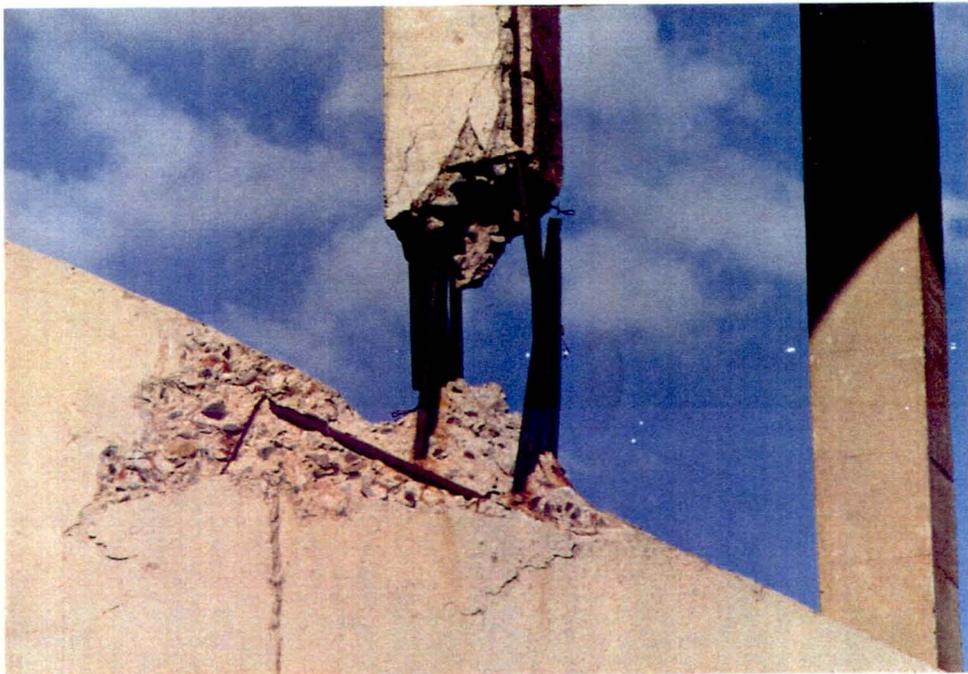
SPAN No. 4, SPANDREL POST No. 4, WEST SIDE

NOTE: Exposed reinforcing steel in arch rib

NOTE: Spandrel post severed

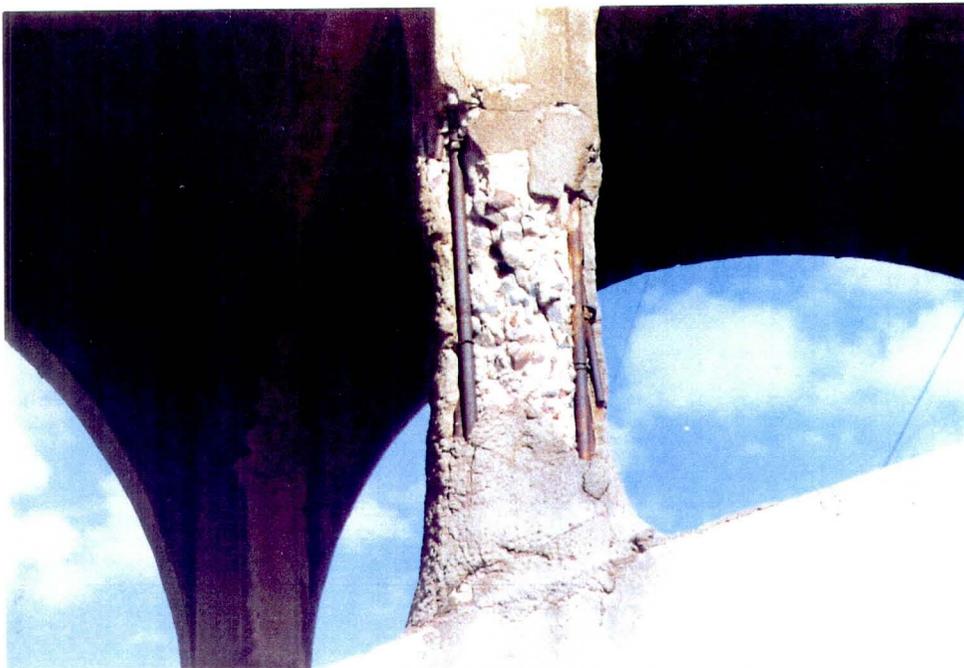
SPAN No. 10, SPANDREL POST No. 2

NOTE: Exposed reinforcing steel

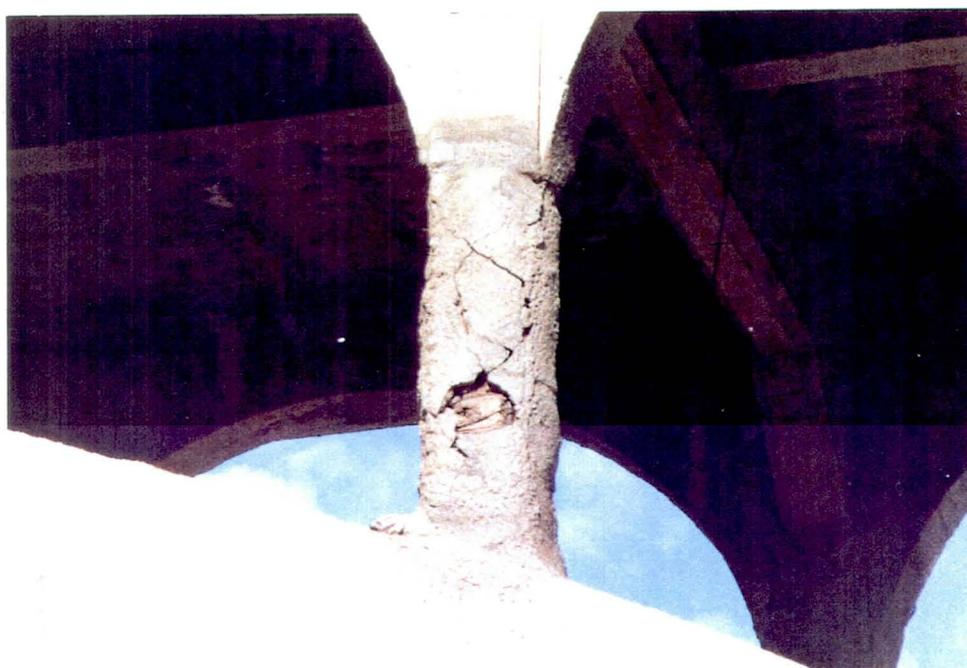
SPAN No. 9, SPANDREL POST No. 2, WEST SIDE

NOTE: Delamination and spalling of concrete

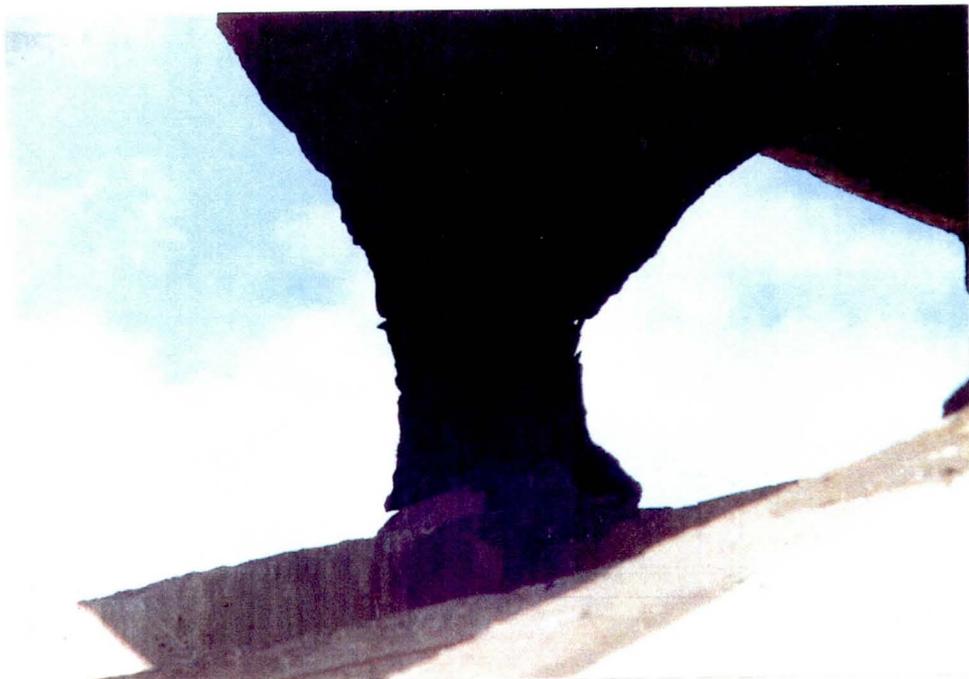
SPAN No. 11, SPANDREL POST No. 10, EAST SIDE

NOTE: Exposed reinforcing steel in spandrel post

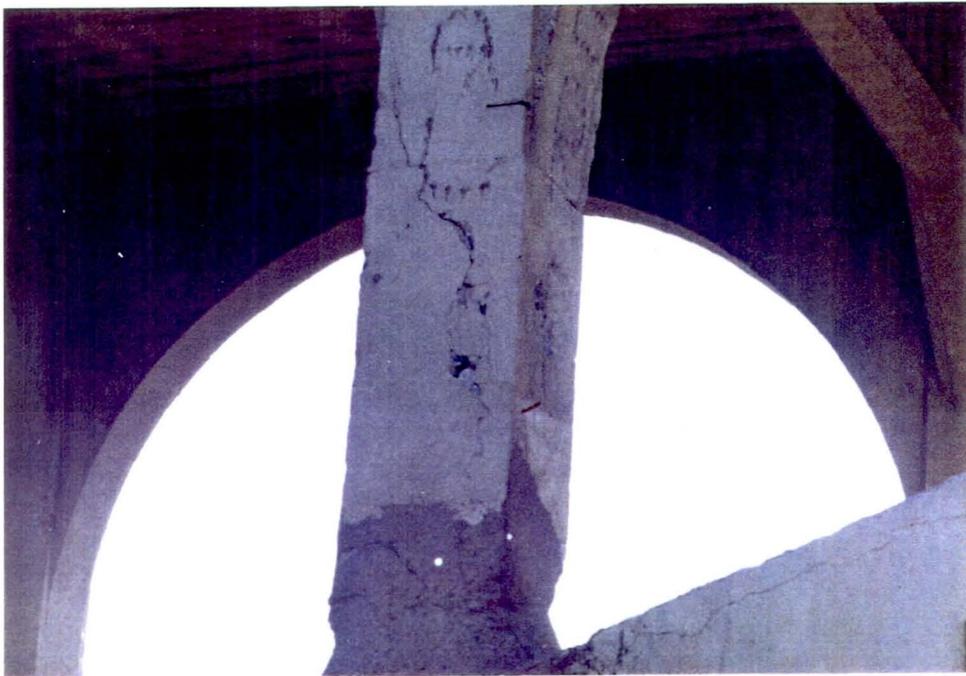
SPAN No. 1, SPANDREL POST No. 2, EAST SIDE

NOTE: Fractures in spandrel post

NOTE: Fractures in arch rib

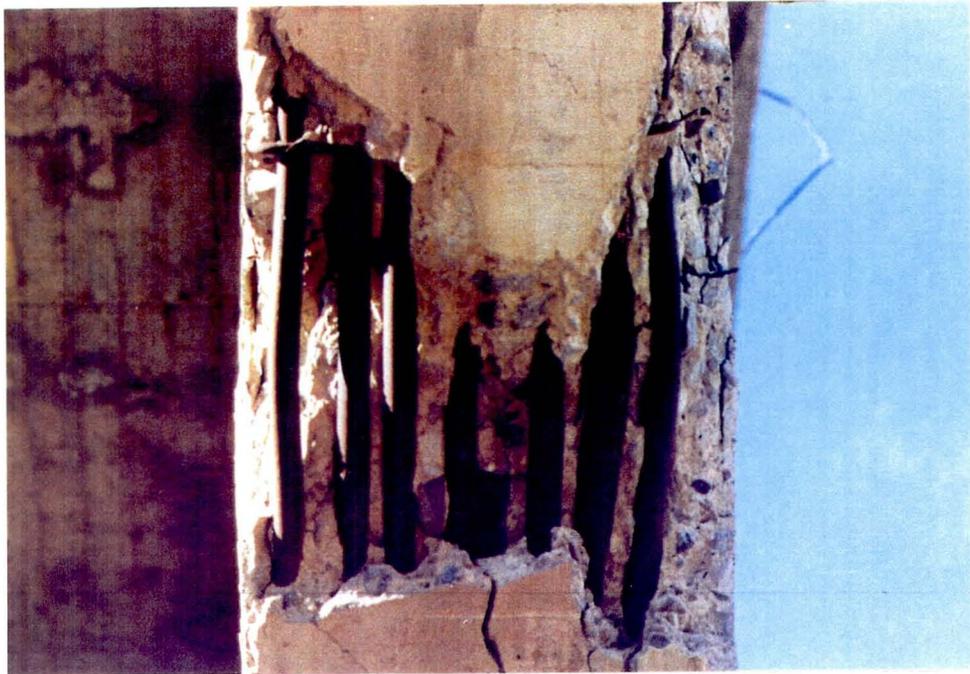
SPAN No. 10, EAST ARCH RIB

NOTE: Exposed reinforcing steel

NOTE: Buckling of exposed reinforcing steel

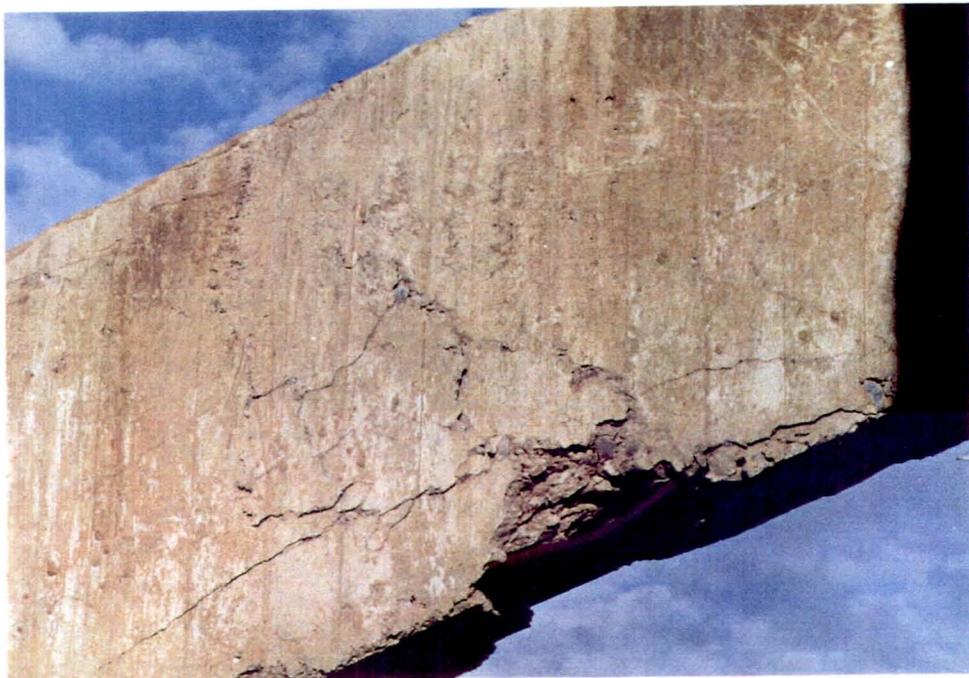
SPAN No. 10, EAST ARCH RIB

NOTE: Exposed reinforcing steel

NOTE: Cracks parallel and perpendicular to  
arch rib

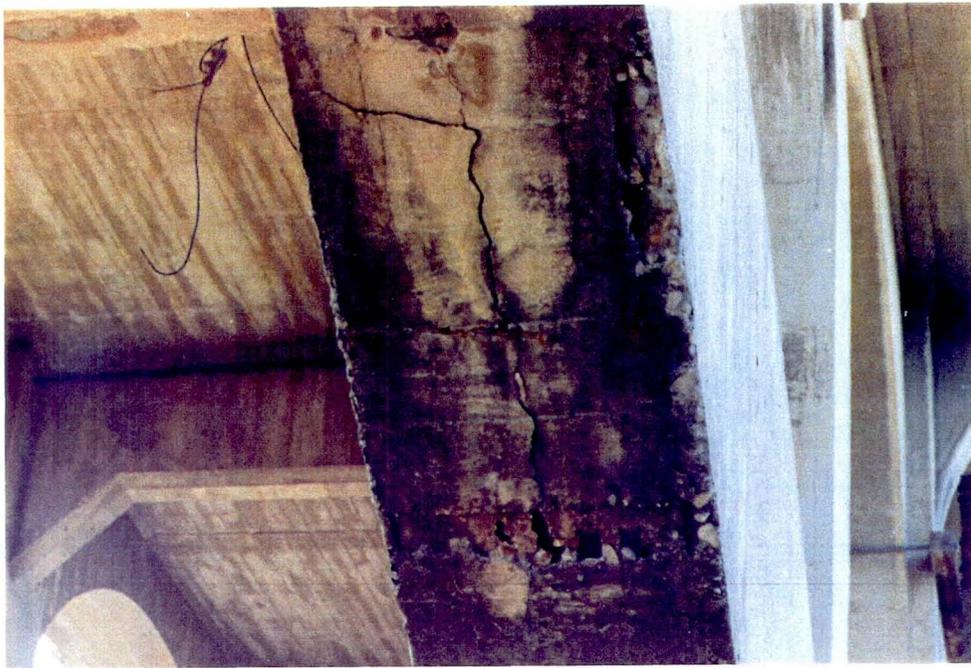
SPAN No. 1, EAST ARCH RIB

NOTE: Delamination and spalled concrete  
NOTE: Exposed reinforcing steel

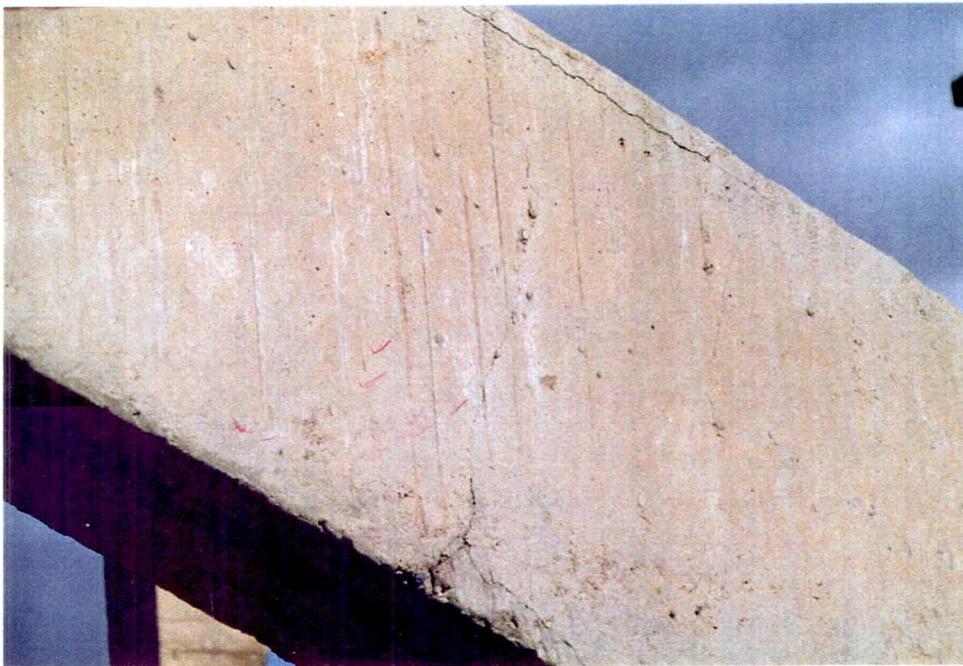
SPAN No. 10, WEST ARCH RIB BETWEEN POST No. 2 AND No. 3

NOTE: Crack perpendicular to arch rib

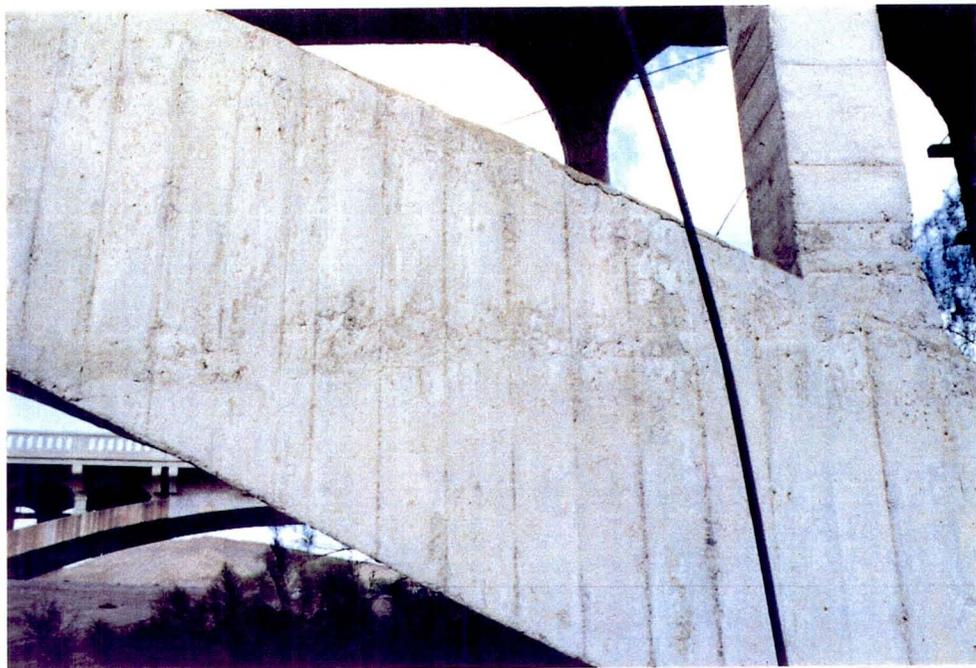
SPAN No. 11, WEST ARCH RIB BETWEEN  
SPANDREL POST No. 1 AND No. 2

At the west arch rib in Span No. 11, there is a horizontal crack extending through the arch rib.

NOTE: Horizontal crack in arch rib

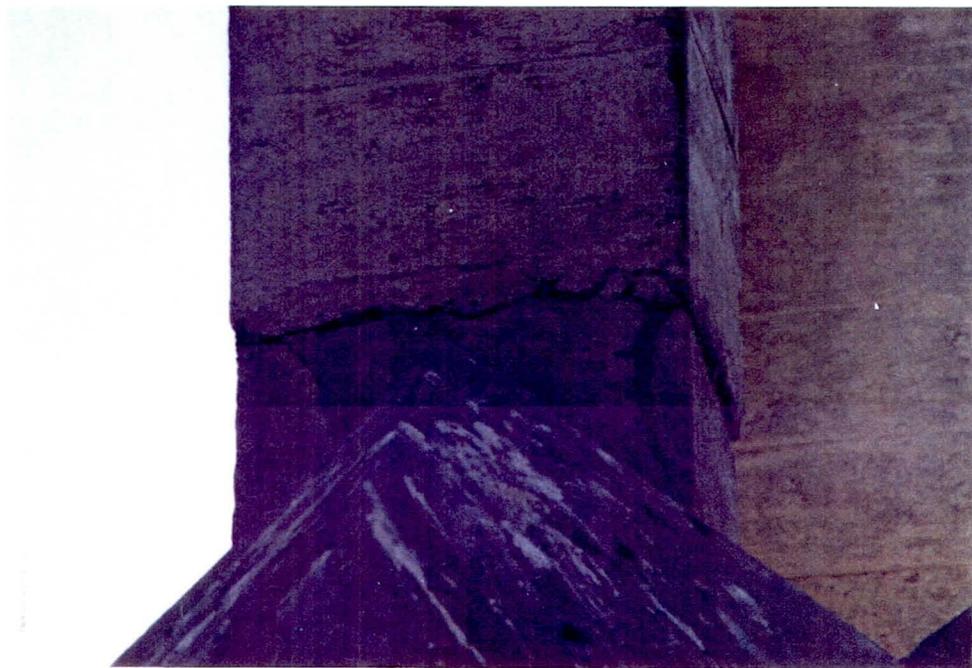
PIER No. 8, EAST SPANDREL COLUMN

NOTE: Fracture horizontal through spandrel  
column

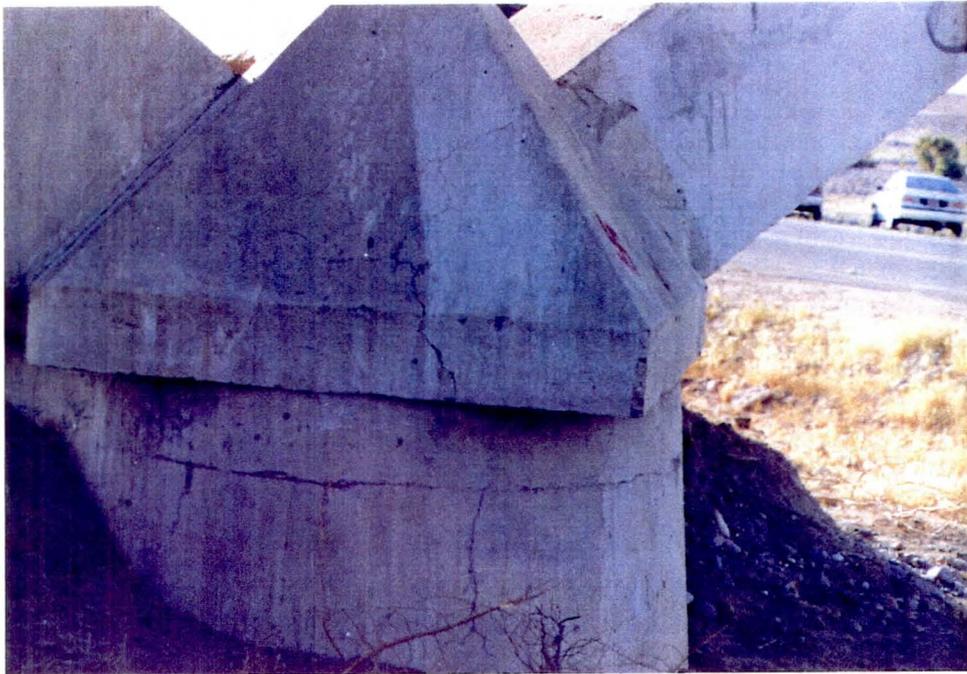
PIER No. 7, EAST SIDE

NOTE: Fractures in pier cap and pier

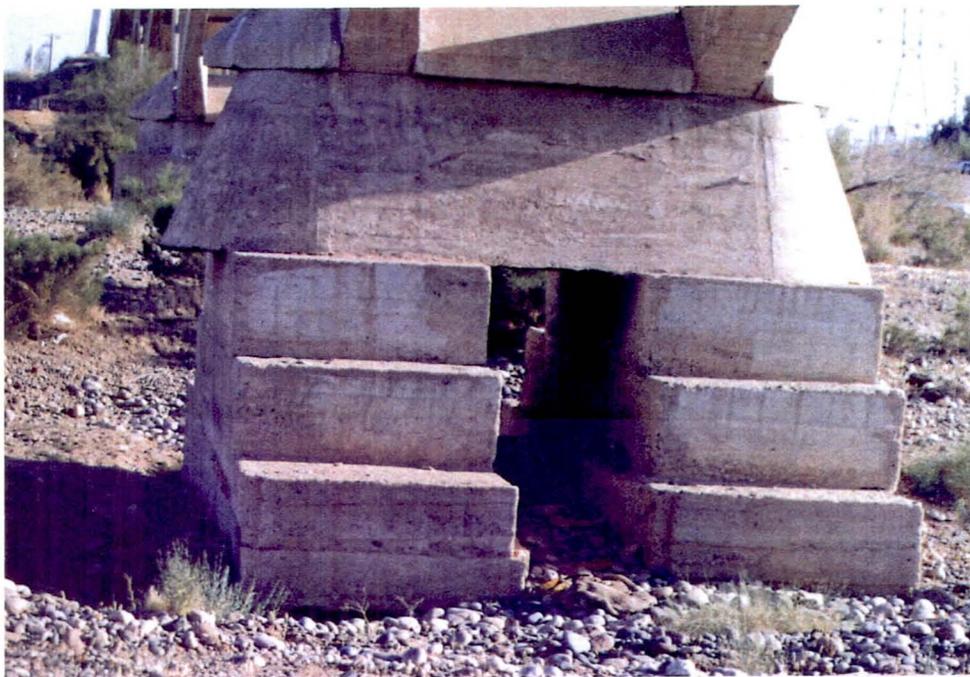
PIER No. 4

NOTE: Scour at pier

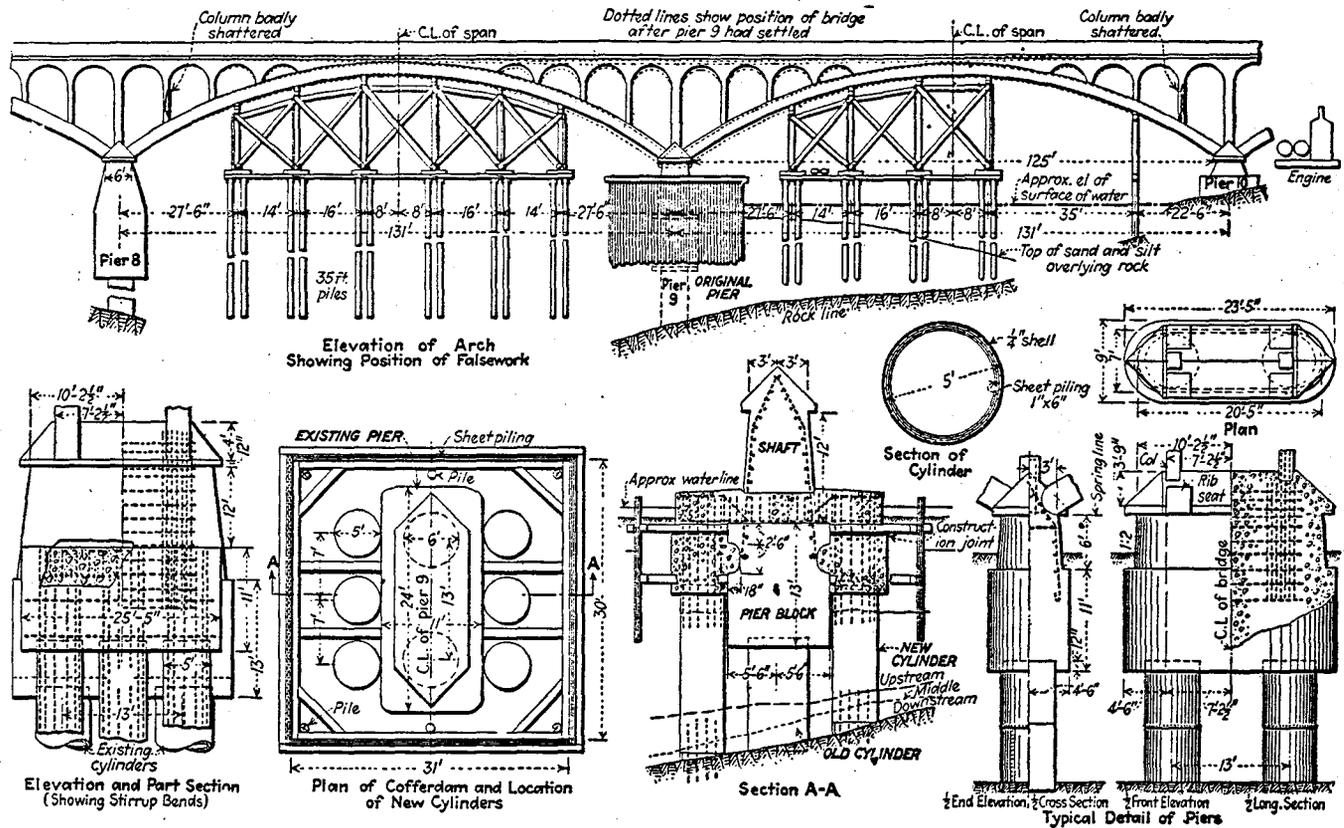
FIG. 4. PIER 9 UNDERPINNED BY NEW CYLINDERS SUNK ALONGSIDE, WITH REINFORCED-CONCRETE BEAM CAP
