DREAMY DRAW DAM

PERIODIC INSPECTION

REPORT NO.1

FEBRUARY 1974

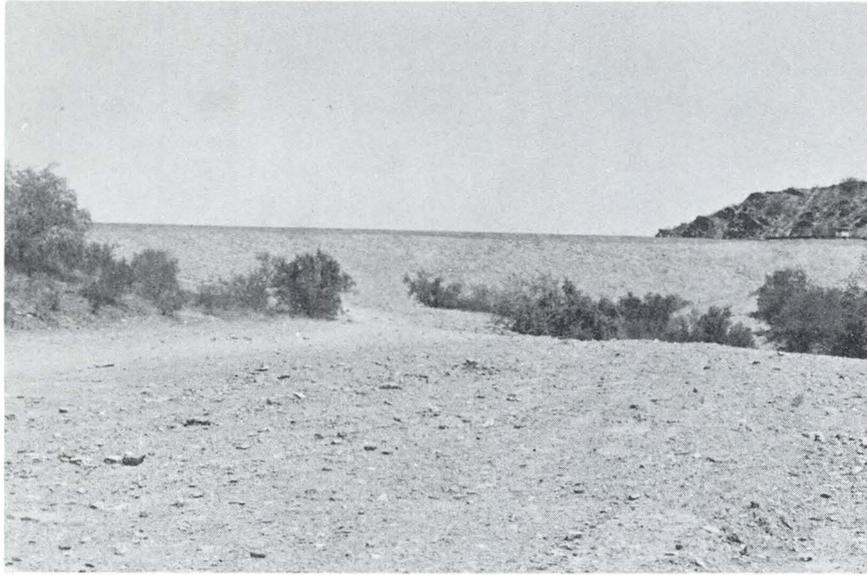
(3) Upstream and downstream slopes - The embankment slopes were in good condition. There was no erosion or evidence of burrowing animals on the slopes. The riprap on the slopes showed no evidence of decomposition.

DREAMY DRAW DAM, LOOKING AT DOWNSTREAM FACE.

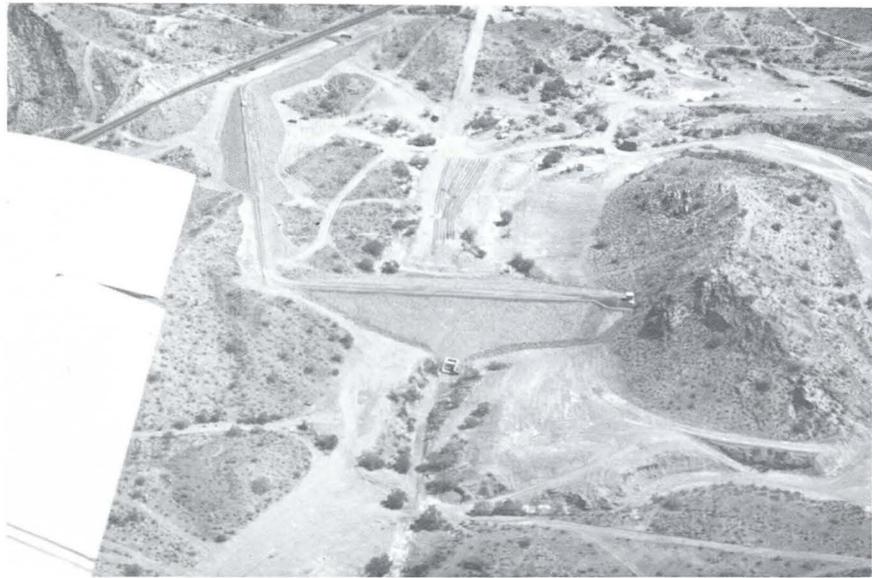
DREAMY DRAW DAM (LOOKING UPSTREAM).

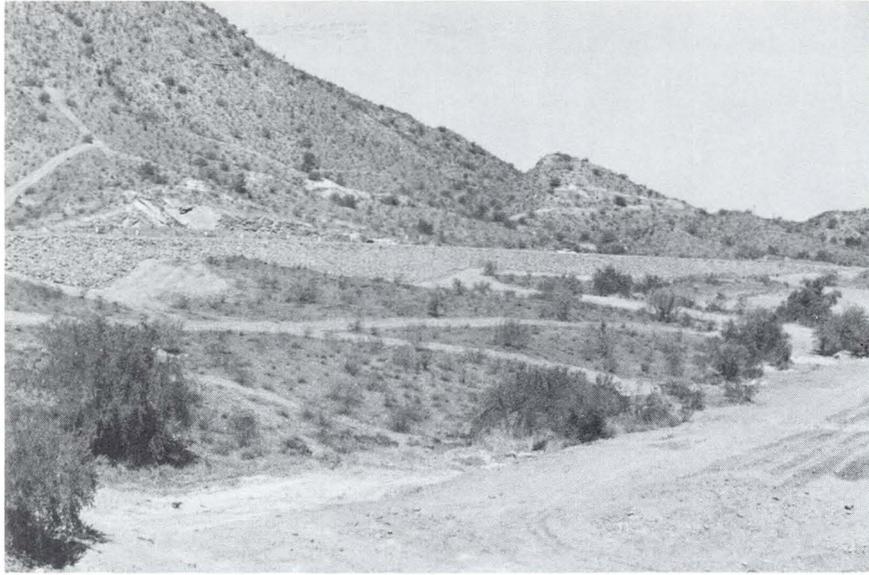
(1) Crest - Condition similar to main embankment.

DREAMY DRAW DIKE, LOOKING FROM DREAMY DRAW DAM.

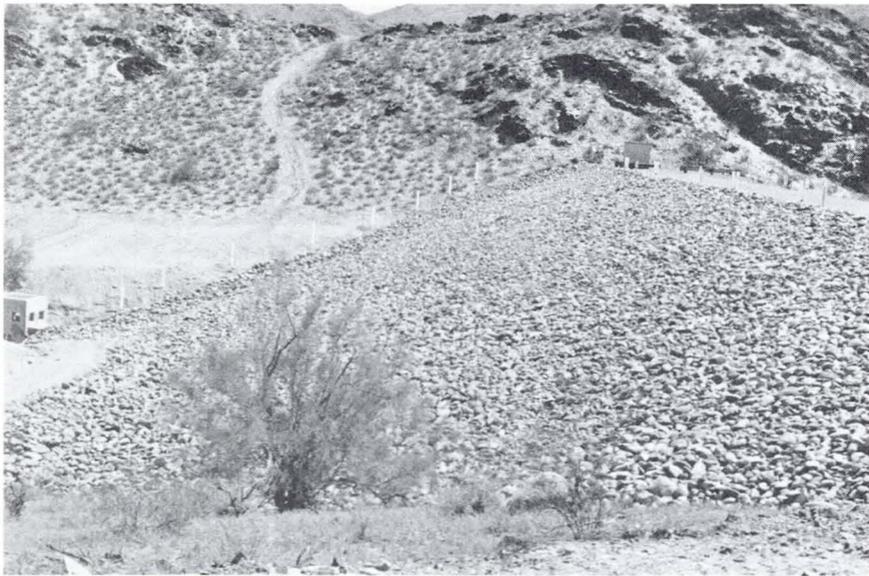
DREAMY DRAW DAM, LOOKING FROM RIGHT ABUTMENT AT
UPSTREAM FACE.

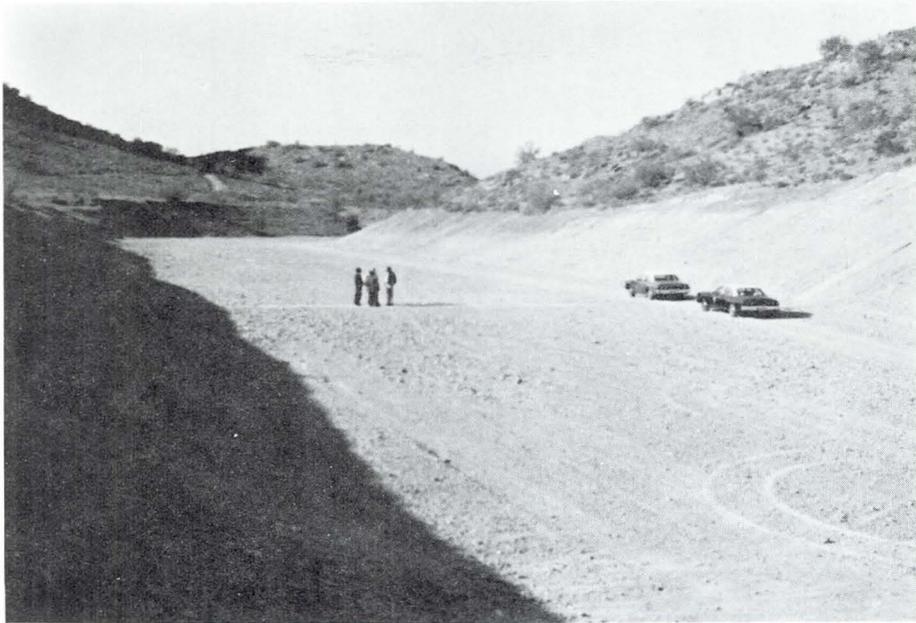
- (1) Approach channel - The approach channel was in good condition. There was no sloughing or raveling of the excavated slopes and the channel was clean and unobstructed.
- (2) Control section - Concrete in the sill was in good condition with no evidence of reactive aggregate. The excavated slopes above the sill remain stable.
- (3) Outlet channel - The outlet channel was clean and unobstructed with no sloughing or raveling of the excavated slope.

LOOKING DOWNSTREAM AT SPILLWAY WITH
CONCRETE SILL IN MIDDLE GOUND

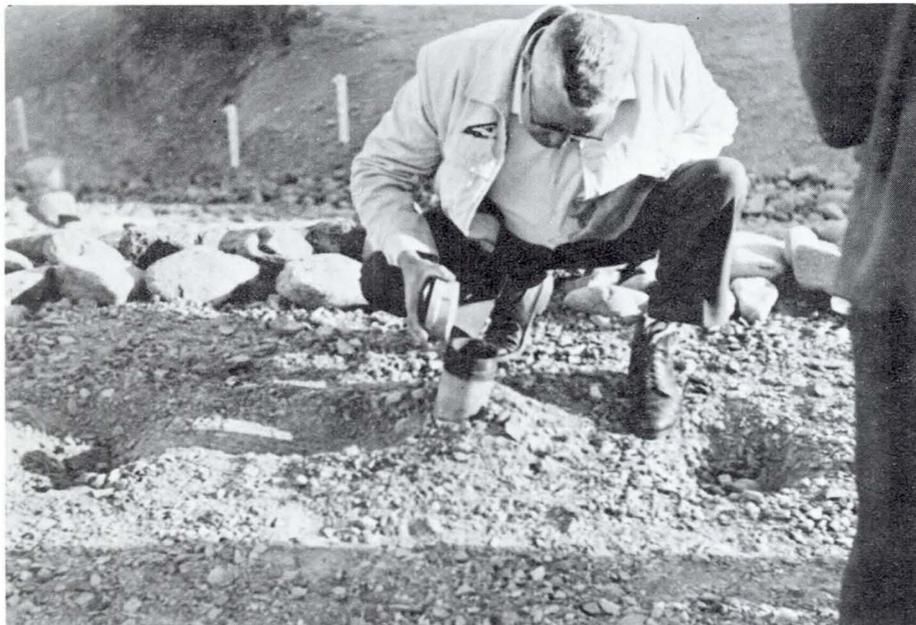
monument had been destroyed, and several settlement monuments displayed signs of having been disturbed. It was noted that one of the monuments had been pushed off line and grade. Six 3-inch x 8-inch x 6-foot guard posts had been pulled out and thrown on the upstream slope of the embankment.

LOOKING AT DISTURBED SETTLEMENT MONUMENT.
NOTE WHEEL TRACK IN SHADOW AT THE BASE OF
THE PIPE.

d. Reset monuments so that protective caps are 3-inches below the surface. Resurvey and reference location of all monuments.

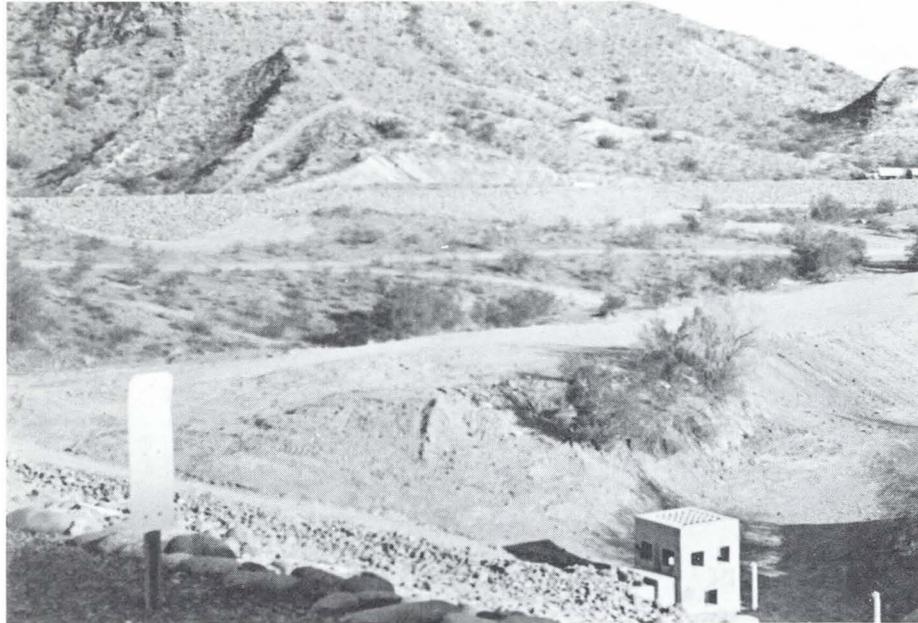
INTAKE STRUCTURE VIEWED FROM CREST NEAR
THE RECORDER HOUSE. NOTE TRAILS CRISS -
CROSSING THE AREA.

a. Eliminate unauthorized vehicular access to the dam crest by dumping rock across trails accessible to four-wheeled vehicles.

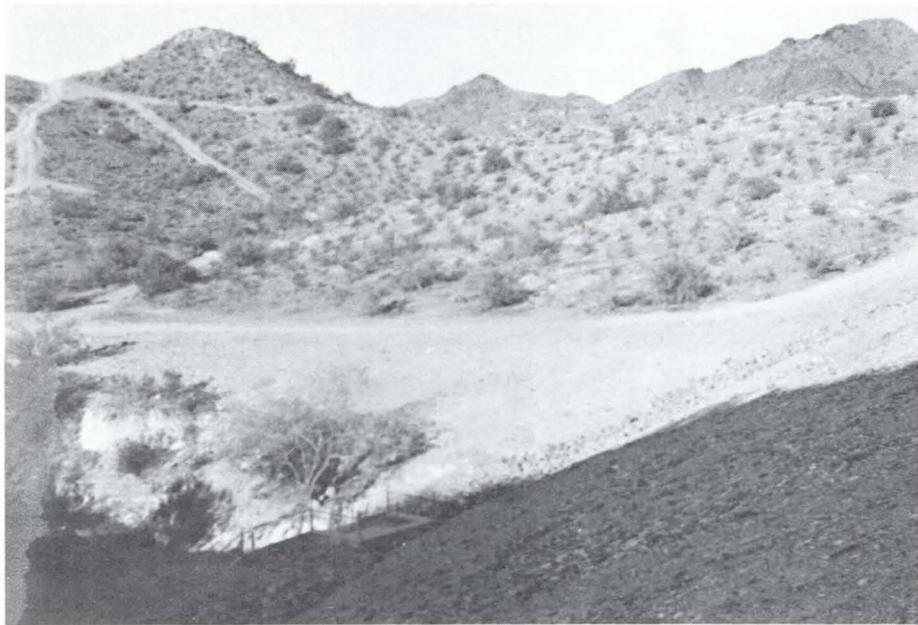
(1) Crest - The bituminous roadway surface along the crest was in excellent condition with no evidence of settlement or cracking. The shoulders of the roadway were clean and straight; however, off-road vehicles had started to wear away the shoulder of the crest near the right abutment of the main embankment.

5. CONCLUSION. Cross country vehicular use of the haul roads up to and crossing the crest near the right abutment of the main embankment is responsible for the beginning of erosion of the crest shoulder. Should such traffic continue it is certain that periodic maintenance of the crest shoulder will be a necessity. Attention is directed to the vandalism discussed in the previous paragraph. Except for these two conditions the project is in excellent condition.

TRAILS MADE BY OFF - ROAD VEHICLES. NOTICE
TRAIL CROSSING IN THE MIDDLE GROUND.

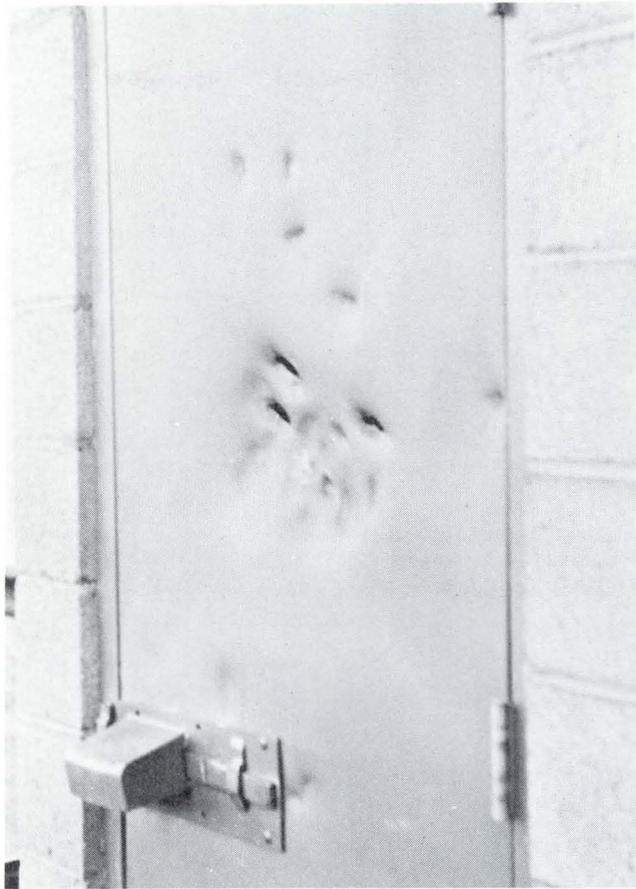
DAMAGE TO DOOR OF RECORDER HOUSE

g. Resurface recorder house door with a single heavy gage sheet metal welded over the damaged surface. Repair latch and locking assembly.

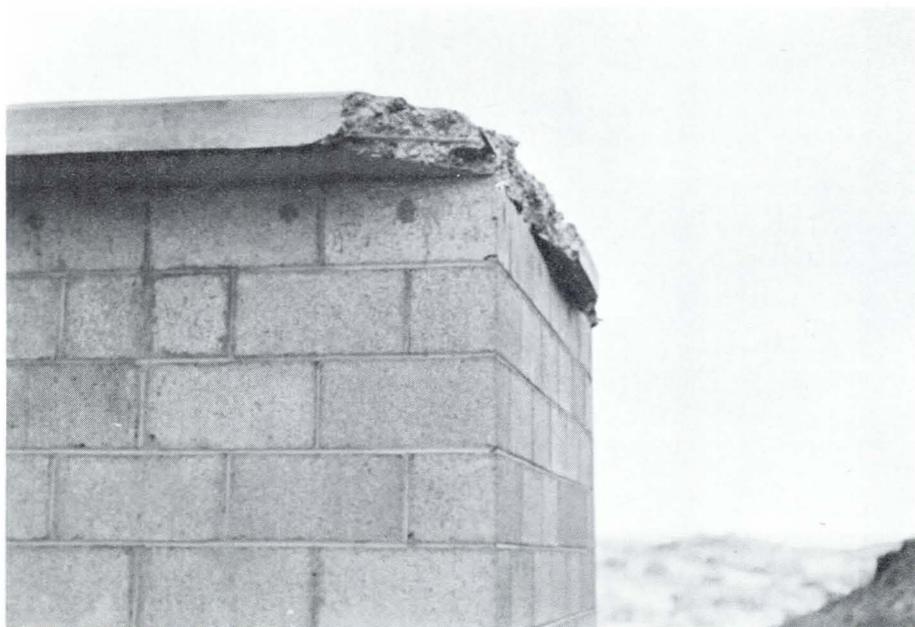
DAMAGE TO ROOF OVERHANG OF RECORDER HOUSE

f. Saw the overhang on the recorder house roof flush with the walls.
