**DAM SAFETY INSPECTION  
GOLDEN EAGLE PARK DAM  
ASSIGNMENT NO. 5  
NEAR GOLDEN EAGLE BOULEVARD  
& PALISADES BOULEVARD  
FOUNTAIN HILLS, ARIZONA**

**April 10, 1998**

**AEE Job No. 8-117-001014**

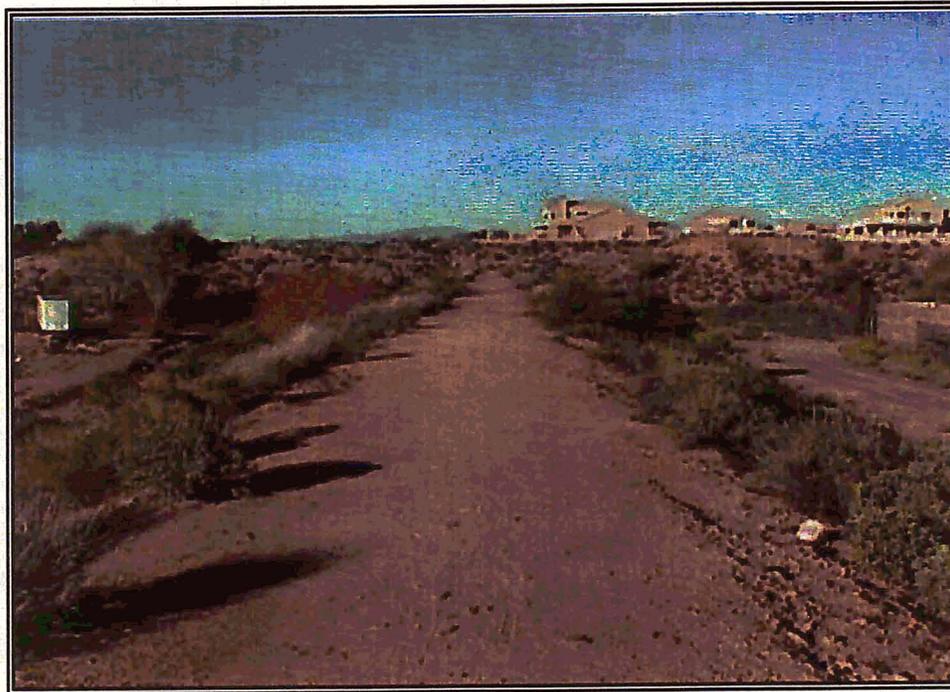
**Photo 1. Crest of Dam**

The visual inspection at the crest indicates that there are no obvious defects. No localized settlement, slides, depressions, misalignment, longitudinal or transverse cracking, animal burrows, adverse vegetation or erosion was noted. A survey with a handlevel indicated that the dam crest elevation does not vary more than about 0.6 feet over its extent. Photo No. 1 (Appendix A) shows the crest of the dam.

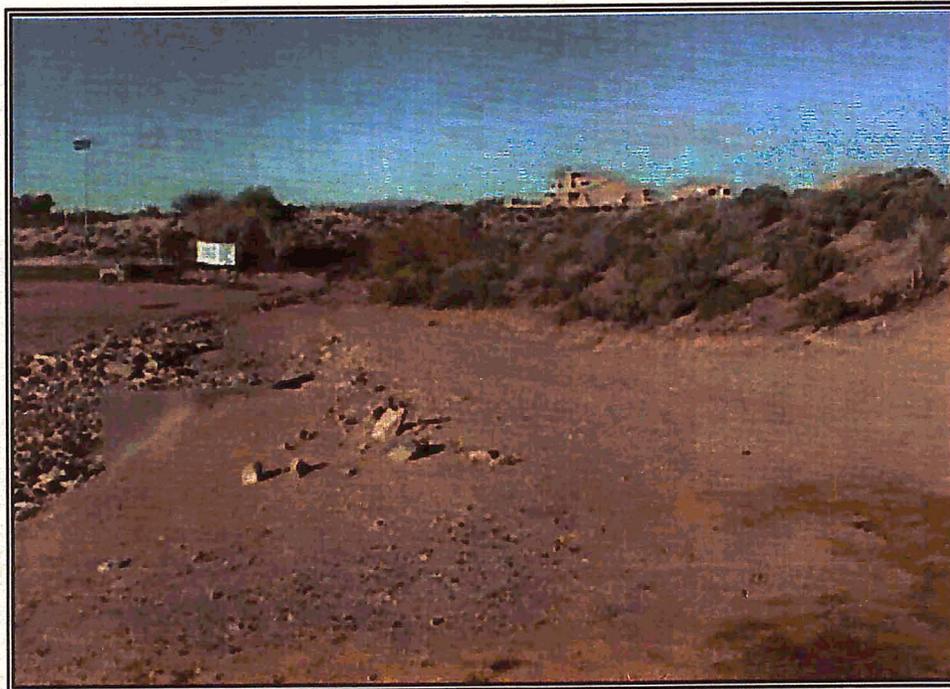
**Photo 2. Cut in Upstream Slope**

The upstream slope of the dam appears to be satisfactory with the exception of trees, large brush and some minor erosion. No animal burrows, settlement, slides, depressions, bulges or cracking was noted. Several tamarisk trees and small palo verde trees are present on the upstream slope. Also, a moderate growth of low brush along with some larger brush is present. A cut has been made on the southern portion of the embankment to allow for

construction traffic to the impoundment area. The cut is about 1 to 2 feet in depth and 12 to 15 feet in width near the base of the embankment. Photos 2 and 3 depict the vegetation and the cut in the embankment.

It is recommended that trees, large brush (2 feet or taller) and desert broom be removed from the embankments and the intake area near the trash rack. The stilling basin should be cleaned of silt and vegetation. The cut on the upstream slope should be repaired. The emergency spillway should be checked for erosion potential.

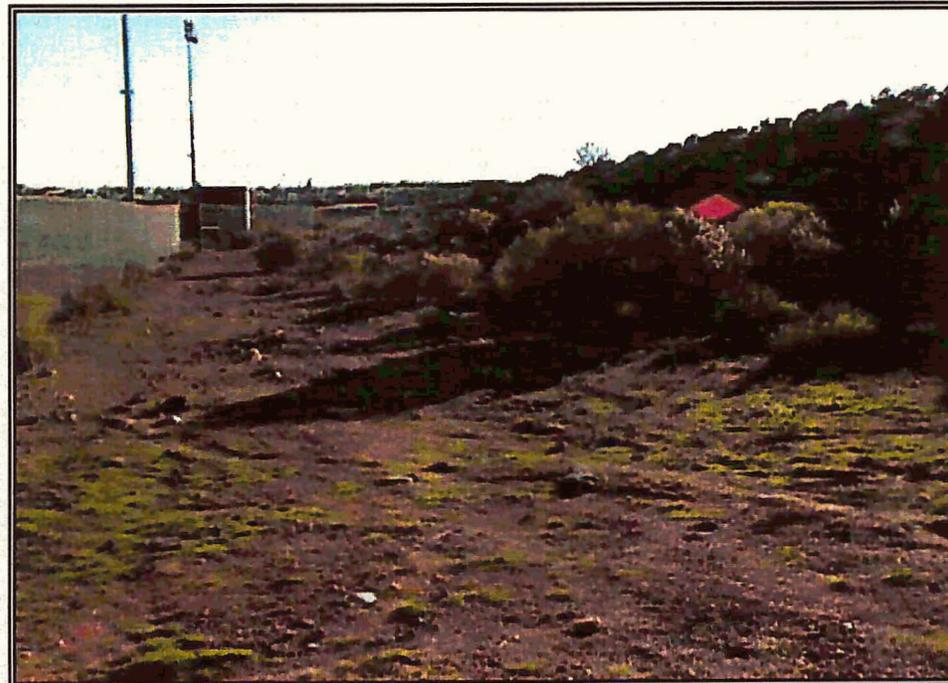
**Photo 4. Downstream Slope**

The downstream slope is satisfactory and has no cracking, settlement, bulges, slides, depressions, soft spots, evidence of movement or animal burrows. Vegetation consists of a moderate growth of brush with some palo verde trees. Also, there are some minor erosion features near the center of the embankment. Photo 4 depicts the vegetation present on the downstream slope.

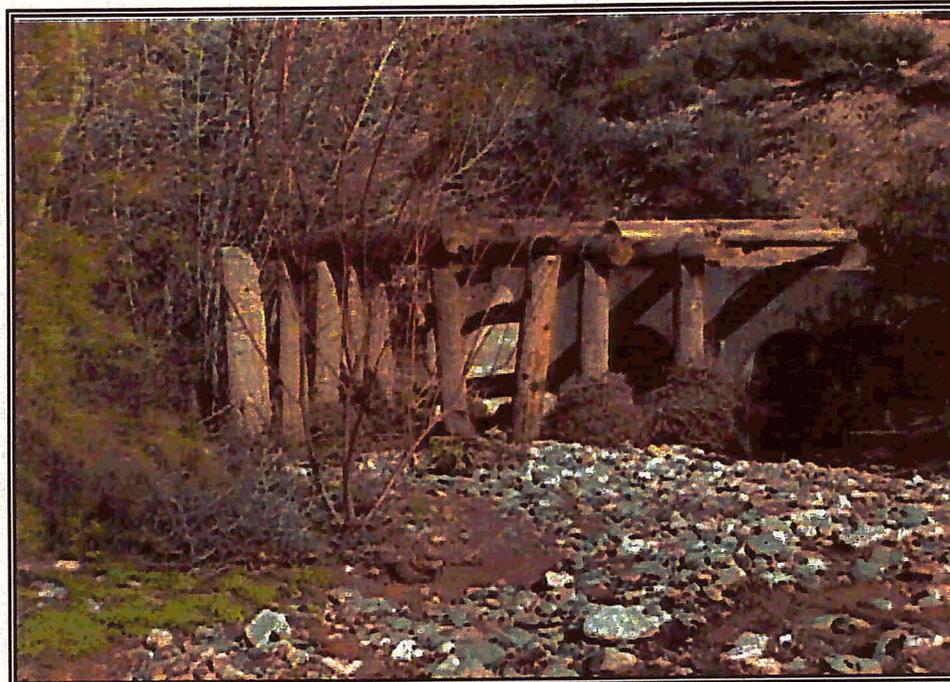
**Photo 5. Trash Rack Area**

The wooden trash racks appeared to be in good condition. Some brush and trees are obstructing inlet and trash rack area. Photo 5 depicts the trash rack.

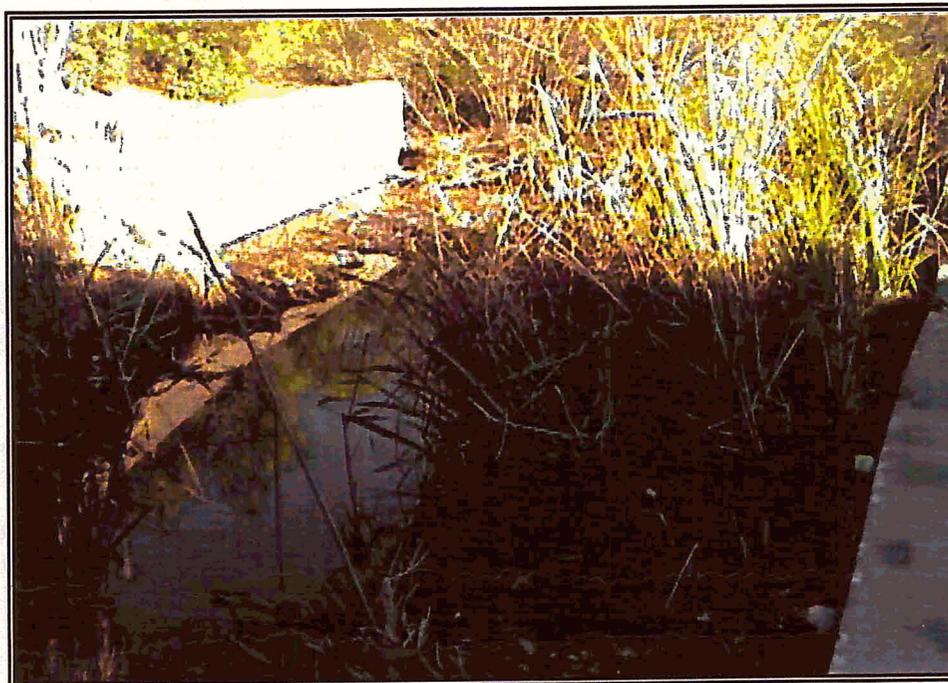
**Photo 6. Outlet Stilling Basin**

A concrete lined stilling basin is present. The exposed concrete joint had no displacement, loss of joint material or leakage. The southern portion of the stilling basin is clogged with silt and vegetation. Photo 6 depicts the stilling basin.

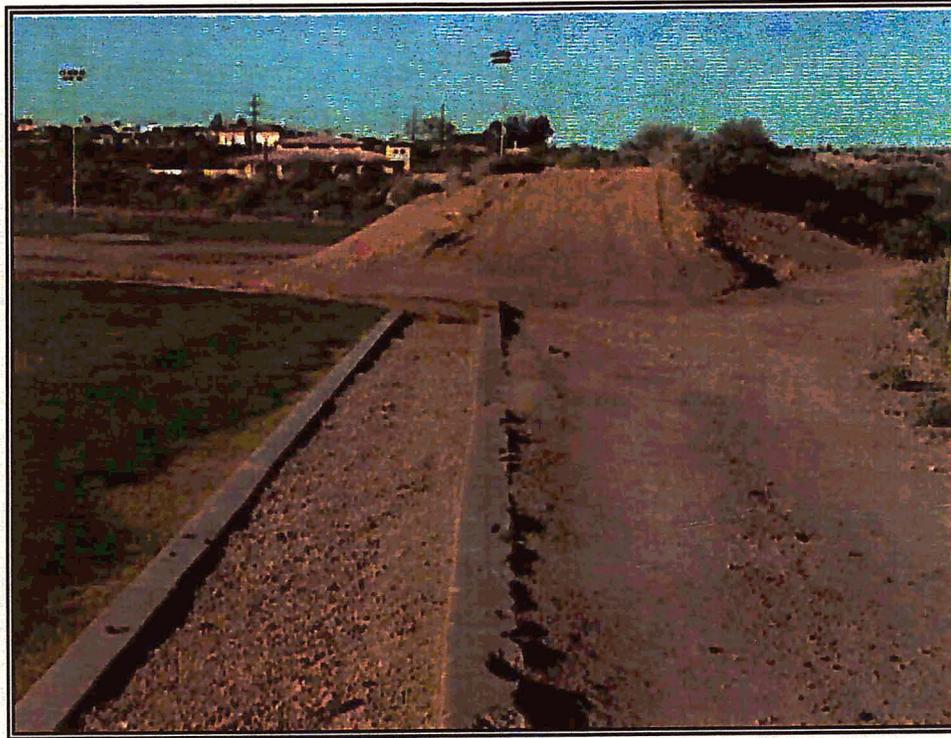
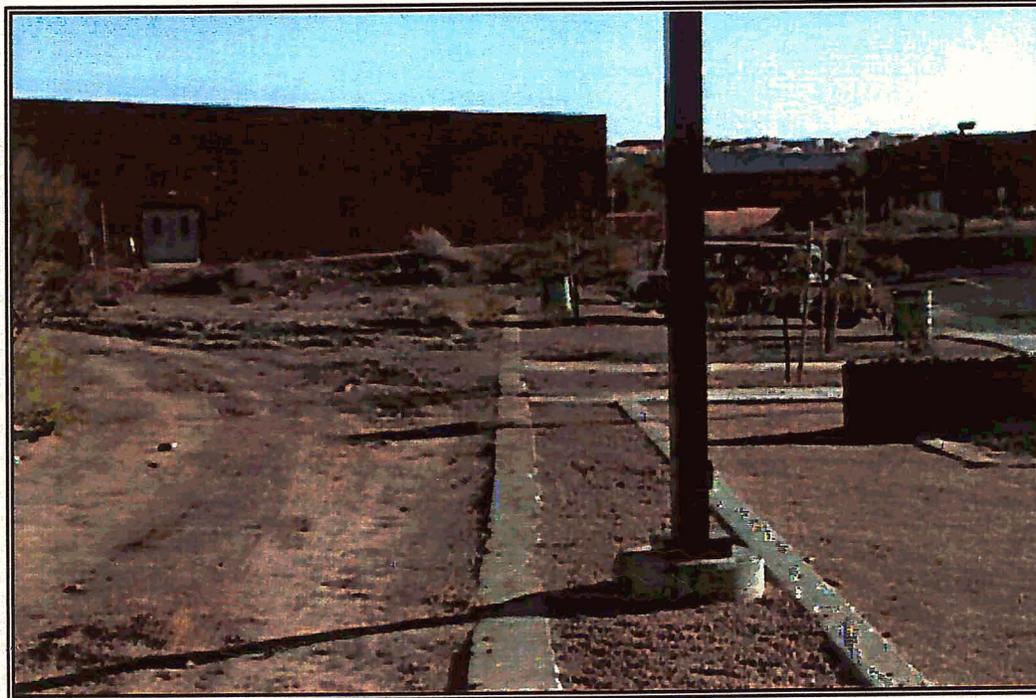
The emergency spillway is unlined and has a concrete sill that extends below ground for the width of the spillway. The upstream portion of the spillway is occupied by an asphaltic concrete paved parking lot and lawn areas for the park. The downstream portion of the spillway is stepped down on three benches that are separated with 2- to 4-foot high block retaining walls. The spillway exits into the south end of a football field that has a cinder running track on its perimeter. About four mesquite trees are located in the emergency spillway and chain-link fence posts spaced about 8 feet apart are located downstream from the concrete sill. The mesquite trees are downstream of the concrete sill and are widely spaced, so they do not obstruct the emergency spillway.

No erosion, sloughing or other distress is evident in the emergency spillway. Riprap is not evident from the surface exposures. However, borings and test pits indicate that dumped riprap is present from the concrete sill to the first downstream retaining wall. Photos 7 and 8 depict the emergency spillway.

**Photo 7. Emergency Spillway**

**Photo 8. Emergency Spillway**
