# Harquahala Flood Retarding Structure Individual Structure Assessment Report

Prepared for  
Flood Control District of Maricopa County  
On-Call Phase I Assessment  
FGD 2003C015  
PCN 050.03.01  
October 2005

**KIMLEY-HORN AND ASSOCIATES, INC.  
7878 NORTH 16<sup>TH</sup> STREET, SUITE 300  
PHOENIX, ARIZONA 85020  
(602) 944-5500**

**OCTOBER 2005**

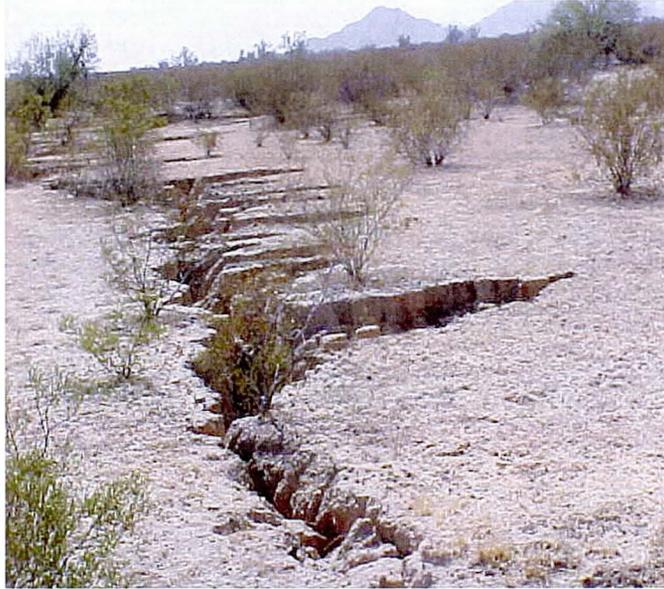
**Photo 1: View of Rogers earth fissure with gully headcutting upslope along the fissure alignment.**

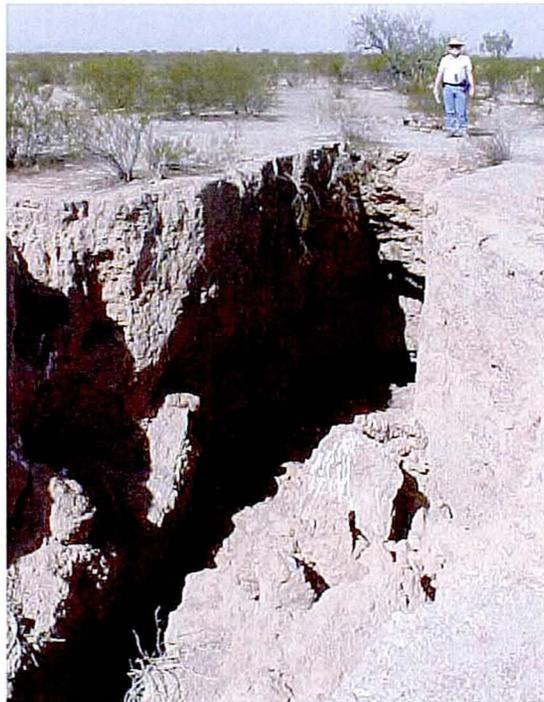
**Photo 2: Well developed fissure gully along portion of Rogers earth fissure. Note slump blocks in bottom center of view generated from the tabular failure of the over-steepened fissure side slopes.**

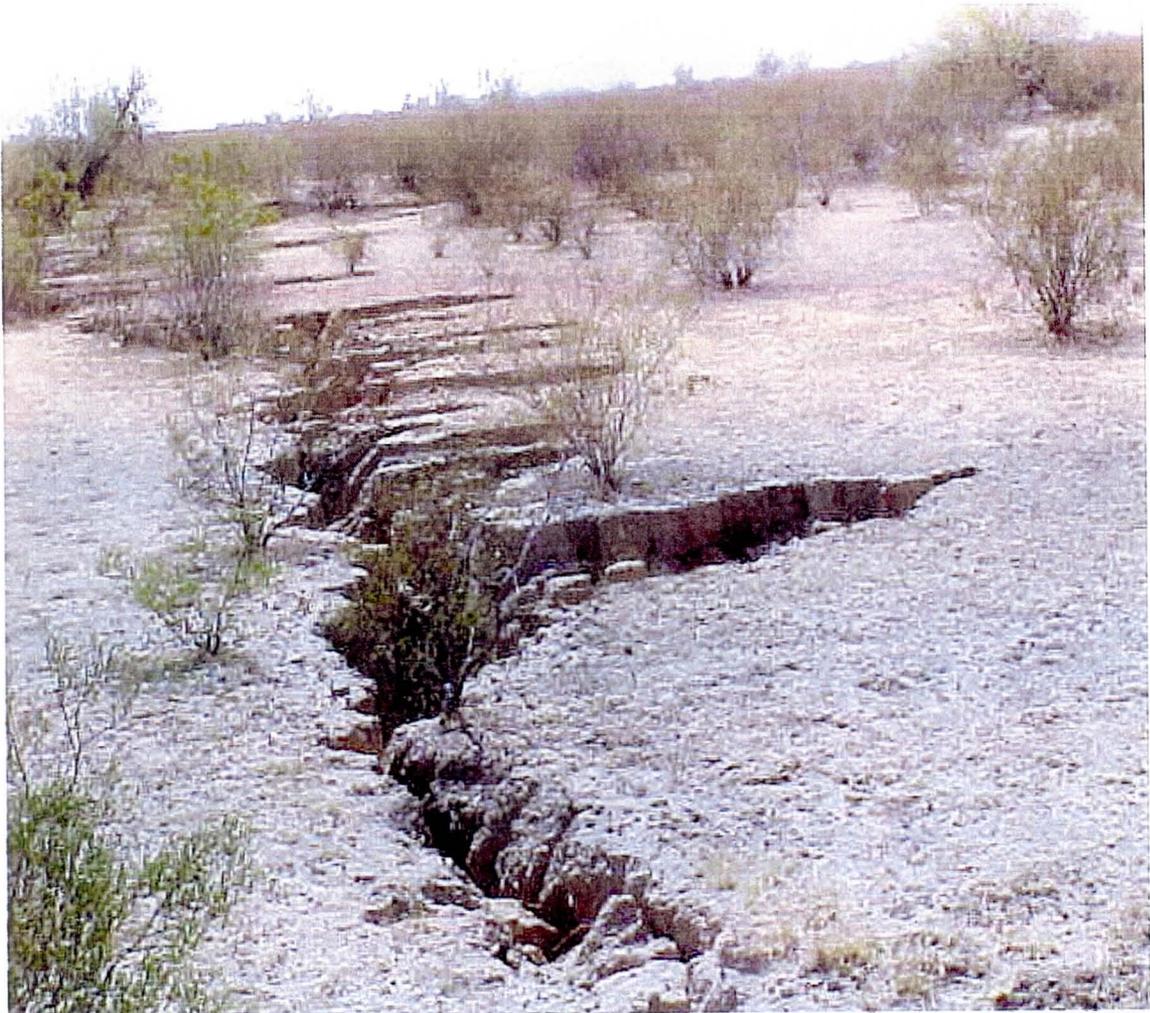
**Photo 1: View of Rogers earth fissure with gully headcutting upslope along the fissure alignment.**

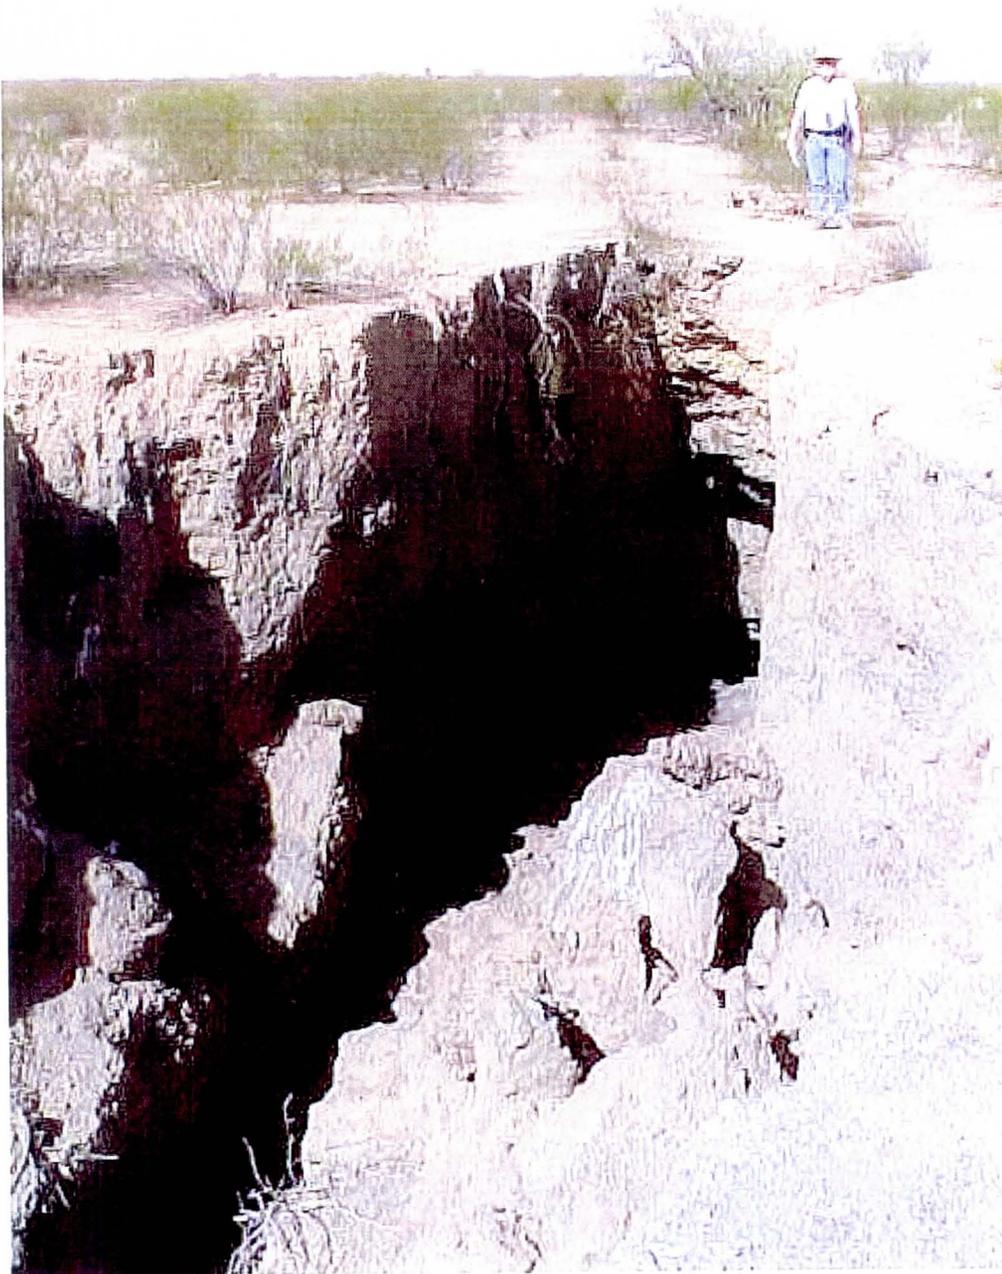
**Photo 2: Well developed fissure gully along portion of Rogers earth fissure. Note slump blocks in bottom center of view generated from the tabular failure of the over-steepened fissure side slopes.**

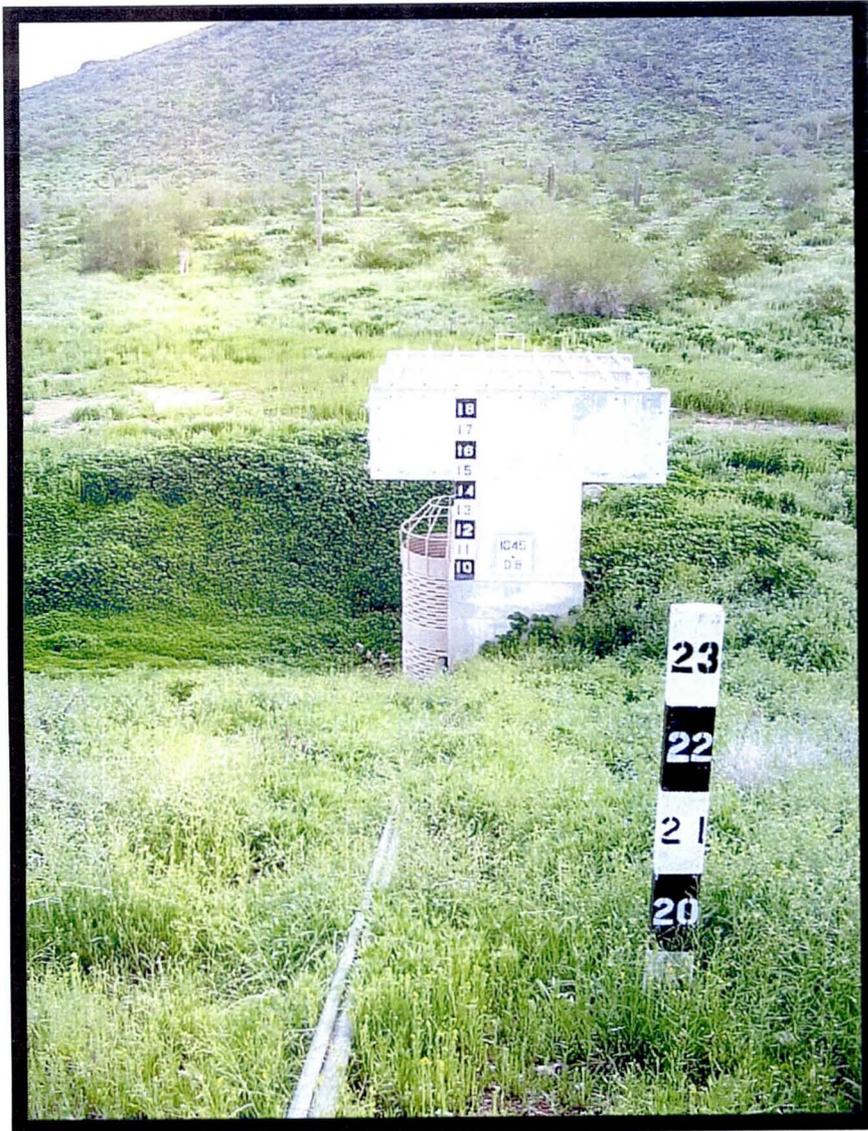
Photo 1 – Principal Outlet: Generally wet/damp conditions, dense low growing vegetation. Outlet structure and operation features appeared to be in good working condition, no significant sediment was observed.

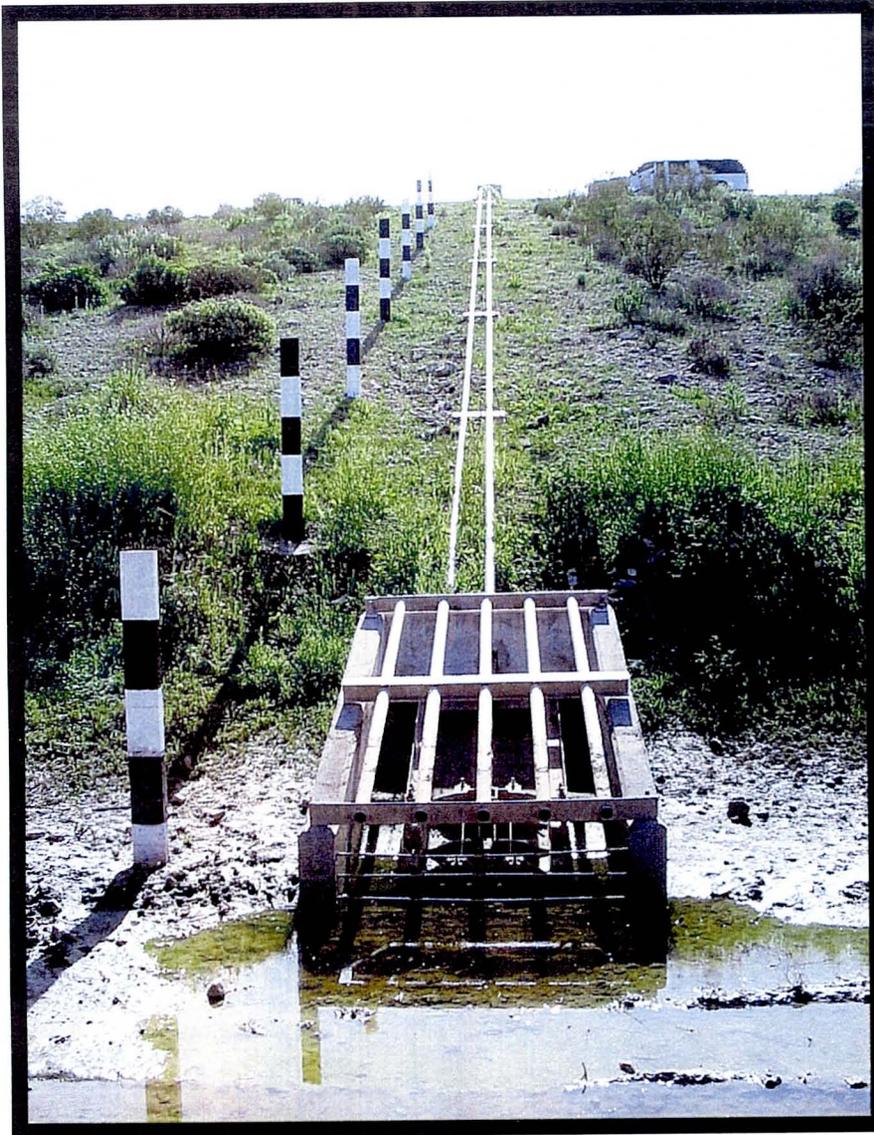
Photo 5 – Drain Outlet at Station 746+00: Gate was closed.

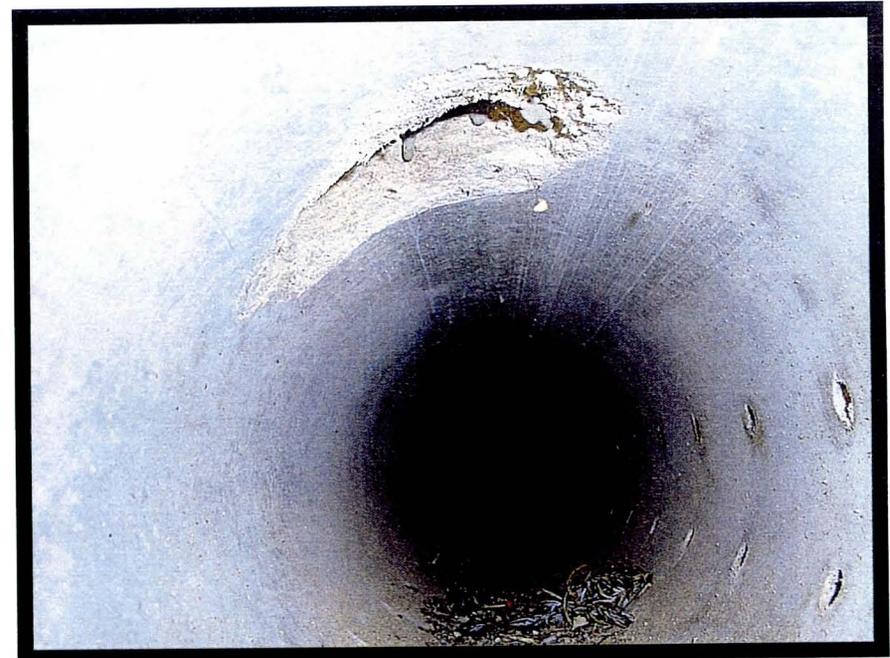
Photo 6 – Outlet Drain at Station 467+72: Drain pipe is disconnected approximately 4-feet from downstream end otherwise appears clear. Recommend video inspection.

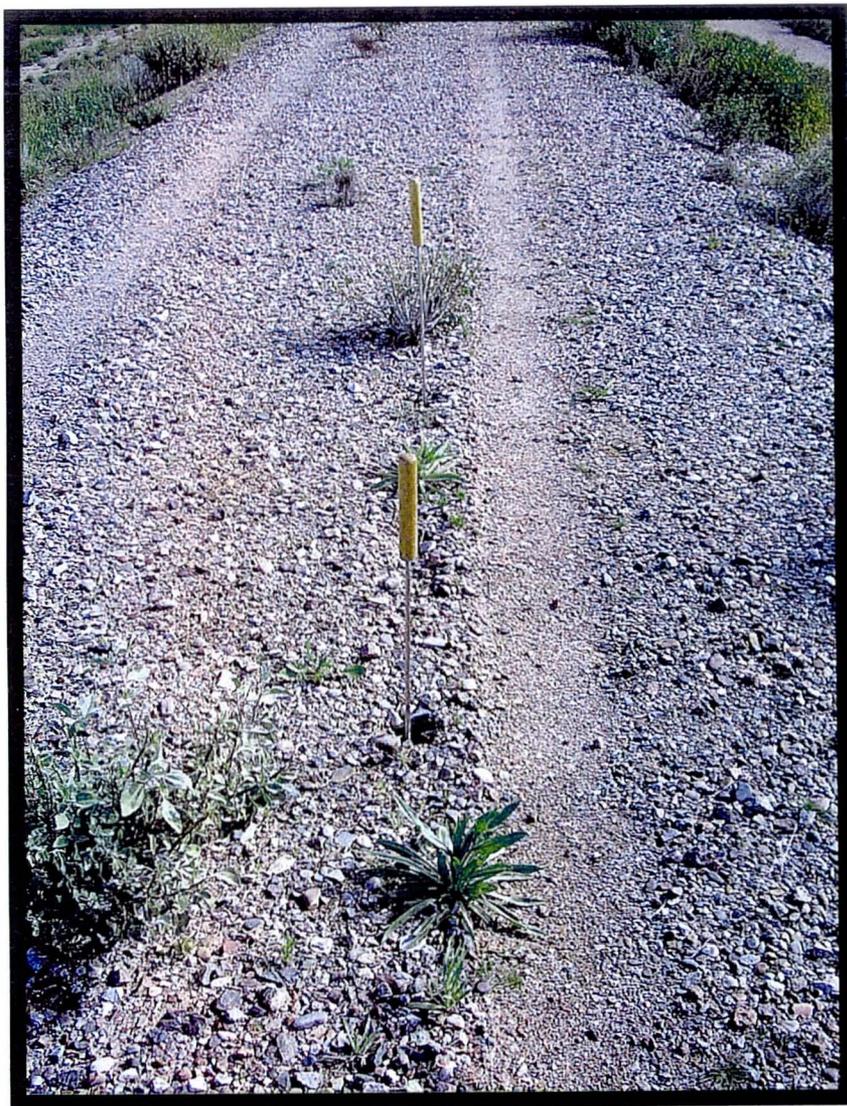
Photo 7 – Sta. 490+92: Two holes along centerline of crest, possible longitudinal crack.

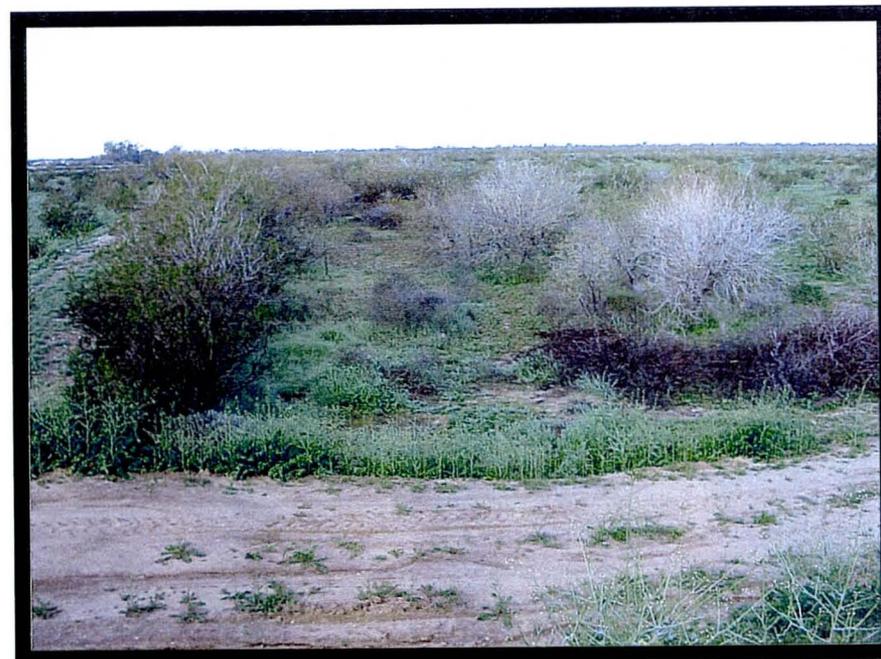
Photo 8 – Reservoir Area, Reach 2. Note large vegetation on embankment

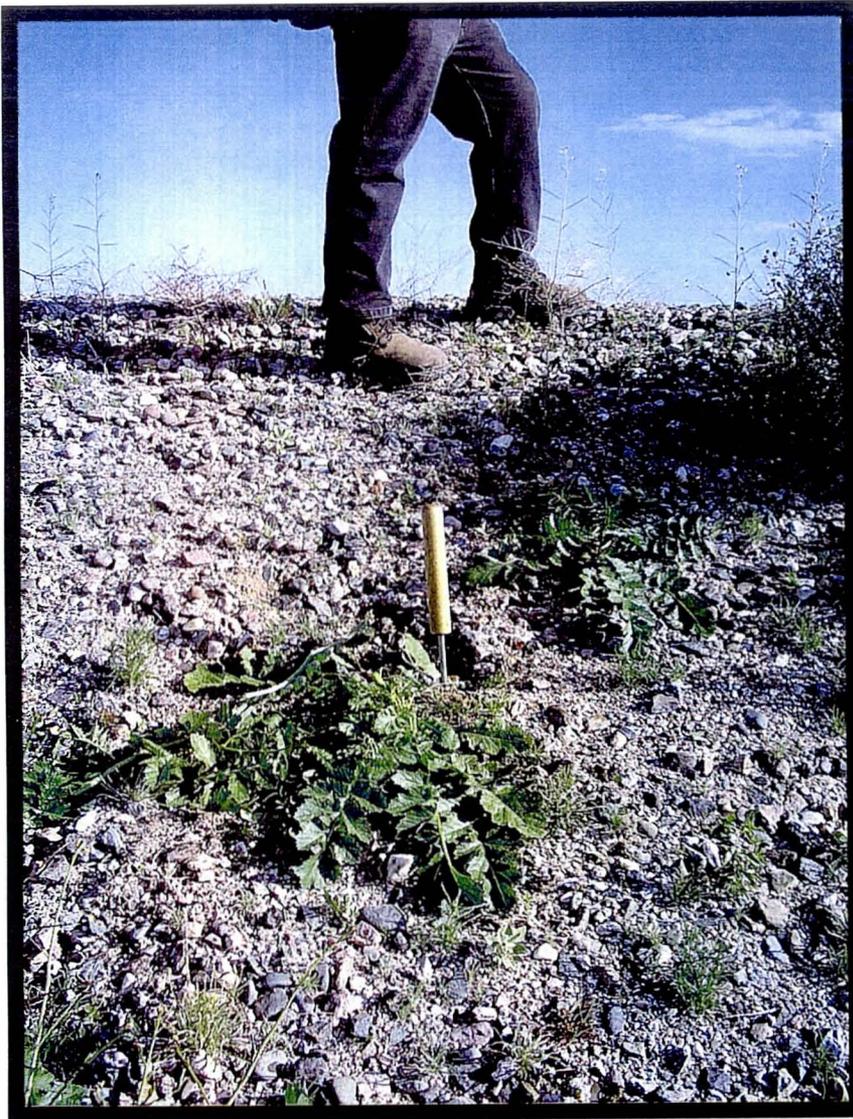
Photo 11 – Reach 2, Station 469+48: 2.5-foot deep hole off of downstream shoulder.

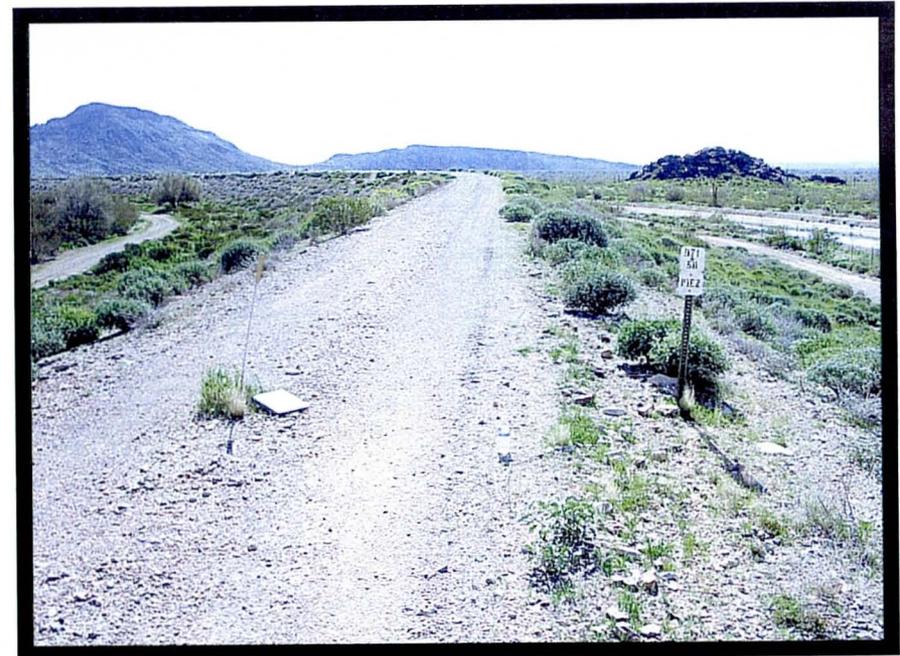
Photo 12 – Dam Crest, Reach 1: Piezometer indicated on station marker at shoulder of crest, piezometer not located. Vegetation noted in center of crest.

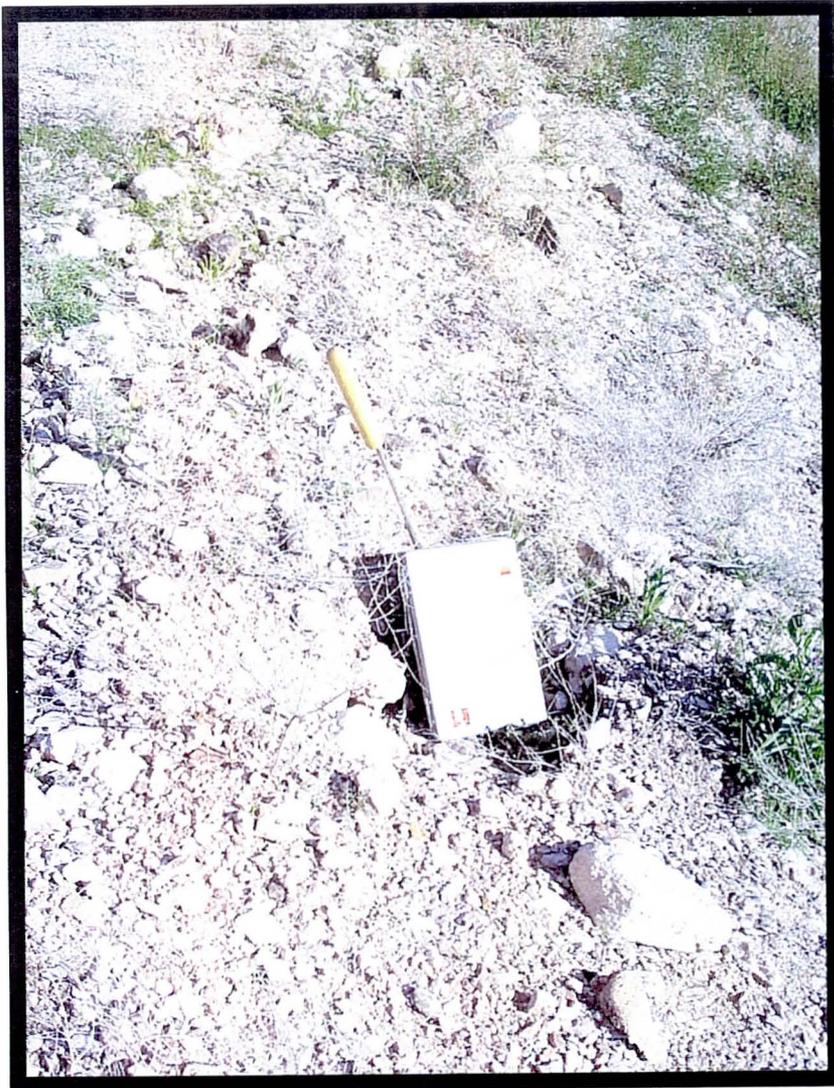
Photo 13 – Approximate Sta. 842+00: Depression/Rodent hole on downstream shoulder, soft in-fill.

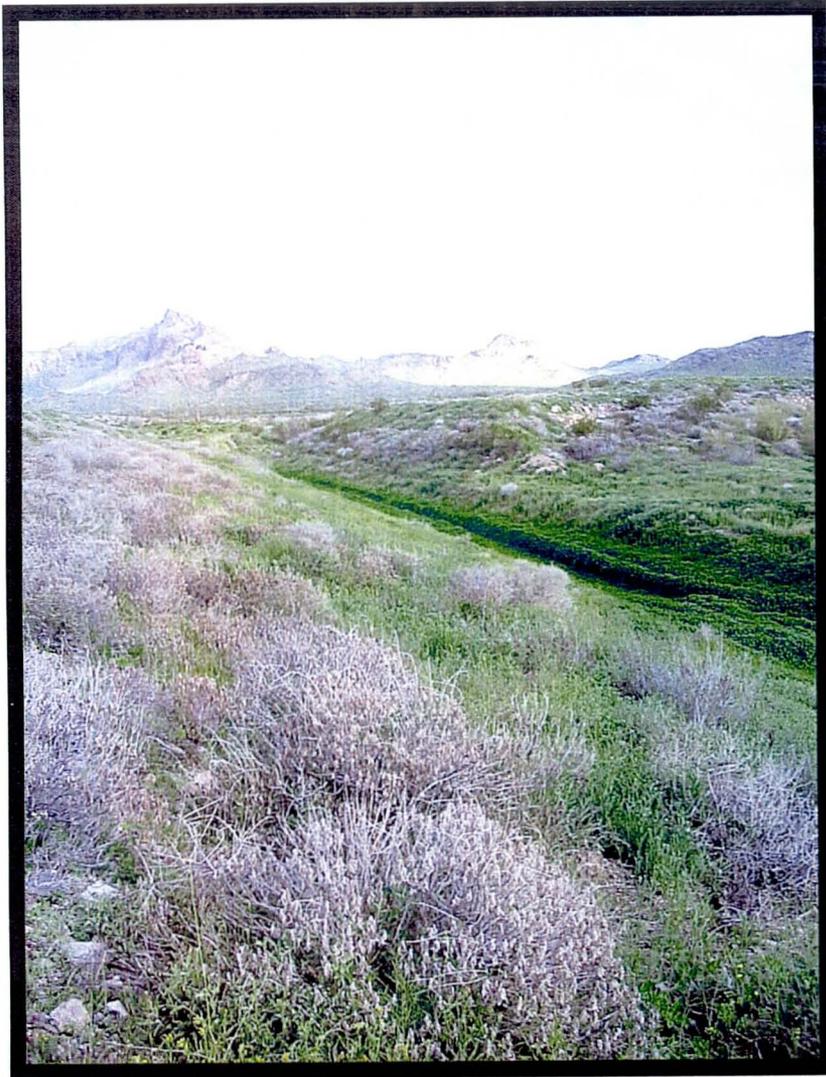
Photo 15 – East Abutment, Upstream Slope, Reach 1: Generally wet/damp conditions, dense low growing vegetation. The upstream slope appeared to be in good condition with no signs of cracking.

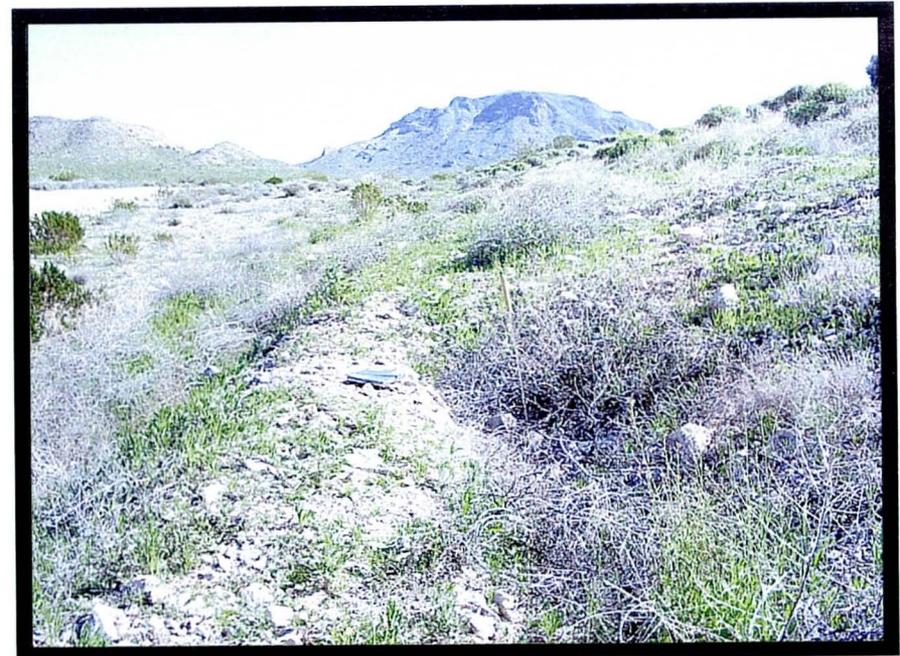
Photo 16 – Upstream Slope, Reach , Station 931+50: Large depression approximately 12-foot long, 2- to 3-foot wide, within 3-feet of upstream toe. No visible erosion.
