**SUN CITY  
DRAINAGE CHANNELS**

**INSPECTION AND REPORT OF EXISTING CONDITIONS**

**DEL WEBB HOME CONSTRUCTION  
P.O. Box 1705  
Sun City West, Arizona 85372**

**STANLEY CONSULTANTS OF ARIZONA, INC.  
3117 North 16th Street  
Phoenix, Arizona 85016**

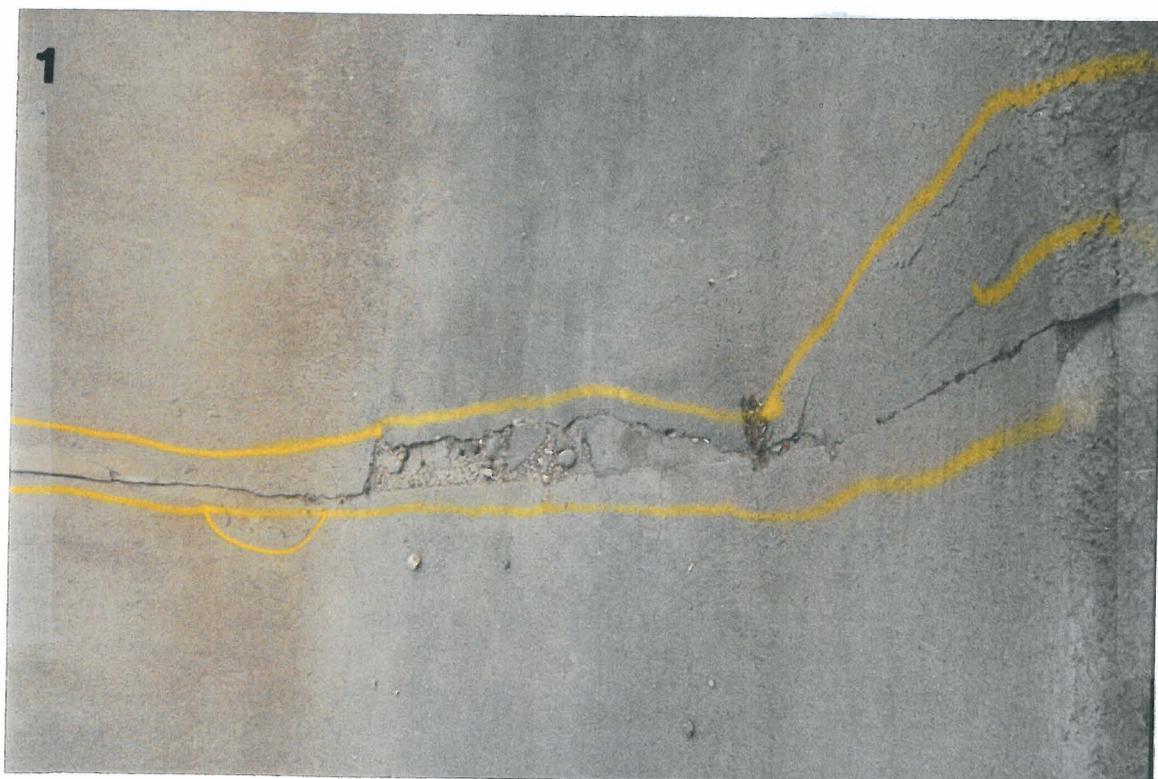
See Photo #1 for typical expansion joint cracking, this channel

Most of the failures in this segment center on the expansion joints. They have apparently ceased to operate properly over time probably due to being filled with sand or pebbles and preventing movement of the slabs, thereby allowing for cracking outside of the joint area. The appearance of the joints are made worse by the application of a mortar top-coat which has chipped away. It is recommended in these areas that all loose concrete and vegetation be removed. Broken areas of concrete at the joints should be saw-cut out and replaced with mortar patch. Joints should be routed clean.

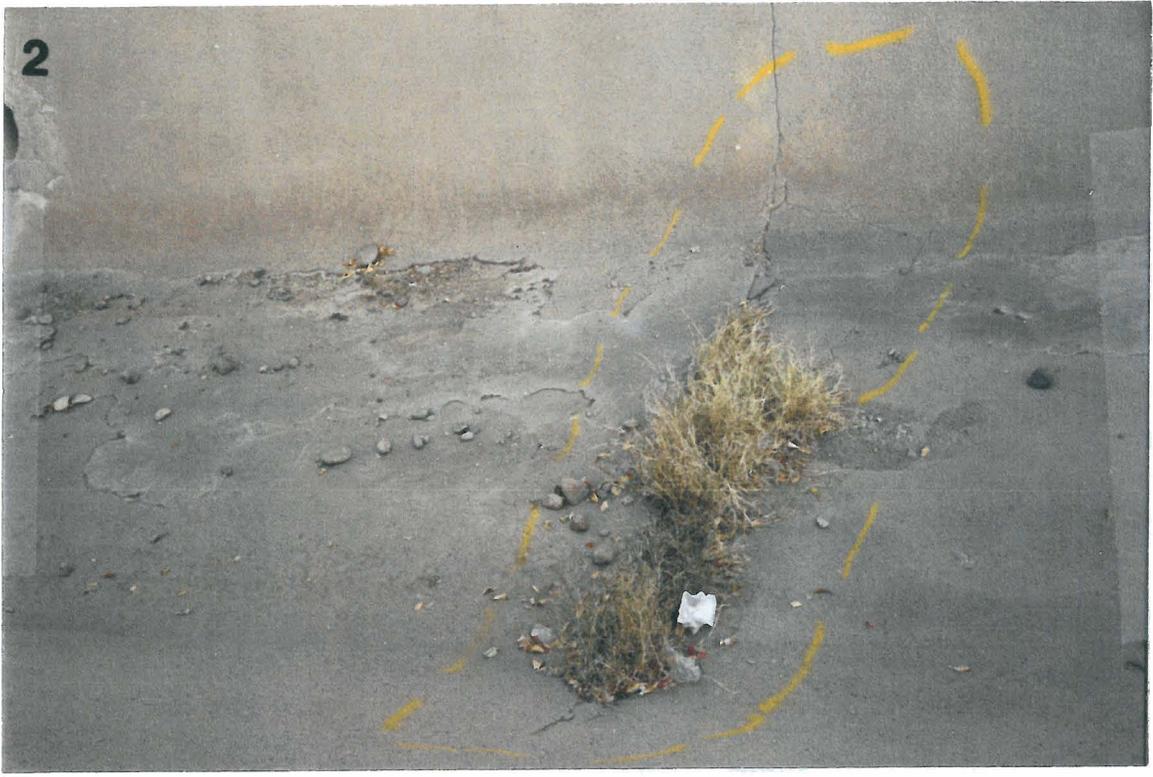
- 5+72 Expansion joint blow out. Large hole with grass growing through. Cracked and broken full width of bottom, 20'x1' to 3'. See photo #2.
- 6+05 Hole in expansion joint with grass growing, 1'x1' and 3'x4' and 1'x1'.

In several areas at either end of the channel, where blow-out has occurred, the concrete should be removed entirely. The base should be allowed to dry and then reshaped. New gunite, complete with wire reinforcing, should then be installed.

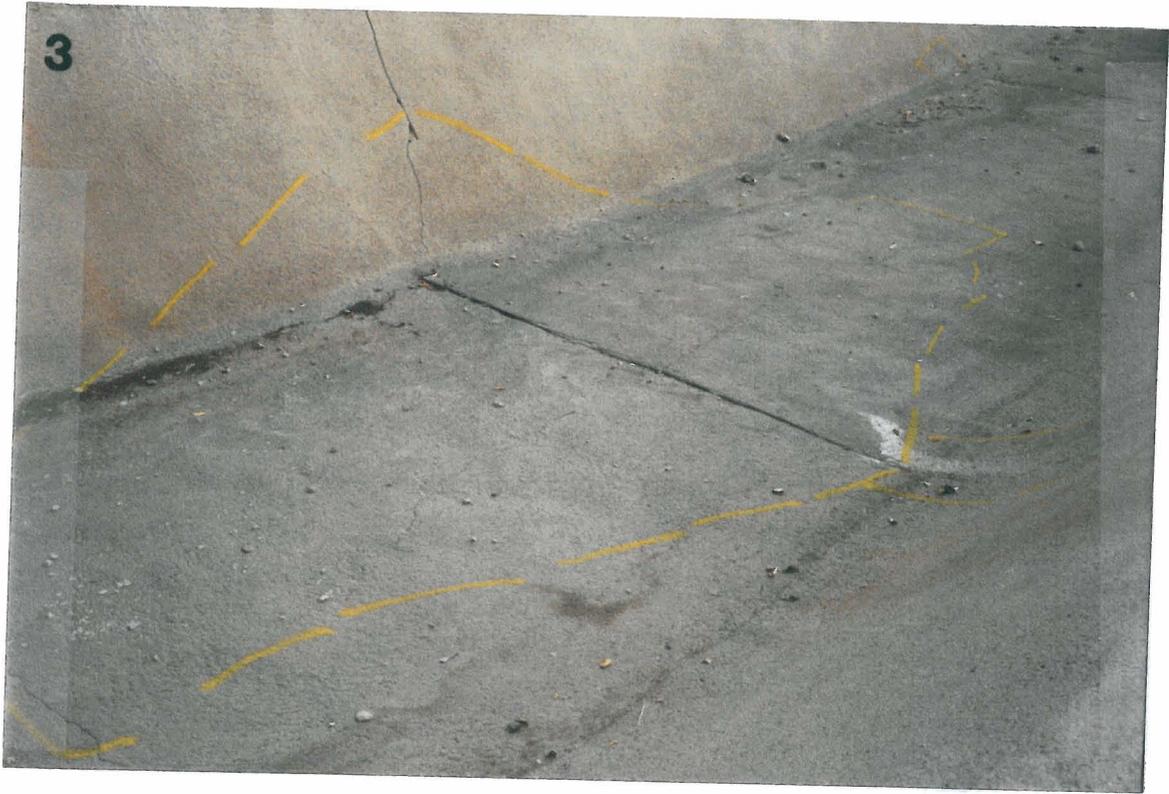
11+89 Whole bottom and 3' wide along expansion joint is bad, 25'x13'. See photo #3.

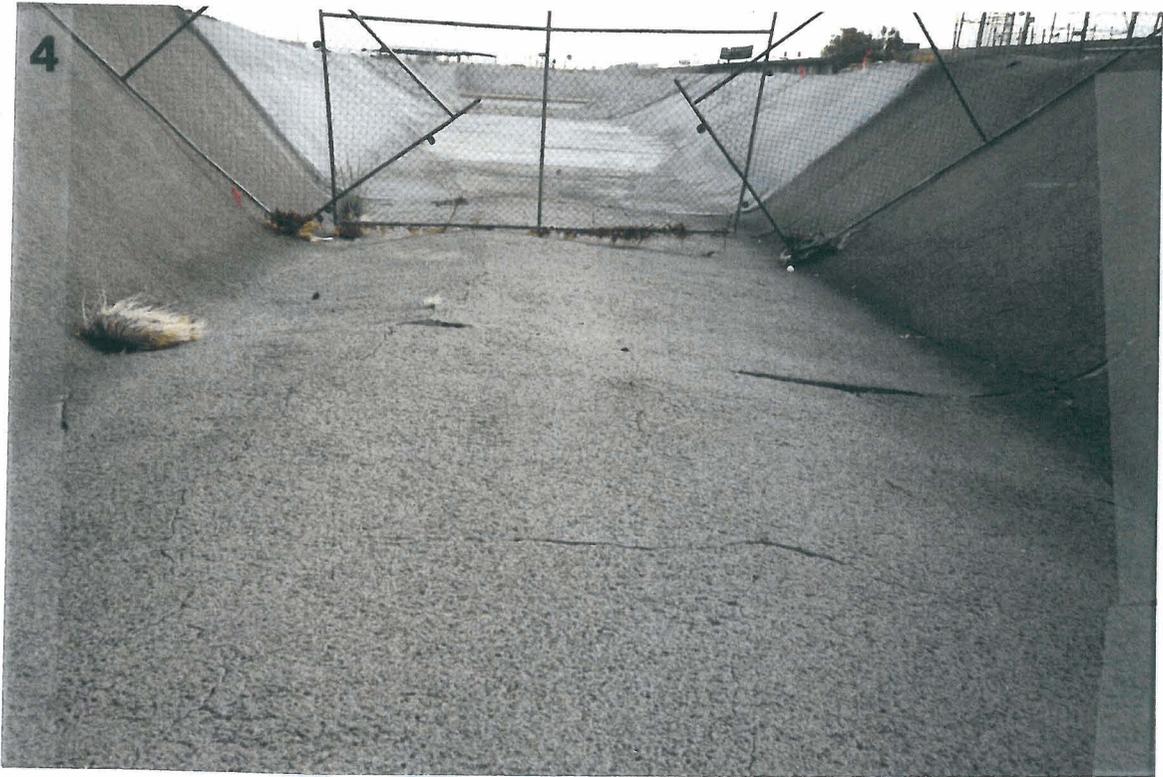
See Photo #4 Station 1+00 looking east to Station 0+00

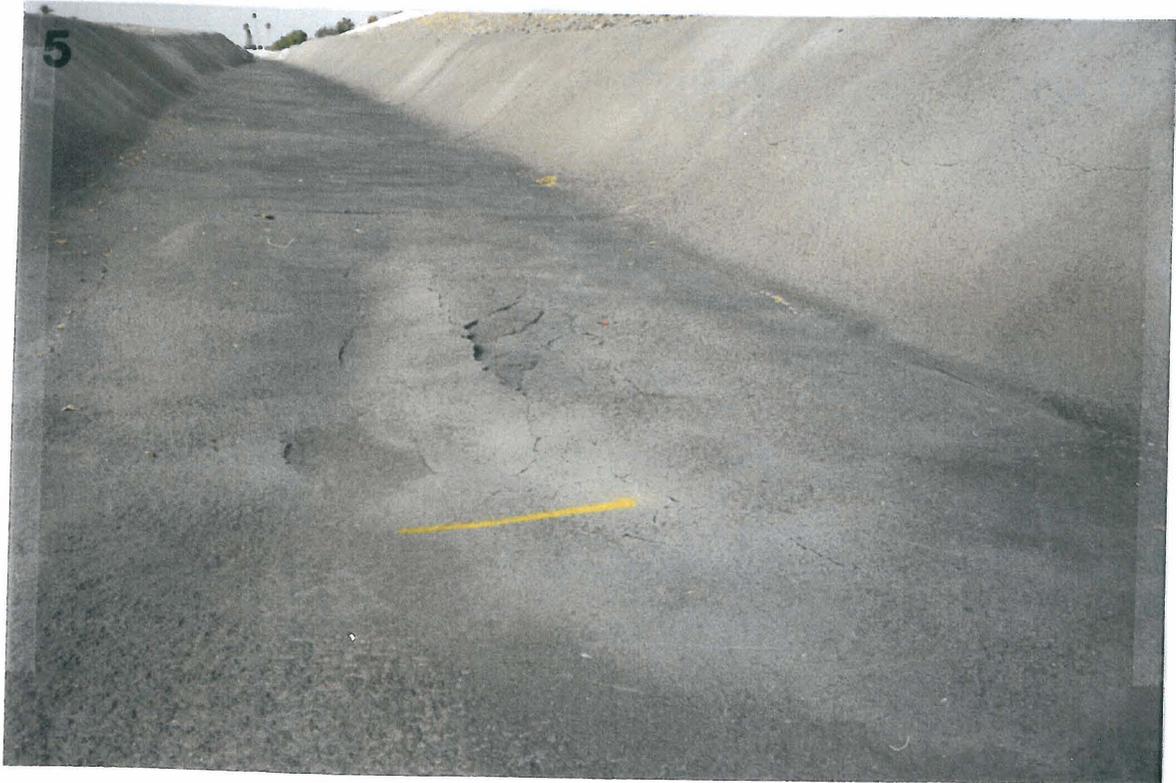
1+26 Bottom is blown out and broken, 126'x18' mostly bad.  
North side 50'x12' is bad.

See Photo #5 Station 1+00 mark and blow out at bottom looking to west.

Recommended repair of this segment includes removal and replacement of all gunite broken up at blow-out areas. Voids created by migration of water should be pressure grouted. Scuppers should be installed along the south edge of the channel at intervals of not more than 200 feet. Minor grading at the top of the channel is recommended to direct flows into the scuppers and discourage ponding adjacent to the channel edge.

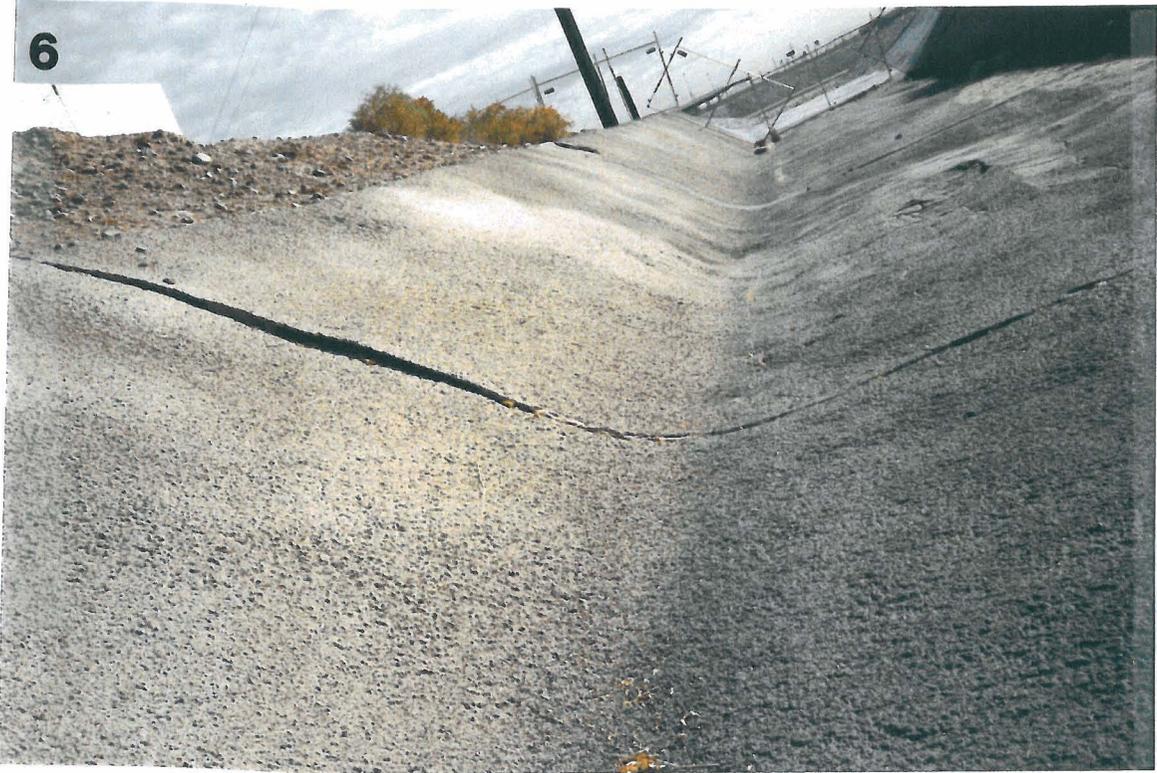
1+26        Expansion joint separating on north slope. See Photo #6.

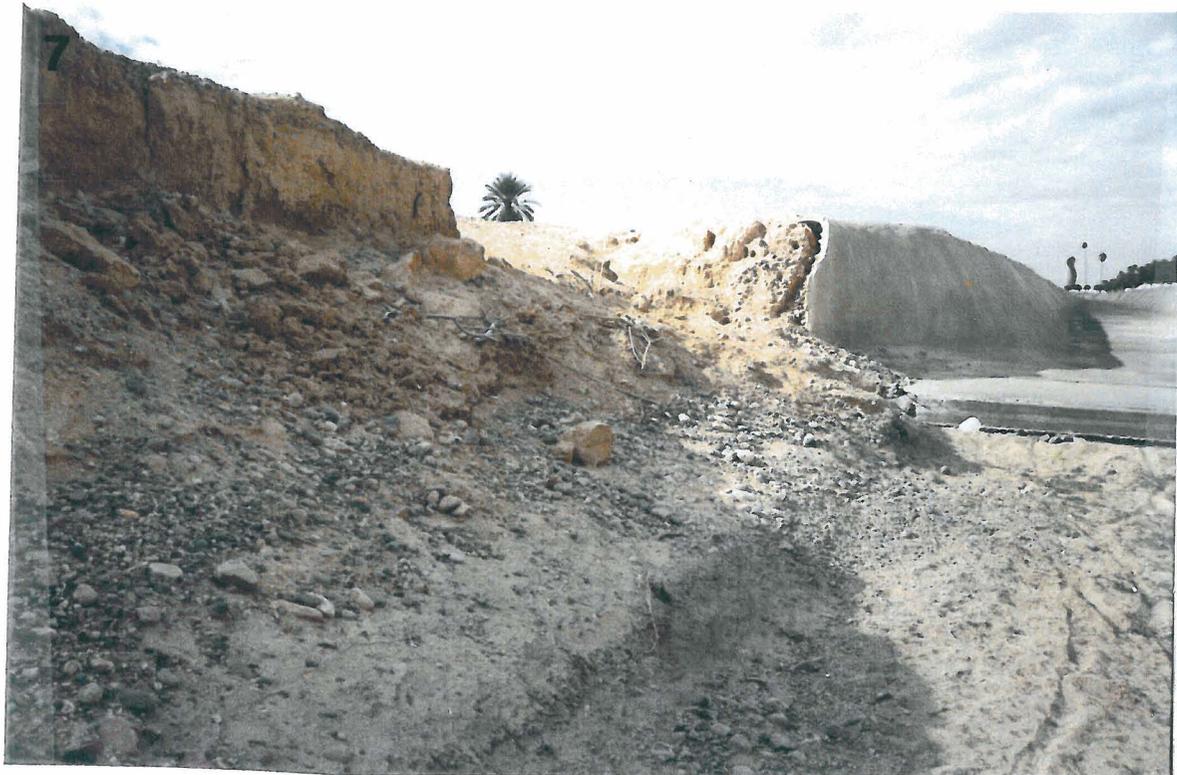
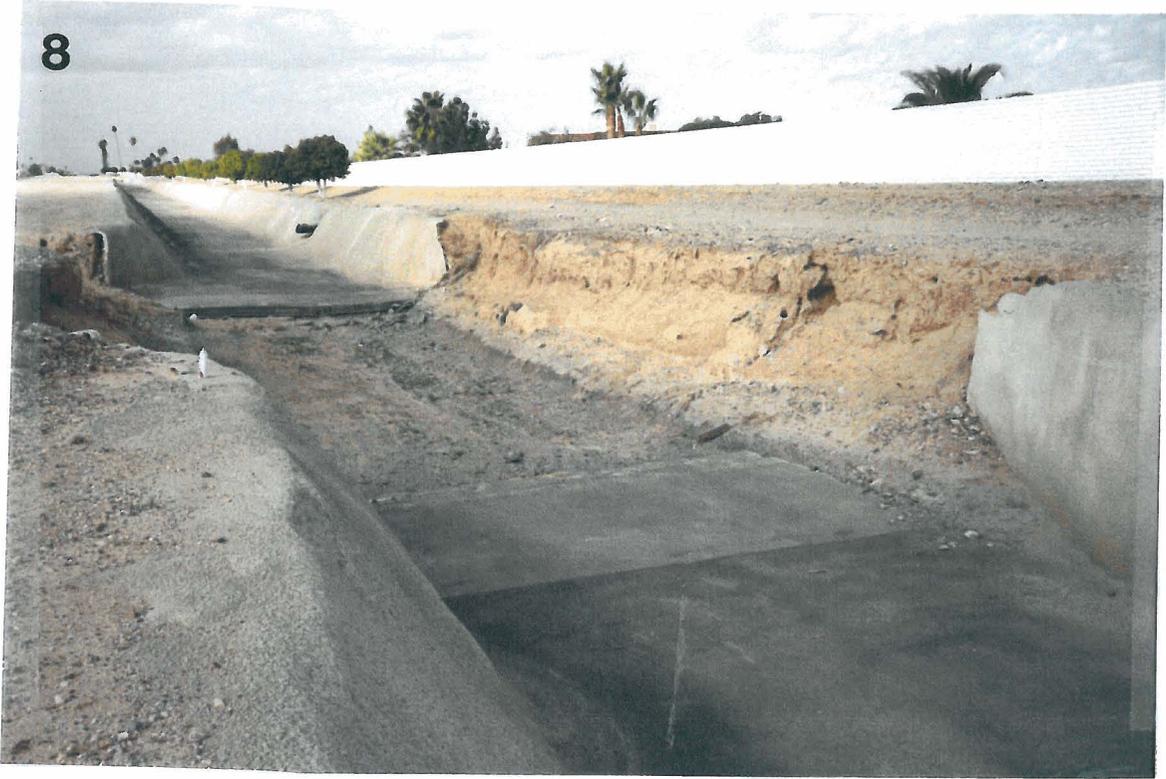
8+75        Begin concrete slab. See photos #7 and #8.

Note: Gunite slopes in the whole area adjacent to  
concrete slabs on both sides. On both sides material  
has washed out from behind and is jagged and cracked  
for a large part.

From stations 8+00 to 8+89, the banks should be reshaped and new gunite lining installed. The existing concrete slabs can remain in place.

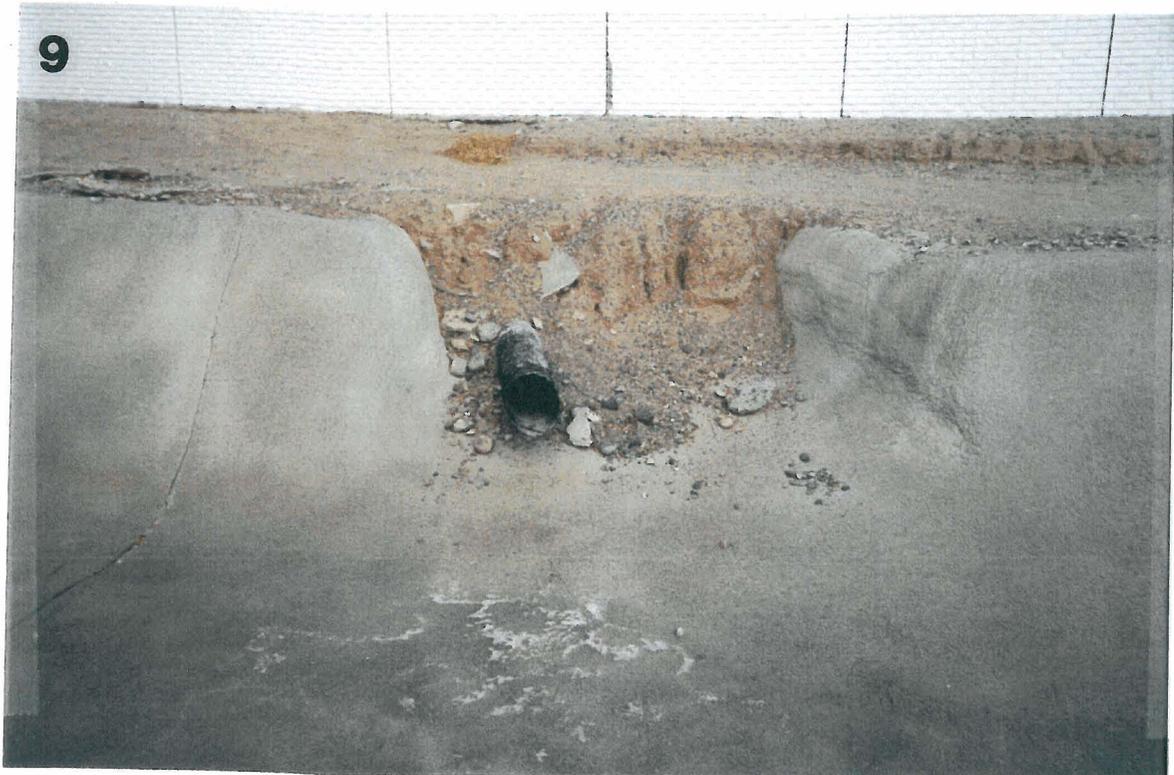
9+77 Pipe from northwest. Break in gunite, may be due to channel access point. See photo #9.

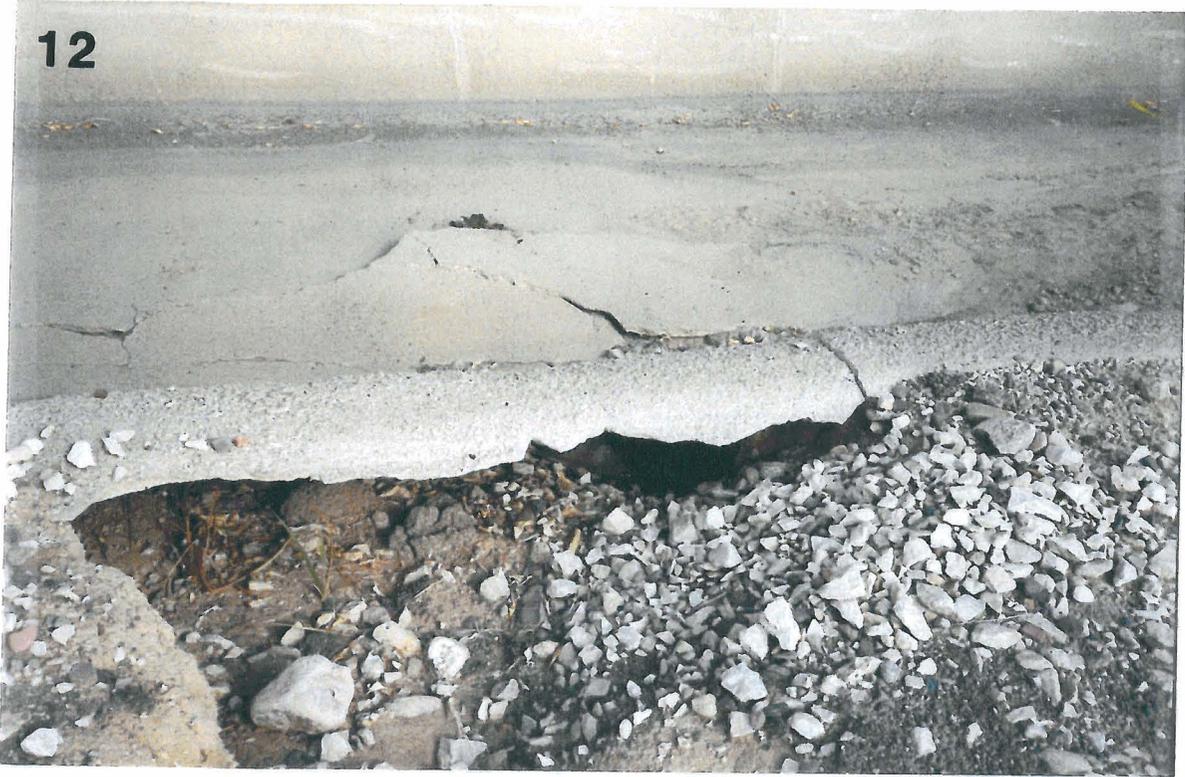
12

28+00      Voids behind south slope.    See Photo #12.

- B. Pressure grouting voids created behind the side slopes.
- C. Install additional scuppers on south side so interval is approximately one per 200 linear feet.
- D. Epoxy fill structural cracks and small holes.
- E. Gunitite large holes.
- F. Latex or silicone caulk temperature cracks.

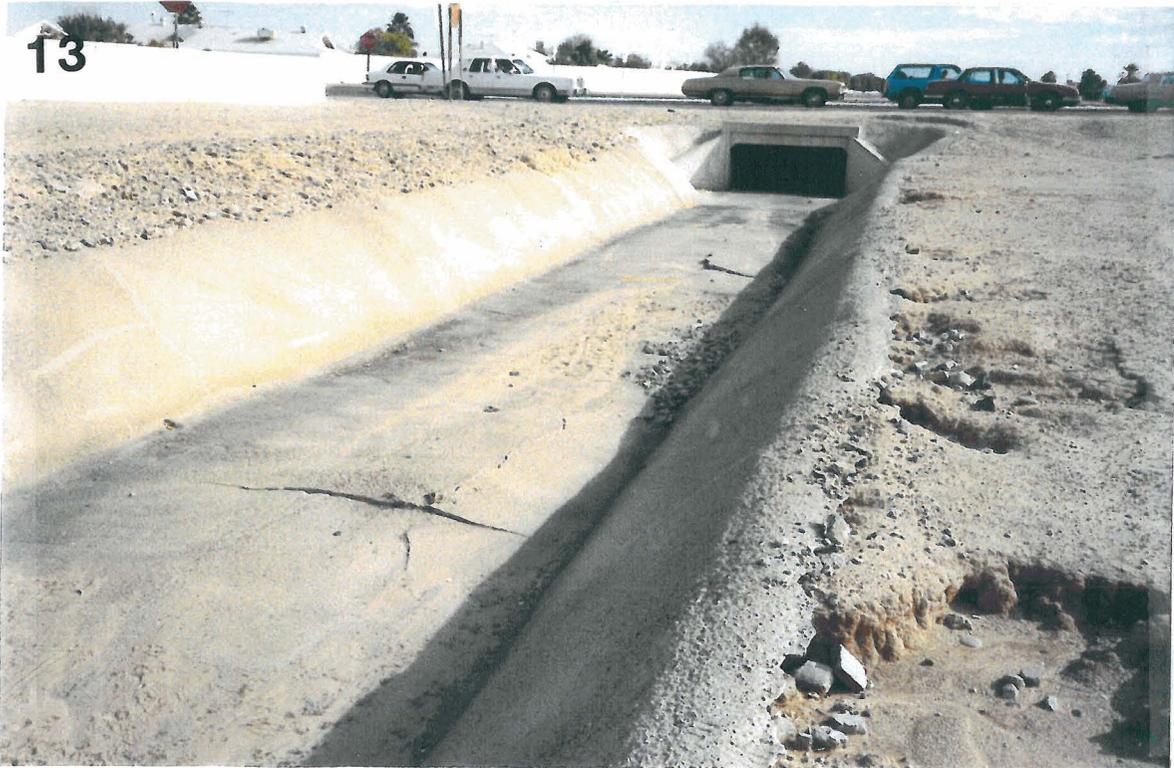
13

28+00      Looking East at 99th Avenue.    See Photo #13.

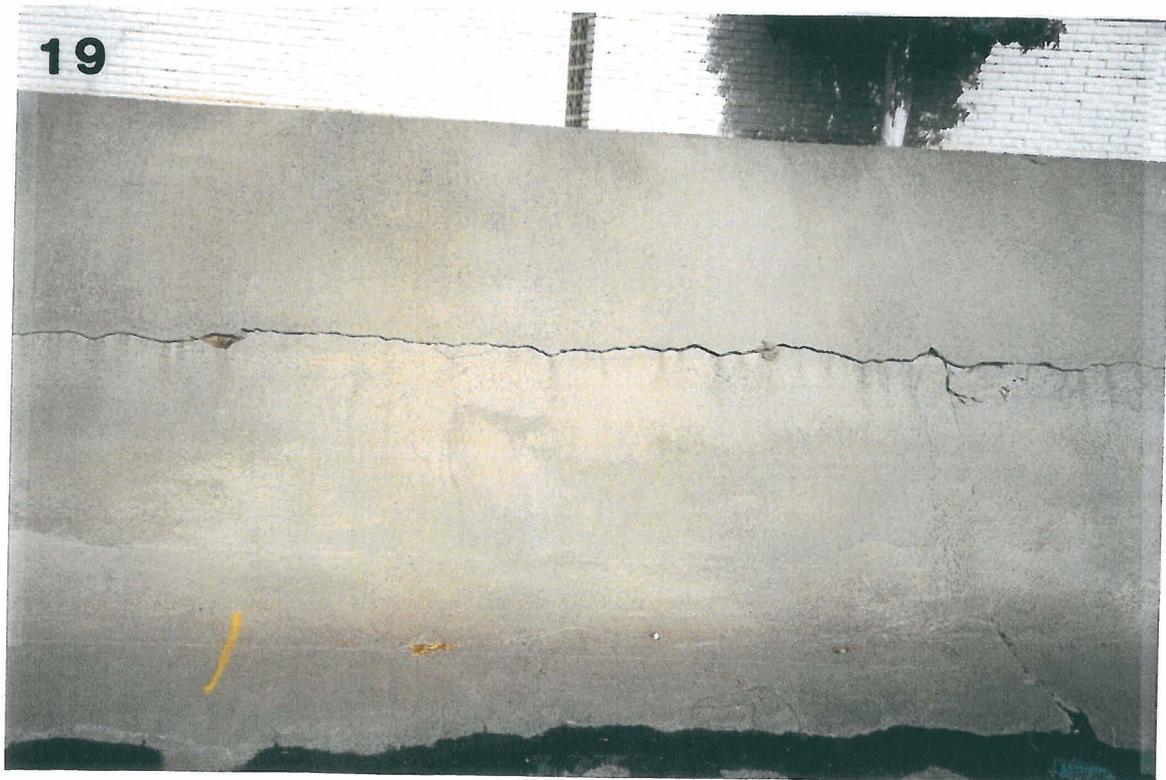
19

117+65 Crack 5-1/2' from bottom on north wall due to gunite overlay. This crack is major and appears in several places but is above the visible high water mark. See Photo #19.

The horizontal crack on the north slope of the channel appears to be the result of the top portion of gunite being placed after the original channel had been constructed. It is not known whether or not steel between the two segments has been tied together. This entire crack should be filled with epoxy in order to produce a rigid joint.

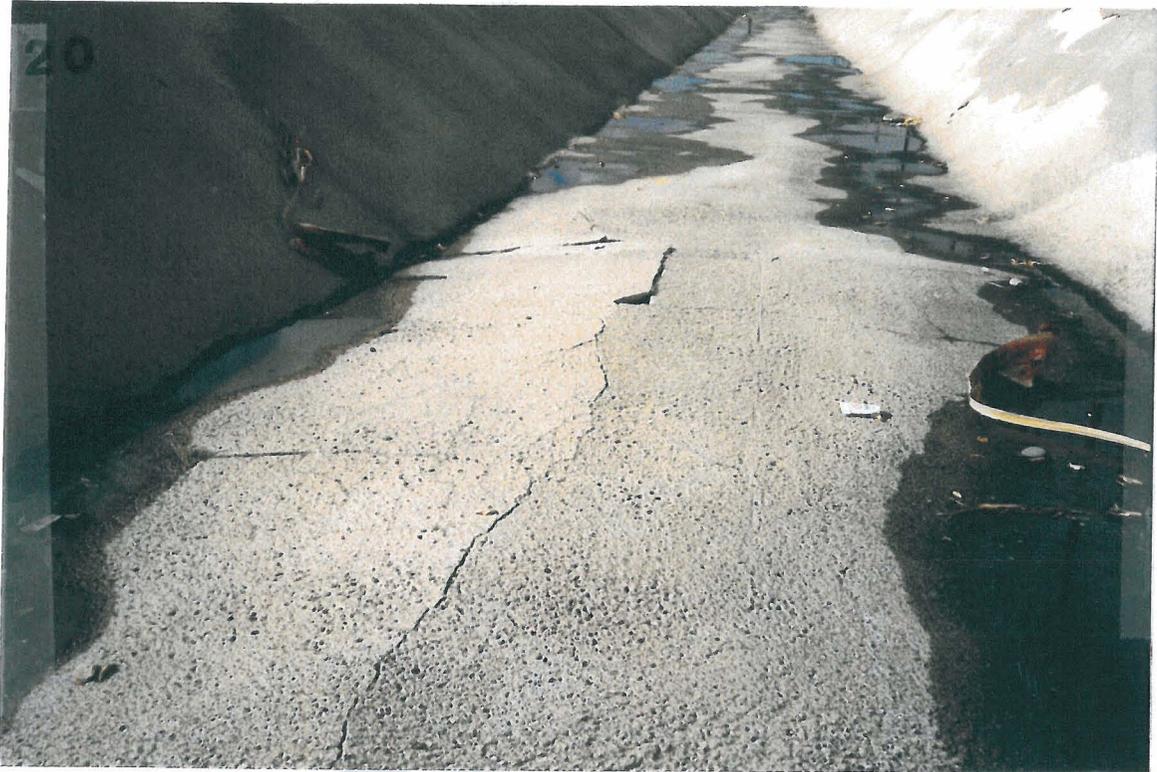
117+48 Blow out bottom. See Photo #20.

The remainder of the repairs should be completed as recommended for the rest of the Grand Avenue channel, including the blow-out areas on the channel bottom.

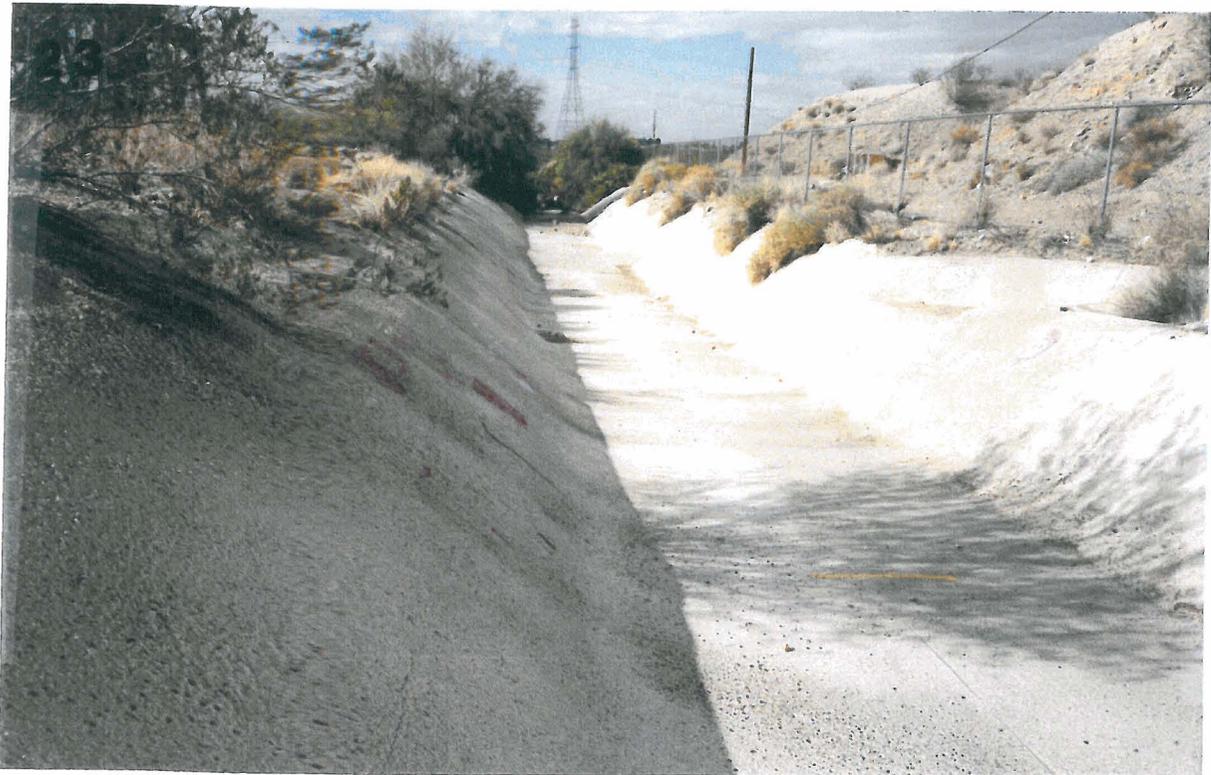
- 128+00 View of channel to west from west property line. See  
Photo #23.
- 128+86 End of gunite.

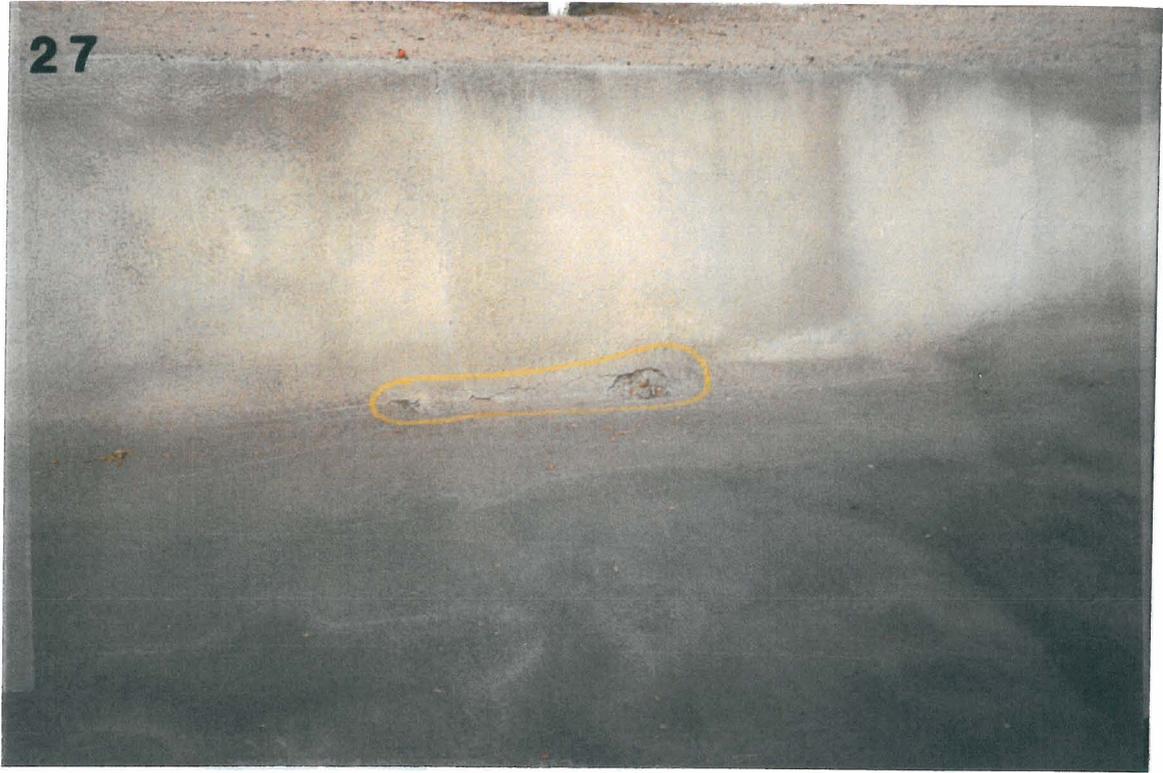
27

18+35 Excessive cracks and flaking along south wall. Typical hole with cracking. See Photo #27.

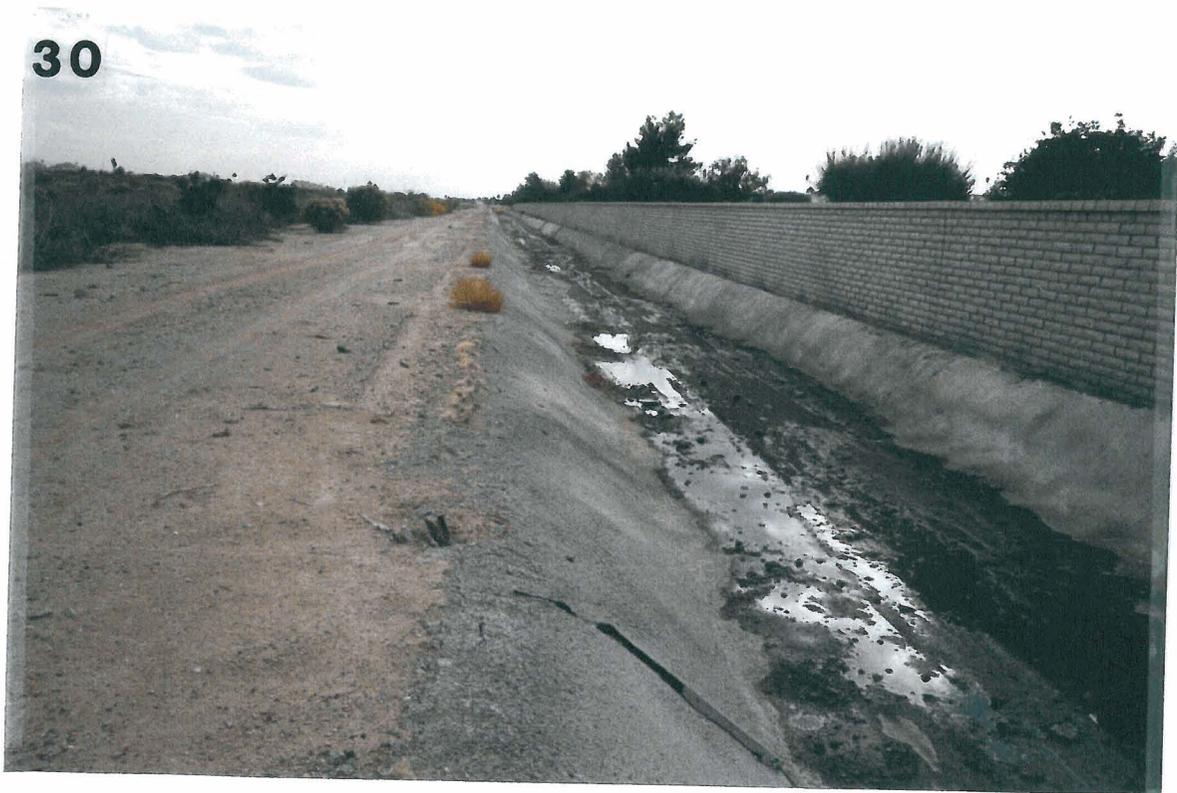
17+00 Typical condition of channel looking south.  
See Photo #30.

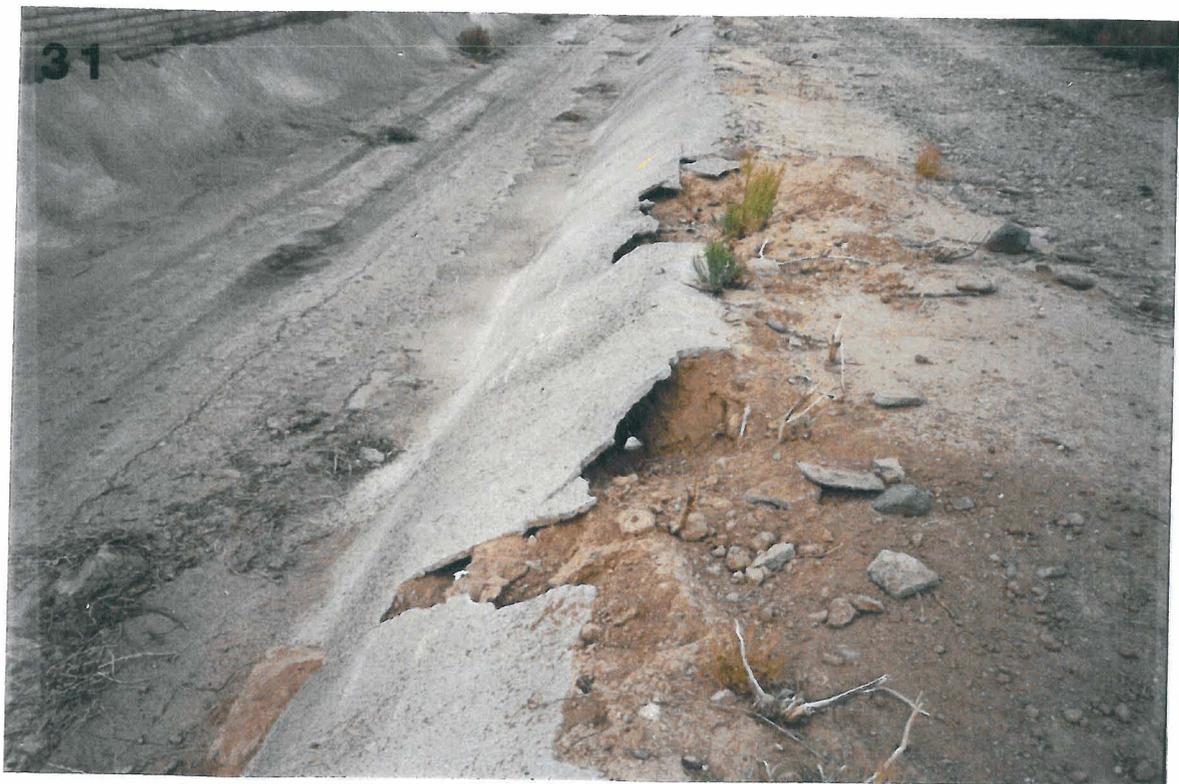
18+64 East wall broken and pieces missing 1' to 3 1/2' high.  
See Photo #31.

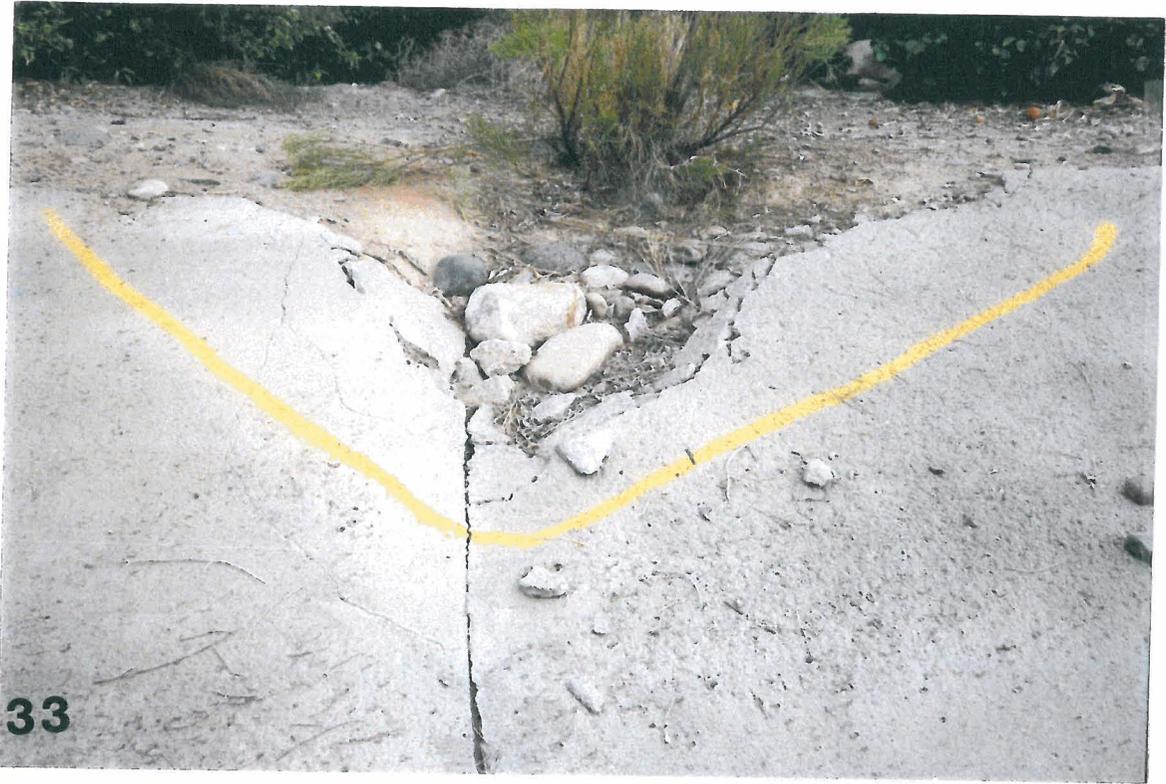
33+54 Broken place at top of east bank, 4'x7'. See Photo #33.

Note: Top of east bank edge broken from equipment  
travel along top of bank.
