Name of Dam: Sunset Flood Retarding-Az. Dam No. (7-49)

# PHASE I INSPECTION REPORT NATIONAL DAM SAFETY PROGRAM

Prepared by: Arizona Water Commission  
Supervision of Dam Safety  
Phoenix, Arizona

Date: January 1979

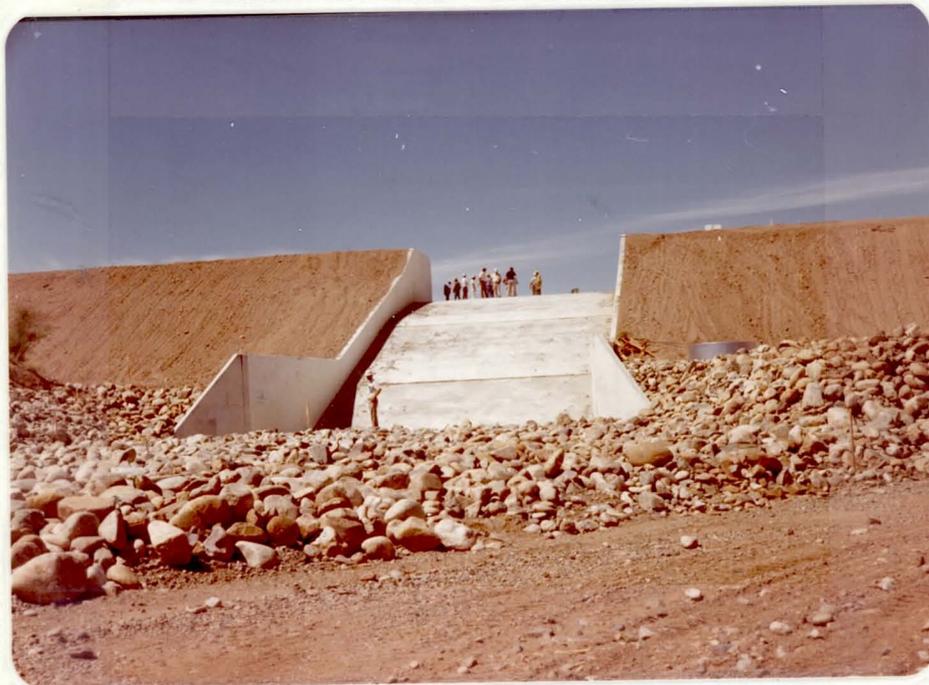
Photo 1 (September 8, 1976) - Downstream face of dam and emergency spillway.

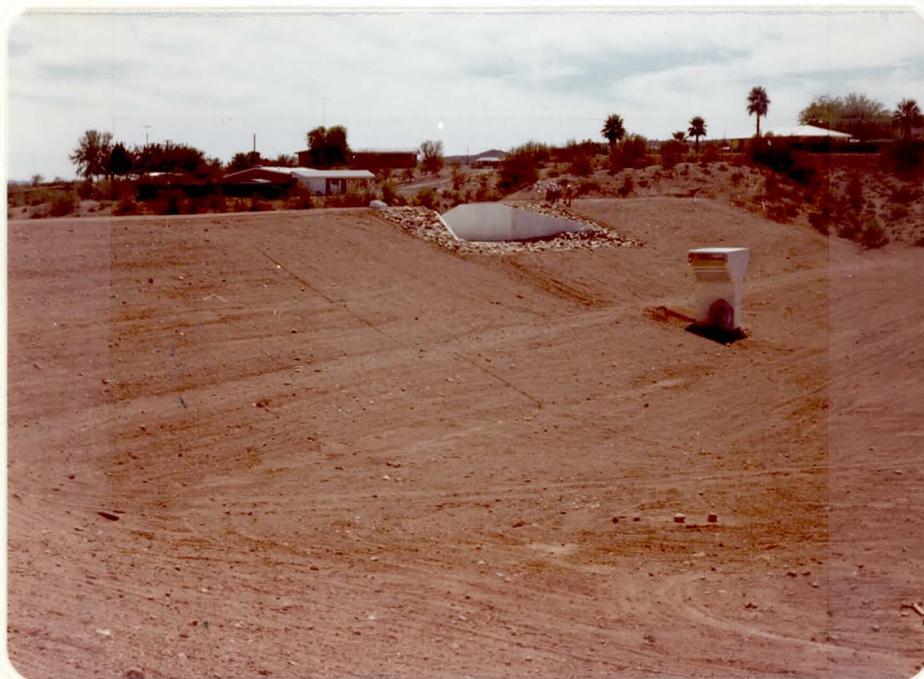
Photo 2 (September 8, 1976) - Upstream face of dam, spillway and intake for outlet structure.
