**PHASE I
ENVIRONMENTAL SITE ASSESSMENT**

**WEST OF TEGNER STREET
CASSANDRO WASH DAM PROJECT
PARCELS CWD-18 THROUGH CWD-21
WICKENBURG, ARIZONA**

January 21, 1994
WRA File AR390-2105

**SUBJECT: PHASE I ENVIRONMENTAL SITE ASSESSMENT, CASSANDRO WASH DAM
PROJECT, PARCELS CWD-18 THROUGH CWD-21, WICKENBURG, ARIZONA**

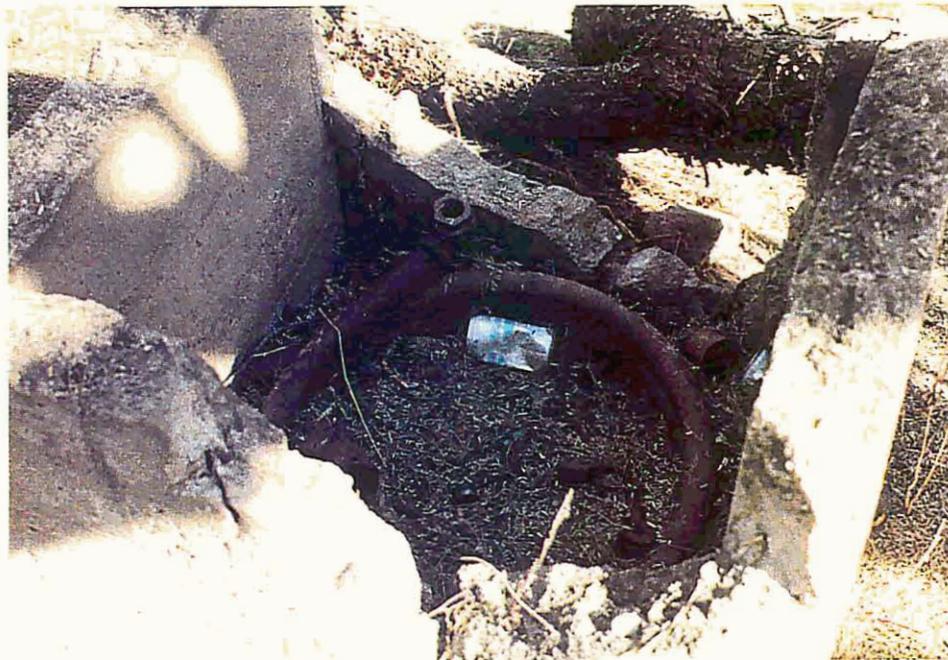
Photograph No. 3

A broken concrete vault was observed in a dense stand of mesquite trees near the northeast portion of the property. A coiled metal pipe was observed among leaves, debris and dirt in the bottom of the vault. The function of the vault is unknown. A sanitary sewer manhole was observed northeast of the vault near the barbed-wire fence.

View of concrete vault with coiled steel pipe near northeast corner of
"My Father's Retirement Ranch."

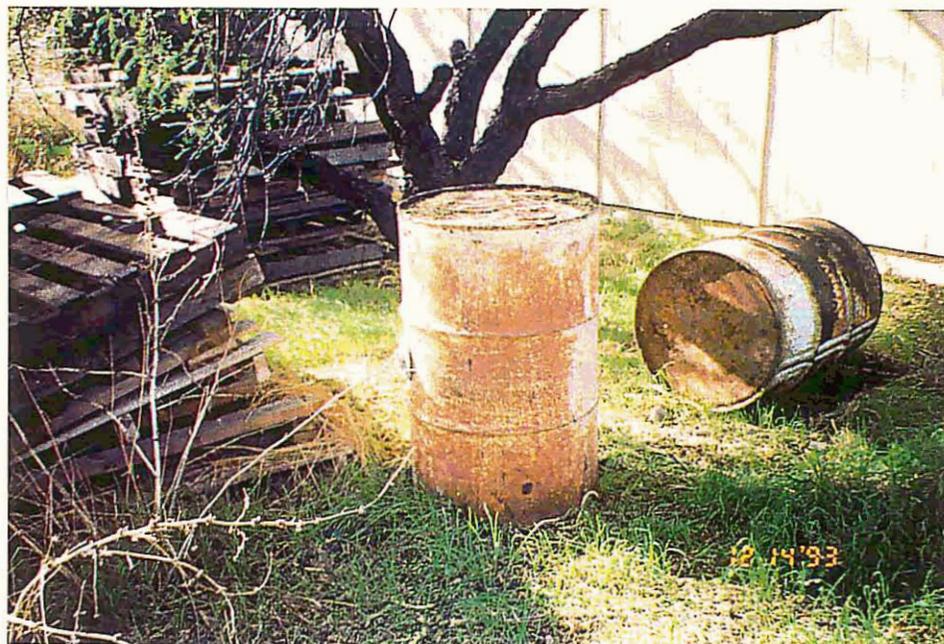
Photograph No. 4

View of 55-gallon drums on east side of garage at "My Father's Retirement Ranch."

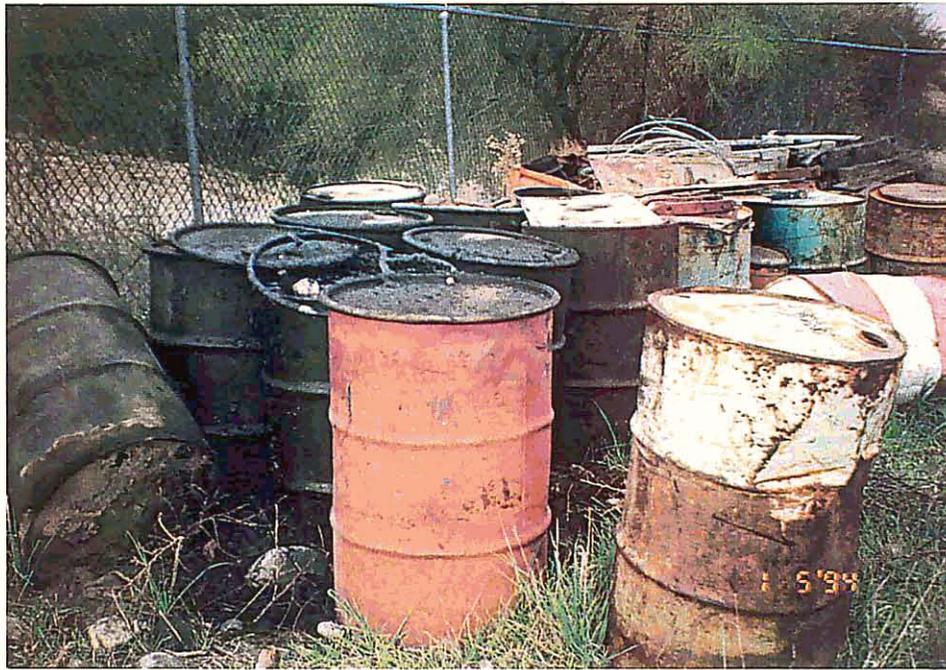
Photograph No. 7

Southwest of Parcel CWD-21, a cleared area located south of the tracks contained a storage area where the railroad stored a large amount of rails, scrap metal, and 55-gallon drums which contained metal rail nails and other small scrap metal. CEC/WRA personnel observed approximately thirteen 55-gallon drums, six of which contained what appeared to contain used oil on a triangular piece of land located south of the railroad tracks. One of the drums was tipped against a chain-link fence. The drums were in very poor condition and the ground under the drums was heavily stained.

View of 55-gallon drums and oily stained soil on south side of AT&SF Railroad tracks.

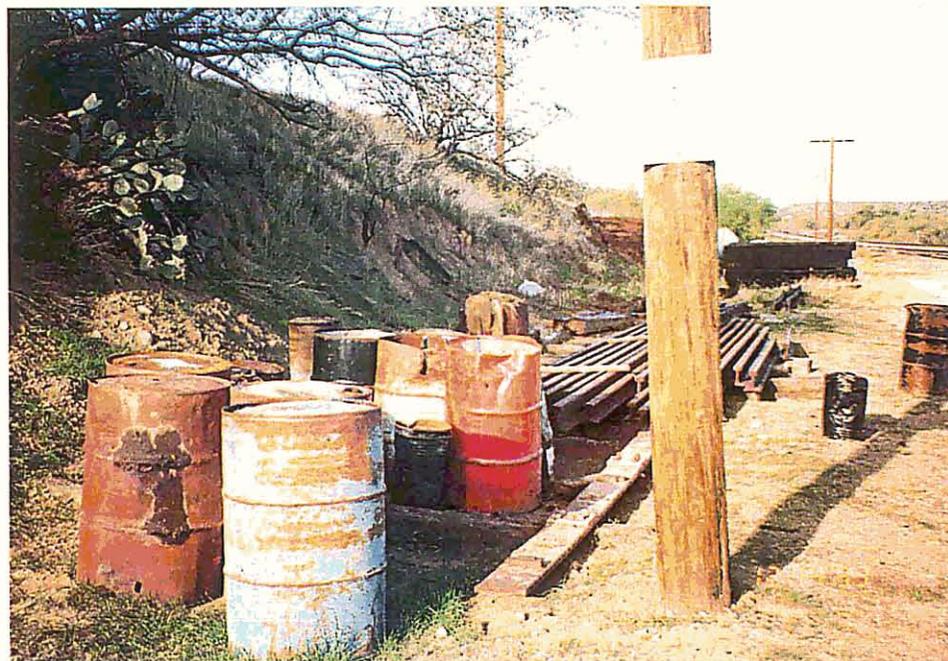
Photograph No. 8

View of 55-gallon drums and sections of track on south side of AT&SF Railroad.

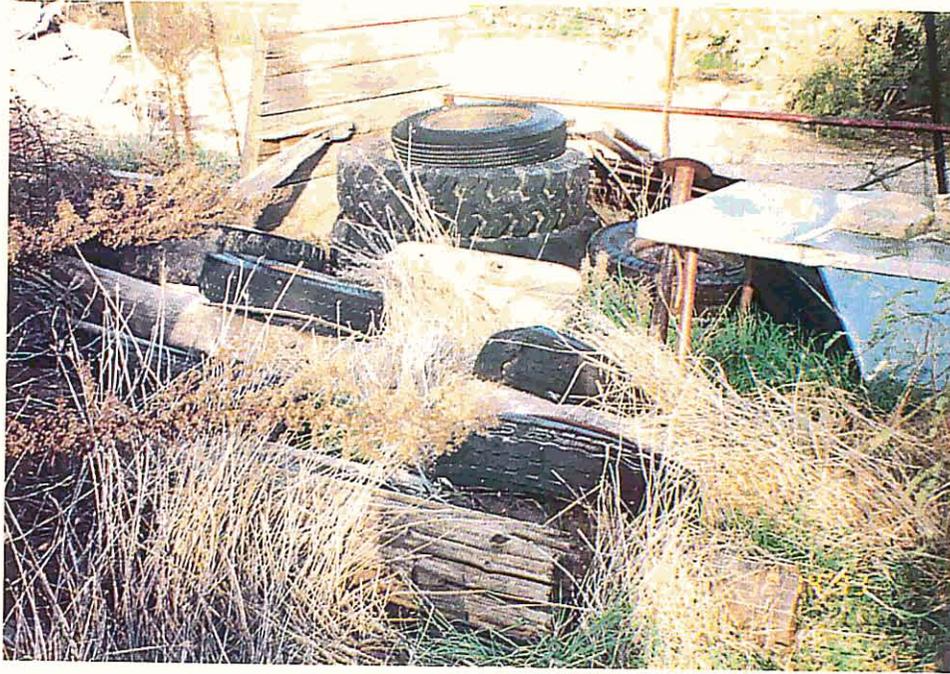
Photograph No. 9

Dumping. The area directly west of the APS equipment yard contains a large amount of dumped materials. Several 55-gallon drums were observed near the east edge of the property. The dumped materials include scrap metal, wood, tires, trailers, bathroom fixtures, 5-gallon cans, evaporative coolers, abandoned vehicles, and four rolls of suspect asbestos containing rolled vinyl material. The rolls of material were labelled "Garlock." A mound of dirt approximately 2.5 - 3 feet in height contains buried material. Chunks of asphalt, pvc pipe, and concrete material were visible on the top of the mound. An upended 5-gallon bucket was buried in the mound. CEC/WRA recommends that the debris be removed from this area if it will be impacted by the construction of the Cassandro Wash Drainage project. In addition, an exploratory trench should be dug to search for potential buried hazardous materials.

View of tires and debris west of APS yard looking in northerly direction.

A knowledgeable person should be located on the site to characterize the debris piles prior to disposal. Any stained soil or potentially hazardous materials observed during excavation should be sampled for hazardous constituents at that time. The household and other non-hazardous debris should be removed from the site and properly disposed of according to applicable local, county or state regulations.

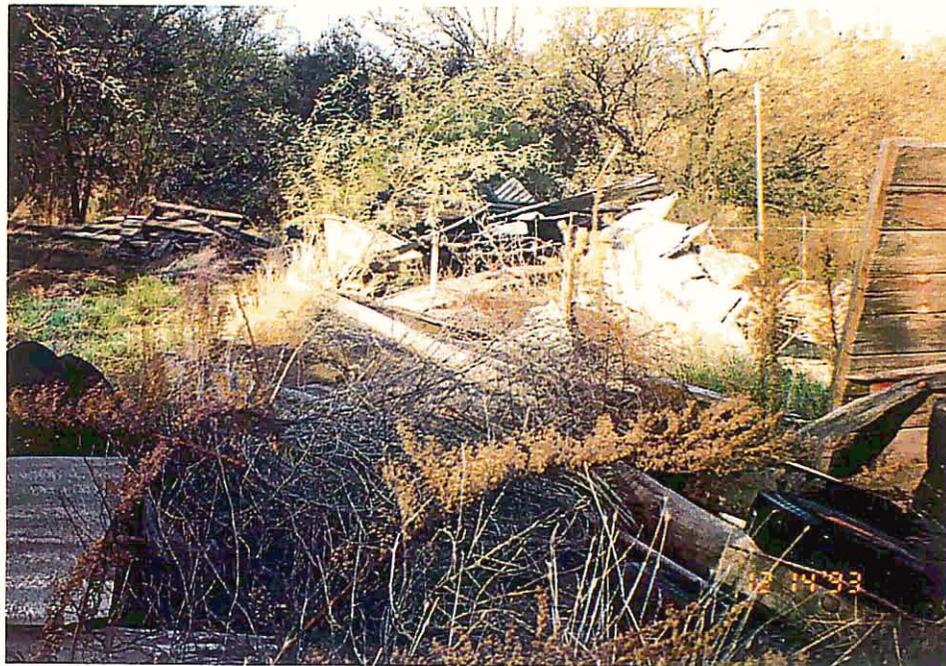
Photograph No. 10

View of debris west of APS yard looking in westerly direction.

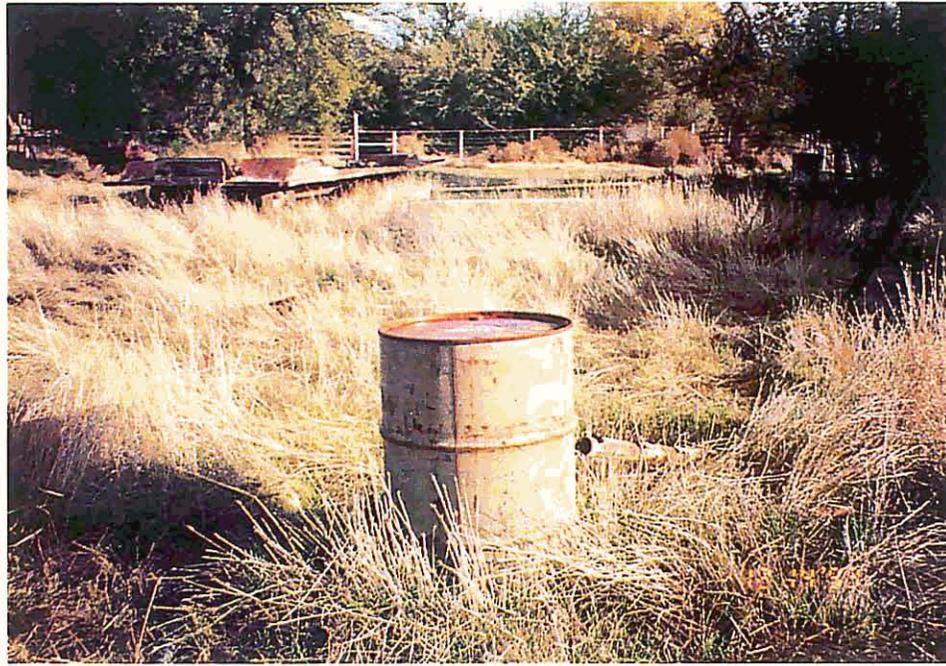
Photograph No. 11

View of 55-gallon drums and debris west of APS yard looking in northerly direction.

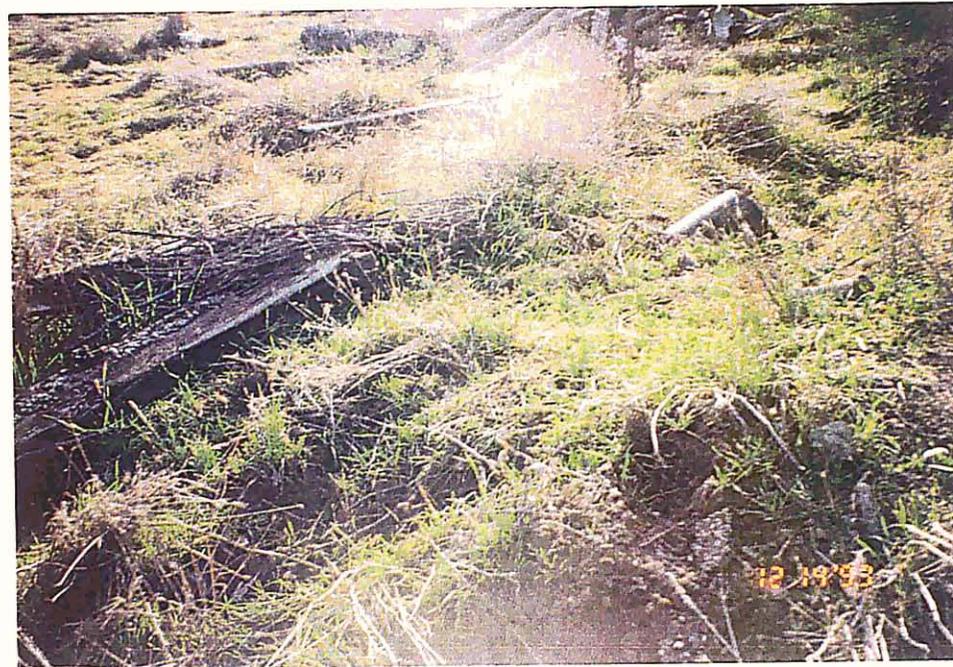
Photograph No. 12

South of the horse property is a gated vacant lot. A dirt road extends to the northwest parallel to the Atcheson, Topeka and Sante Fe Railroad which forms the southern boundary. The vacant lot is vegetated with grass and mesquite trees. Heavy dumping has occurred in this area. The dumped materials included 55-gallon drums, scrap metal, wood, tires, trailers, bathroom fixtures, 5-gallon cans, evaporative coolers, abandoned vehicles, and four rolls of suspect asbestos containing rolled vinyl material. The rolls of material were labelled "Garlock." A mound of dirt approximately 2.5 - 3 feet in height contains buried material. Chunks of asphalt, PVC pipe, and concrete material were visible on the top of the mound. An upended 5-gallon bucket was buried in the mound.

View of mounded dirt and buried debris in vacant lot west of APS yard looking southeast.

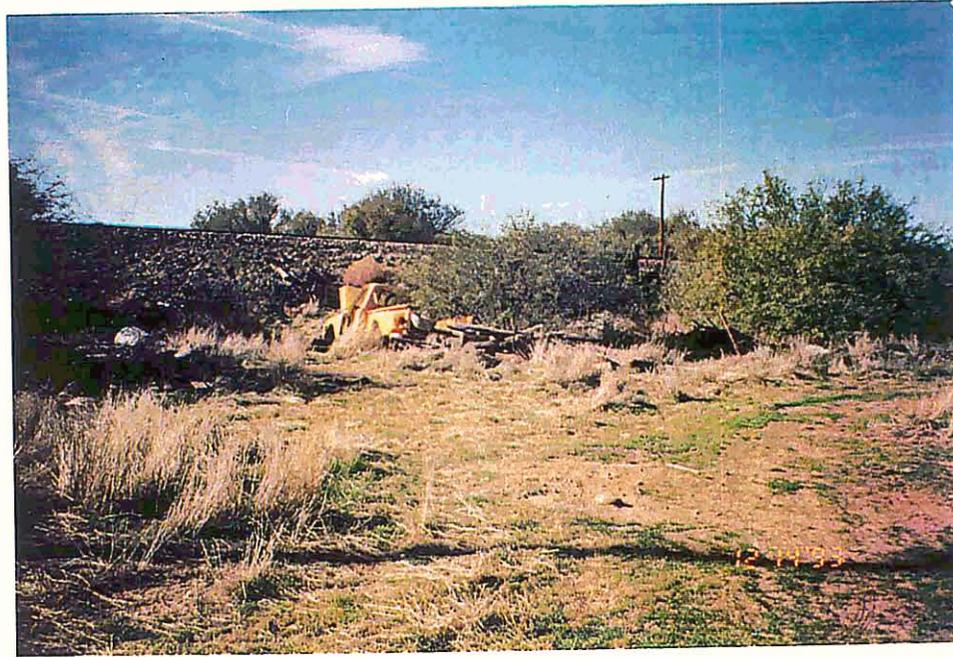
Photograph No. 13

View of debris in vacant lot west of APS yard. View is looking south.

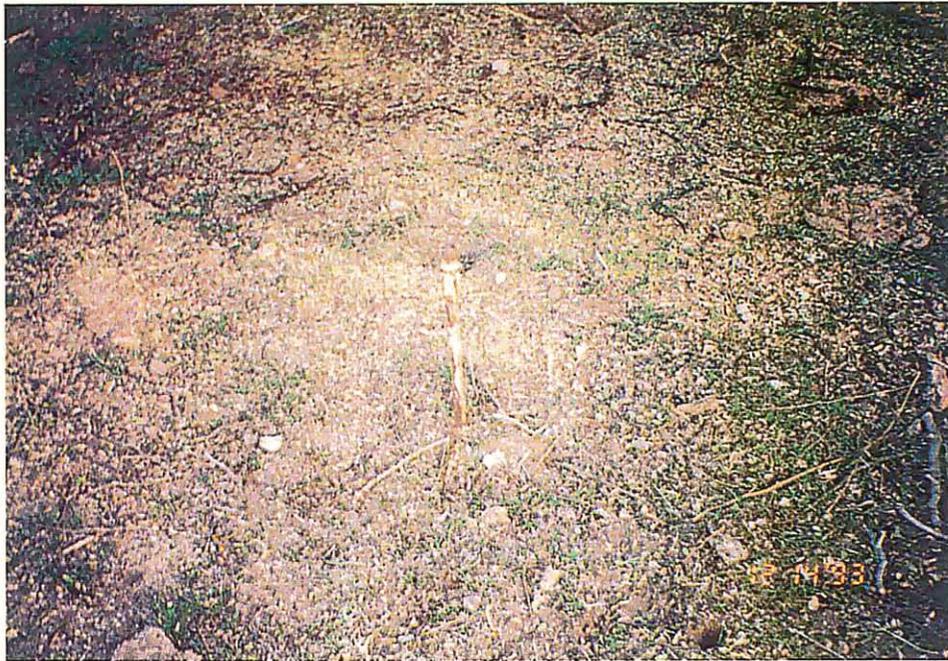
Photograph No. 17

An unidentified one-inch capped steel pipe was observed west of the Town of Wickenburg well site. Further investigation is needed to determine the nature of this pipe. If the unidentified pipe is a well, the well should be properly abandoned if the pipe is in the right-of-way for MCFCD's drainage system.

View of unidentified pipe protruding from ground west of Sols Wash well.

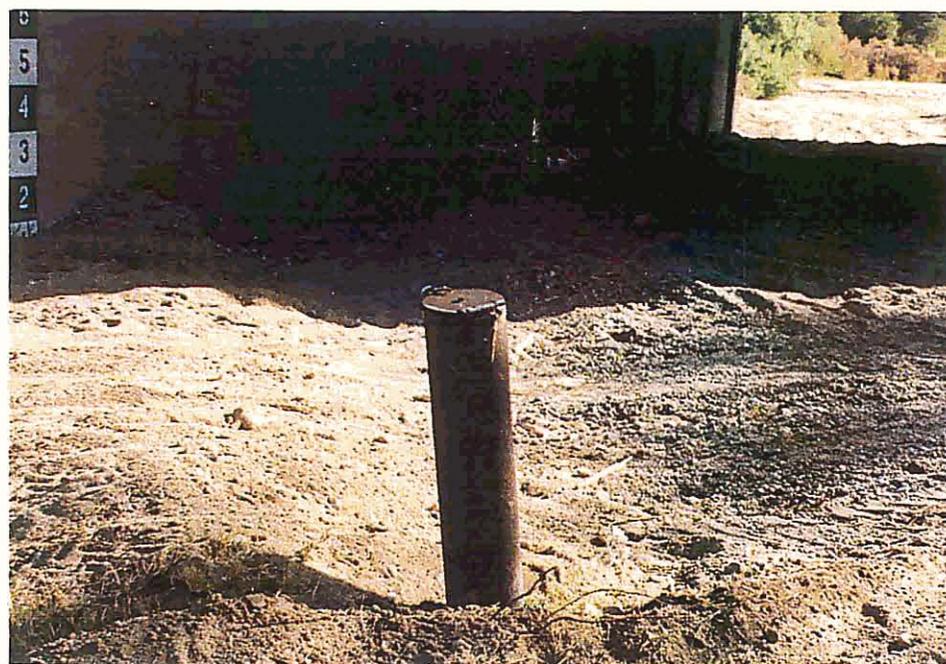
Photograph No. 22

Potential Wells. A well which does not appear to be registered with the Arizona Department of Water Resources is located adjacent to a dirt road near the southwest corner of the underpass at Tegner Street and Sols Wash. The well is capped but not securely locked and does not appear to be property abandoned. In addition, paint marks were observed on the steel casing that appear to be from being struck by a vehicle. Due to its location near the entrance to the Town of Wickenburg well, a barricade should be constructed around the well to prevent further damage to the casing.

View of well near confluence of Sols and Cassandro Washes.

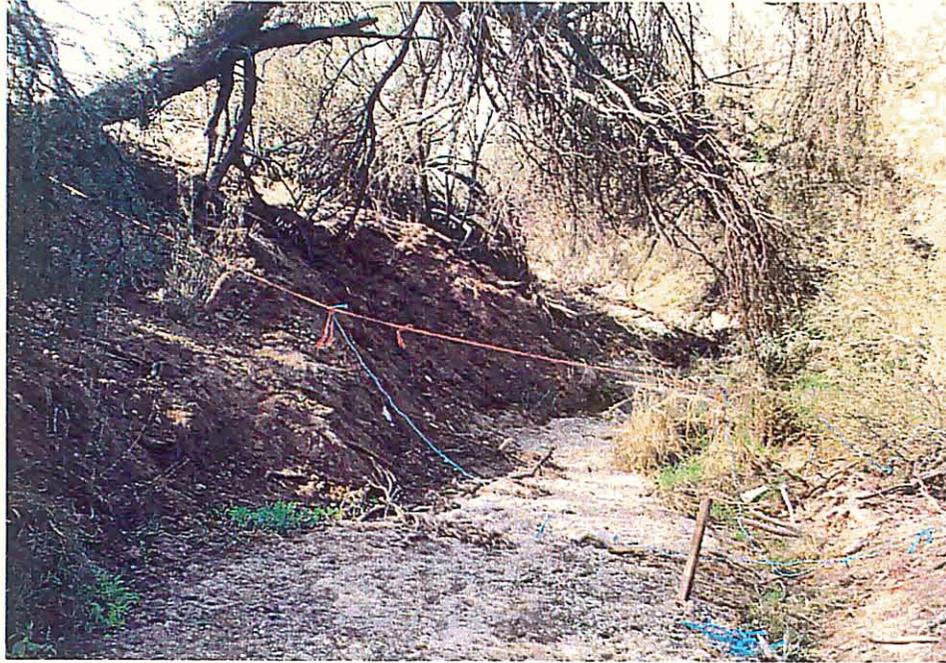
Photograph No. 23

Cassandro Wash flows onto this portion of the subject property from a underpass at Mohave Street and northeastward onto the north property. A manure pile was observed east of the corral area on the bank of Cassandro Wash near the confluence of Sols Wash.

View of manure pile on south bank of Cassandro Wash, looking in southwesterly direction.

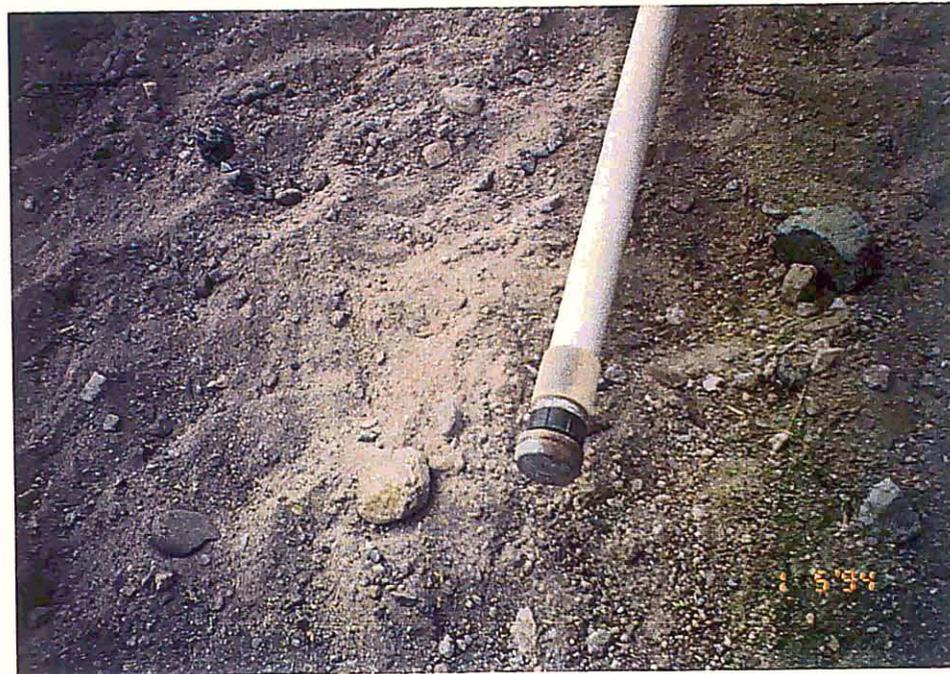
Photograph No. 24

tanks were observed in each horse pen. The overflow and clean-out for the gravity fed watering system appeared to flow to a drain pipe which discharged into Cassandro Wash. The end of the PVC pipe was plugged with a threaded cap.

View of discharge pipe in Cassandro Wash.
