**WITTMANN AREA DRAINAGE  
MASTER STUDY UPDATE  
SUN VALLEY PARKWAY  
CULVERT EVALUATION  
VOLUME SV  
CONTRACT FCD 2002C029**

**SUN VALLEY PARKWAY  
CULVERT EVALUATION**

**VOLUME SV**

**March 2005**

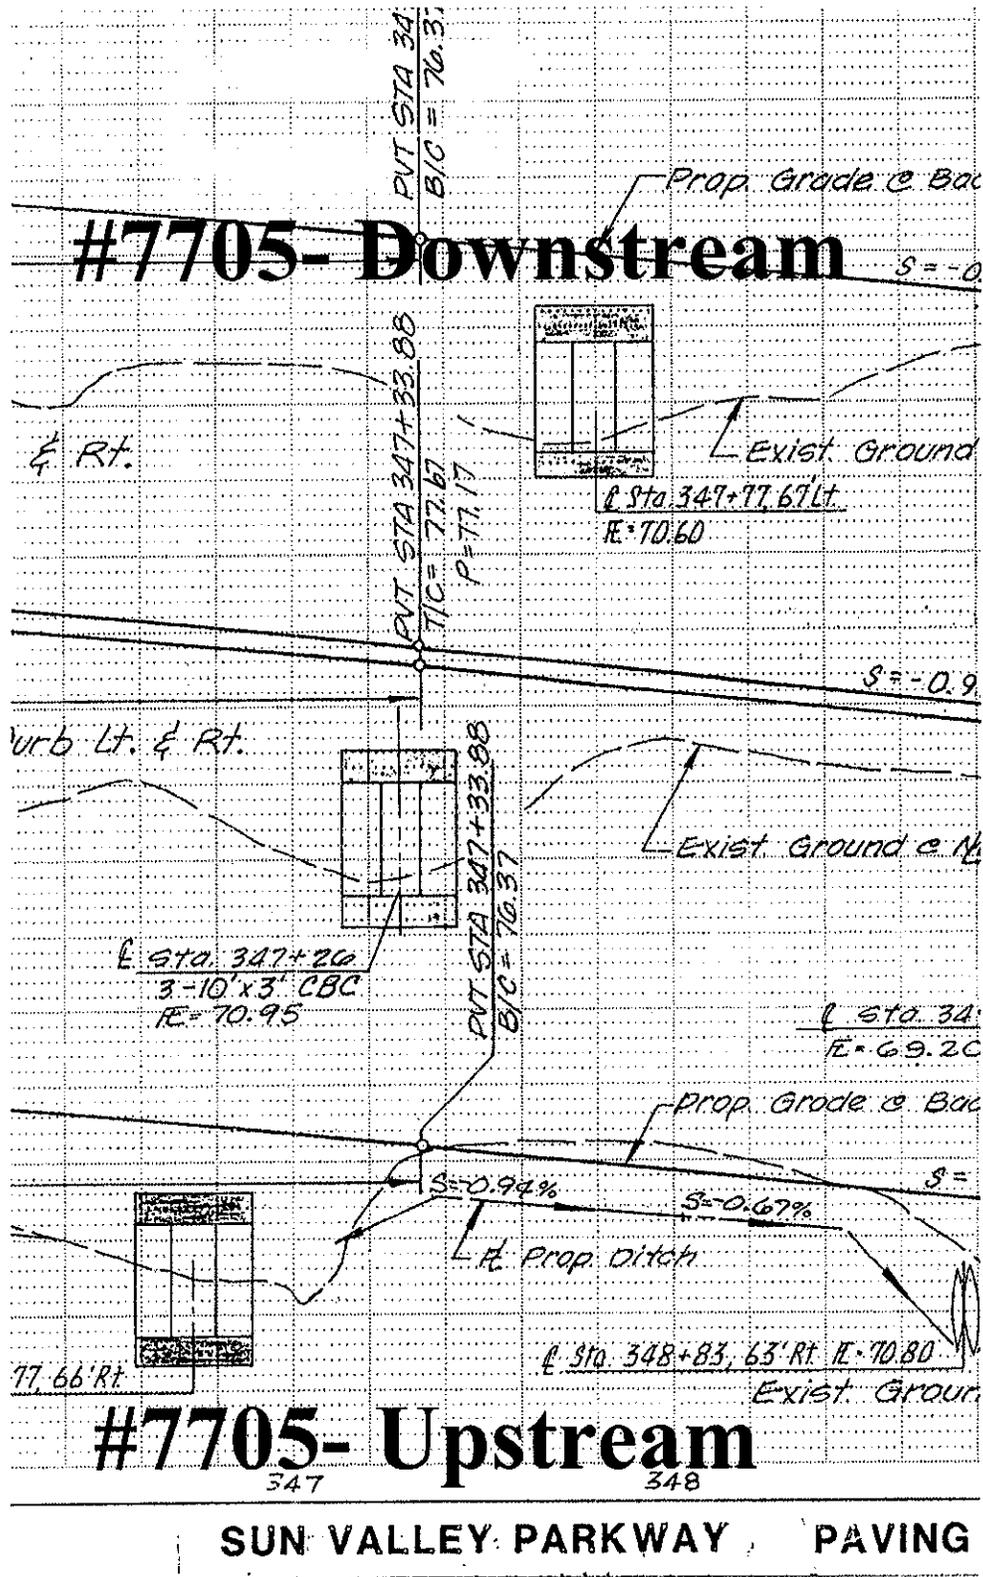
Figure SV-2.1

Severe sedimentation occurs in six (6) culverts along the Sun Valley Parkway, and some sedimentation occurred in 31 additional culverts. Culvert #7705 had the most severe sedimentation problem attributed to its proximity to the White Tank Mountains,

which provide the upstream watercourse with larger and more angular sediment. The downstream end of the culvert shows minor sediment accumulation, but the upstream end of the culvert for two of the three barrels is completely blocked. The remaining barrel is relatively sediment free. As shown in **Figure SV-2.1**, the upstream end of the culvert appears to have been designed below grade, while the downstream end was designed to be at grade. The wash seems to be reacting to this and attempting to re-stabilize its equilibrium slope, thus the heavy sediment at the upstream end, but minimal at the downstream end. This sediment tends to interlock and stabilize at a steeper grade than a less angular sediment load.

A possible solution for the general sedimentation problem might be to direct all low flows to only one of the barrels and make the other barrels available only for larger flows. Limiting the low flows to one barrel will increase the velocity through the culvert and decrease the potential for sediment deposition. This basically mimics the current balance condition for low flows (sediment obstructing unused barrels), but maintains the other barrels free of sediment and available to convey larger flows. To accomplish this, a berm could be constructed that would force all flow below a specified elevation to a single barrel. Once that elevation was exceeded, flow would overtop the berm and flow into the other barrel(s).

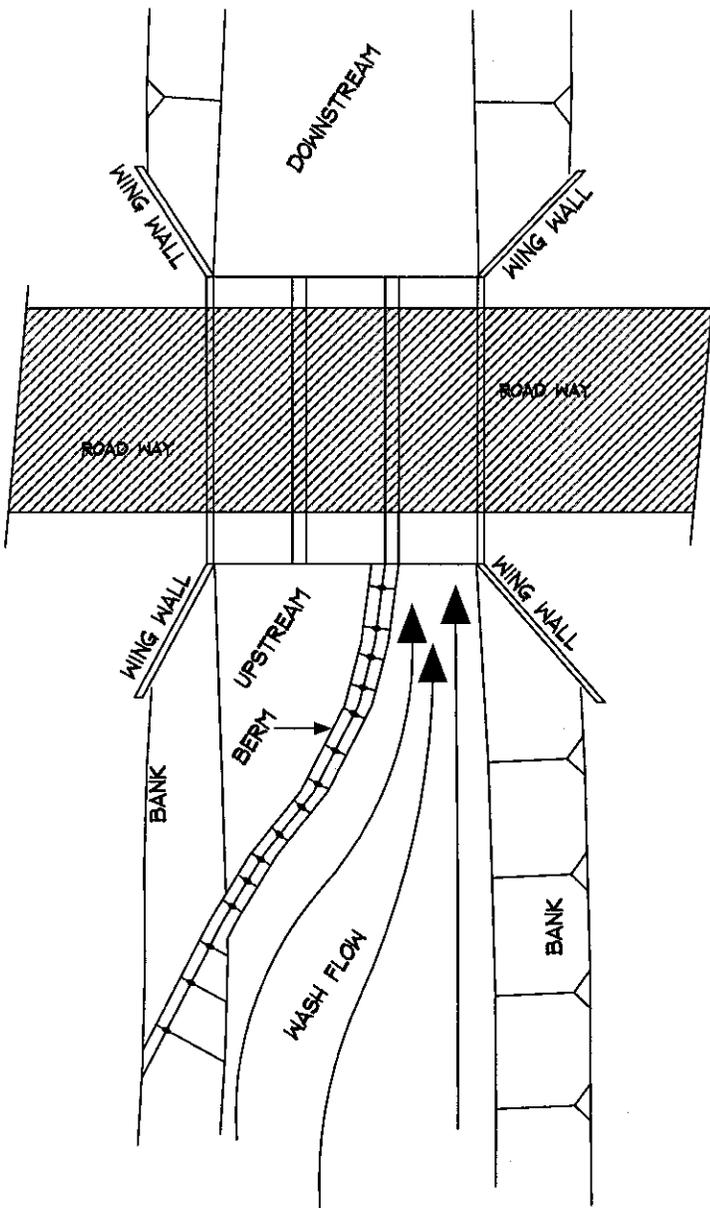
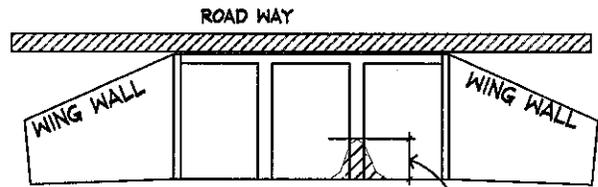
FIGURE SV-2.2  
UPSTREAM SEDIMENTATION FIX

BERM HEIGHT APPROX. 1/3 OF TOTAL CULVERT HGT. CONSTRUCTED OF GROUTED RIPRAP.

Some sedimentation would build up over time in the high flow barrels due to more significant flows that would overtopped the berm; however, most of the larger particles are carried along the bottom of the wash and are less likely to be carried by flow over the berm. Once a larger flow occurs, the smaller grain size deposits would be flushed by the flow. A typical configuration, with relative dimensions, can be seen in **Figure SV-2.2**. Possible

structures that this remedy might be applied to are those with a rating category of 'C' or 'D', specifically Cculverts 7646, 7647, 7649, 7650, 7663, 7705, and any others that might exhibit severe sedimentation problems in the future.

The recommended remediation for culverts experiencing severe sedimentation problems is the construction of a small berm to direct low flows into one barrel of multiple-barrel culverts (**Figure SV-2.2**).

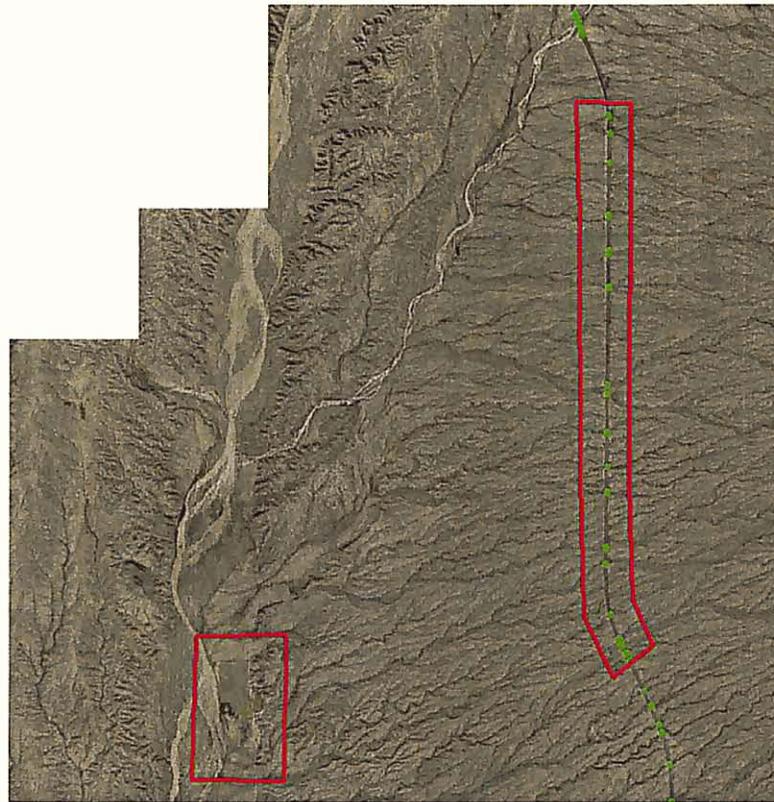
Figure SV-2.3A

Downstream headcutting appears to start at some point downstream and work its way upstream until it is stopped by an immovable object such as the riprap at the downstream end of a culvert. There appears to be a very distinct group of culverts with severe headcutting affecting all 24 structures between Structure 7664 and 7675, which is just south of Wagner Wash. Upon review of the 2003 color aerial photography, there appears to be a man-made operation occurring at the edge of the Hassayampa River at the downstream-most portion of the affected culverts. This operation might be adversely affecting the headcutting conditions of the culverts in question. The locations of affected culverts, as well as the man-made operation, are enclosed in red in **Figure SV-2.3A**, and a zoomed aerial view of the man-made operation is shown in Figure SV-2.3B.

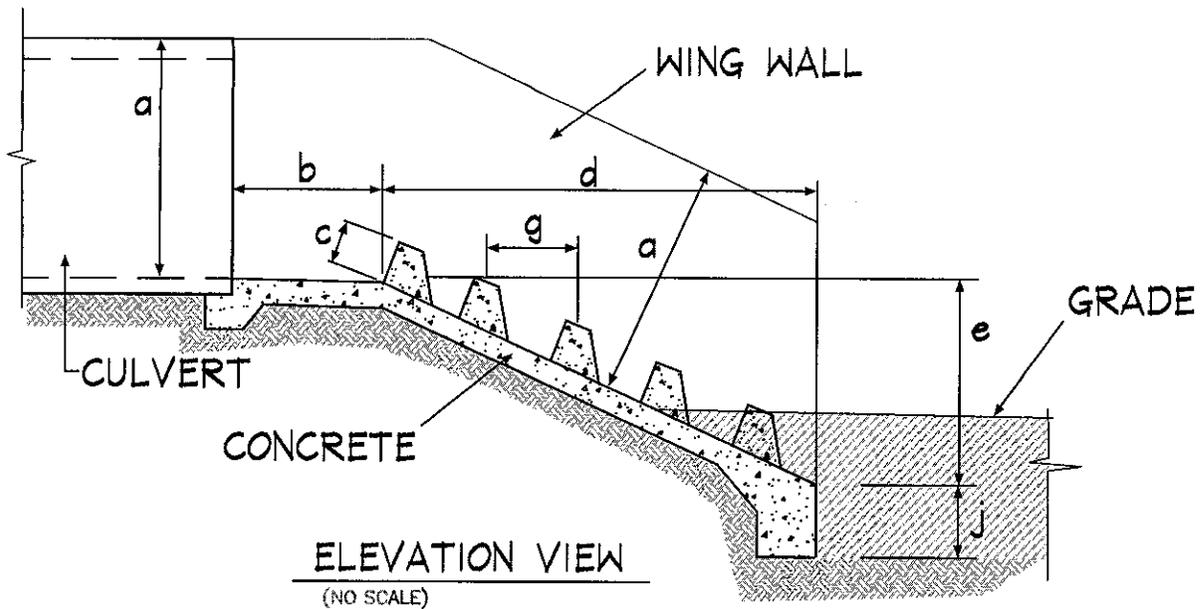
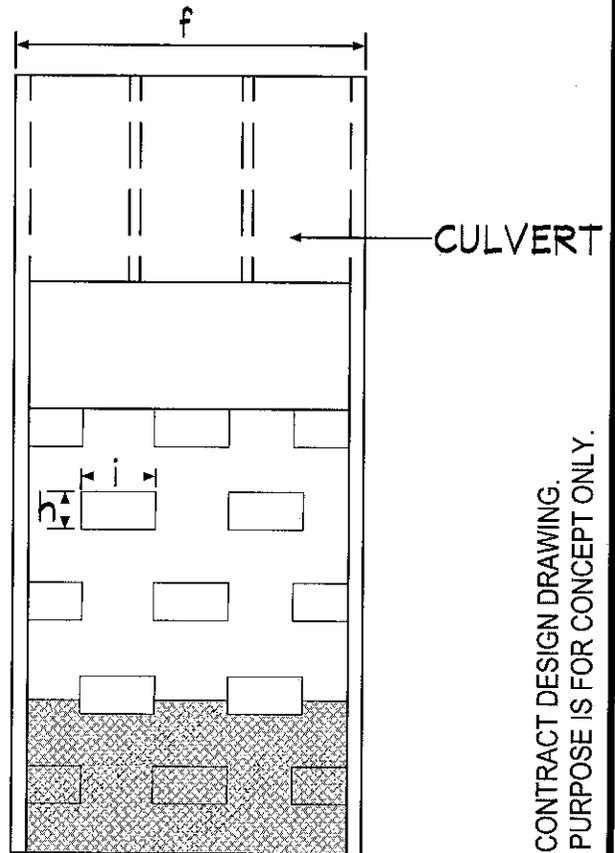
FIGURE SV-2.4  
BAFFLE OUTLET

- $3' < a < 8'$
- $a < b < 3a$
- $.25a < c < a$
- $6c < d < 30c$
- $6' < e < 15'$
- $10' < f < 100'$  (Width of Culvert)
- $c < g < 3c$
- $6'' < h < 12''$
- $1' < i < 3'$
- $2' < j < 4'$

The first is recommended in general for culverts where the downstream headcut is greater than four (4) feet. There are five

structures that currently fall into this category: 7667, 7668, 7673, 990148, and 990149.

For headcutting of four (4) feet or less, the gabion basket is recommended as shown in **Figure SV-2.5**. For headcutting greater than four (4) feet, the baffle outlet as shown in **Figure SV-2.4** is recommended.

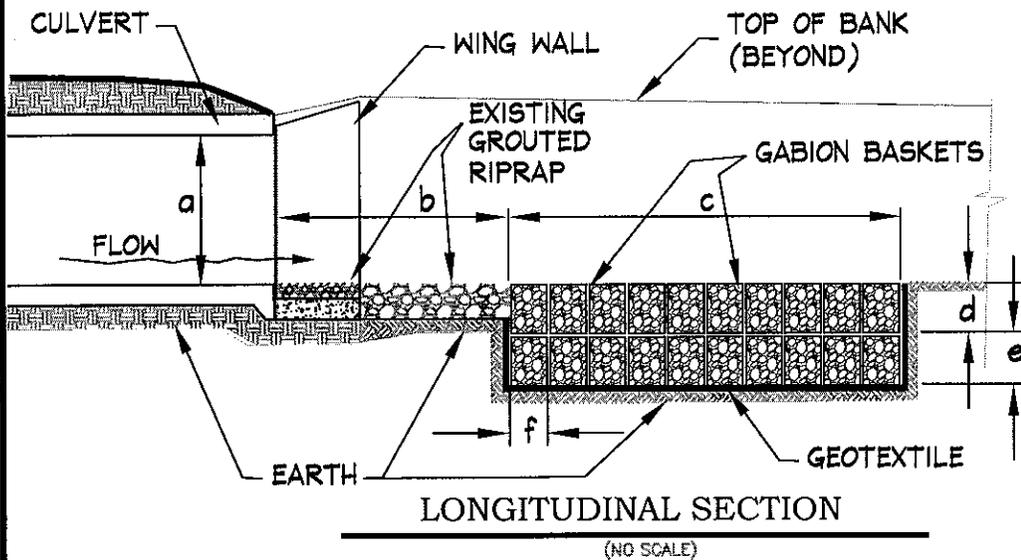
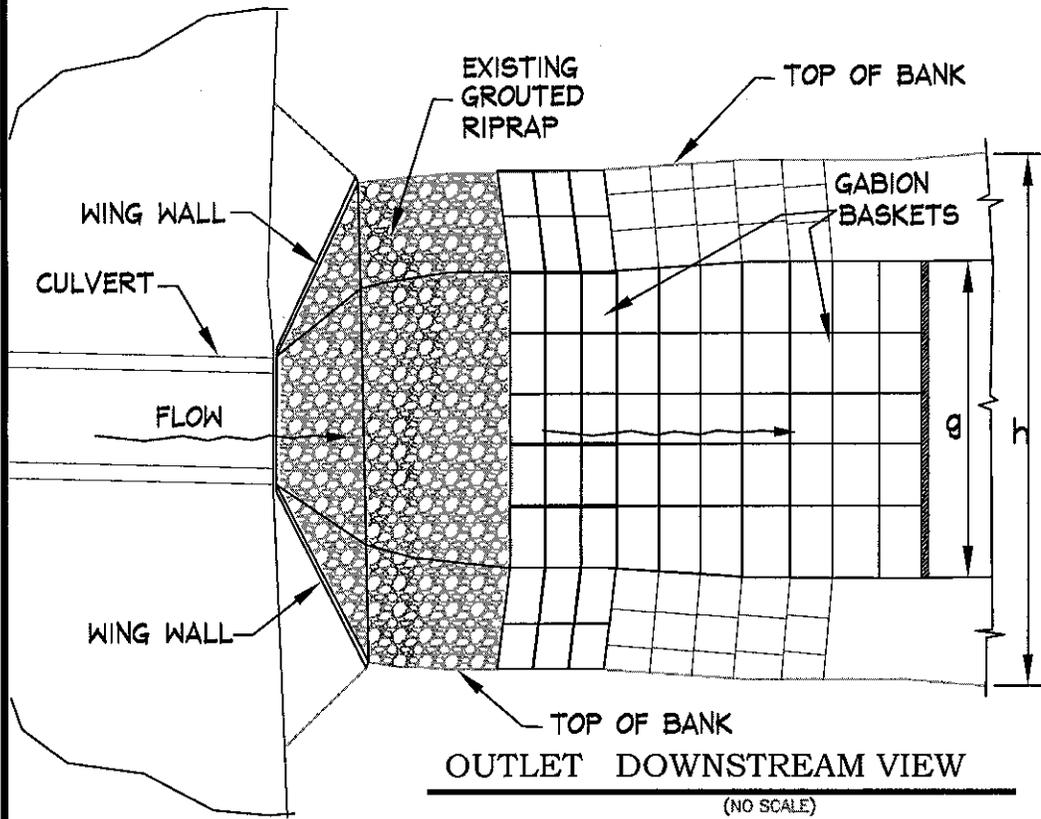
FIGURE SV-2.5  
GABION BASKETS

- $3' < a < 8'$
- $5' < b < 100'$
- $3' < c < 18'$
- $1' < d < 3'$
- $1' < e < 3'$
- $1.5' < f < 6'$
- $9' < g < 120'$
- $18' < h < 400'$

The second recommendation is for culverts where the downstream headcut is four feet or less. There are 18 structures that currently fall into this category: 39A, 7647, 7654, 7656, 7664, 7665, 7666, 7669, 7670, 7671, 7674, 7675, 7676, 7677, 7685, 990140, 990141, and 990189.

An exception to the less than four feet of headcut is Structure #7685. There was greater than six feet of headcut in the downstream portion of the channel, but because of the amount of grouted riprap that is already in place, a gabion basket was recommended.

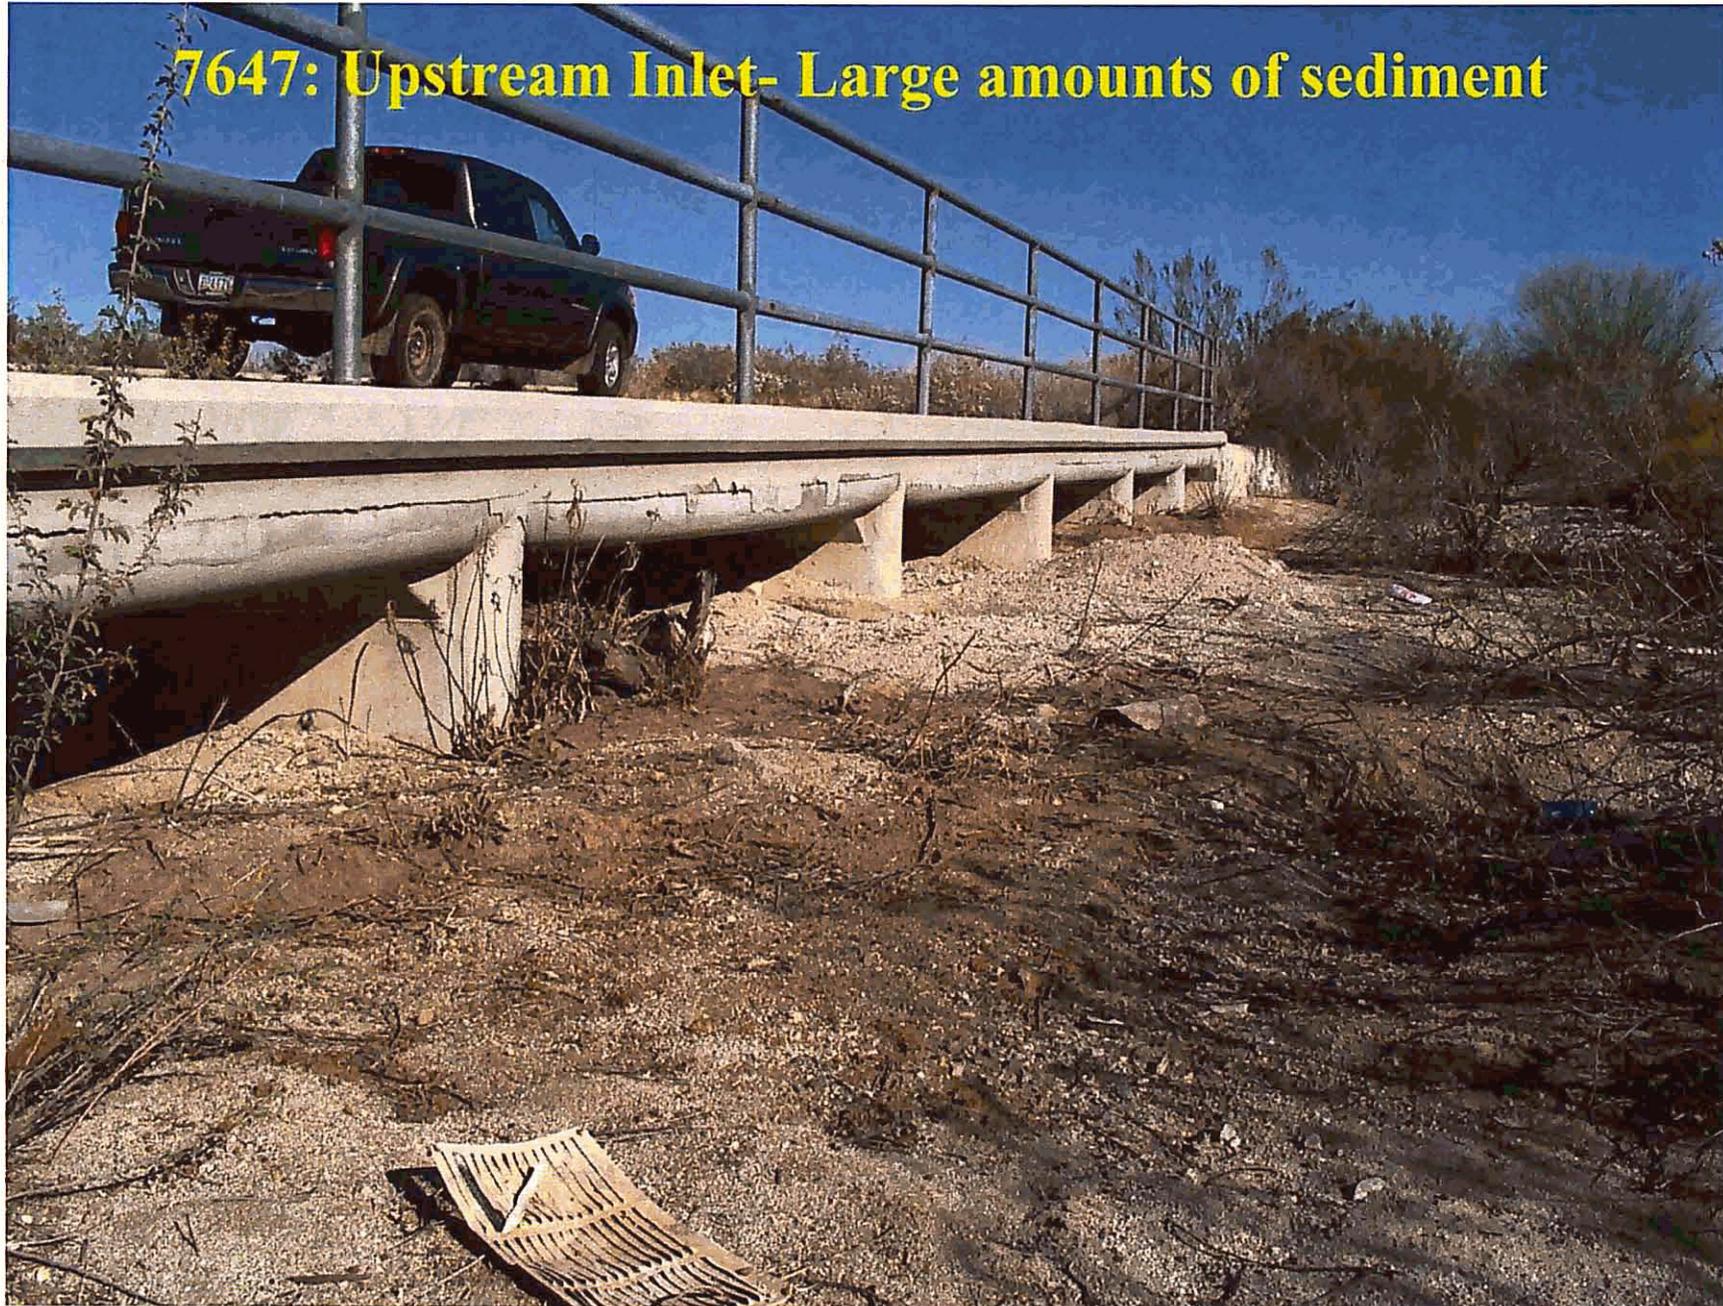
7647: Upstream Inlet- Large amounts of sediment

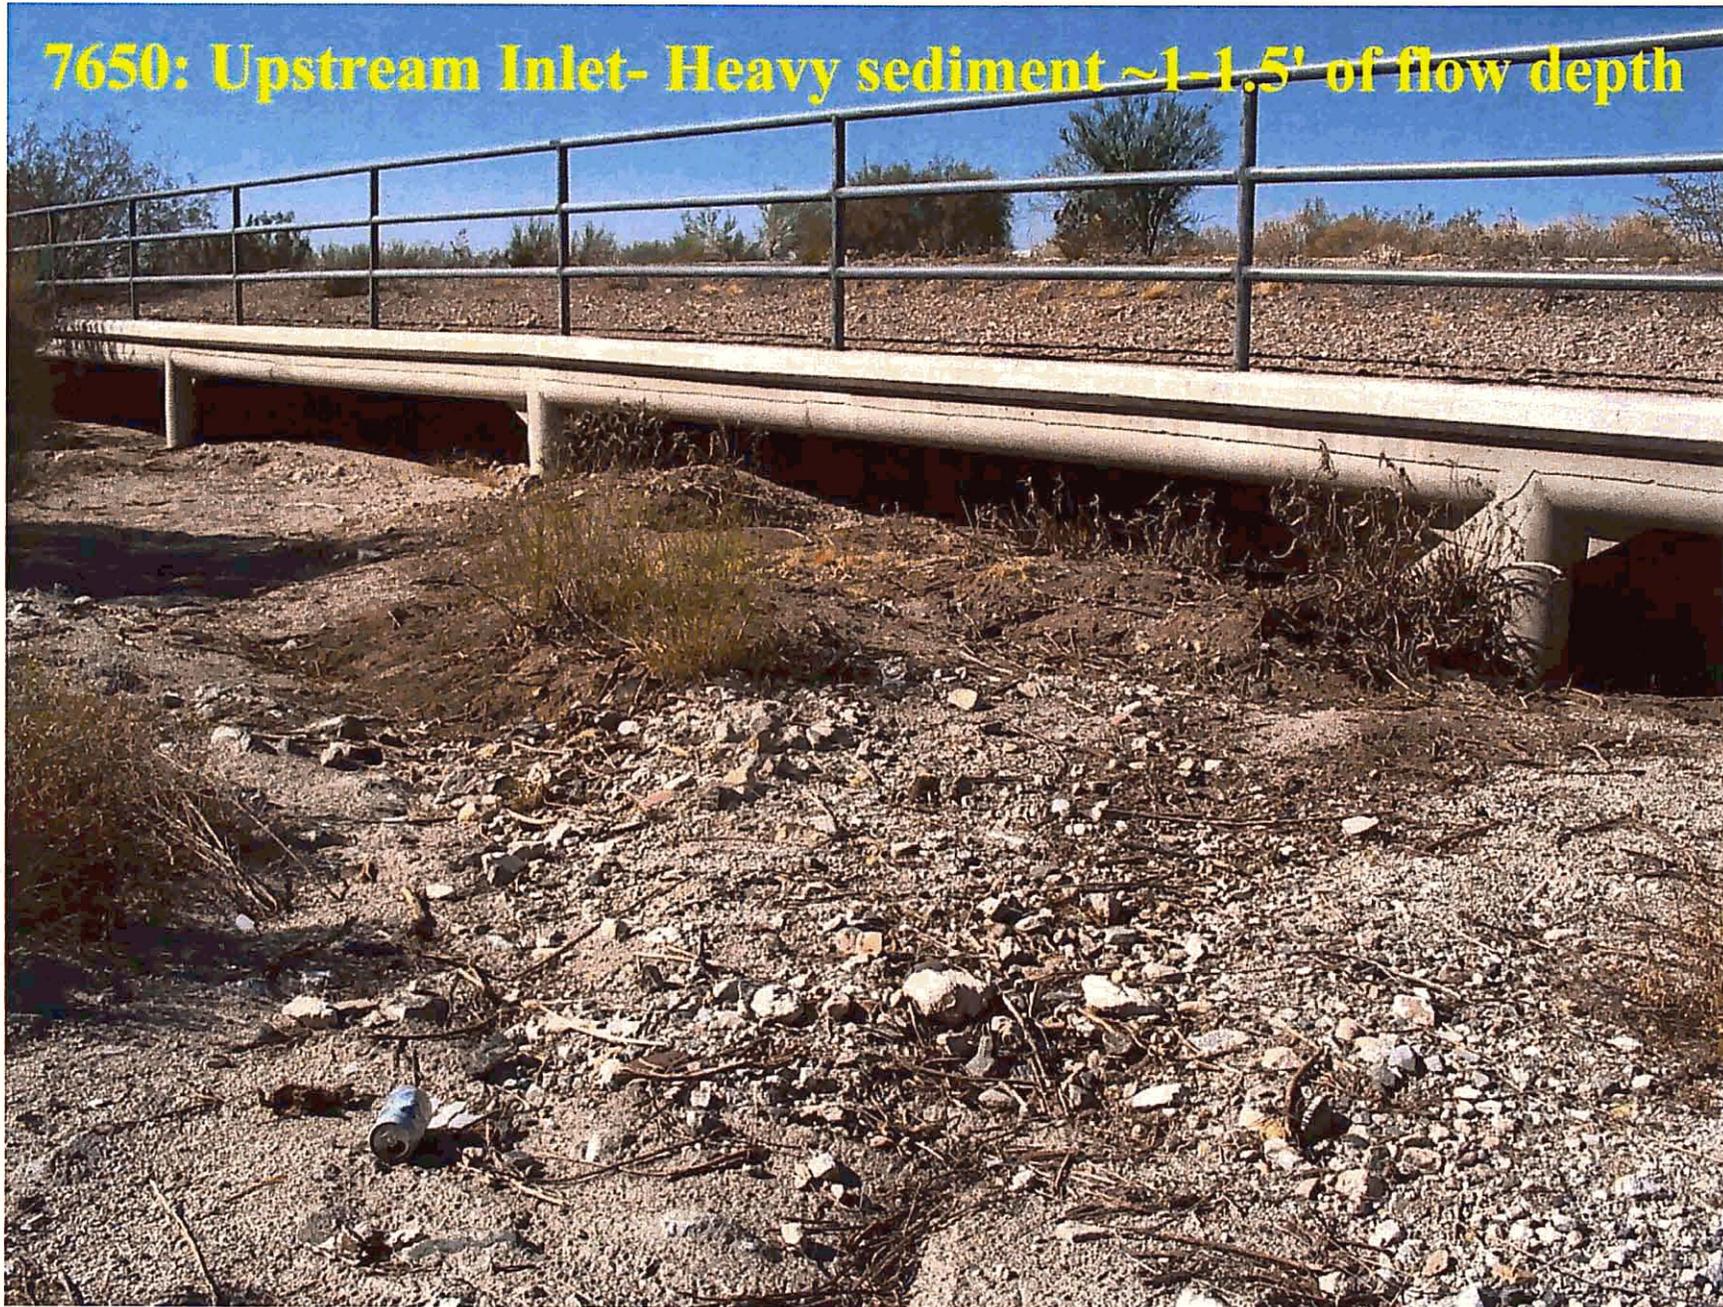
**7650: Upstream Inlet- Heavy sediment ~1-1.5' of flow depth**

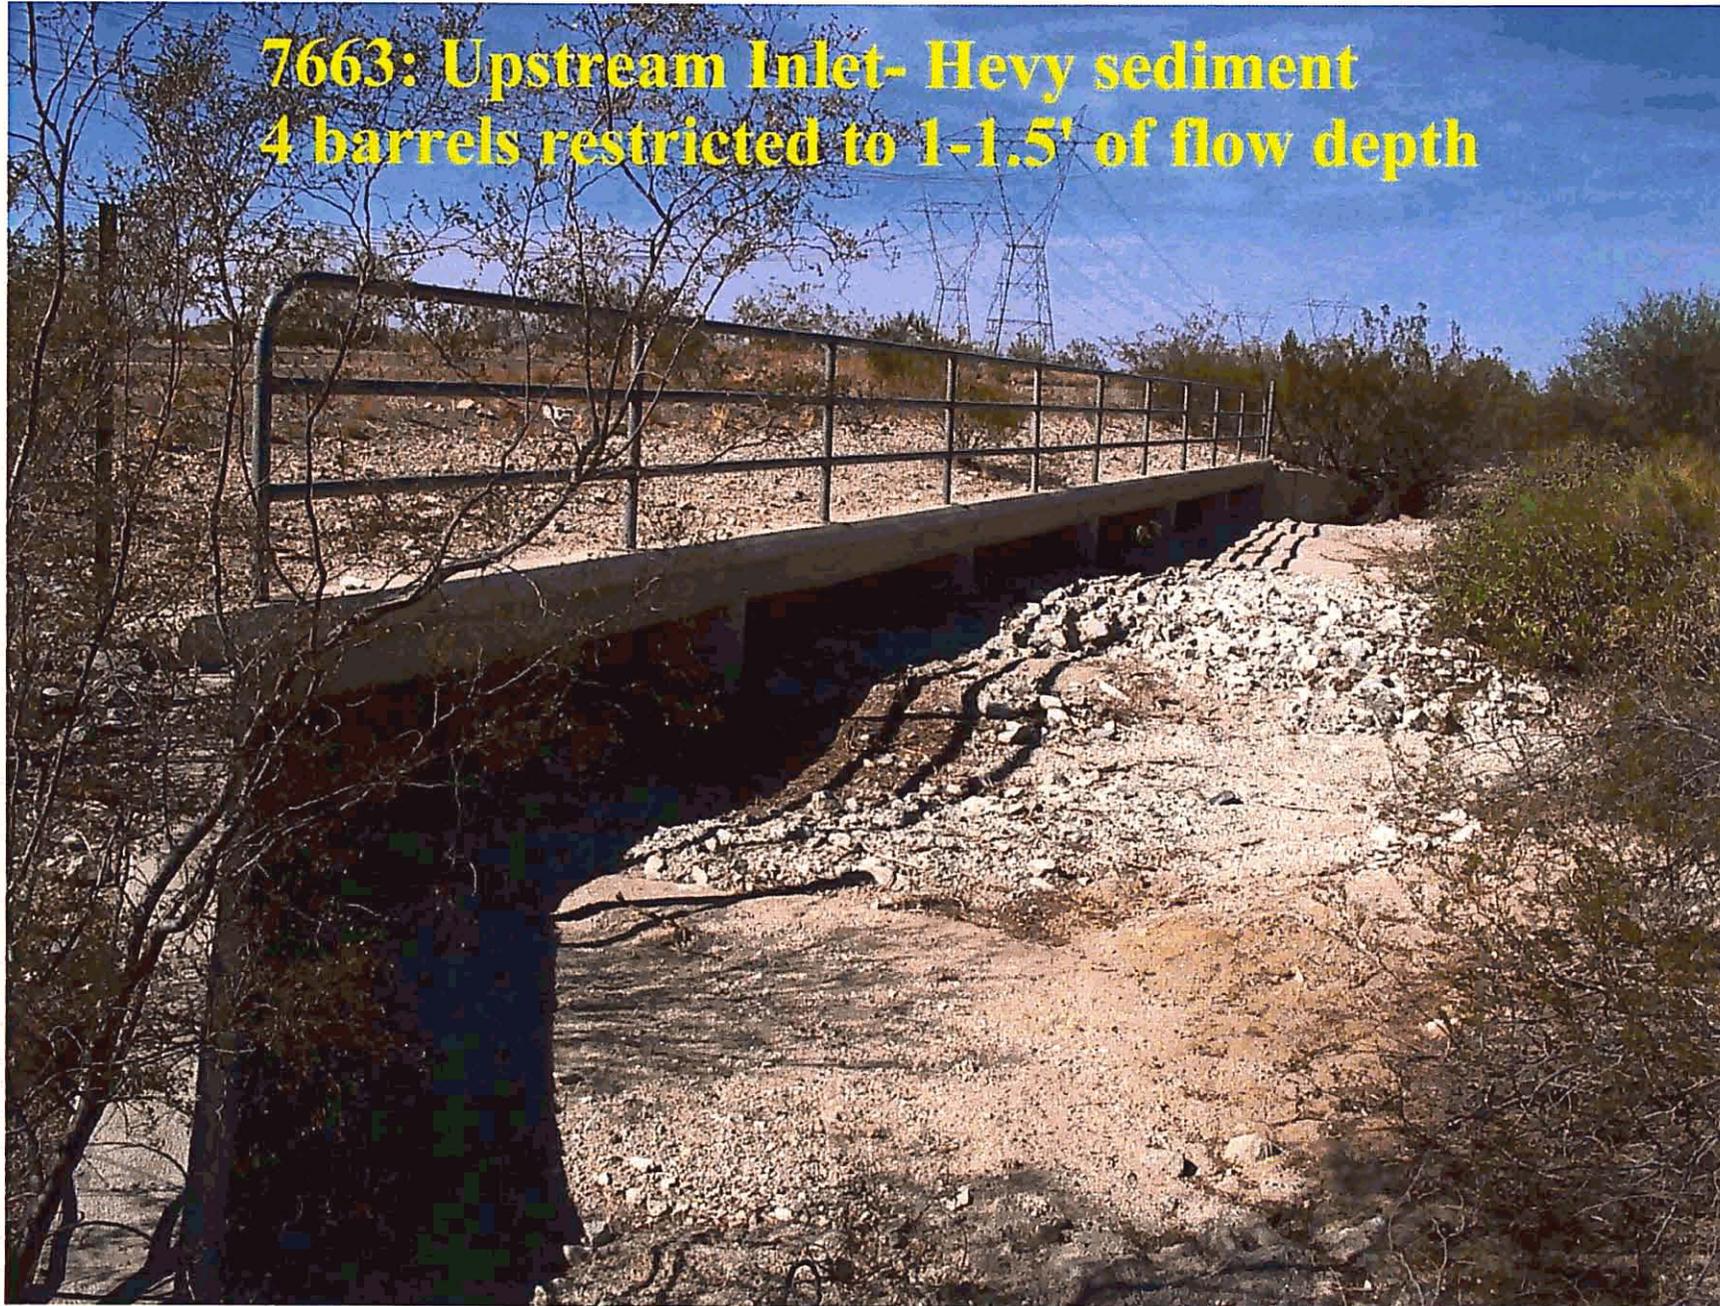
**7663: Upstream Inlet- Heavy sediment  
4 barrels restricted to 1-1.5' of flow depth**

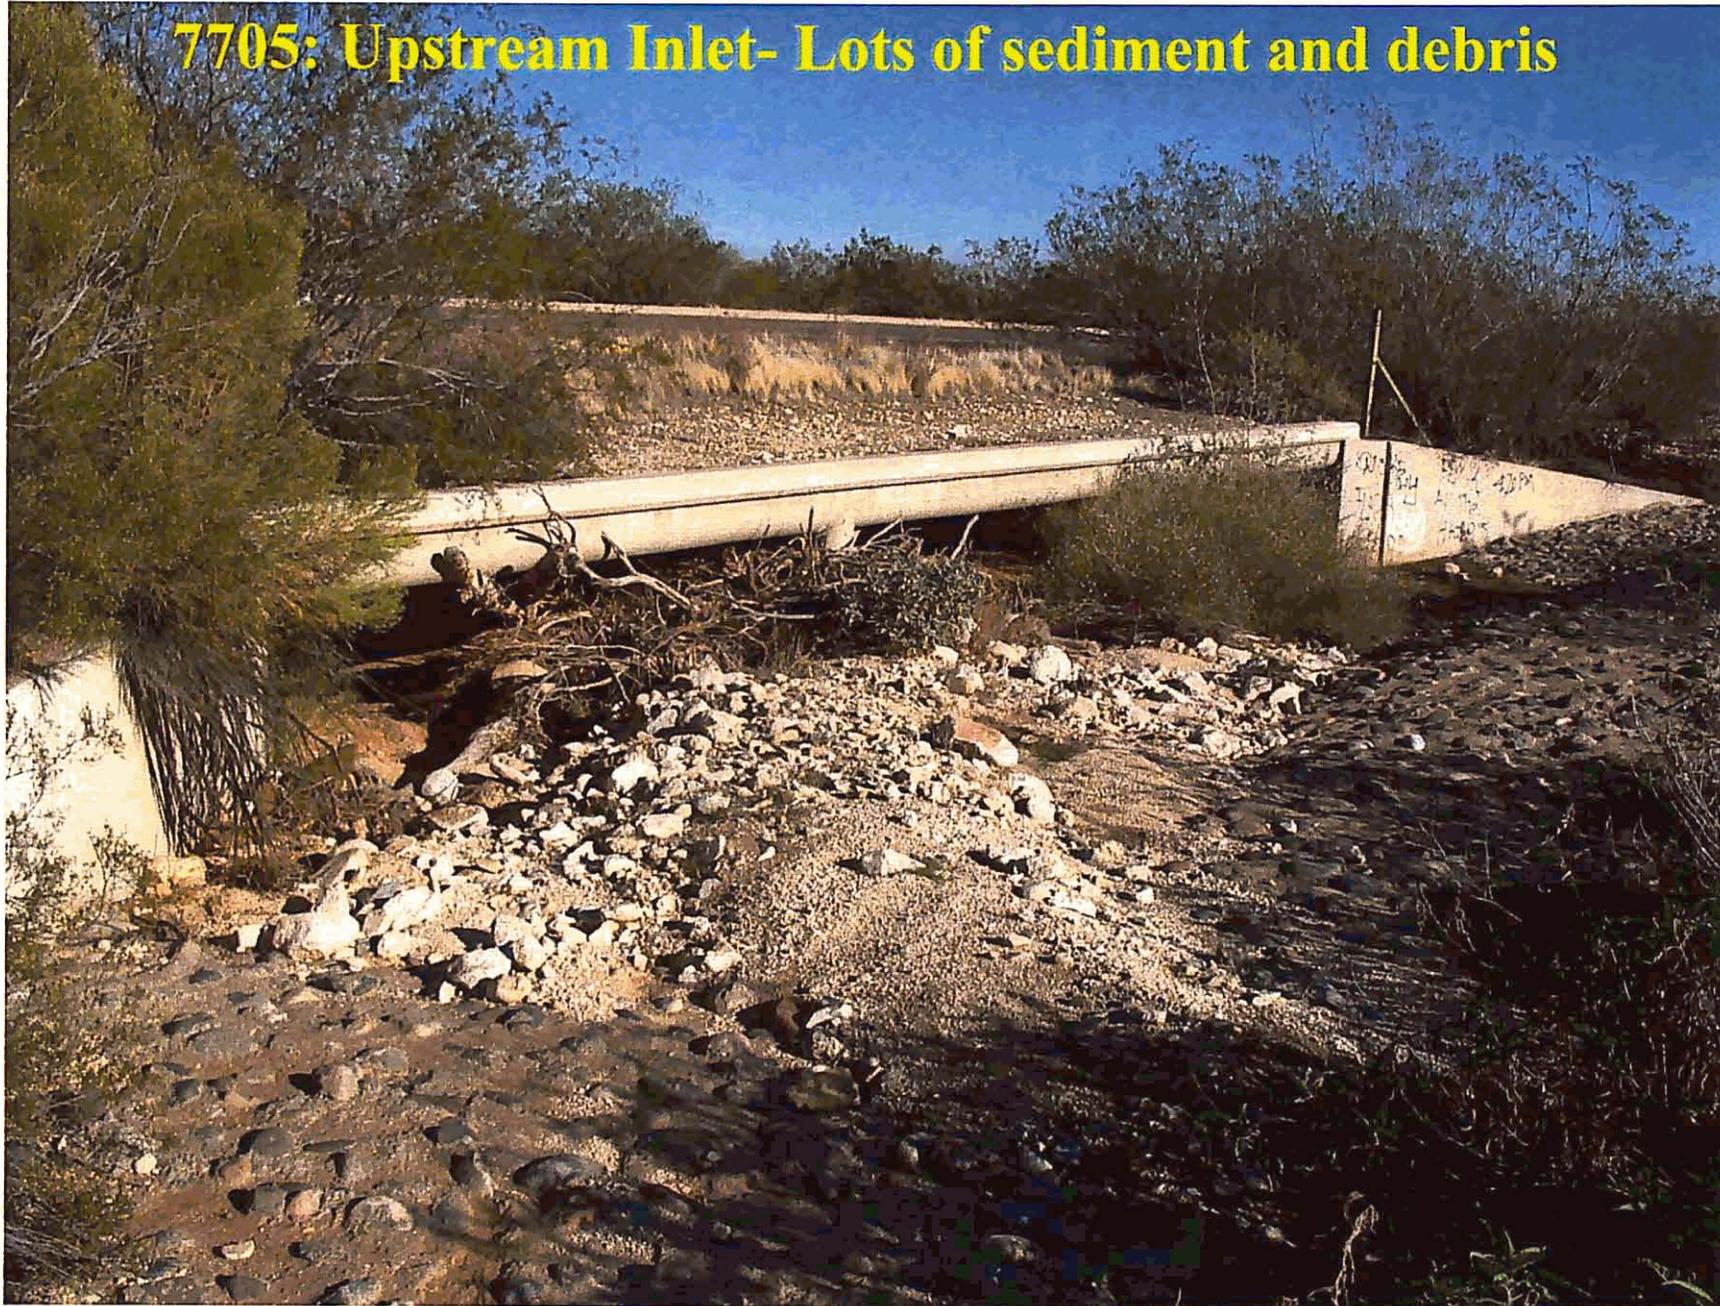
**7705: Upstream Inlet- Lots of sediment and debris**

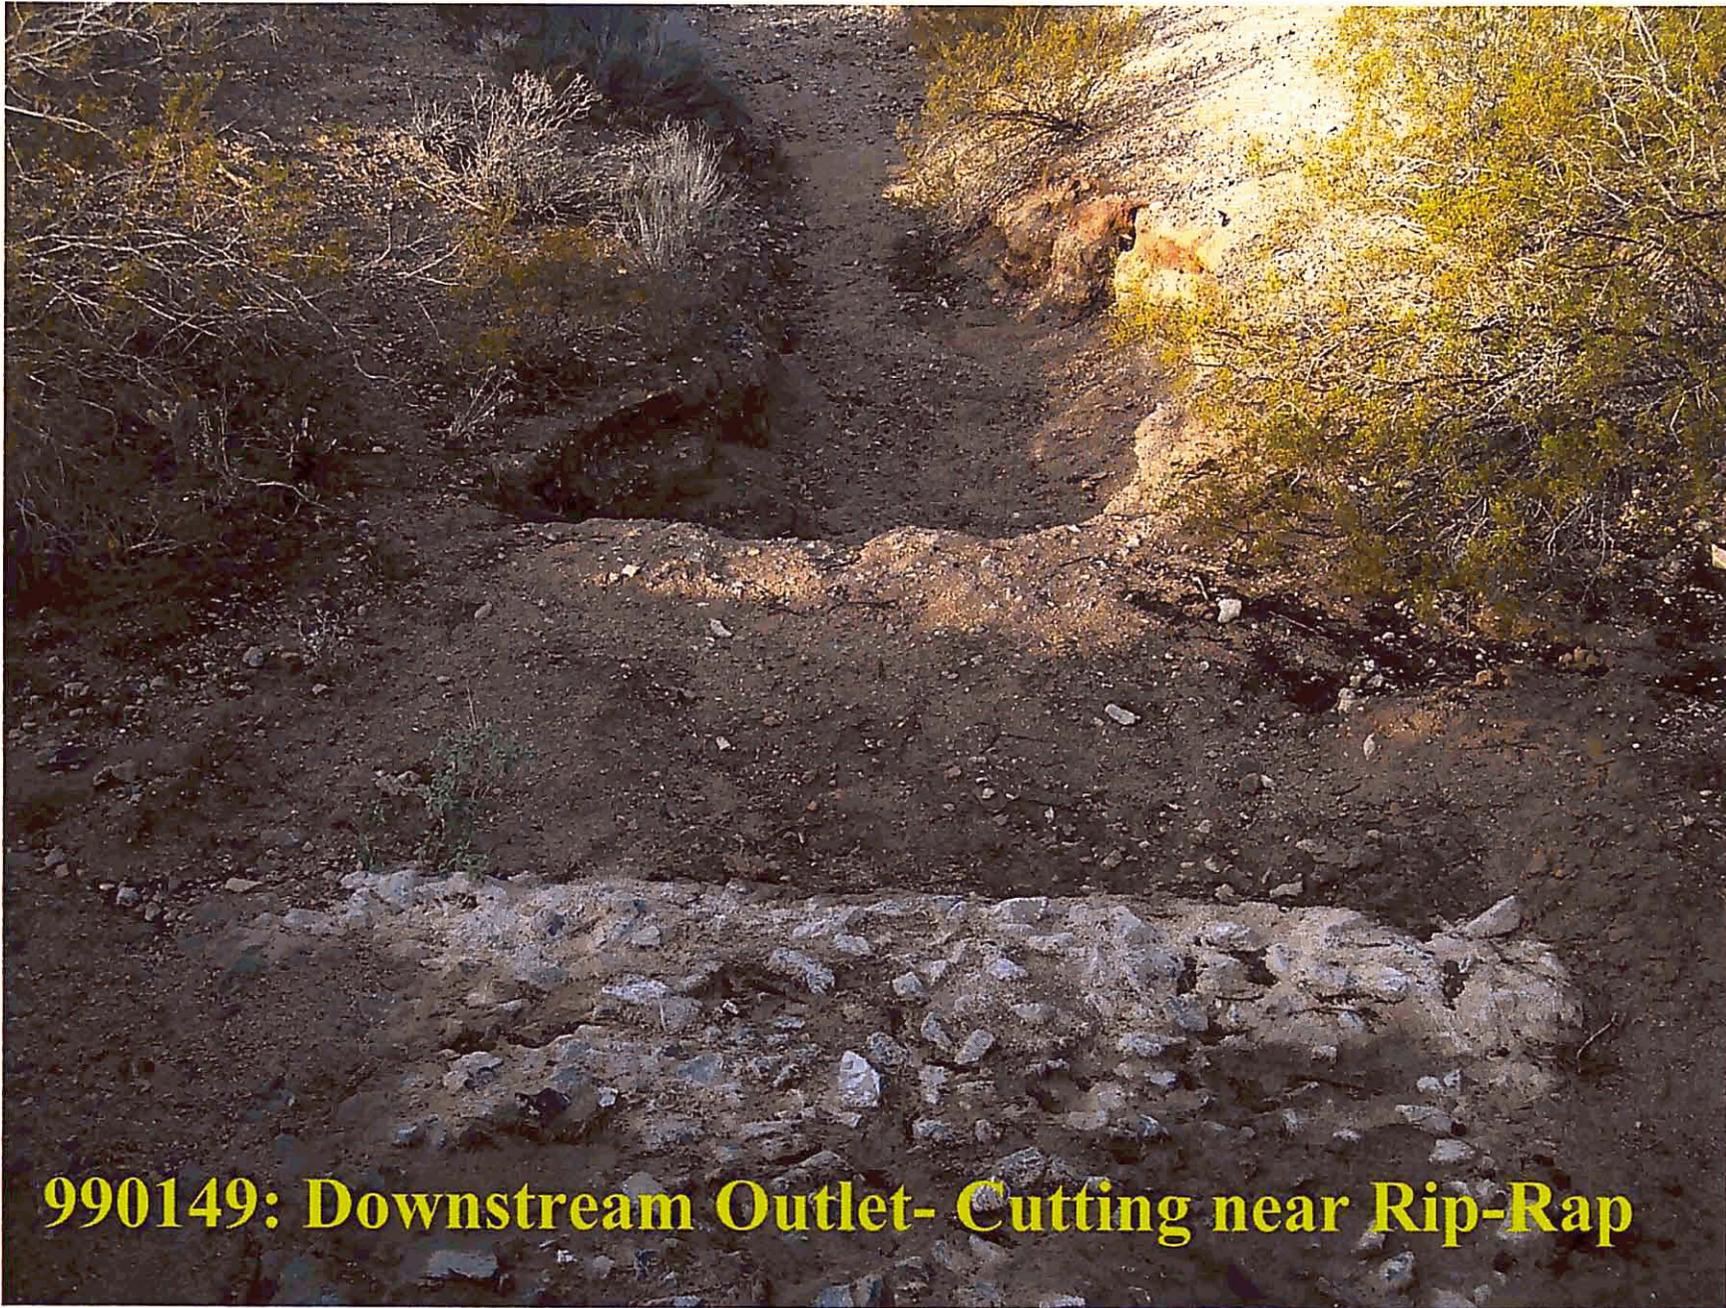
**990149: Downstream Outlet- Cutting near Rip-Rap**

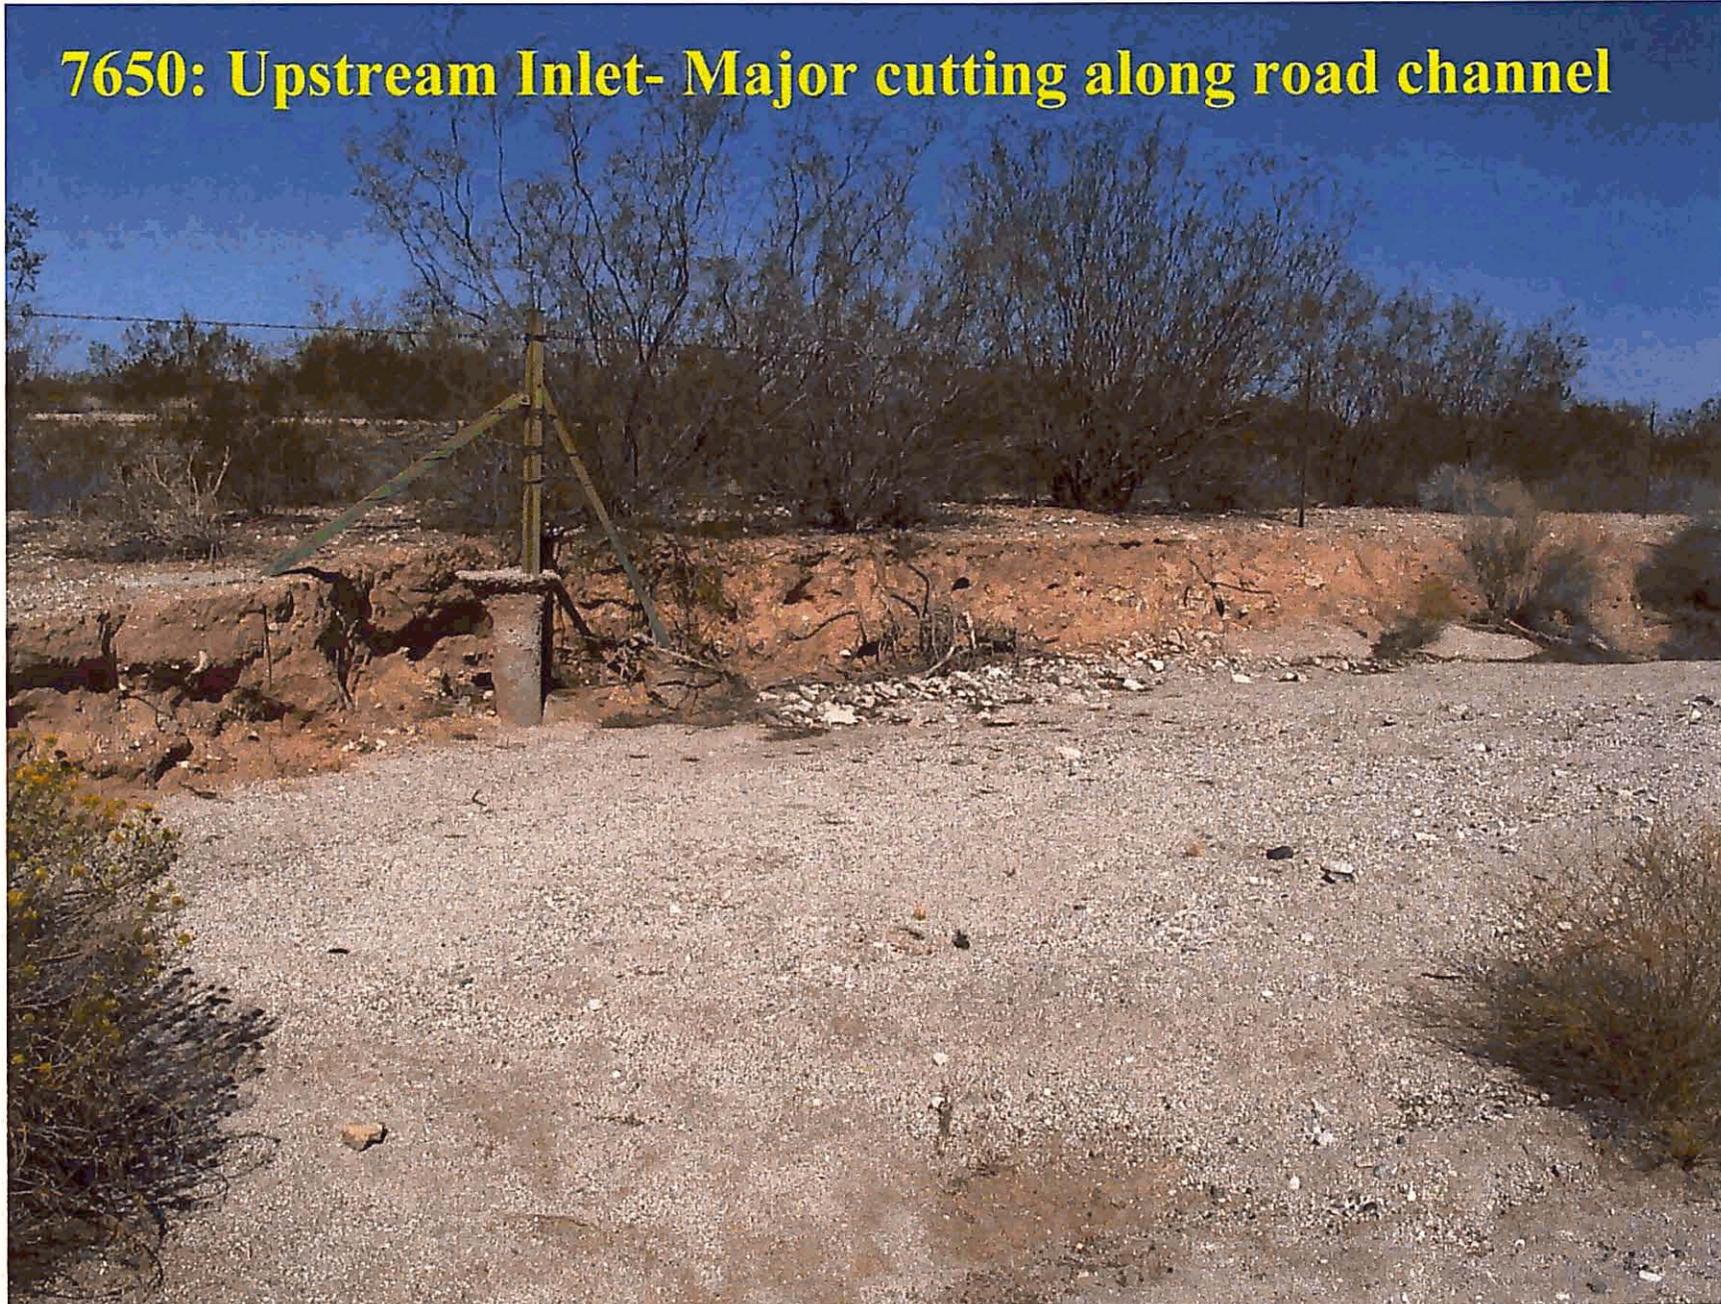
## 7650: Upstream Inlet- Major cutting along road channel

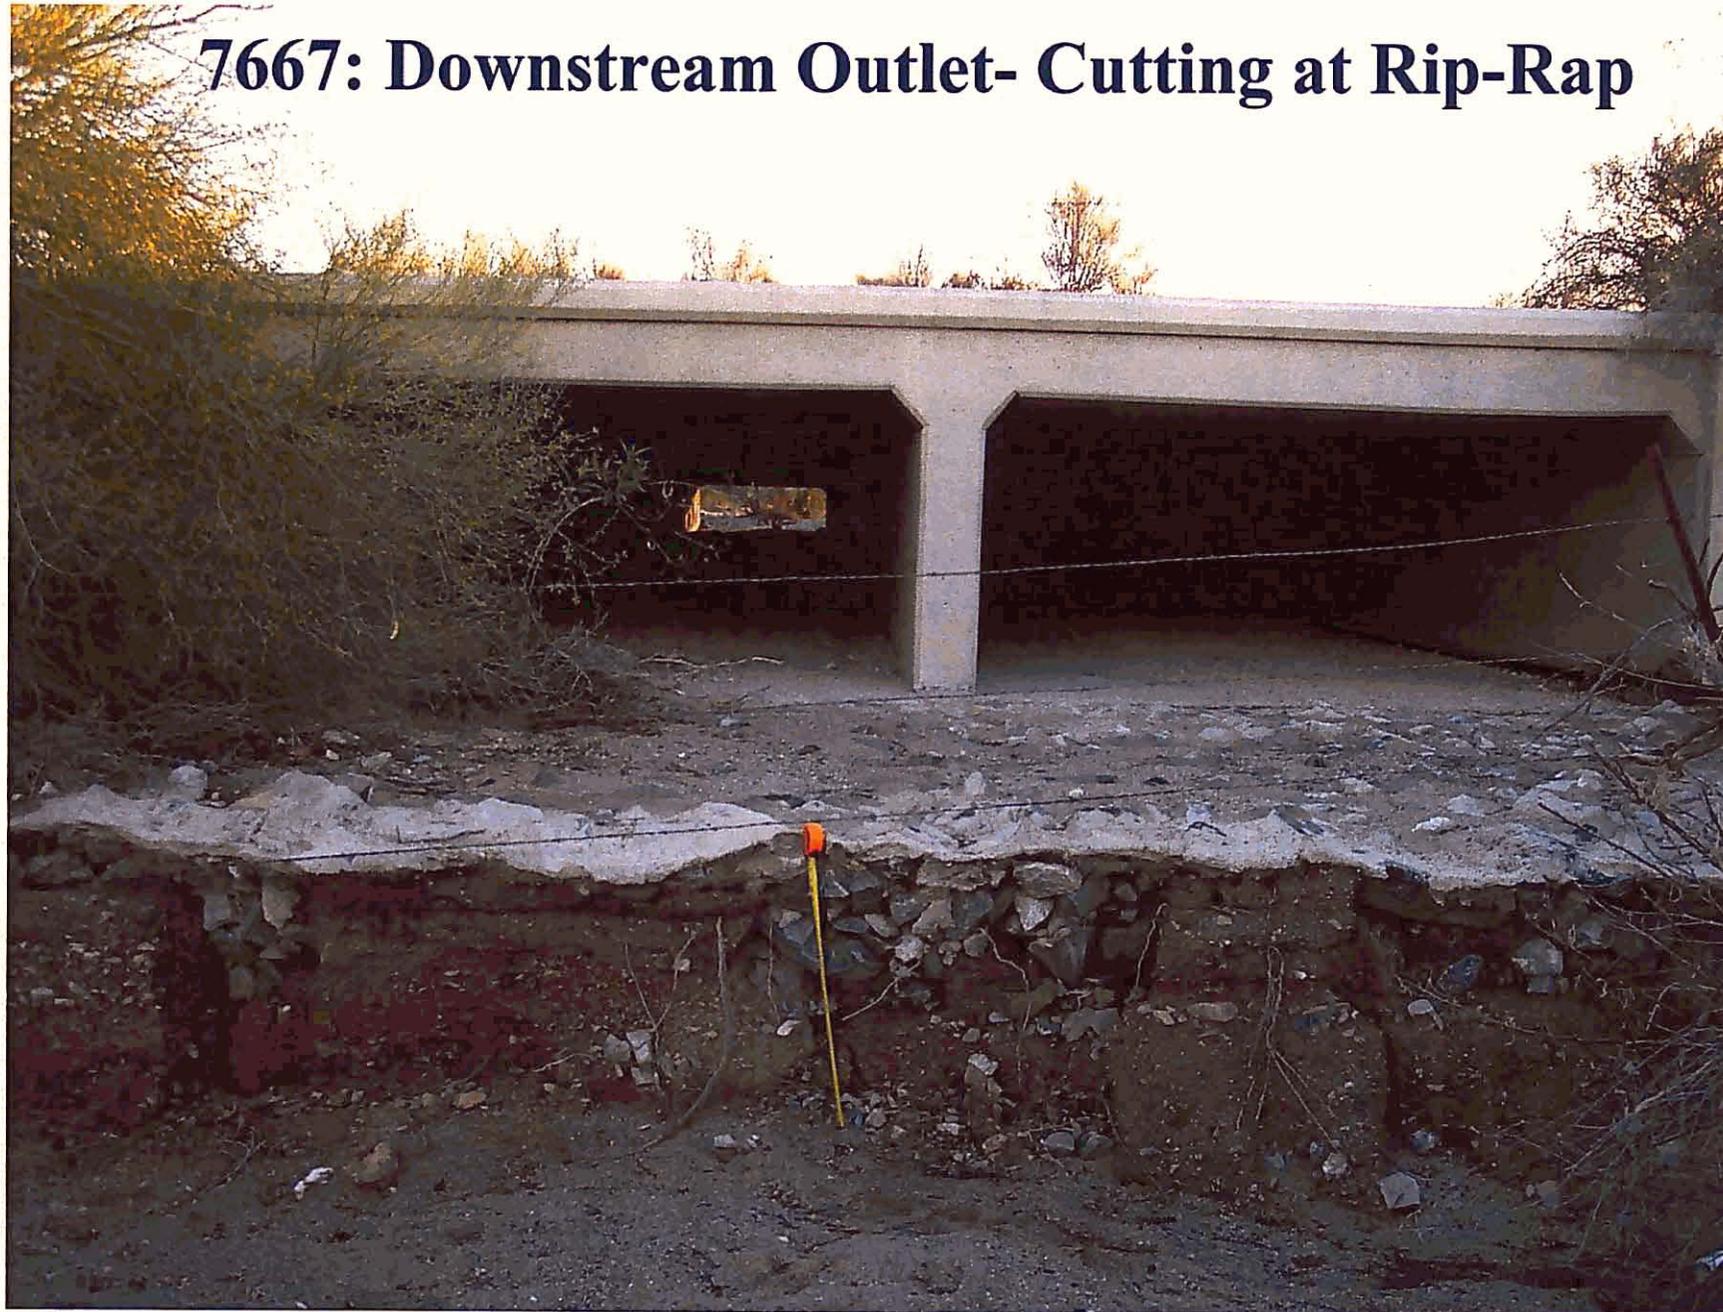
# 7667: Downstream Outlet- Cutting at Rip-Rap
