**WITTMANN AREA DRAINAGE  
MASTER STUDY UPDATE  
SUN VALLEY PARKWAY  
CULVERT EVALUATION  
VOLUME SV  
CONTRACT FCD 2002C029**

**SUN VALLEY PARKWAY  
CULVERT EVALUATION**

**VOLUME SV**

**March 2005**

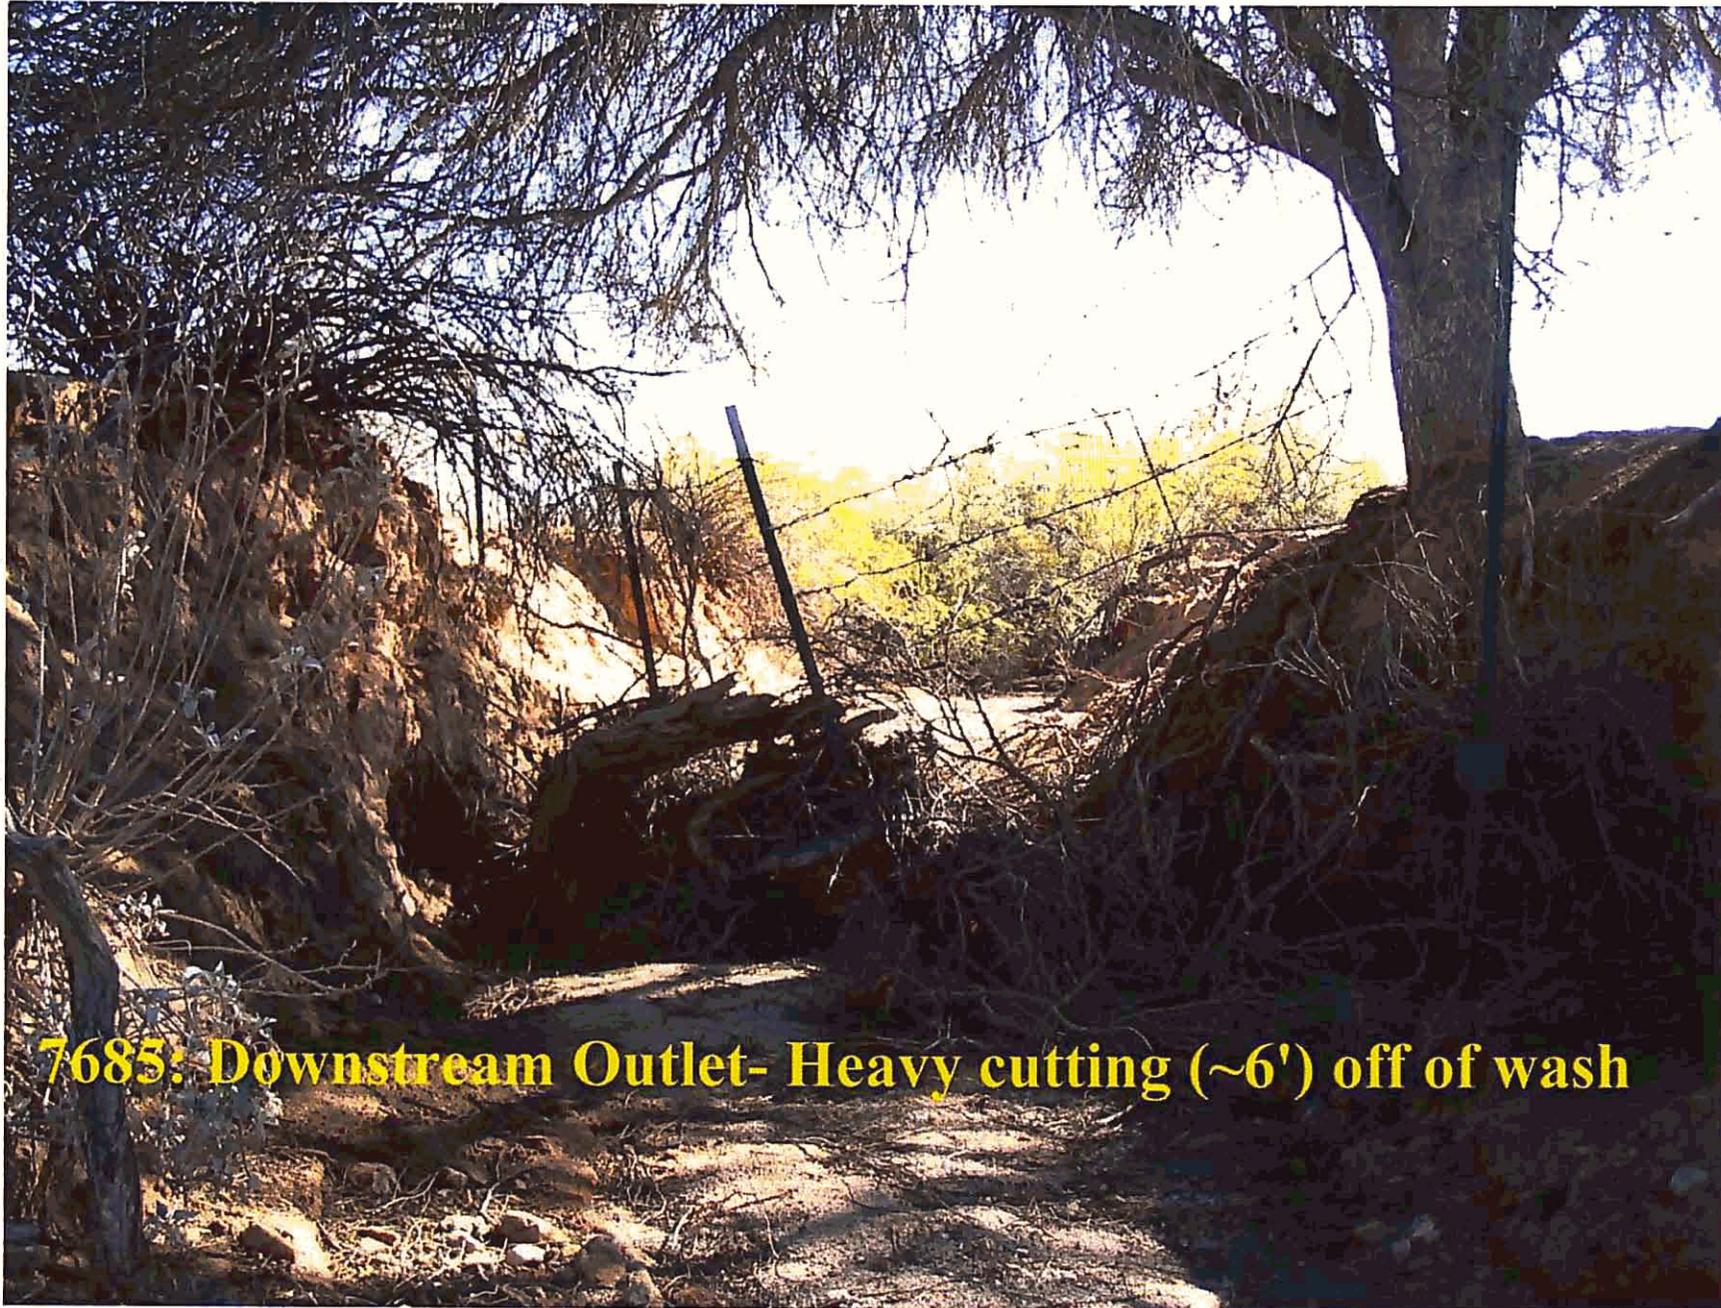
An exception to the less than four feet of headcut is Structure #7685. There was greater than six feet of headcut in the downstream portion of the channel, but because of the amount of grouted riprap that is already in place, a gabion basket was recommended.

**7685: Downstream Outlet- Heavy cutting (~6') off of wash**

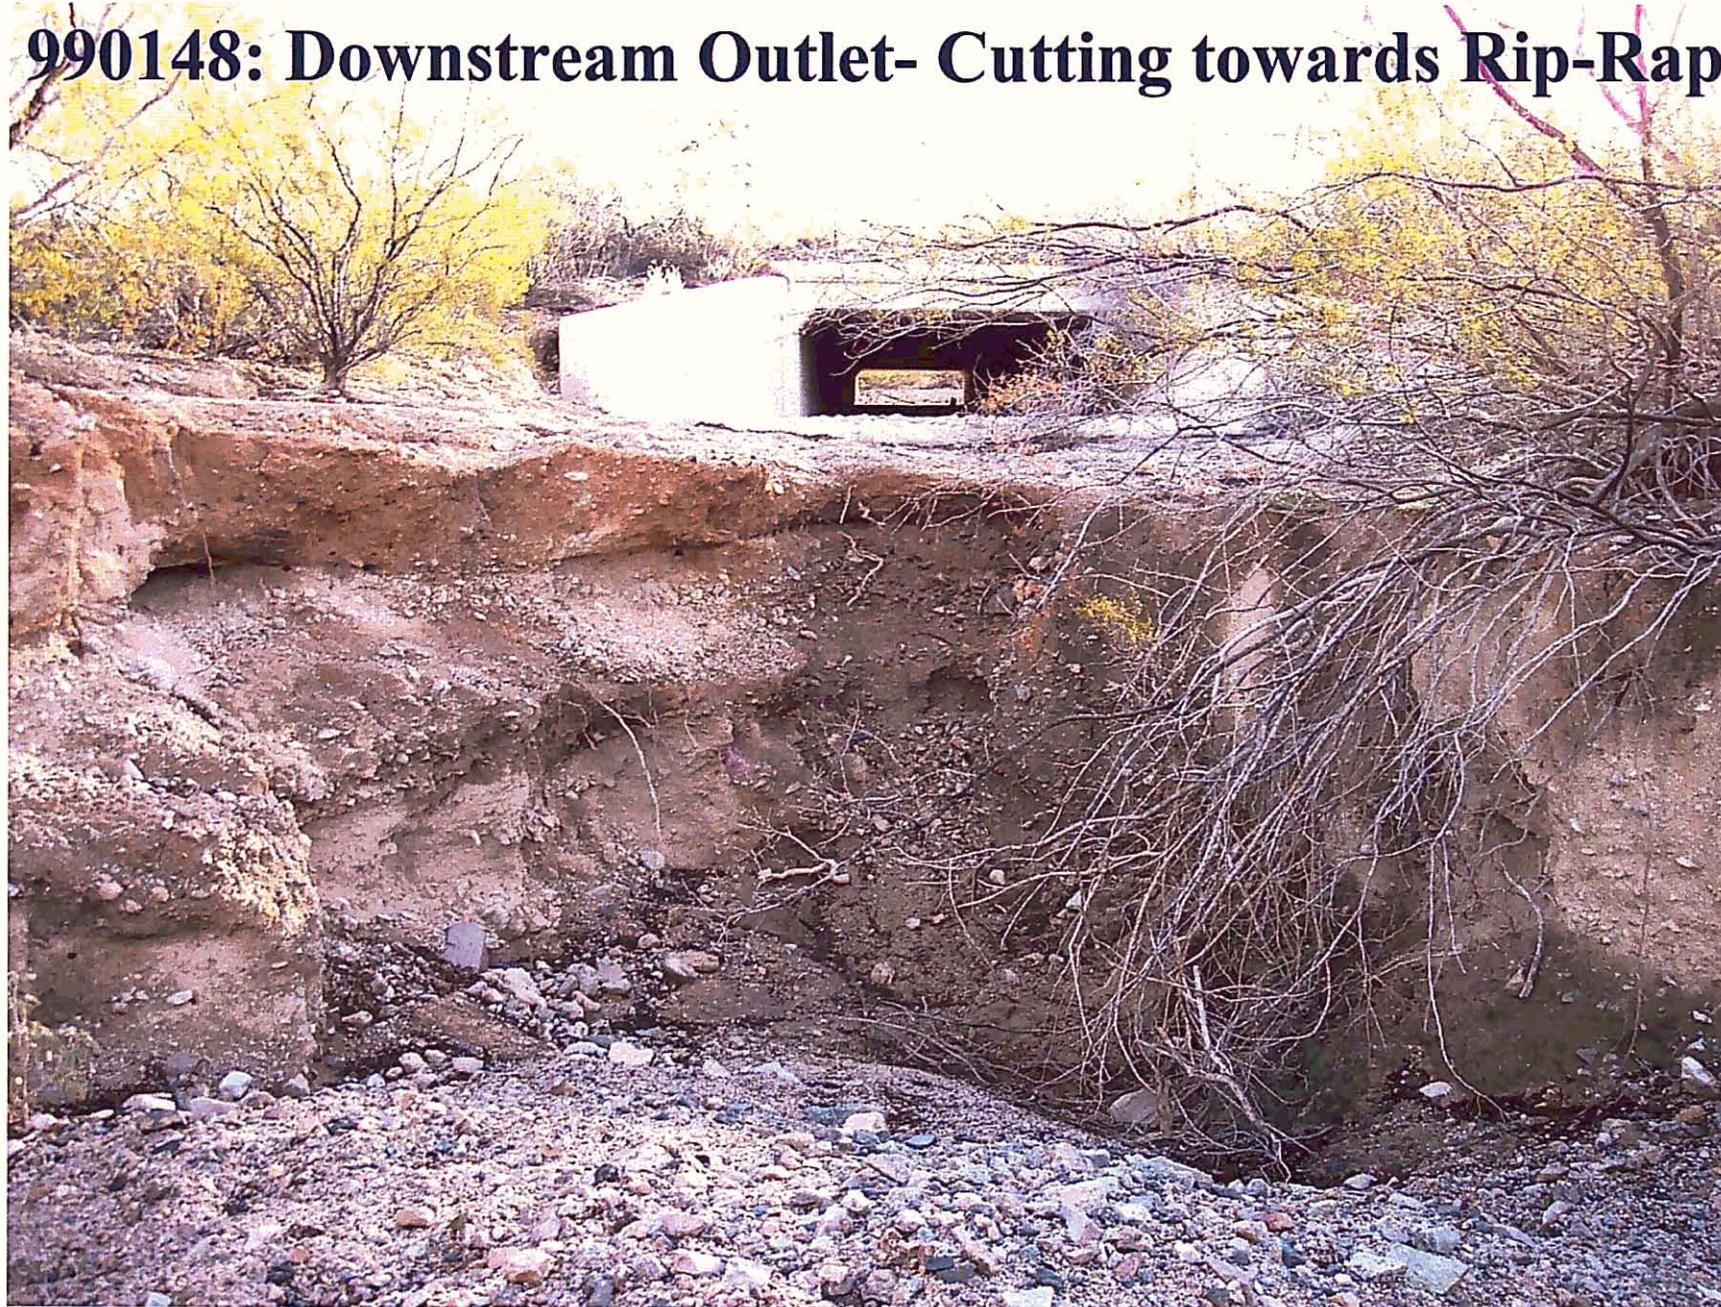
# 990148: Downstream Outlet- Cutting towards Rip-Rap

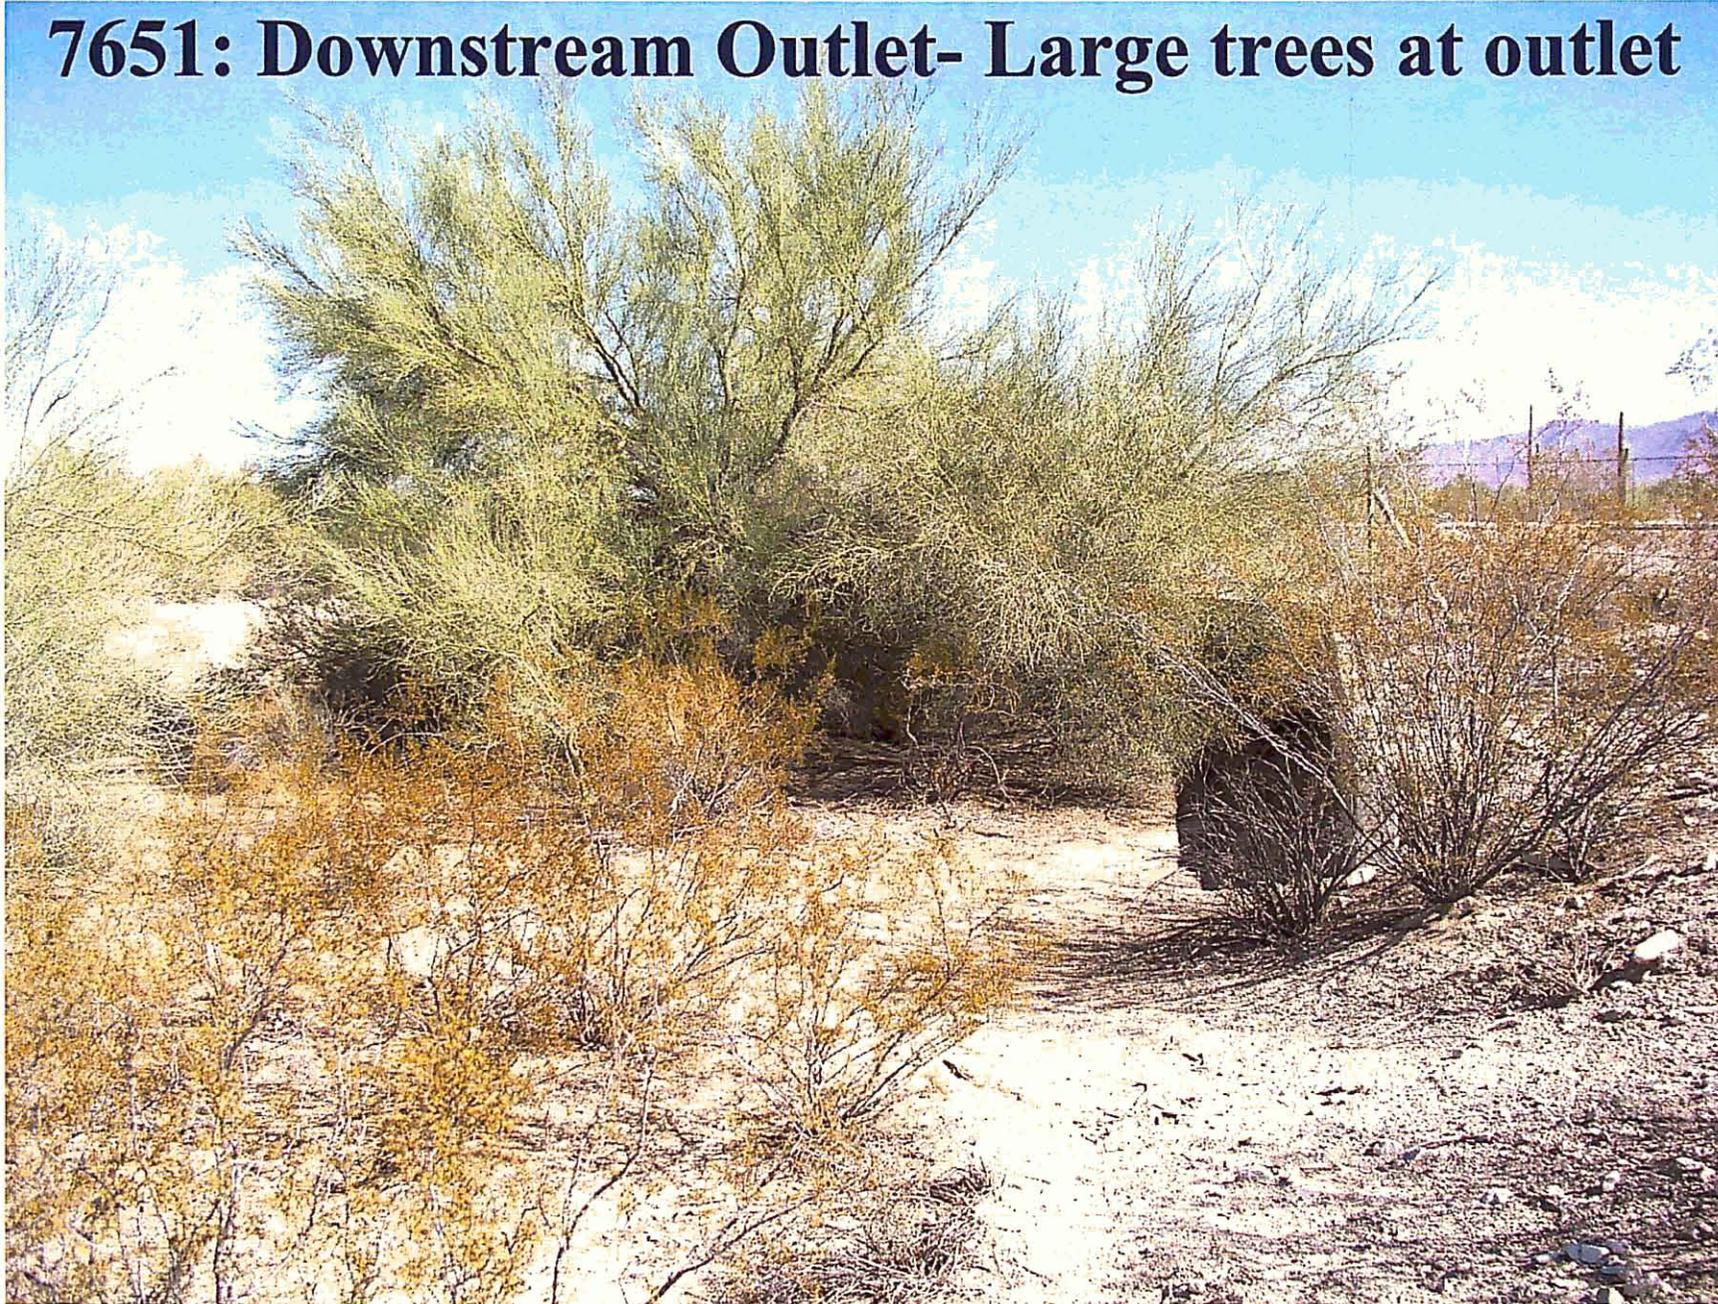
# 7651: Downstream Outlet- Large trees at outlet

The recommended remediation for culvert vegetation obstruction is to obtain any needed permits, remove the tree(s) or tree seedling(s), and to maintain the structure on a regular basis to prevent excessive growth.
