Hassayampa River Post-Flood Study Final Report

June 17, 2005

Prepared For:
Flood Control District of Maricopa County
FCD 2002030

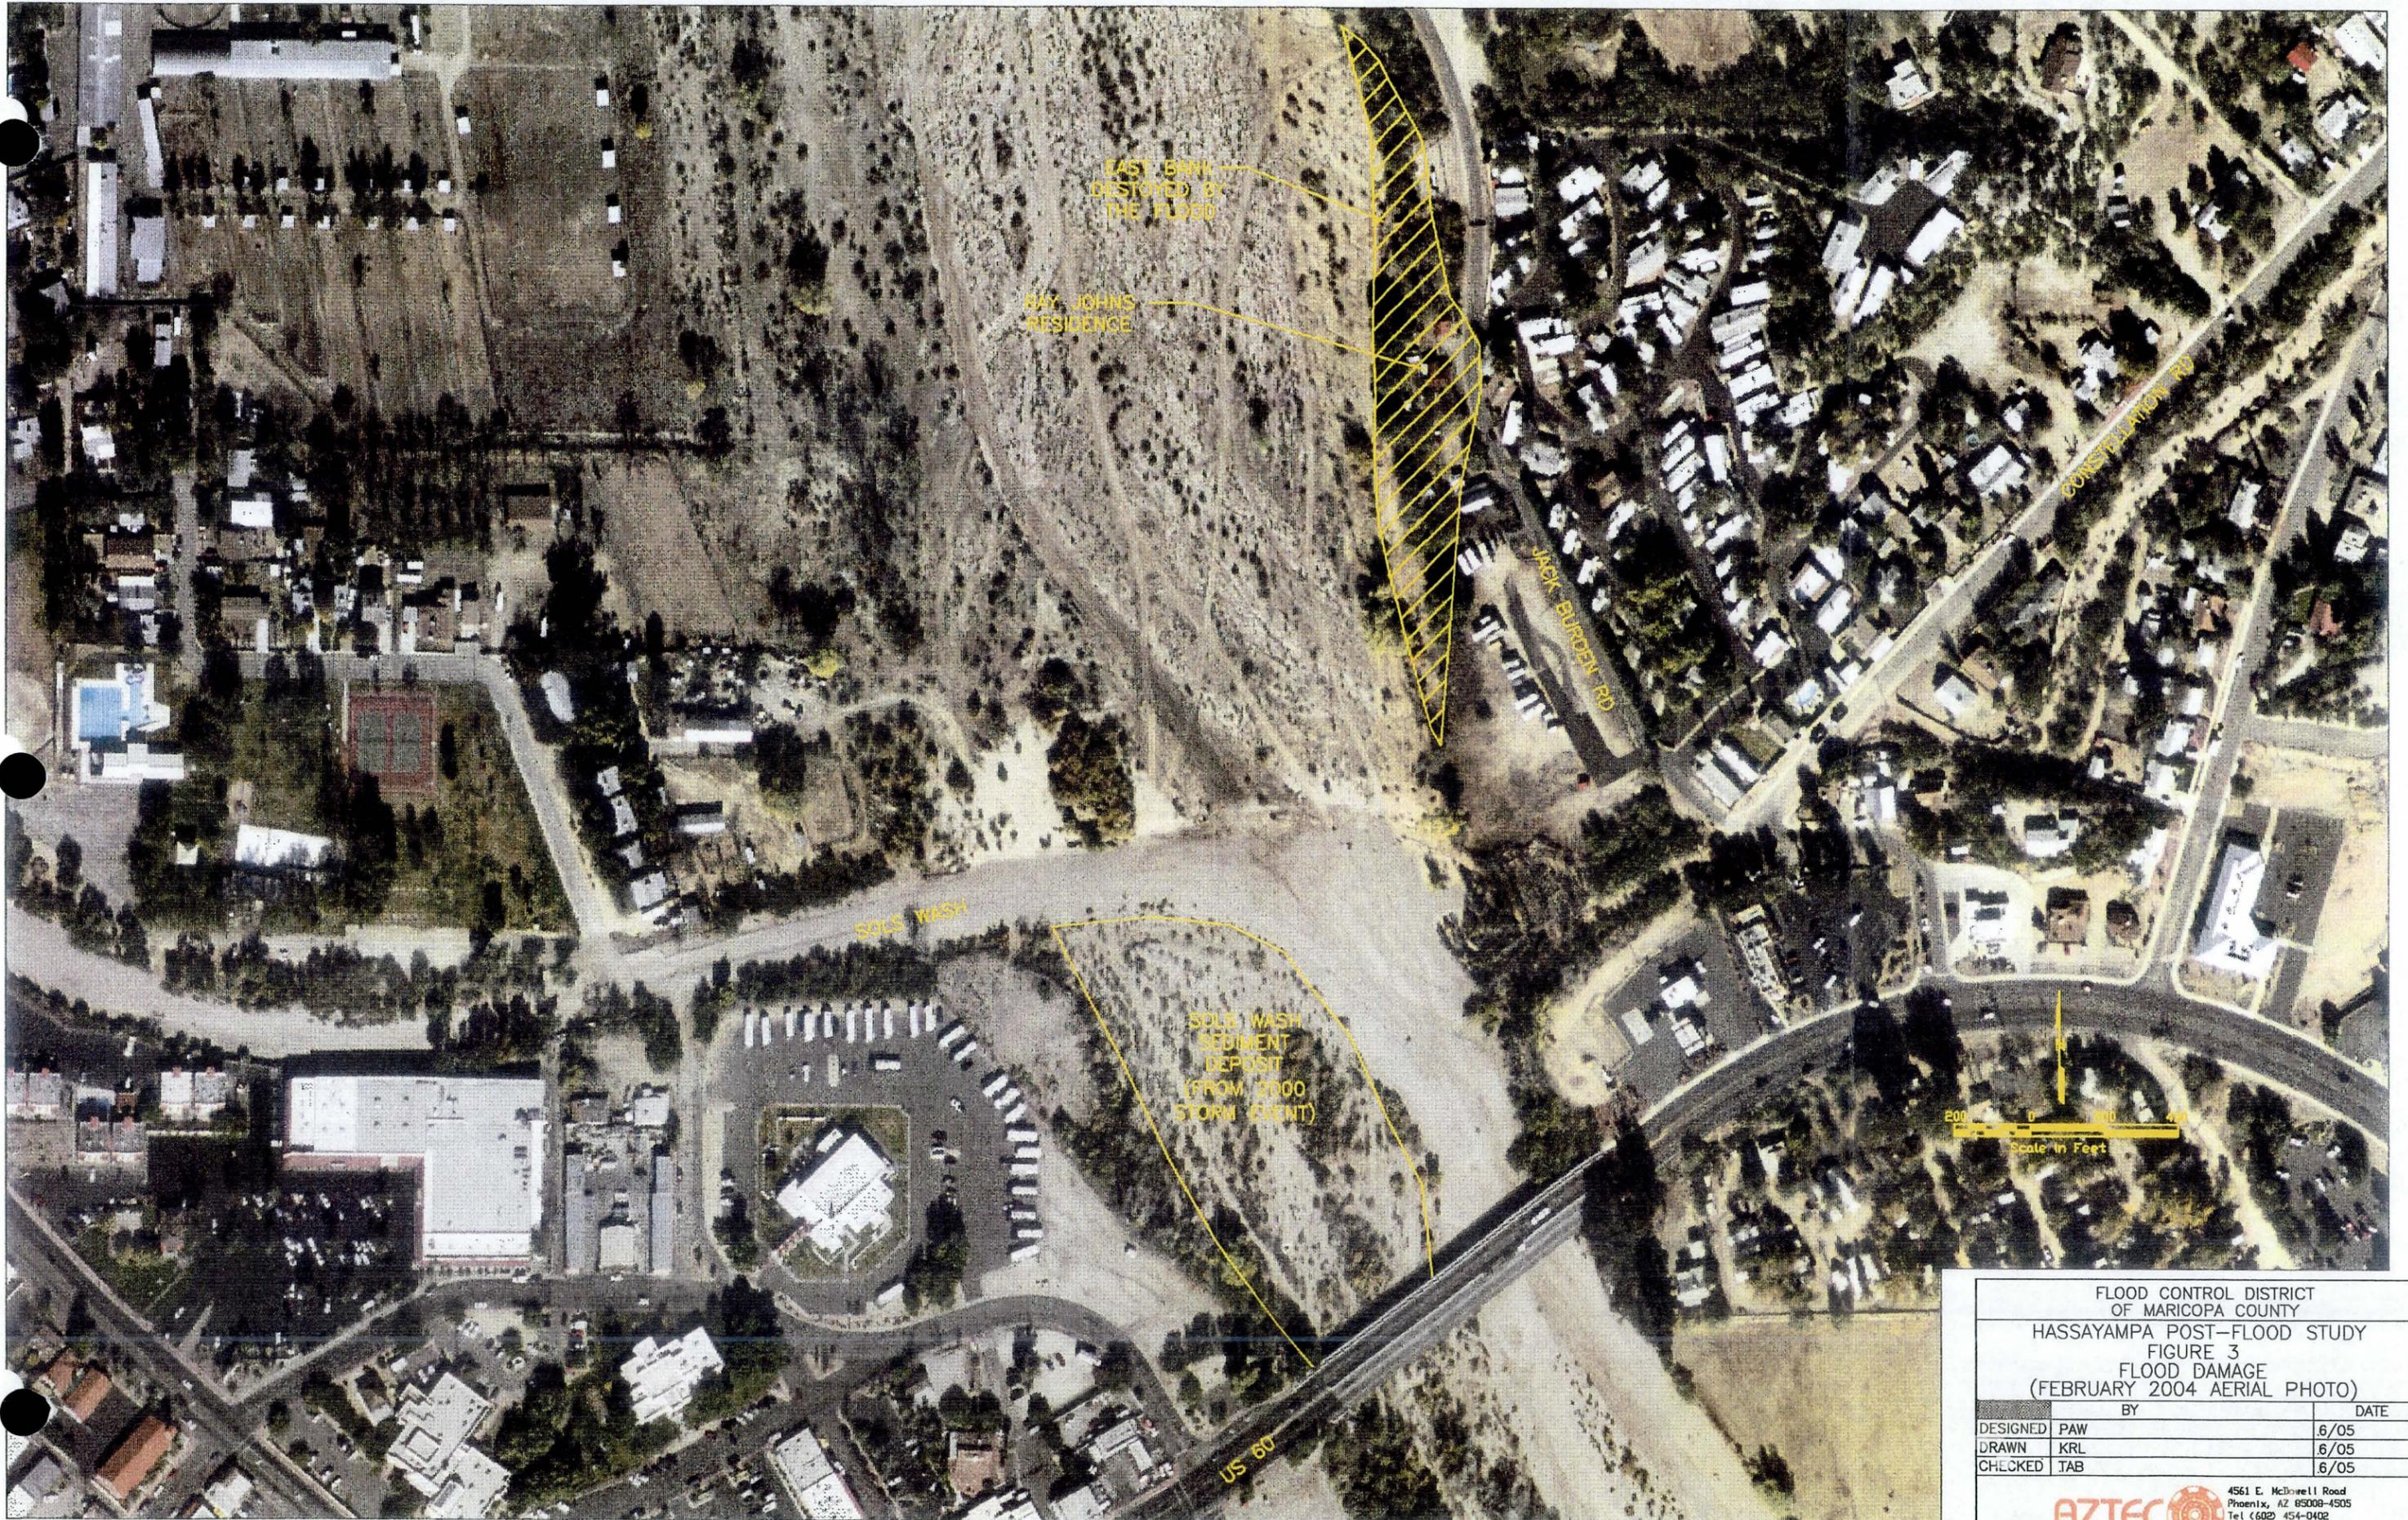
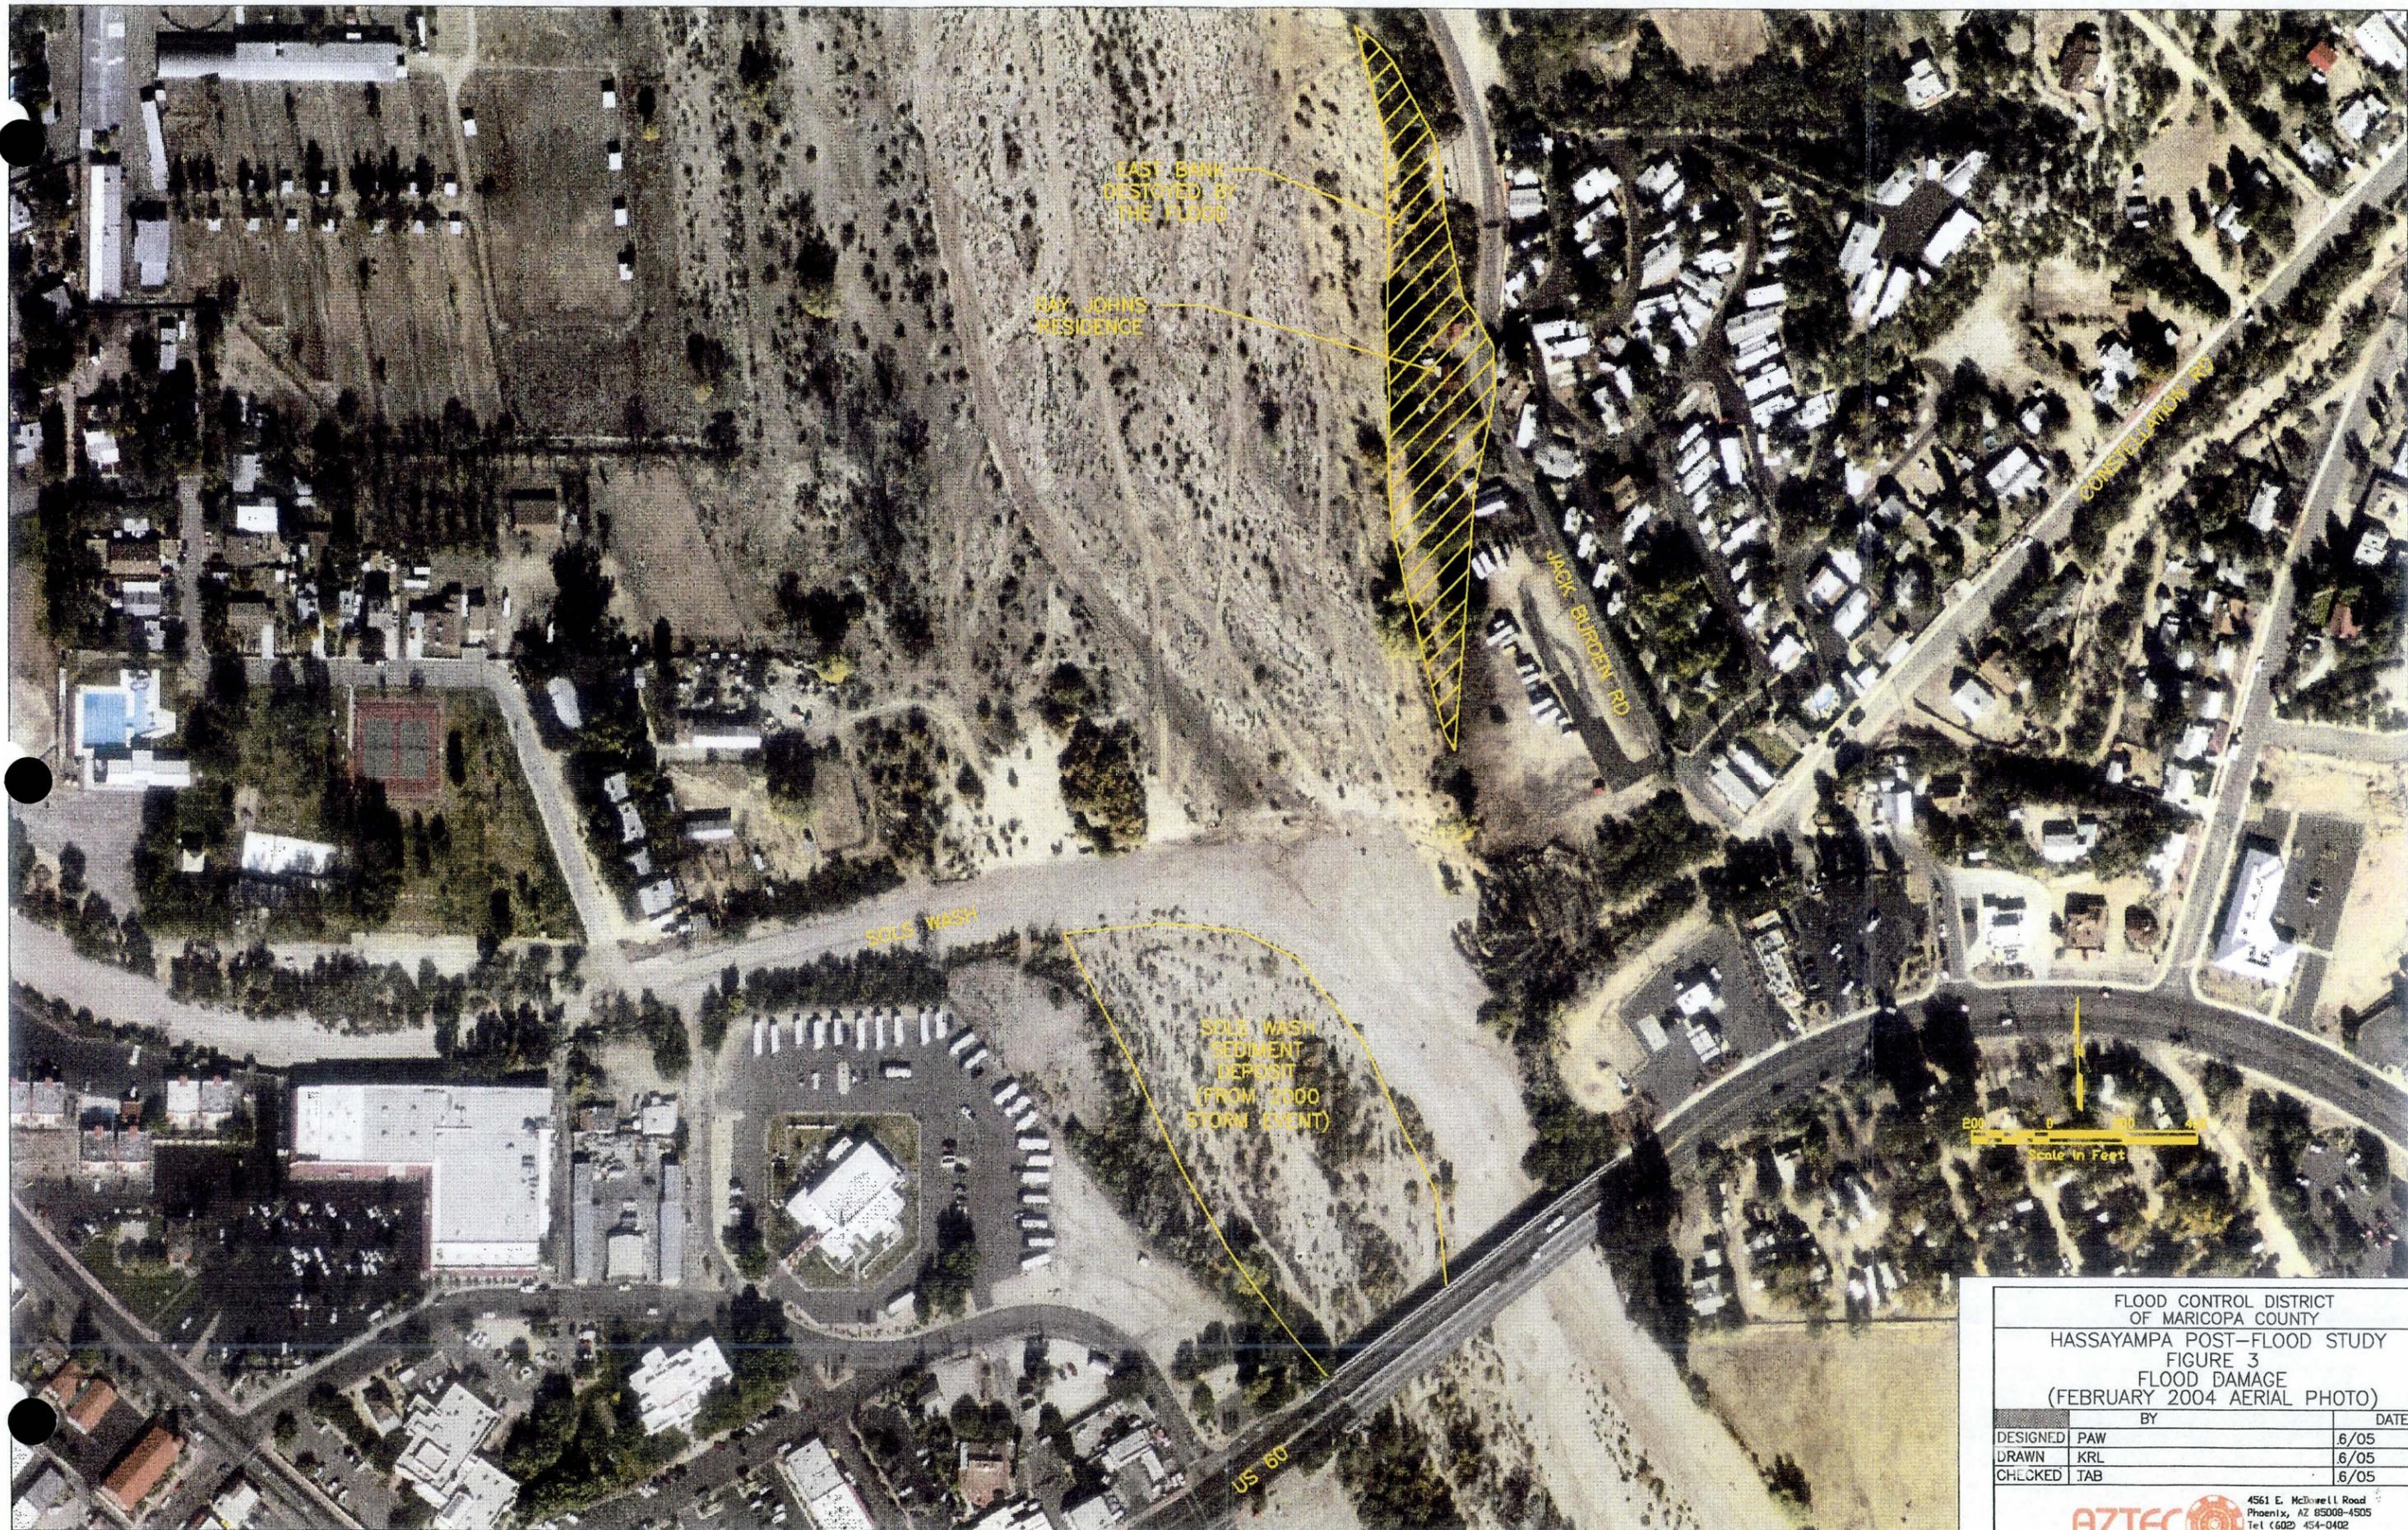
FLOOD CONTROL DISTRICT
OF MARICOPA COUNTY
HASSAYAMPA POST-FLOOD STUDY
FIGURE 3
FLOOD DAMAGE
(FEBRUARY 2004 AERIAL PHOTO)

The flooding that occurred during the weekend of February 12 and 13, 2005 destroyed two homes, a trailer, a shed, and two cars (see Figure 3). The flood also destroyed a portion of Jack Burden Road, the waterline in the road and a power line along the road. Two homes had significant damage due to the flood, but were able to be repaired. According to a letter from the Town of Wickenburg to the Arizona Department of Emergency Management, the damage was estimated as approximately \$2.4 million. A copy of this letter has been included in Appendix A1.

EAST BANK
DESTROYED BY
THE FLOOD

RAY JOHN'S
RESIDENCE

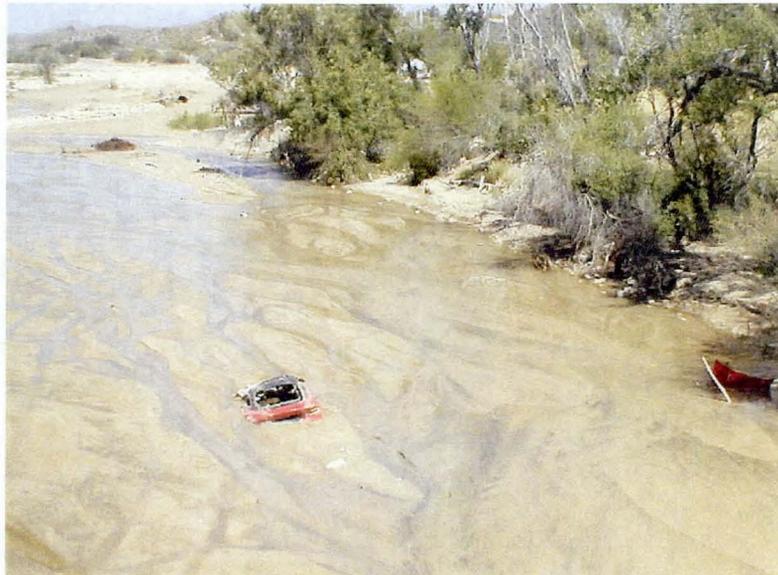
Photo 3: Automobile in the river near the eastern bank of the Hassayampa River just upstream of the US 60/93 Bridge. (April 2005)

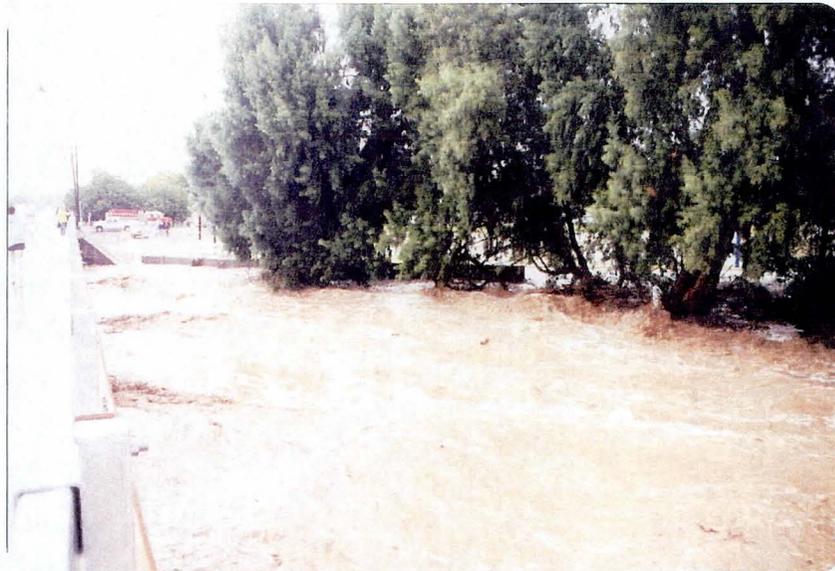
Photo 5: The brown sediment laden flow at the downstream side of existing US 93 Bridge over Sols Wash looking north. (October 2000)

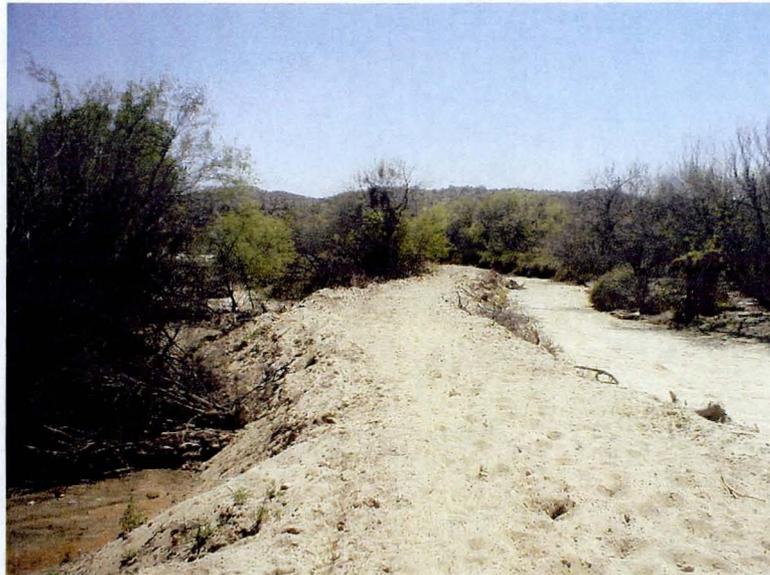
*Photo 6: Along the temporary dike for the Horspitality Trailer Park.
(April 2005)*

The temporary dike constructed by the Horspitality RV Park is not an engineered structure. Any flow event of consequence could damage or breach this temporary dike. There is no other protection for the trailer park should the temporary dike fail.

- The temporary dike protecting the Horspitality RV Park could incur damage during a minor to moderate flow events. Permanent bank protection should be considered to protect this property. The property owners are currently working with the NRCS to construct a permanent bank. After the completion of the permanent bank protection, additional analysis should be performed to determine its impact on future flow events along the Hassayampa River.

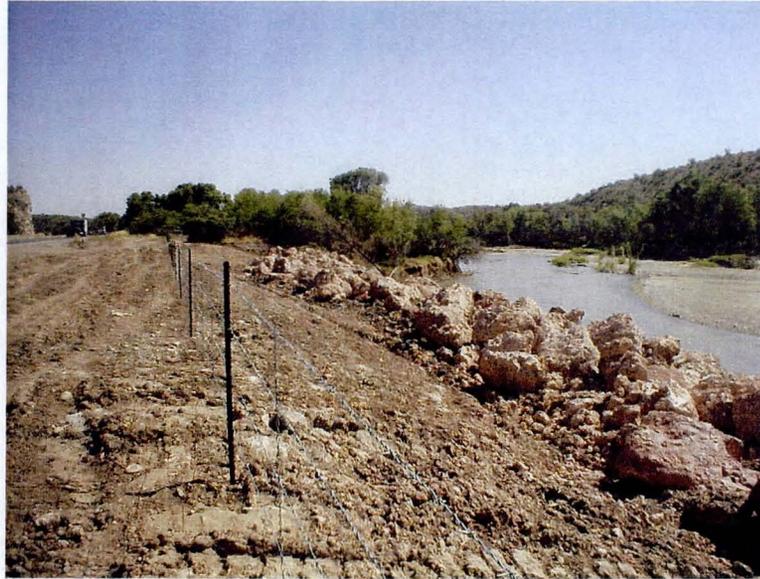
*Photo 7: The bank protection along US 60 constructed by ADOT.
(April 2005)*

The bank stabilization constructed by ADOT consisted of dumping “soil-cement” dirt boulders (see Section 6.2) along the eastern bank of the river. This construction did not account for scour along the bank and therefore toe-down protection was not provided. The boulders are very large in diameter, but are not durable stone and easily broken apart. This bank protection does not provide permanent remedy, only temporary protection.

- The dumped riprap placed by ADOT seven miles south of the US 60/93 Bridge was an emergency protection measure. The riprap bank protection was not engineered. The material is not a durable stone but rather fractured cement stabilized alluvium (CSA), which was placed during the flood to halt the advance of erosion on the highway embankment. The riprap is ADOT's property and was placed by them to protect their highway. If it's within the jurisdiction of the District, the bank protection should be analyzed to determine if it is adequate, or needs to be replaced.

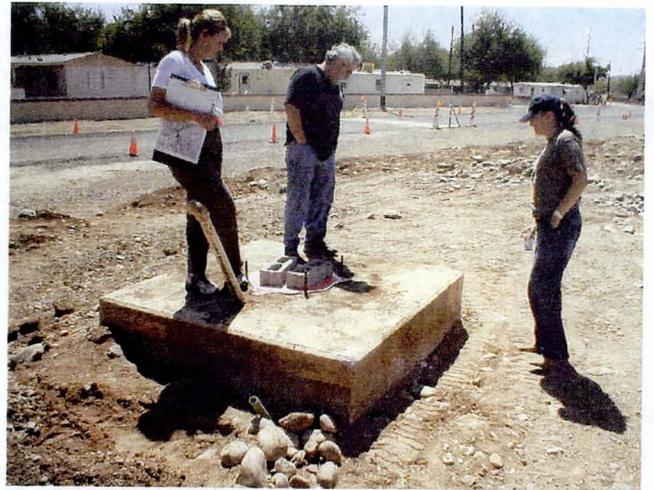
Damaged well on the west side of Jack Burden Rd.

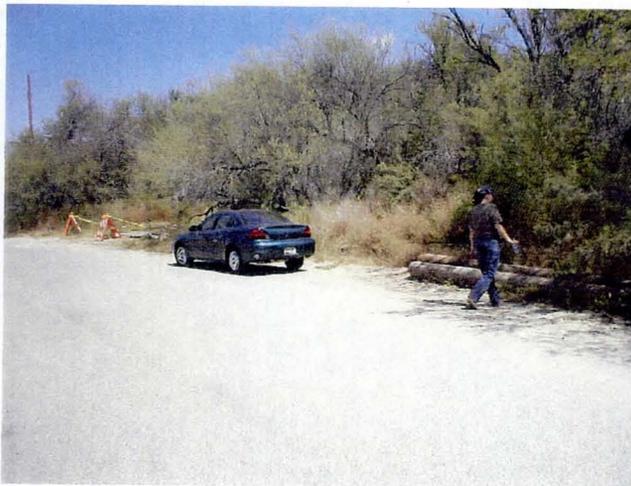
Electrical pole damaged along Jack Burden Rd.

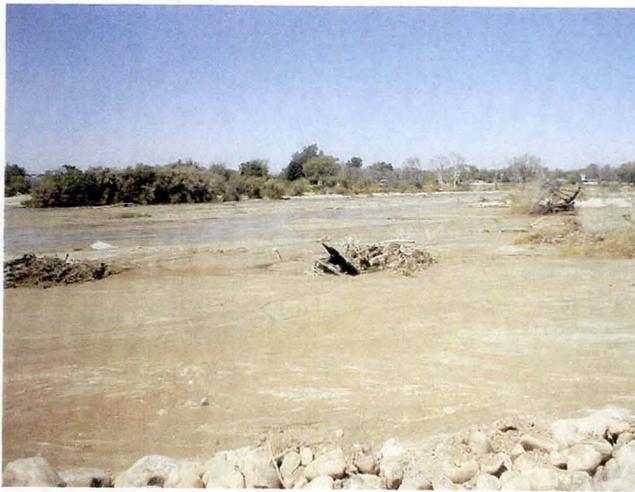
Looking towards the west bank, damaged jeep in river bed

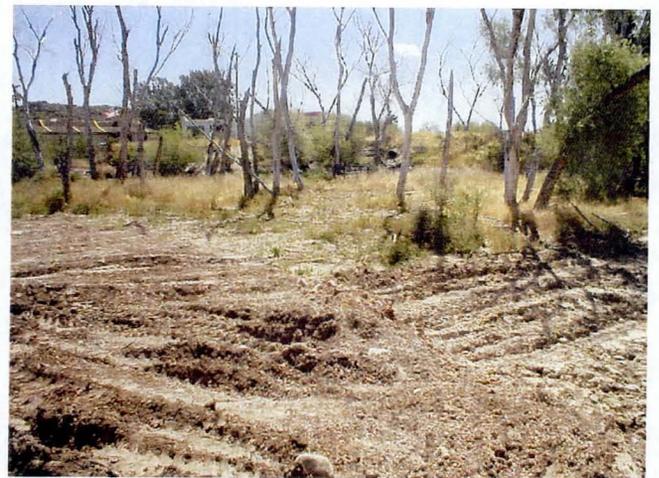
Damaged trees, accumulation of silt upstream of bridge

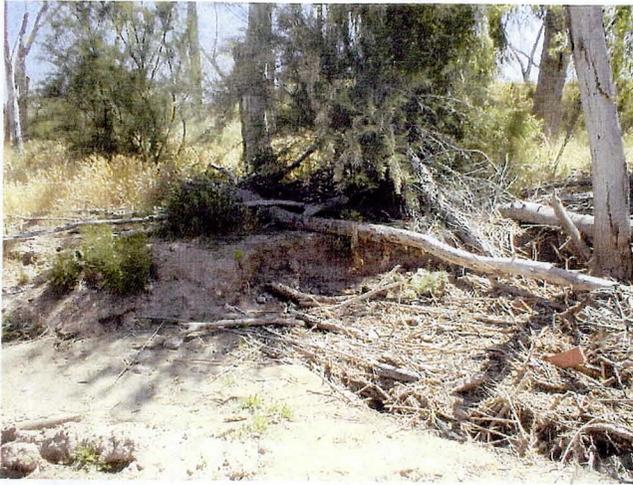
Debris from flood upstream of bridge

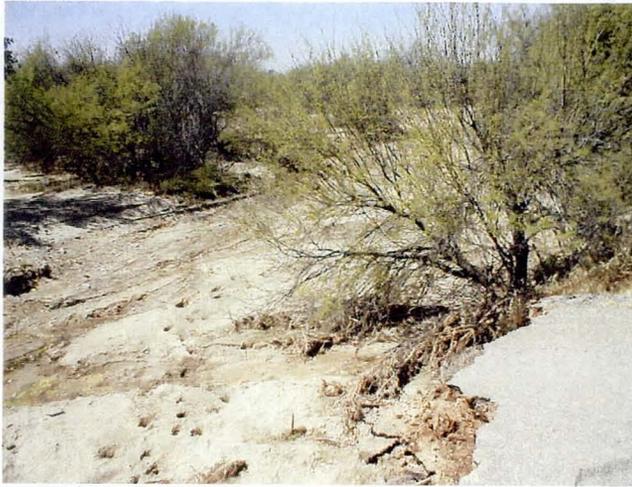
Damaged road at Horspitality RV park.

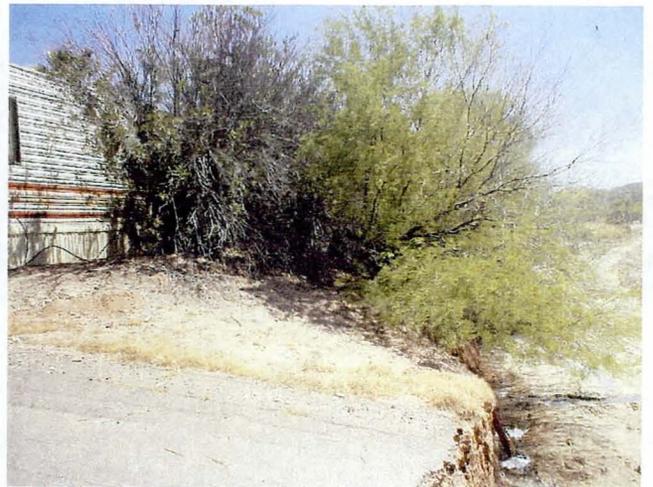
Damaged road at Horspitality RV Park

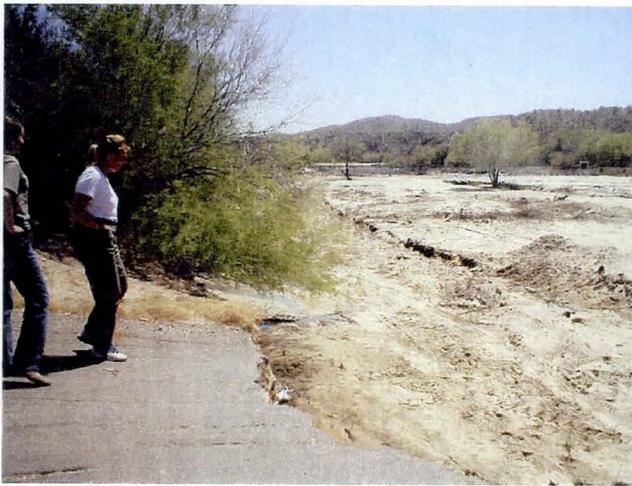
Damaged road at Horspitality RV park that used to lead to the horse pens

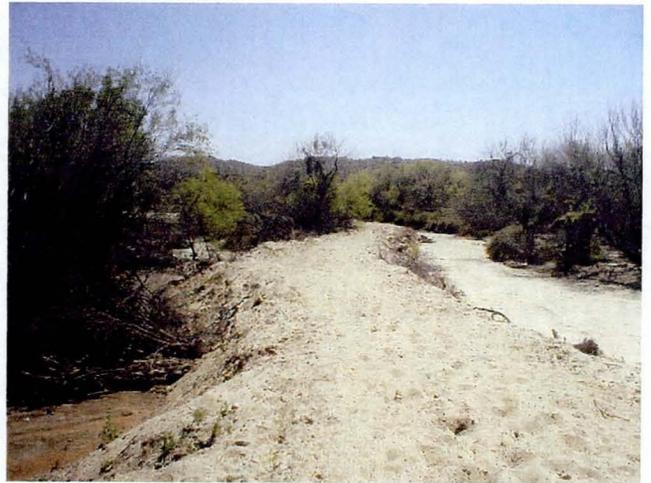
Temporary berm built behind Horspitality RV Park
