PROPOSAL FOR REHABILITATION

WHITE TANK MOUNTAINS
FLOOD RETARDING
STRUCTURES #3 AND #4

PILOT WATERSHED PROJECT
MARICOPA COUNTY, ARIZONA

UNITED STATES DEPARTMENT OF AGRICULTURE
SOIL CONSERVATION SERVICE
NOVEMBER 1991

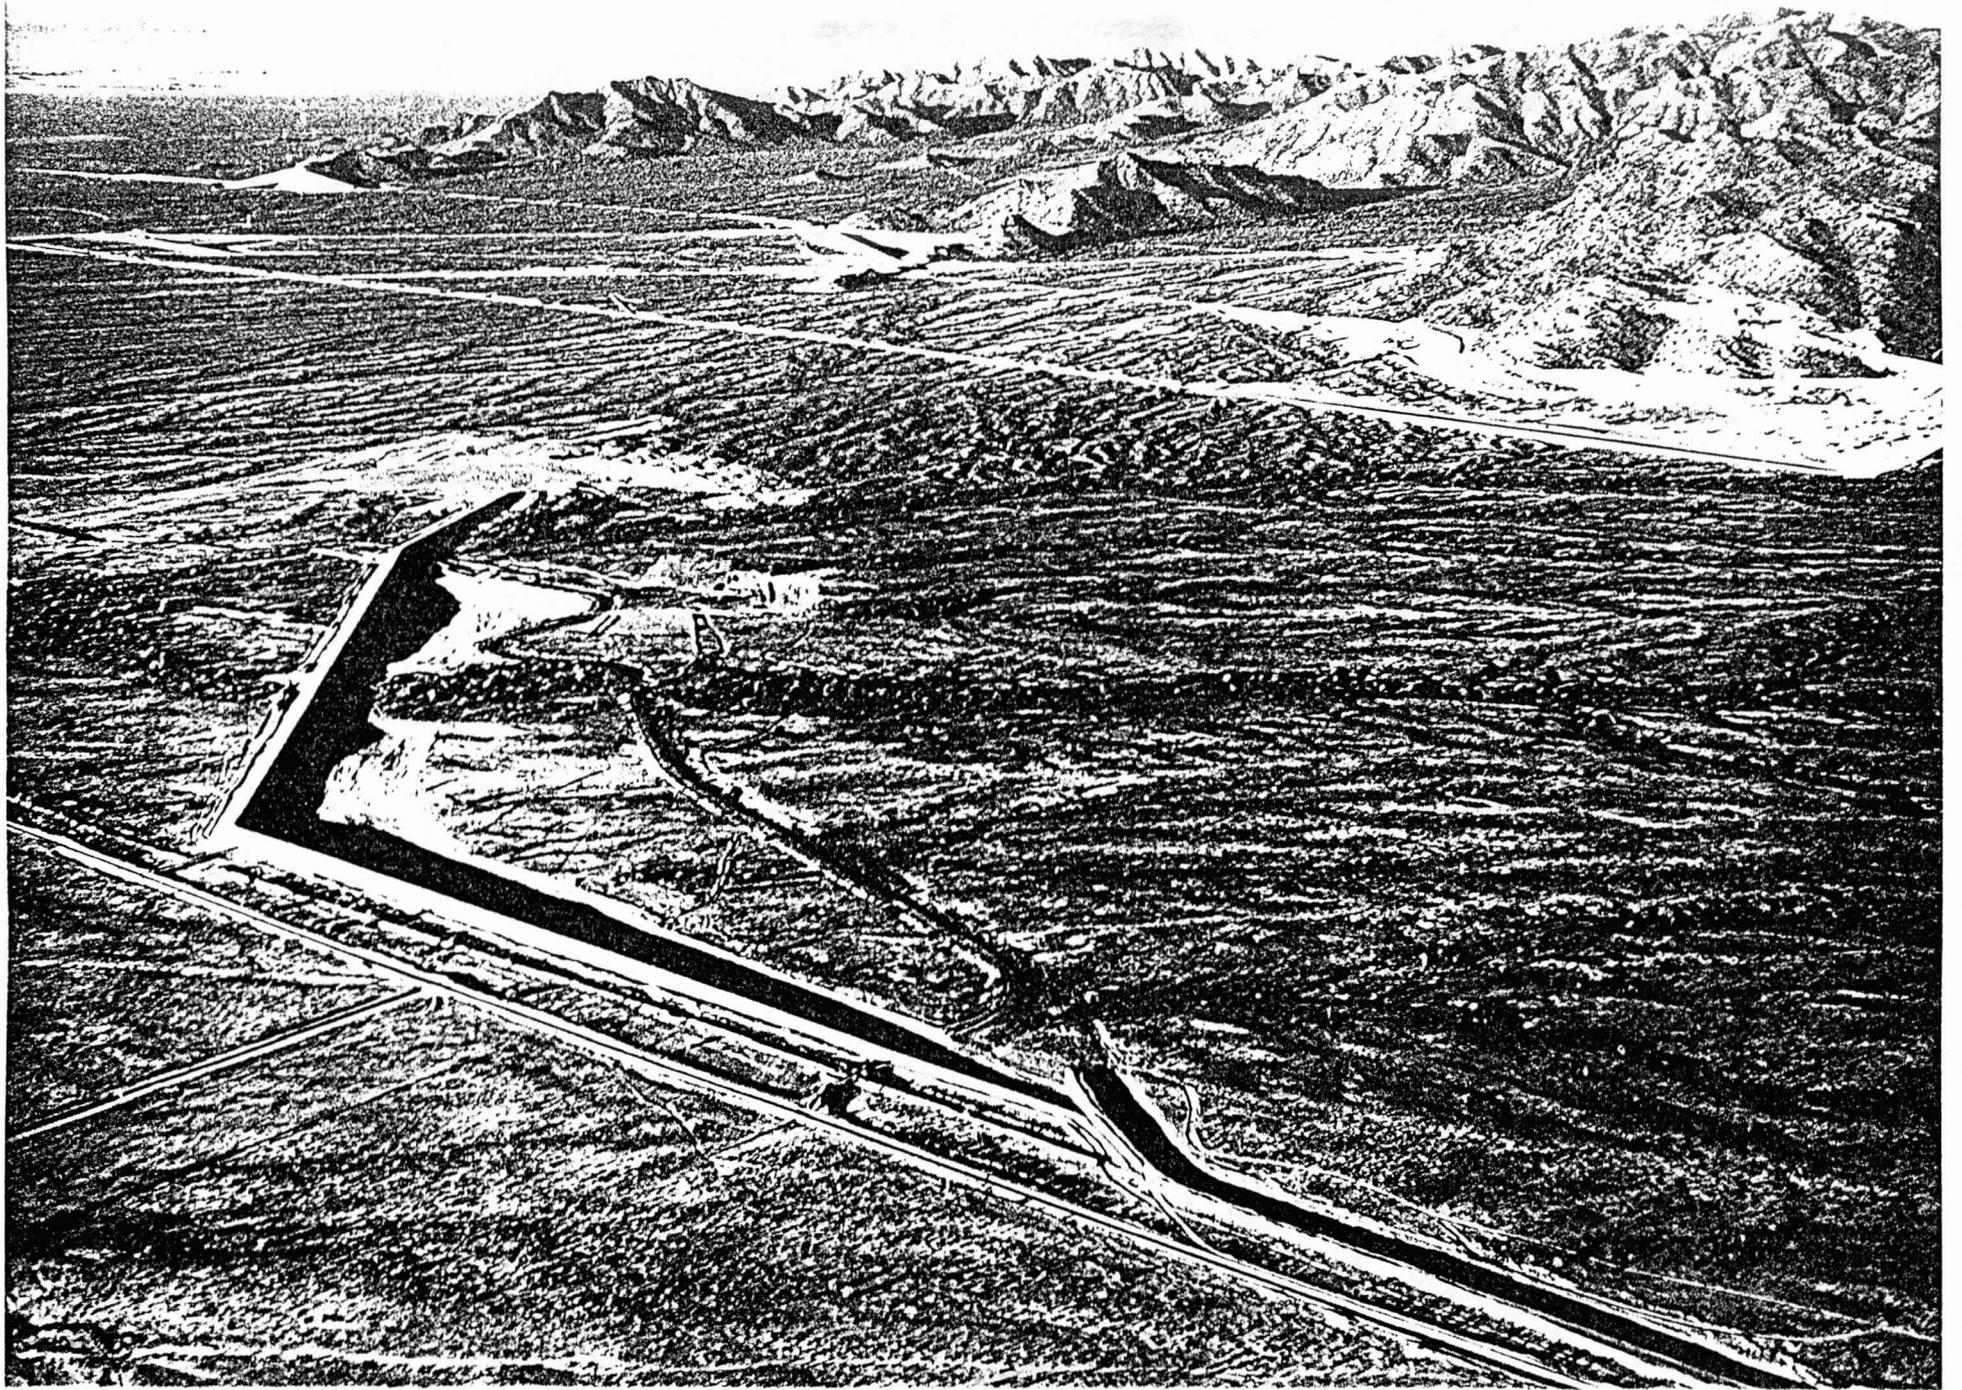
White Tanks Project Structure #3
and diversion dikes in foreground,
White Tank Mountain in background.
View facing southwest.

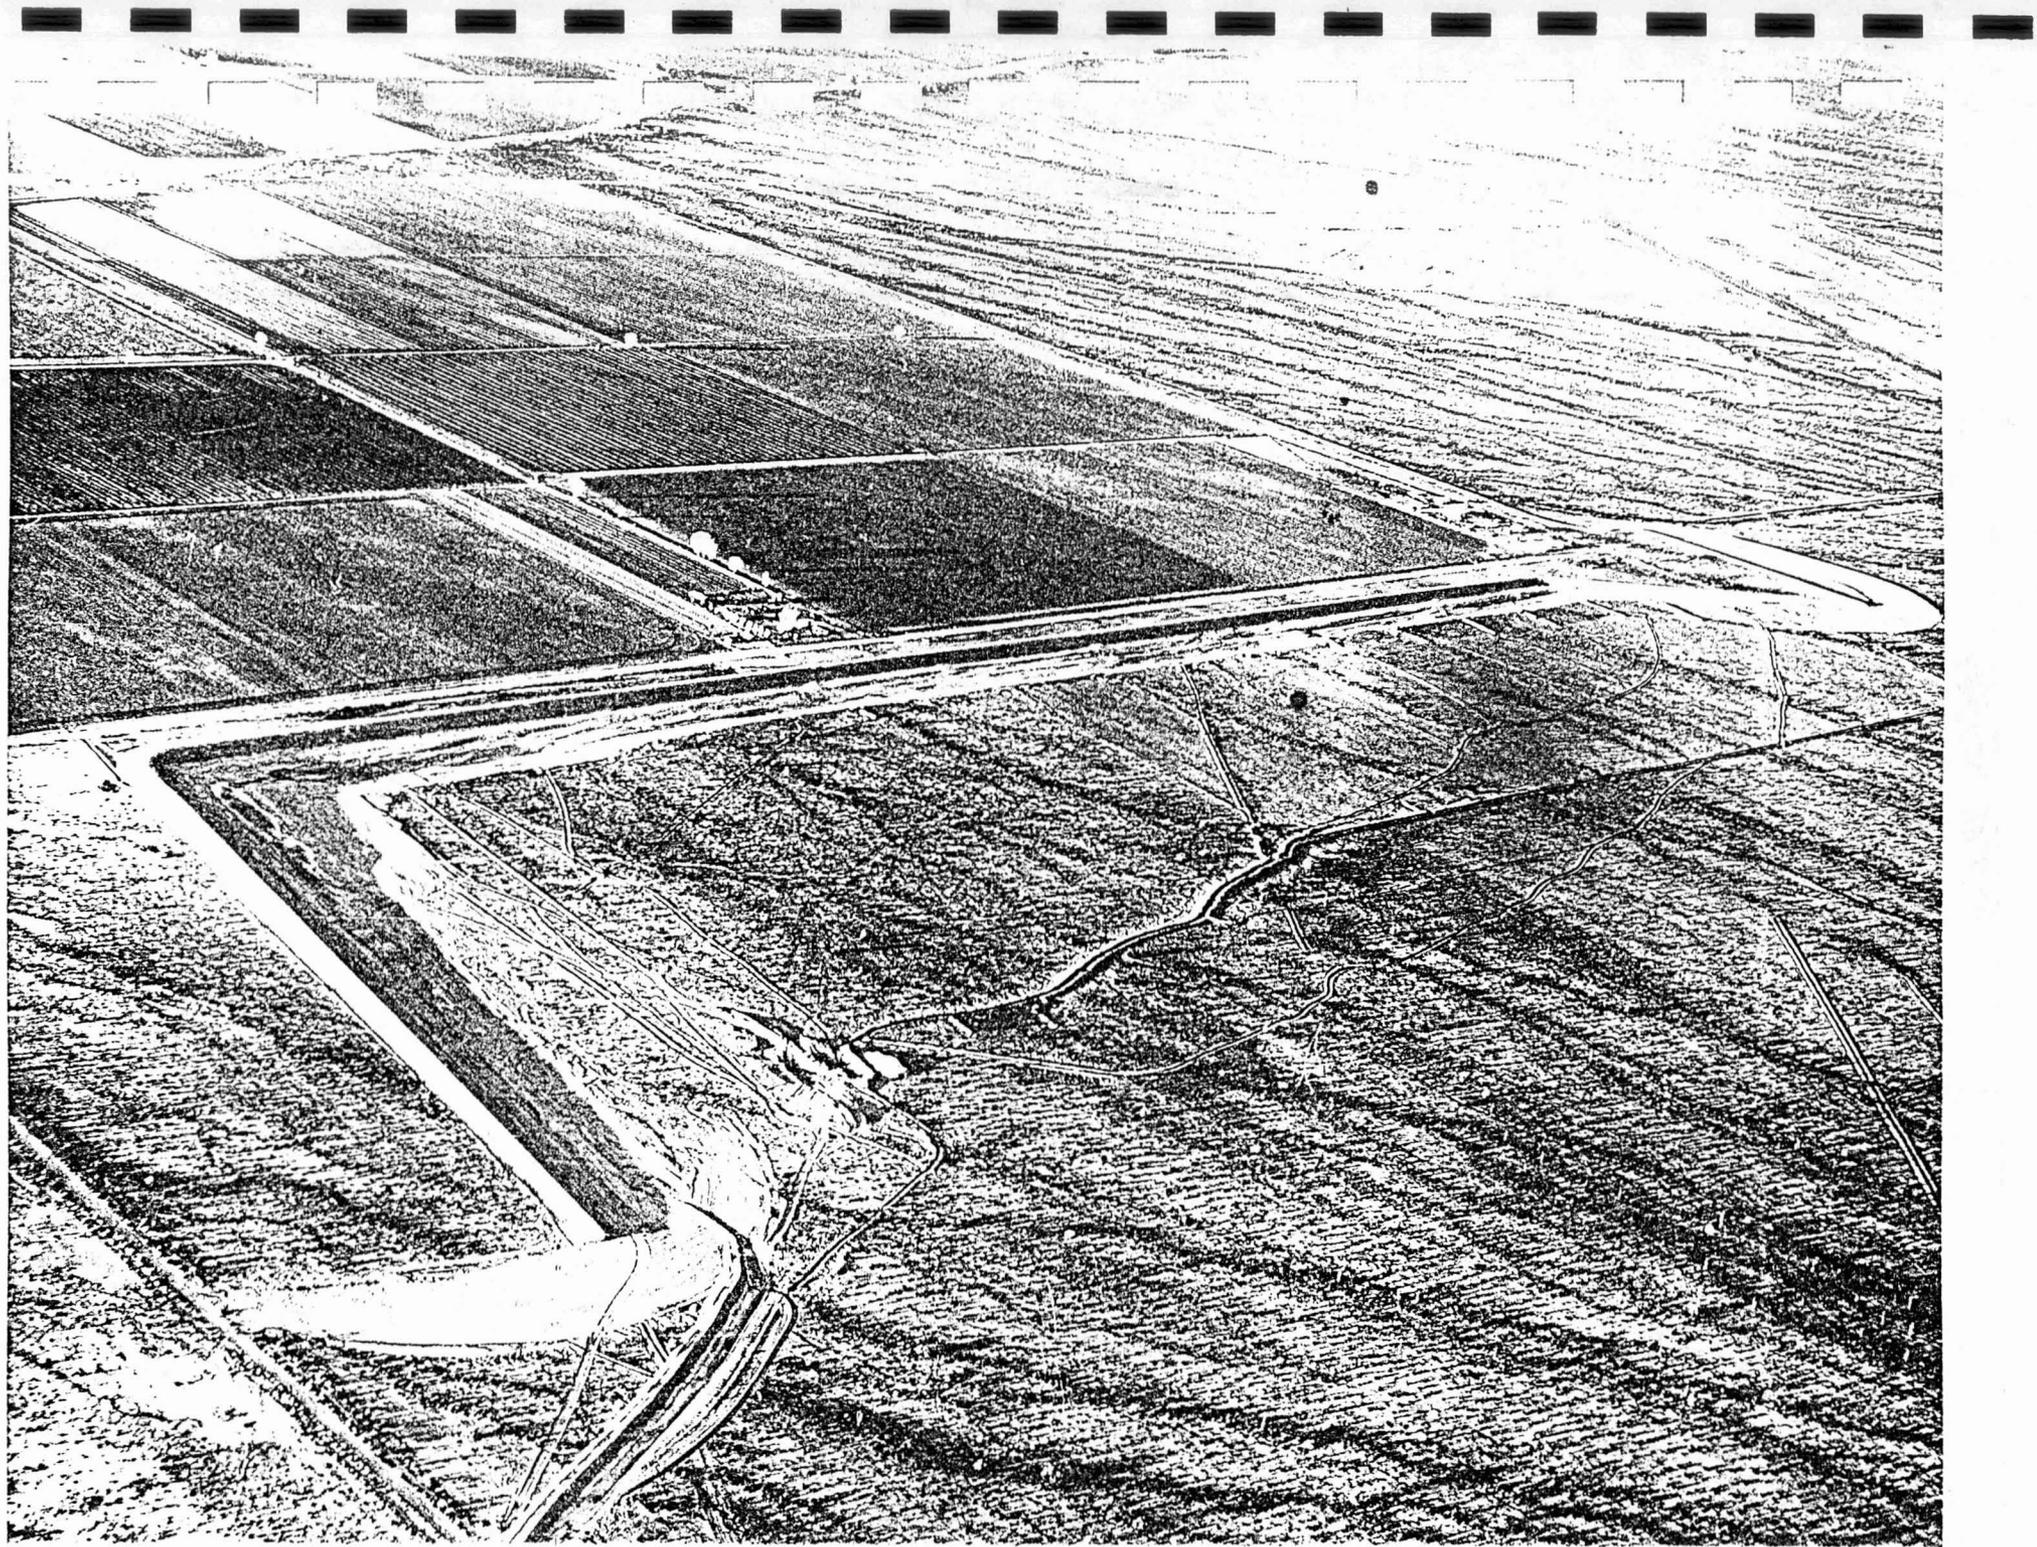
AZ-5318

White Tanks Structure #4.
View facing southwest, showing farm
lands protected. Diversion dike into
flood retarding basin in center foreground.

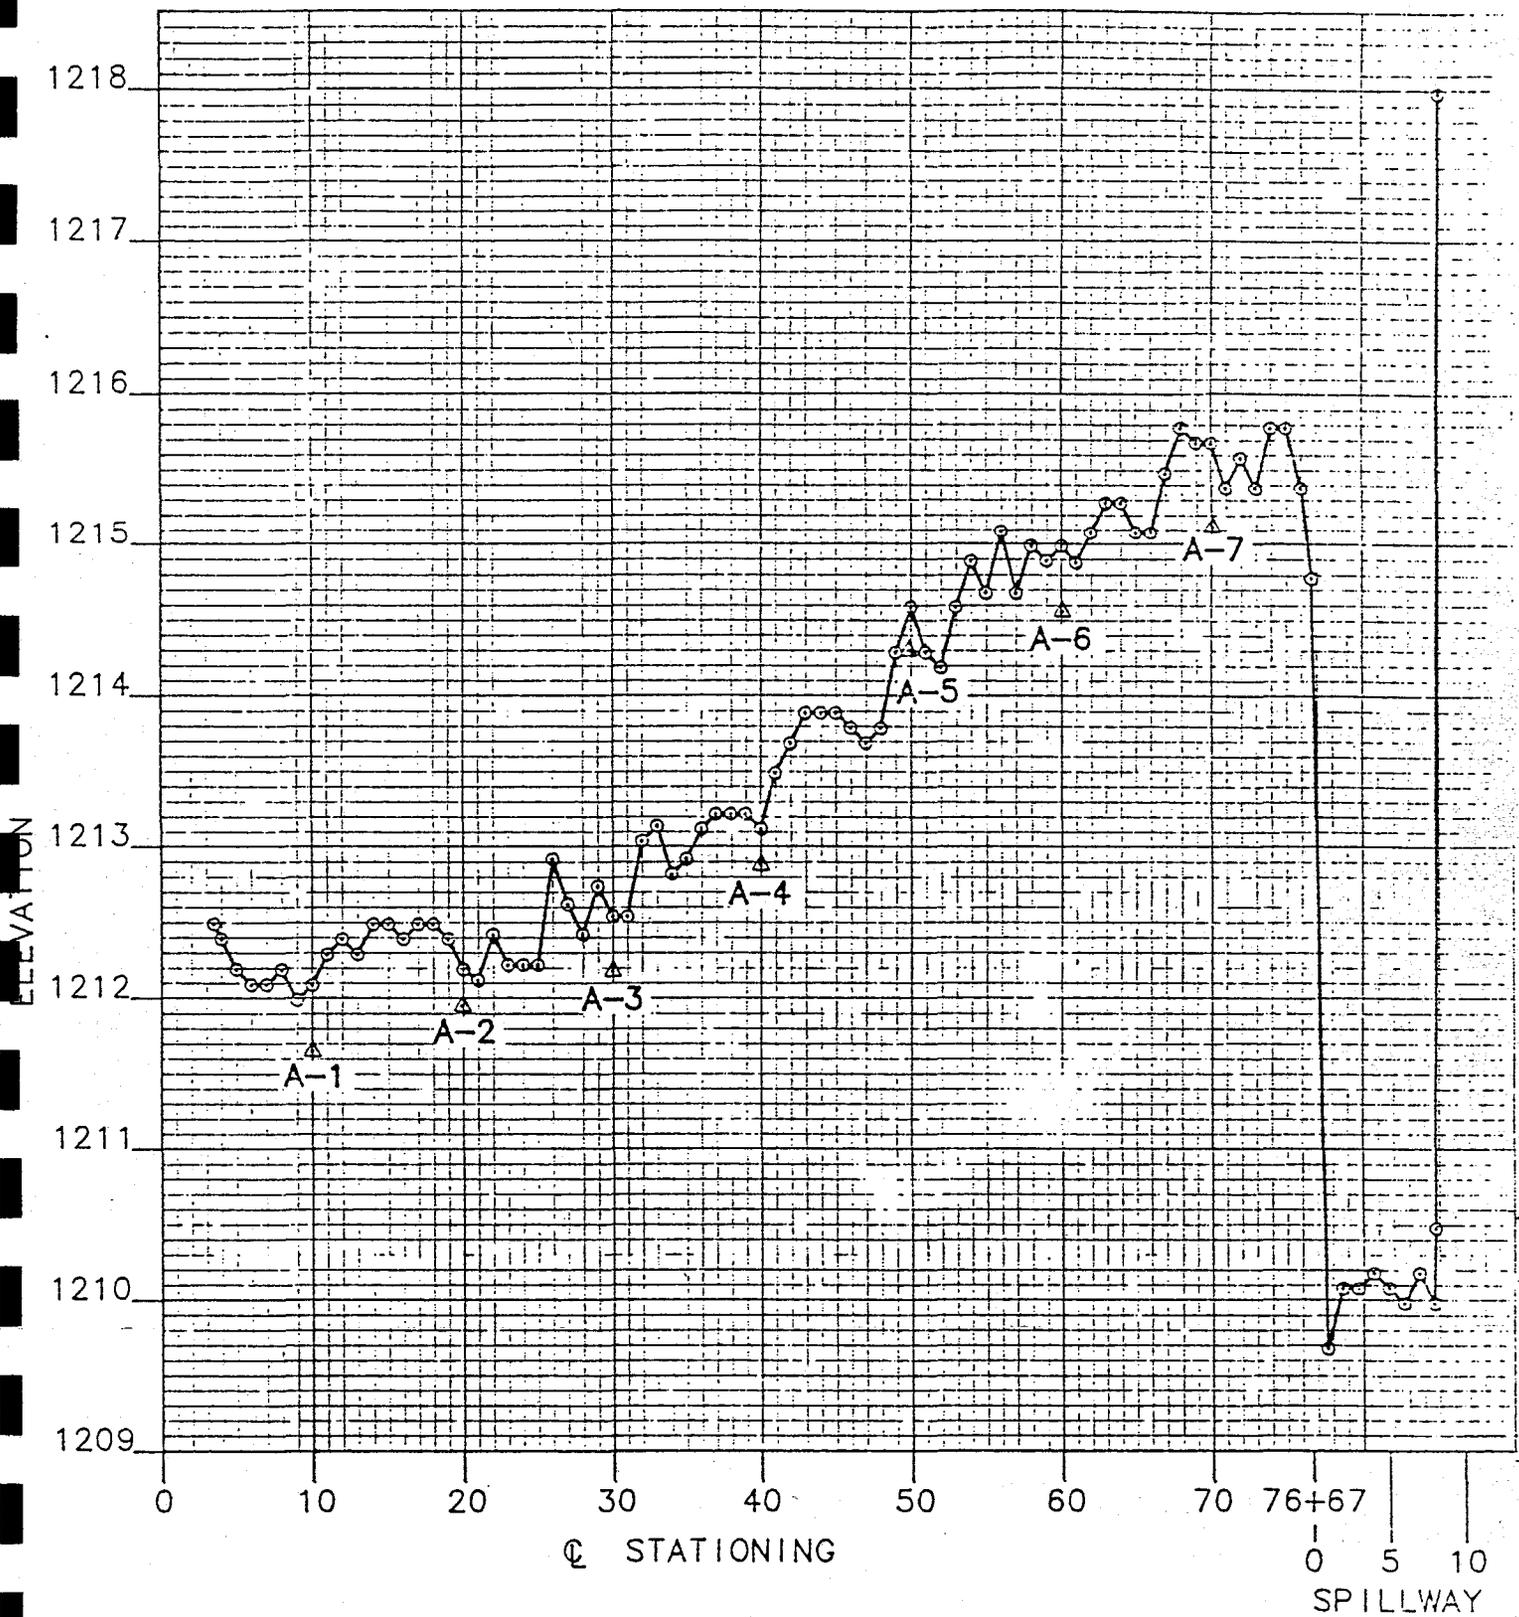
FIGURE 4
 WHITE TANKS #3
 1990 CENTERLINE SURVEY

The most recent survey of dam centerline was taken December 17, 1990. Figure 4 is a plot of that survey, and shows the current relationship between the spillway and the dam. The approximate average elevation of the spillway is 1.9 ft below the lowest point surveyed on the dam. The design maximum water surface was 3 ft above the spillway demonstrating that the dam could not withstand such an event.

Figures 3 and 4 also demonstrate that little differential subsidence took place between Stations 0+00 and 30+00 on the northerly end, and between 60+00 and 75+00 on the southerly end as previously discussed. The elevation of subsidence monument A-1 was 1207.883 in July 1991, based on BM 8-90. Ties to USC&GS monuments showed the correct elevation to be 1211.561 in accordance with BM Q475. The original design called for a crest elevation of 1216.0, so the lowest existing crest elevation is 4.439' below design level.

1. Raise the dam crest to the elevation required to pass the full PMF without failure.

2. Enlarge the emergency spillway to pass the required design flow through the structure. Note, a mechanical spillway may be required due to the highly erosive soils present at the site.
3. Raise the height of the crest elevation to accommodate future subsidence.
4. Extend the dam as needed for catch point to reach the elevation of top of crest.
5. Provide gravel surface to embankment slopes to prevent rilling, gullyng, and crack protection.

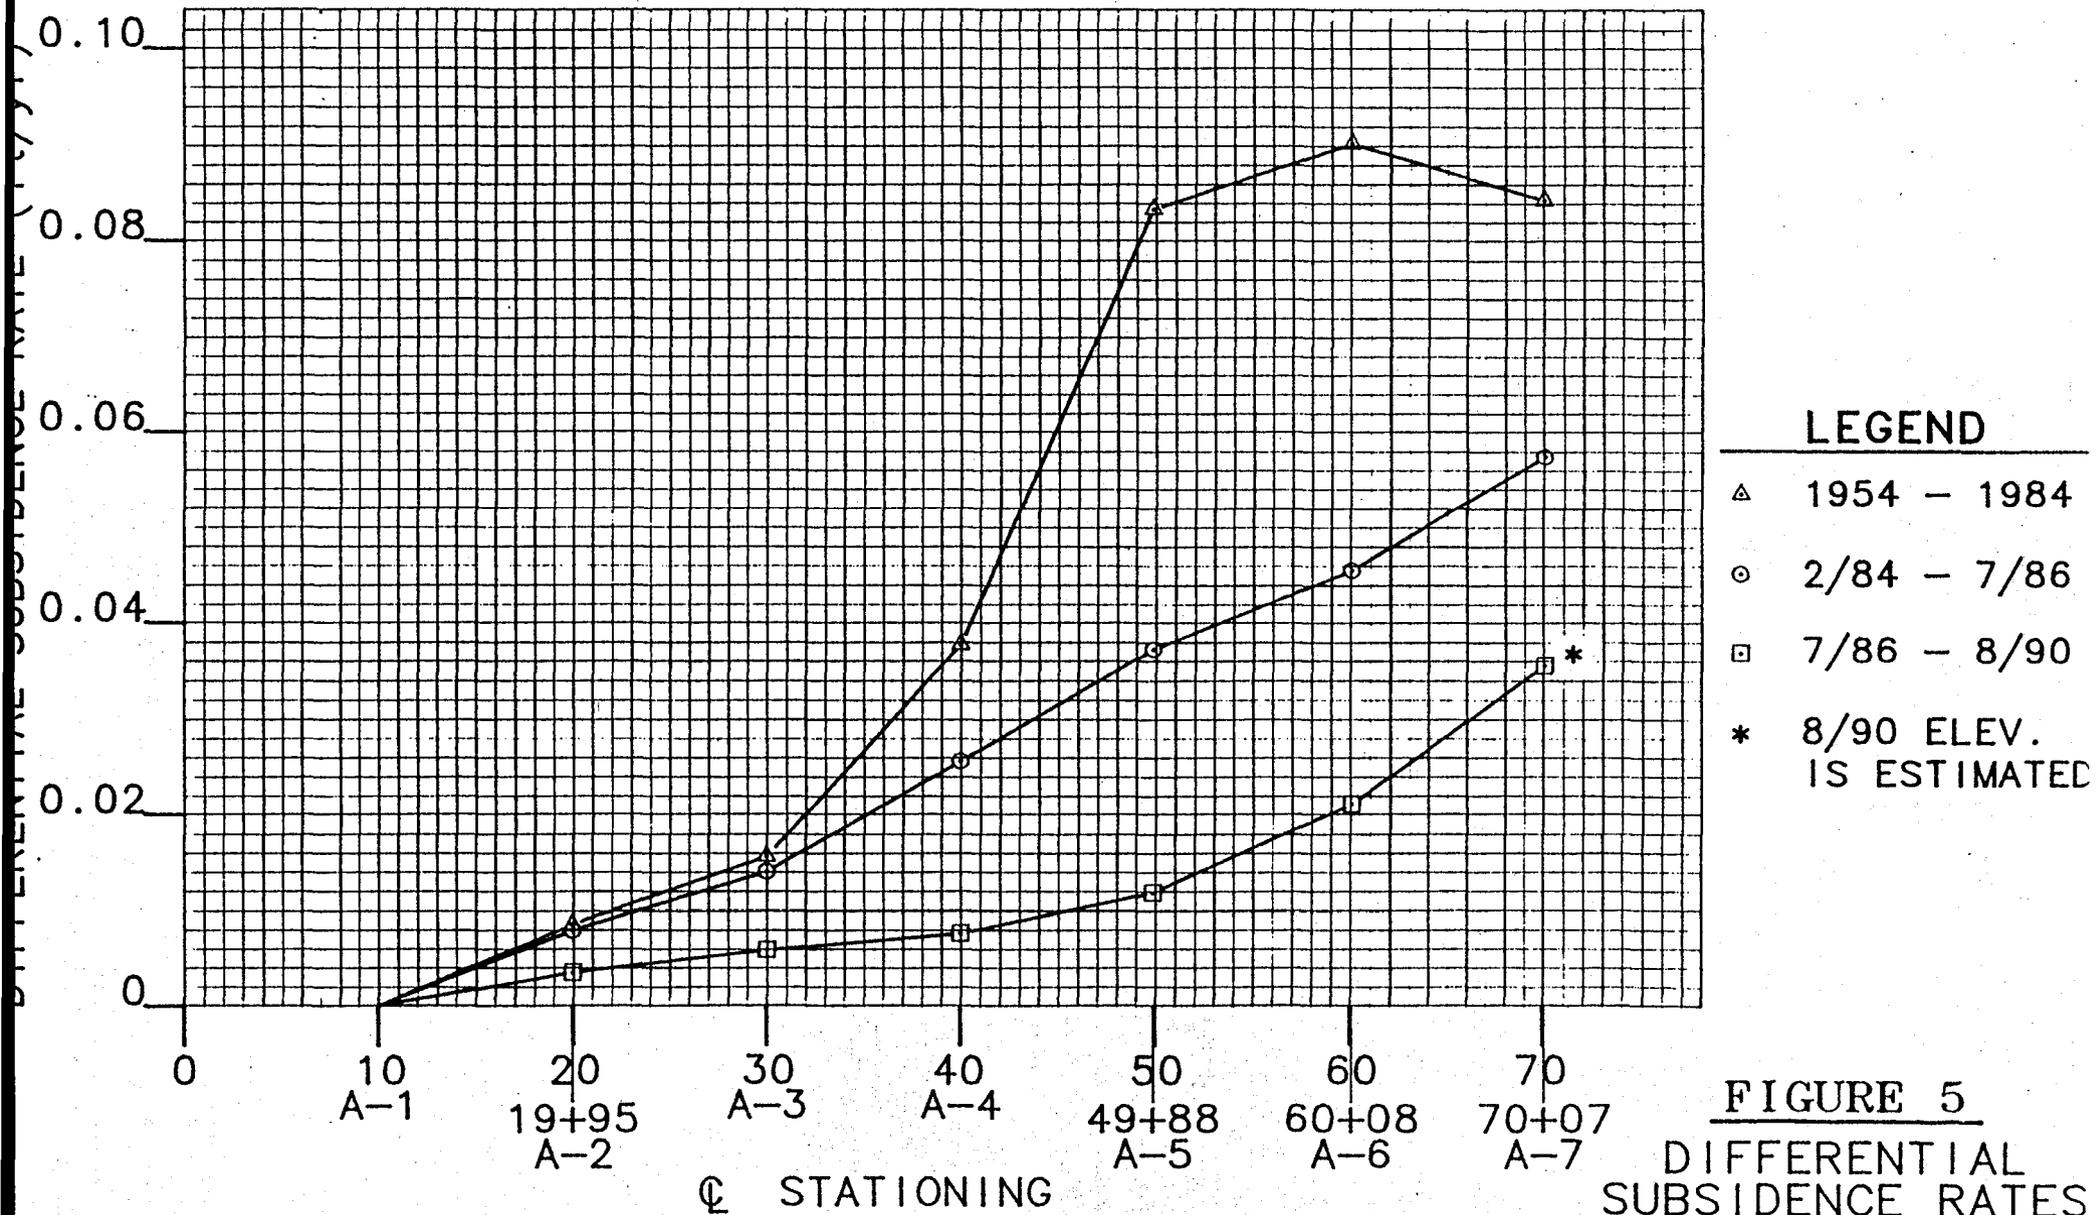
FIGURE 5
DIFFERENTIAL SUBSIDENCE RATES OF "A" MONUMENTS

POINTS ON CURVES REPRESENT RATES OF DIFFERENTIAL SUBSIDENCE OF BENCH MARK A-1 WITH RESPECT TO OTHER "A" BENCH MARKS.

the dam fill has been in the area of stations 50+00 to 70+00 during the most recent years.

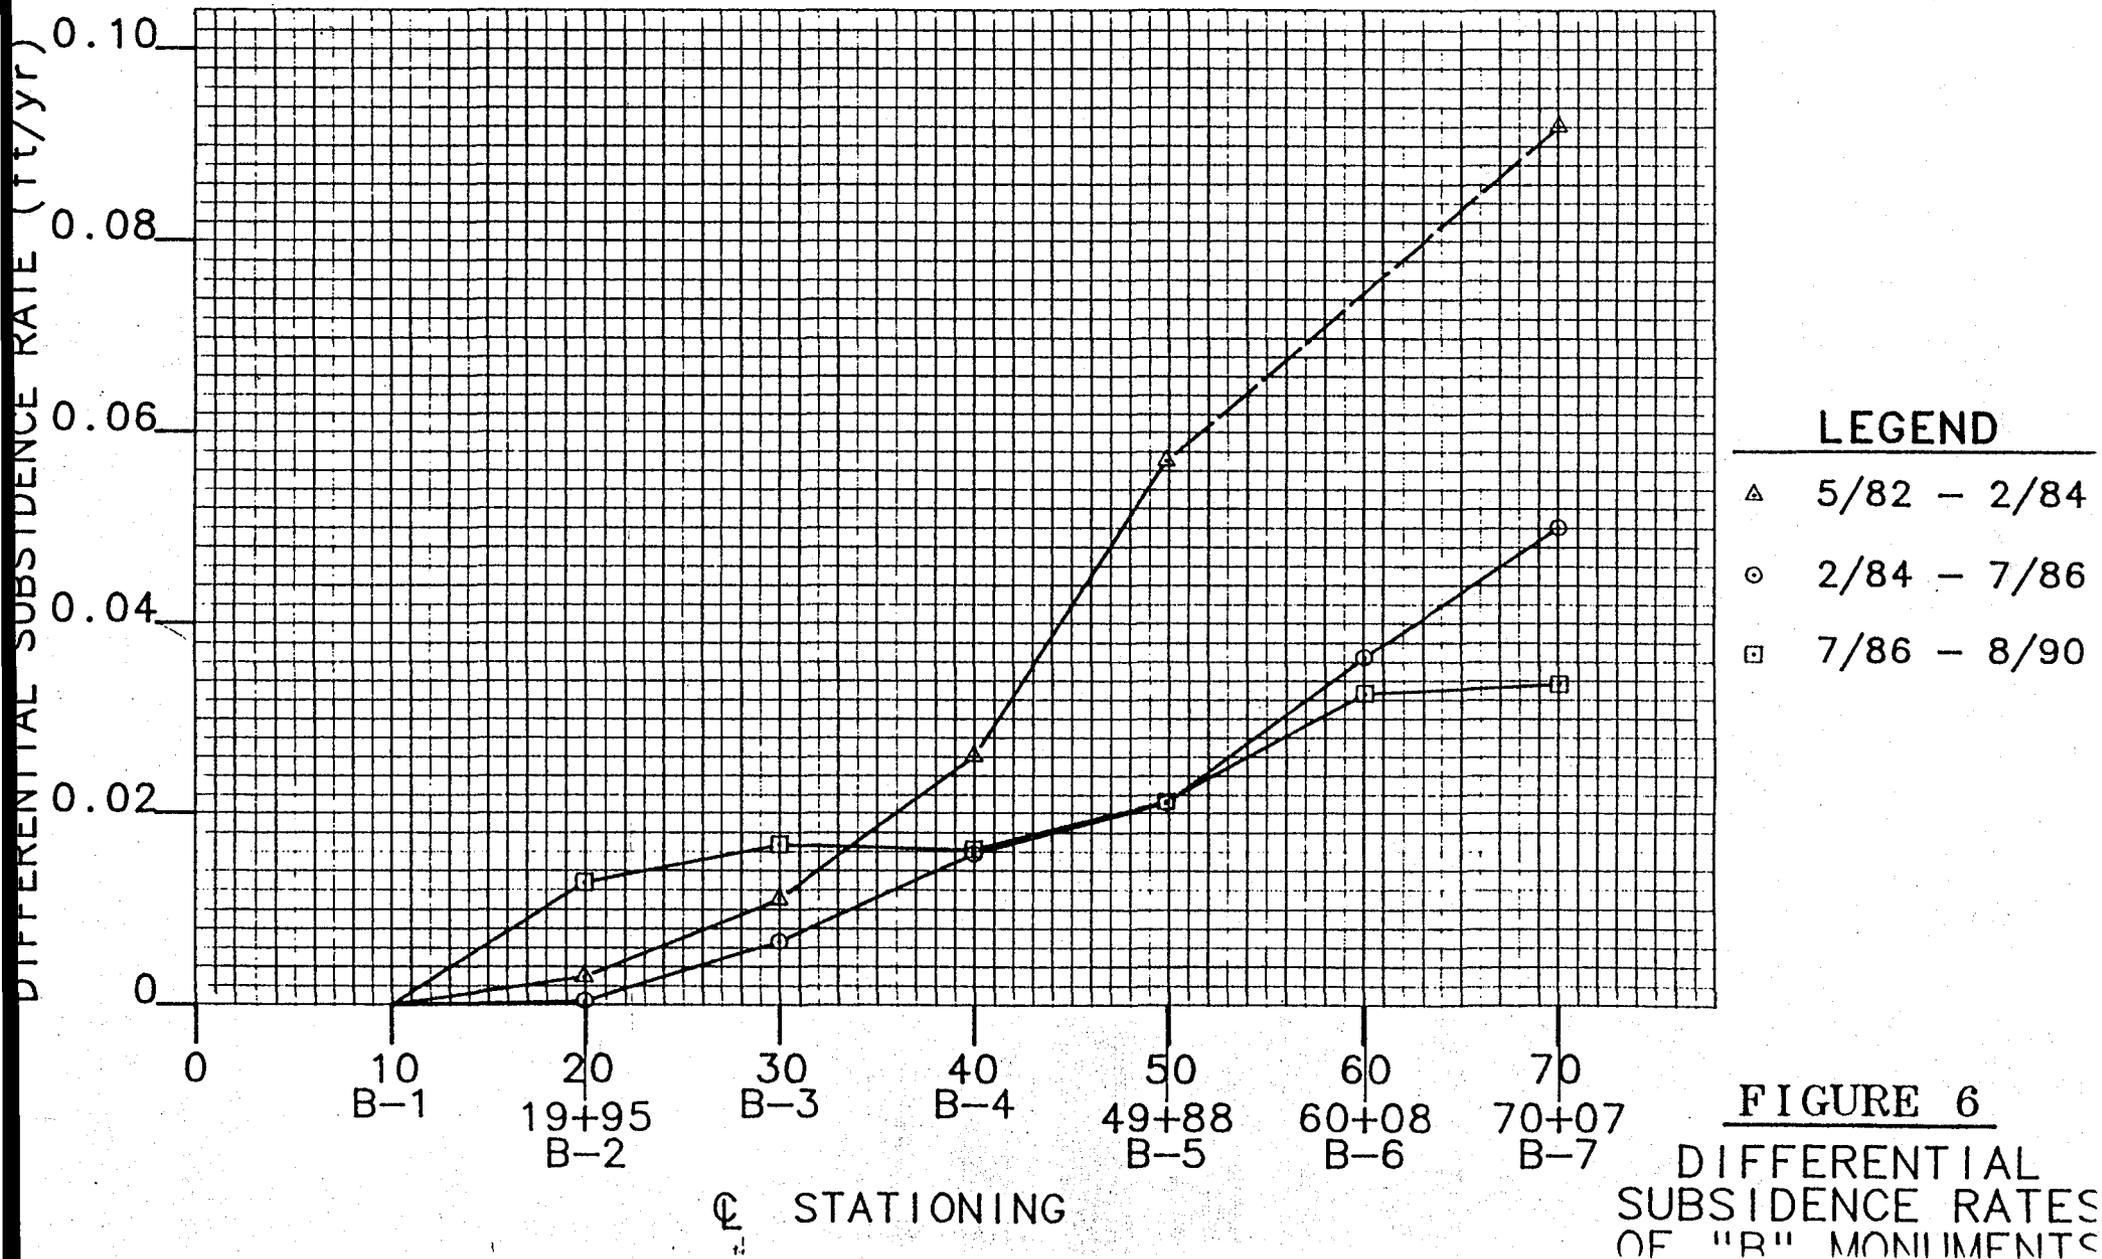
FIGURE 6
DIFFERENTIAL SUBSIDENCE RATES OF "B" MONUMENTS

POINTS ON CURVES REPRESENT RATES OF DIFFERENTIAL SUBSIDENCE OF BENCH MARK B-1 WITH RESPECT TO OTHER "B" BENCH MARKS.
