CONCRETE QUALITY REPORT

CAVE CREEK DAM
Maricopa County, Arizona

RE: CAVE CREEK DAM

JOB No. 69-36

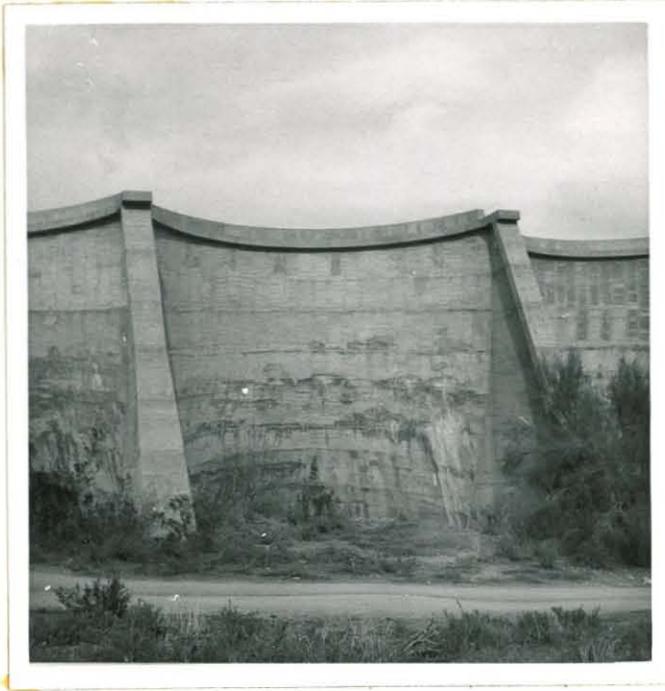
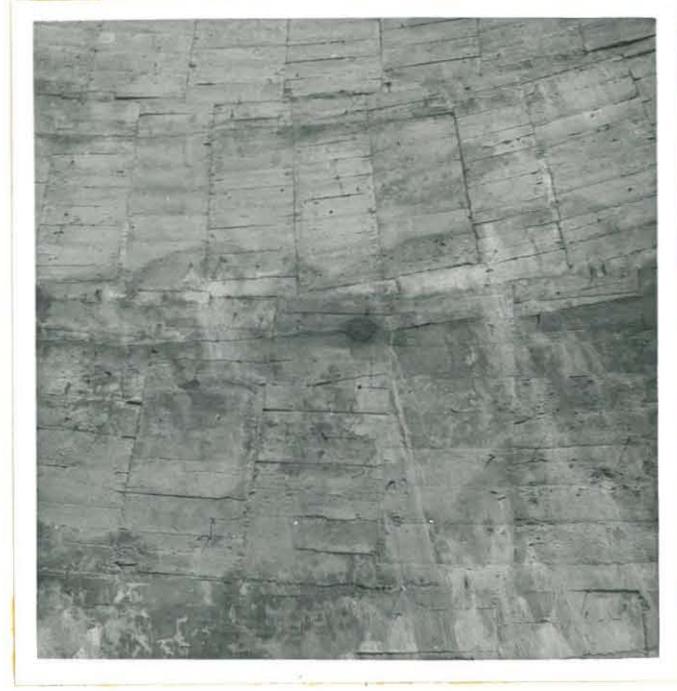
4" CORE No. 1
ARCH No. 6

CORE No. 1 - ARCH No. 6: 4" DIAMETER, $12\frac{1}{2}$ " LONG. CORED IN CRACK, 20' DOWN FROM DAM TOP AND $5'6''$ FROM EAST ABUTMENT. THE CRACK WAS SMALL, EXTENDING TO A DEPTH OF $3\frac{1}{2}$ ". CORE WENT COMPLETELY THROUGH DAM AND INDICATED GOOD DENSE CONCRETE THROUGHOUT.

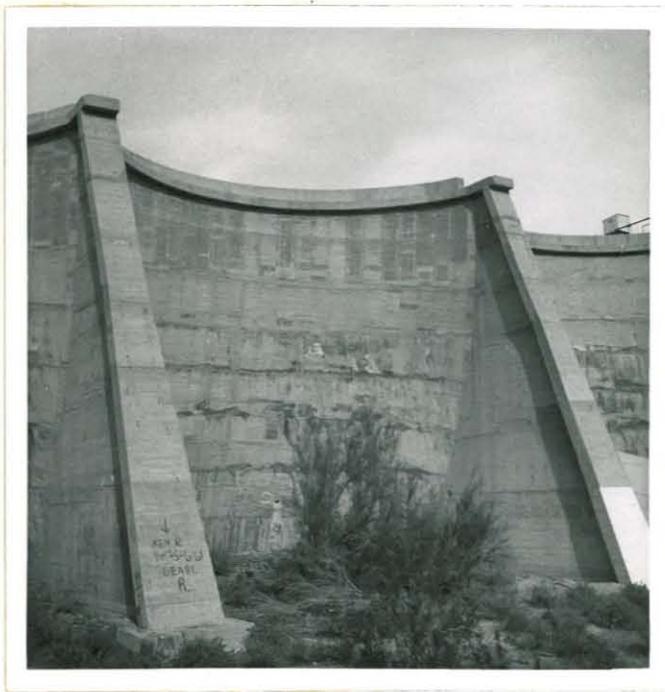
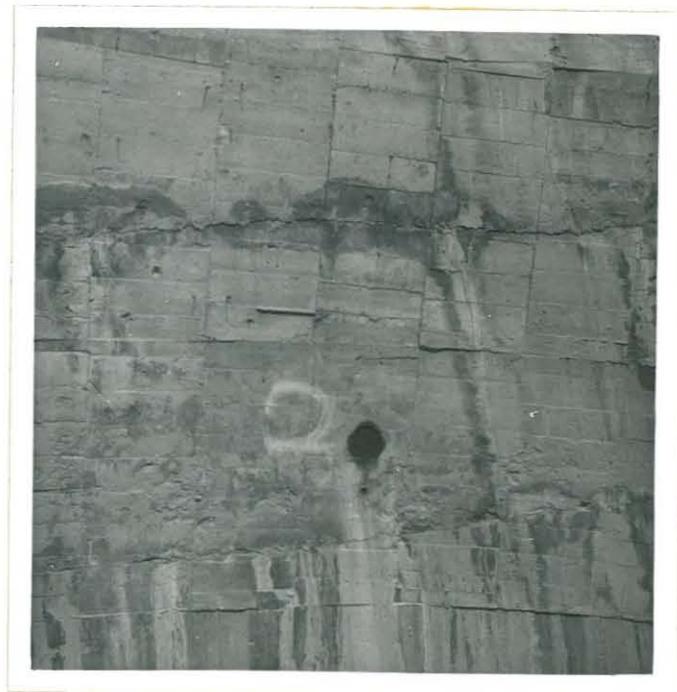
4" CORE No. 2
ARCH No. 8

CORE No. 2 - ARCH No. 8: 6" DIAMETER, 12" LONG. CORED BETWEEN JOINTS ONE AND TWO, DOWN 33' FROM DAM TOP AND $15'4''$ FROM EAST ABUTMENT. THIS CORE WAS TAKEN FOR TEST PURPOSES AND RESULTED IN A COMPRESSIVE STRENGTH OF 3842 PSI.

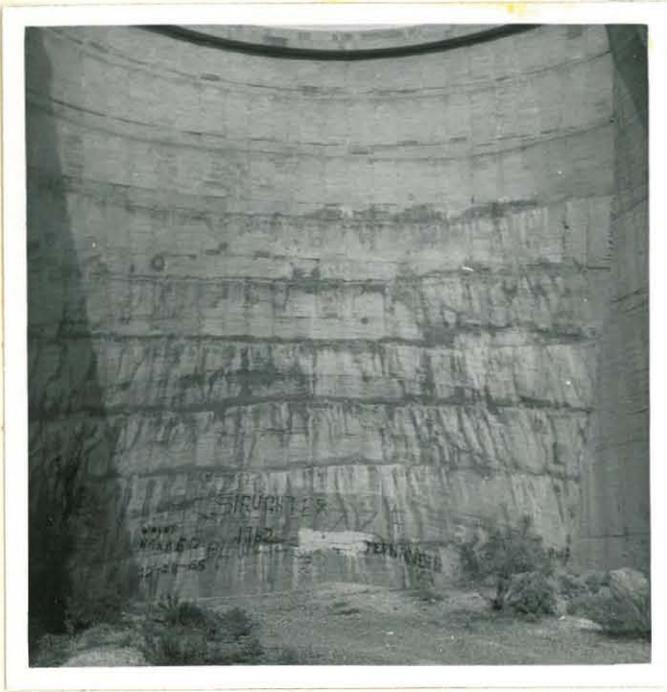
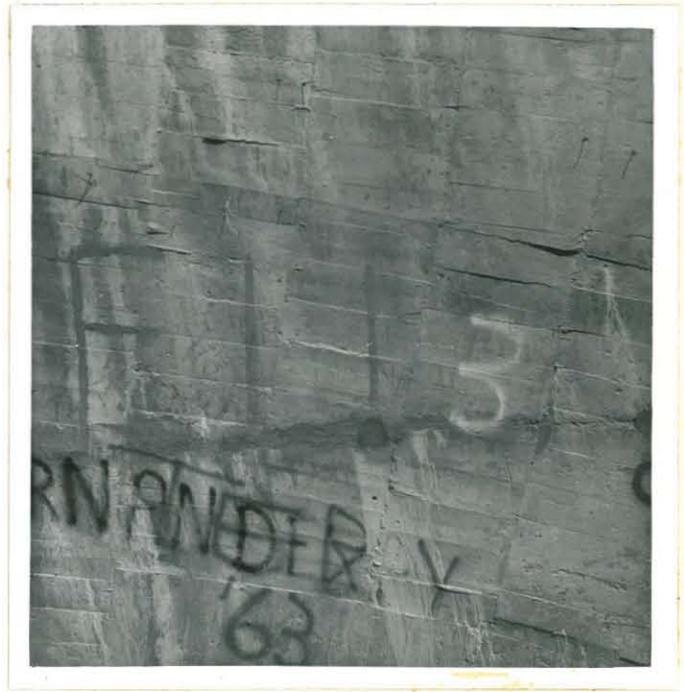
4" CORE No. 3
ARCH No. 10

CORE No. 3 - ARCH No. 10: 4" DIAMETER, $18\frac{1}{2}$ " LONG. CORED IN PATCHED CRACK, DOWN $39'7''$ FROM DAM TOP AND 7' FROM EAST ABUTMENT. CORE WENT COMPLETELY THROUGH DAM, AND BROKE AT A DEPTH OF APPROXIMATELY 8" DUE TO POOR BOND WITH SOME FLAT AGGREGATE, OTHERWISE THE CONCRETE APPEARED TO BE OF GOOD QUALITY.

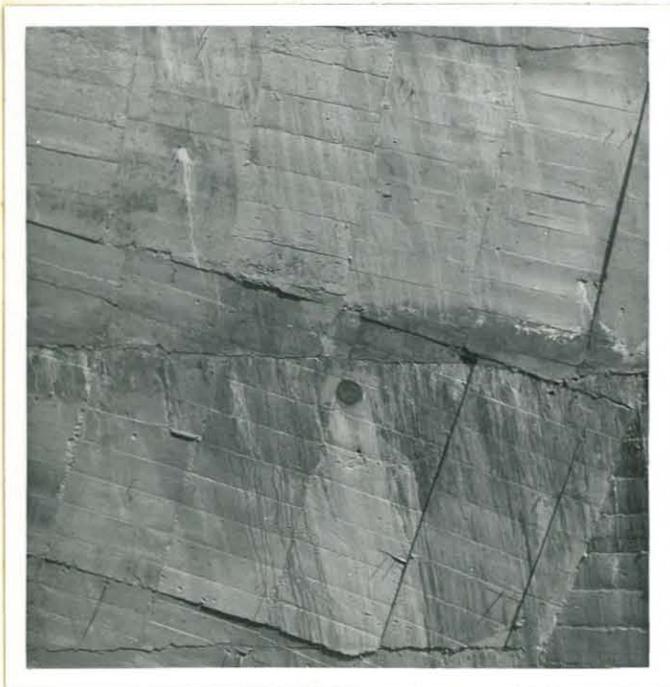
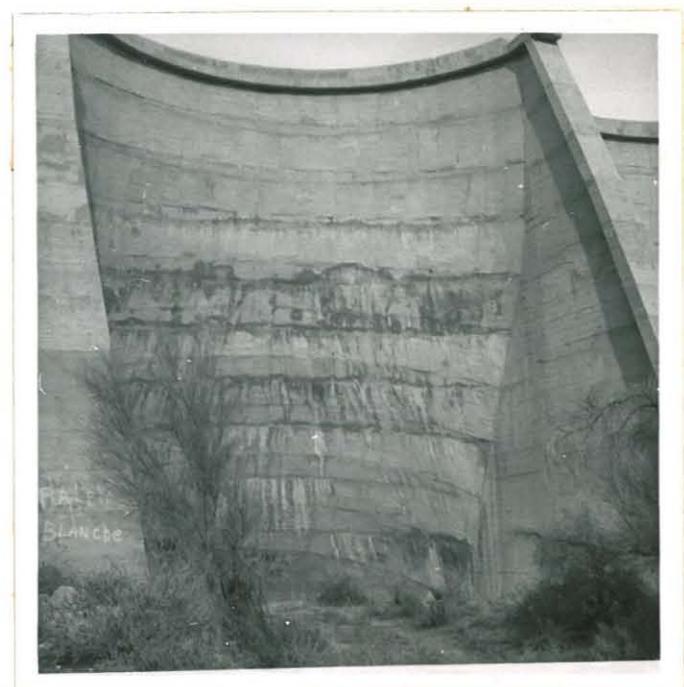
4" CORE No. 4
ARCH No. 11

CORE No. 4 - ARCH No. 11: 4" DIAMETER, $19\frac{1}{2}$ " LONG. CORED BELOW CRACK IN AREA COVERED WITH BROWN MUD STAINS, DOWN $45'3''$ FROM DAM TOP AND $2'6''$ FROM EAST ABUTMENT. CORE WENT COMPLETELY THROUGH DAM, WAS STARTED BELOW A CRACK IN AN EFFORT TO INTERSECT SAME. HOWEVER, THE CRACK WAS NEVER INTERSECTED. GOOD DENSE CONCRETE EXCEPT FOR A DEPTH OF FROM 10" TO 16" WHERE SMALL VOIDS WERE NOTICED AROUND AGGREGATE ON ONE SIDE.

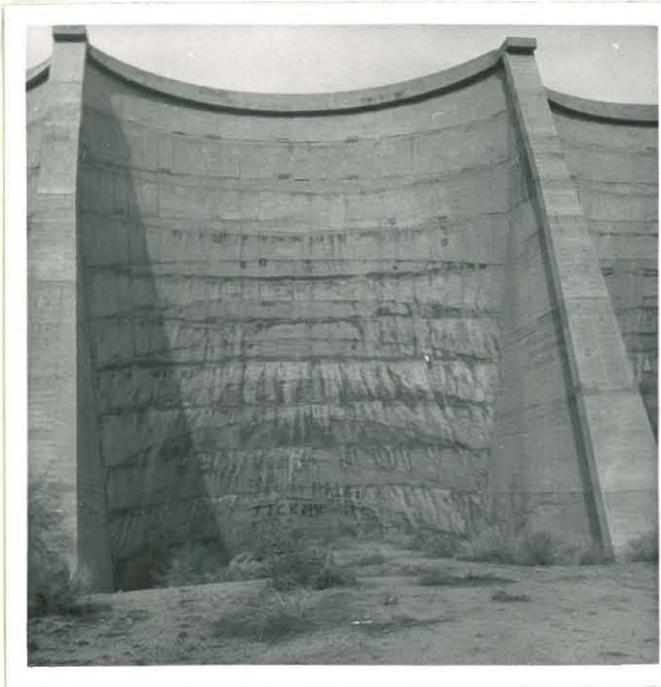
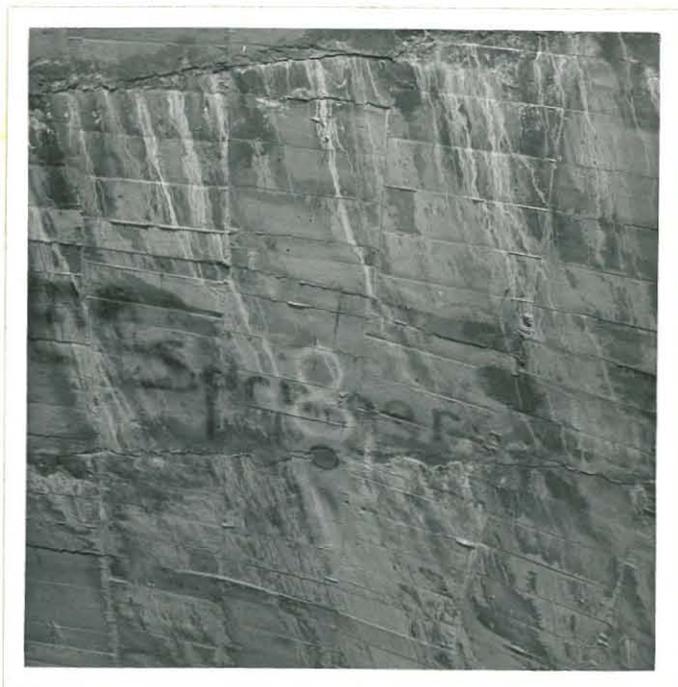
4" CORE No. 8
ARCH No. 18

CORE No. 8 - ARCH No. 18: 4" DIAMETER, 12 $\frac{1}{2}$ " LONG. CORED IN CRACK, HEAVY BROWN STAIN ALONG WITH HEAVY EFFERVESCENCE, 48'5" DOWN FROM DAM TOP AND 6'4" FROM EAST ABUTMENT. CRACK EXTENDED TO A DEPTH OF 5 $\frac{1}{2}$ ". CUT THROUGH $\frac{3}{4}$ " REINFORCING BAR 3 $\frac{1}{2}$ " IN. NO RUST ON BAR AND CONCRETE APPEARED TO BE GOOD AND DENSE THROUGHOUT.

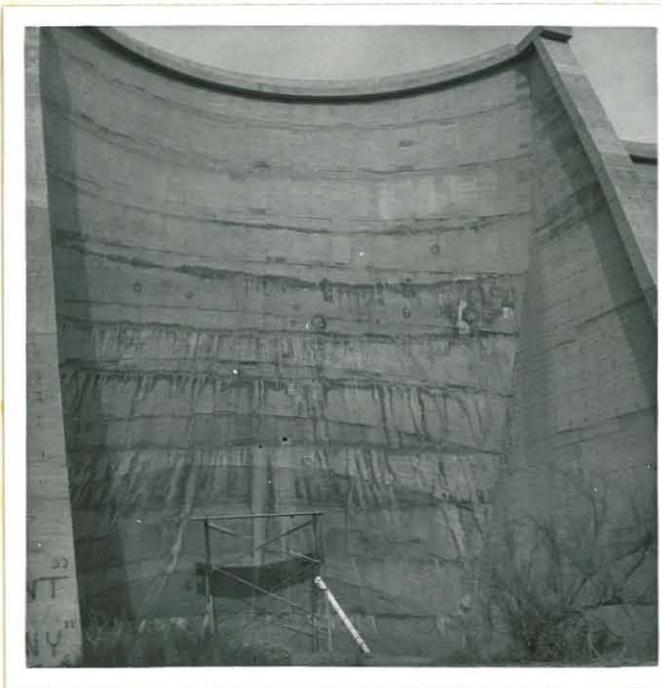
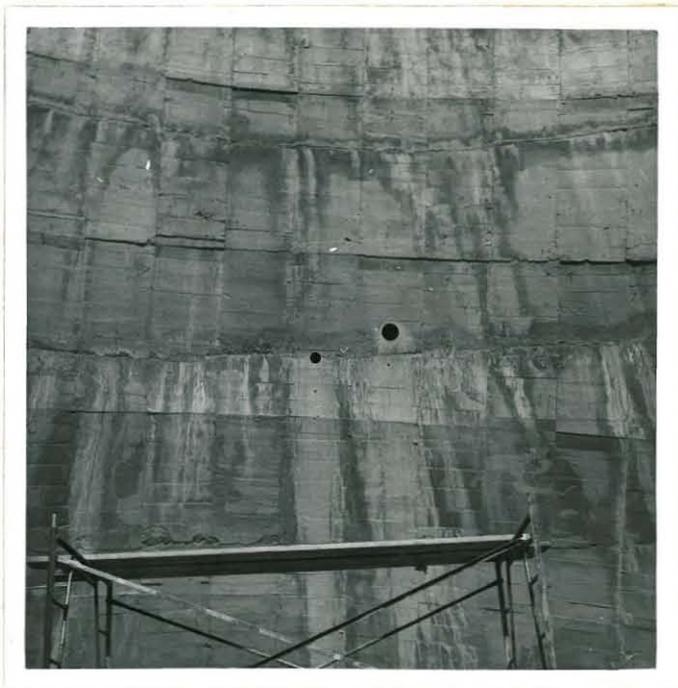
4" CORE No. 9
6" CORE No. 10
ARCH No. 22

CORE No. 9 - ARCH No. 22: 4" DIAMETER, 12" LONG. CORED IN CRACK, HEAVY EFFERVESCENCE, 34' DOWN FROM DAM TOP AND 17' FROM EAST ABUTMENT. CRACK EXTENDED TO A DEPTH OF 3 $\frac{1}{2}$ ". CORE BROKE OFF AT END DUE TO CONCENTRATION OF AGGREGATE. OTHERWISE, CONCRETE APPEARED TO BE GOOD AND DENSE THROUGHOUT.

CORE No. 10 - ARCH No. 22: 6" DIAMETER, 12" LONG. CORED 34'9" DOWN FROM DAM TOP AND 18'6" FROM EAST ABUTMENT. THIS CORE WAS TAKEN FOR TEST PURPOSES AND RESULTED IN A COMPRESSIVE STRENGTH OF 2933 PSI.

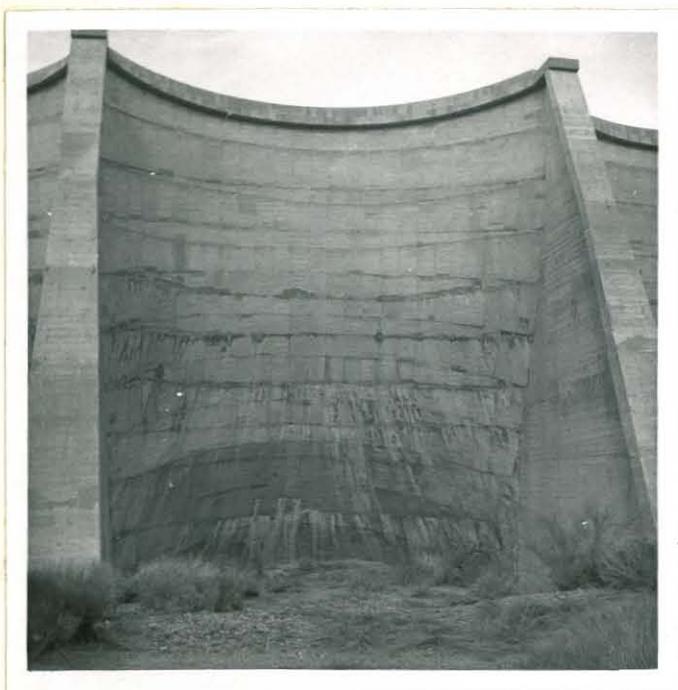
4" CORE No. 12
ARCH No. 27

CORE No. 12 - ARCH No. 27: 4" DIAMETER, 16" LONG. CORED IN CRACK, HEAVY EFFERVESCENCE IN THIS AREA, 43' DOWN FROM DAM TOP AND 22'10" FROM EAST ABUTMENT. CUT THROUGH $\frac{3}{4}$ " REINFORCING BAR $2\frac{3}{4}$ " IN. BAR SHOWED NO RUST, BUT CONCRETE AREA SHOWED A SMALL CRACK FROM FACE OF BAR TO THE FACE OF THE DAM. CORE BROKE AT DEPTHS INCLUDING LOCATIONS AT REBAR ON END (16") AND AT 8" IN WHERE A LARGE ROCK WAS BUT, $6\frac{1}{2}$ " OF WHICH WAS IN THE CORE. ROCK WAS BONDED WELL TO THE OTHER SECTION OF THE CORE. WITH THE EXCEPTION OF THE CRACK AND ROCK, THE CONCRETE APPEARED TO BE GOOD AND DENSE.

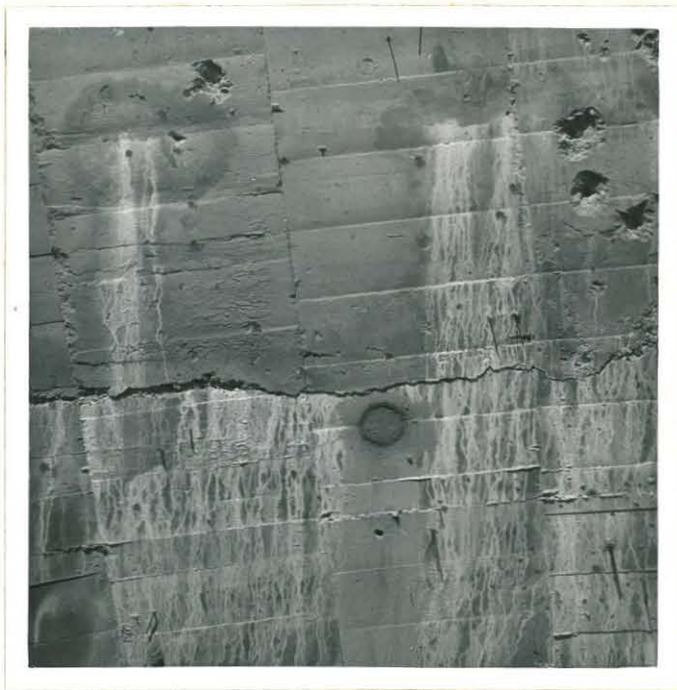
4" CORE No. 12
ARCH No. 27
NOTE: HOLES FROM
RIFLE BULLETS

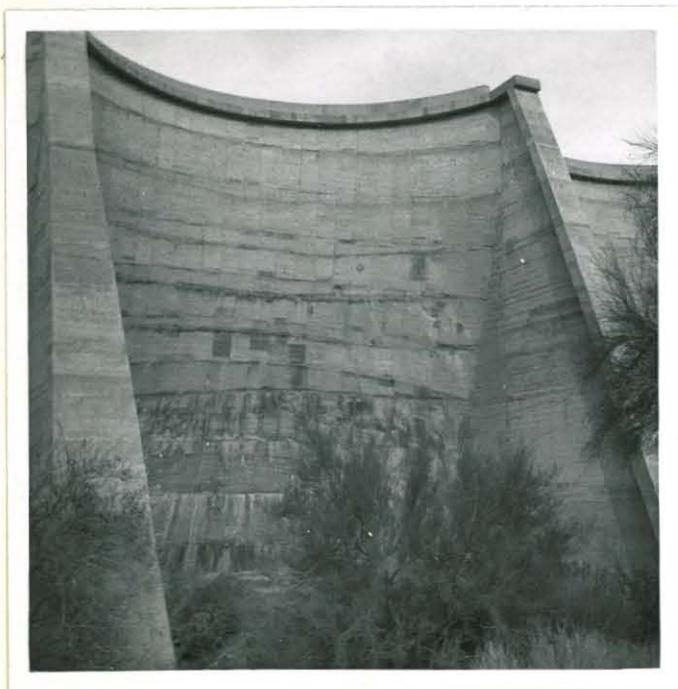
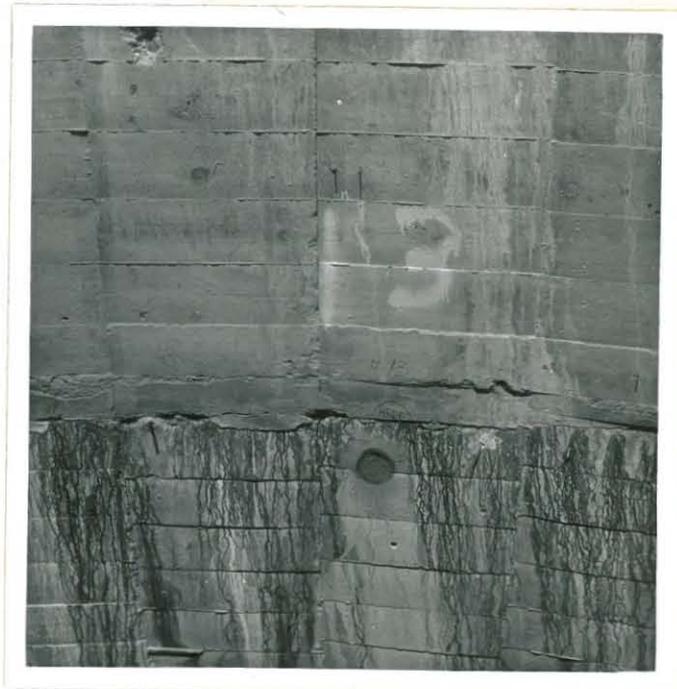
4" CORE No. 13
ARCH No. 29

CORE No. 13 - ARCH No. 29: 4" DIAMETER, $12\frac{1}{2}$ " LONG. CORED IN CRACK, HEAVY BROWN STAIN AREA, 44' DOWN FROM DAM TOP AND 17'6" FROM EAST ABUTMENT. STARTED CORING BELOW CRACK, ENCOUNTERED CRACK AT A DEPTH OF $8\frac{1}{2}$ " AND CORE BROKE AS CRACK ANGLED ACROSS IT. CONCRETE APPEARED TO BE GOOD AND DENSE WITH THE EXCEPTION OF SMALL CHECK CRACKS IN AREA 3" TO 6" IN ON THE CORE.

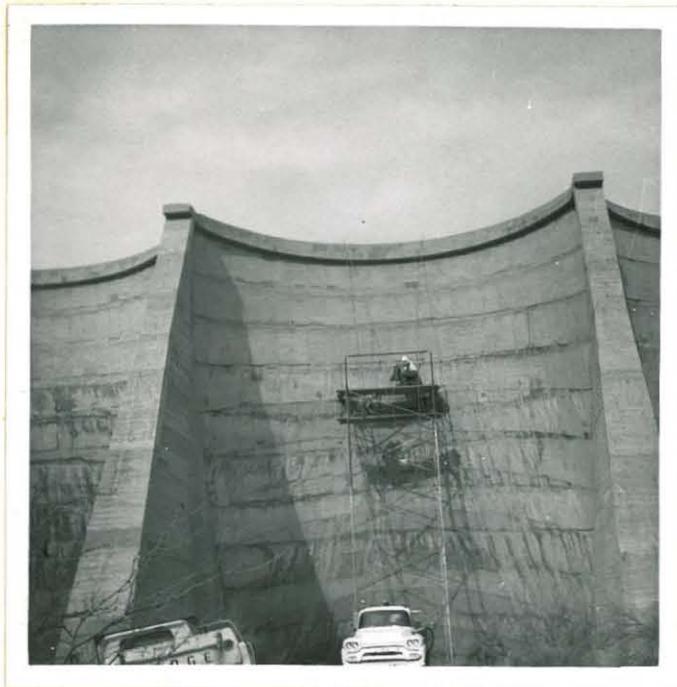
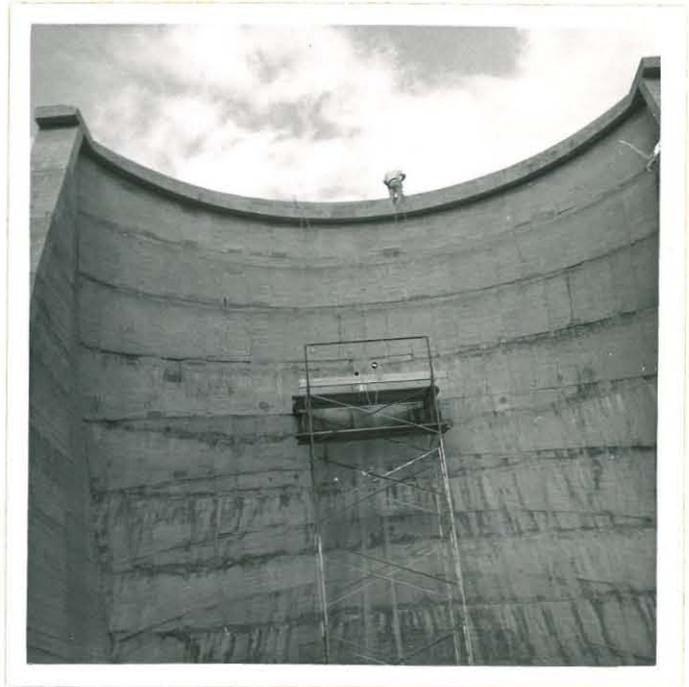
4" CORE No. 5
6" CORE No. 6
ARCH No. 13

CORE No. 5 - ARCH No. 13: 4" DIAMETER, $12\frac{3}{4}$ " LONG. CORED IN MUD STAINED AREA, $16'3''$ DOWN FROM DAM TOP AND $21'6''$ FROM EAST ABUTMENT. CORE WENT COMPLETELY THROUGH DAM. STARTED CORING BELOW A CRACK AND ENCOUNTERED SAME AT A DEPTH OF 2" IN. THE CRACK EXTENDED COMPLETELY THROUGH DAM, WITH THE BROWN STAIN NOTICEABLE THROUGHOUT. CUT THROUGH $\frac{3}{4}$ " REINFORCING BAR AT $9\frac{1}{2}$ " DEPTH, ONE FACE OF WHICH WAS EXPOSED IN THE CRACK. THIS FACE WAS SLIGHTLY RUSTY WITH NO PITTING EVIDENT. CONCRETE APPEARED TO BE GOOD, DENSE CONCRETE.

CORE No. 6 - ARCH No. 13: 6" DIAMETER, 12" LONG. CORED IN SAME AREA AS No. 5, 15'6" DOWN FROM DAM TOP AND 20'3" FROM EAST ABUTMENT. THIS CORE WAS TAKEN FOR TEST PURPOSES AND RESULTED IN A COMPRESSIVE STRENGTH OF 3103 PSI.

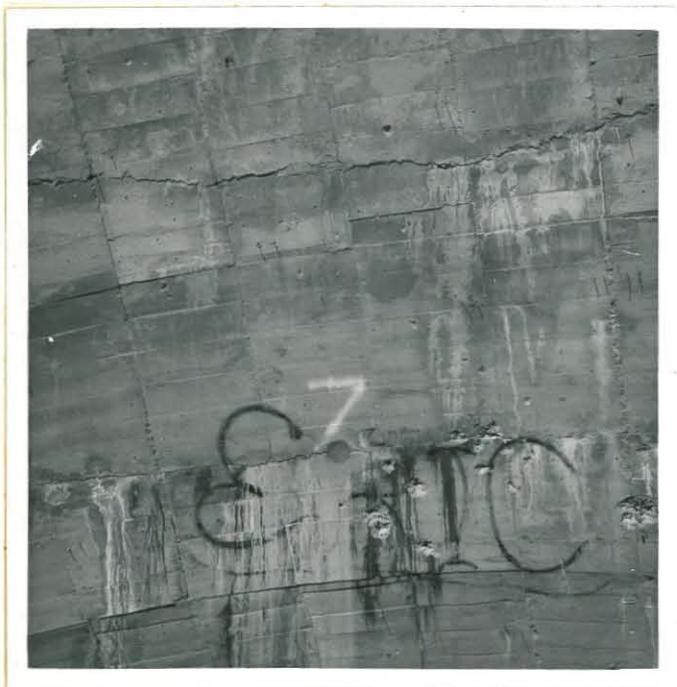
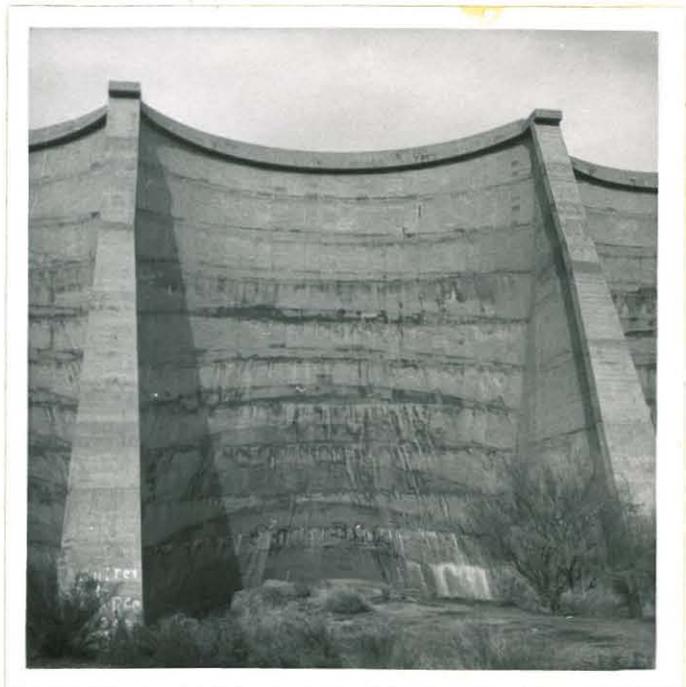
4" CORE No. 7
ARCH No. 16

CORE No. 7 - ARCH No. 16: 4" DIAMETER, 12" LONG. CORED IN CRACK 43'7" DOWN FROM DAM TOP AND 25' FROM EAST ABUTMENT. CRACK EXTENDED TO A DEPTH OF 4 $\frac{1}{2}$ ". CUT THROUGH $\frac{3}{4}$ " REINFORCING BAR 3 $\frac{1}{4}$ " IN. NO RUST ON BAR AND CONCRETE APPEARED TO BE GOOD AND DENSE THROUGHOUT.

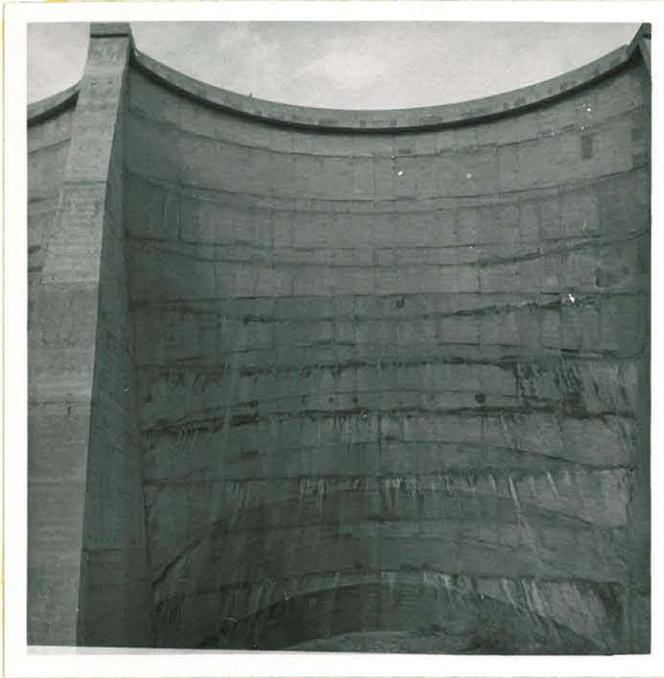
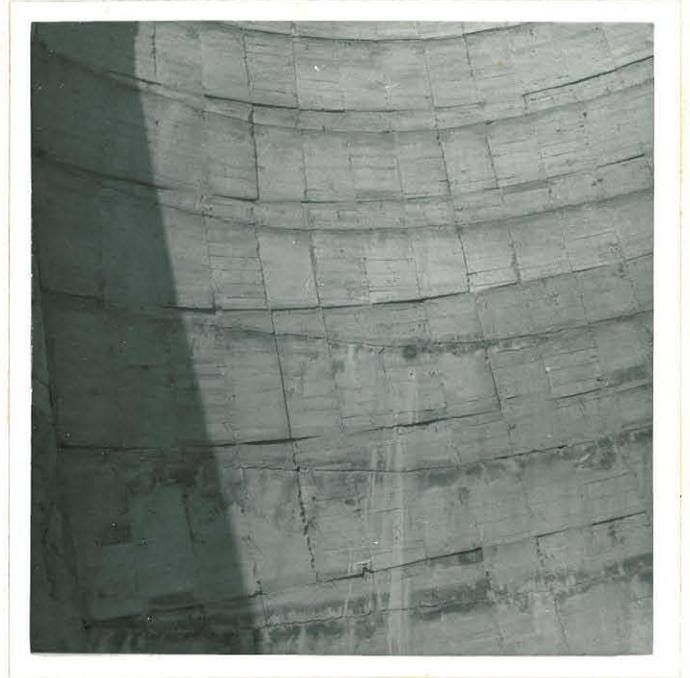
4" CORE No. 11
ARCH No. 25

CORE No. 11 - ARCH No. 25: 4" DIAMETER, 12" LONG. CORED IN CRACK 21' DOWN FROM DAM TOP AND 34'8" FROM EAST ABUTMENT. STARTED BELOW CRACK AND ENCOUNTERED CRACK AT A DEPTH OF 5". CRACK WAS IN THE APPROXIMATE CENTER AT THE END OF THE CORE. CONCRETE APPEARED TO BE GOOD AND DENSE THROUGHOUT.

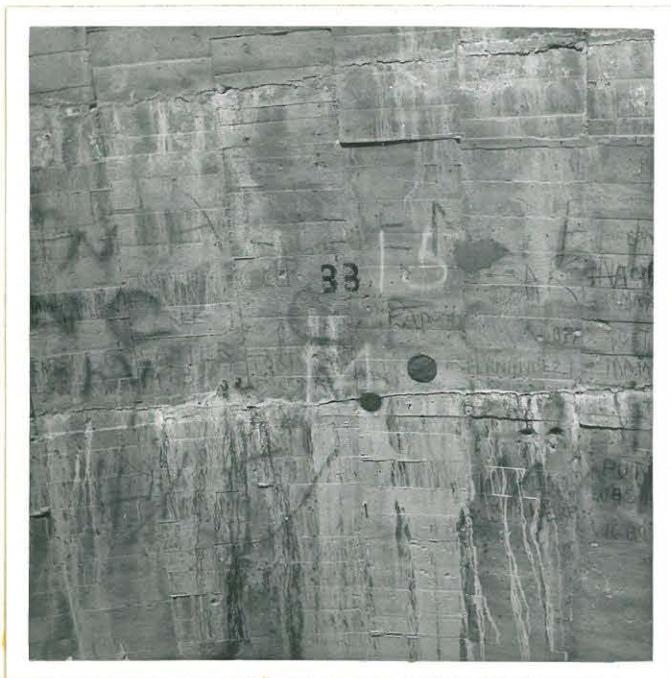
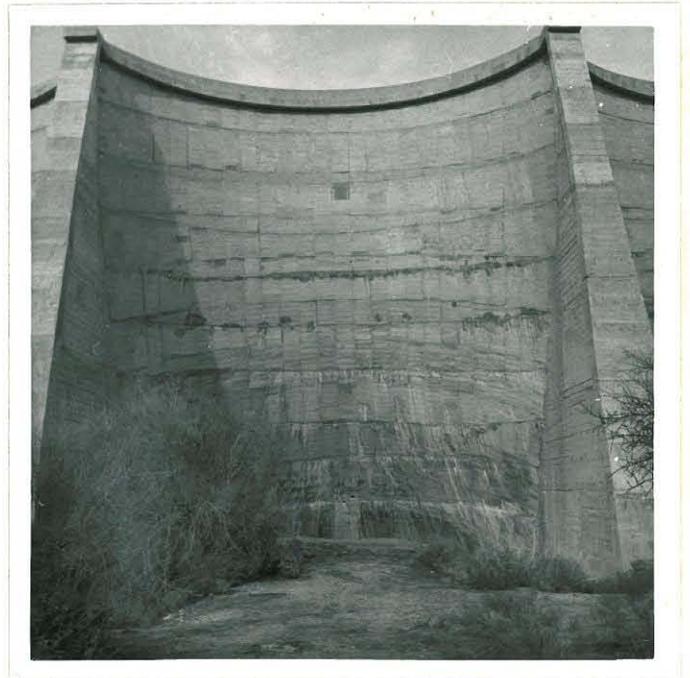
6" CORE No. 15
ARCH No. 33
4" CORE No. 14

CORE No. 14 - ARCH No. 33: 4" CORE, $10\frac{1}{2}$ " LONG. CORED IN CRACK WHERE CONCRETE SURFACE WAS COVERED WITH A BROWN STAIN AND HEAVY EFFERVESCENCE, 42'3" DOWN FROM DAM TOP AND 28'6" IN FROM EAST ABUTMENT. CRACK EXTENDED TO A DEPTH OF $5\frac{1}{2}$ ". CORED 12" BUT CORE BROKE AT $10\frac{1}{2}$ " DUE TO LARGE FLAT ROCK. CONCRETE APPEARED TO BE GOOD AND DENSE.

CORE No. 15 - ARCH No. 33: 6" DIAMETER, 12" LONG. CORED IN SAME AREA AS No. 14, 42'10" DOWN FROM DAM TOP AND 19'6" IN FROM EAST ABUTMENT. THIS CORE WAS TAKEN FOR TEST PURPOSES AND RESULTED IN A COMPRESSIVE STRENGTH OF 4061 PSI.

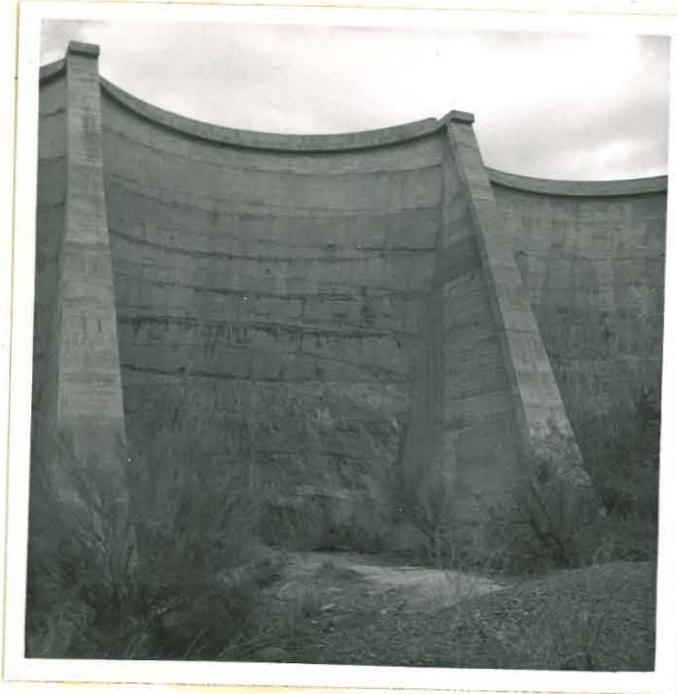
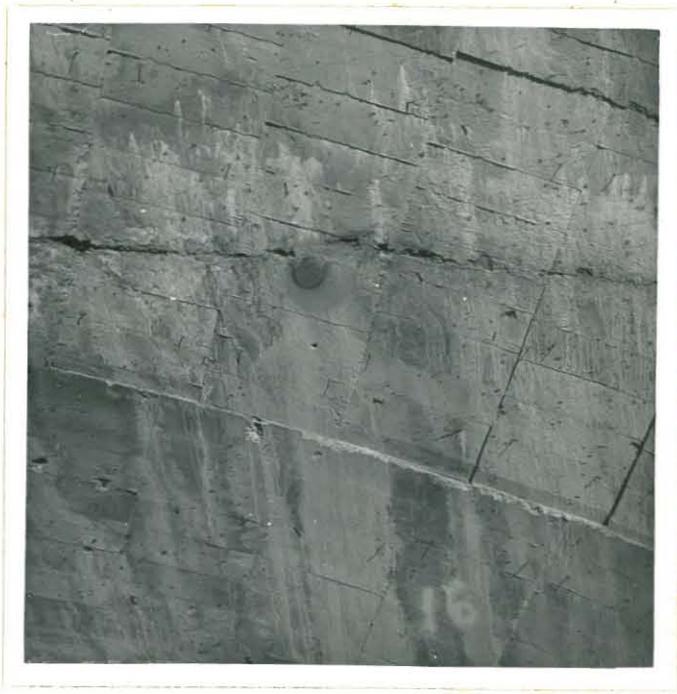
4" CORE No. 16
ARCH No. 36

CORE No. 16 - ARCH No. 36: 4" DIAMETER, 12" LONG. CORED IN CRACK AND SPALLED AREA, 44'4" DOWN FROM DAM TOP AND 7'3" FROM EAST ABUTMENT. STARTED CORING BELOW CRACK AND ENCOUNTERED CRACK 3" TO 11"

CONTINUOUSLY FROM DEPTH WHERE IT EMANATED AWAY FROM CORE AREA. CRACK WAS COVERED THROUGHOUT WITH A HEAVY BROWN STAIN. CONCRETE APPEARED GOOD AND DENSE THROUGHOUT.

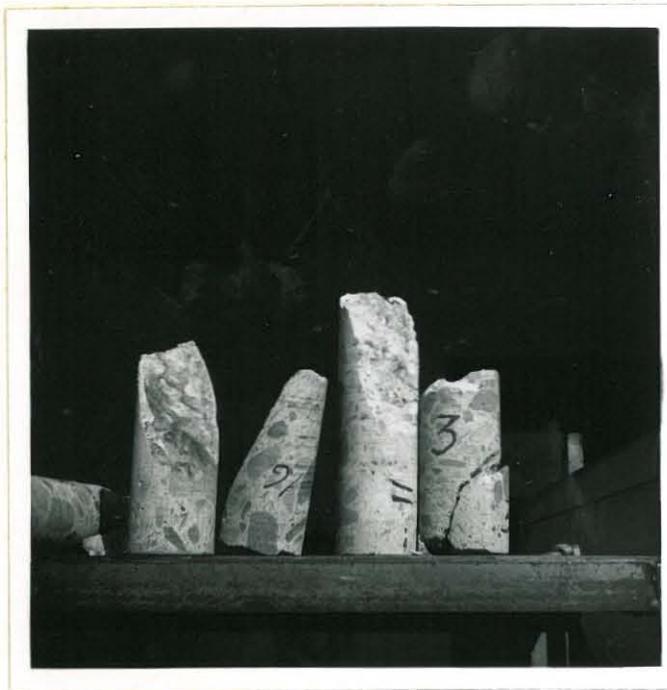
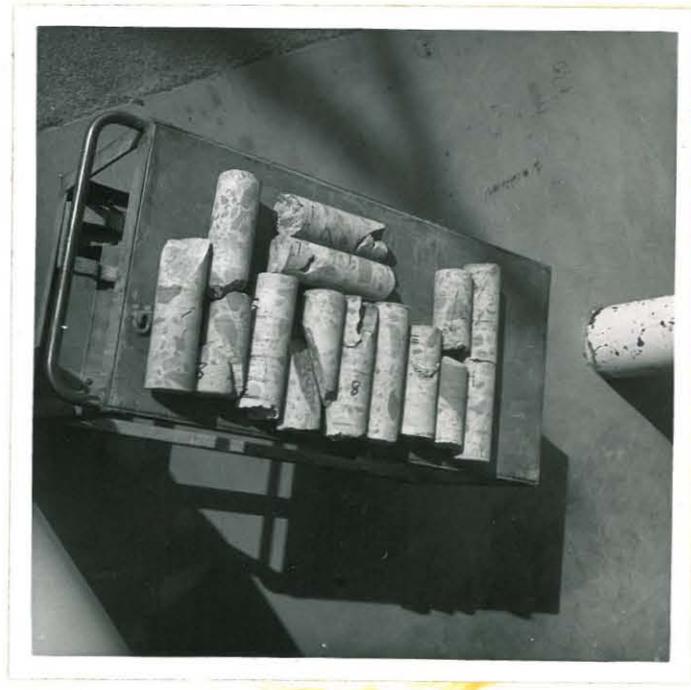
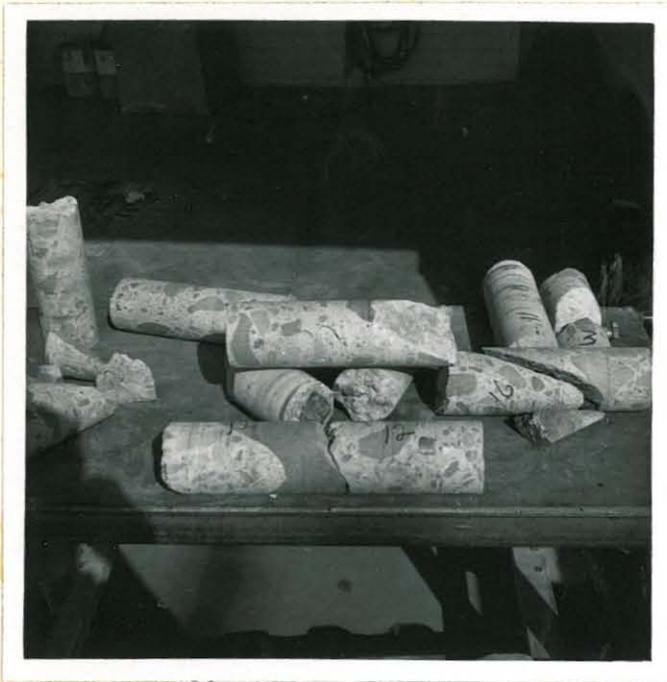
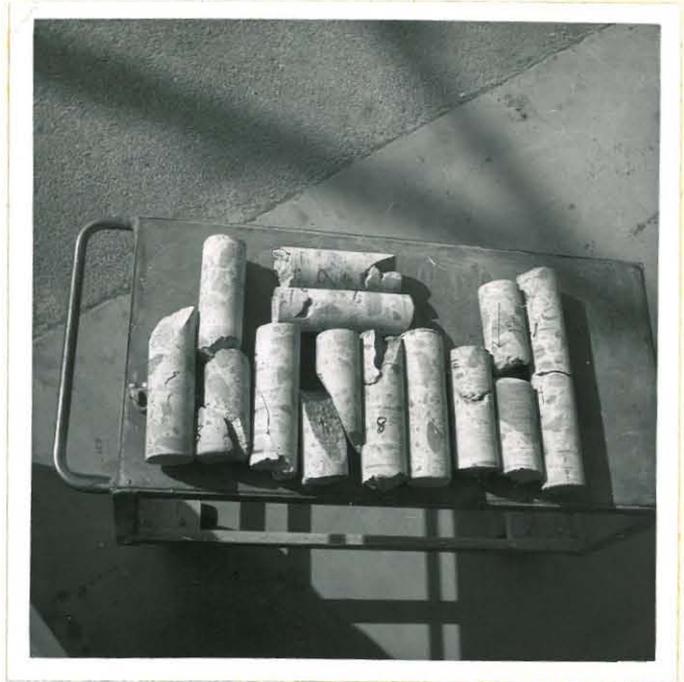
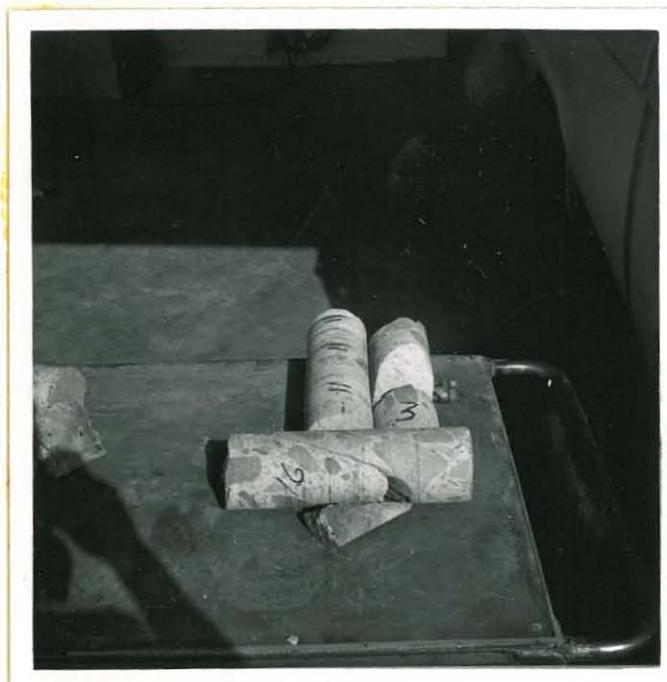
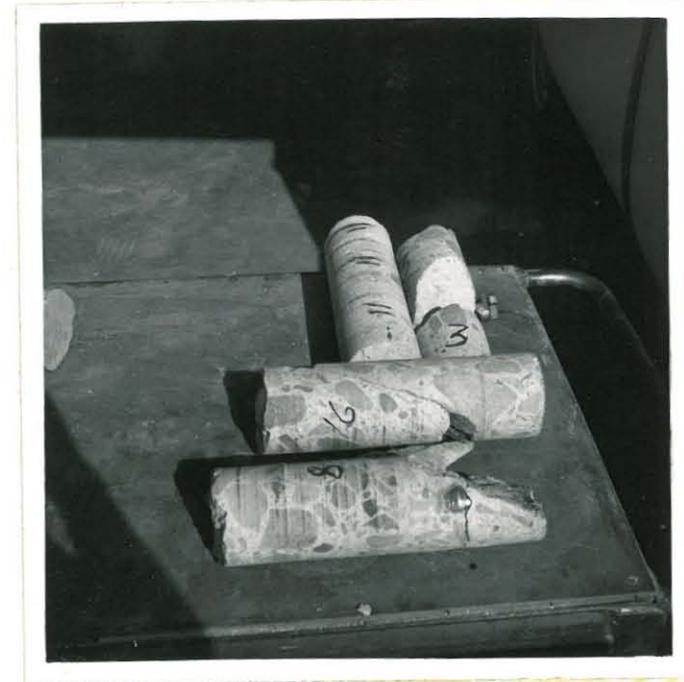
CONCRETE CORES

PICTURES OF THE CORES ARE ENCLOSED. ALL DIAGONAL CRACKS ARE DUE TO DRILLING THROUGH THE COLD OR POUR JOINTS. IT WAS DIFFICULT TO FOLLOW THE CRACKS THROUGH THE DAM, SINCE THE DAM FACE IS CURVED, BOTH VERTICALLY AND HORIZONTALLY. THE DRILL WAS FASTENED TO THE DAM FACE, SO THE CORE WAS DRILLED NORMAL TO THE SURFACE, WHILE THE COLD OR POUR JOINT WAS FORMED IN A HORIZONTAL PLANE. BY STARTING THE CORE DRILL BELOW THE CRACK, THE CRACK WAS ENCOUNTERED AT DIFFERENT DISTANCES IN FROM THE DAM FACE AND AS HAS BEEN STATED, SOME OF THE CORES SHOWED THE JOINT COMPLETELY THROUGH THE DAM.

THE LARGEST ROCK ENCOUNTERED IS SEEN IN CORE No. 8. EVIDENTLY NATIVE ROCK FROM THE AREA WAS USED AS AGGREGATE AND IN GENERAL IT CONSISTS OF GOOD DENSE ROCK.
