ASSESSMENT OF FLOOD DAMAGES

SALT-GILA AQUEDUCT REACH I B

JULY 17-18, 1984

Subject: Assessment of Flood Flow Damage near the CAP
Salt-Gila Aqueduct Reach 1B.
July 17-18, 1984
Final Report

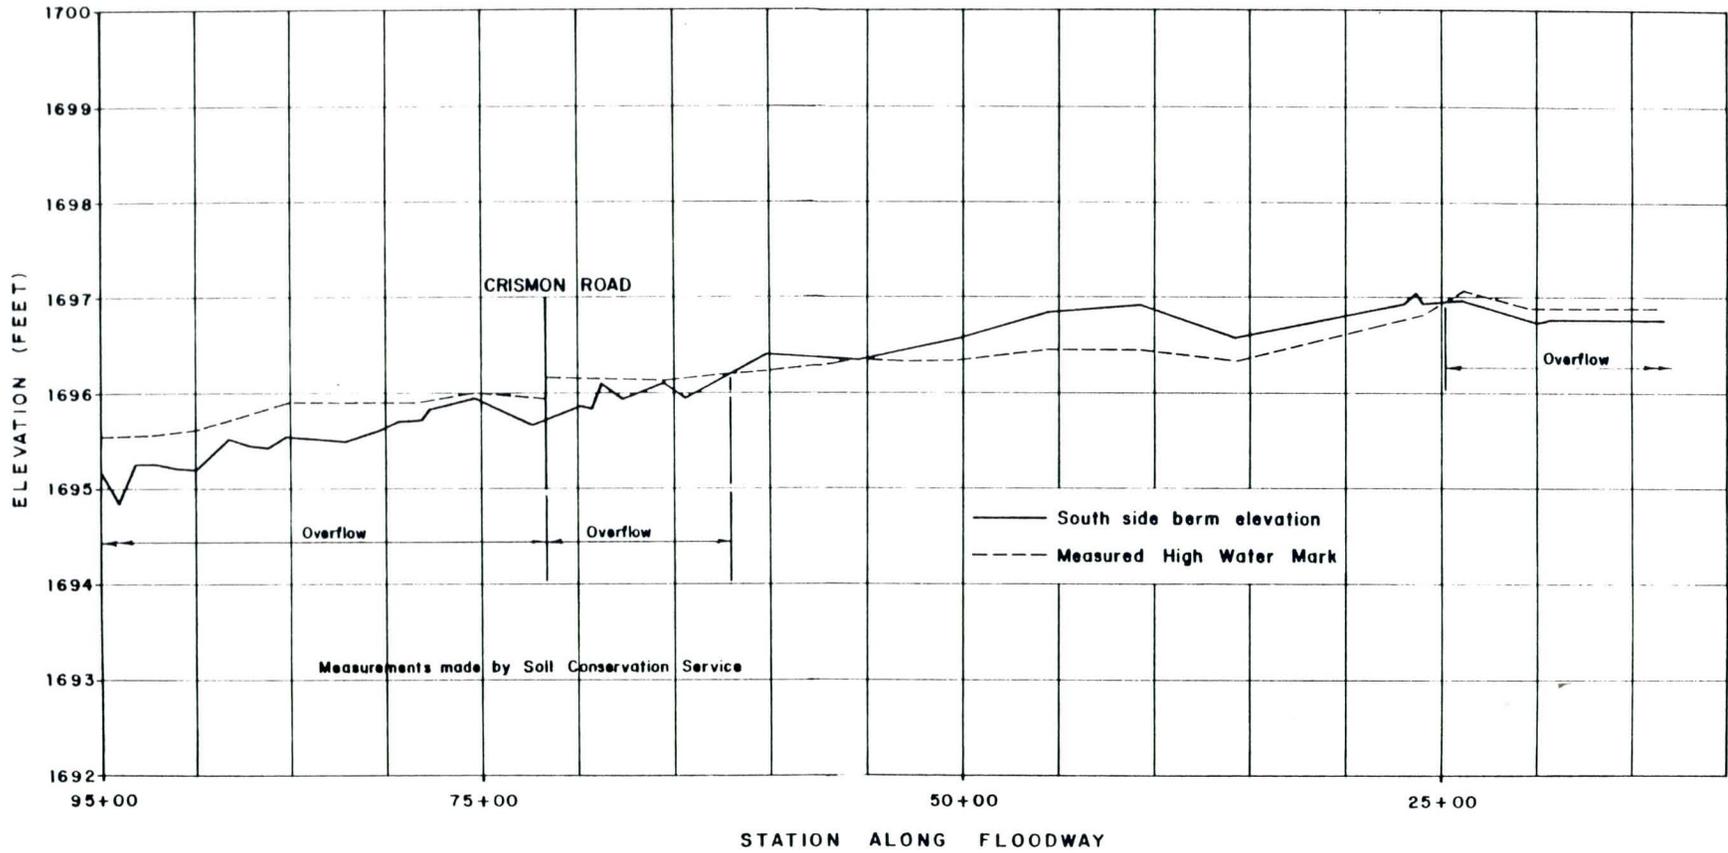
SIGNAL BUTTE FLOODWAY BERM AND HIGHWATER ELEVATIONS JULY 17-18, 1984

A profile of floodway south berm elevations and high-water levels is shown on Exhibit 4-4. These measurements were made by SCS staff. The high-water levels are elevations of maximum high-water marks found on the north floodway berm.

The model results indicate that the outflows from the floodway are higher than can be justified by the evidence shown on Exhibit 4-4. A total floodway peak outflow of 3458 cfs occurring at 2353 hours was

computed by the model, as shown on Table 4-2. The maximum overflow depth along the length of the berm was estimated to be approximately 0.14 feet higher than that shown on Exhibit 4-4. It should be noted that the outflow calculations are sensitive to small variations in head because of the low depths of flow over the floodway berm. The peak outflow is also directly related to the estimated peak inflow, which is highly dependent on watershed characteristics, such as time of concentration and retention loss rates. The use of the SCS dimensionless unit hydrograph is also a major factor in the determination of the inflow hydrograph.
