# Attachment 5 LATERAL MIGRATION ANALYSIS REPORT

## El Rio Watercourse Master Plan and Area Drainage Master Plan

# EL RIO WATERCOURSE MASTER PLAN

## Lateral Migration Analysis Report

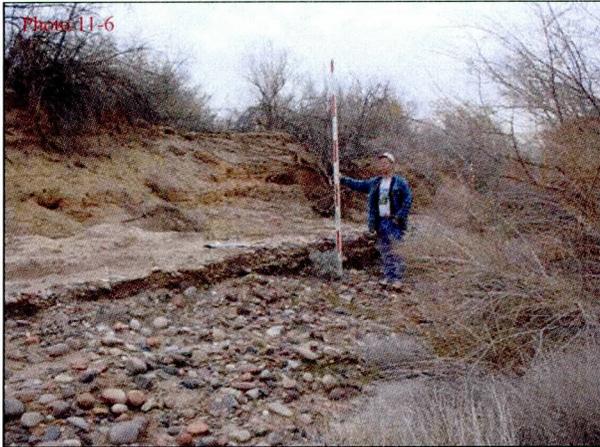
**Figure 39. Cutbank composed of weakly cemented cobbles capped by fine overbank sediment**

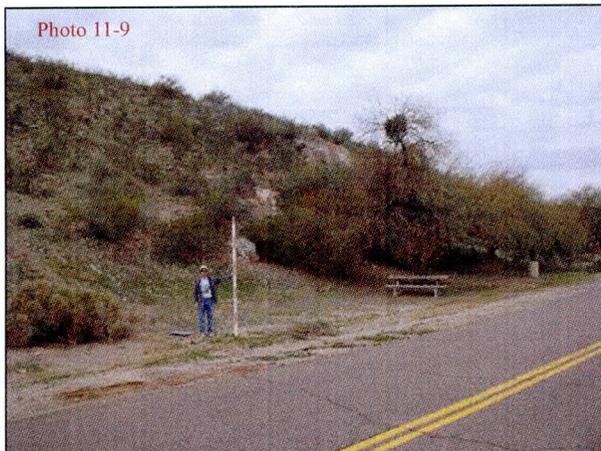
Figure 45. Bedrock near Estrella Mtn. Park

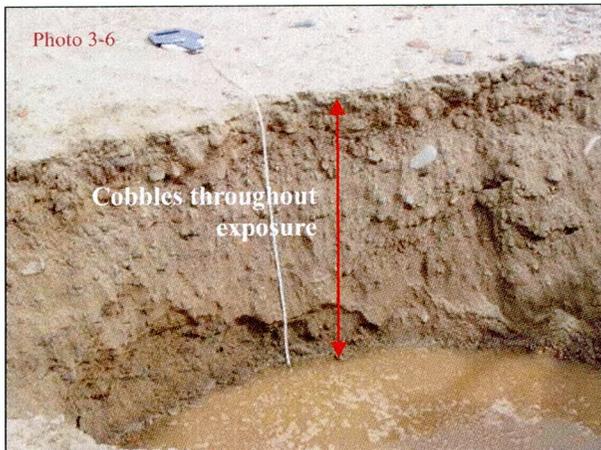
Field observations of a trench excavated by Stantec in March 2003 confirmed that no armor layer was present, and that, in fact a similar distribution of sediment sizes occurred at depths up to six feet as at the surface (Figure 54). Field observations of sediments exposed in sand and gravel mine pits upstream of the SR85 Bridge similarly confirmed that no effective armor layer is present in the study reach (Figure 55). These exposures had large cobble lenses buried by accumulations of floodplain sediment. The coarse grained lenses may represent historic, discontinuous cobble bars similar to those found presently within the active channel.

Figure 54. Trench exposure near cobble bar

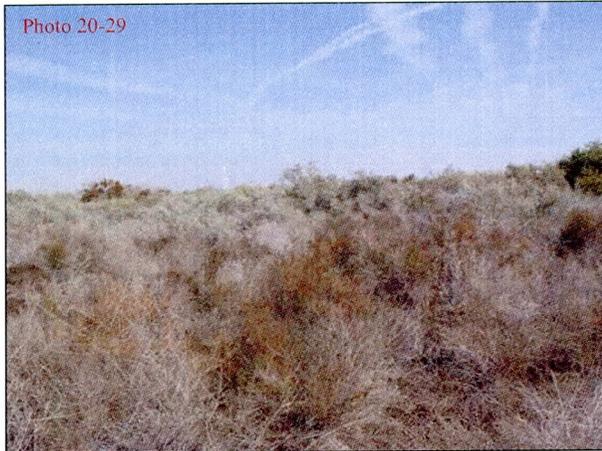
**Figure 60. Dense Tamarix forest between active and compound channel banks**

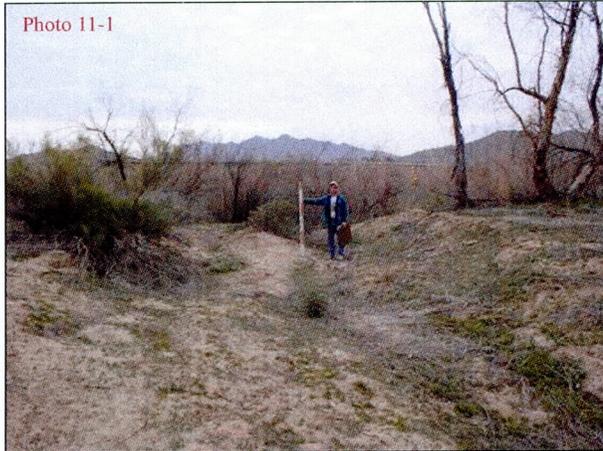
Figure 64. Right-bank avulsive channel just downstream of Agua Fria confluence

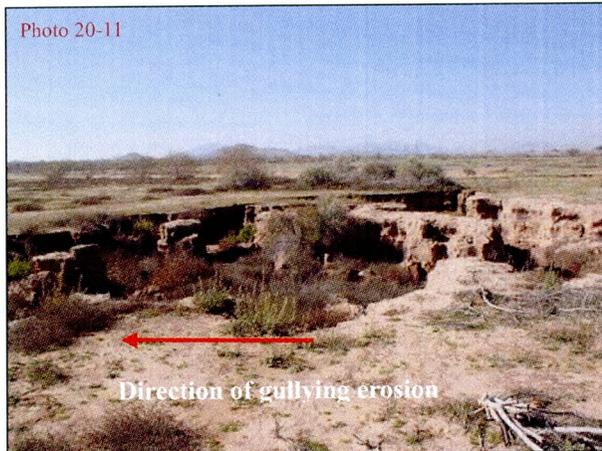
**Figure 68. Active gully gully in de-vegetated surface**

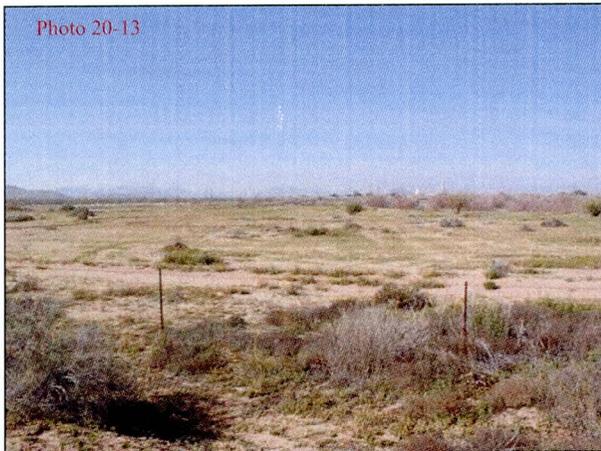
**Figure 72. De-vegetated floodplain surface**

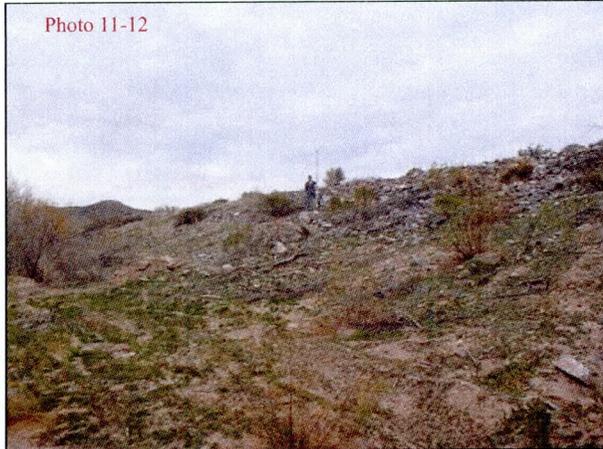
Figure 74. Bullard Avenue left bank fill for bridge approach, looking upstream.

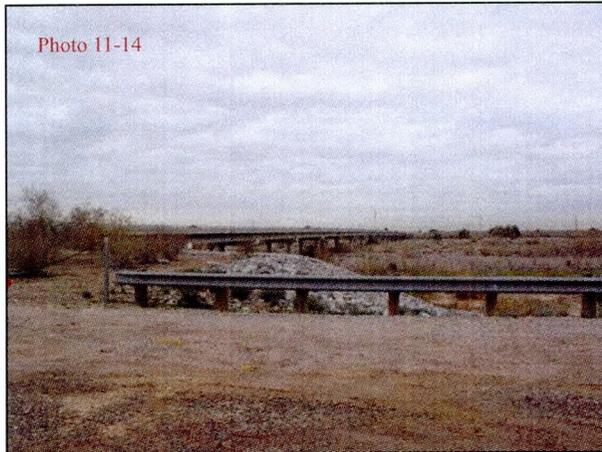
**Figure 77. Estrella Parkway Bridge left bank engineered fill with protection, looking downstream across river**

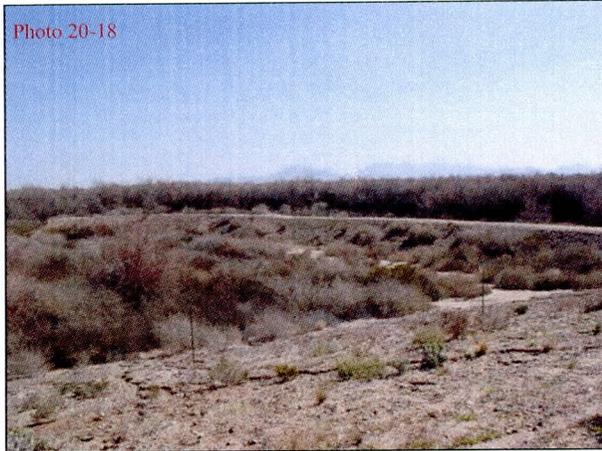
Figure 81. Right bank fill upstream of SR 85 Bridge, looking upstream

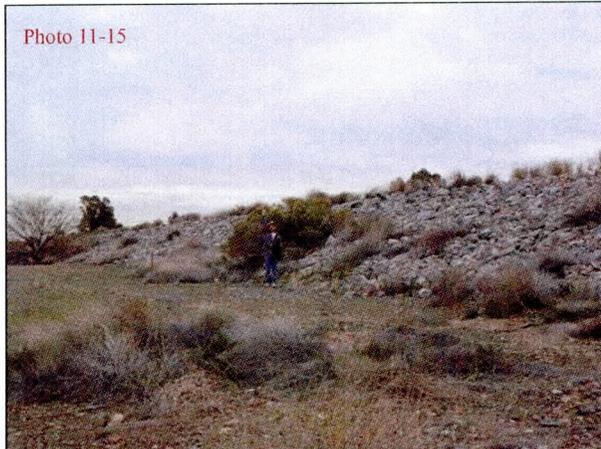
**Figure 84. Left-bank levee just downstream of Estrella Parkway Bridge, looking upstream**

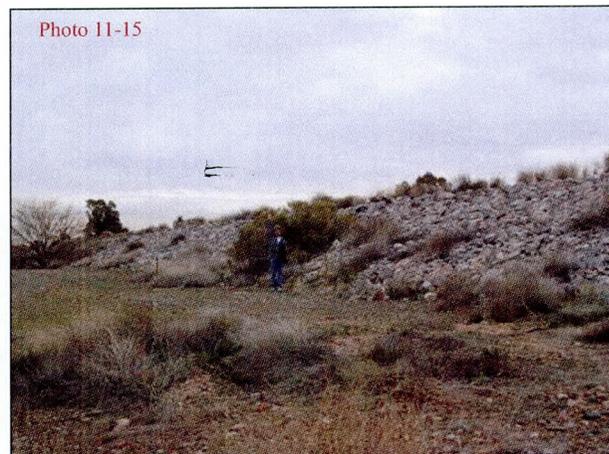
Figure 93. King Ranch Levee just downstream of Estrella Mtn. Regional Park, looking upstream direction
