Manning's Roughness Coefficient Analysis

WATERMAN WASH

Maricopa County, Arizona

March, 1990

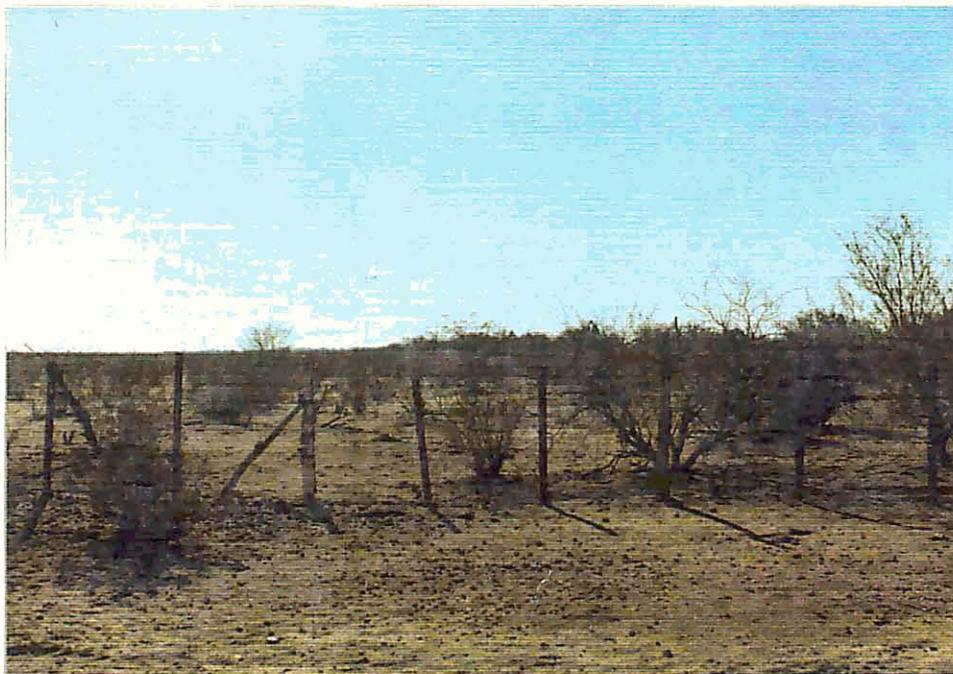
Left Overbank Area -

Looking upstream.
Typical vegetative
growth.

"n" = 0.060

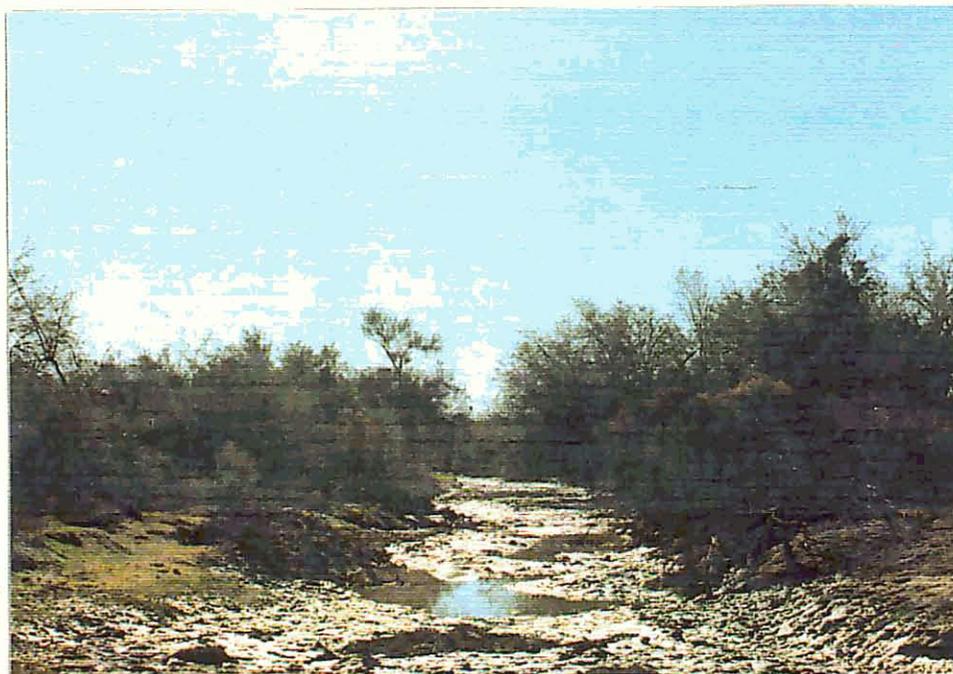
Main Channel -
East Prong

Dense growth on sides.
Silty bottom, adverse
grades, partial
obstruction.

"n" = 0.055

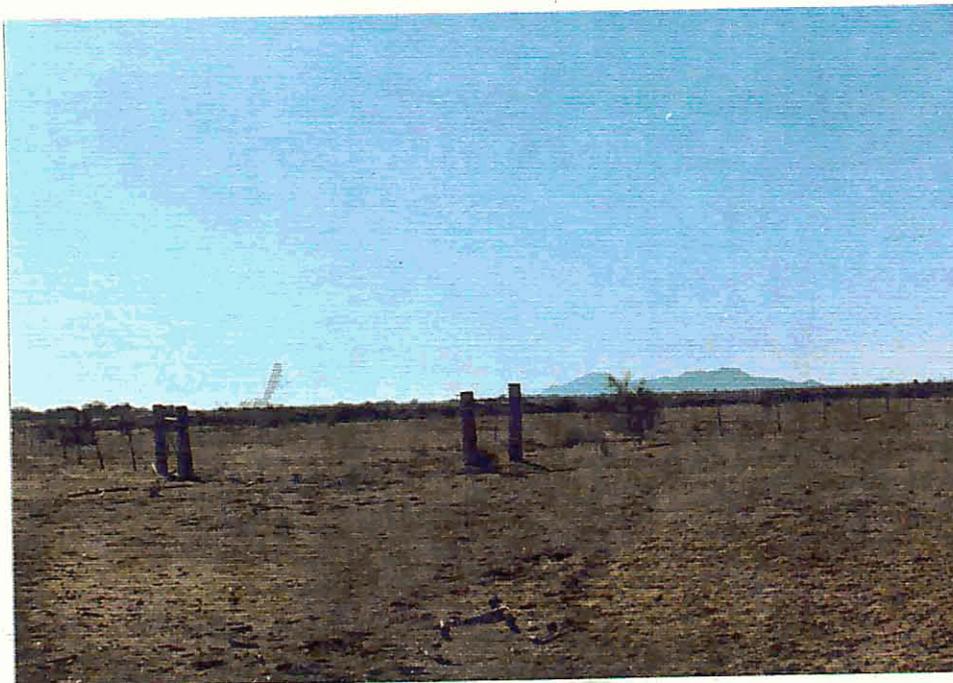
Delta area between
East and West Prongs

Fenced rangeland with
sparse vegetative
cover.

"n" -0.045

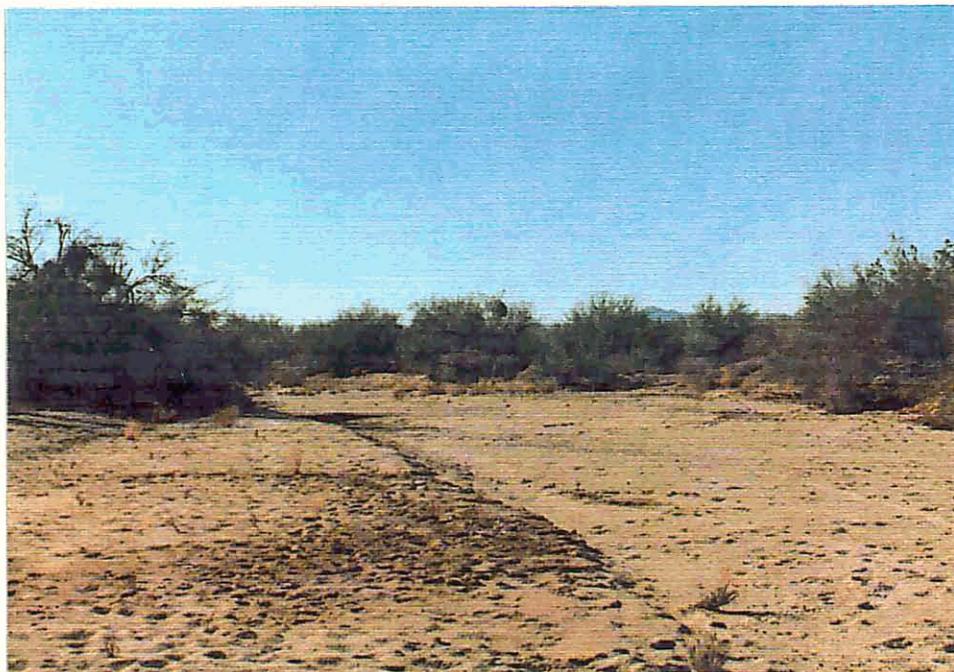
Main Channel -
West Prong

Wide sandy bottom with
occasional growth.

"n" = 0.045

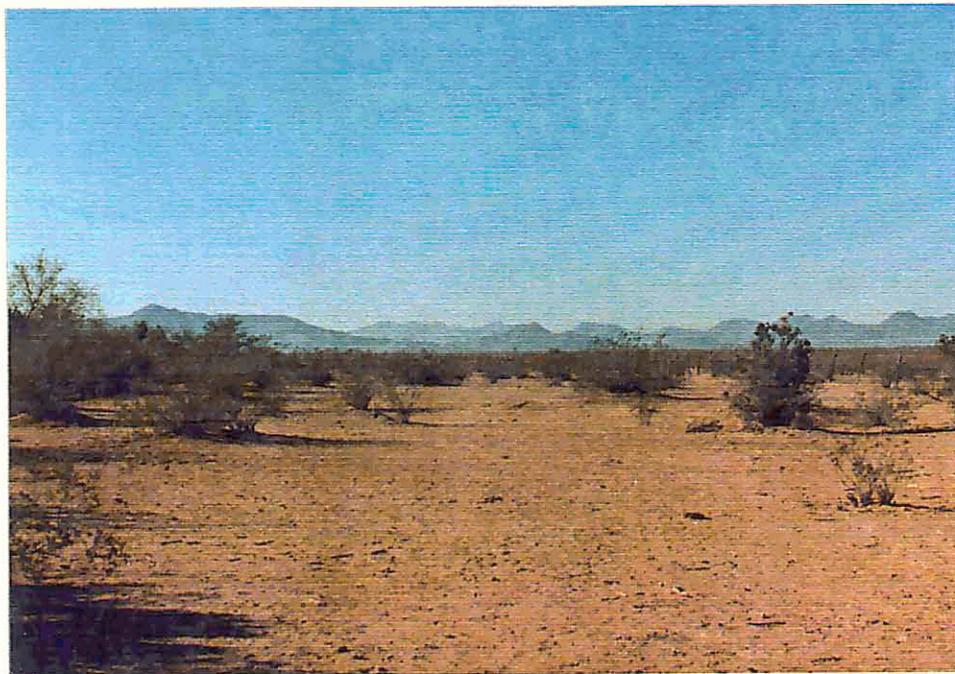
Right Overbank Area -

Looking upstream.
Sparse cover.

"n" = 0.055

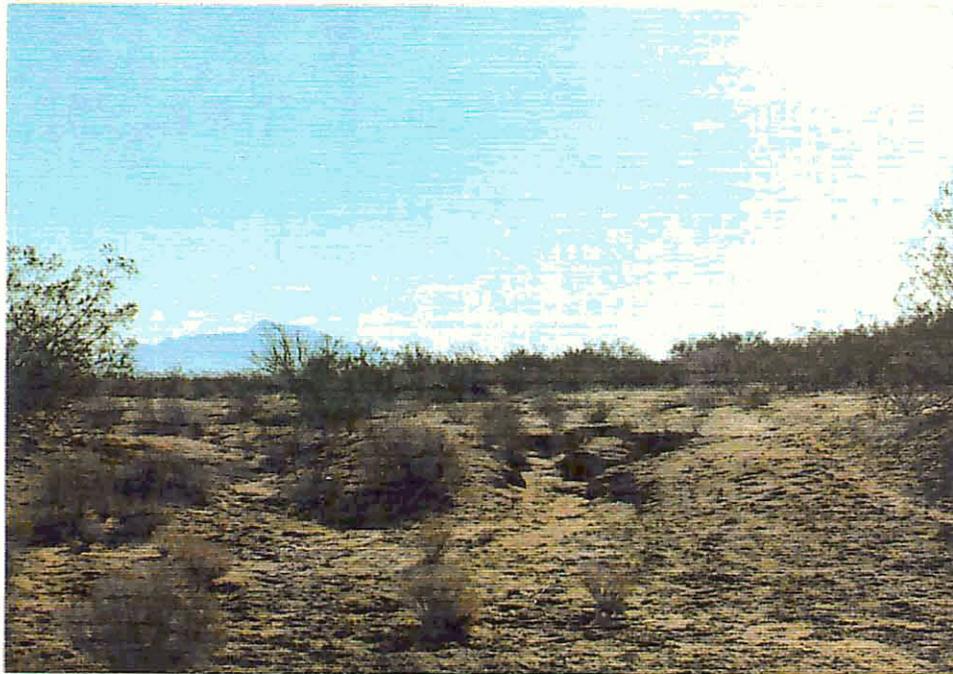
Left Overbank Area -

Looking upstream.
Average vegetation
with numerous braided
rivulets.

"n" = 0.065

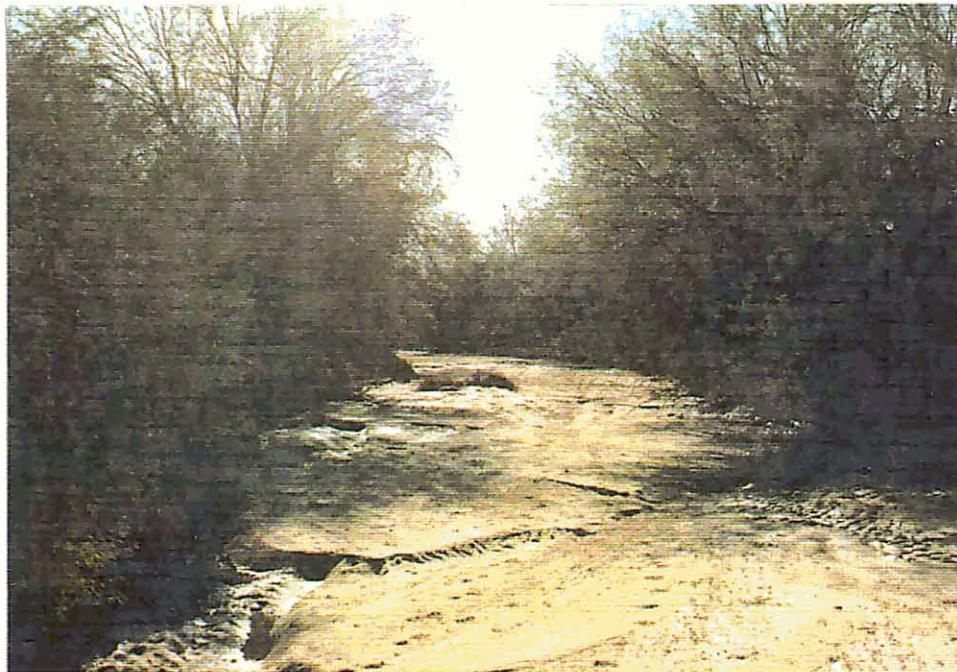
Main Channel -

Silty bottom with
dense vegetative
sides.

"n" = 0.050

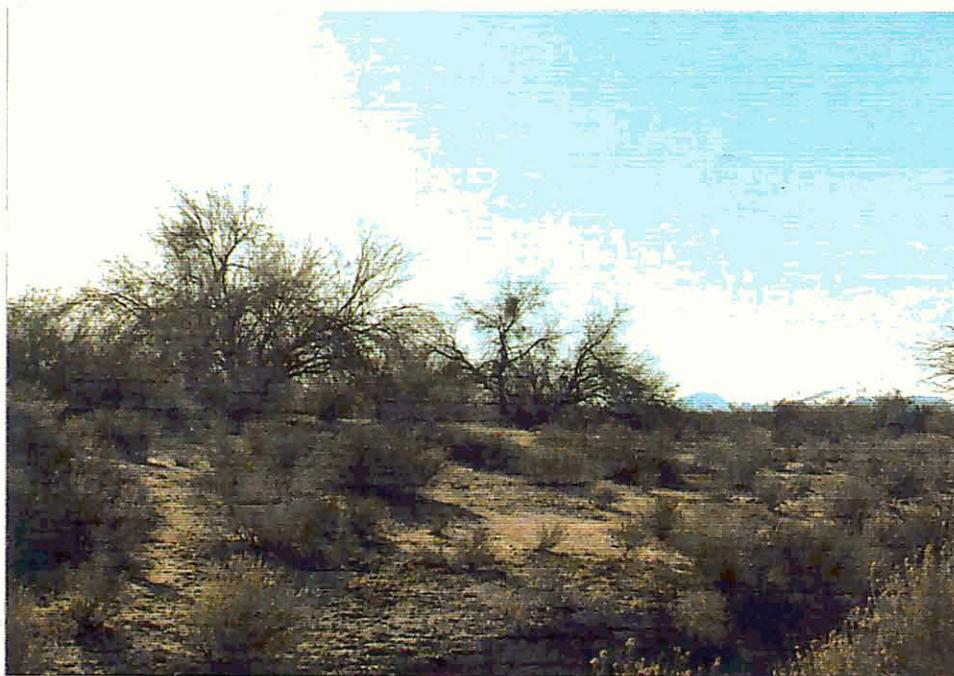
Right Overbank Area -

Typical vegetation.

"n" = 0.060

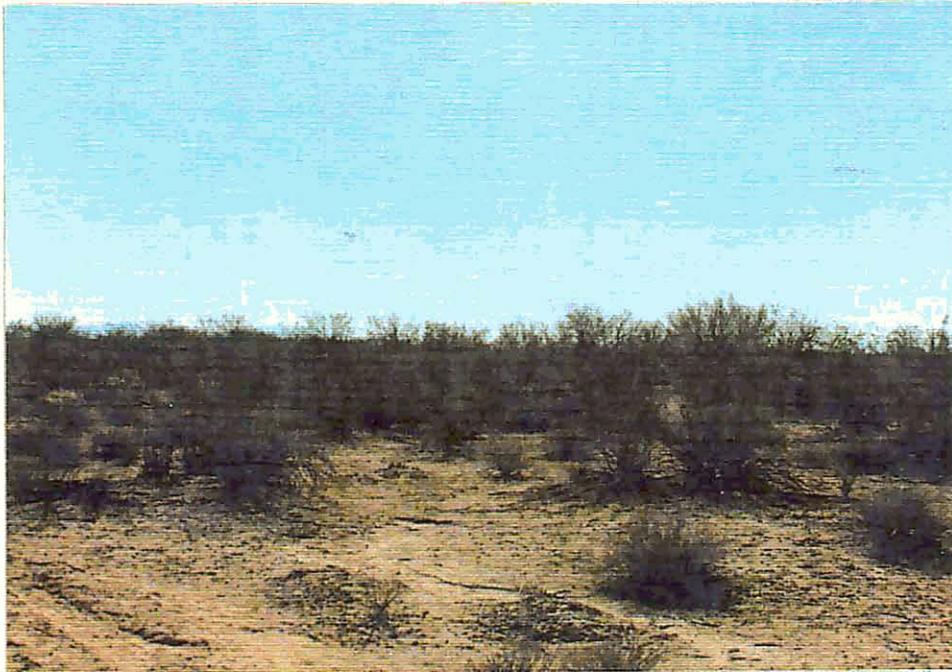
Left Overbank Area -

Looking upstream.
Dense vegetation.

"n" = 0.065

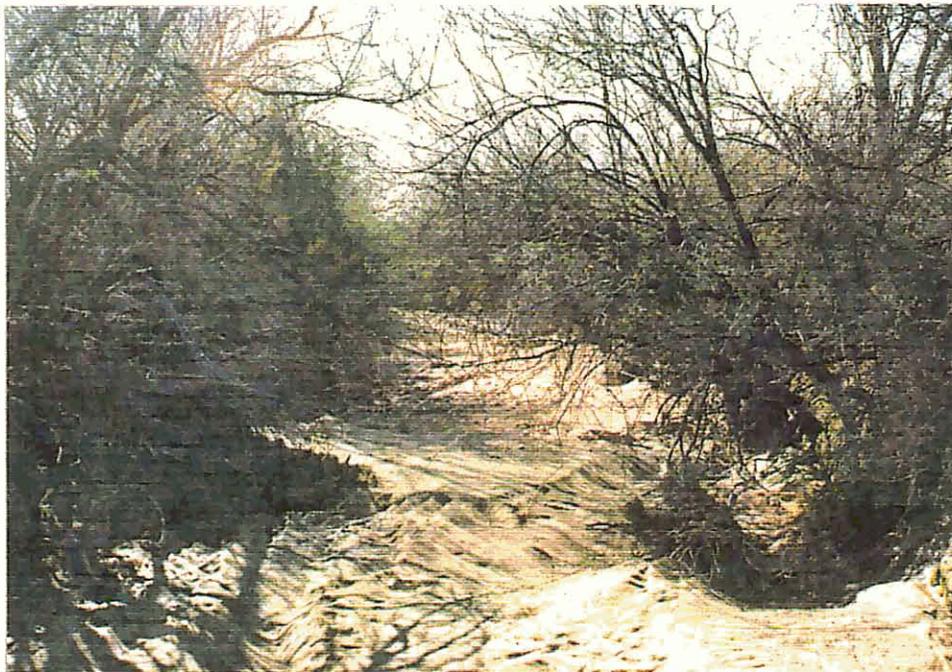
Main Channel -

Dense growth on sides,
sandy bottom,
irregular.

"n" = 0.060

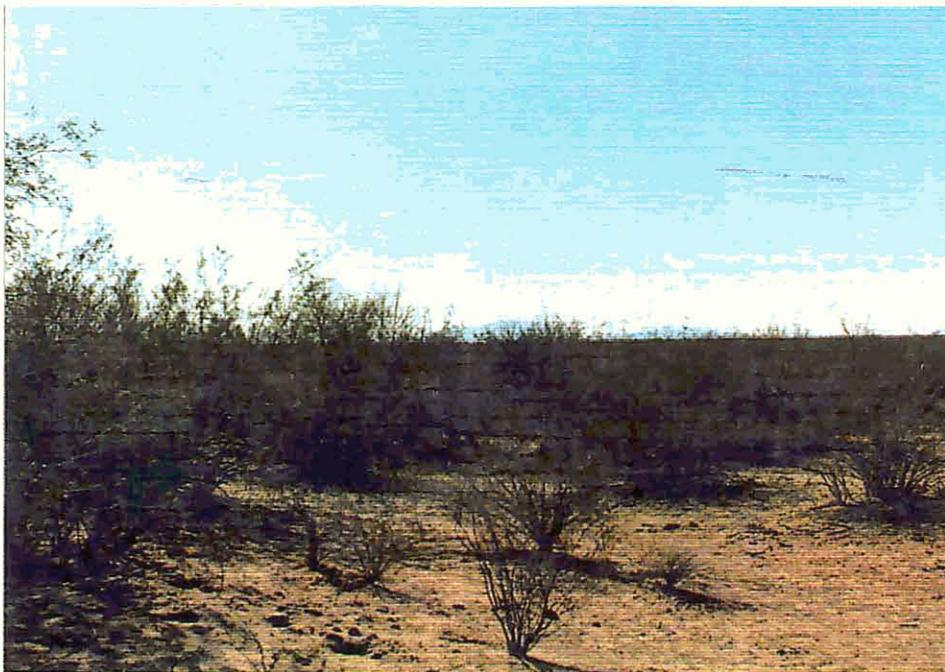
Right Overbank Area -

Looking upstream.

"n" = 0.065

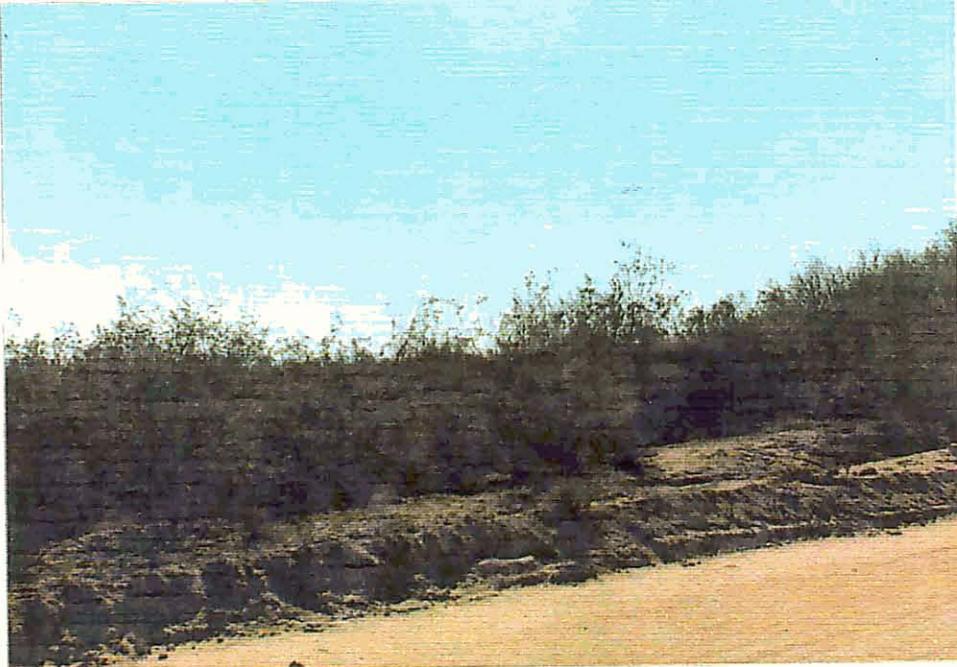
Left Overbank Area -
Dense vegetation.

"n" = 0.065

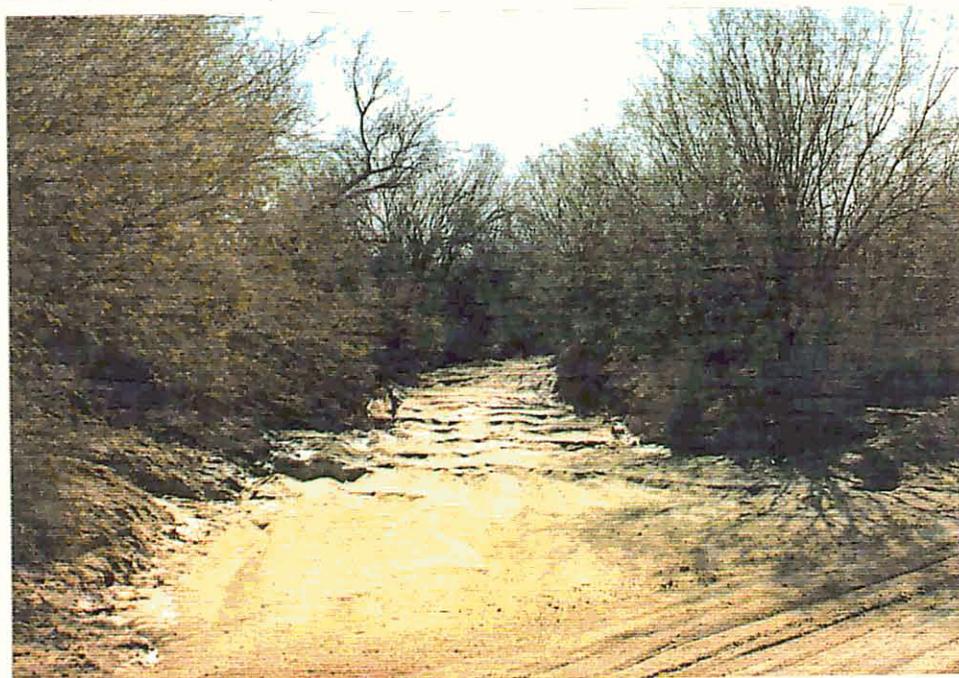
Main Channel -

Silty bottom, dense
growth on sides.

"n" = 0.055

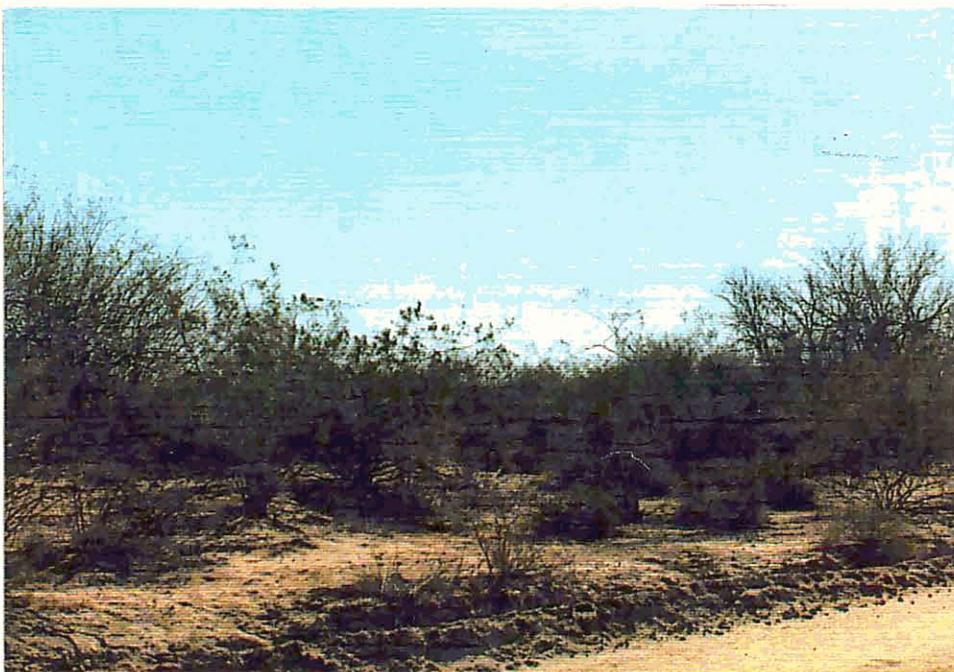
Right Overbank Area -
Dense vegetation.

"n" = 0.065

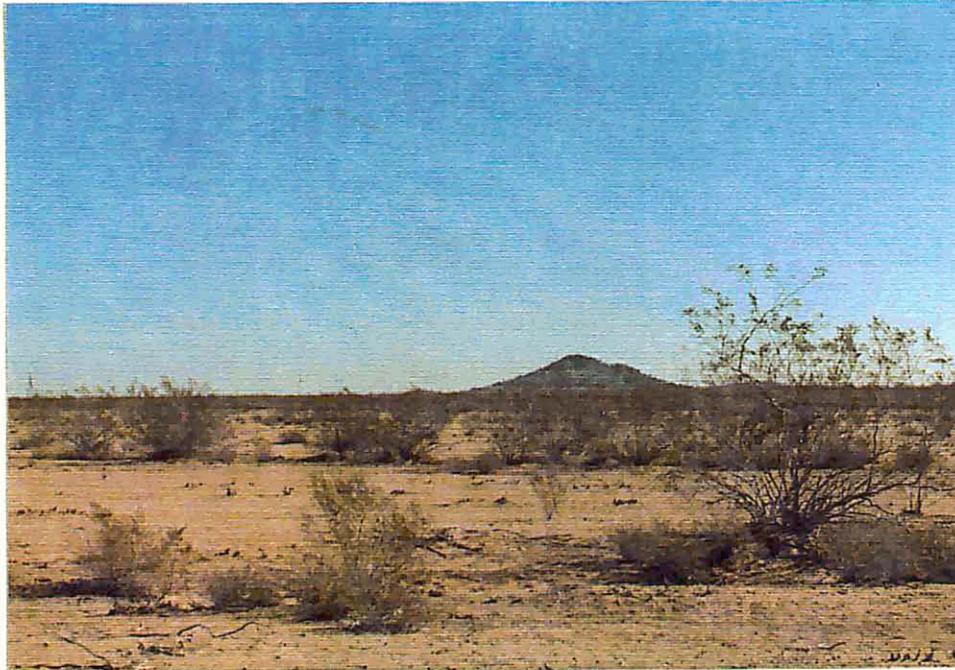
Left side looking
upstream -

Main channel has
disappeared, reverted
to shallow
flooding/sheet flow.

"n" = 0.060

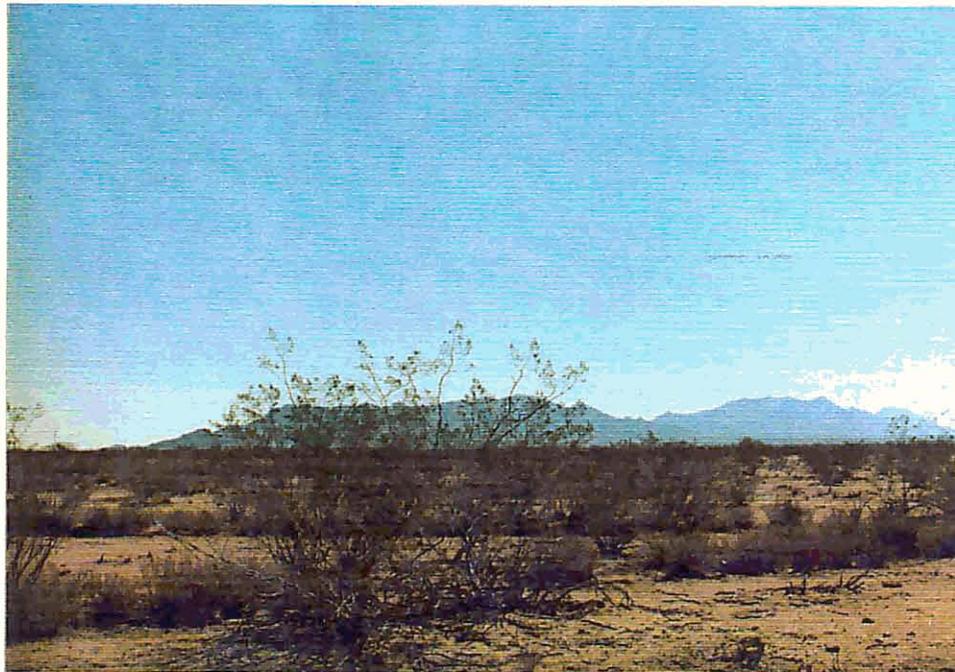
Right side looking
upstream.

"n" = 0.060

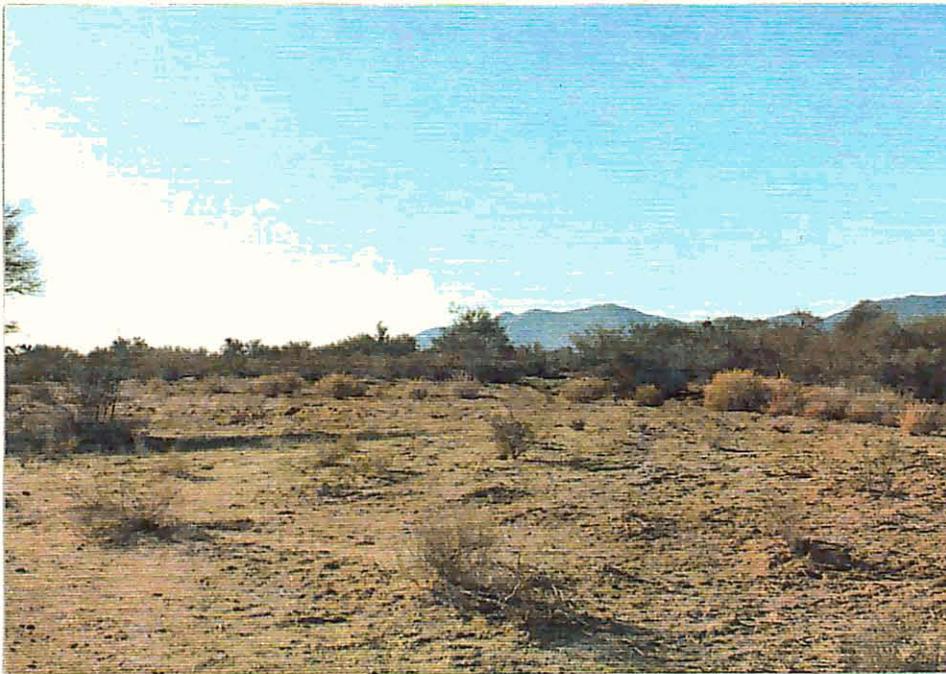
Left Overbank Area -

Looking upstream.
Typical vegetative
cover.

"n" = 0.060

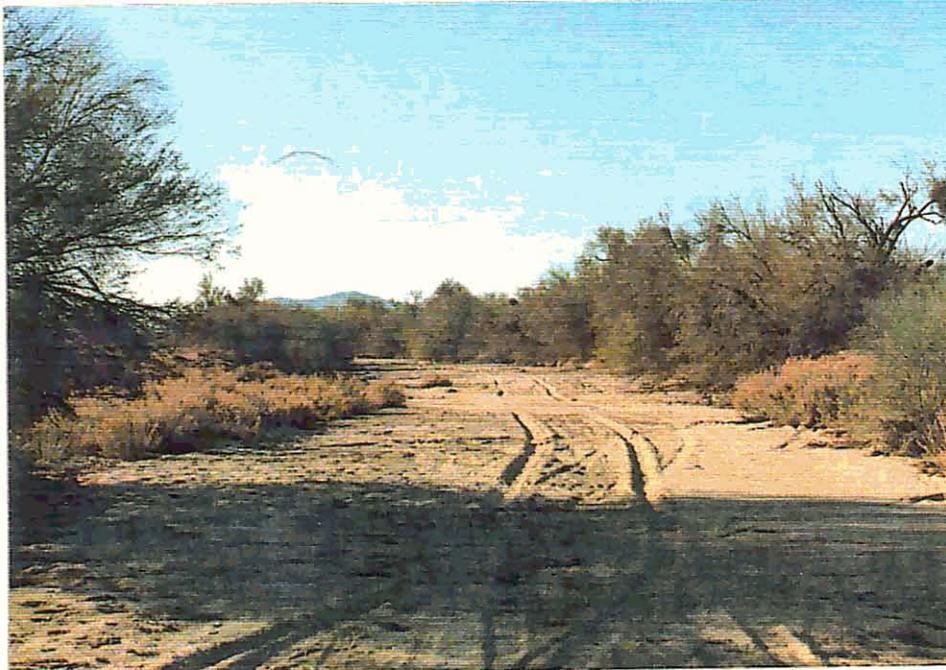
Main Channel -

Typical sandy bottom
with vegetation on
side slopes.

"n" = 0.045

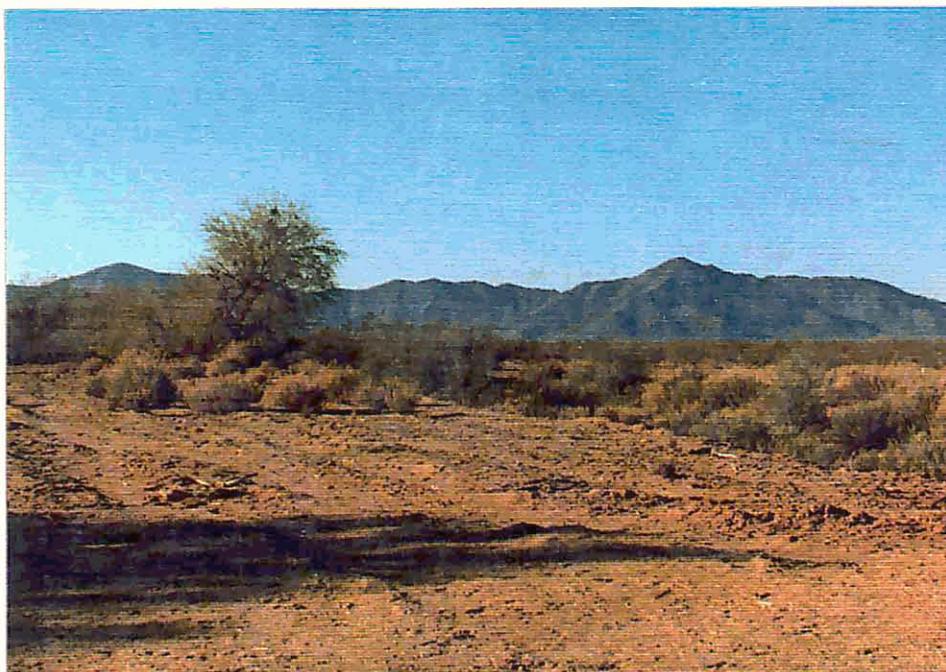
Right Overbank Area -

Looking upstream.
Typical vegetative
cover.

"n" = 0.060

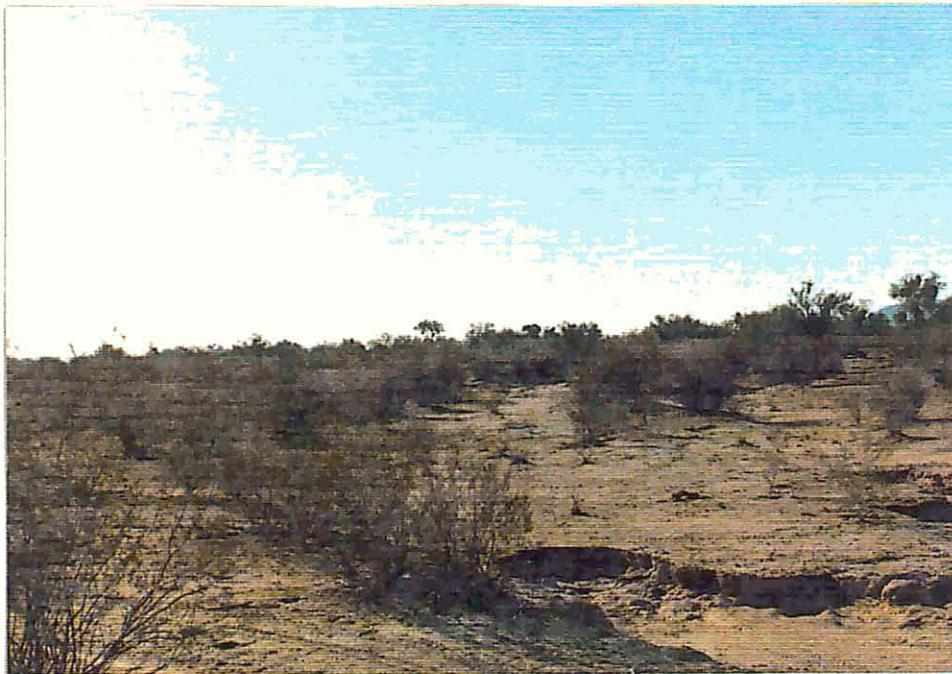
Left Overbank Area -

Vegetative cover
slightly dense than
average.

"n" = 0.060

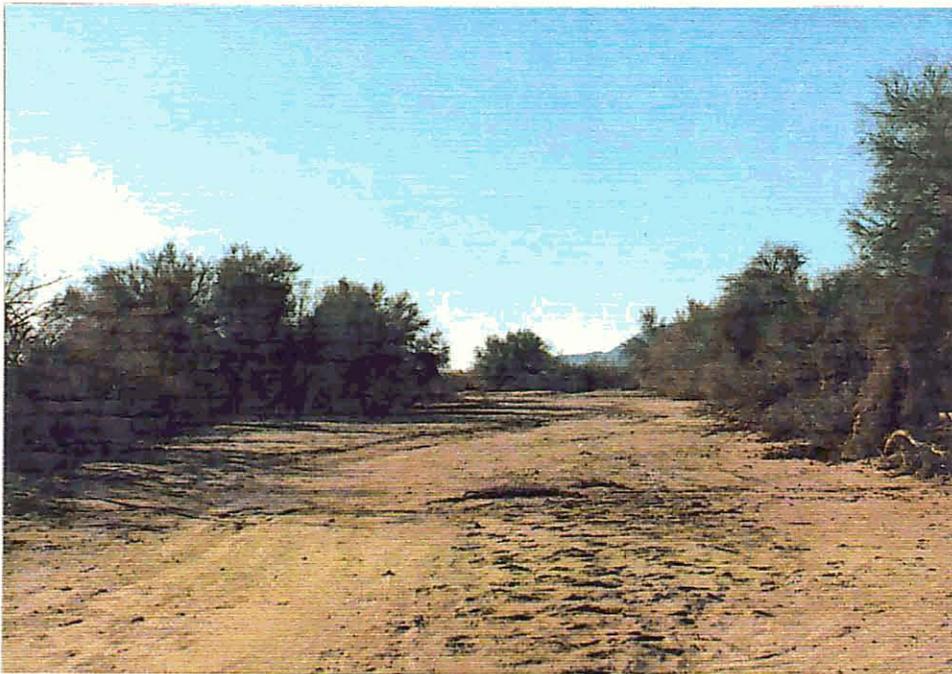
Main Channel -

Side slopes are less
defined.

"n" = 0.045

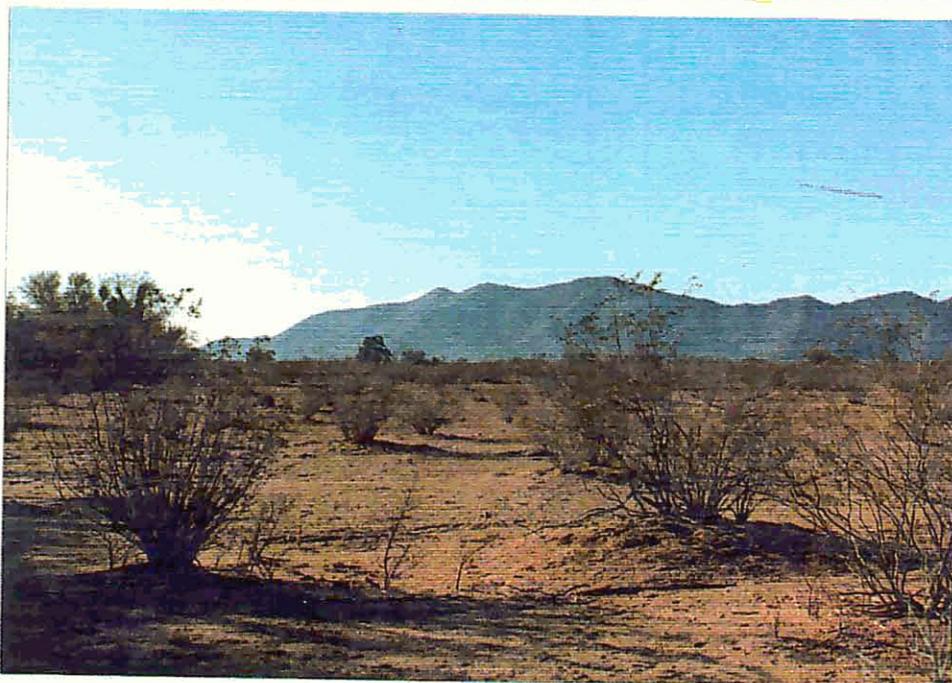
Right Overbank Area -

Typical vegetative
cover.

"n" = 0.060

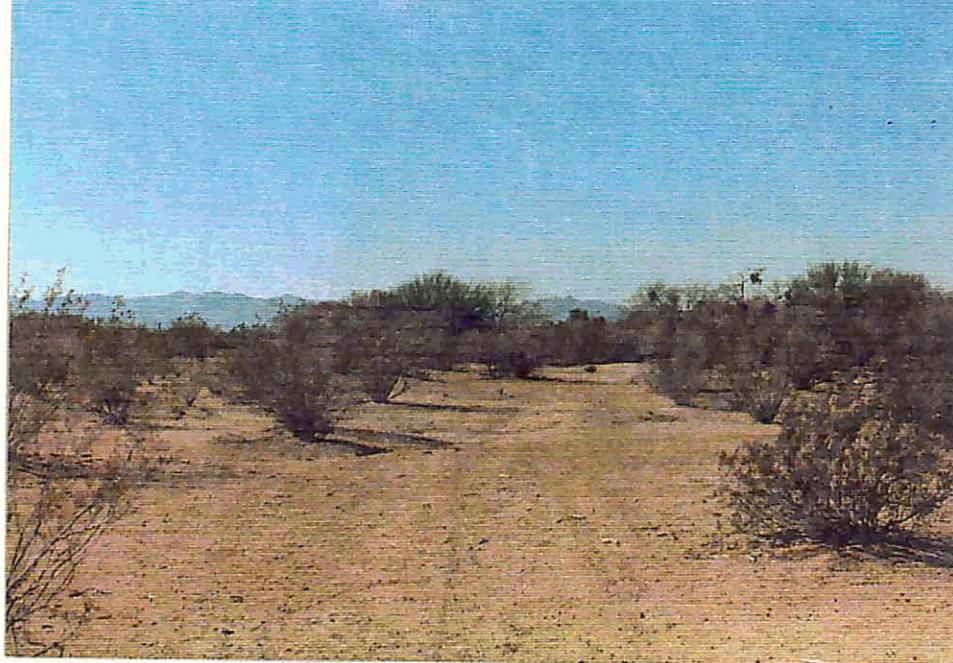
Left Overbank Area -
Sparse vegetation,
well defined rivulets.

"n" = 0.060

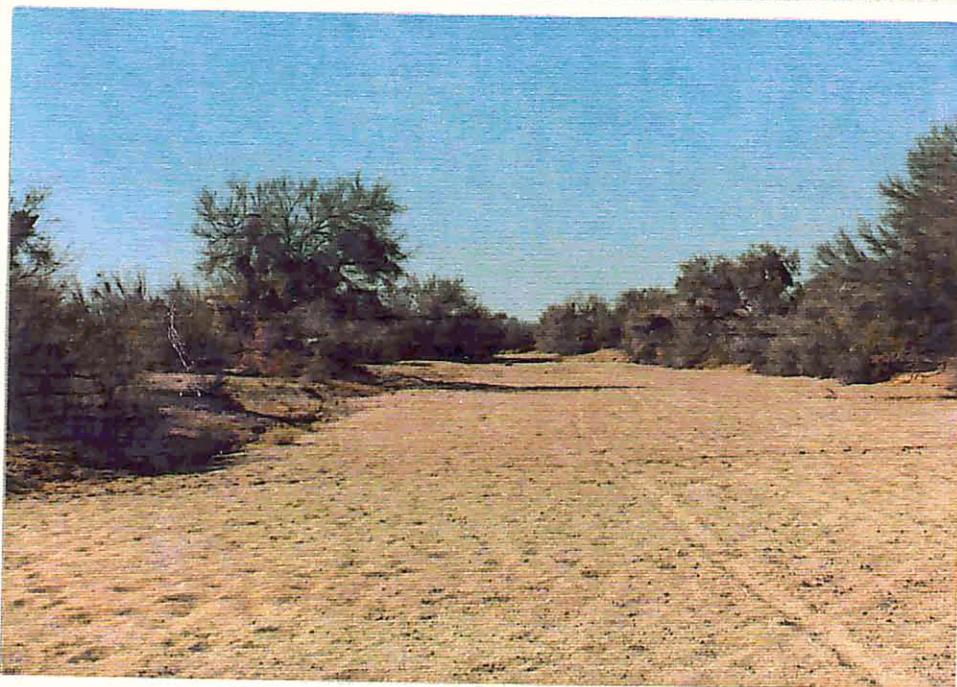
Main Channel -
Coarse sandy bottom,
ill defined side
slopes, shallow
depths.

"n" = 0.050

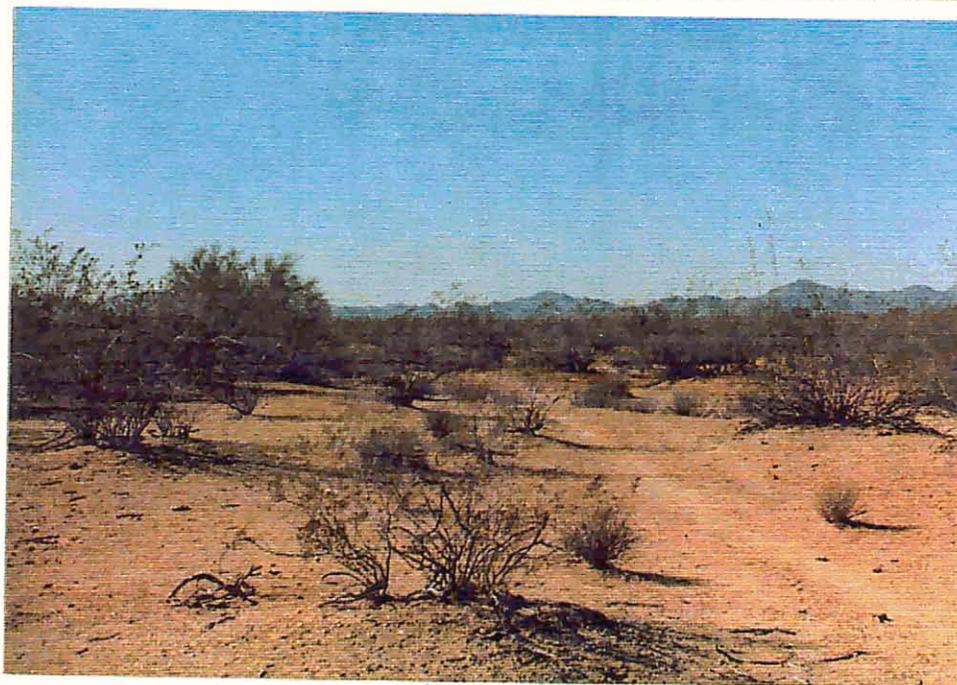
Right Overbank Area -
Typical vegetation.

"n" = 0.060
