Erosion Hazard Study

Skunk Tank Wash

October 2000

DATE: October 31, 2000
TO: Joe Tram, P.E./ FCDMC
FROM: Jon Fuller, P.E.
RE: FCD #2000CO13 – Assignment #1
Skunk Tank Wash Erosion Hazard Study
CC: Dave Johnson, P.E./ FCDMC

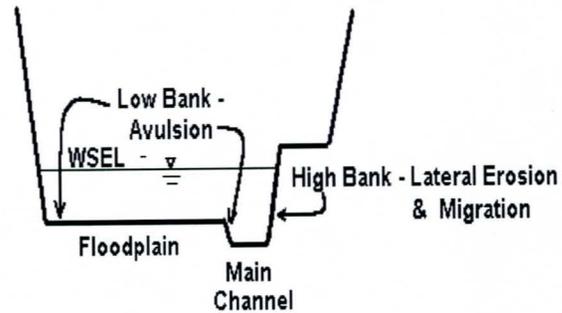
Figure 6. Sketch showing bank erosion type relative to bank height.

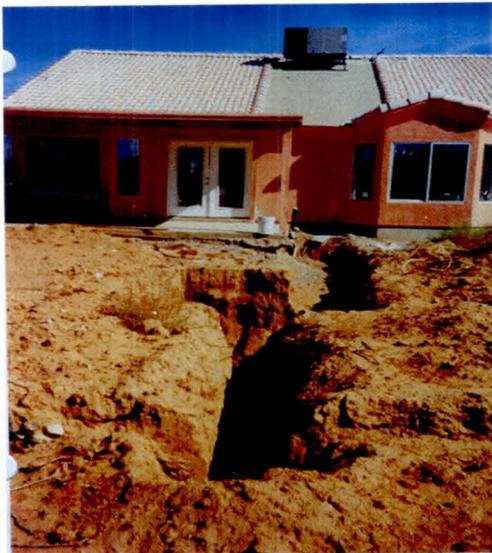
- Floodplain Soils. The soil materials underlying the natural floodplains adjacent to the main channels appear to be comprised of erosive, unconsolidated sand and gravel. A soil profile observed at a septic tank excavation is shown in Figure 7.

Figure 7. Soil profile for home in floodway of Skunk Tank Wash Reach 3.

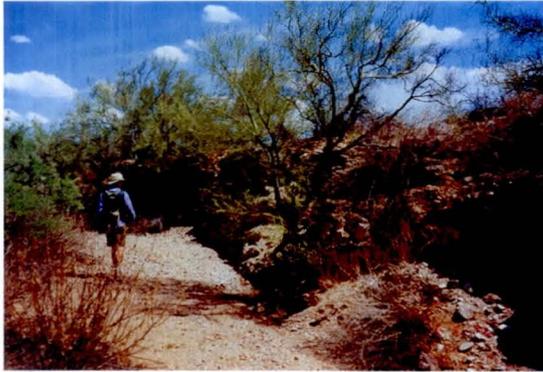
- Caliche. Carbonate-rich soil layers (a.k.a. “caliche”) were observed throughout Reach 1, and are exposed in cut banks where the main channel intersects the margins of older geomorphic surfaces (Figures 8 and 9; Table 3). While the caliche layers themselves are more resistant to erosion than the non carbonate-cemented soil layers, field data suggest that the carbonate layers have been eroded by recent stream flows. The carbonate layers erode primarily by undercutting the non-cemented underlying layers (cantilever failures), but also by direct shear and impact forces on the carbonate layers themselves (Figure 10). Locations of caliche outcrops observed in the field are shown on Exhibit 1.

Figure 8. Caliche-cemented bank in Reach 1.

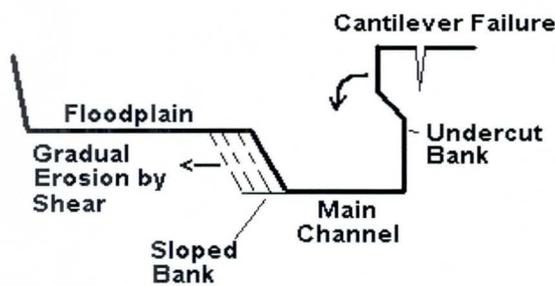
Figure 10. Illustration of cantilever failure and failure by shear.

Lateral migration hazard zone. Lateral migration erosion hazard occurs by failure of the main channel banks (Figure 10), and is caused primarily by the force of flood water flowing against the bank. Historical and field evidence suggests that lateral migration hazards have been moderate along Skunk Tank Wash during the past 40 years. Therefore, the lateral migration erosion hazard zone (LMEHZ), shown in red on Exhibit 2, was delineated using the following principles:

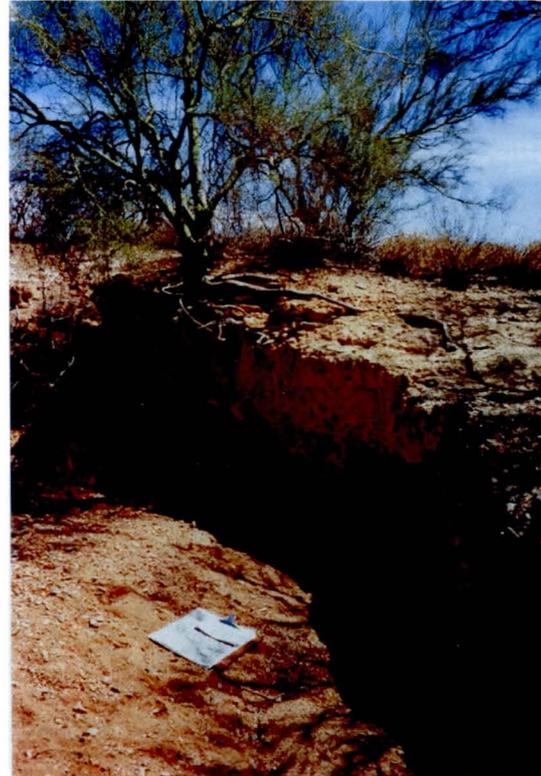
Figure 9. Undercut bank capped by carbonate layer.

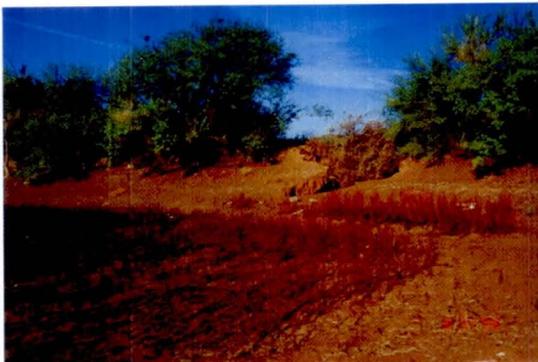
- Skunk Tank. Skunk Tank, the stock tank from which the wash derives its name, consists of an 8-foot high earthen dam located immediately upstream of the confluence with Skunk Creek. The dam is currently breached (Figure 11a), but continues to pond a small amount of water after flow events. No information on the construction date of the dam was readily available. The tank is visible on 1962 aerial photographs and does not appear to have been recently constructed at that time, so it must pre-date 1962. The ponding area of the tank has partially filled with fine-grained sediment. Sediment deposition in the ponding area appears to impact the morphology of the wash for a distance of about 0.4 miles upstream of the dam.

After the photograph in Figure 11a was taken, a small flood occurred on Skunk Tank Wash on October 22, 2000. Figures 11b to 11d show the condition of the breach in the dam on October 26, 2000. Further degradation of the dam and subsequent floods will lead to headcutting through the tank impoundment area and increased lateral erosion in Skunk Creek downstream of the tank.

Figure 11a. Partial breach in Skunk Tank, looking downstream at dam on August 31, 2000.

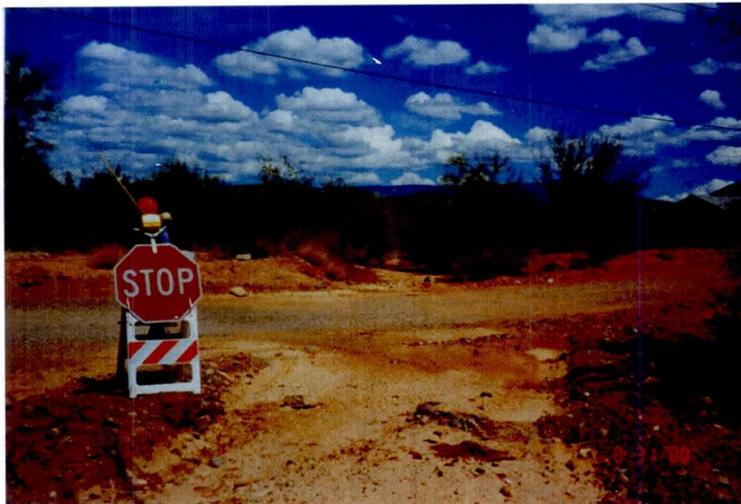
- Road Dip Crossings. At-grade crossings of the few dirt roads that cross the streams in the study area have minimal impact on the streams, aside from trapping fine-grained sediment in the road section during flow events (Figure 12).

Figure 12. Dip crossing of Skunk Tank Wash at Irvine Road. Note evidence of recent sediment deposition.

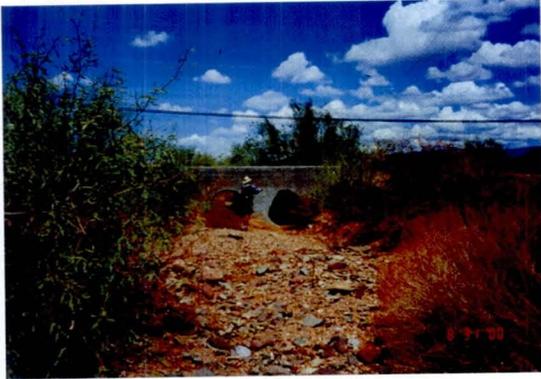
- Culverts. Culverts have been constructed at Desert Hills Drive (2-5ft. CMP; Figure 13), 7th Avenue (3-4 ft. CMP; Figure 14), and Joy Ranch Road (3-4 ft. CMP). The culverts at Desert Hills Drive and 7th Avenue are in good condition with no obvious sedimentation impacts on the main channel. The Joy Ranch Road culverts are about ½ filled with sediment, probably because they were installed below the natural grade of the main channel. Because these culverts are undersized with respect to the 100-year flood, they will be overtopped. Overtopping flows may cause erosion of road grades or may direct flows away from the main channel and cause avulsive erosion of the floodplain.

Figure 13. Irregular CMP culverts at Desert Hills Drive.

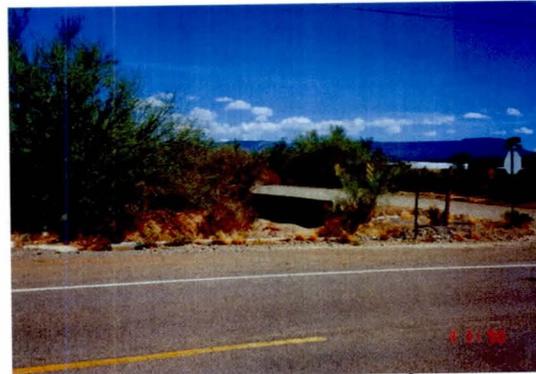
Figure 14. CMP culverts at 7th Avenue.

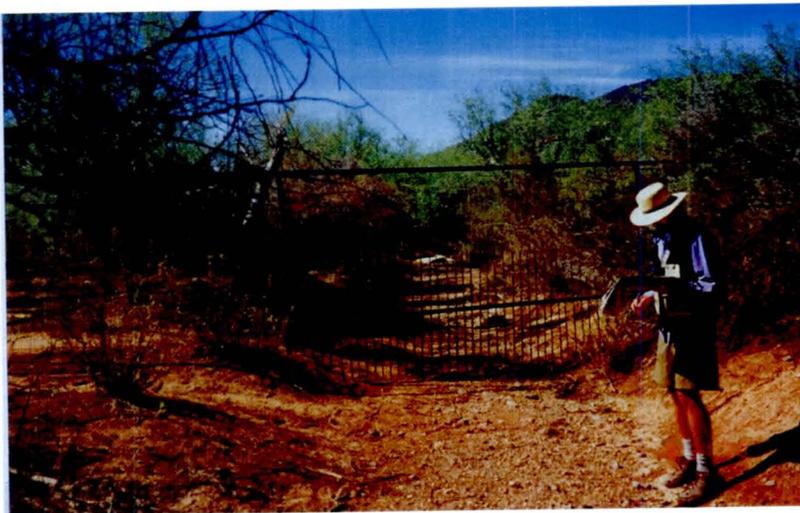
- Fences. Several homeowners have built fences over the main channel of Skunk Tank Wash (Figure 15). These fences will tend to trap sediment and debris, increasing local scour immediately surrounding the fence, and ultimately causing failure of the fence. More importantly, the fences will trap flood debris and divert water from the main channel into the floodplain, increasing the likelihood of avulsions or scour in the floodplain.

Figure 15. Chain link and iron grate fence over Skunk Tank Wash.

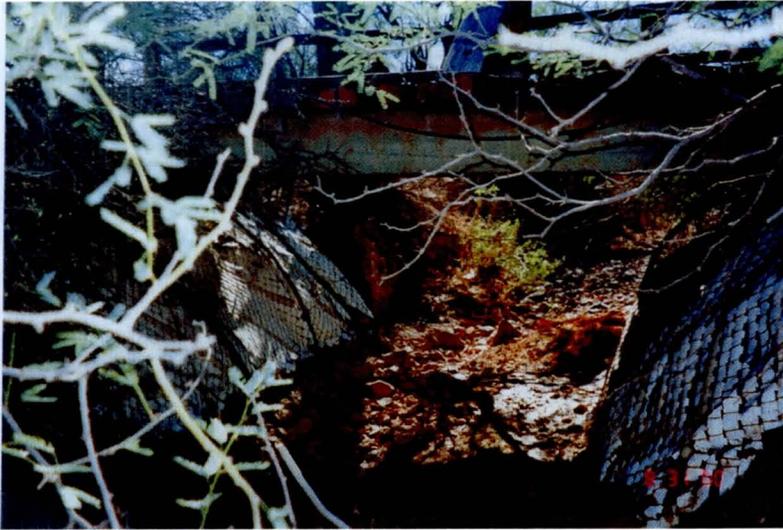
- Bridges. A number of homeowners have constructed small one-lane bridges over the main channel (Figure 16). These bridges tend to be undersized with non-standard construction materials. The bridges will tend to block flow and divert flow onto the floodplain, increasing the chance of avulsions and scour in the floodplain. Where bank vegetation was removed near the bridge abutments, the channel banks will be more erodible.

Figure 16. Small driveway bridge over Skunk Tank Wash.

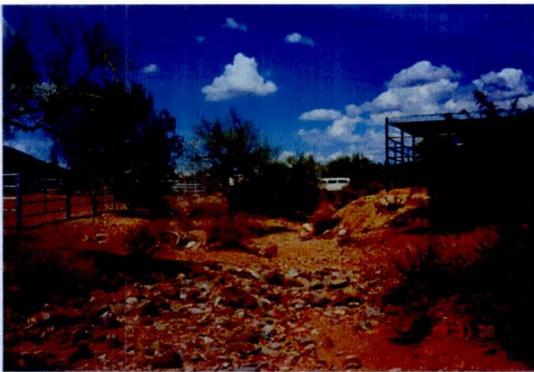
- Homes. Several homes and barns have been built in the floodway of Skunk Tank Wash within several feet of the main channel banks, and are at risk of erosion and flood damage (Figure 17). In a few cases improvements associated with new home construction have obliterated the natural channel by grading, and blocked the floodplain with chain link fences (Figure 18). Excessive erosion of the floodplain should be expected where the natural channel no longer exists.

Figure 17. Horse barn on fill encroaching in the floodway.

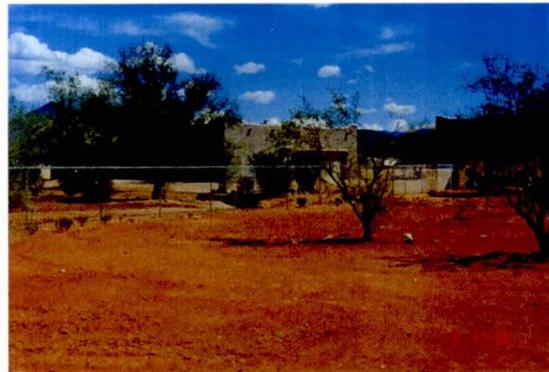
Figure 18. Homes with grading obscuring natural wash and blocking floodplain.

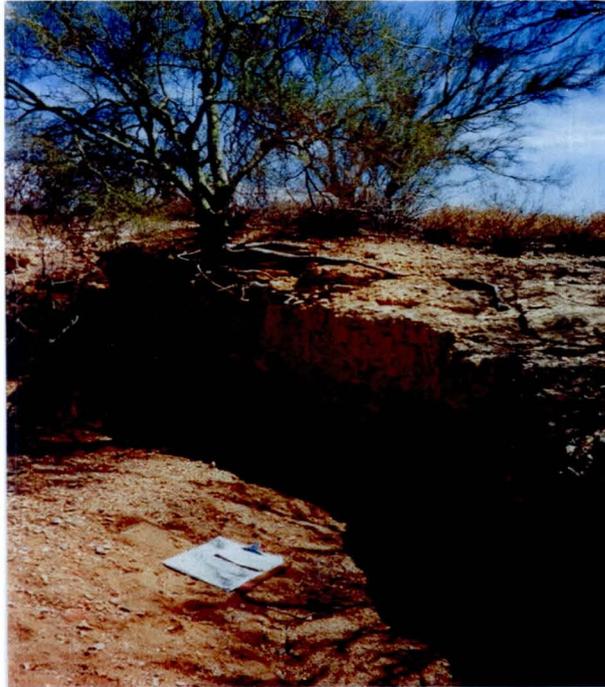
- Cut banks. The locations of cut banks observed in the field are plotted on Exhibit 1. The presence of cut banks indicates that active lateral erosion can occur within the stream systems in the study area regardless of bank vegetation, soil lithology, and soil composition (Figure 19).

Figure 19. Cut bank in caliche cemented bank.

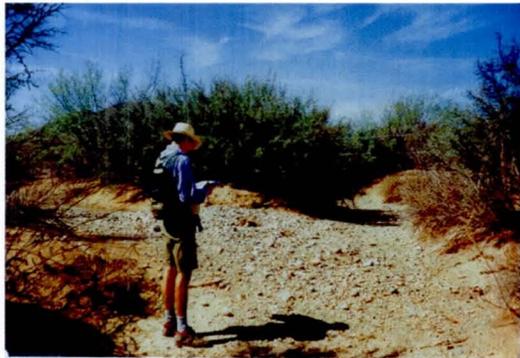
- **Avulsions.** Where the main channel becomes small, the potential for high volumes of flow in the floodplain is high. That is, if the elevation of the overbank floodplain is low relative to the main channel, the floodplain will convey frequent flows of sufficient volume and peak to cause new channels to form (Figures 23 and 24). With time, these floodplain channels can capture the main channel and cause an avulsive shift of the main channel into the floodplain channel, resulting in a sudden relocation of the active channel from one side of the floodplain to the other. Remnants of past avulsions or incipient avulsive channels were observed on the wider floodplains in Reach 2. Small avulsions are found at a number of points in Reaches 1 and 2.

Figure 23. Channel bifurcation.

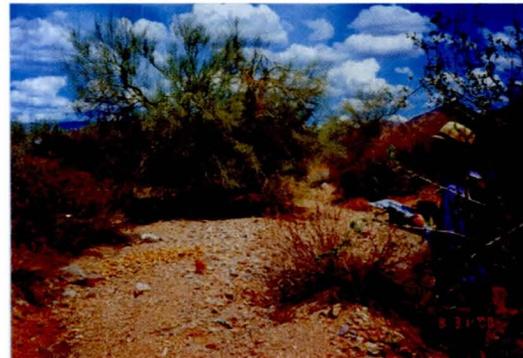
Figure 24. Channel split around mid-channel tree and debris.

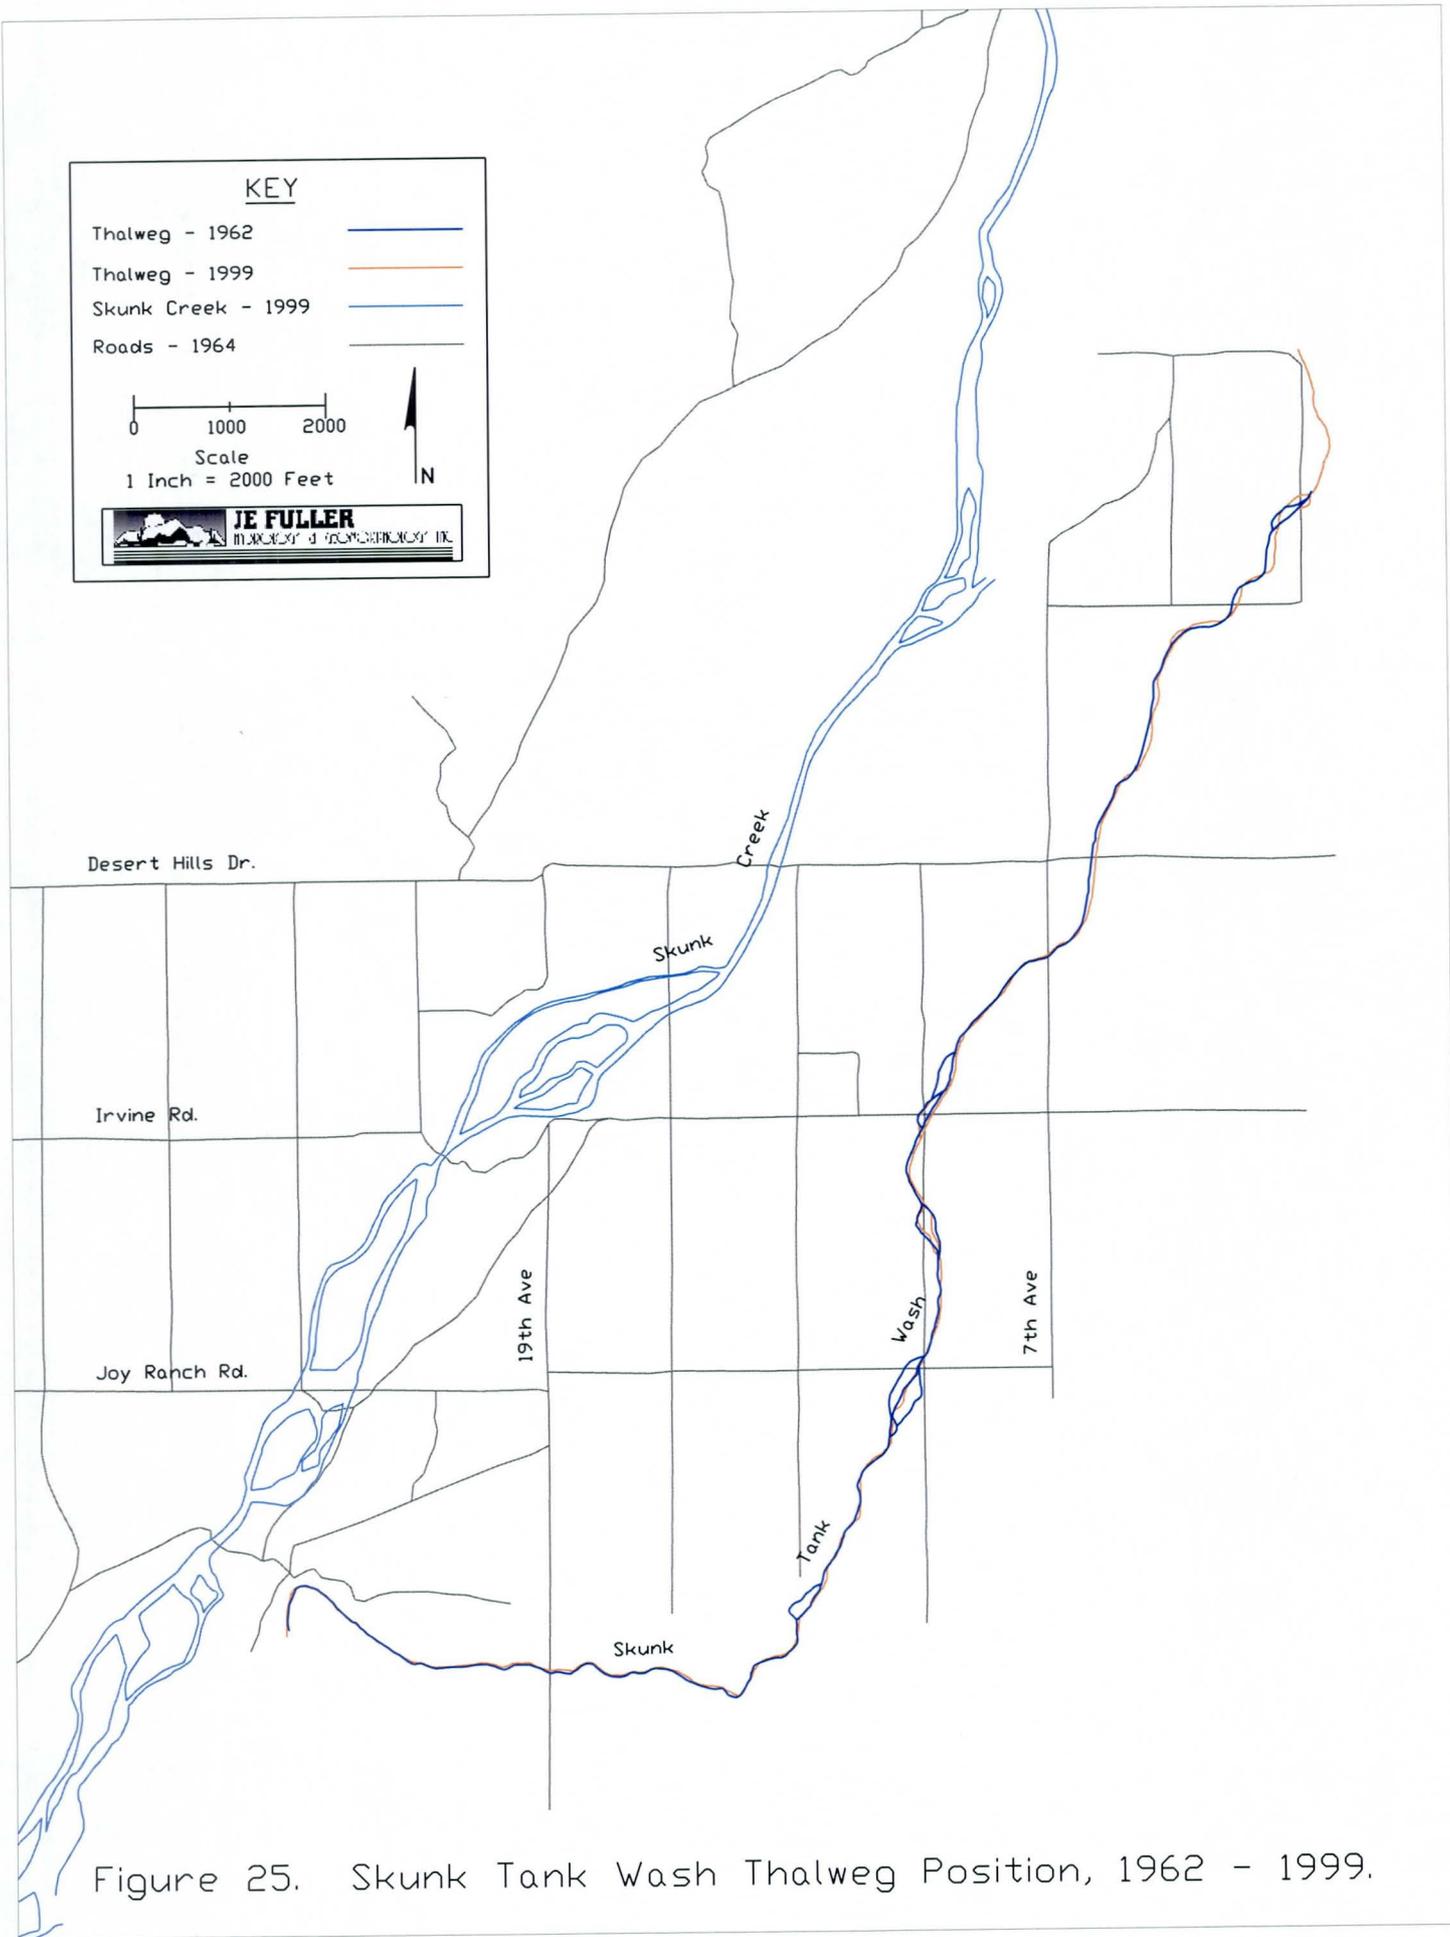
Figure 25. Skunk Tank Wash Thalweg Position, 1962 - 1999.

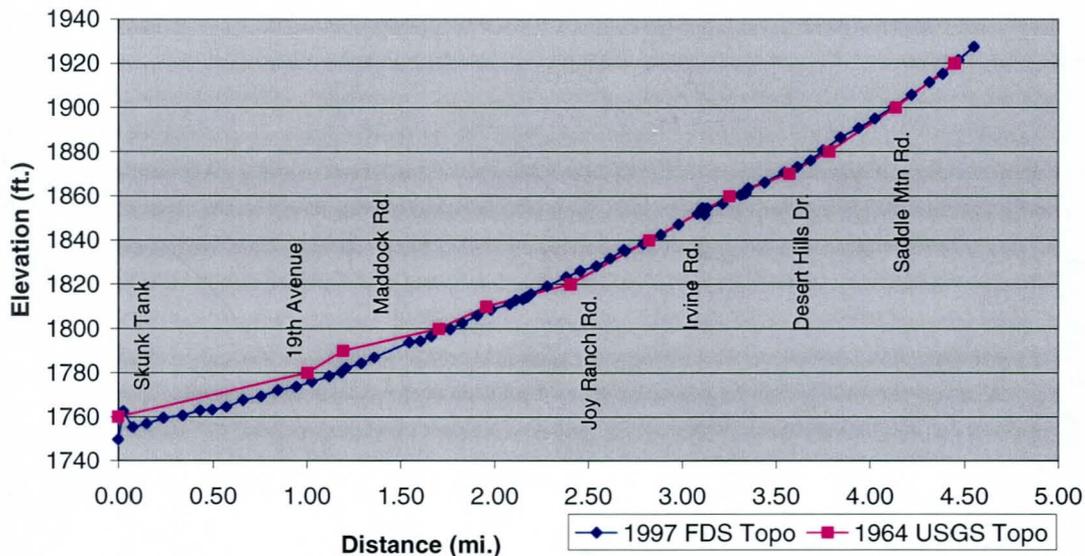
Figure 29. Skunk Tank Wash Longitudinal Profile

The following conclusions about lateral stability and erosion hazards can be drawn from the longitudinal profiles of Skunk Tank Wash shown in Figure 29:

- **Shape.** The Skunk Tank Wash longitudinal profile has concave up shape, which is the typical profile for an alluvial river. Active alluvial fans commonly have a concave down shape due to net aggradation of sediment below the fan apex. The 1997 Skunk Tank Wash profile indicates that the fan-like portions of the piedmont have not been actively aggrading in recent geologic time, although the 1964 profile has a classic concave down shape in the reach between Joy Ranch

- Profile comparison. Despite the difference in contour interval and map scale, the 1964 and 1997 profiles are almost identical, except in the reach between Maddock Road and 19th Avenue. It is not likely that the concave down profile of the 1964 topography is due only to differences map accuracy, since the discrepancy in bed elevations is greater than the vertical accuracy of the USGS mapping (± 10 ft.), and because the trend of elevation differences is consistent over a considerable reach. However, no physical evidence of significant long-term degradation in this reach was observed in the field. At this time, no completely satisfactory explanation of the elevation differences for the longitudinal profiles of the reach between Joy Ranch Road and 19th Avenue exists. Throughout the rest of the study area, the two longitudinal profiles indicate that no significant long-term scour has occurred, a conclusion supported by field observations.

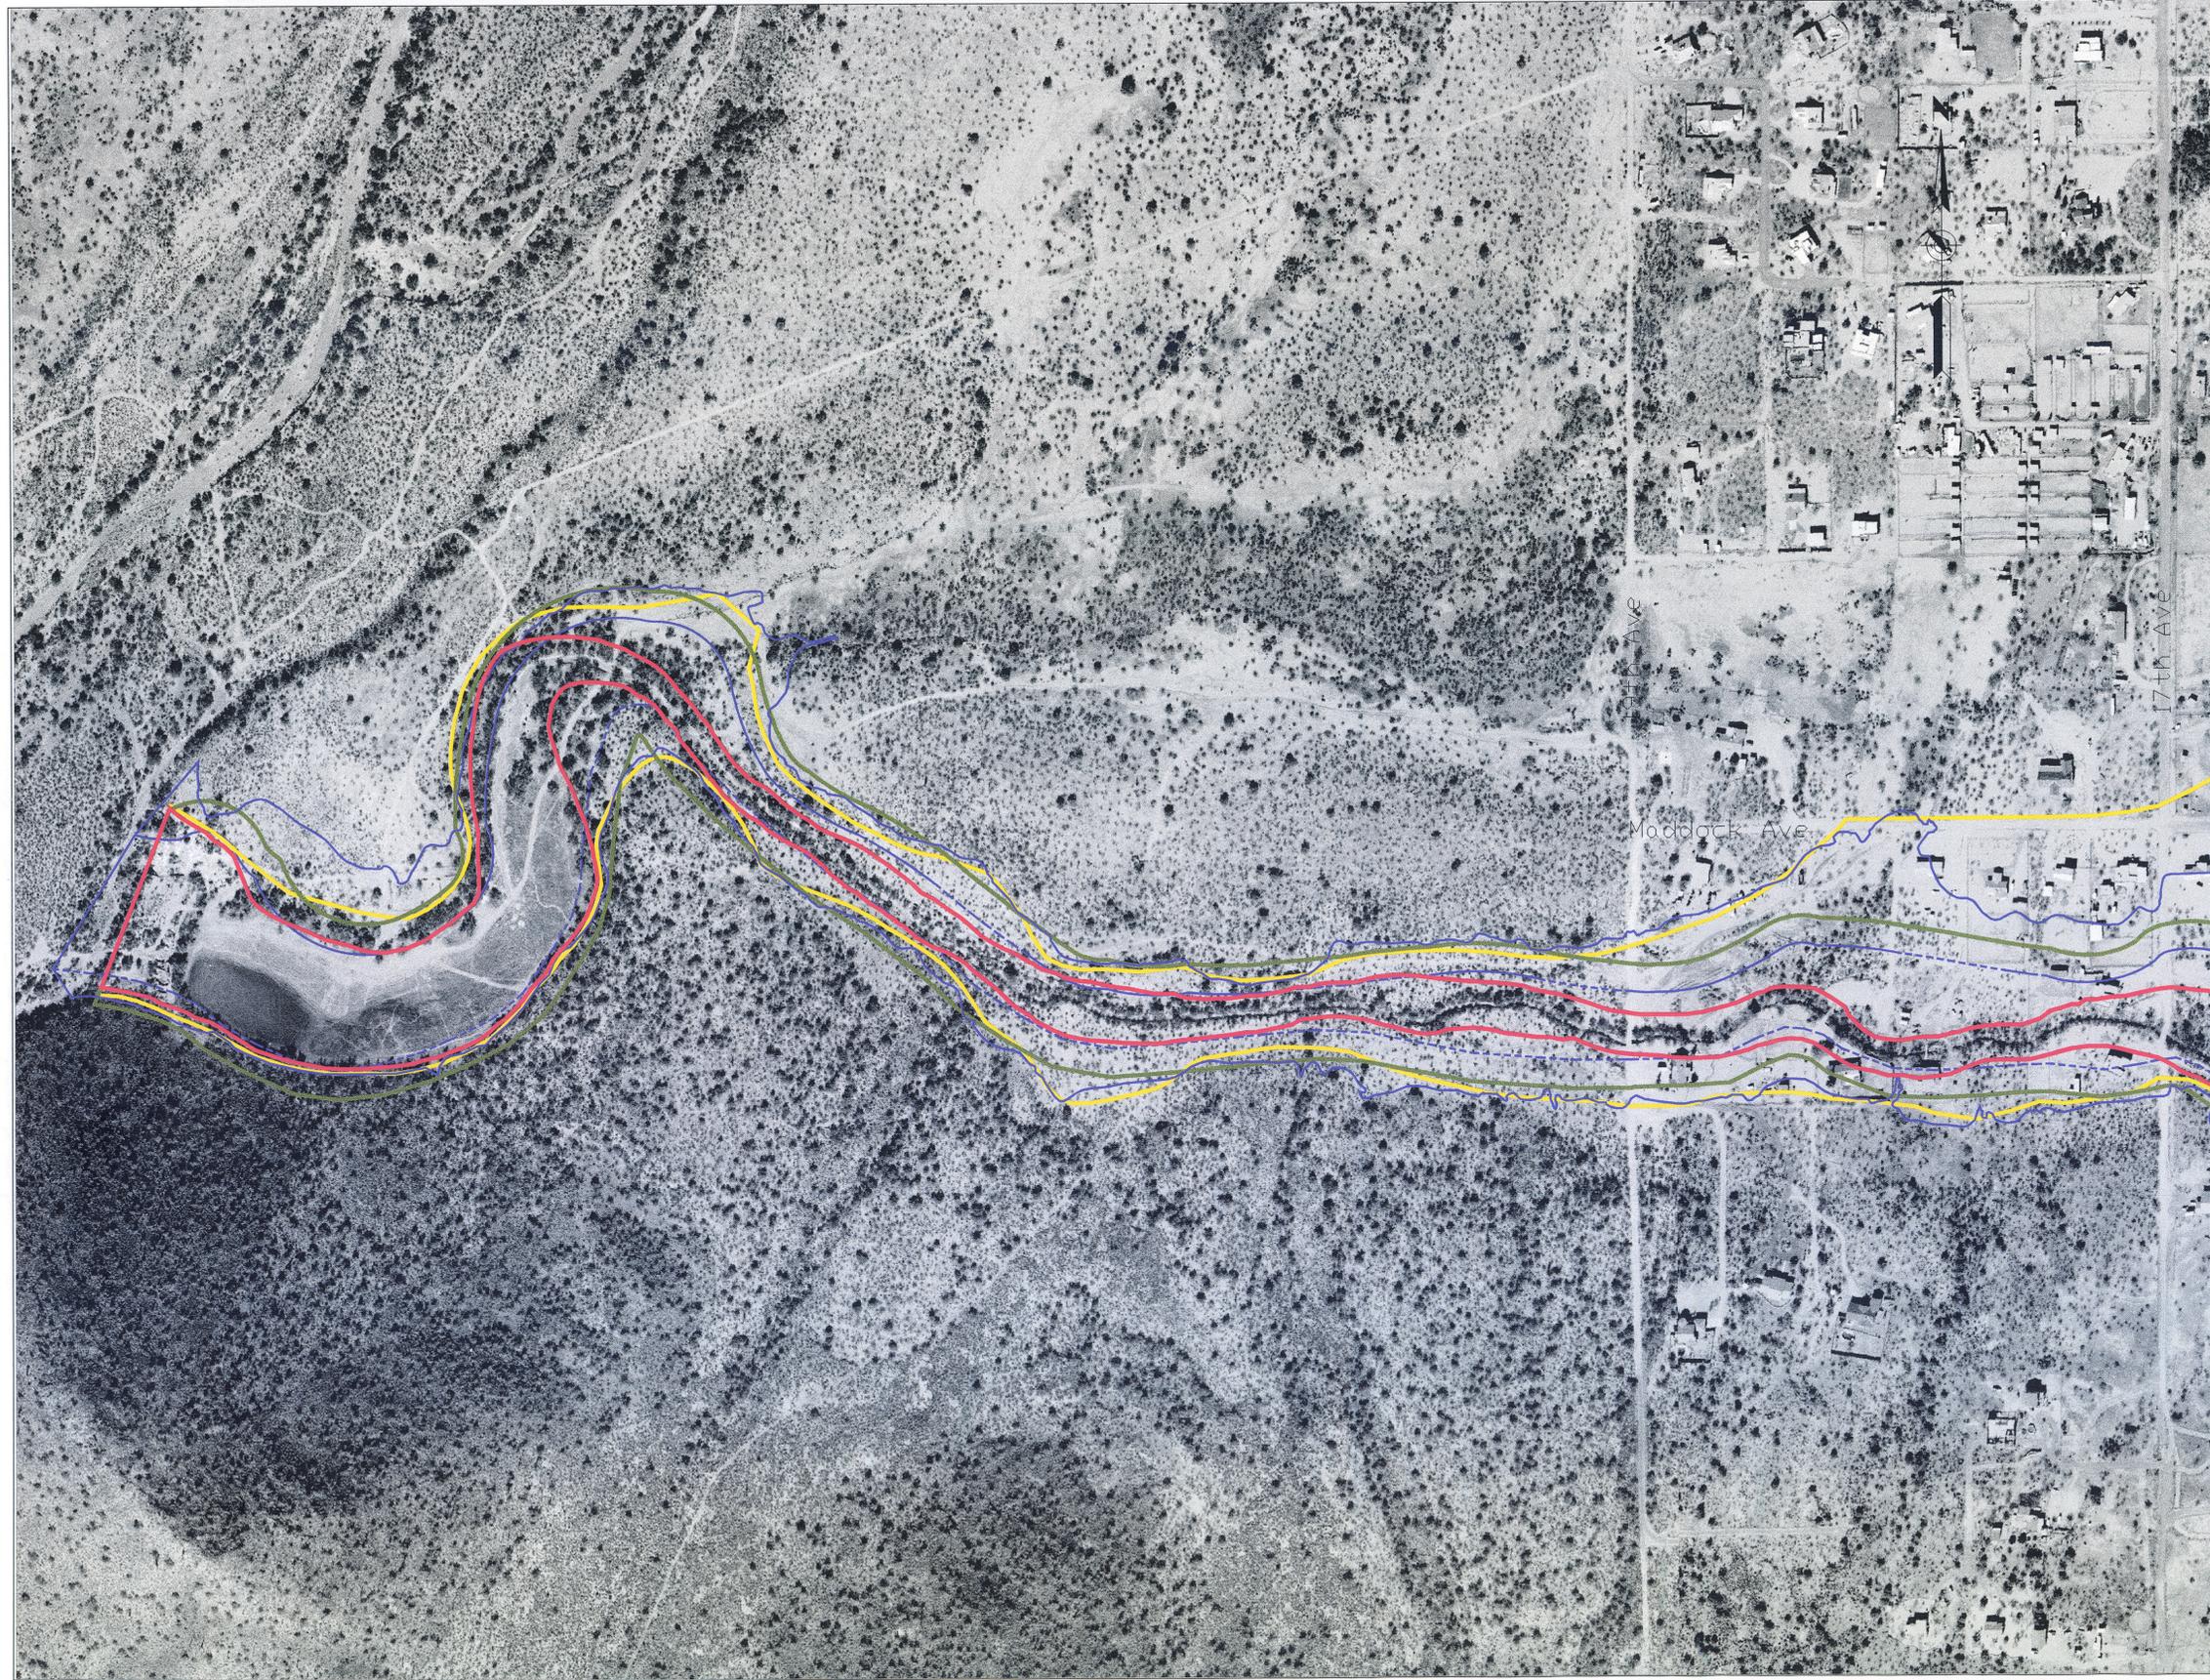
EXHIBIT 2 SHEET 1 OF 4

Long-term erosion hazard zone. The long-term erosion hazard zone includes erosion caused by obstructions in the floodplain and potential channel avulsions. Channel avulsions will occur along Skunk Tank Wash where significant overbank flooding occurs with sufficient depth and duration to scour overbank channels. Overbank channels which grow and intercept the main channel can lead to sudden relocation of the main channel to a new position in the former floodplain. The long-term erosion hazard zone (LTEHZ), shown in yellow on Exhibit 2, was delineated using the following principles:

The highest risk of erosion occurs within the lateral-migration erosion hazard zone. It is recommended that no development occur within the lateral migration erosion hazard zone without engineered bank protection, or without a detailed engineering and geomorphic analysis of the potential impacts of bank protection on adjacent reaches. Within the long-term erosion hazard zone, developers and residents should be warned of the potential for erosion caused by overbank flow concentration, diversion of overbank flows, and impact by shallow flooding. Structures and improvements that concentrate, divert or obstruct flow should be discouraged within the long-term erosion hazard zone.
