Public Meeting March 14, 2013

McMicken Dam Rehabilitation Project

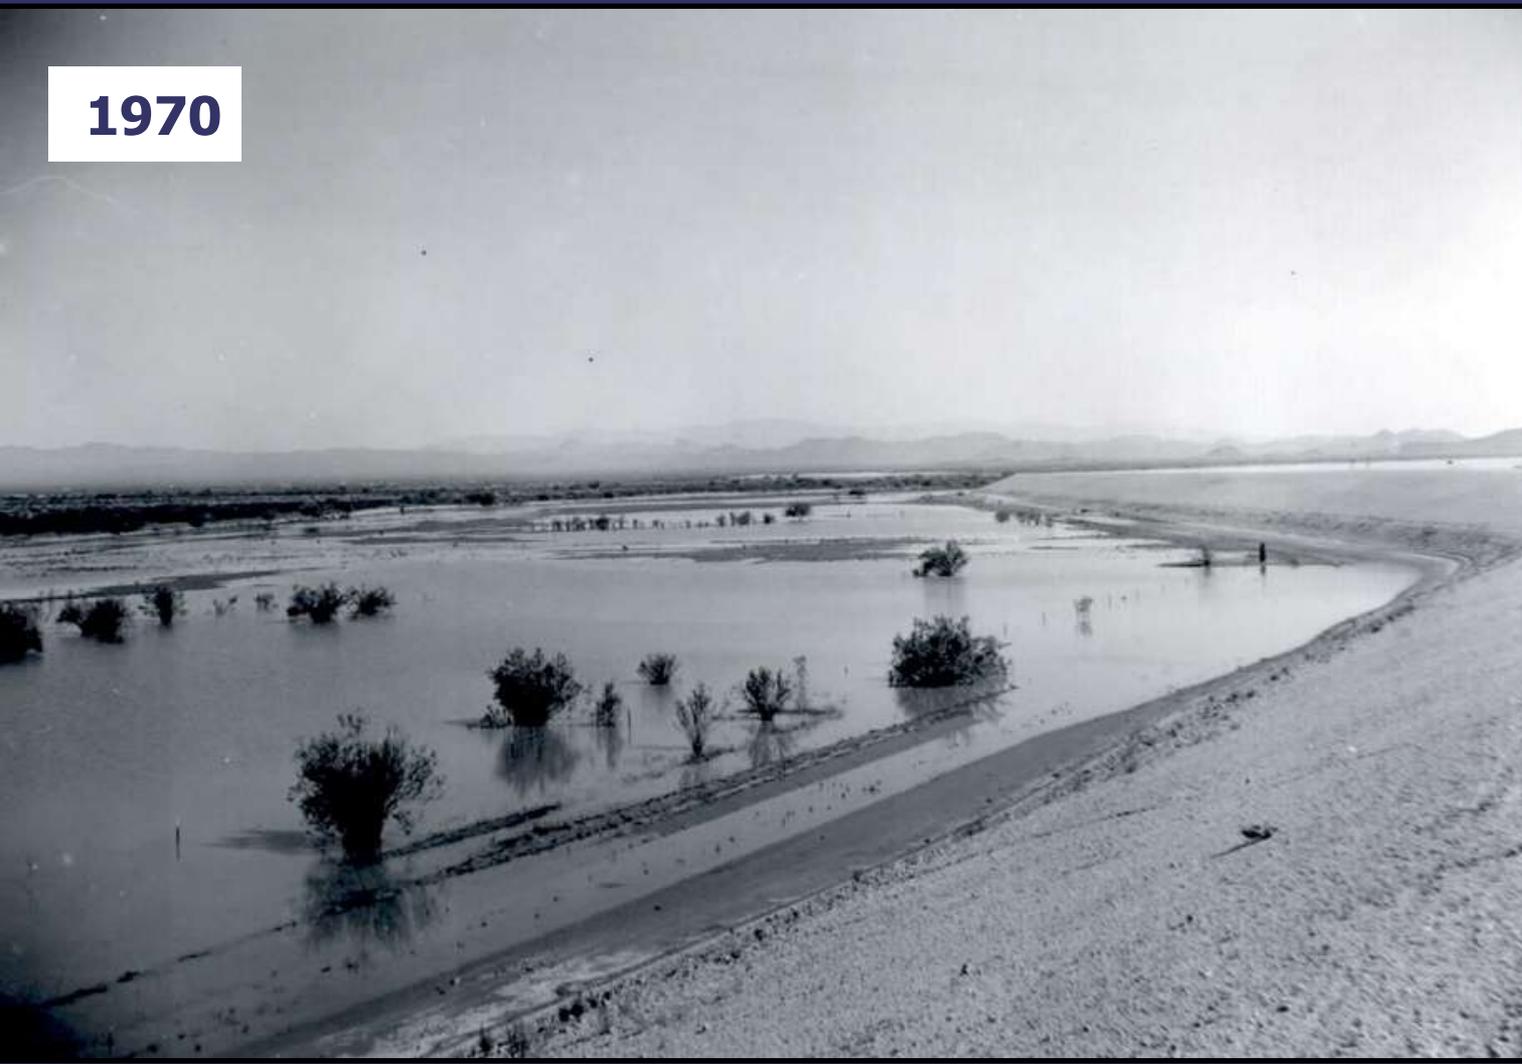
1970 – First significant filling (within 15 feet of dam crest)

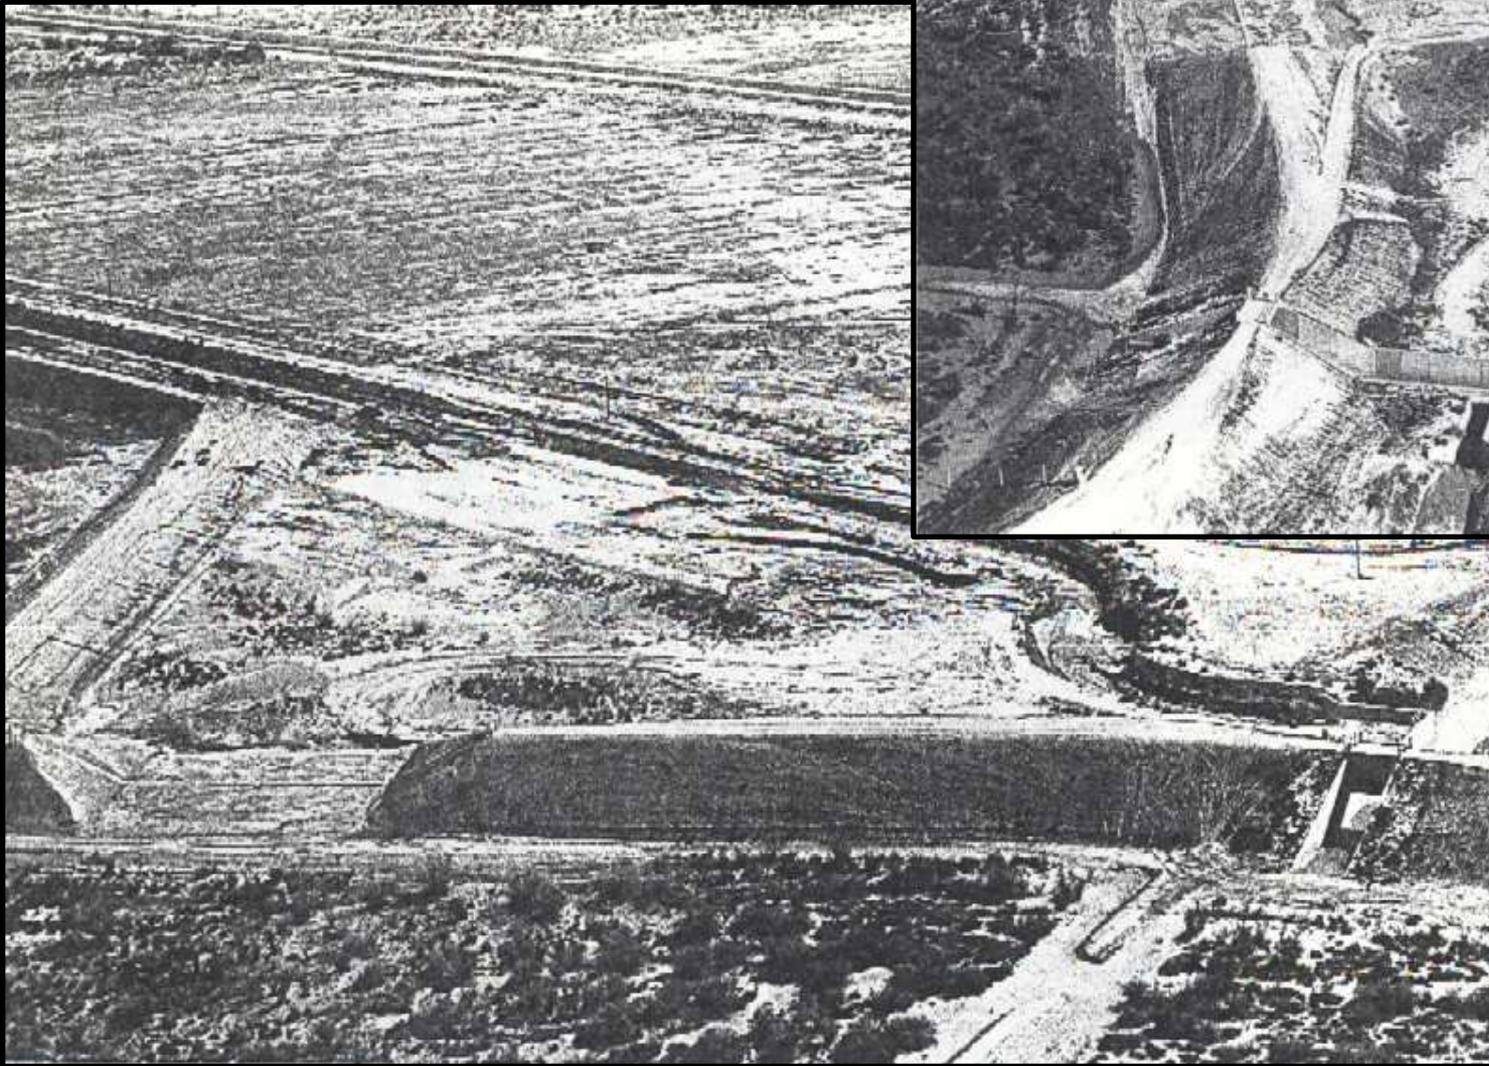
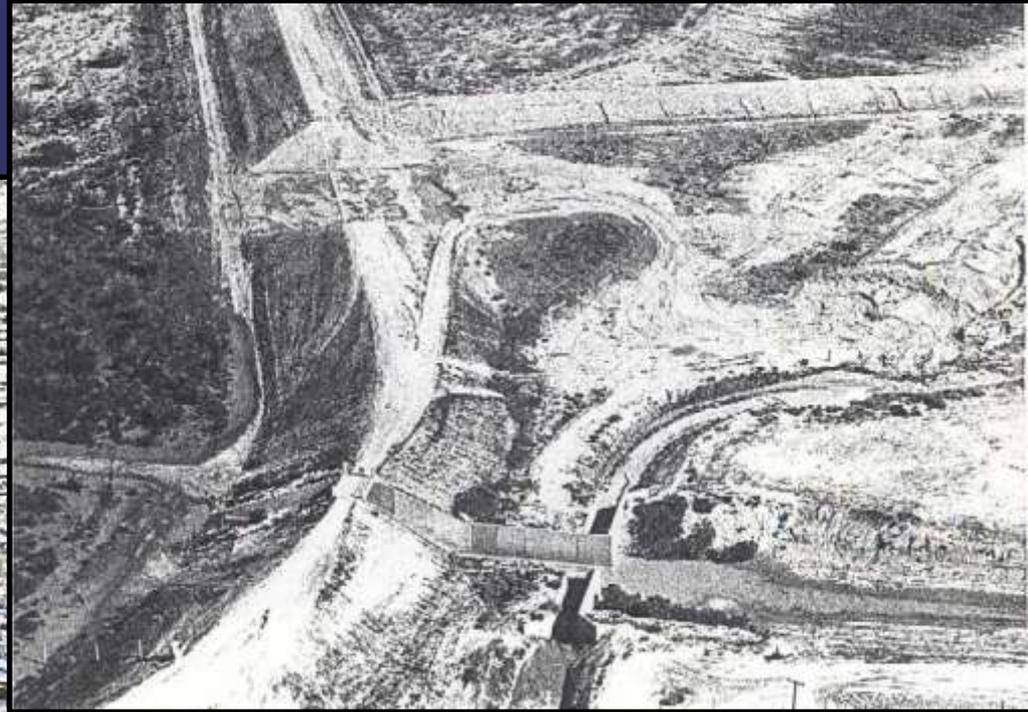
1977 - Army Corps of Engineers Breaches the Dam

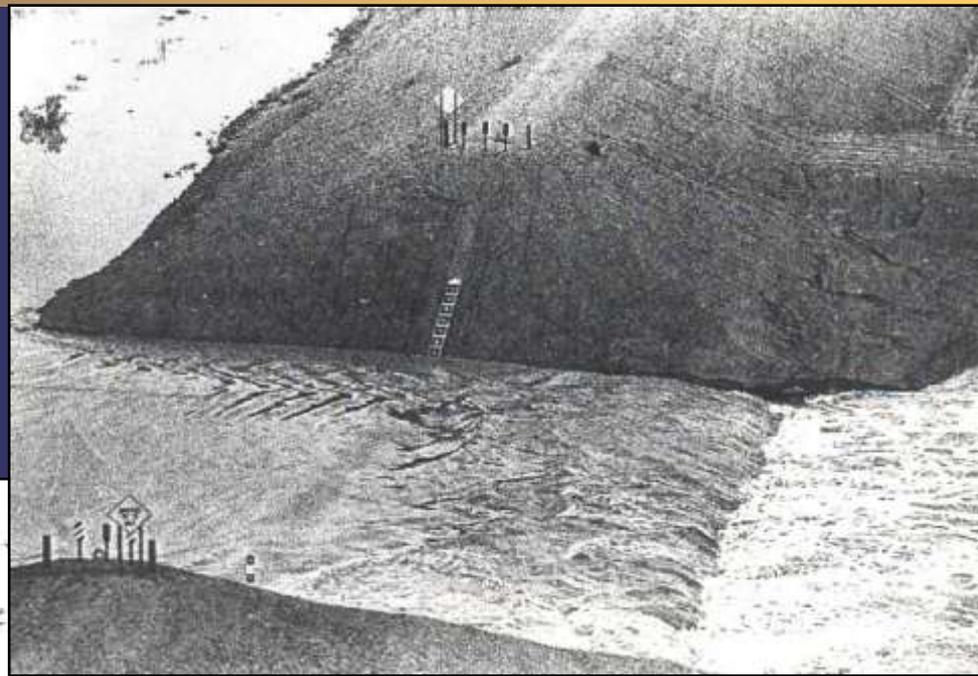
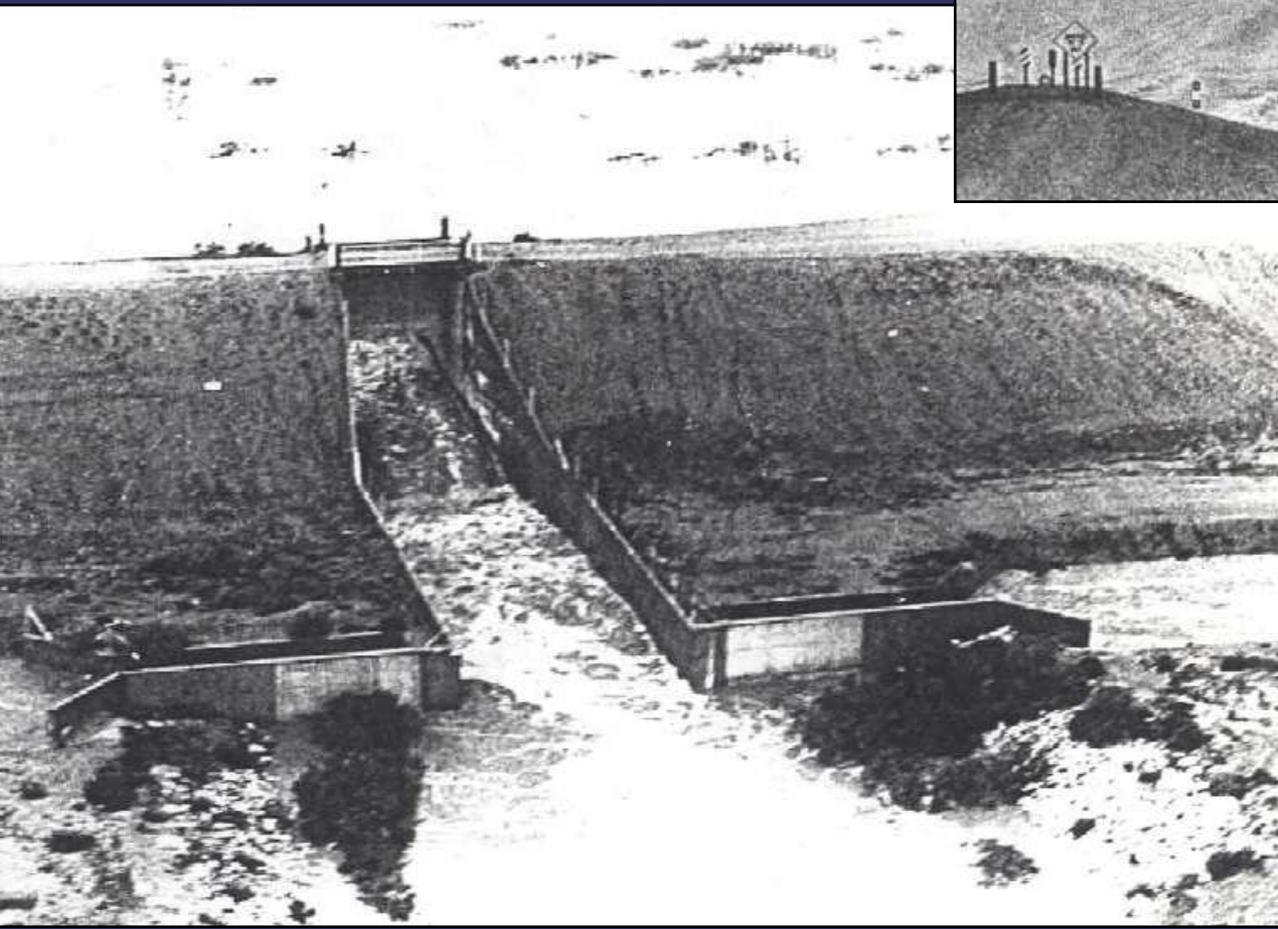
1978 – Significant Flows through Breach in Dam

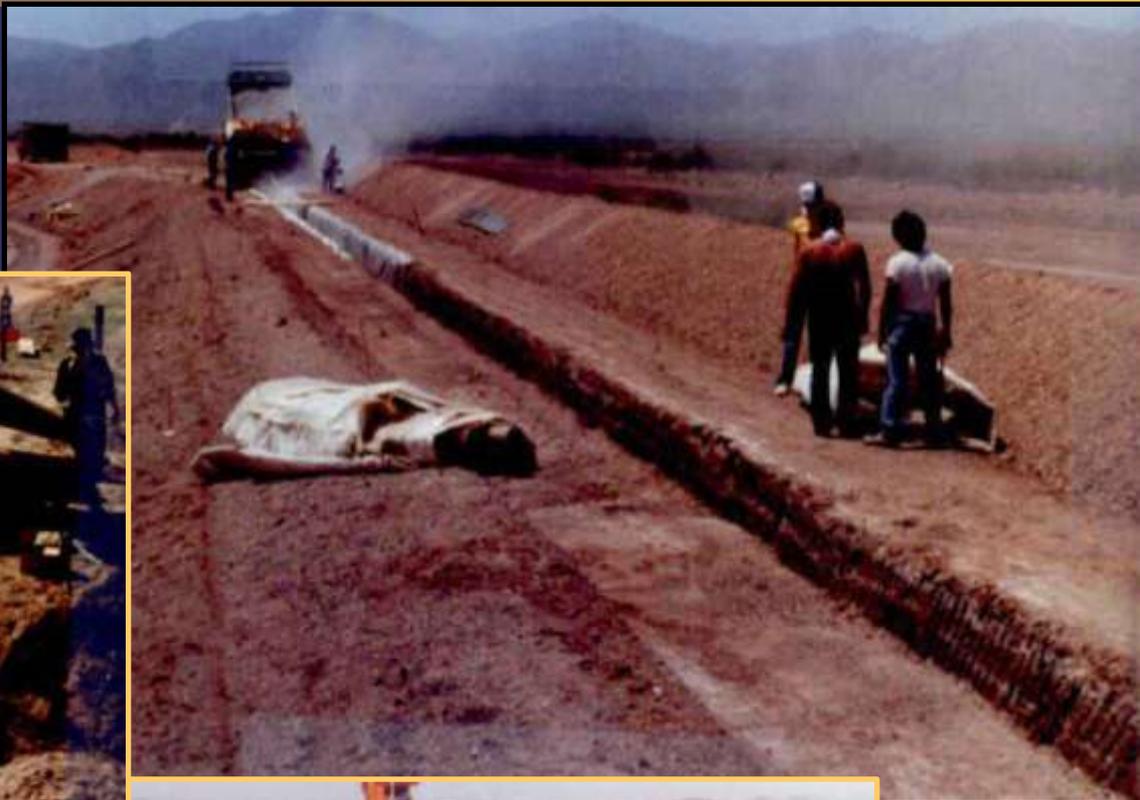
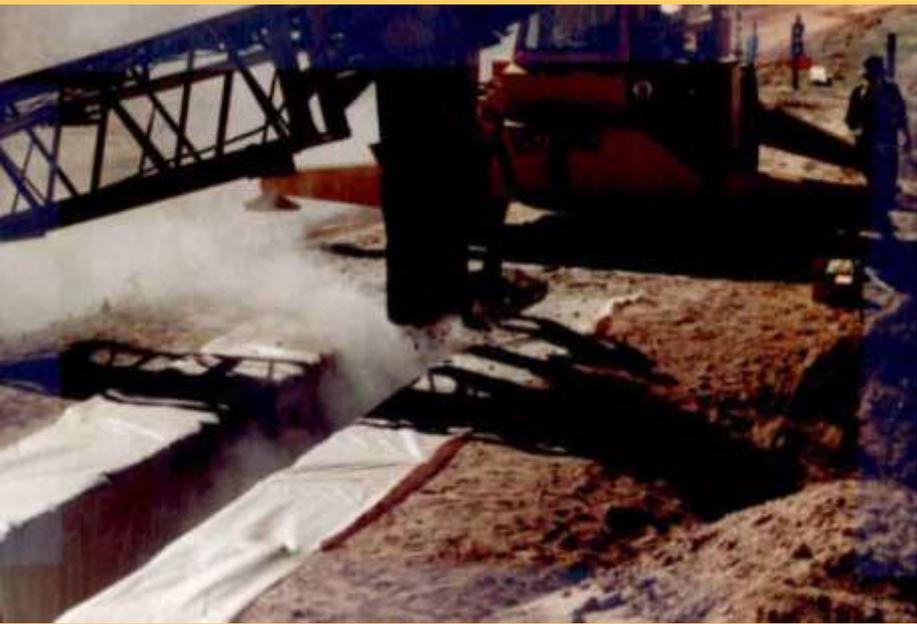
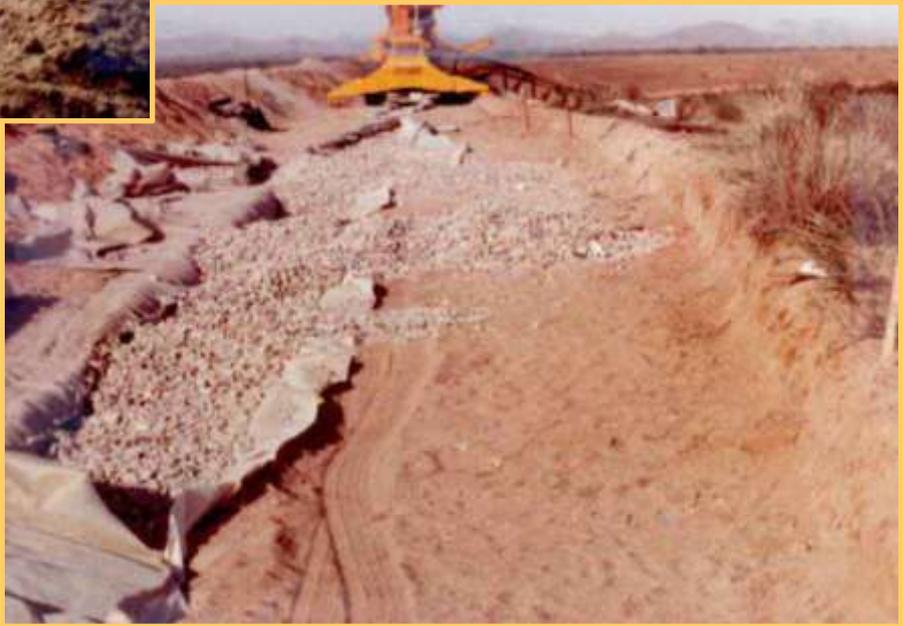
1985 – Dam Modifications by District

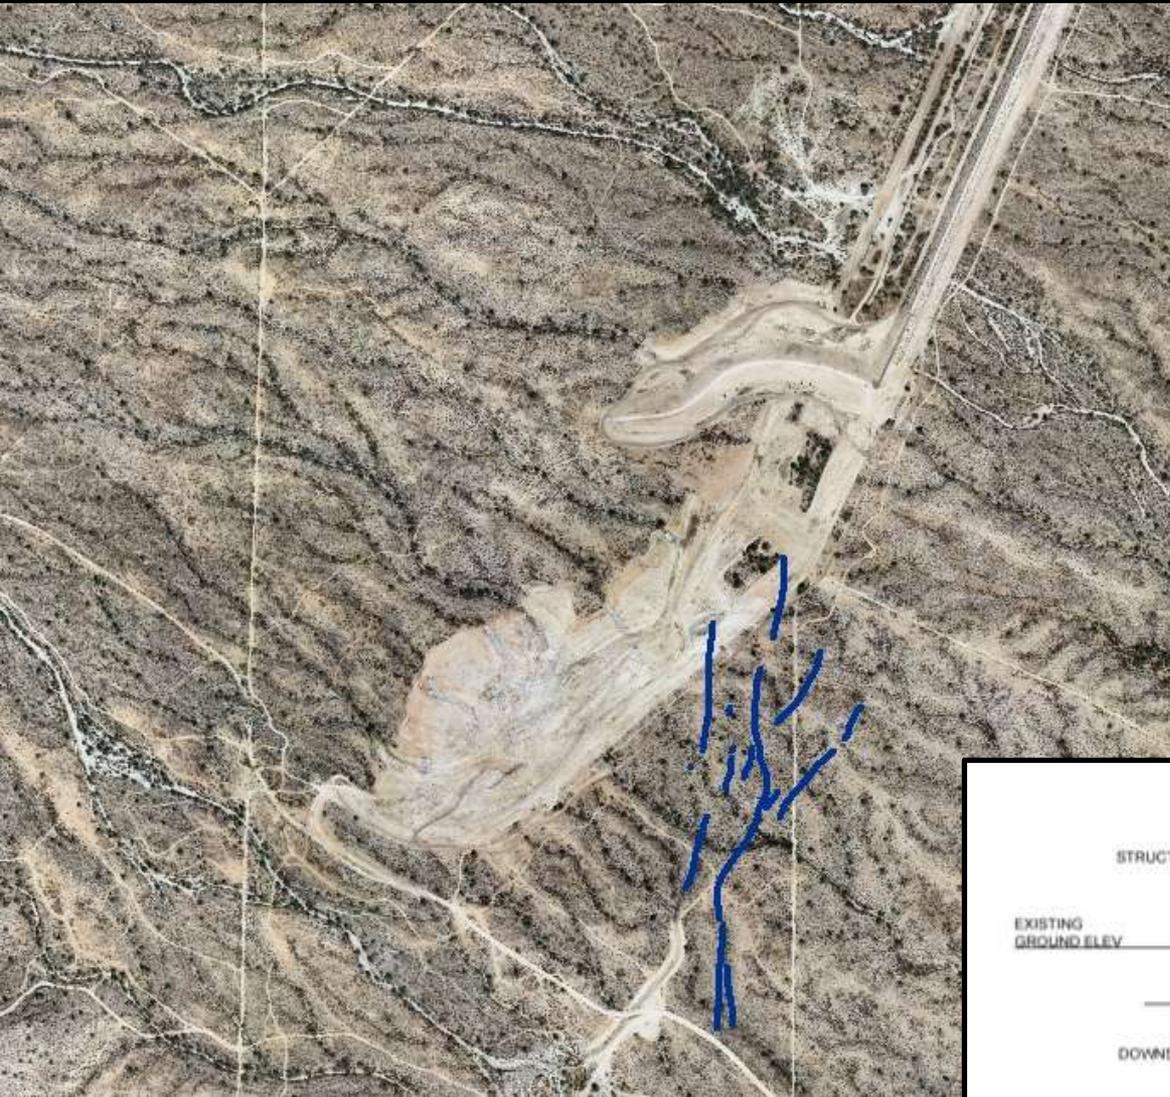
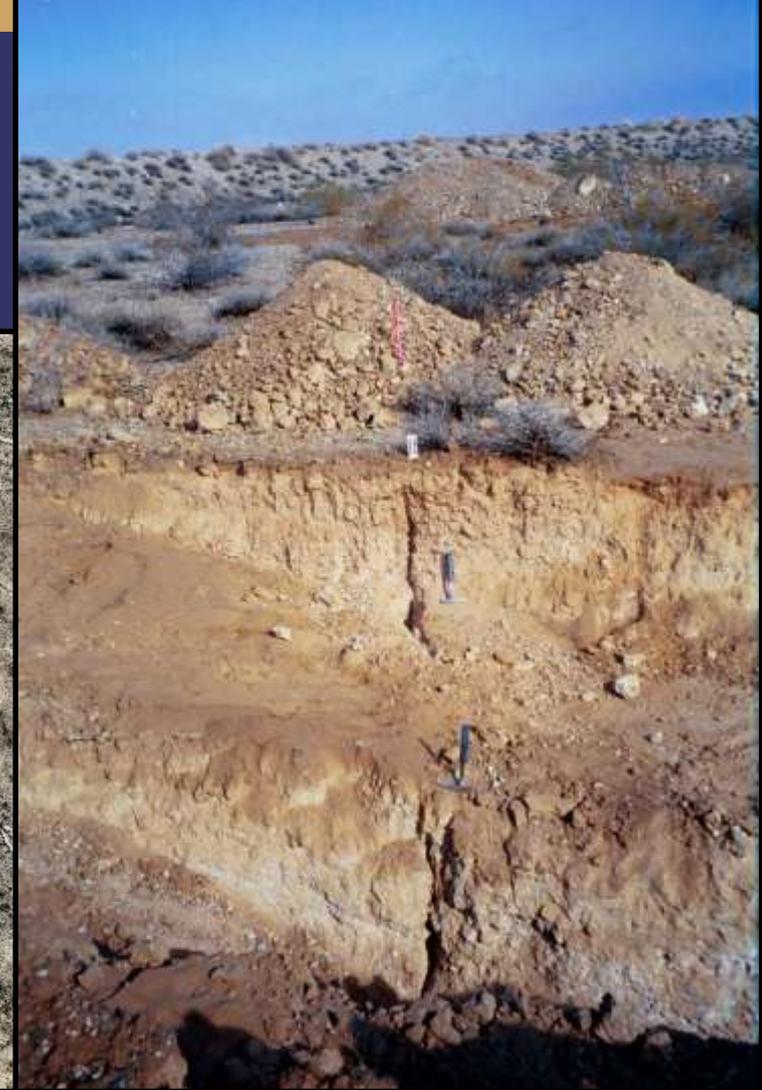
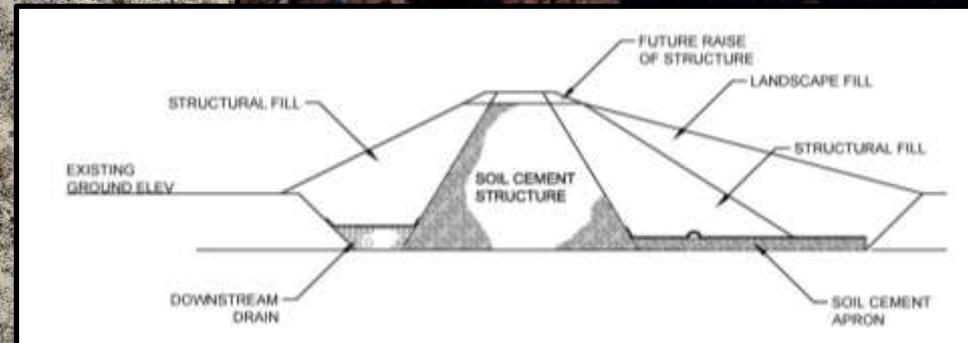
2006 – Dam Modifications by District

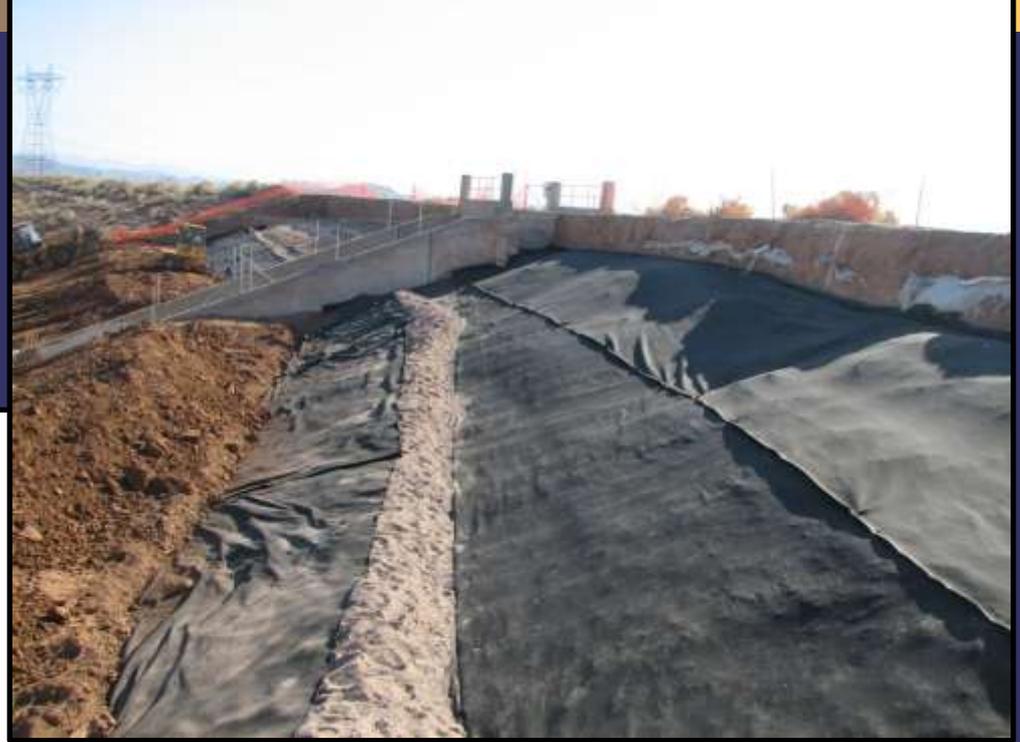
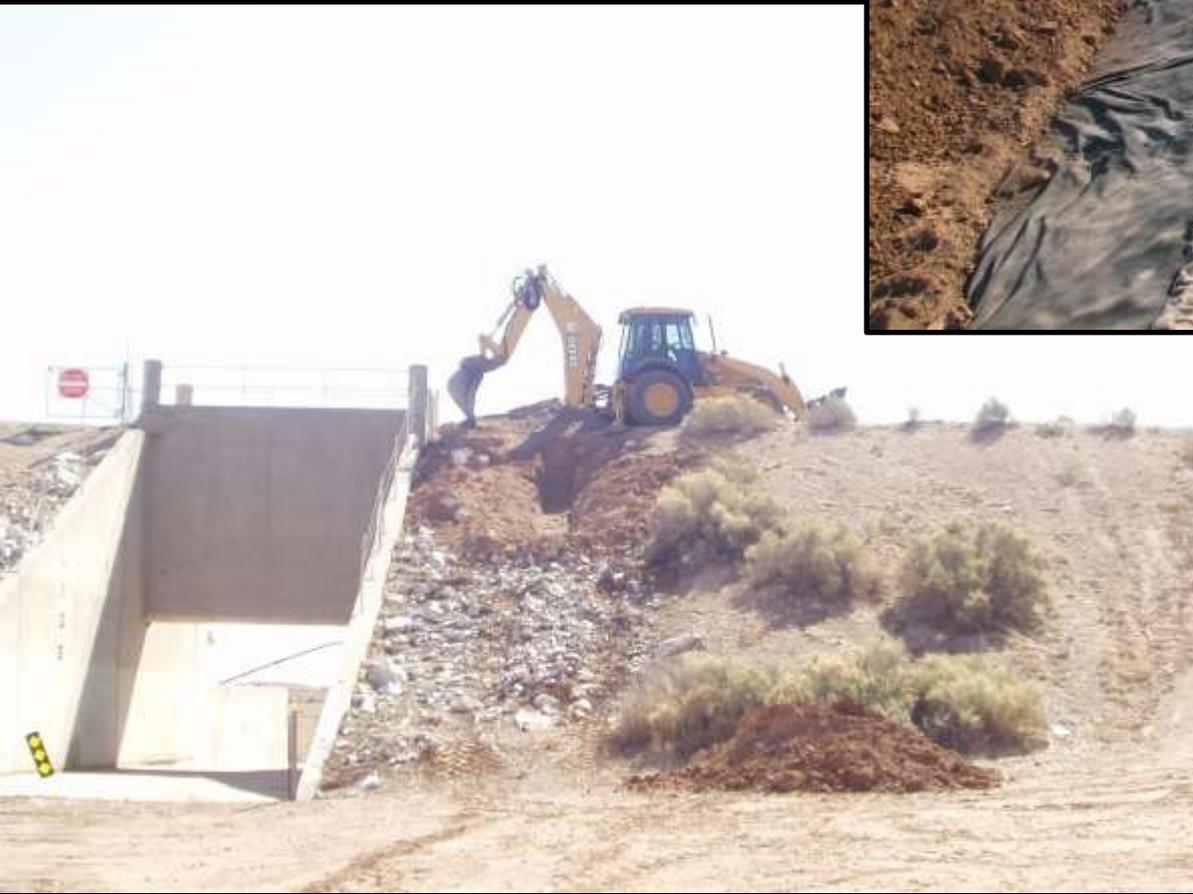
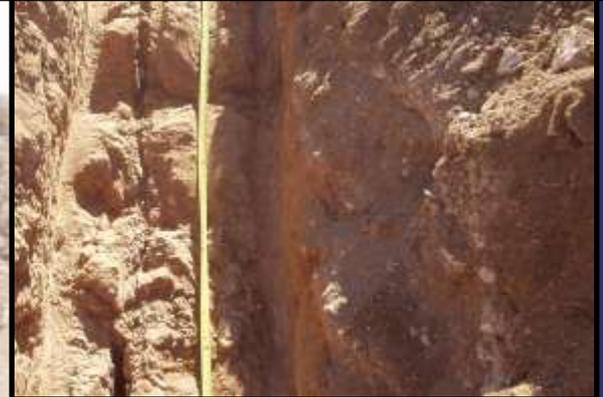
2007 – Dam Modifications by District

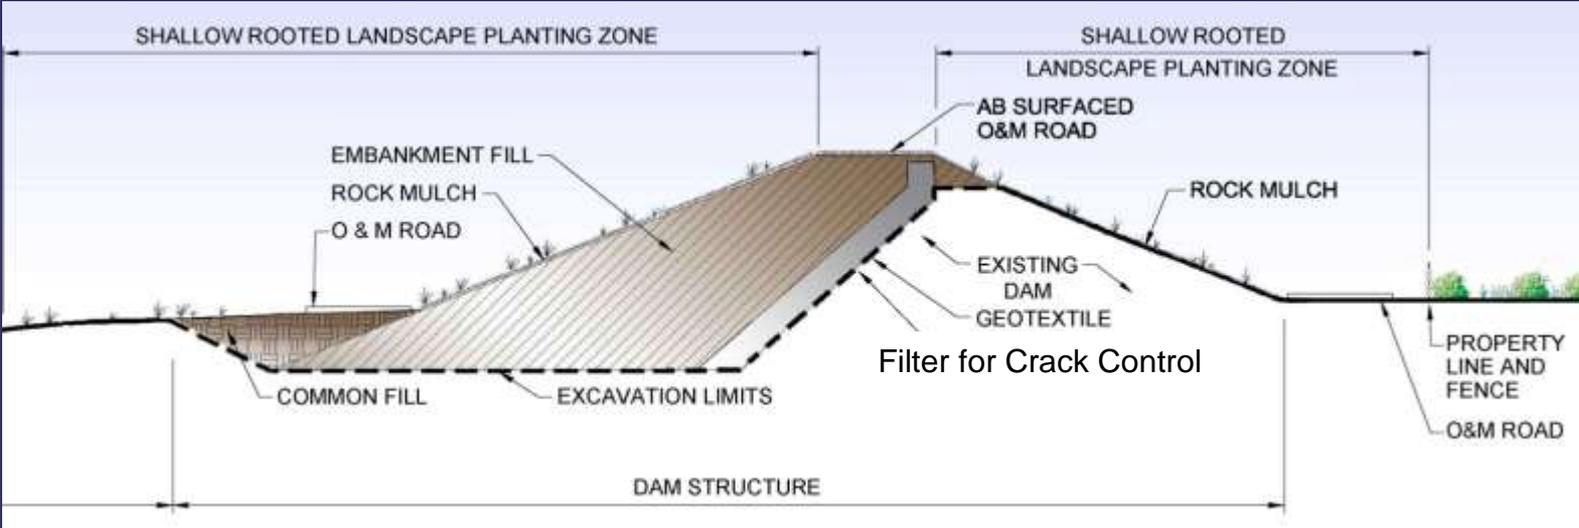
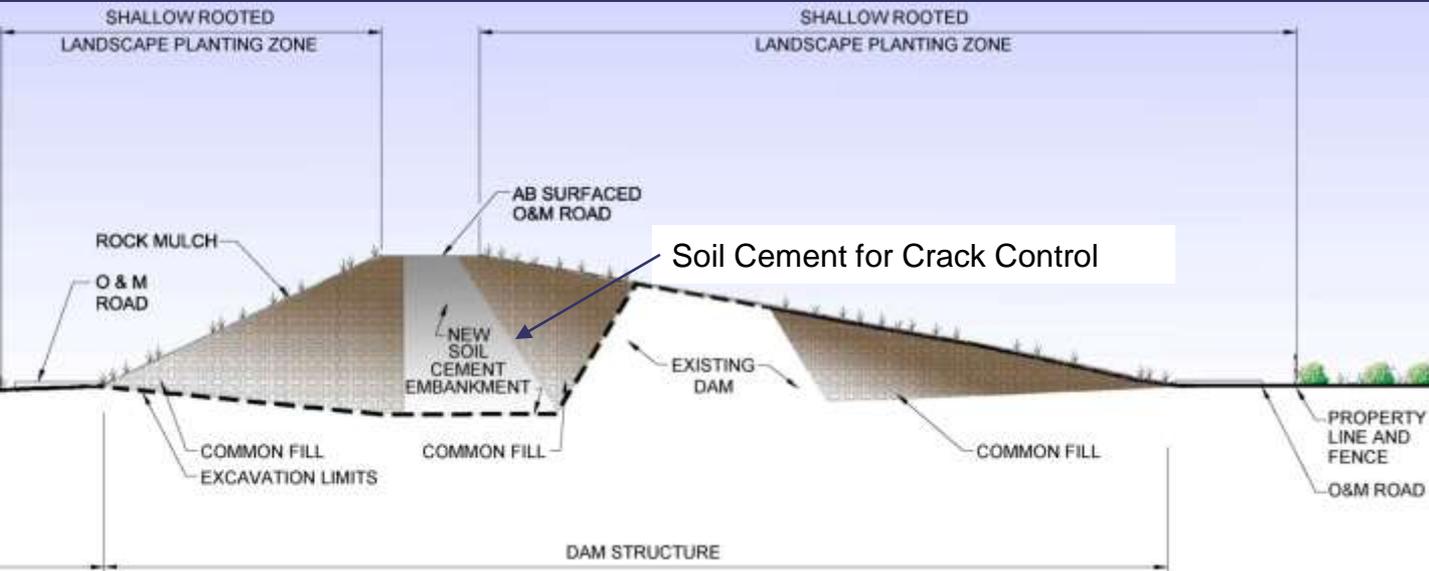
Selected Alternative - Dam Rehabilitation

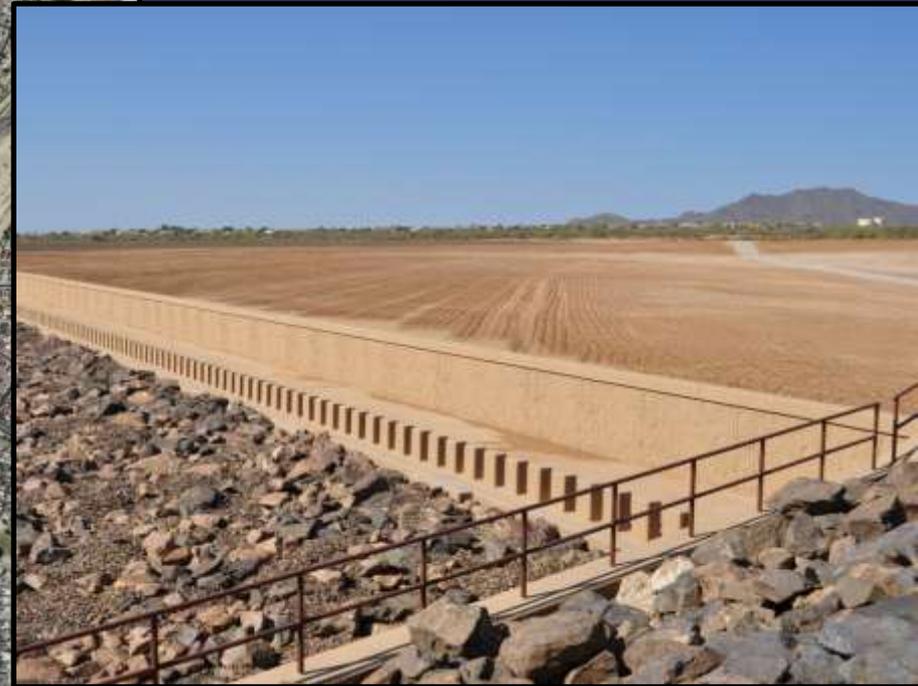
Emergency Spillway and Principal Outlet Relocation

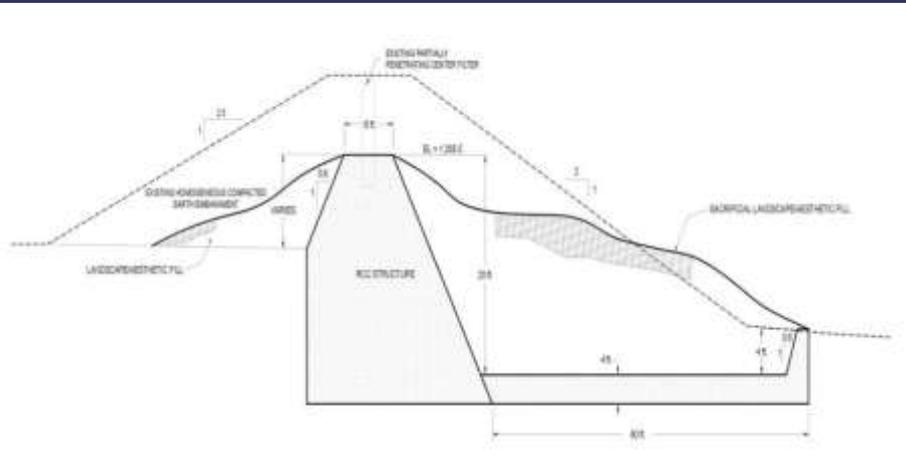
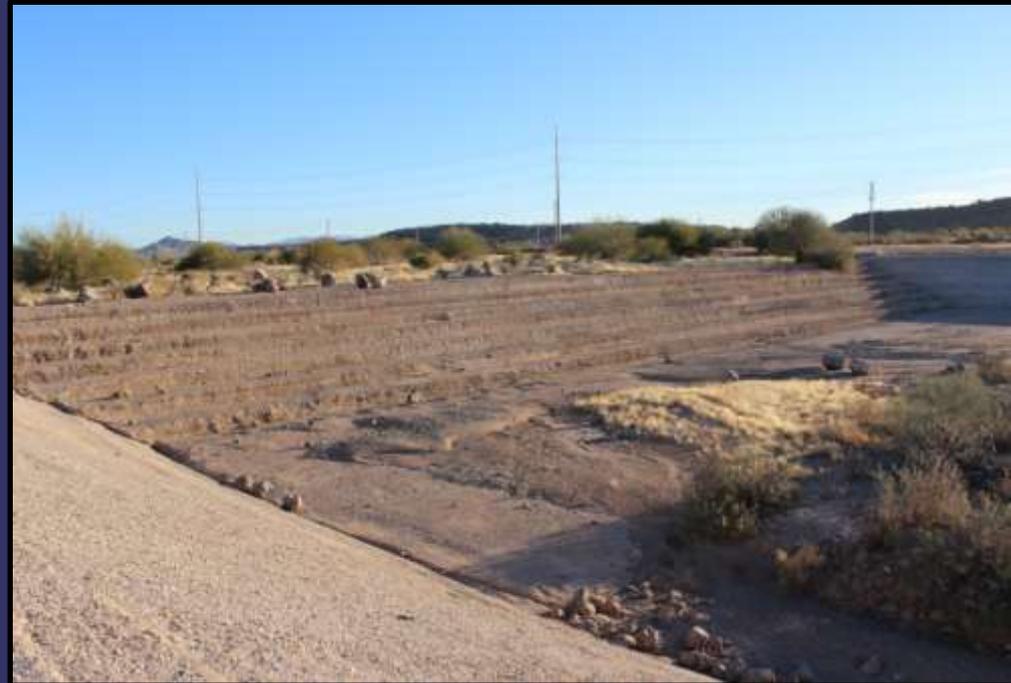
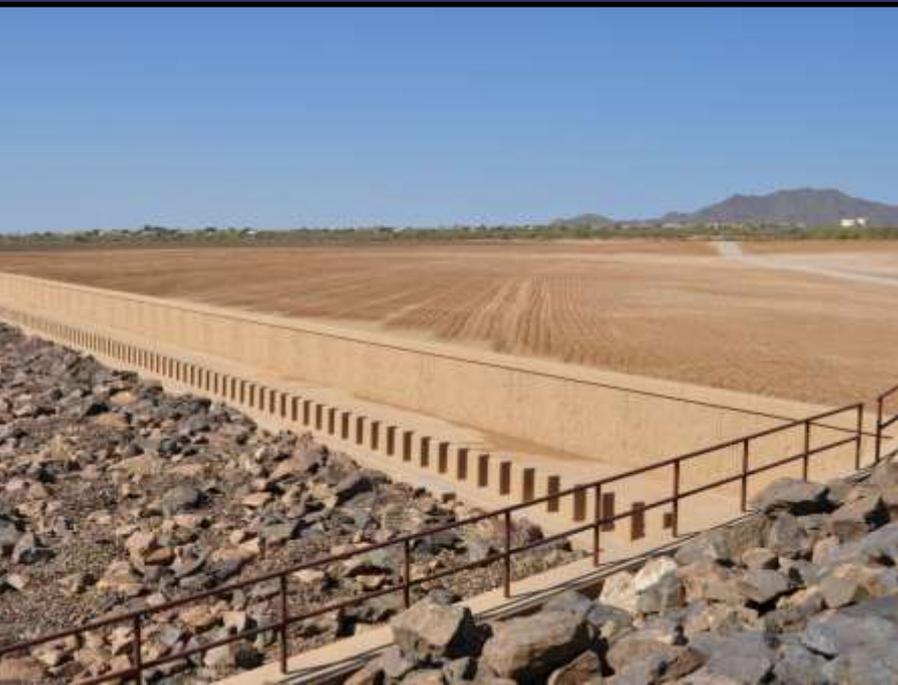
Emergency Spillway Concepts

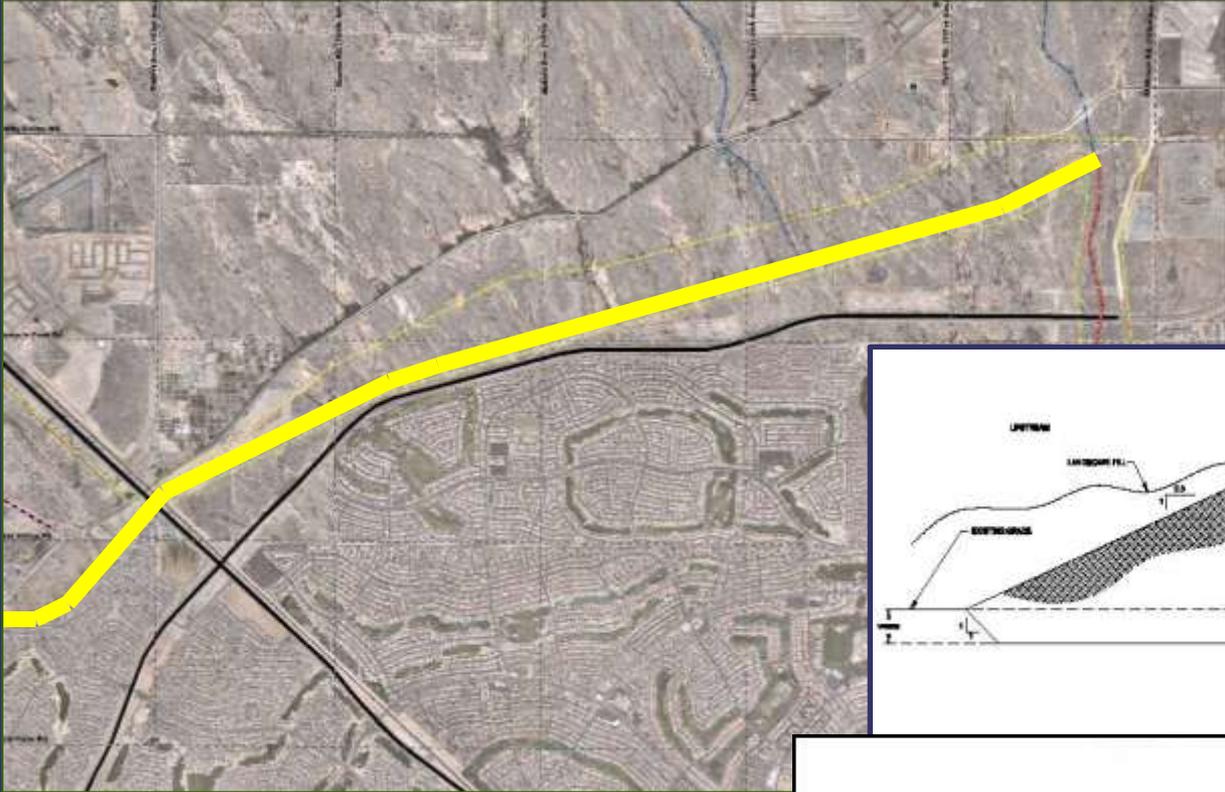
Outlet Channel

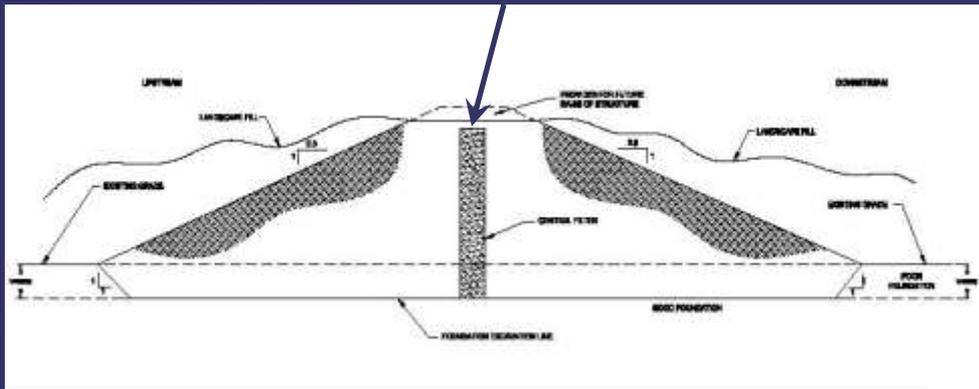
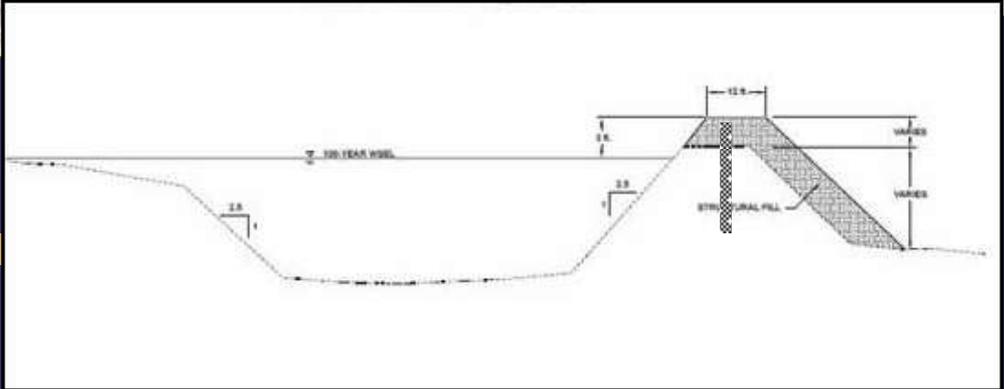
Filter for Crack Control

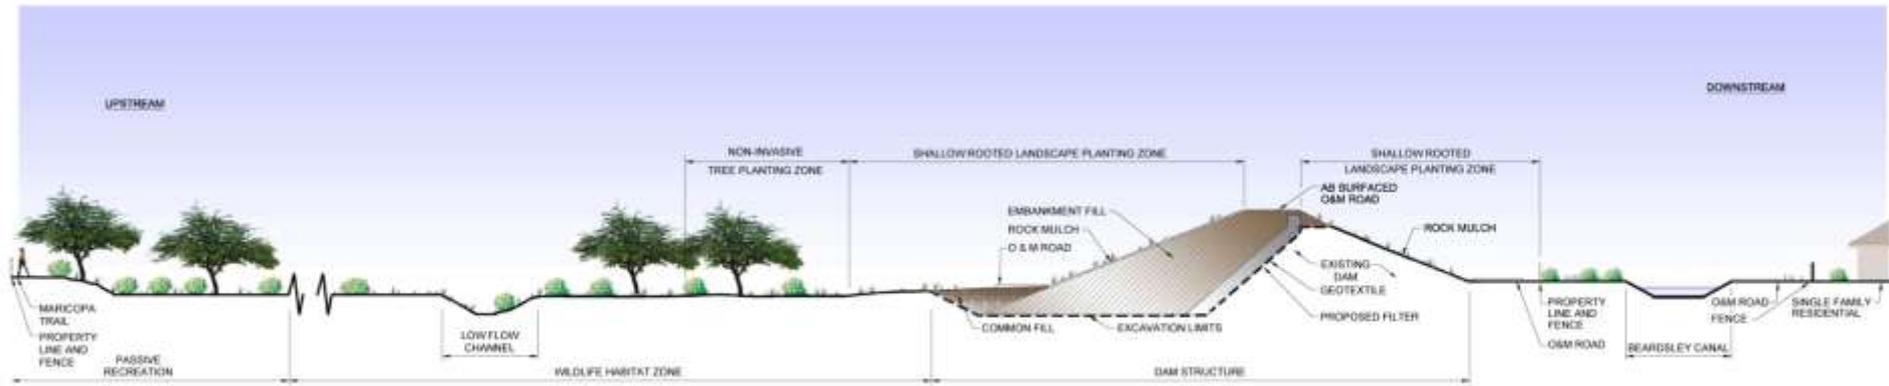
NON-FISSURE RISK ZONE EMBANKMENT (UPSTREAM RAISE)

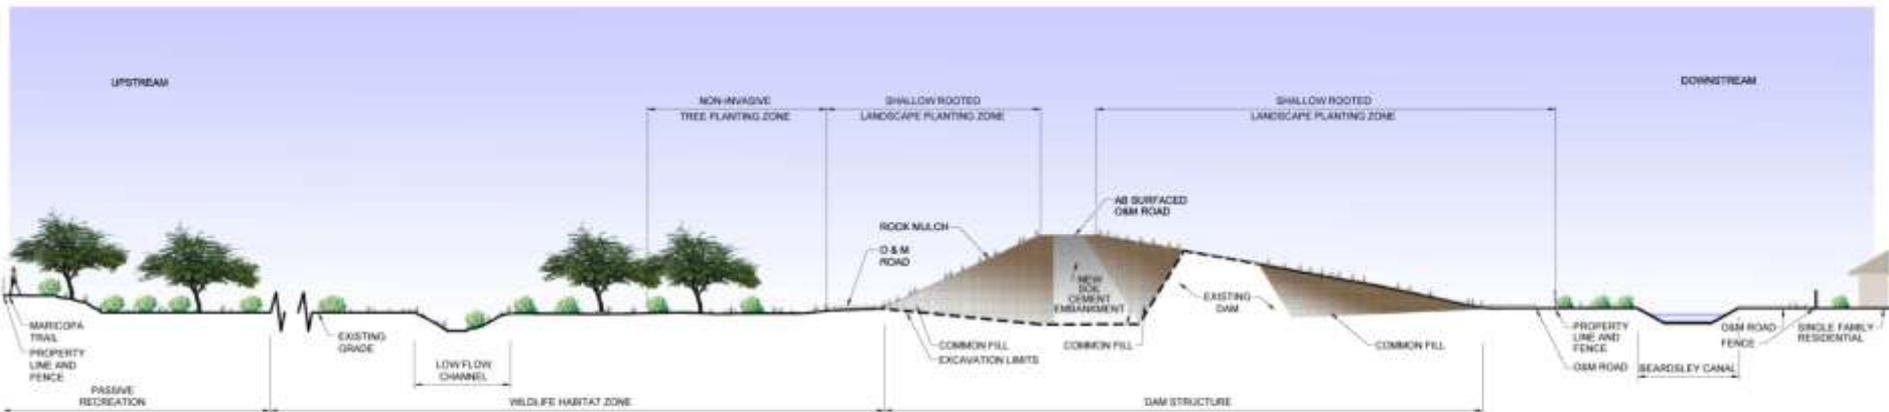
FISSURE RISK ZONE EMBANKMENT
