Sand and Gravel Mining

Floodplain Use Permit Application

Interim Guidelines

Flood Control District of Maricopa County
Interim Guidelines
Sand and Gravel Mining Floodplain Use Permit Application

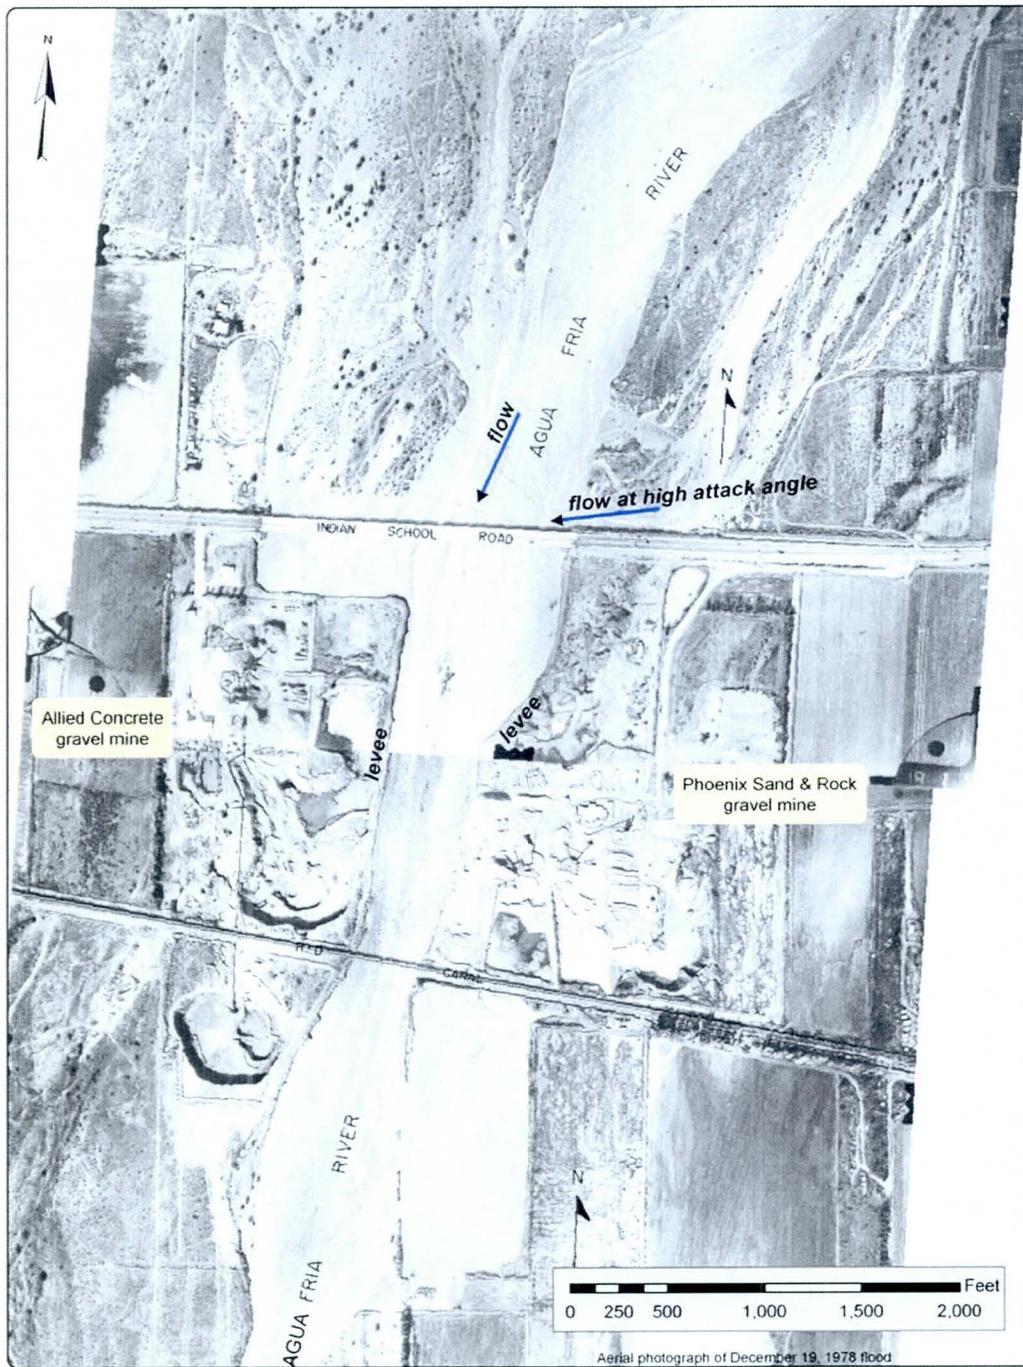
Figure 3. Aerial photograph showing channel conditions at Indian School Road prior to the 1980 flood.

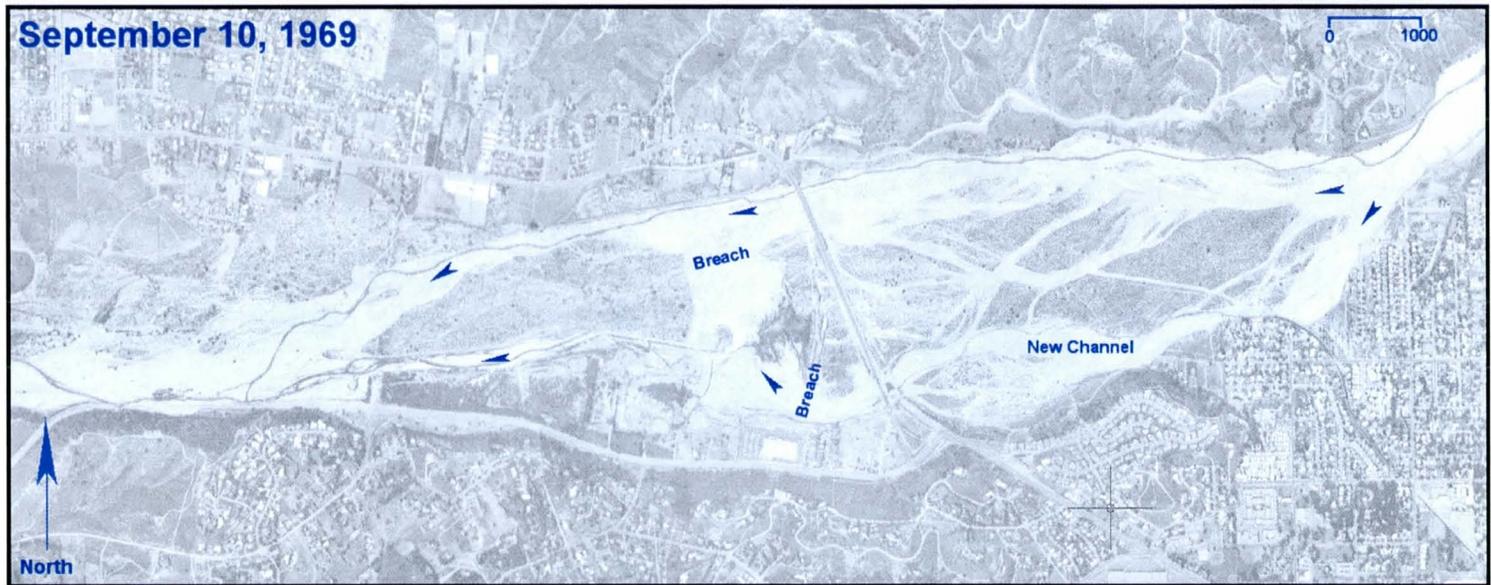
Figure 4. Pre- and post-flood view of entire reach. Note: 1969 photography was taken after two of the original three bridges were replaced.

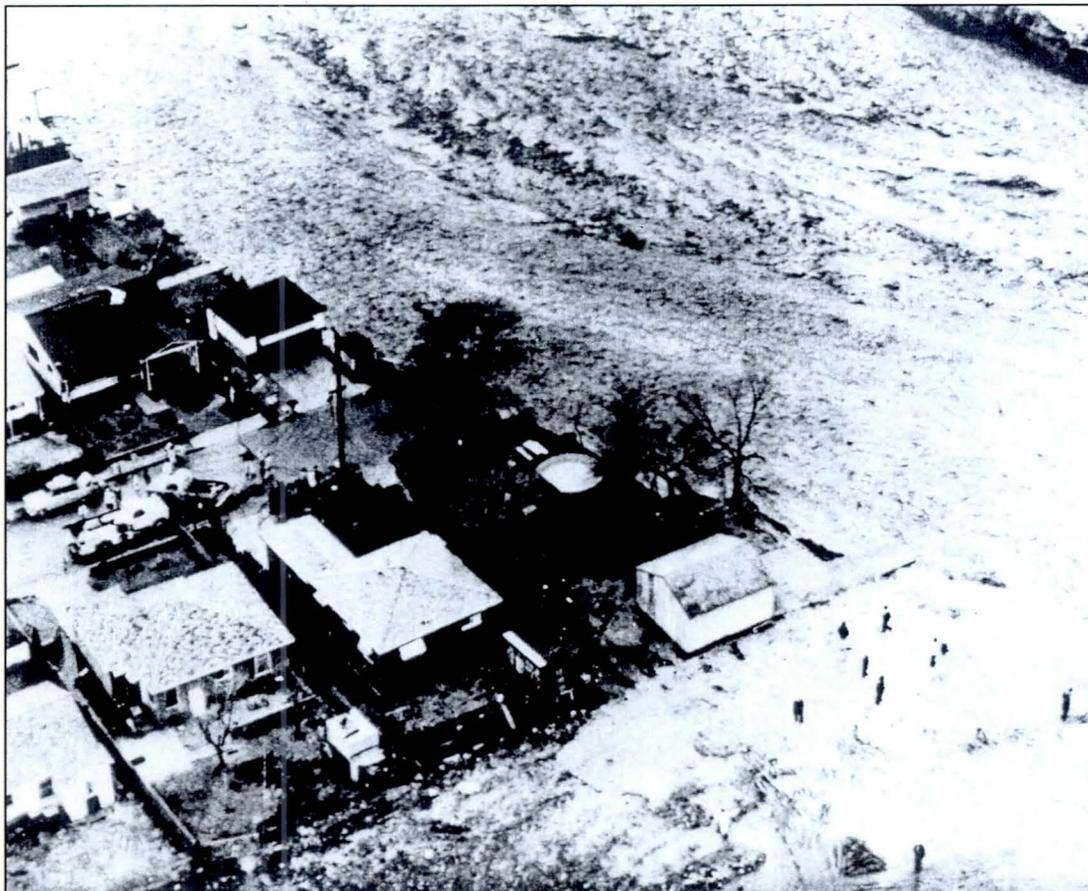
Figure 7. Photograph by Harold Morby looking downstream (NW) at lateral erosion of left bank near Bengal Street. From Scott, 1973. See Figure 8 for photo location.

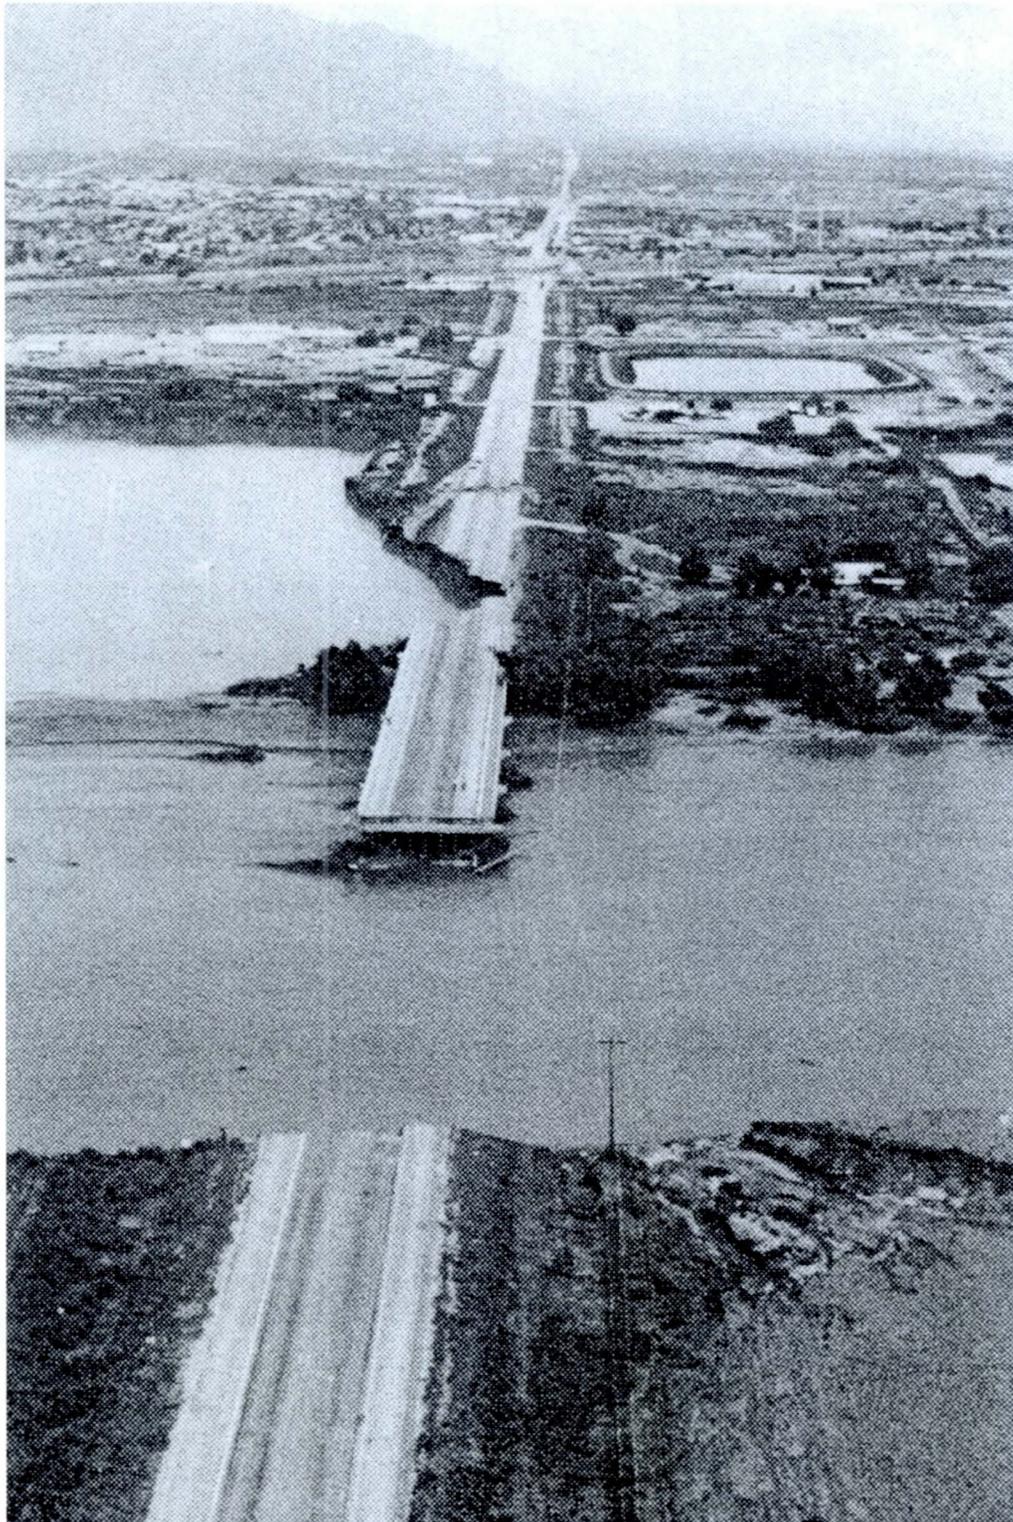
Figure 3. Aerial photograph of the Ina Road Bridge, Santa Cruz River, AZ, looking east (PCDOT, 1984)

On the morning of October 3rd, 17 of the 18 bridges crossing the Santa Cruz River in Pima County were inoperable or unsafe for occupation (Saarinen et al., 1984). The Ina Road Bridge suffered extensive damage including failure of the west abutment as a result of erosion to the west bank, breaking off of the south wing wall and support pile, settling of the southwest corner of the west abutment, and loss of east and west approaches (Figure 2 to 4).

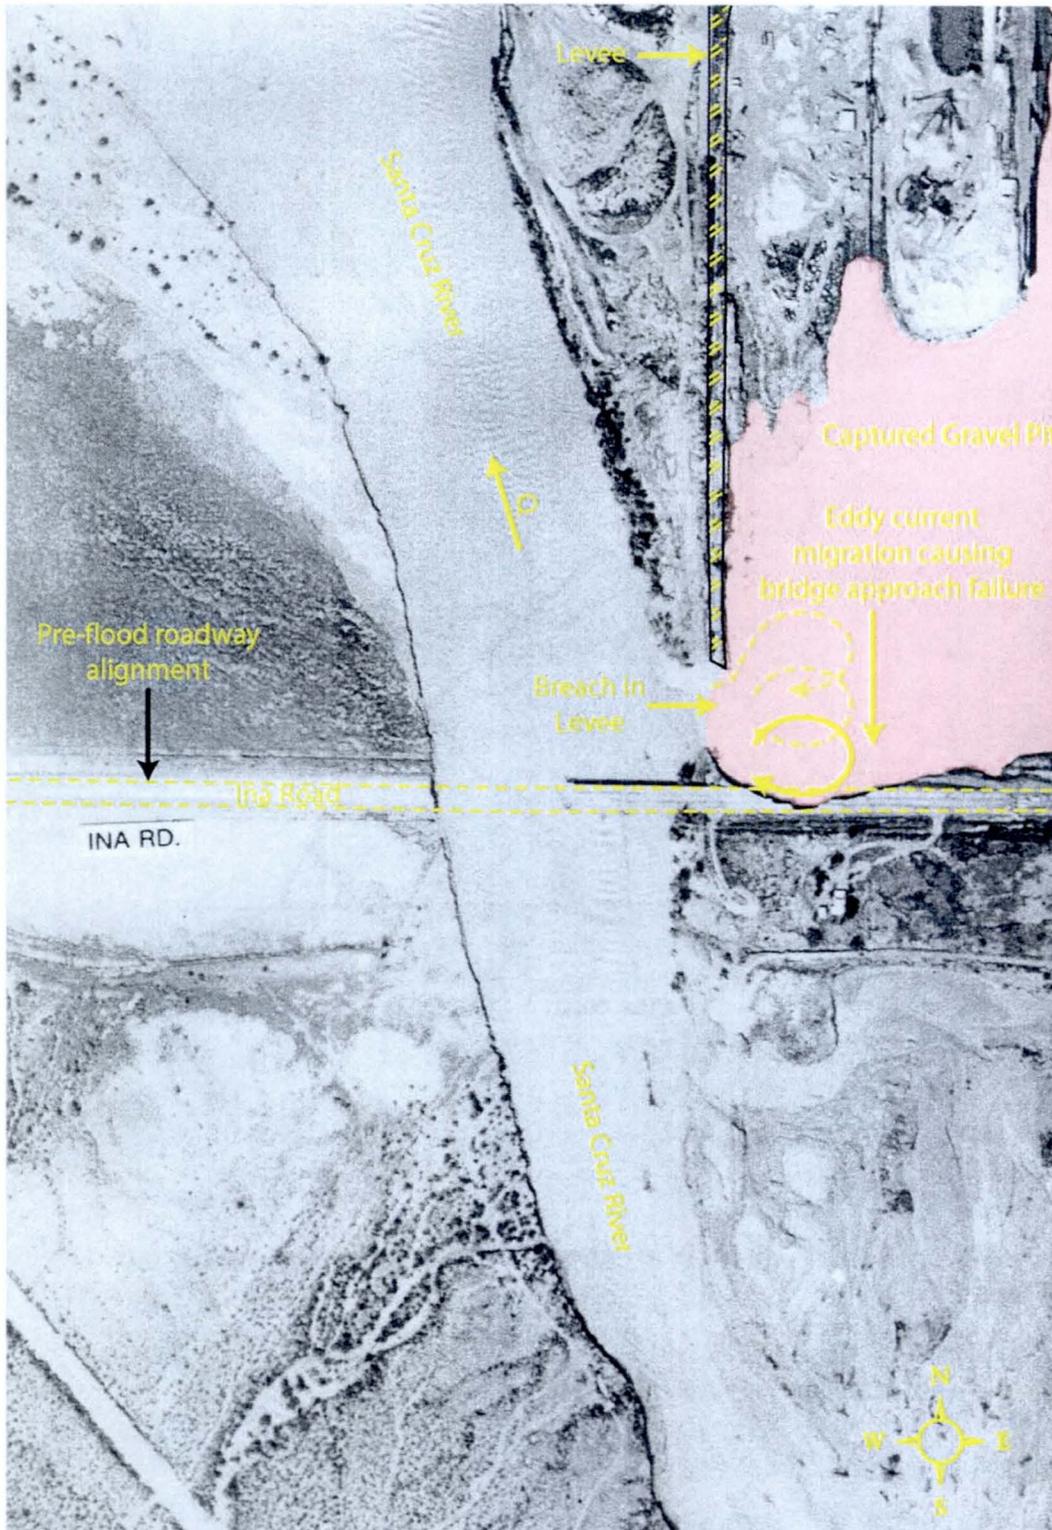
Figure 6. Ina Rd Bridge during the October, 1983 flood. Note the erosion of Ina Road east of the bridge and main channel due to circulatory currents and local inflow to the pit (PCDOT, 1984).

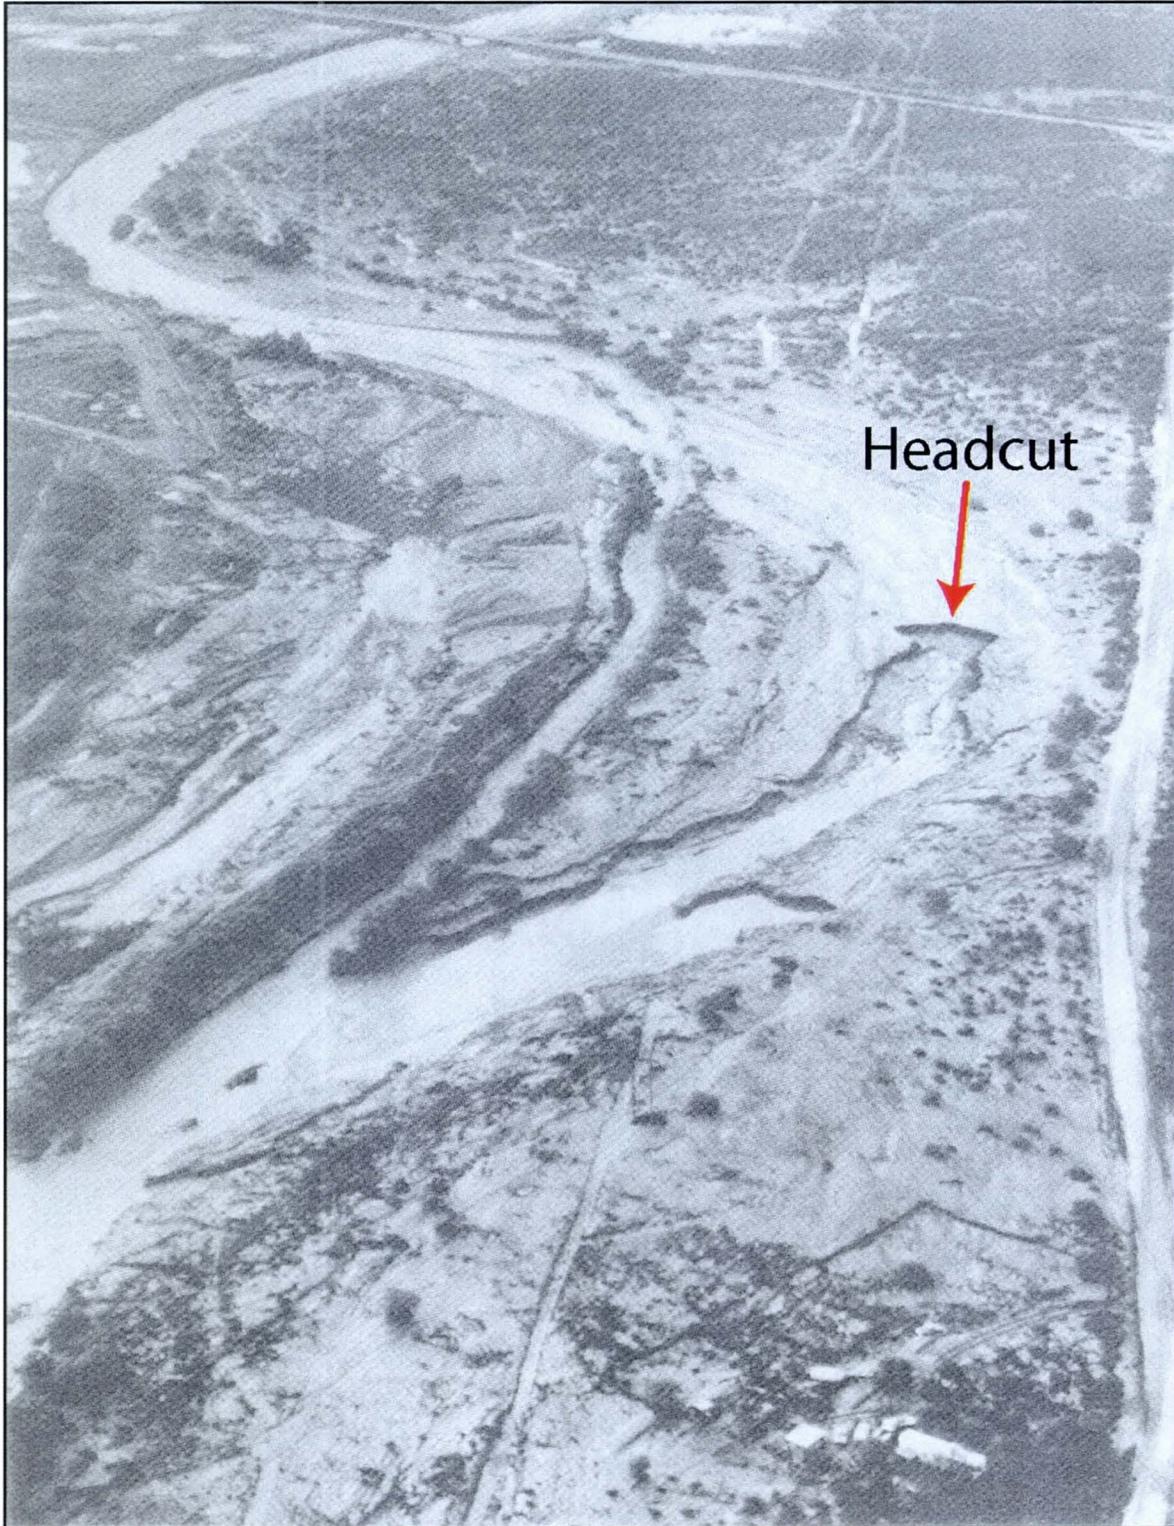
Figure 10. Headcut on the Santa Cruz River floodplain, October 1983 (Baker et al., 1988).

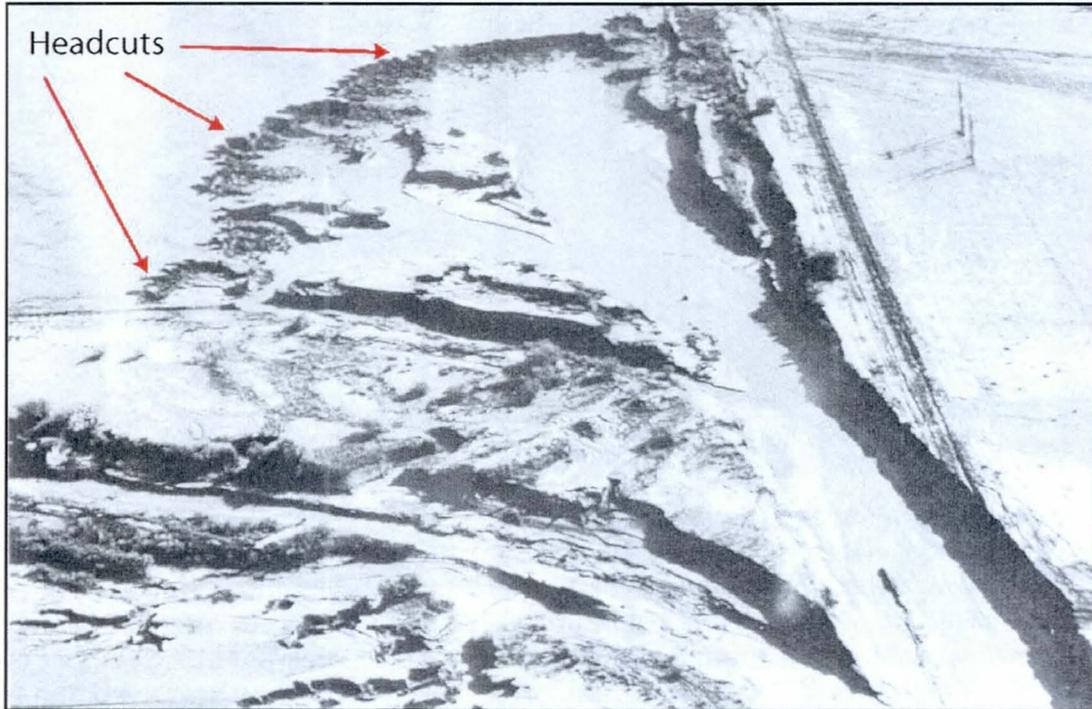
Figure 15. Headcutting on the Santa Cruz River 9 miles northwest of Marana, AZ, October 1983 (Saarinen et al., 1984).

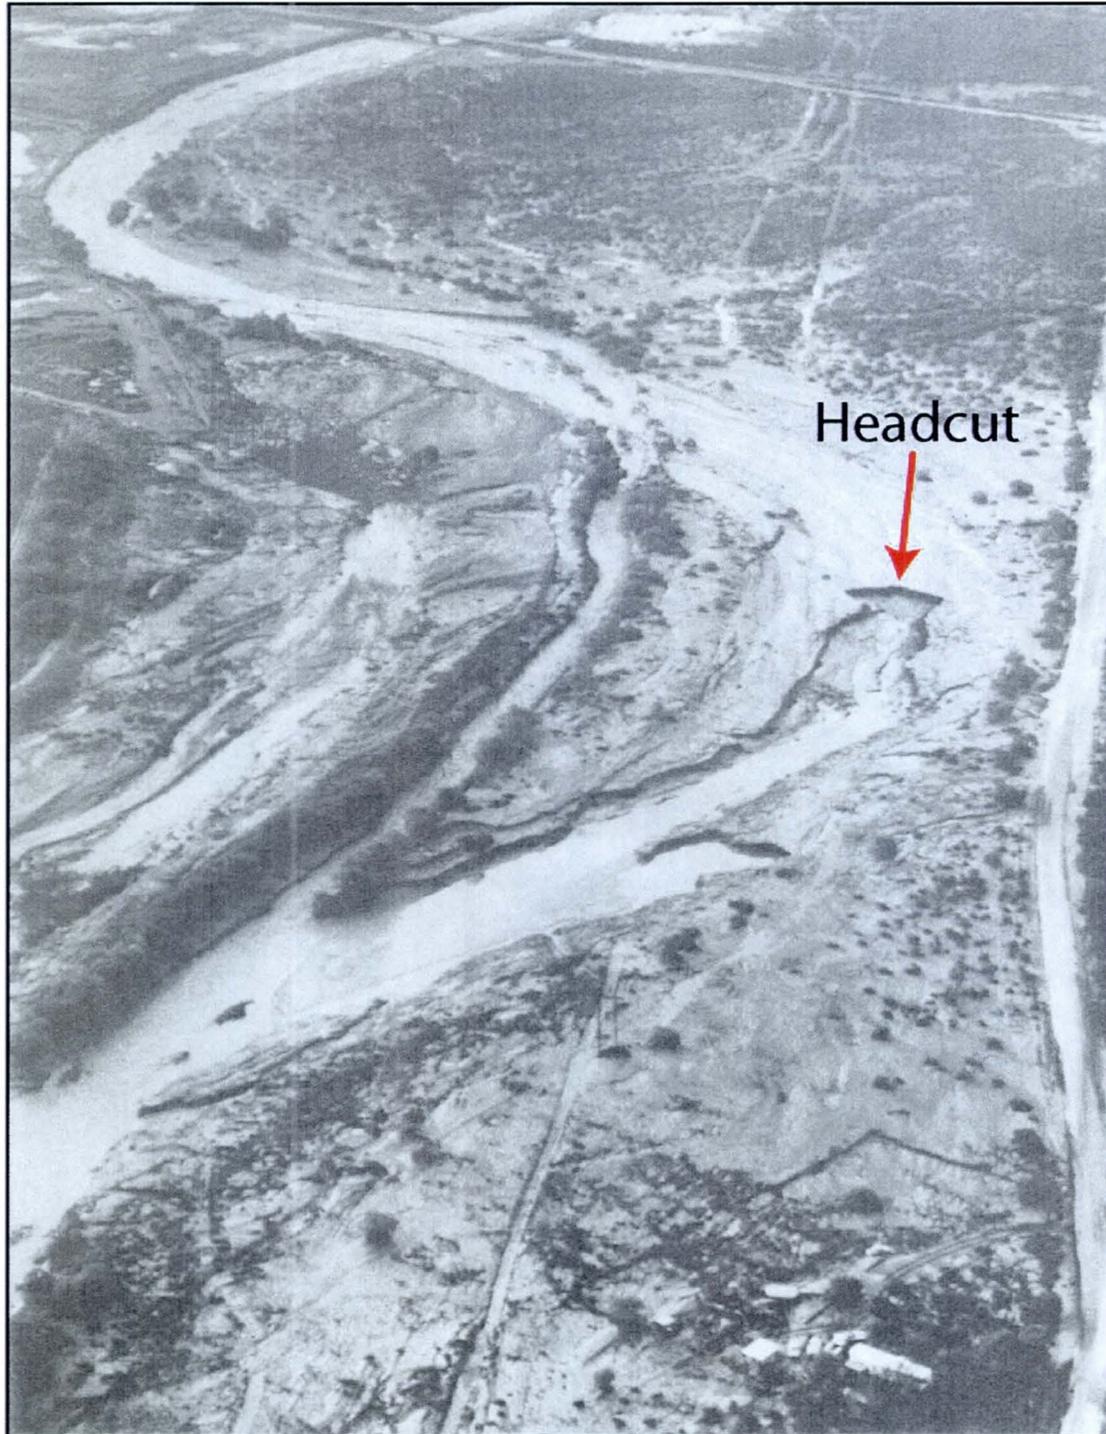
Figure 17. Headcuts on the Santa Cruz River floodplain, October 1983 (Baker et al., 1988) .
