EROSION STUDY TO DETERMINE
BOUNDARIES FOR ADJACENT
DEVELOPMENT - CALABACILLAS
ARROYO, BERNALILLO COUNTY,
NEW MEXICO

Albuquerque Metropolitan Arroyo
Flood Control Authority
PO Box 25851
Albuquerque, New Mexico 87125

Simons, Li & Associates, Inc.
3555 Stanford Road
PO Box 1816
Fort Collins, Colorado 80522

Project NM-AMA-02

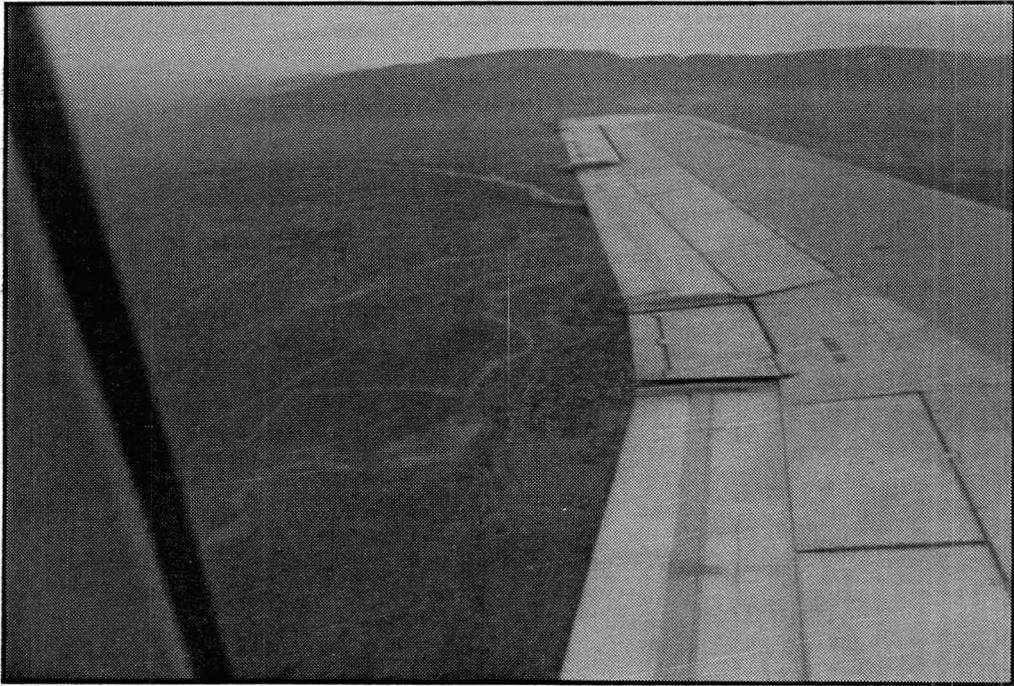
Plate 3.1. Aerial view of Calabacillas Arroyo study area including location of borrow pit.

During the site visit, several features significant to an erosion/sedimentation study of the Calabacillas system were noted. In particular, a large excavated area (borrow pit) was found to exist in the main channel at the confluence of the north and west forks of the Calabacillas. Plate 3.1, taken from a commercial flight into Albuquerque, shows the location and areal extent of the borrow pit. The view in this photograph is eastward towards the Rio Grande. A portion of the Paradise Hills development is visible beneath the wing of the aircraft. Plate 3.2 is another view of the excavated area looking upstream to the northwest. The north fork of Calabacillas Arroyo enters the borrow pit in the upper left corner of this picture. The wide, relatively
