**DESERT FLOOD OF  
AUGUST 3, 1943**

**PREPARED BY  
L. L. LEE**

DESERT FLOOD OF AUGUST 3, 1943

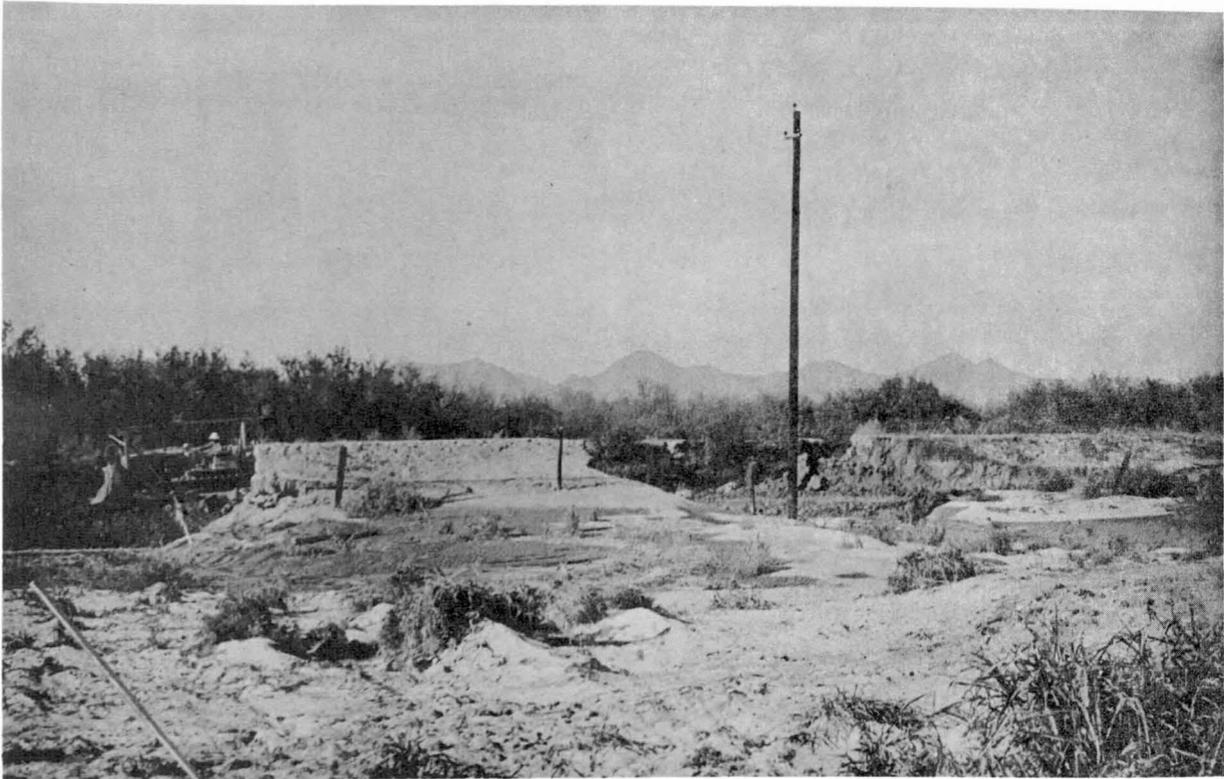
(1) Breaks in canal bank east of Indian Bend (8/5/43)

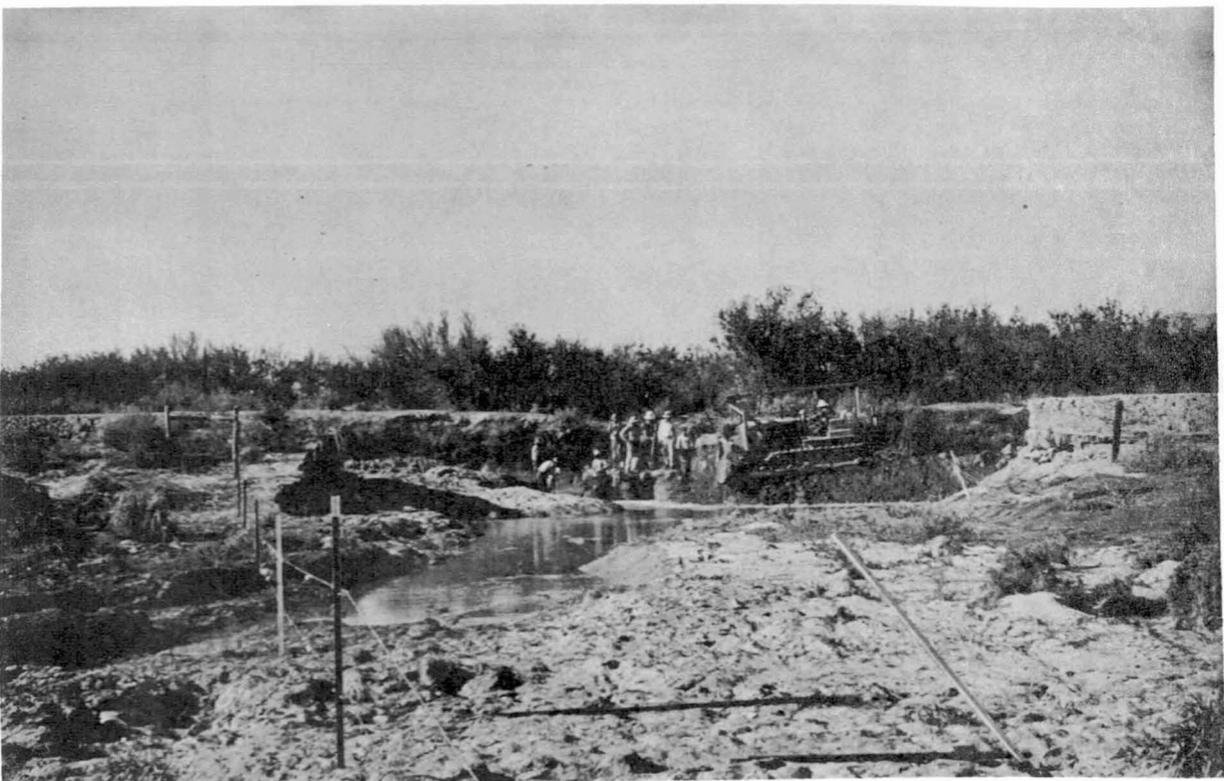
(2) Sand bagging and bulldozer repairing canal bank east of Indian Bend (8/5/43)

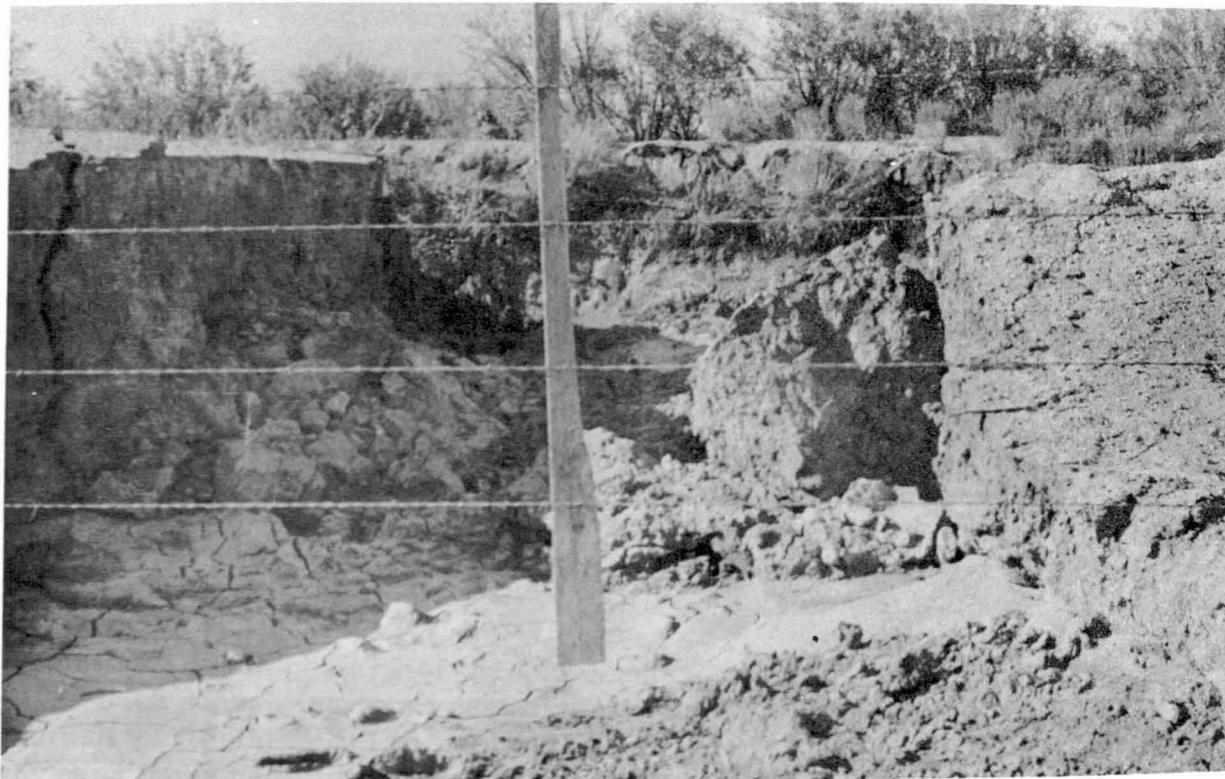
(3) Result of a gopher hole - West of Indian Bend 8/5/43

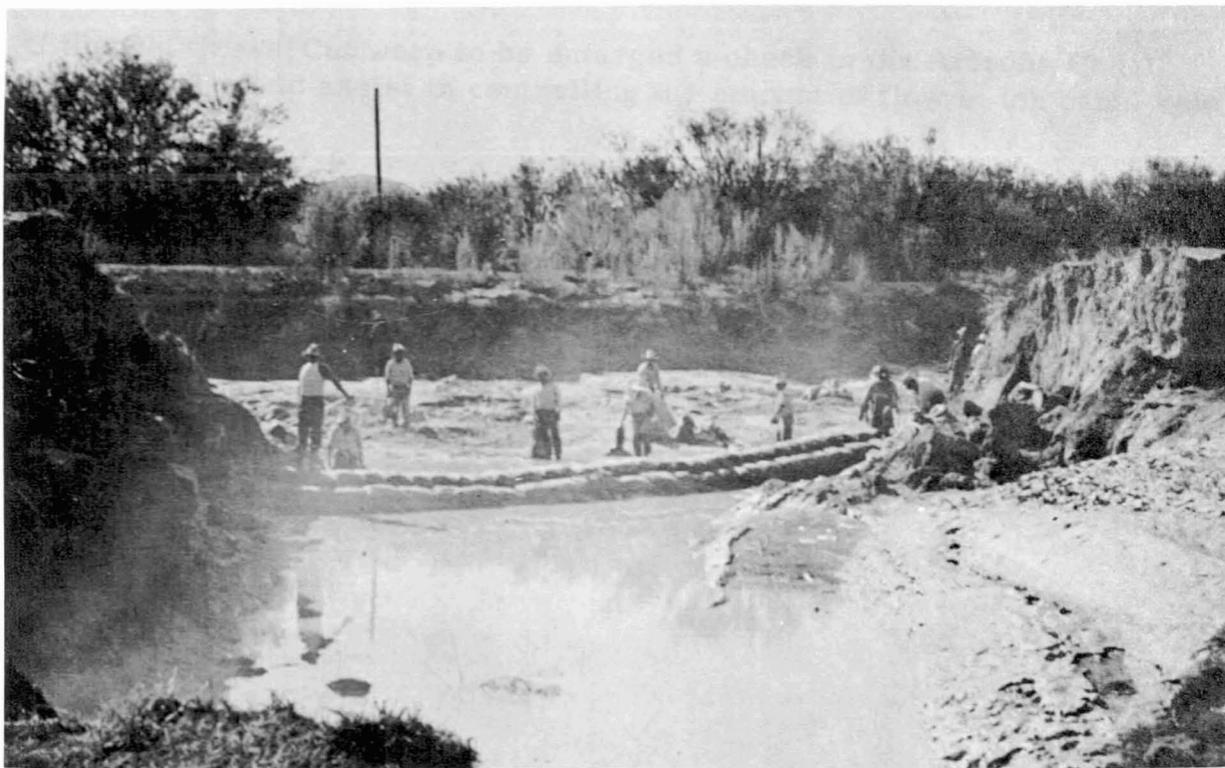
(4) Sand bagging break East of Indian Bend 8/5/43

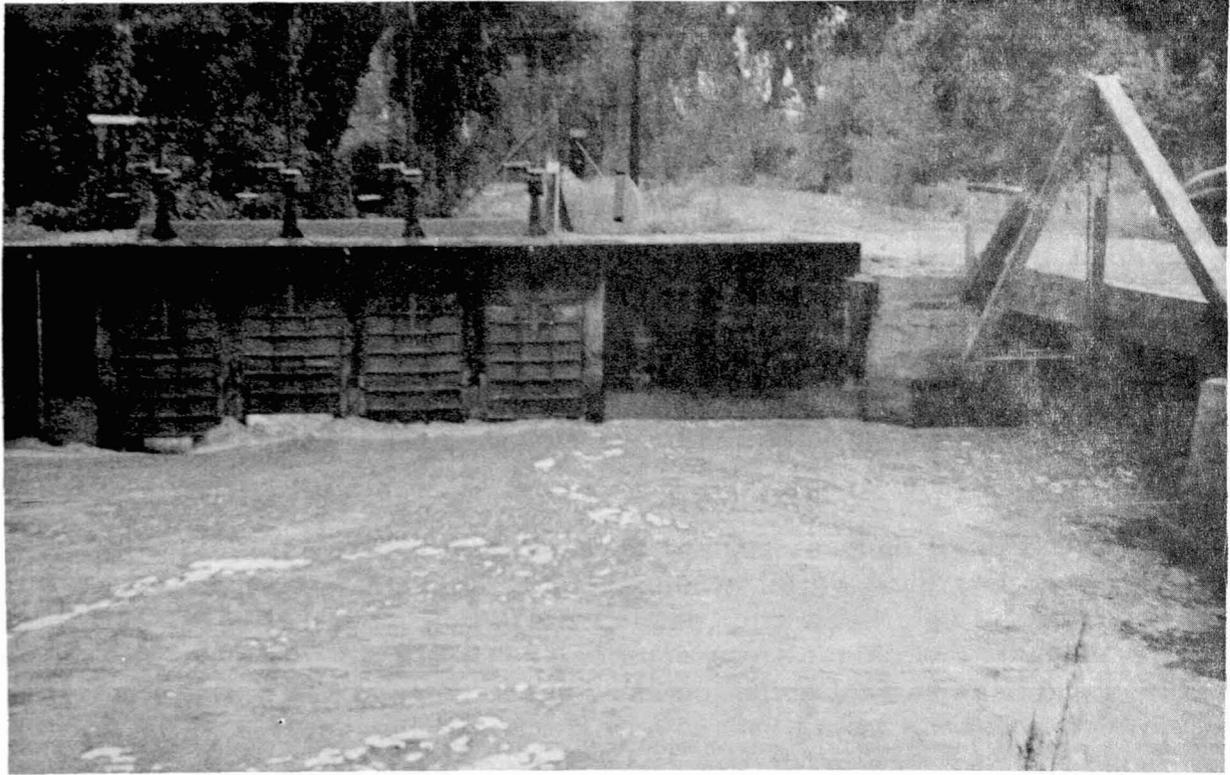
The flow in the channel of the Old Cross-Cut Canal is retarded by vegetation and bank sloughing to a great extent, and the gate capacity was inadequate to furnish sufficient relief to the canal at this point. Although no breaks in the canal bank happened in this section, undoubtedly the large amount of water going down the canal below Lateral 6 was a contributing factor to the breaks in the vicinity of Lateral 10.

(5) Head Gates old Cross Cut 10:00 A.M. 8/3/43  
48TH ST. & ARIZ. CANAL

If the Old Cross-Cut were to be enlarged a check in the Arizona Canal below Lateral 6 would assist in controlling the amount of flow in the canal below Lateral 6.

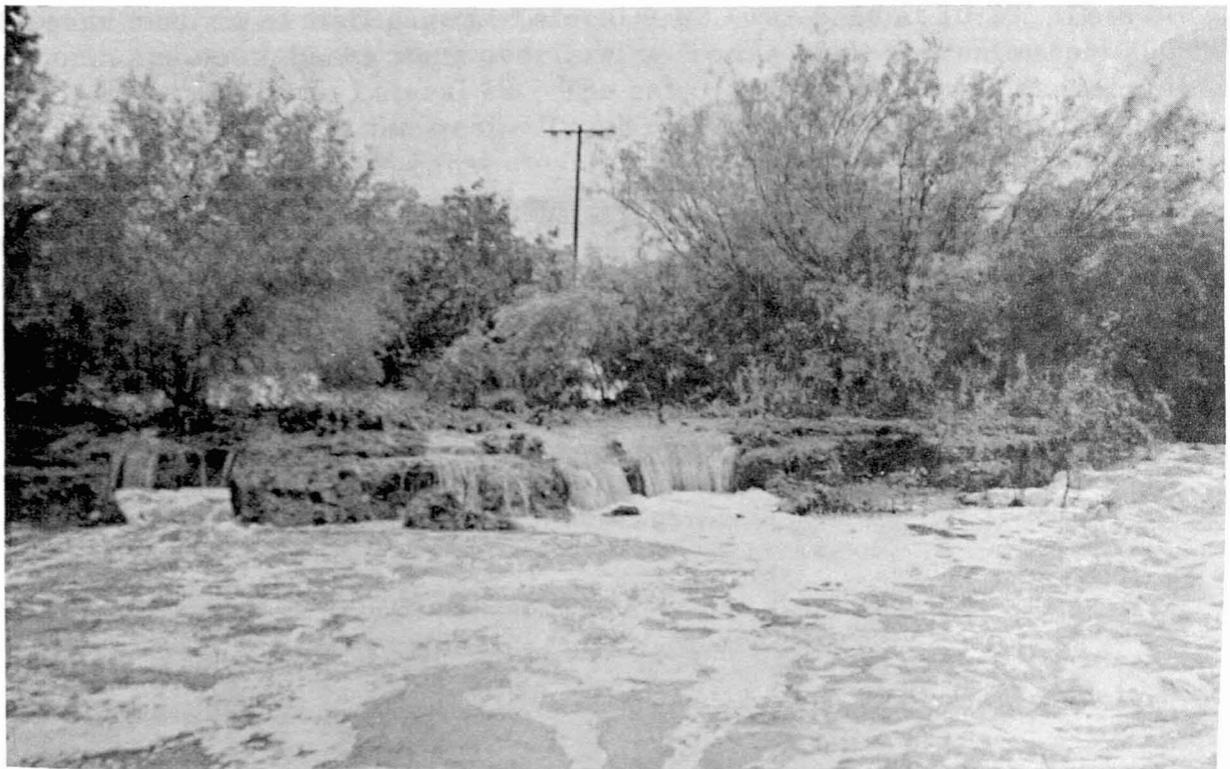
Both north and south banks in this section were intact with exception of a heavy inflow approximately 100 ft. east of Lateral 7, which was the accumulation of the runoff from the south side of Camelback Mountains which followed the course of the canal in a northwesterly direction until intercepted by Camelback Road. The inflow to the Arizona Canal was at a point where the north bank was very low and appeared to be a natural waterway. Inflow at this point was very heavy.

(6) Inflow 100' East of Camelback Road  
JUST EAST OF 40TH ST. & CAMELBACK RD.

Water was impounded north of the north bank all along this section and it is suggested that culverts with flood gates be placed in the north of canal at several points to relieve the pressure on the north bank.

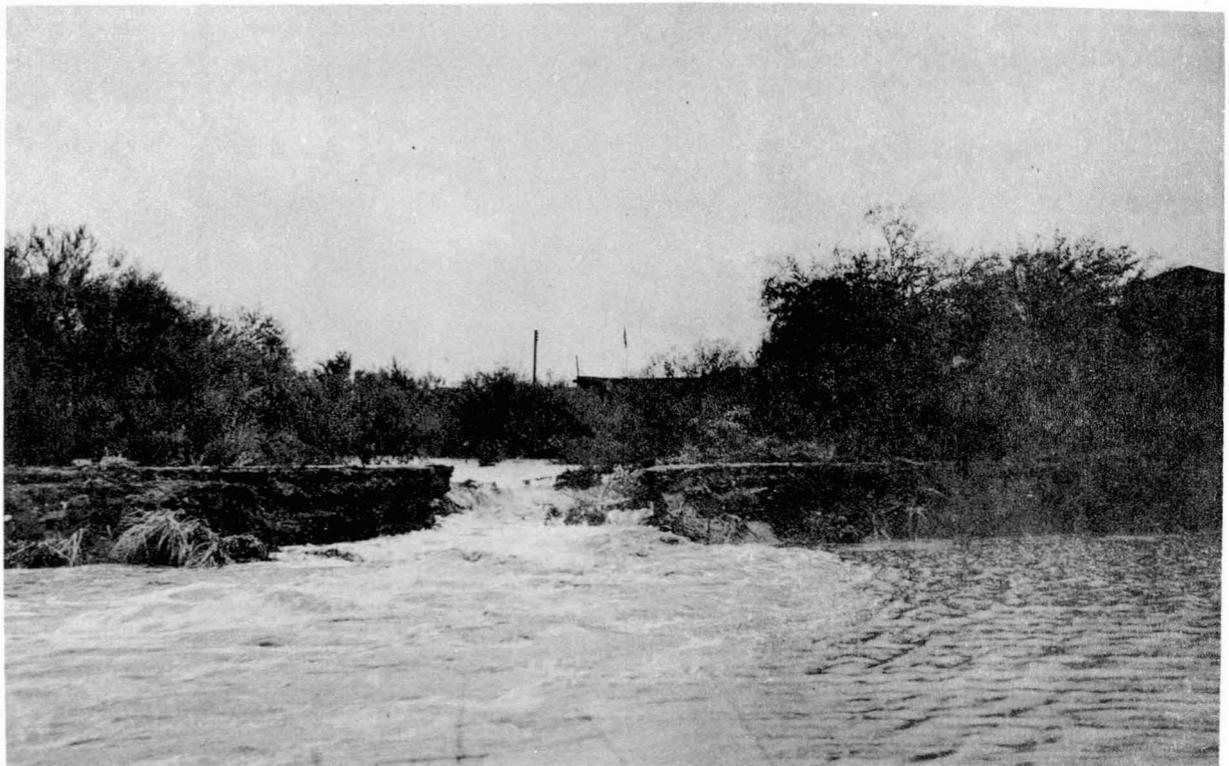
A heavy inflow of flood water from the Squaw Peak-Camelback area occurred approximately 1/10 of a mile west of Lateral 7. The north bank overflowed for approximately 1500 ft. in this vicinity. The spillway in south bank at Lateral 7 1/4 was not flowing at 10:15 A. M. , and showed no indications of having been in operation previous to that time. A very heavy inflow occurred opposite the spillway at Lateral 7 3/4. This spillway was not flowing at 10:17 A. M. , and showed no indication of having operated prior to that time.

(7) Inflow west of Lateral 7 10:15 AM (8/3/43)  
ABOVE 500 FT. WEST OF 40TH ST. NORTHSIDE OF ARIZONA CANAL  
PRESENT CUDIA LOCATION

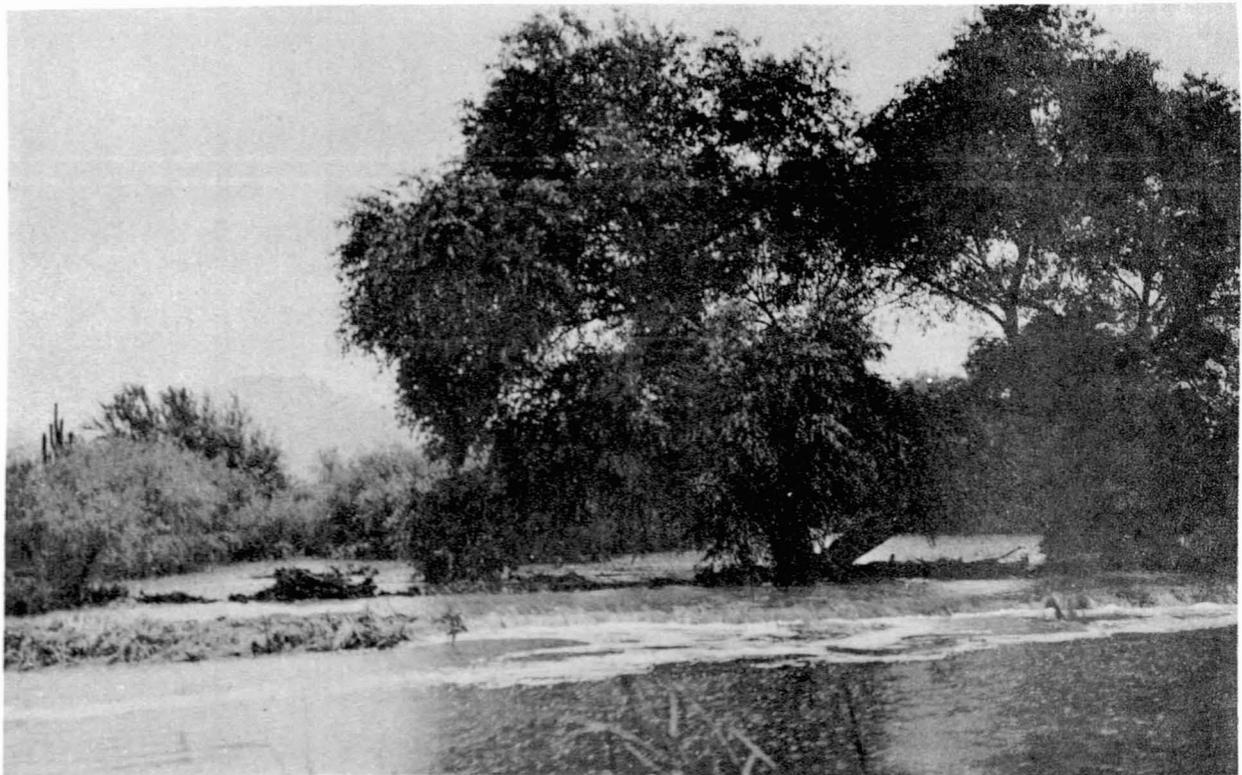
The flow from the desert was reported to have reached Lateral 9 at 6:00 A. M. and Lateral 7 and 7:00 A. M. A heavy inflow occurred opposite the spillway at the Biltmore Hotel Golf Course, and water was flowing over this spillway at 10:19. This spillway was operating perfectly and when inspected after flow had ceased, there were no indications of wash or erosion below the spillway. The Arizona Canal was banked full at the Biltmore Hotel, and water standing on the lawn approximately 2/3 of the way from the canal to the hotel. There were two points of definite inflow in the vicinity of the hotel, one approximately 300 ft. east and the other 300 ft. west.

(8) Inflow opposite spillway at 17 1/4E - 9 1/2N 10:17 AM  
(8/3/43) ABOVE 30TH ST. ARIZ CANAL

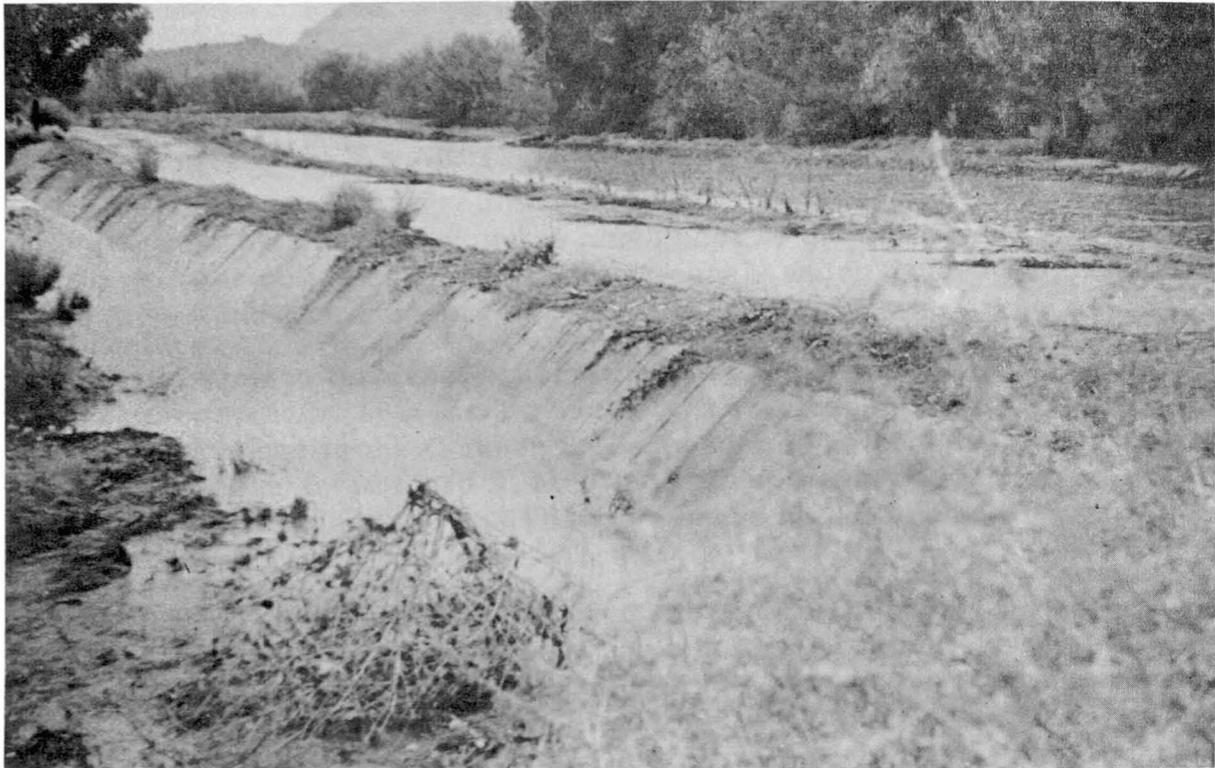
(9) Spillway at Biltmore Golf Course Lateral 8 1/2 10:20 AM  
(8/3/43) 36TH ST. & ARIZONA CANAL OVER SOUTH BANK

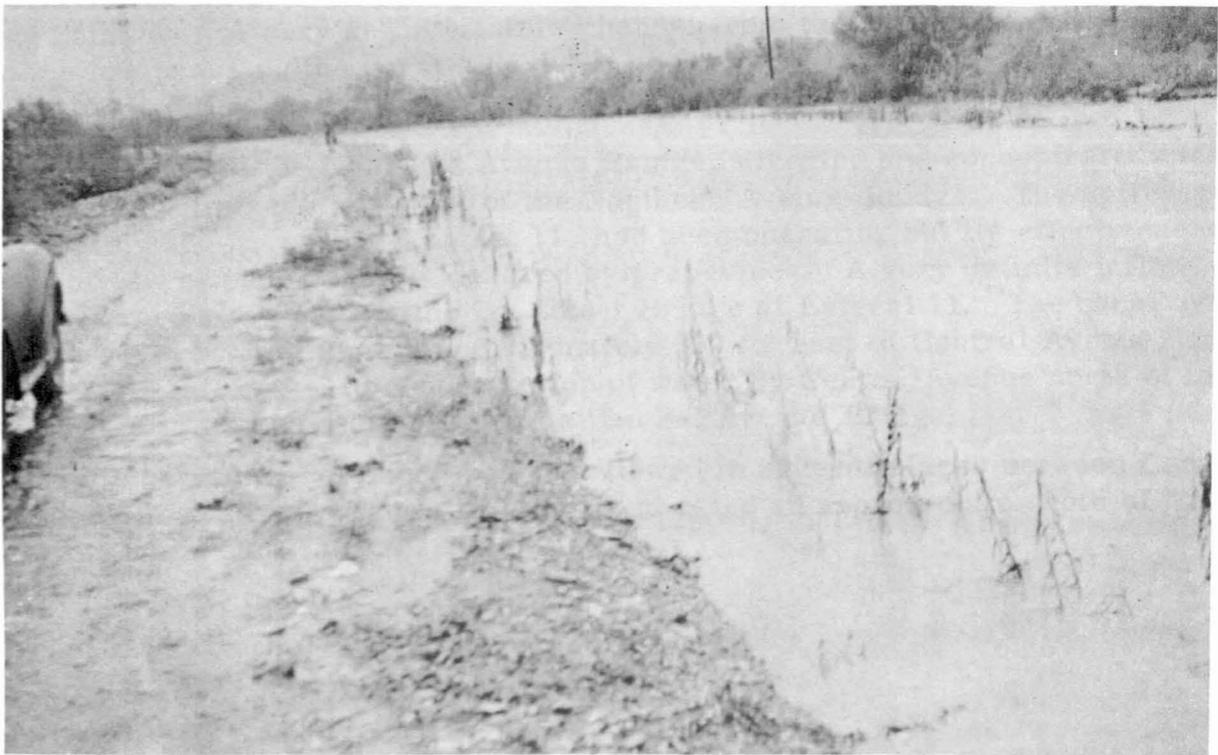
There is a very definite original waterway at Lateral 9 1/4 which if equipped with a spillway would afford relief for the canal between this point and Lateral 10. Heavy inflow occurred immediately west of Lateral 9 1/2. The gage reading of staff gage at Lateral 9 1/2, was 5.56 at 10:26. Both the north and south banks were overflowing from a point approximately 200 ft. east of Lateral 9 3/4 to Lateral 10. The canal at Lateral 10 was banked full with a strong current to the west. Trash crews encountered some difficulty in keeping the check in the canal clear of trash. At 10:40 A. M. trash was cleared, all check gates up, and canal discharging through check gates at full capacity.

(10) Looking west from Lateral 9 3/4 10:28 AM (8/3/43)  
ABOUT MARYLAND AVE & ARIZ CANAL PRESENT FILTERING PLANT AREA

All Laterals were found to be open in this section, and the desert inflow was in excess of the capacity of the canal. Additional spillways should be constructed at various points in this section.

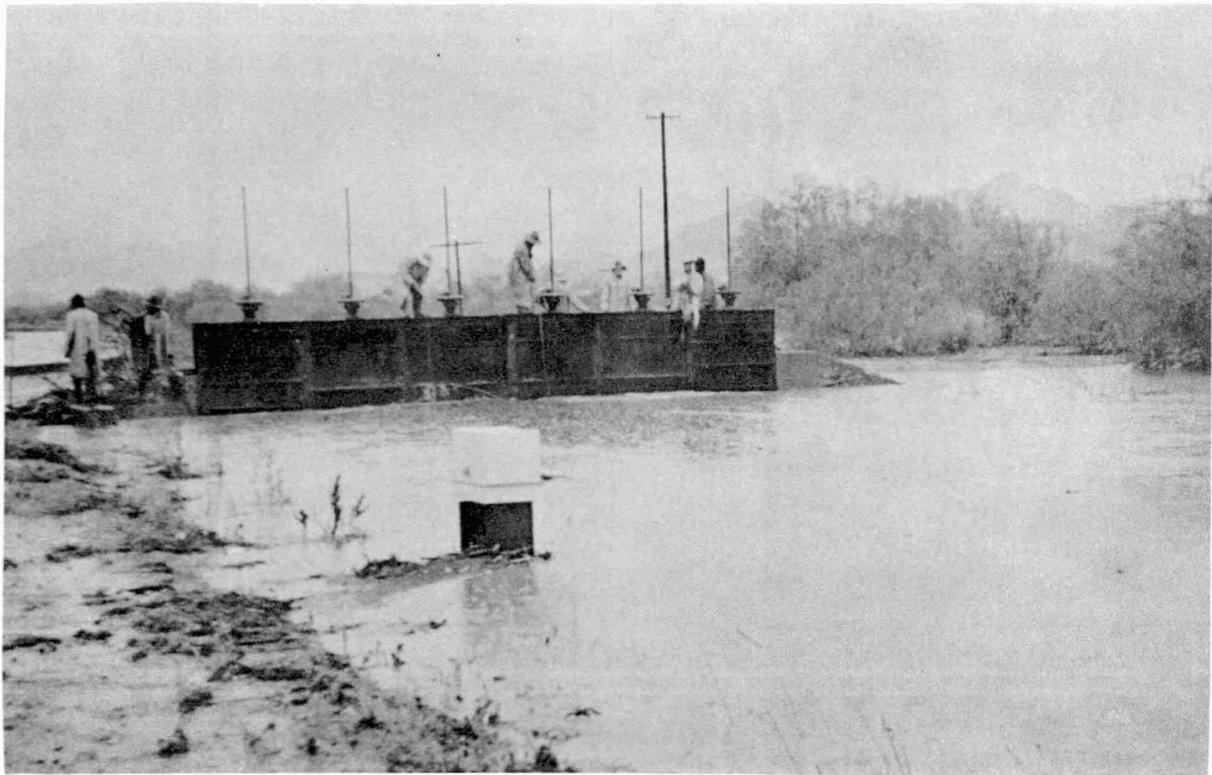
(11) Trash crew working on check at Lateral 10 10:32 AM  
(8/3/43) 16TH ST & ARIZONA CANAL

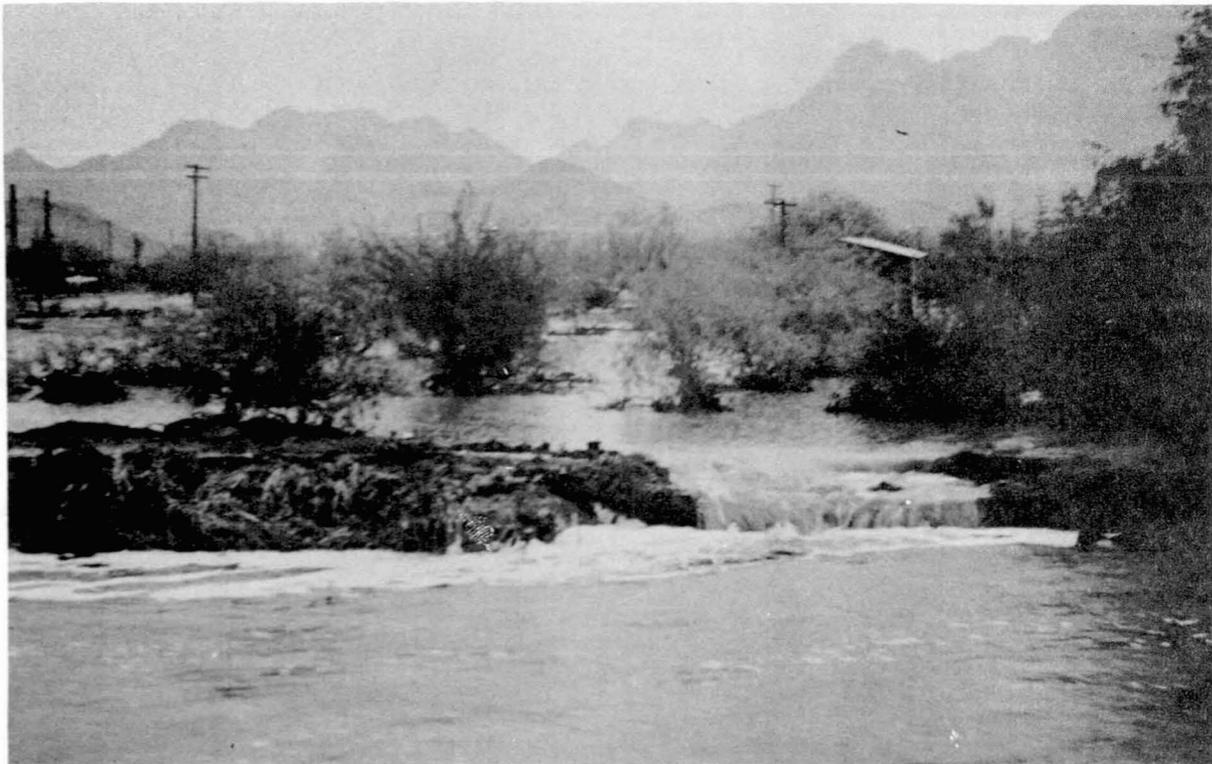
A very heavy inflow to the canal occurred immediately west of Lateral 10 from flood waters intersected by 16th Street, north of the Arizona Canal. The second inflow channel was opposite the Clausen Spillway east of Lateral 10 1/8. This spillway was spilling prior to 11:10 A. M. , and an inspection below the spillway after the water had subsided indicated that no damage had occurred to the orchard and no indications of wash were found.

(12) Inflow 1/8 mile west of Lateral 10 10:35 AM (8/3/43)  
ARIZONA CANAL

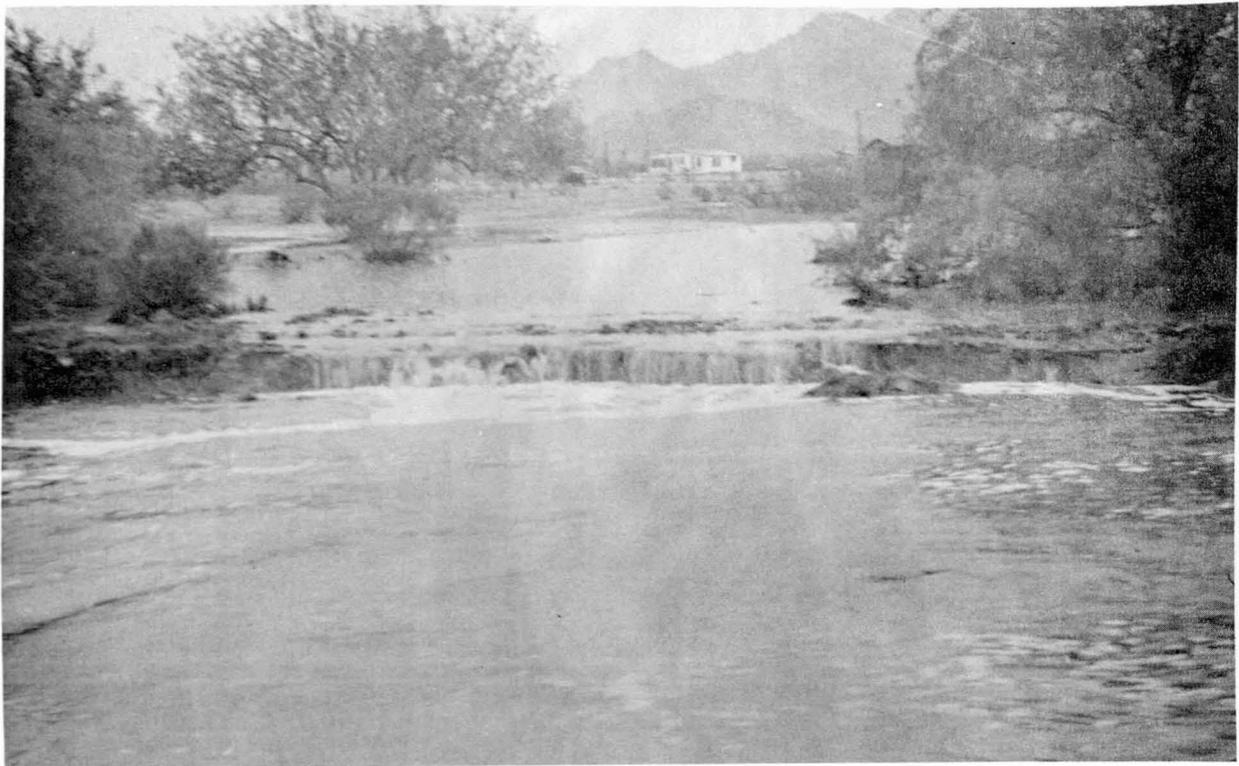
(13) Inflow opposite Clausen Spillway 10:30 AM (8/3/43)  
*ABOUT 11TH ST. & ARIZ. CANAL*

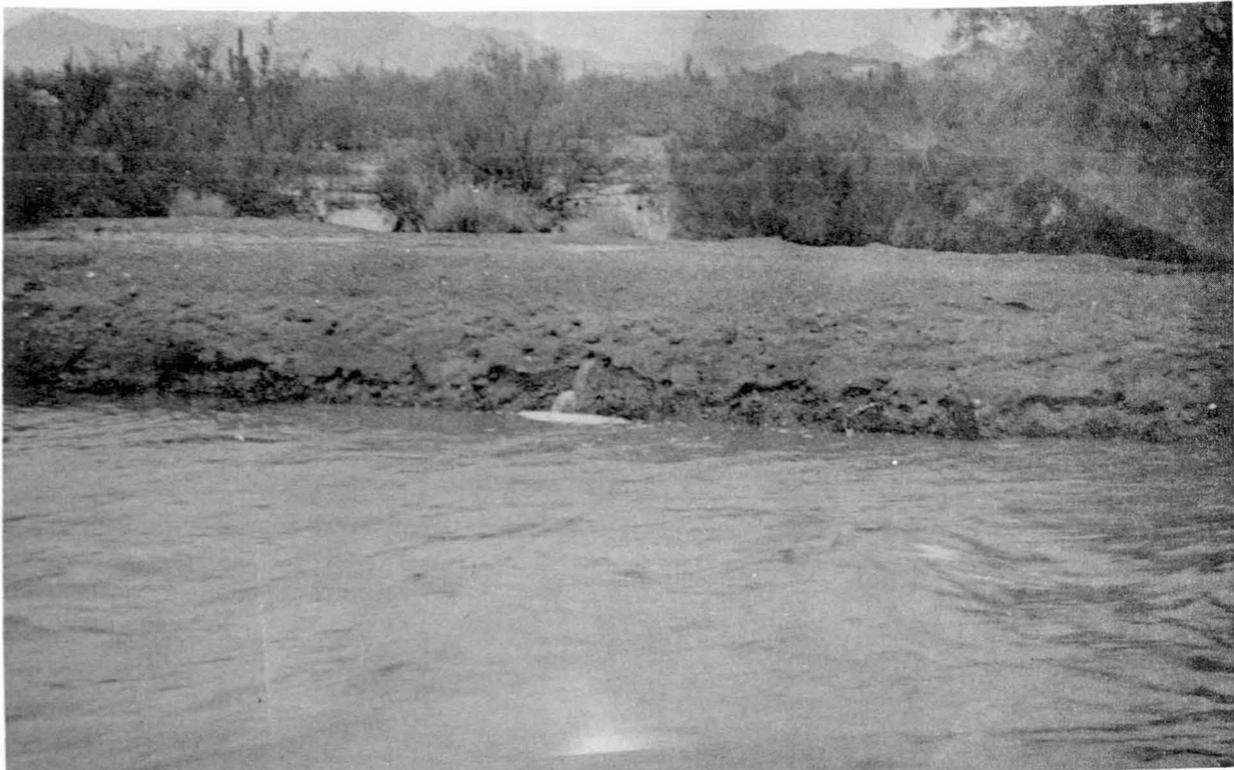
(14) Gopher hole in north bank northwest of Clausen Spillway  
*ABOUT 11TH ST. & ARIZ. CANAL*

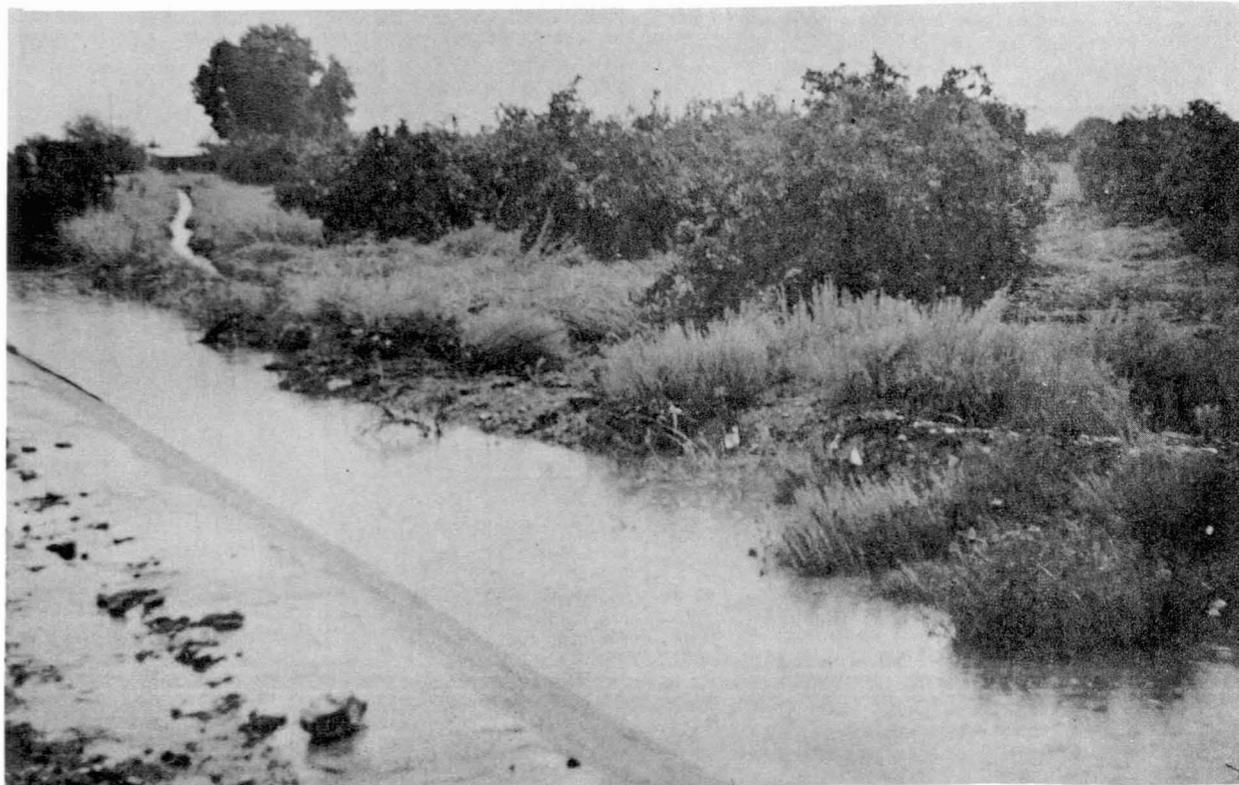
(15) Clausen Spillway 10:50 AM (8/3/43)  
*ABOUT 11TH ST. & ARIZ. CANAL*

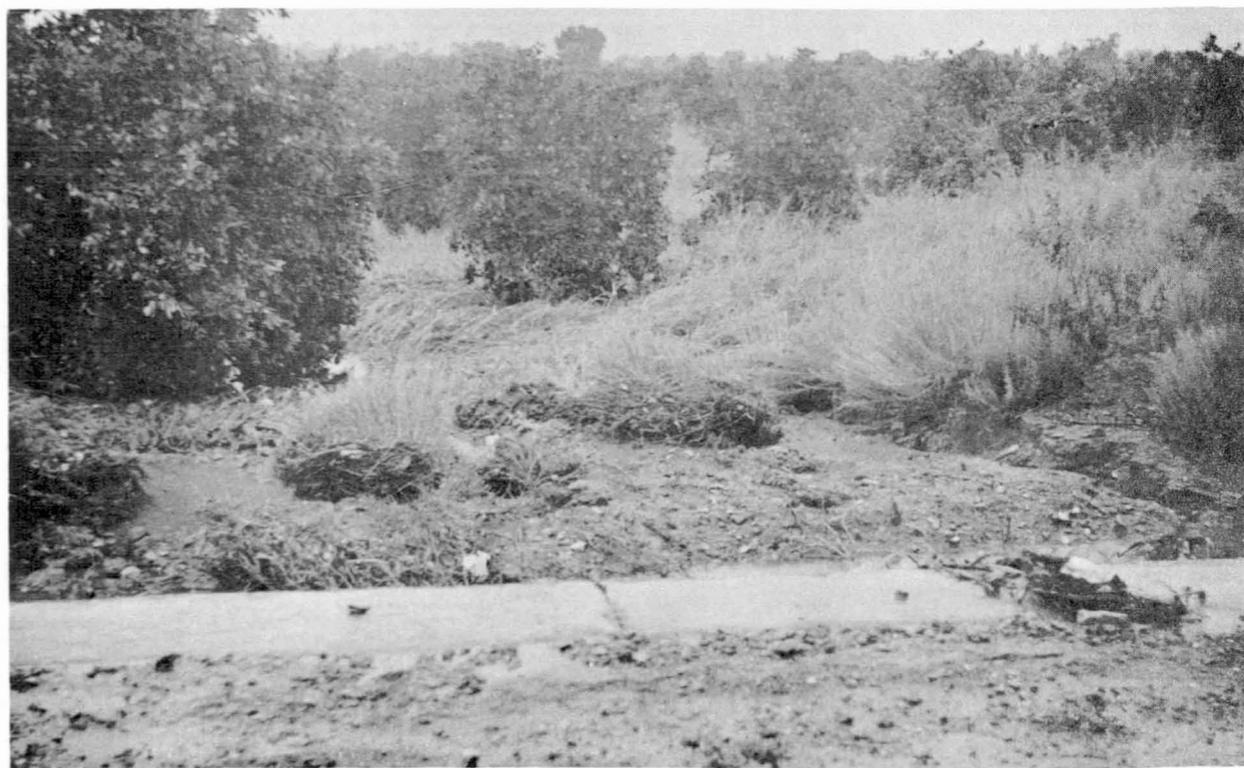
(16) Looking southwest from Clausen Spillway  
*ABOUT 11TH ST. & ARIZ. CANAL*

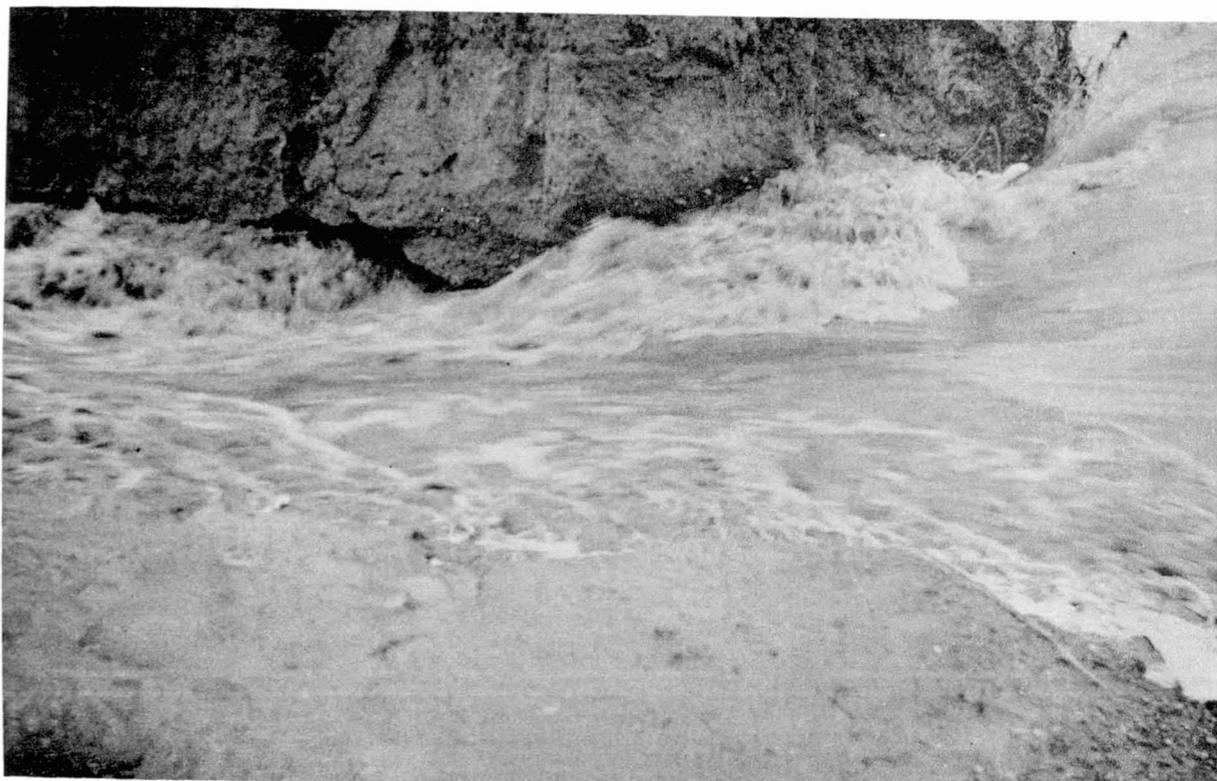
The water from the break at Lateral 10 1/8 flowed in a southwesterly direction and combined with the water from the break at Lateral 10 5/8 in the vicinity of the Grand Canal and Central Avenue. The break at Lateral 10 5/8 inundated 7th Street but not sufficiently to entirely stop traffic. Central Avenue and 7th Avenue were inundated from the combined flow of the breaks at 10 5/8, and the one just east of Lateral 12. At 1:00 P. M. it was impossible to travel south of Northern Avenue on either 7th Avenue or Central Avenue.

(17) Break at Lateral 10 1/8 10:37 (8/3/43)  
*ABOUT 15TH ST. & ARIZ. CANAL*

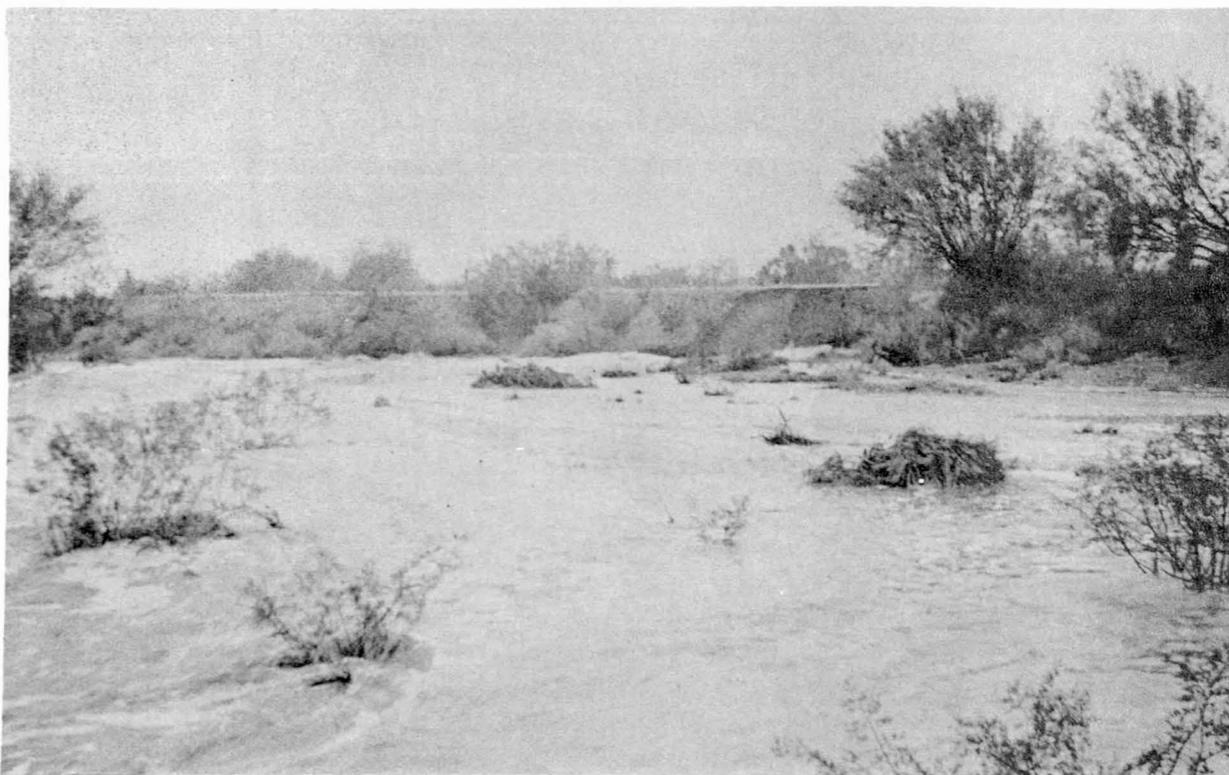
(18) Looking towards break at Lateral 10 1/8 10:45 AM (8/3/43)  
*ABOUT 15TH ST. & ARIZ. CANAL*

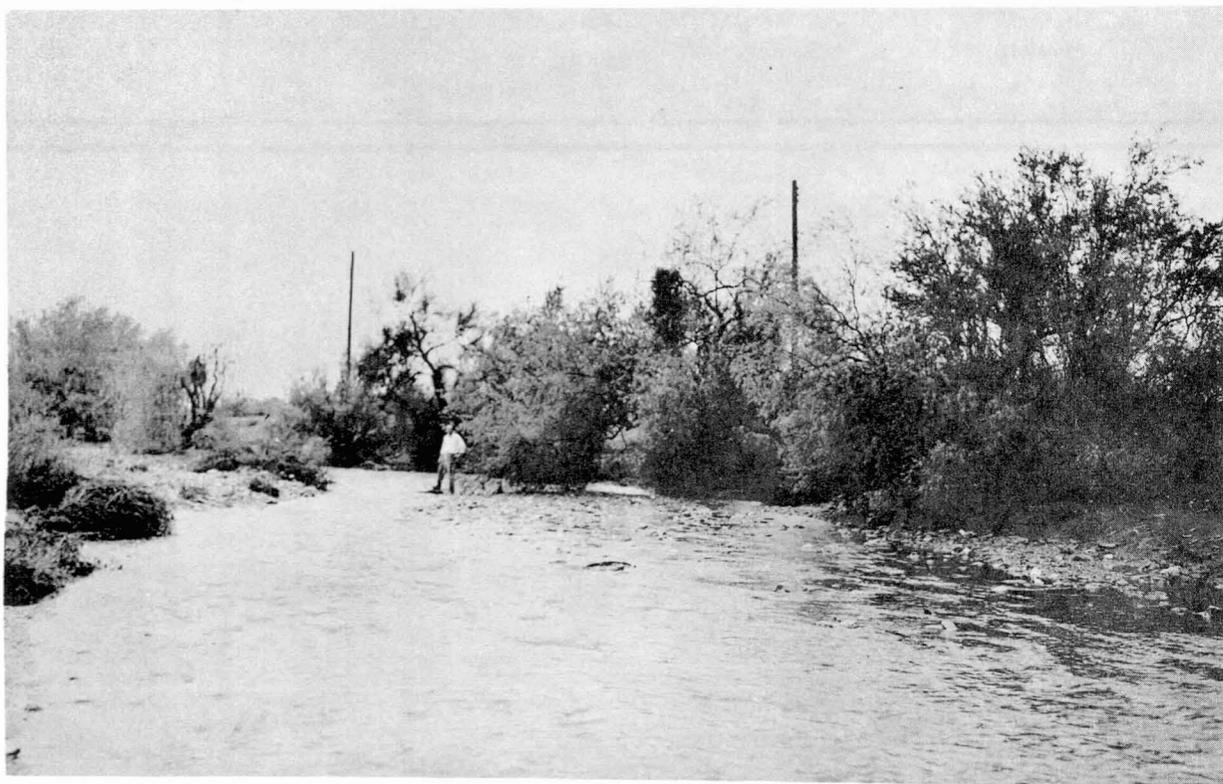
(19) Dreamy Draw opposite Fransen House-one mile north  
of Arizona Canal 11:30 AM (8/3/43) ~~FIRST WASH S. OF NORTHERN AVE.~~  
~~CROSSES 16TH ST.~~

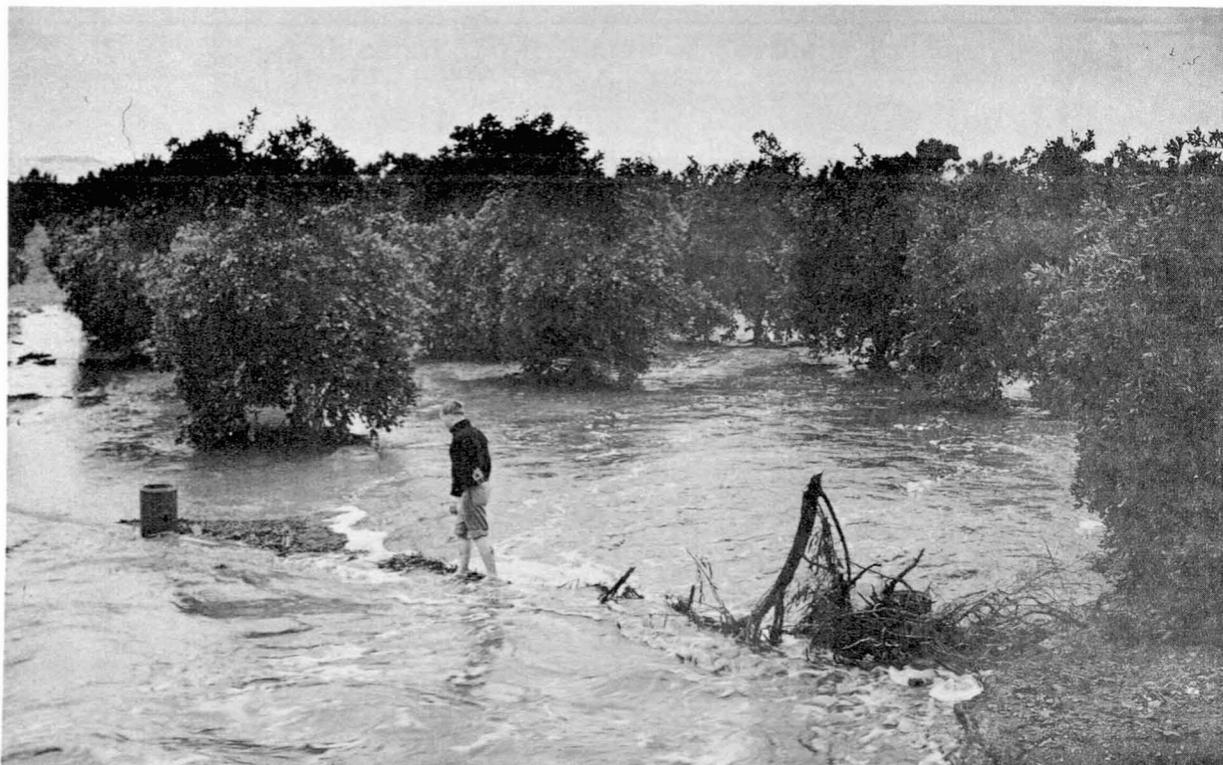
(20) Break in canal 350 ft. south of Northern Ave. 11:35 AM  
(8/3/43) ~~ABOUT 9TH ST. & ARIZ. CANAL~~

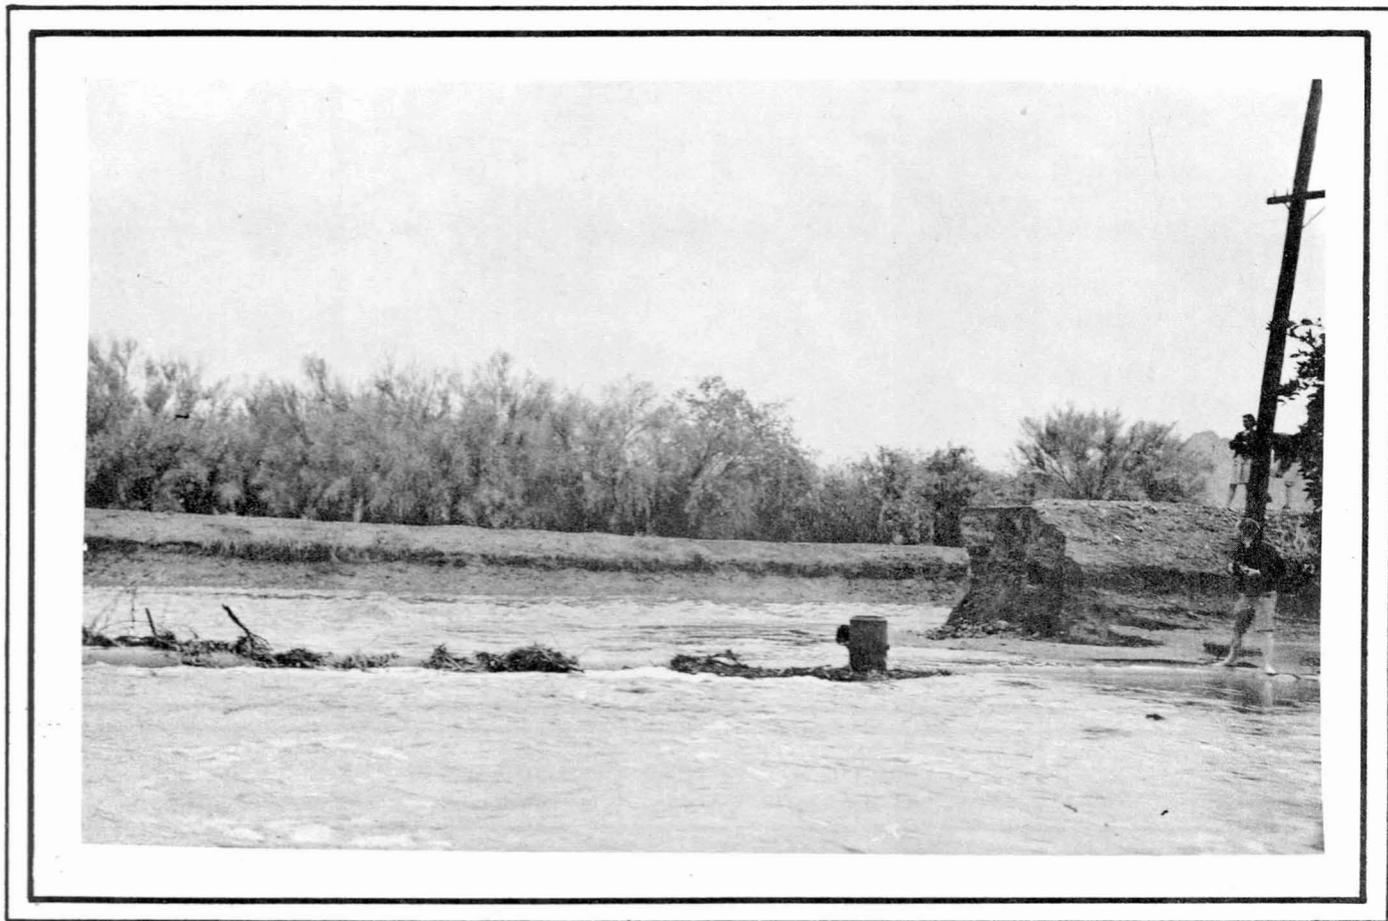
(20a) Break in canal 350 ft. south of Northern Avenue  
ABOUT 9TH ST. & ARIZ. CANAL

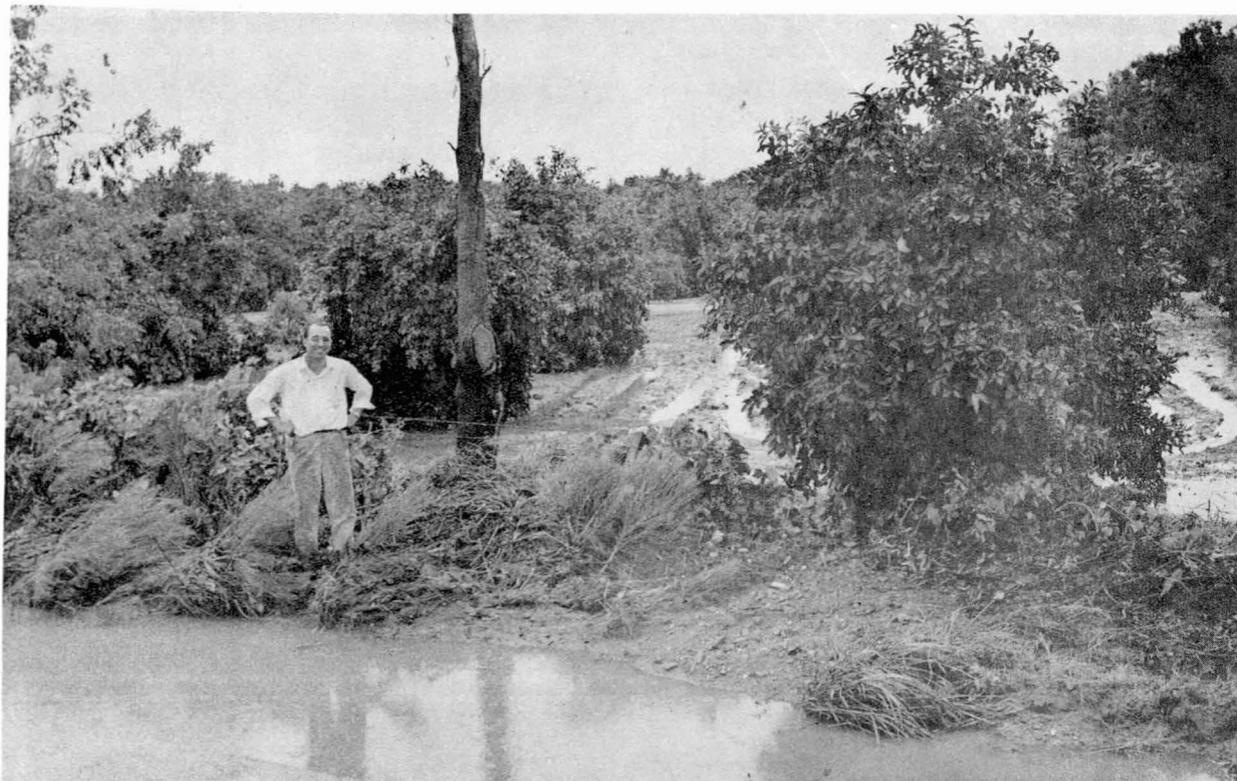
(21) Looking south from Spillway east of 7th Street  
*ABOUT 400 FT. E. OF 7TH ST. SOUTH BANK OF ARIZ. CANAL*
