**DESERT FLOOD OF  
AUGUST 3, 1943**

**PREPARED BY  
L. L. LEE**

DESERT FLOOD OF AUGUST 3, 1943

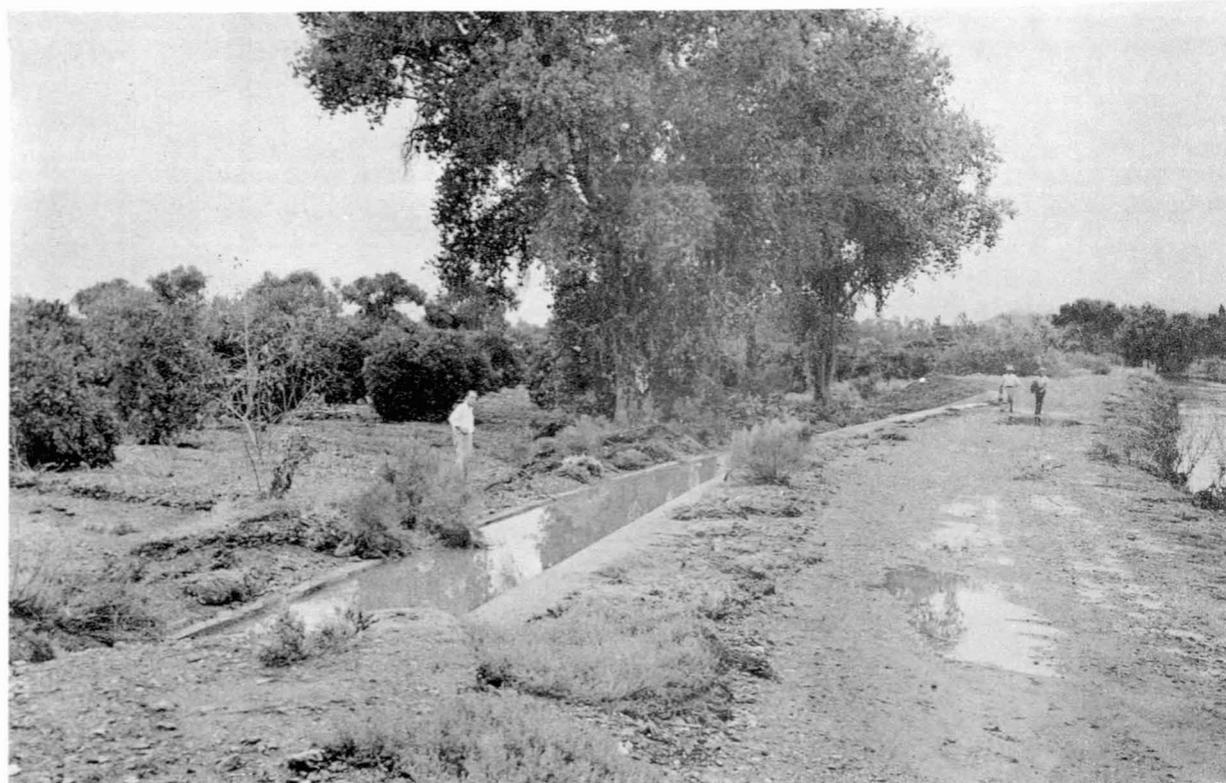
The first break west of Scottsdale occurred at 10:05 A. M. approximately 500 ft. east of Lateral 10 1/4. The Power Conway Spillway, approximately 300 ft. west of Lateral 10 1/2, had operated prior to 11:48 A. M. , but was not spilling at that time. There are cottonwood trees immediately below Power Conway Spillway, which should be removed for its most efficient operation. This spillway apparently had operated effectively prior to the break at Lateral 10 1/8. Indications of drift in the Conway Orchard showed a maximum of 8 inches depth immediately below the spillway. Although a slight amount of top soil was washed by flood water from the spillway, no damage was apparent to the orchard or property below the spillway.

(22) Looking north along Conway Spillway 12:04 PM (8/3/43)  
*ABOUT 1/2 MI. E. OF ARIZONA CANAL*

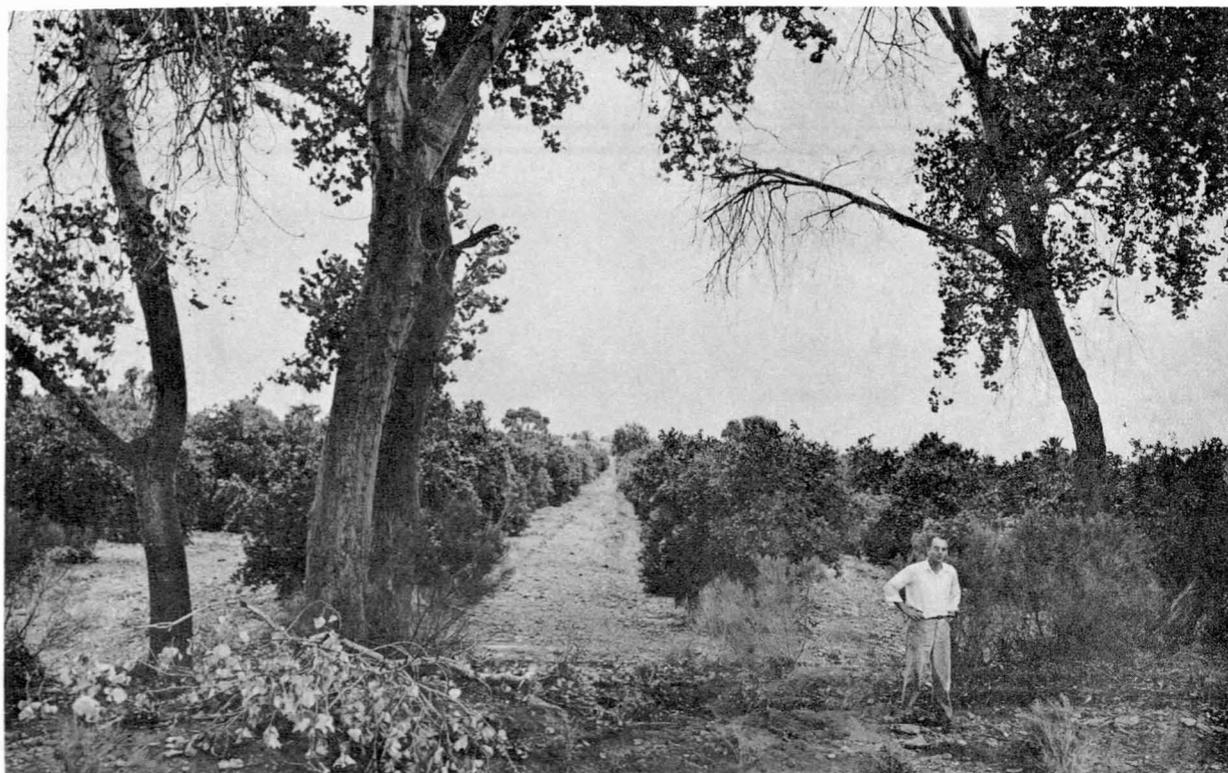
(23) Looking west at Conway Orchard below Spillway 12:08 PM  
(8/3/43) ABOVE 11<sup>TH</sup> ST & ARIZ. CANAL

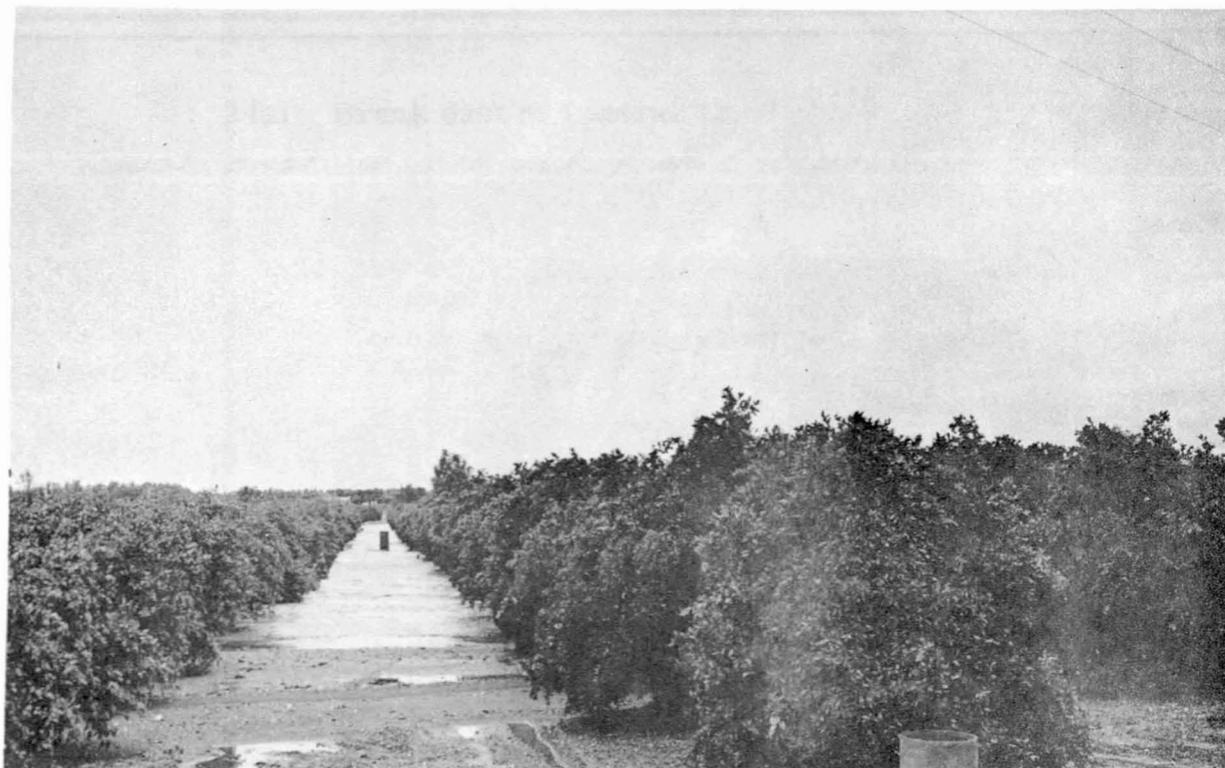
(24) Orchard north of Conway. Water from break near Northern Ave.  
12:20 PM (8/3/43) ORCHARD NORTH OF 11<sup>TH</sup> ST & ARIZ. CANAL

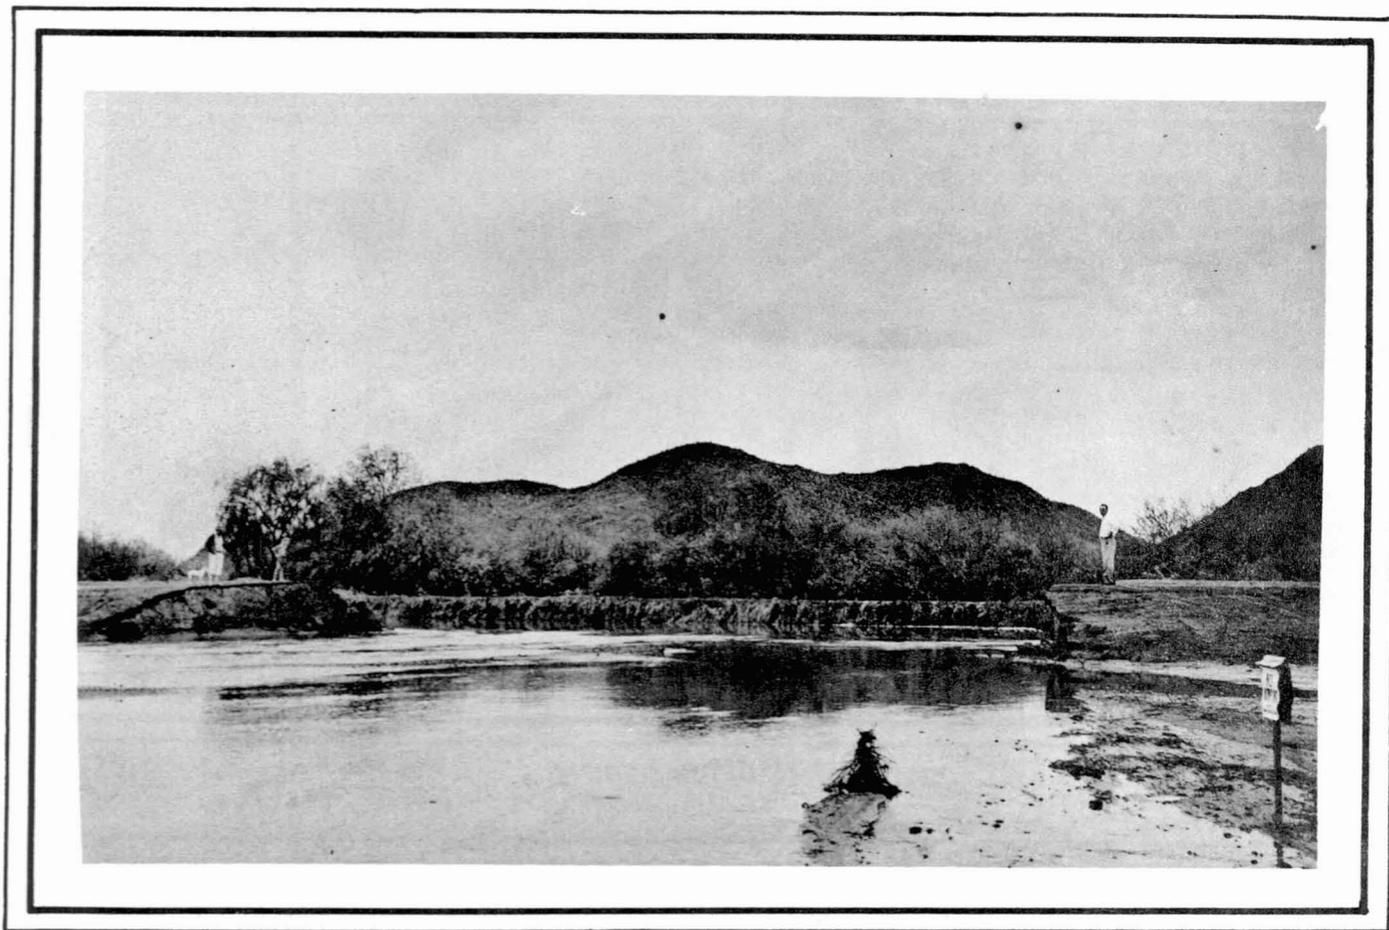
(24a) Break east of Lateral 12.

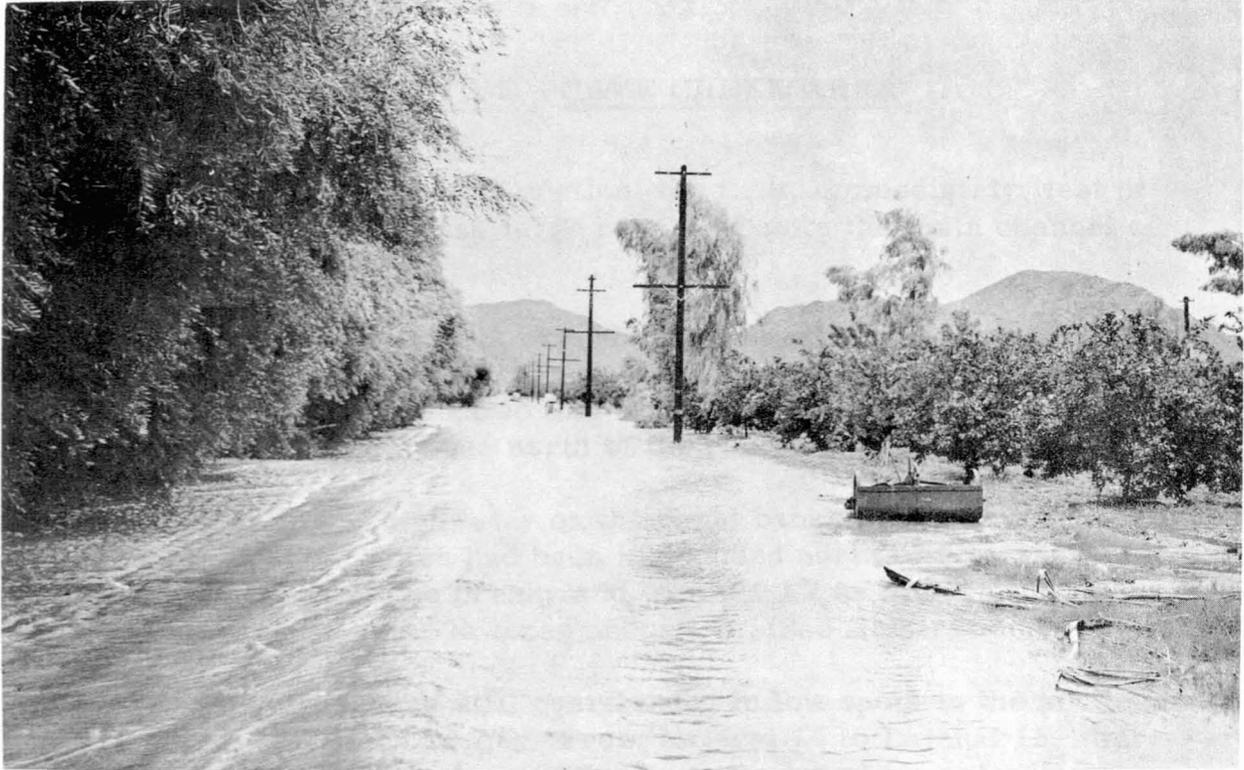
(25) Looking north on 7th Avenue north of Northern 12:54 PM  
(8/3/43)

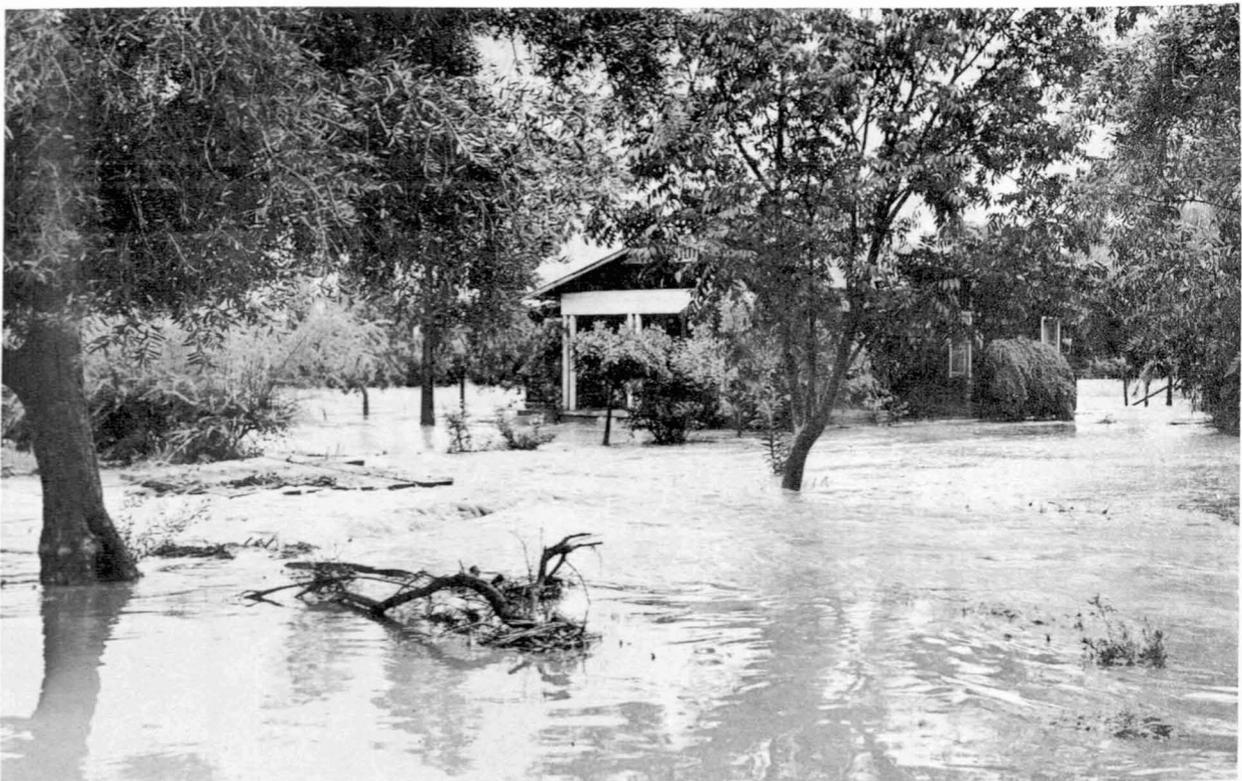
(26) Looking southwest from 7th Avenue south of Northern - Lateral 12 Spillway -  
flood waters from break east of Lat. 12 - 1:00 PM (8/3/43)

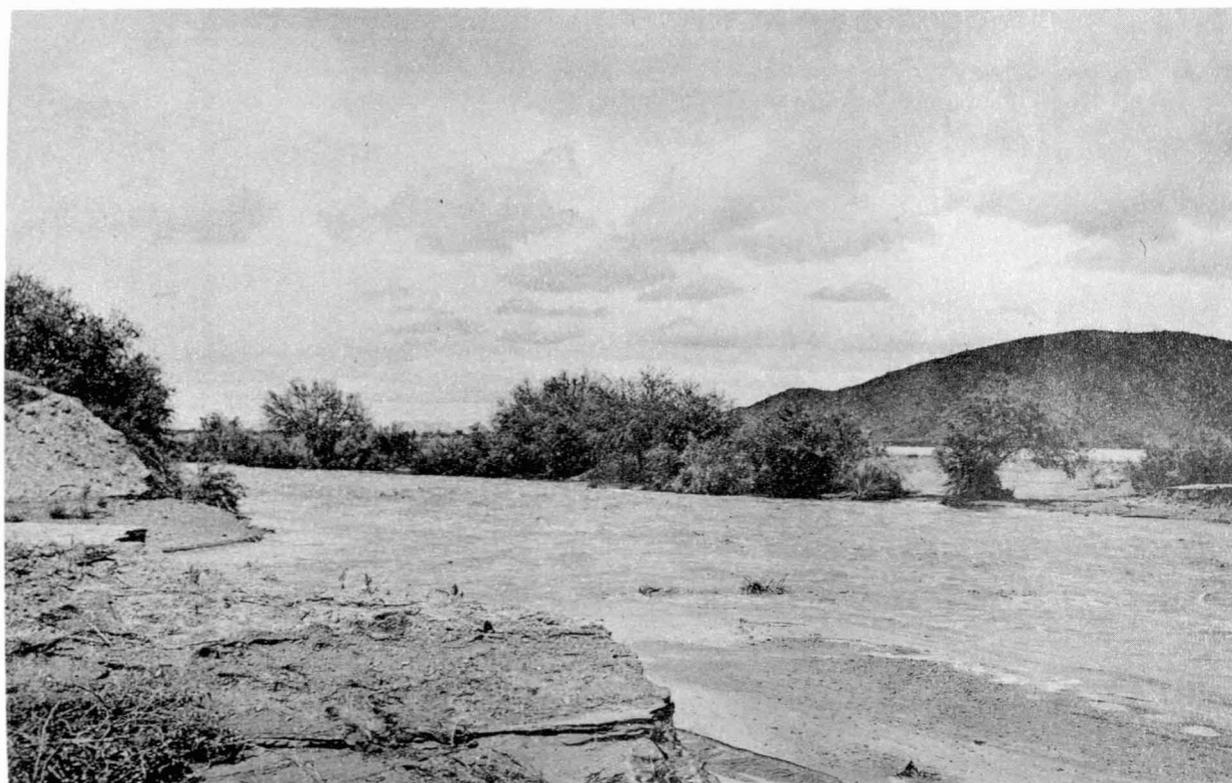
From indications of highwater on the canal banks at the Cave Creek break, large volumes of water which had been impounded north of the canal was released immediately after the break, and within 1 1/2 to 2 hours the water level at the Cave Creek break had lowered about 4 ft. (See illustrations #27 & #28).

(27) Looking up Main Channel of Cave Creek from west  
bank of break 3:20 PM (8/3/43) 23RD AVE. & ARIZ. CANAL

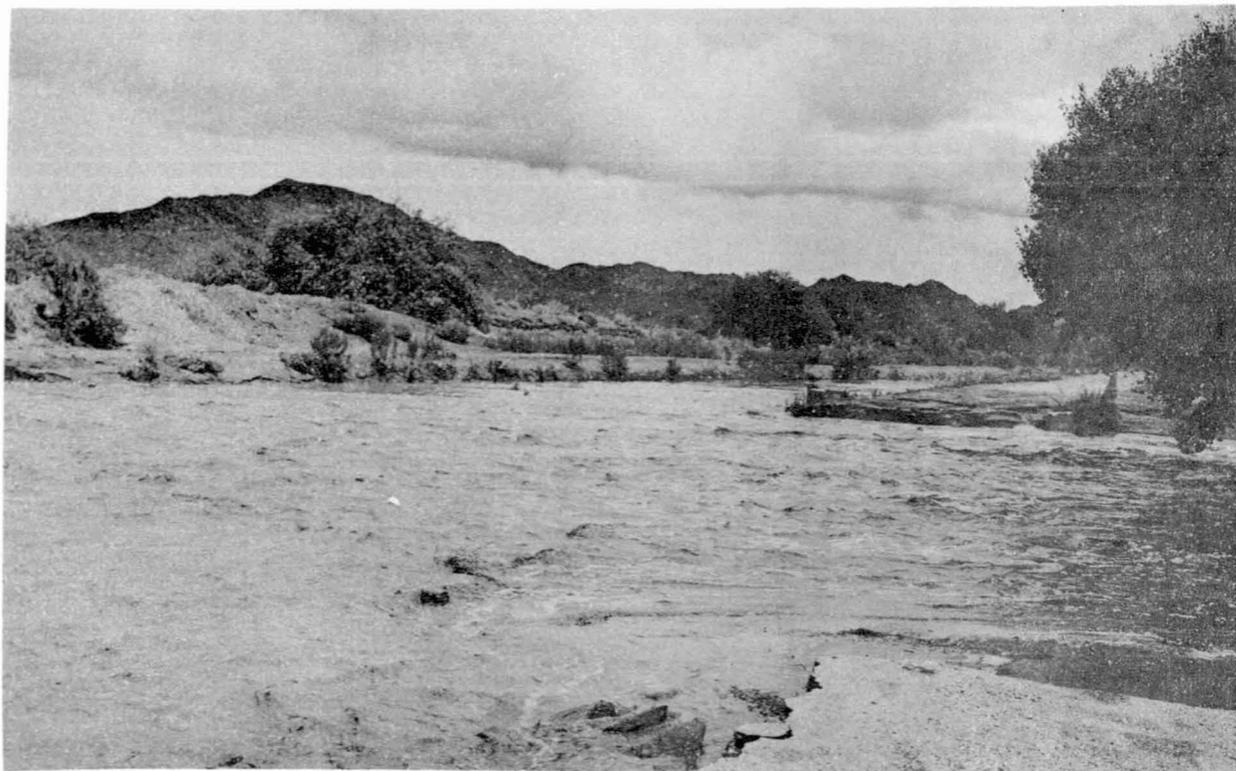
(28) Looking east across Cave Creek break (8/3/43) 23RD AVE. & ARIZ. CANAL

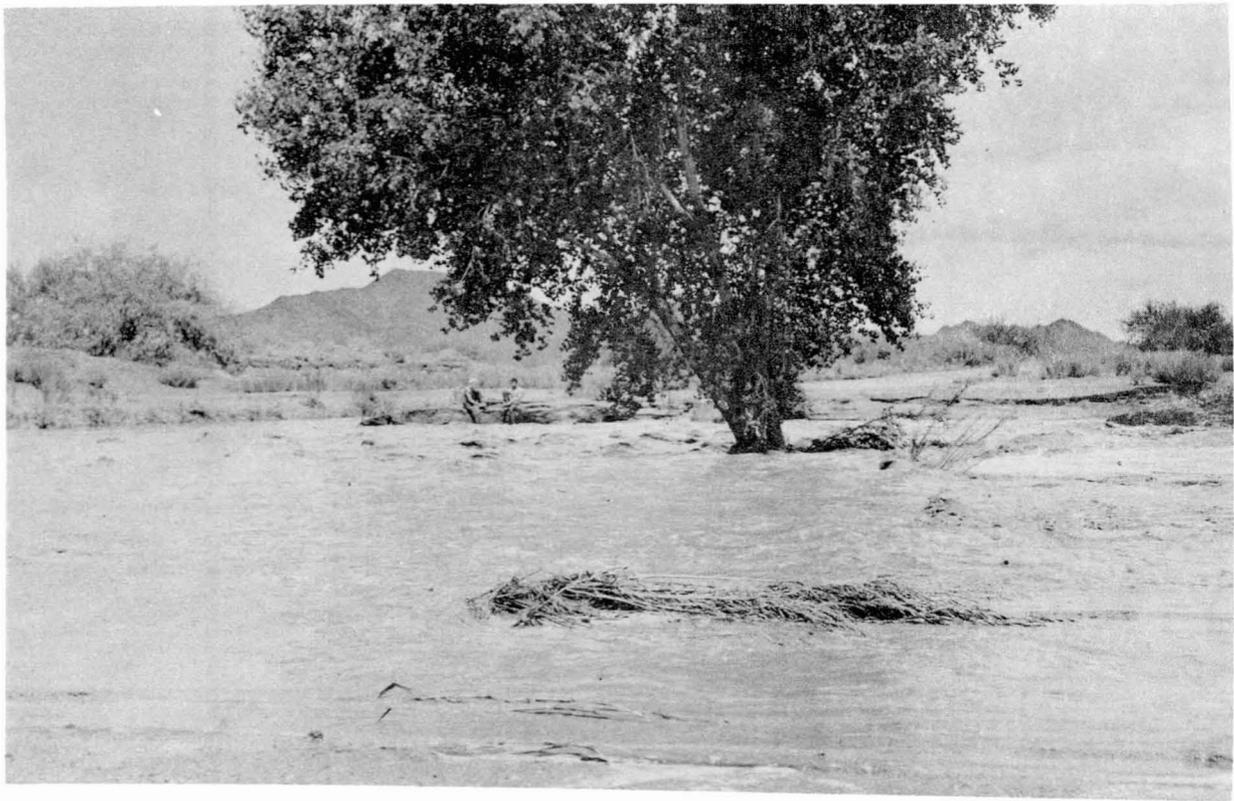
(29) Looking across Cave Creek break 3:25 PM (8/3/43)  
*23 RD. AVE. & ARIZ. CANAL*

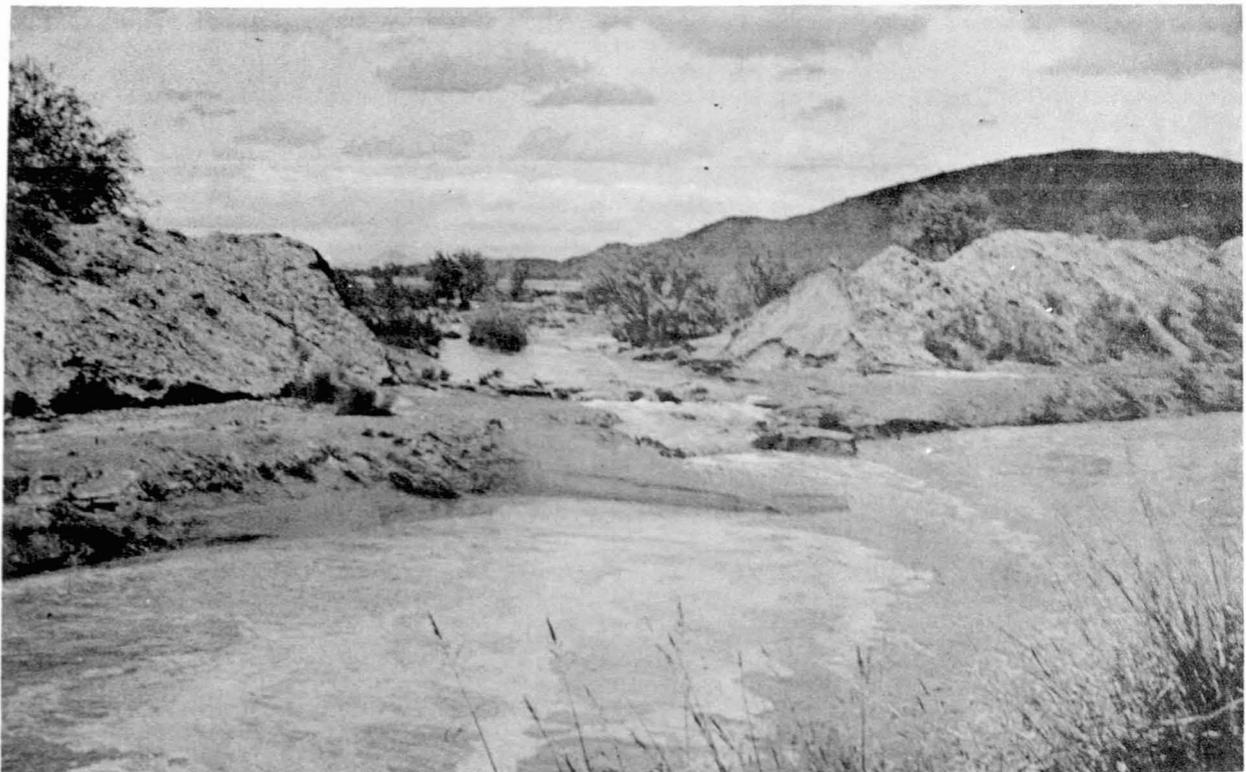
(30) Inflow from west branch of Cave Creek 3:40 PM (8/3/43)  
*NEAR 23 RD. AVE. & ARIZ. CANAL*

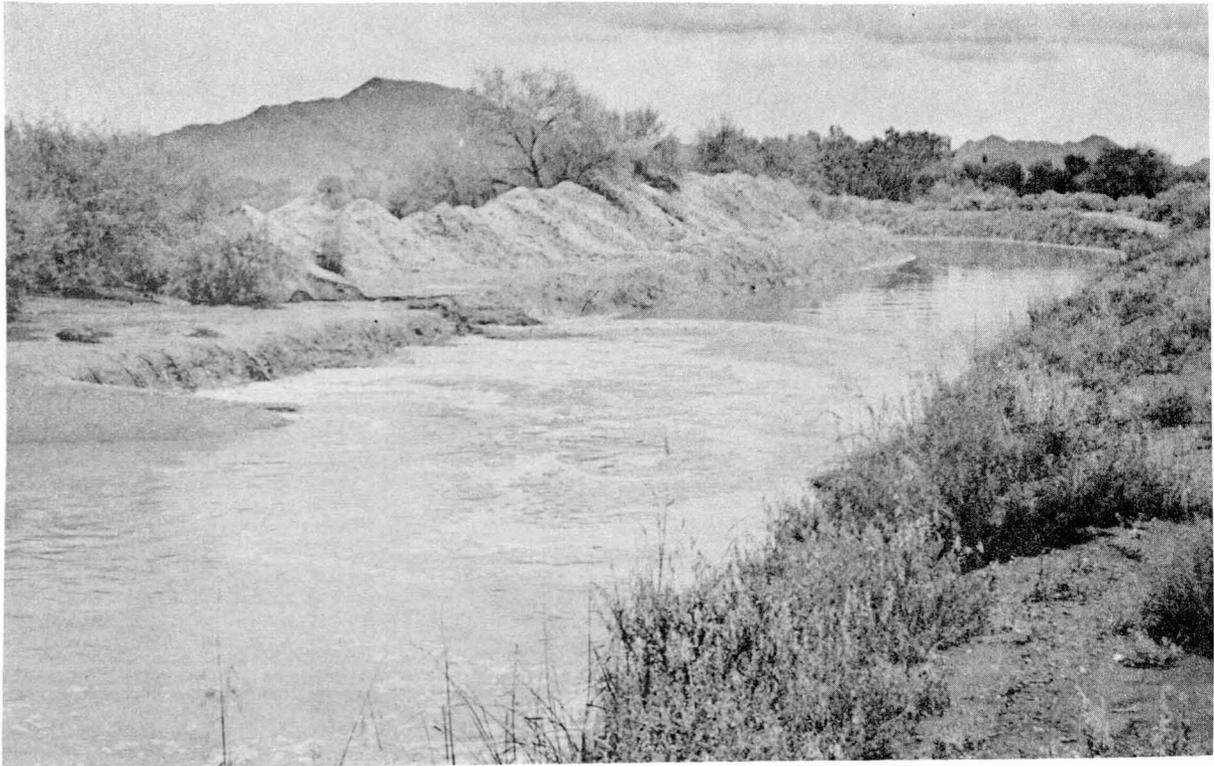
(31) Inflow from Cave Creek east of Lateral 14 3:45 PM (8/3/43)  
*27<sup>TH</sup> AVE. & ARIZ. CANAL*

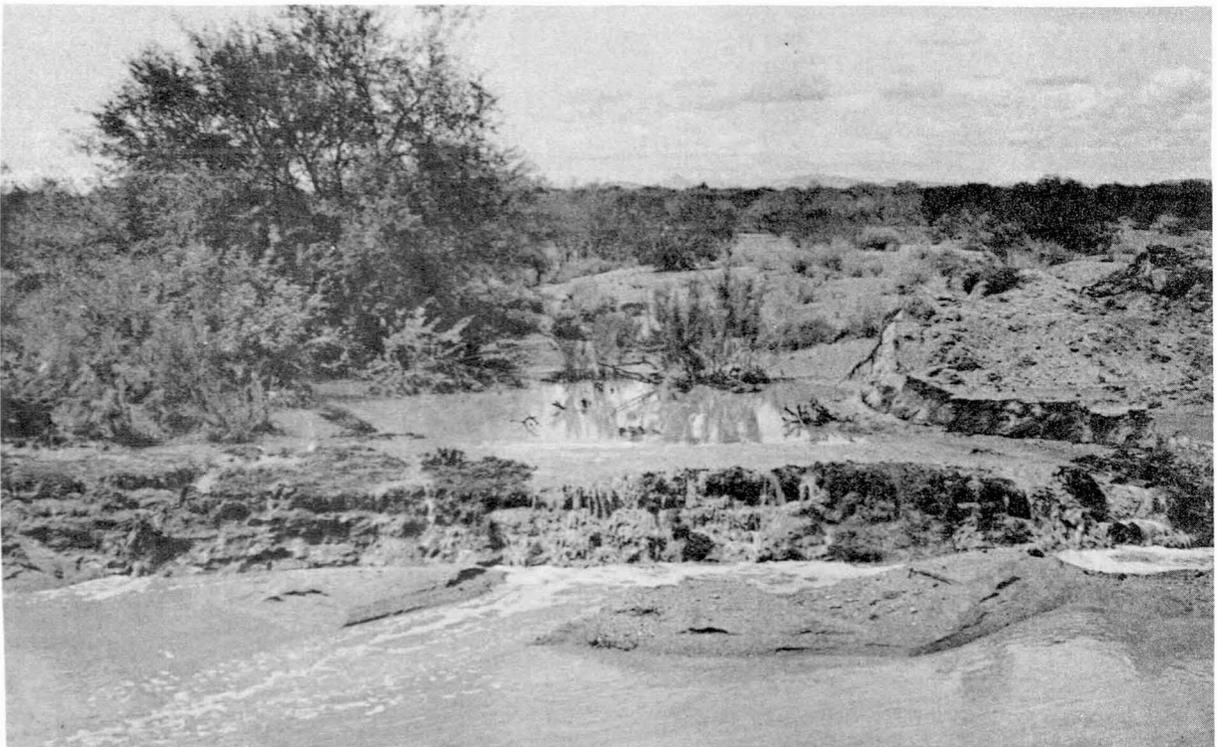
(32) Inflow east of Lateral 14 3:47 PM (8/3/43)  
*27<sup>TH</sup> AVE. & ARIZ. CANAL*

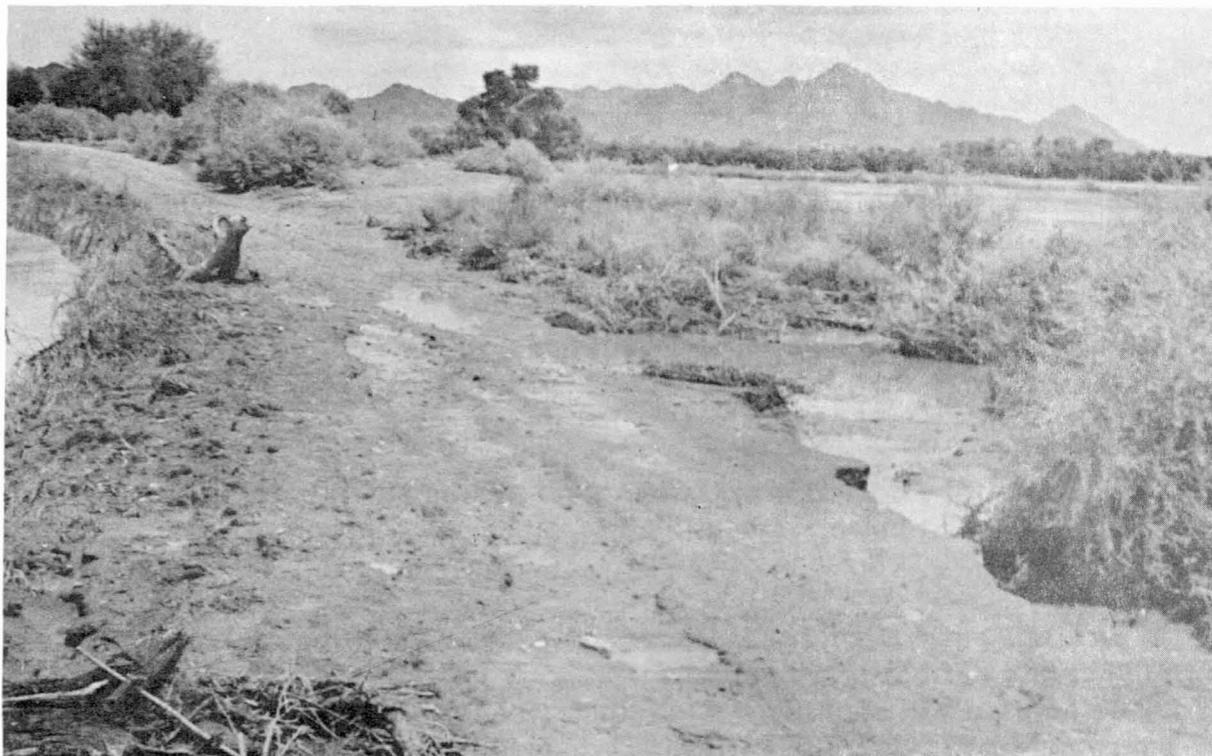
At 3:17 P. M. water was still overflowing in low spots in the south canal banks at Lateral 13 3/4 and 13 7/8. From Lateral 14 to Lateral 15, there were eight definite overflowed sections in the south bank and almost a continuous inflow of the low banks on the north side. From Lateral 15 to Lateral 16, there were nine definite overflow sections on the south bank and almost continuous inflow off flat fields from the north.

(33) East of Lateral 14. Looking east at damage to canal banks by overflow 3:47 PM (8/3/43) EAST OF 27 TH AVE.  $\frac{1}{2}$  ARIZ. CANAL

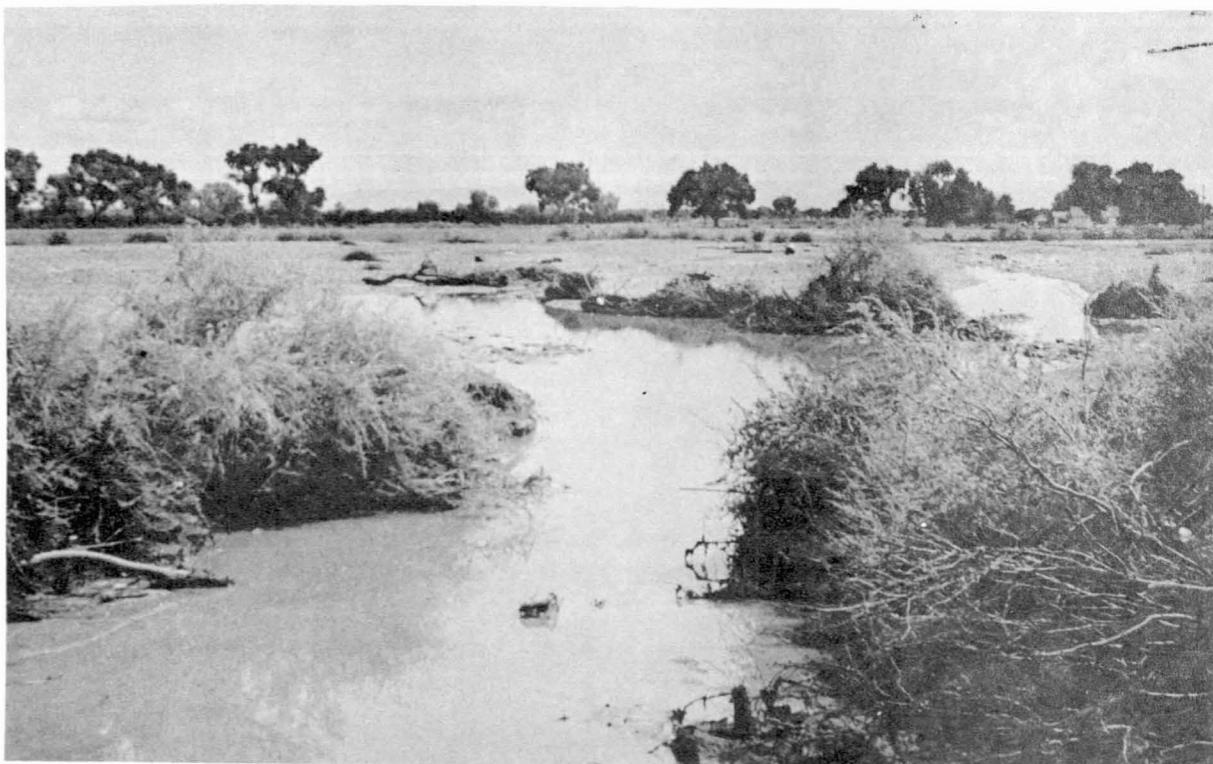
(34) Looking south from Arizona Canal east of Lateral 14. Frank Kinnley land below breaks (8/3/43) 27 TH AVE.  $\frac{1}{2}$  ARIZ. CANAL

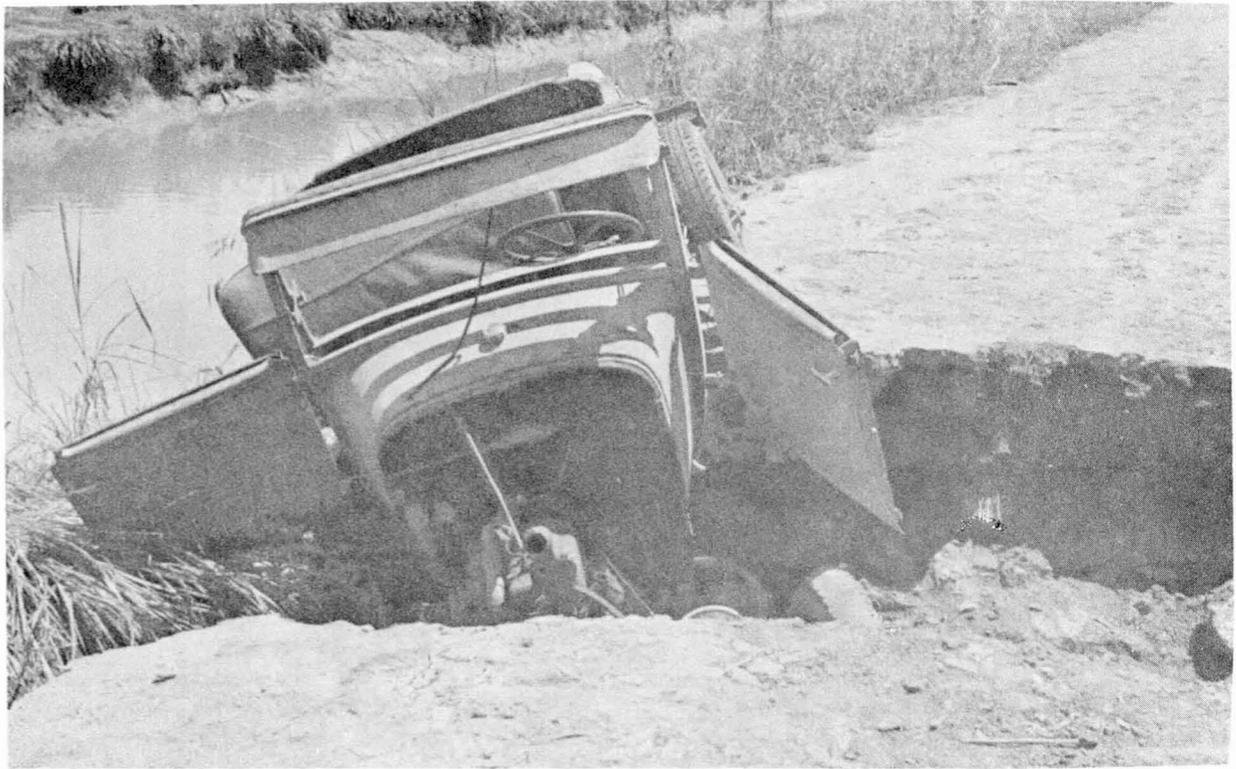
(35) Fourth break east of Lateral 19 1:30 PM (8/5/43)  
*JUST EAST OF 67TH AVE. & ARIZ. CANAL*

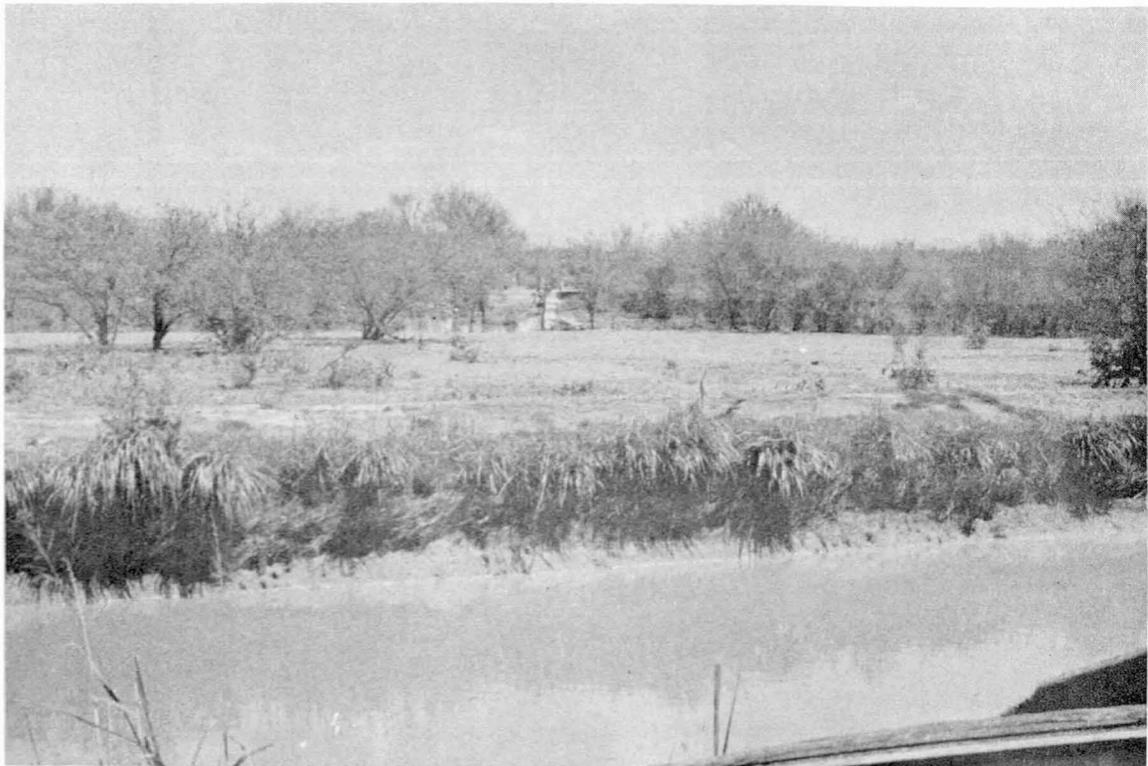
(36) Looking north from fourth break east of Lateral 19 (8/5/43)  
*JUST EAST OF 67TH AVE. & ARIZ. CANAL*

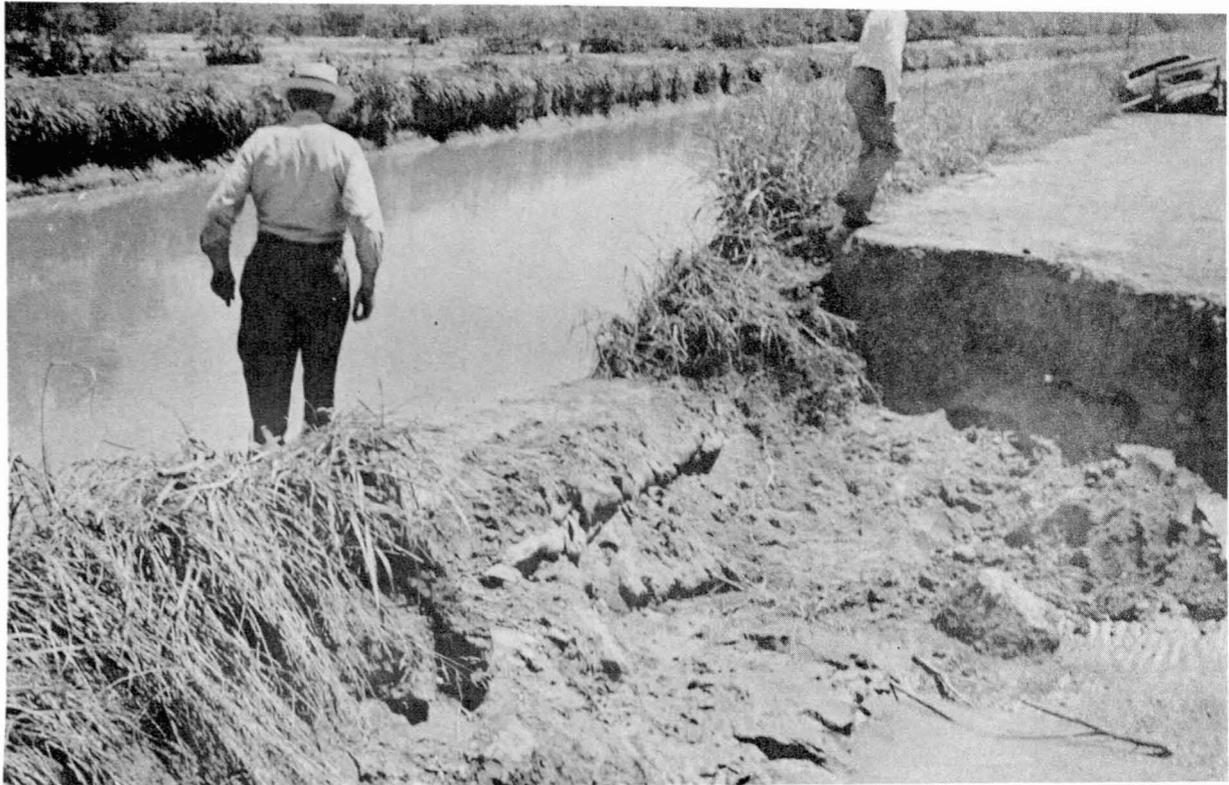
(37) Third break east of Lateral 19 (8/5/43)  
*JUST EAST OF 67TH AVE. & ARIZ. CANAL*

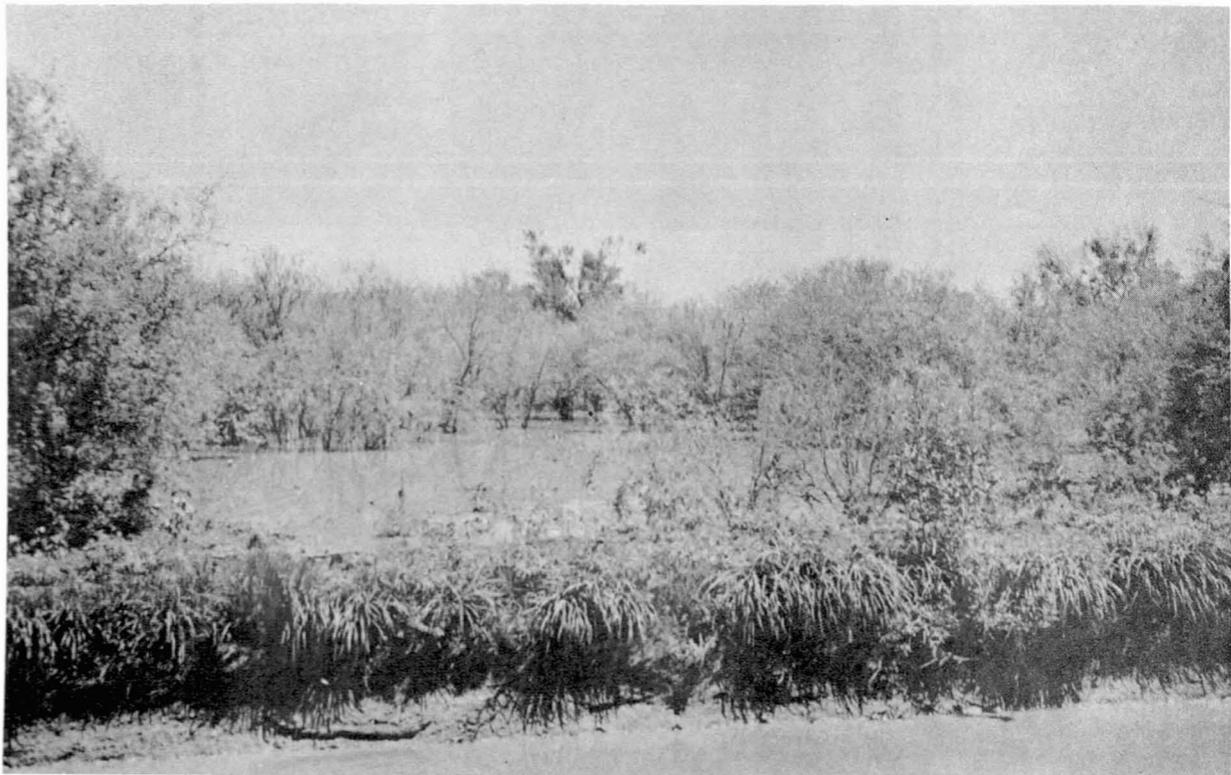
(38) Looking north from Lateral 18 3/4 (8/5/43)  
*ABOUT 65TH AVE. & ARIZ. CANAL*

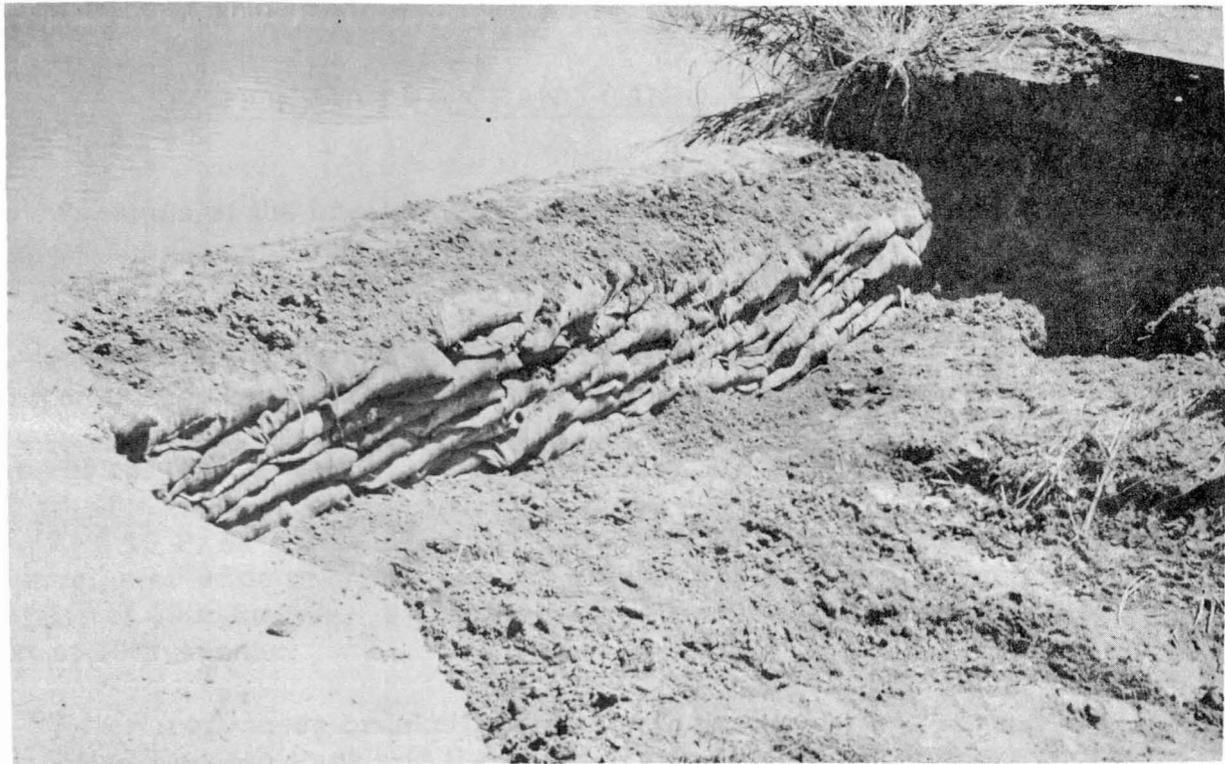
(39) First break east of Lateral 19 (8/5/43)  
*EAST OF 67TH AVE. & ARIZ CANAL*

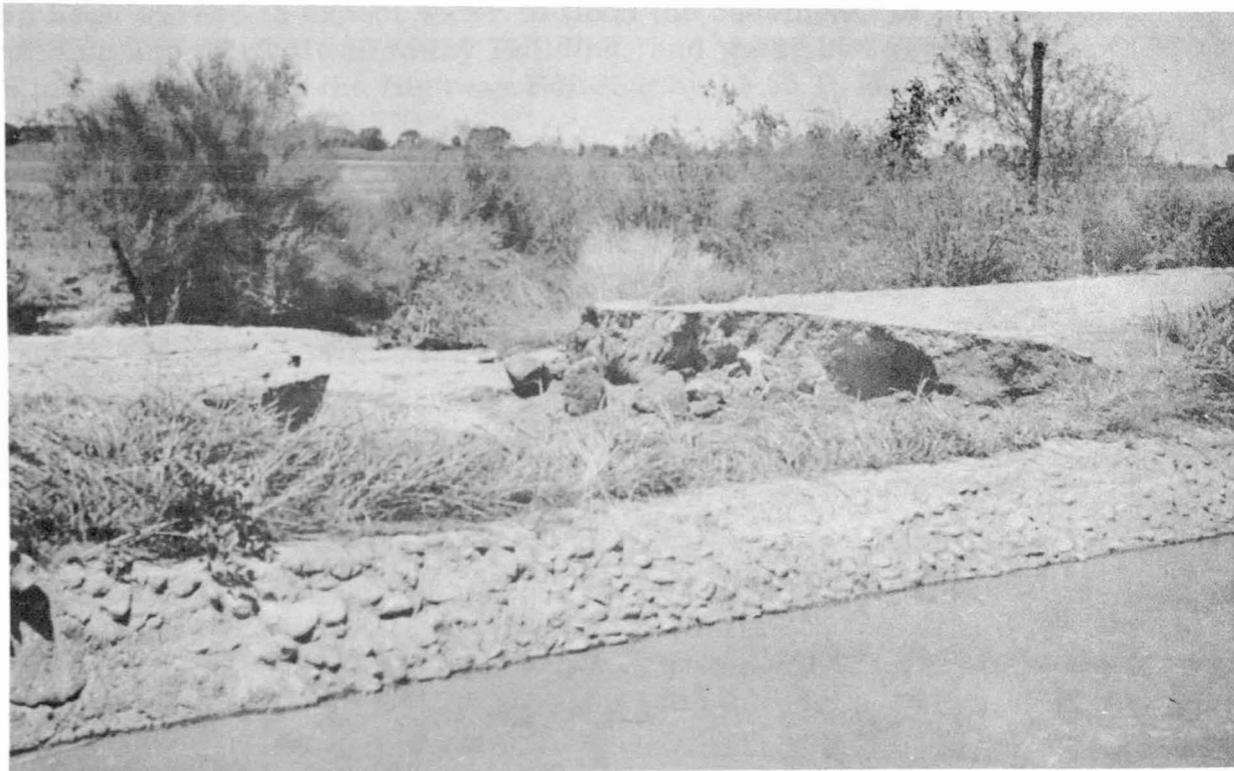
2 breaks occurred in the south bank between Lateral 19 and Lateral 20. The first being approximately 50 ft. west of Lateral 19, and the other 600 ft. west. Indications of overflow of the south bank were found at Lateral 19 1/8 and Lateral 19 1/4. The inflow between Lateral 18 and Lateral 20 appeared to contain some overflow from the Skunk Creek drainage areas.

(40) One of two breaks west of Lateral 19 (8/5/43)  
*WEST OF 67TH AVE. & ARIZ CANAL*

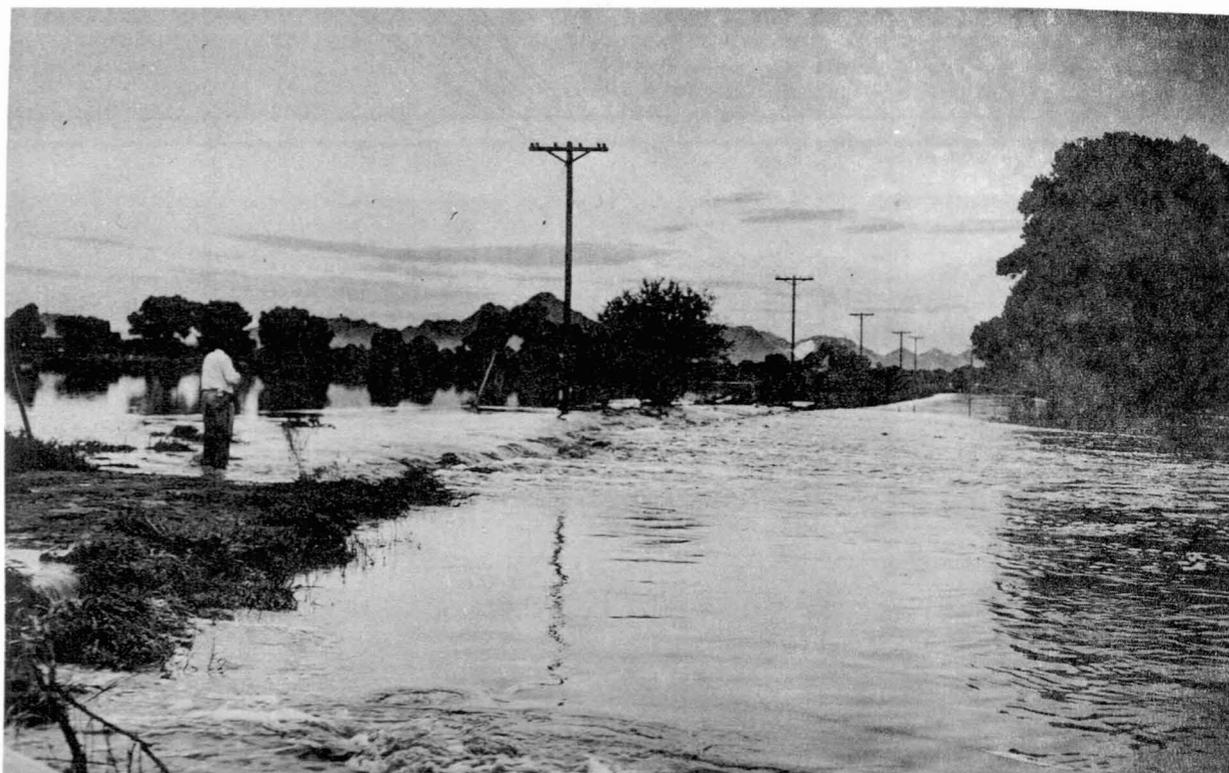
(41) Inflow east of Lateral 13 on Grand Canal 6:00PM (8/3/43)  
*19<sup>th</sup> AVE & GRAND CANAL*

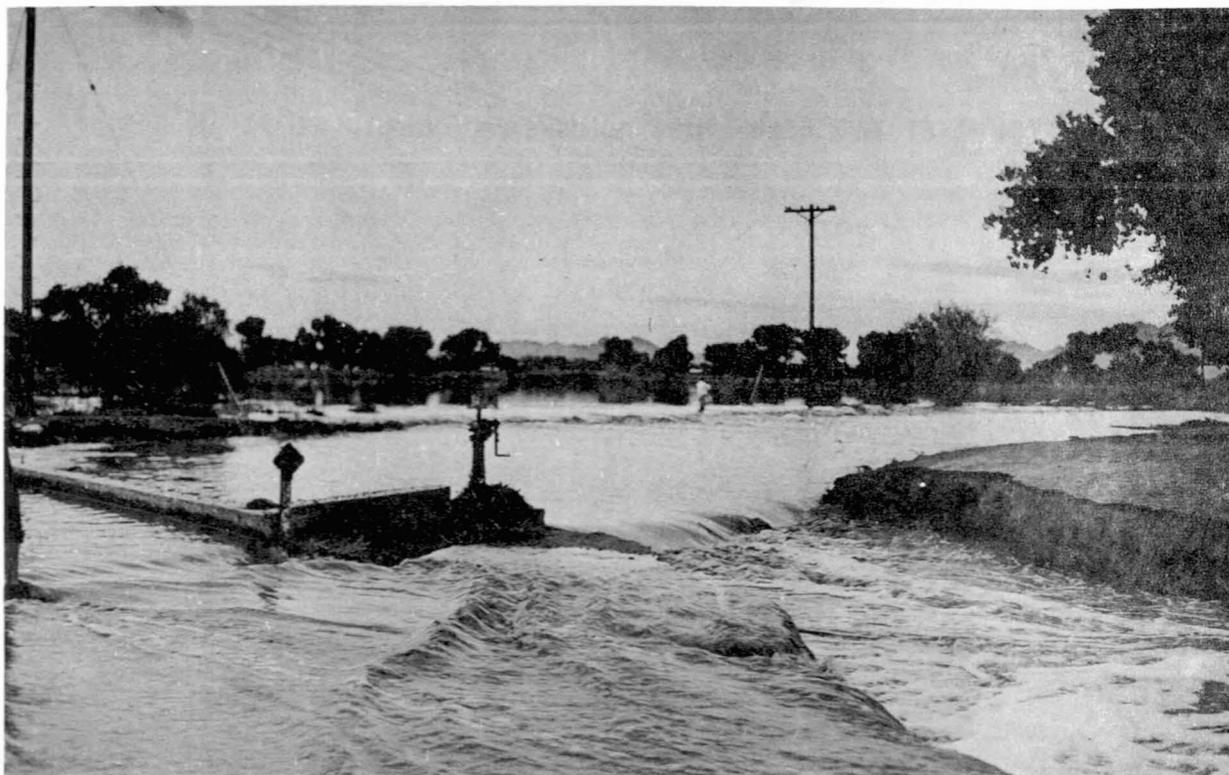
(42) Lateral 13 on Grand Canal 6:05 PM (8/3/43)  
*19<sup>th</sup> AVE & GRAND CANAL*
