**DESERT FLOOD OF  
AUGUST 3, 1943**

**PREPARED BY  
L. L. LEE**

DESERT FLOOD OF AUGUST 3, 1943

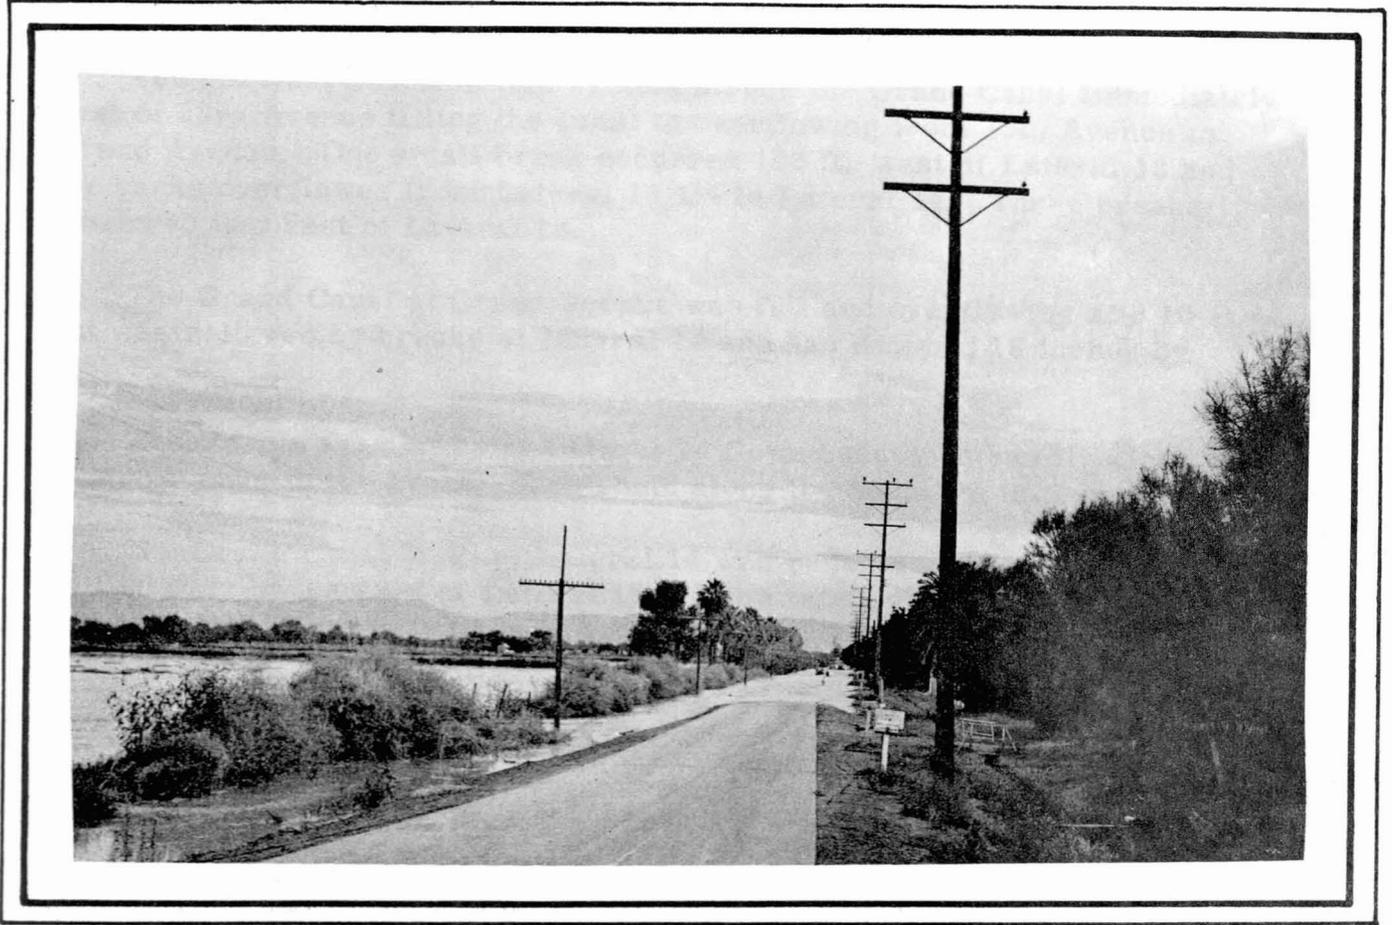
(44) Looking south on 19th 6:25 PM (8/3/43)

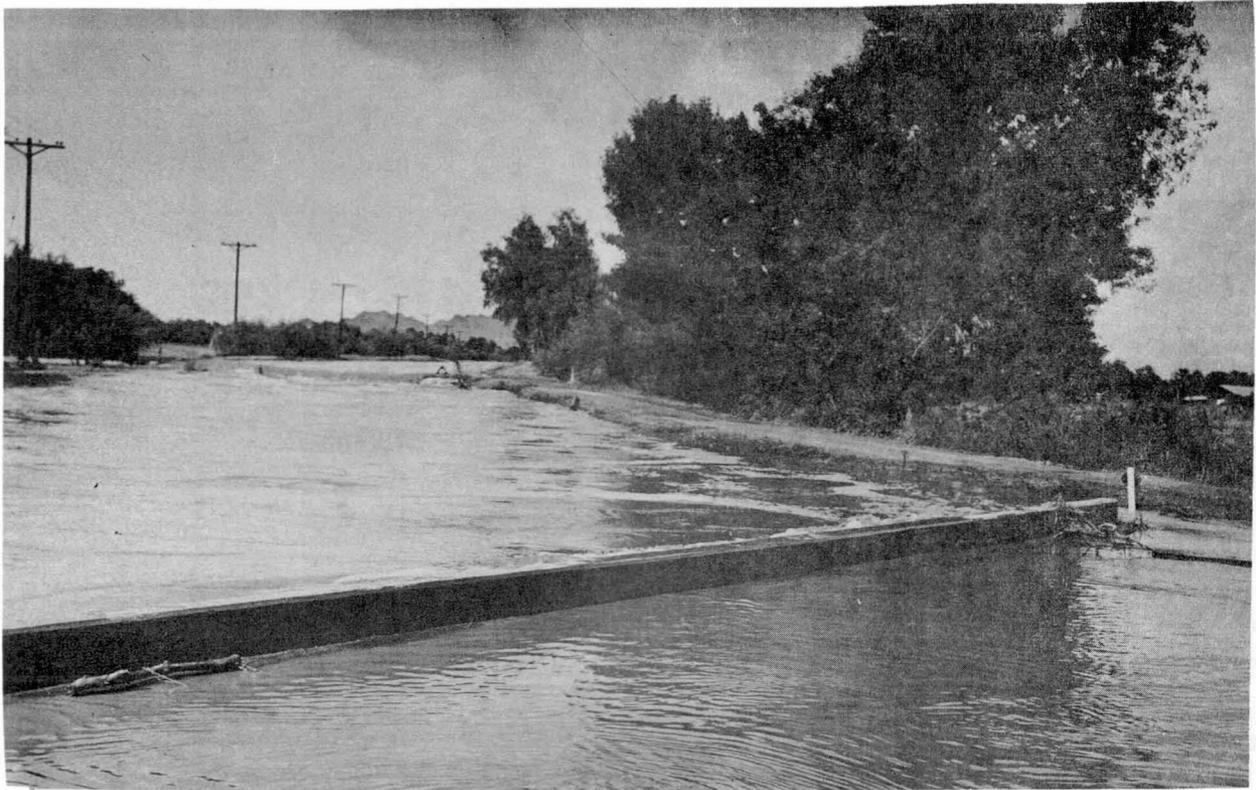
(45) Looking east from Indian School Road east  
of 23rd Avenue 5:15 PM (8/3/43)

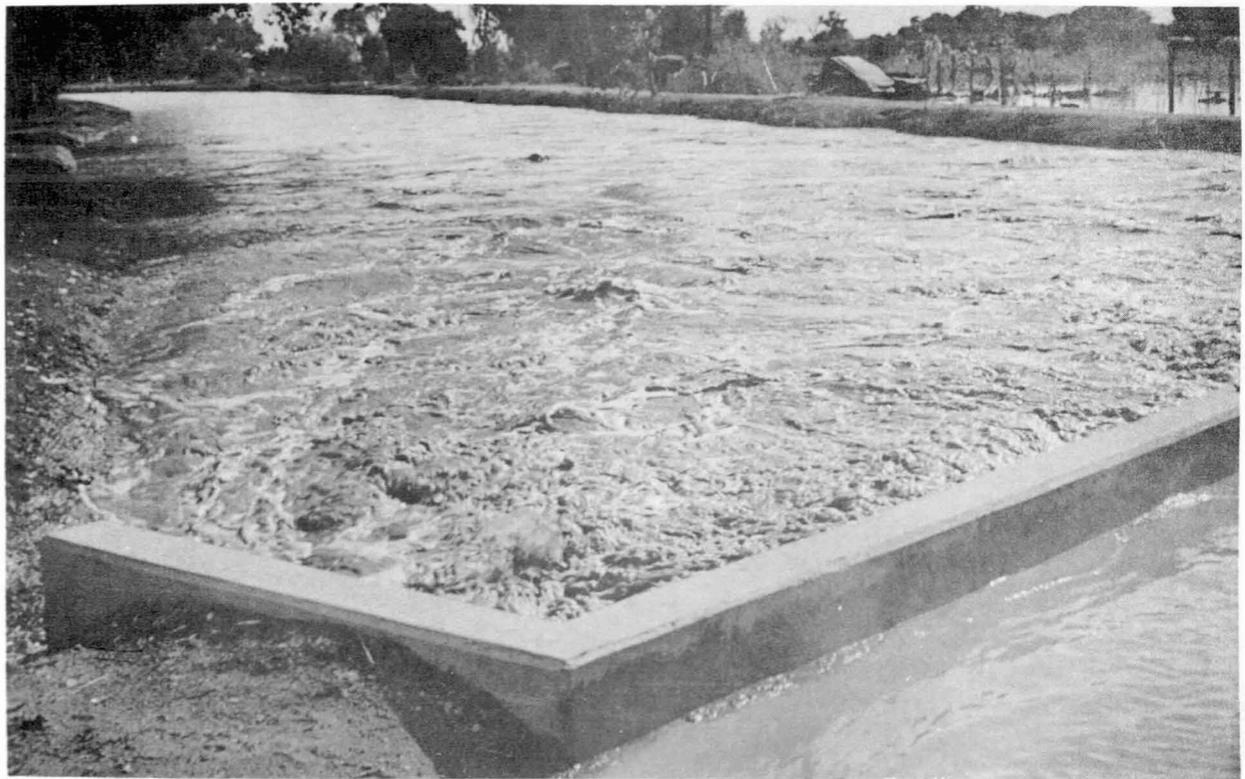
(46) Looking west from same point

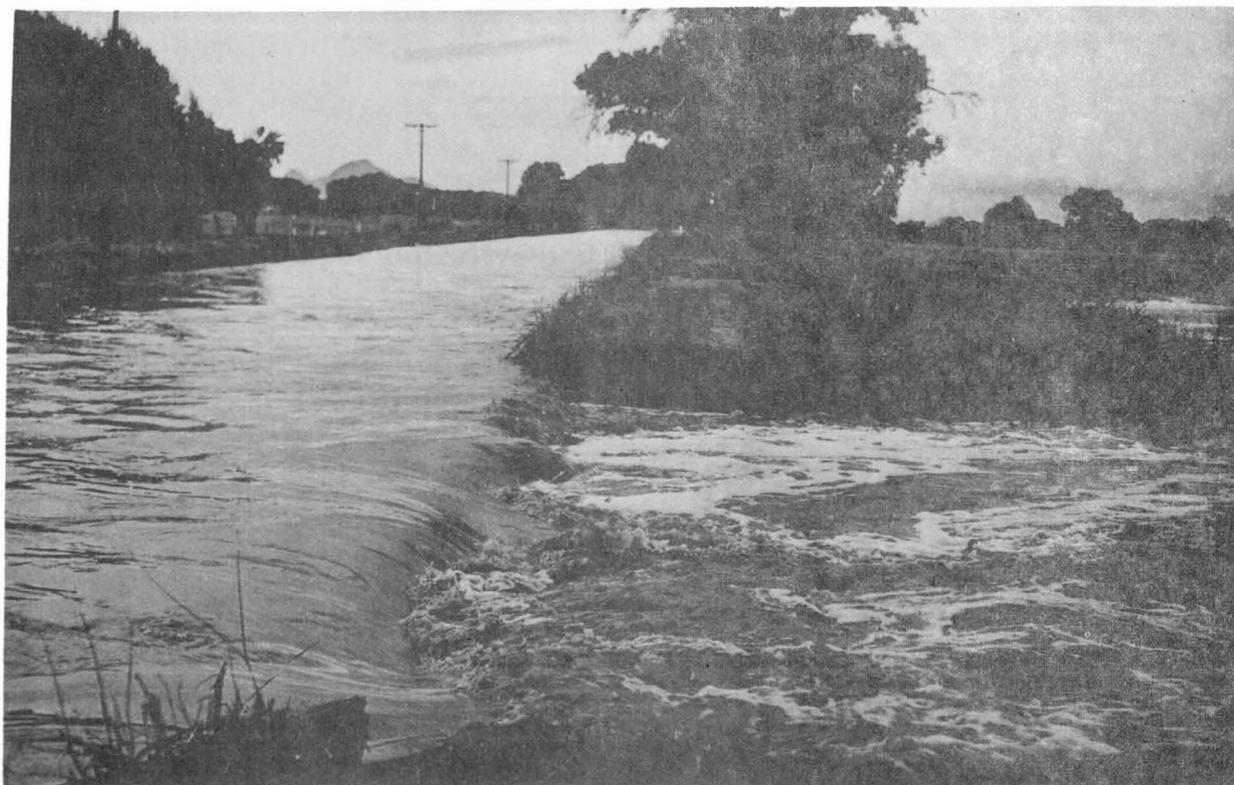
(47) Break east of Lateral 14 on Grand 5:30 PM (8/3/43)  
*27TH AVE. & GRAND CANAL*

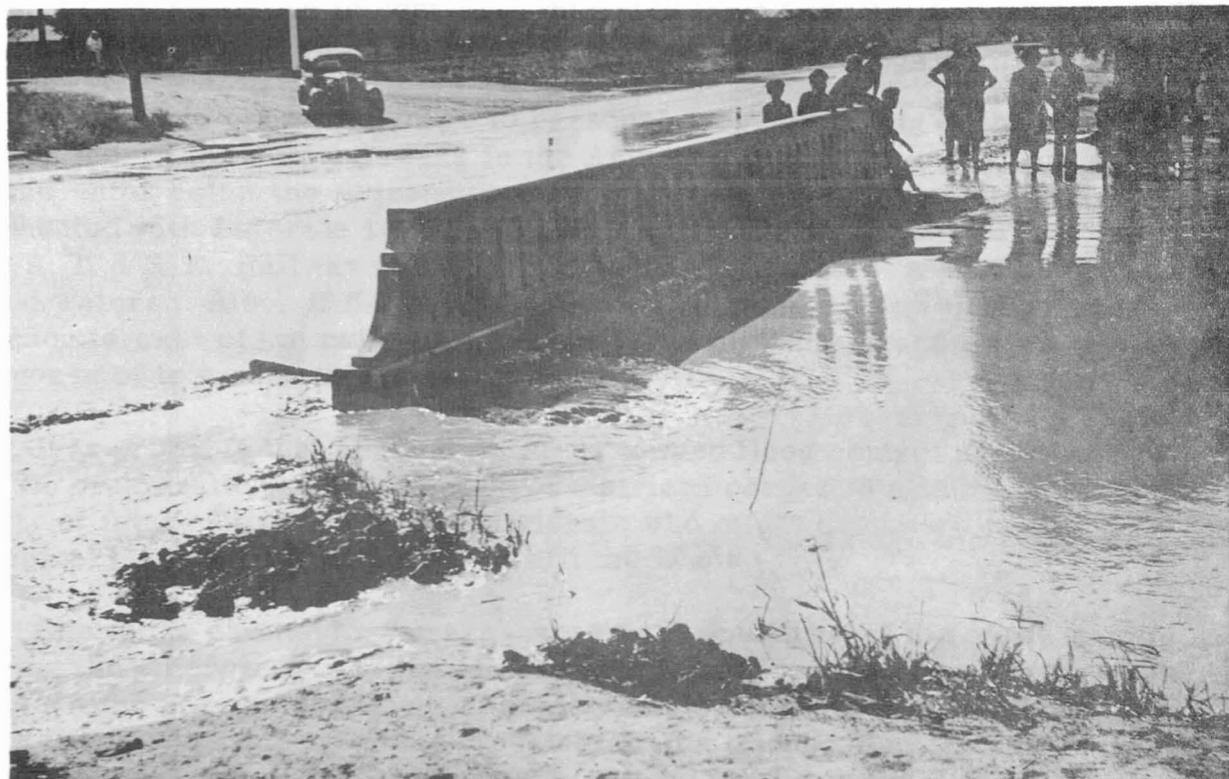
(48) Grand Canal at Grand Ave. 5:35 PM (8/3/43)  
*27TH AVE. & GRAND CANAL*
