U.S. ARMY CORPS OF ENGINEERS
LOS ANGELES DISTRICT

REPORT ON FLOOD OF 22 JUNE 1972
IN
PHOENIX METROPOLITAN AREA, ARIZONA

OCTOBER 1972

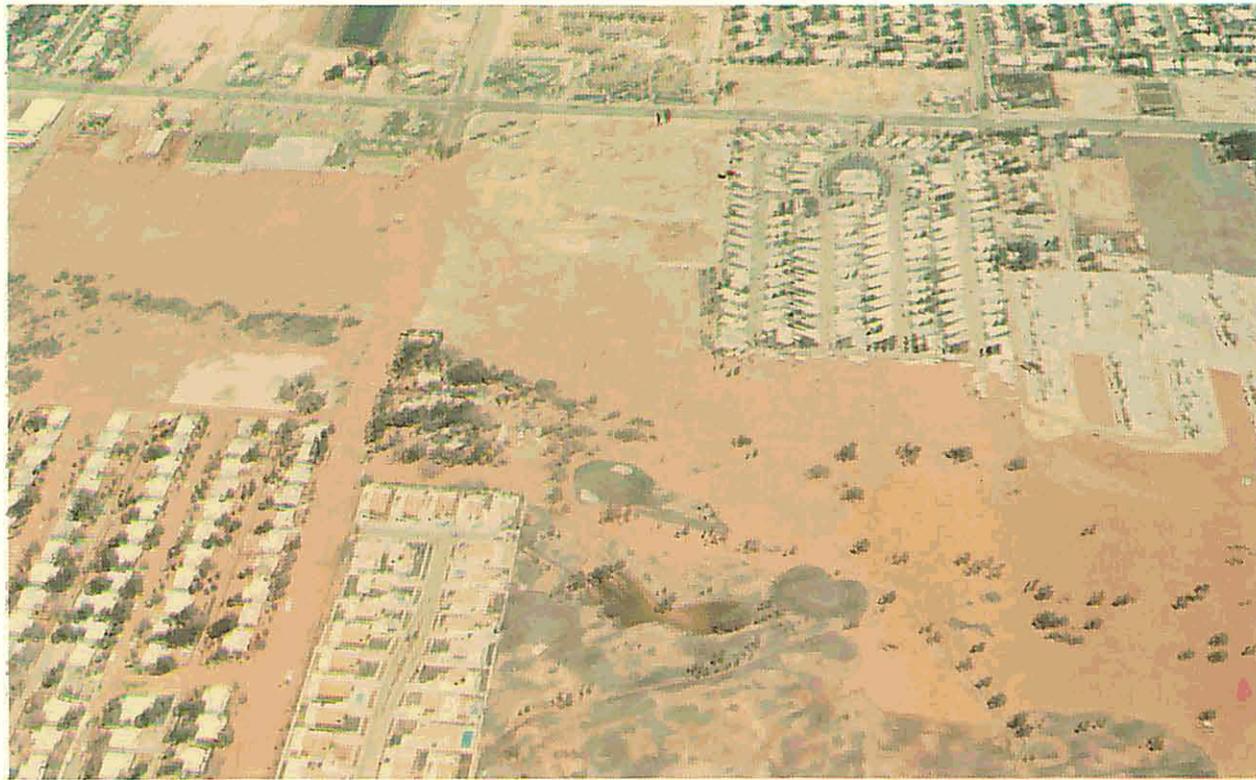
Silt deposit was a major problem along Indian Bend Wash as is evident from this view of homes north of Thomas Road in Scottsdale.

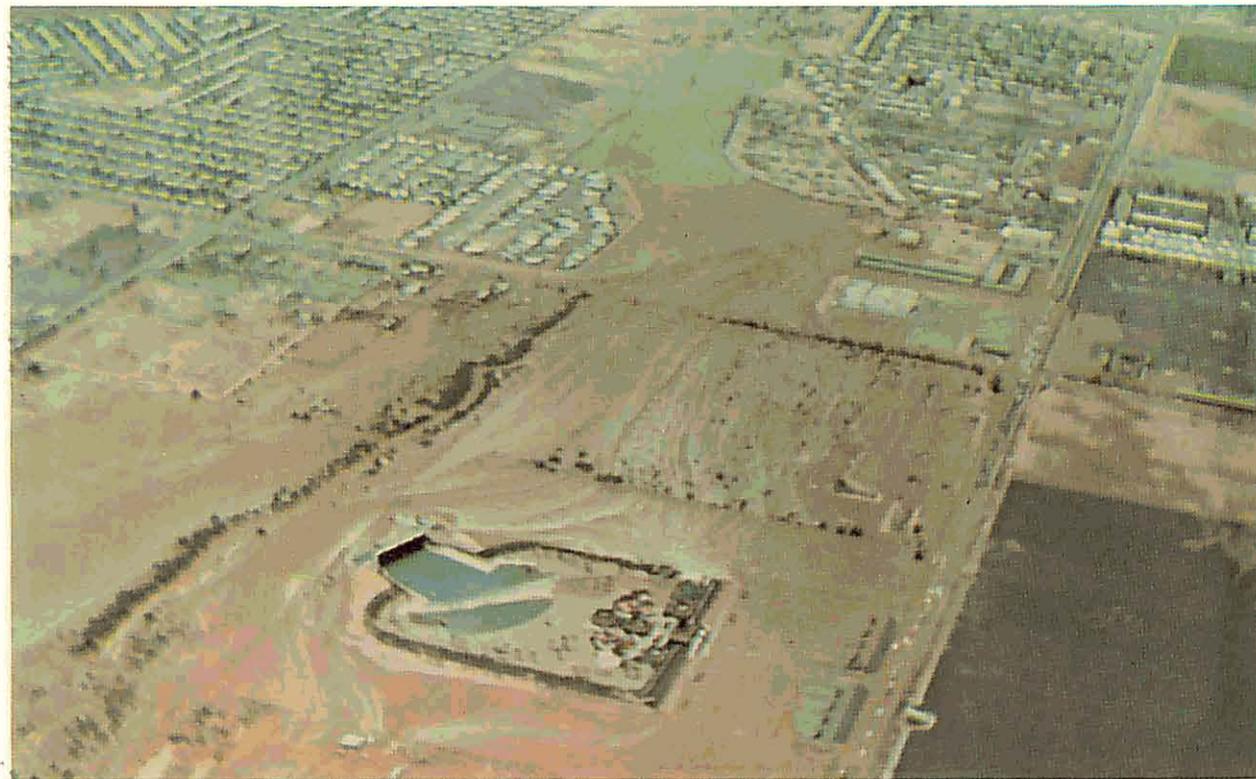
Silt was also deposited on properties along Indian Bend Wash near McKellips Road in the City of Tempe.

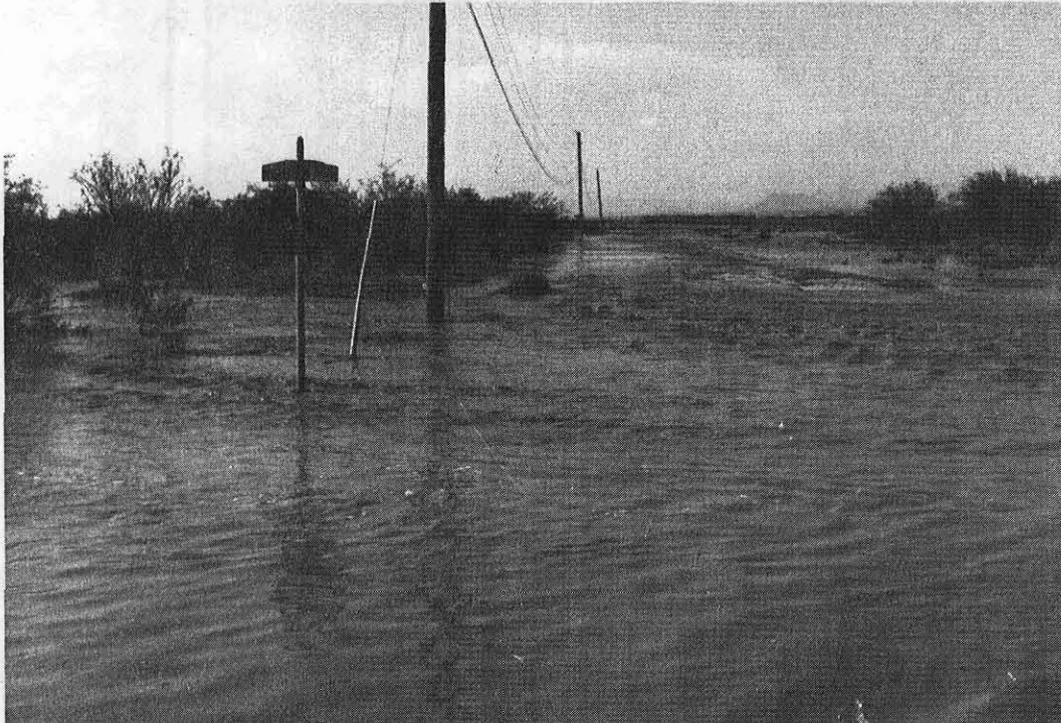
A street sign is the only evidence of the intersection as sheetflow covers Shea Blvd. and 50th Street in Paradise Valley.

e. Damages to streets, roads, and bridges. The streets most severely damaged during the flood were Shea Boulevard and Double Tree Ranch Road. Segments of pavement were washed out and silt was deposited on the streets. The total damages to streets were about \$4,000.

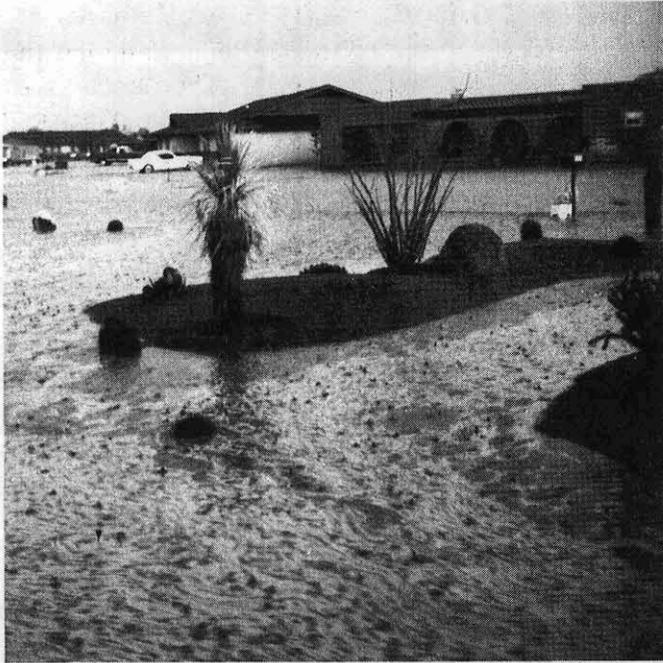
Floodwater from a tributary of Indian Bend Wash converted landscaping into an island near these homes at 58th place in Paradise Valley.

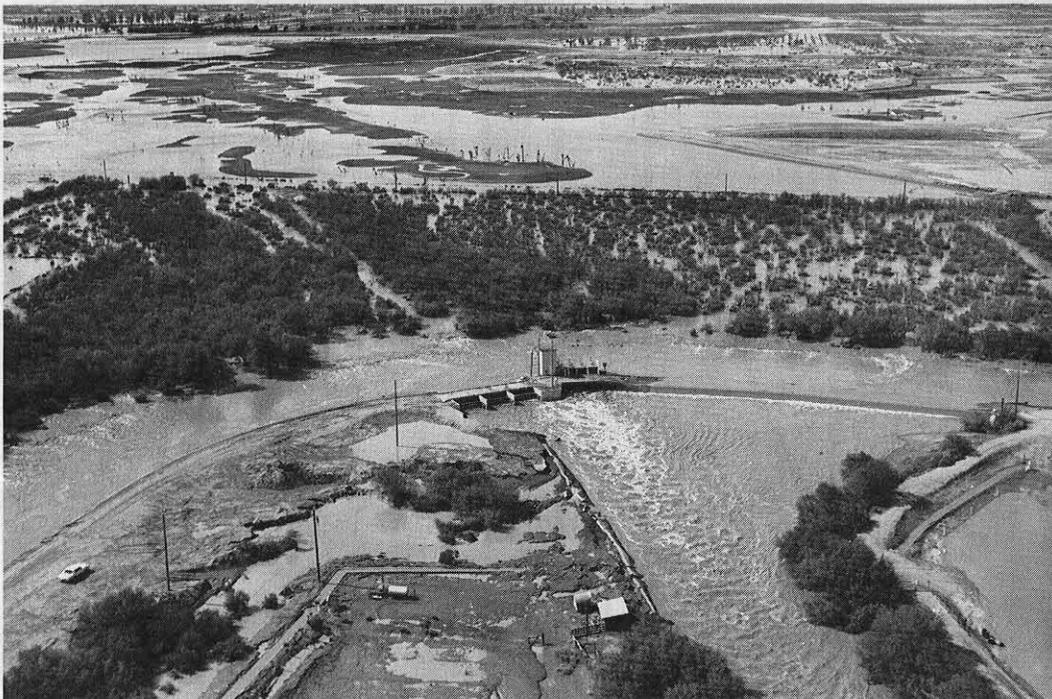
Floodwaters inundated the golf course above the Arizona Canal and overtopped the flood gates and spillway on the canal.

c. Damages to parks and recreation areas. A golf course in the wash north of Indian Bend Road was flooded by muddy waters ranging from 1 to 4 feet in depth. The turf in the fairway was damaged and silt was deposited in the lakes on the course. Total estimated damages are \$152,000.

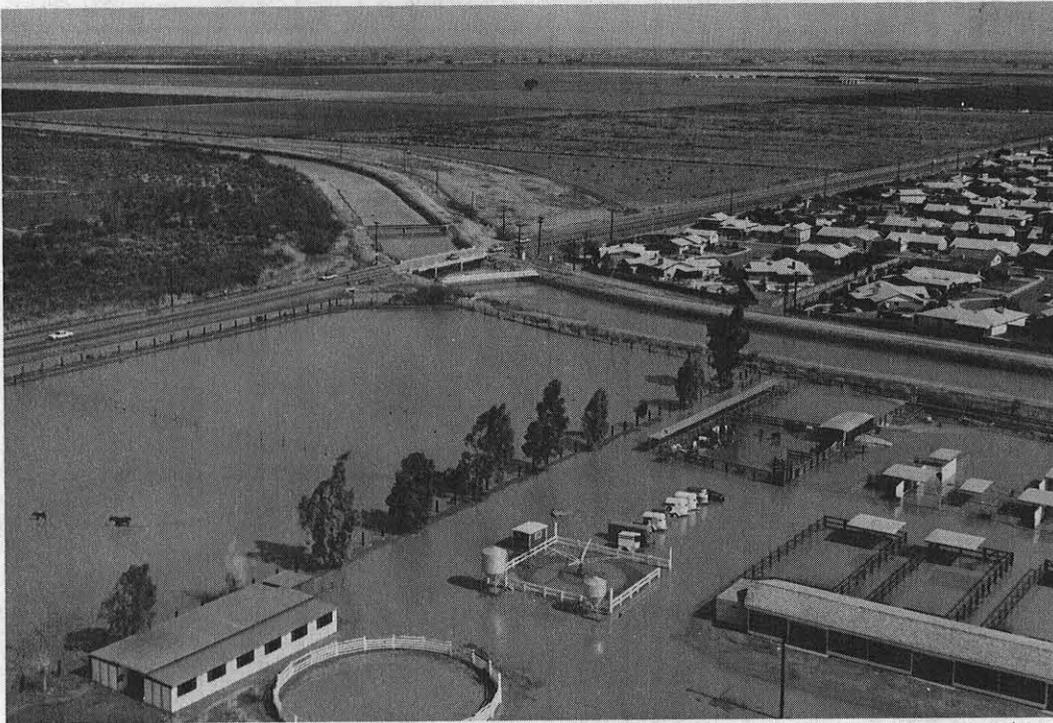
③ ✓

d. Damages to agricultural property. Five ranches above the Arizona Canal were damaged when floodwaters ranging in depth from 1 to 2 feet deposited silt and debris on the land. A horse-riding ranch south of Indian Bend Road was covered with silt and debris. The total damages to agricultural property were about \$29,000.

Horses wade through knee-deep floodwaters on a farm near Arizona Canal and Pima Road.

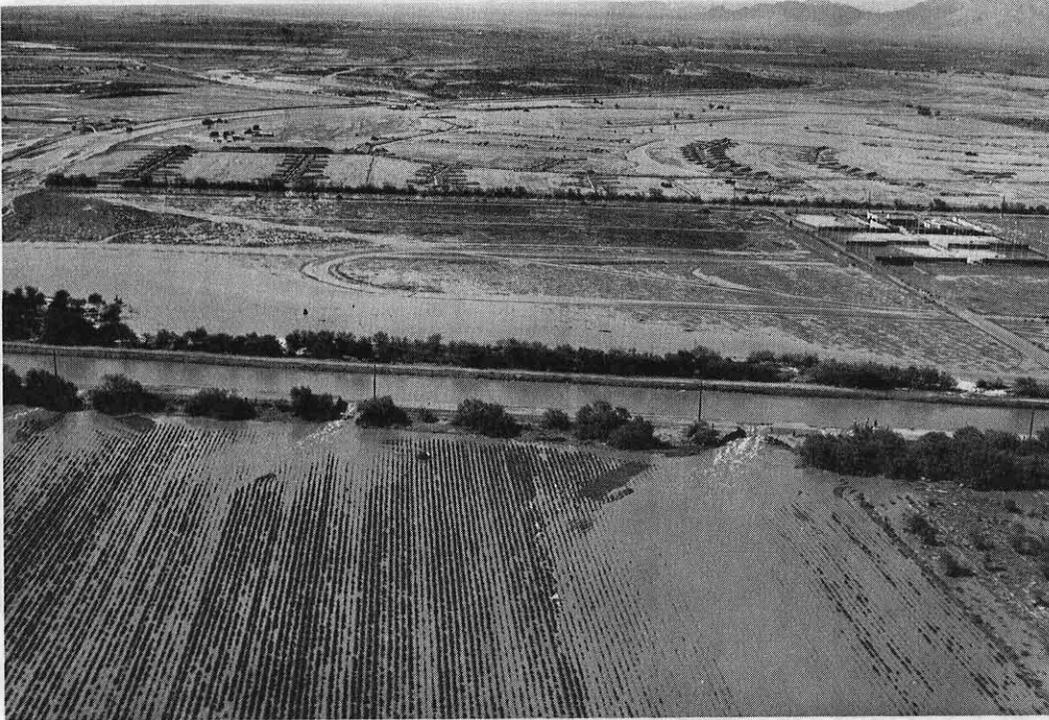
Floodwaters escaping through breaks in the south bank of the Arizona Canal damaged a farm below the canal.

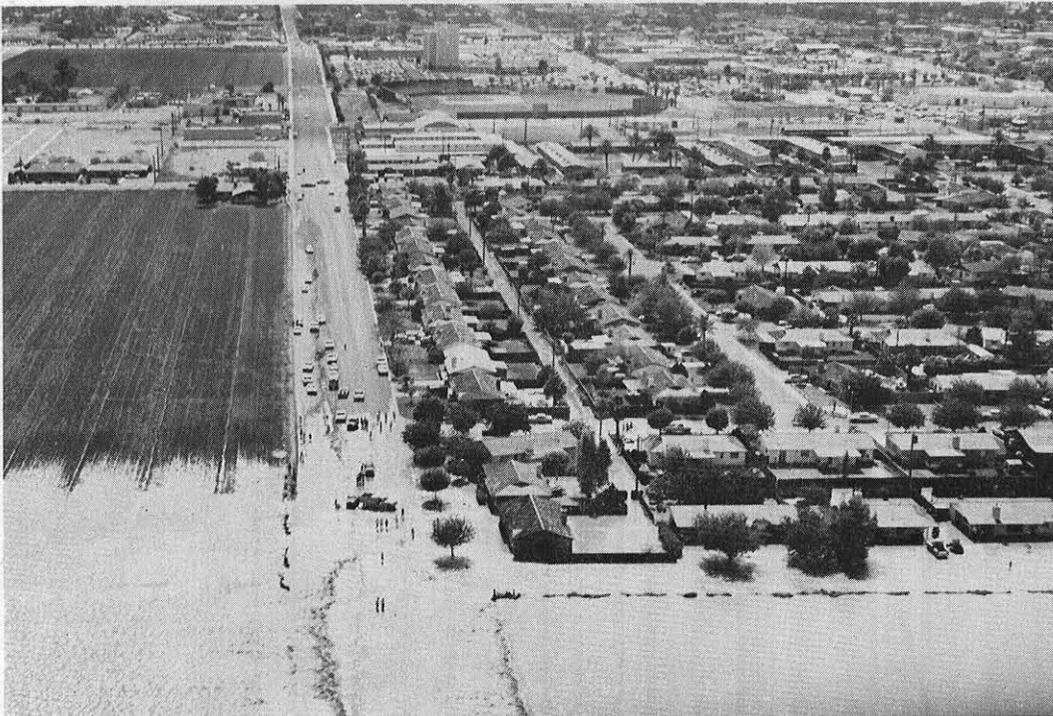
Persons on Osborn Rd. view the damages caused by floodwaters from Indian Bend Wash which inundated a farm and several homes in the area.

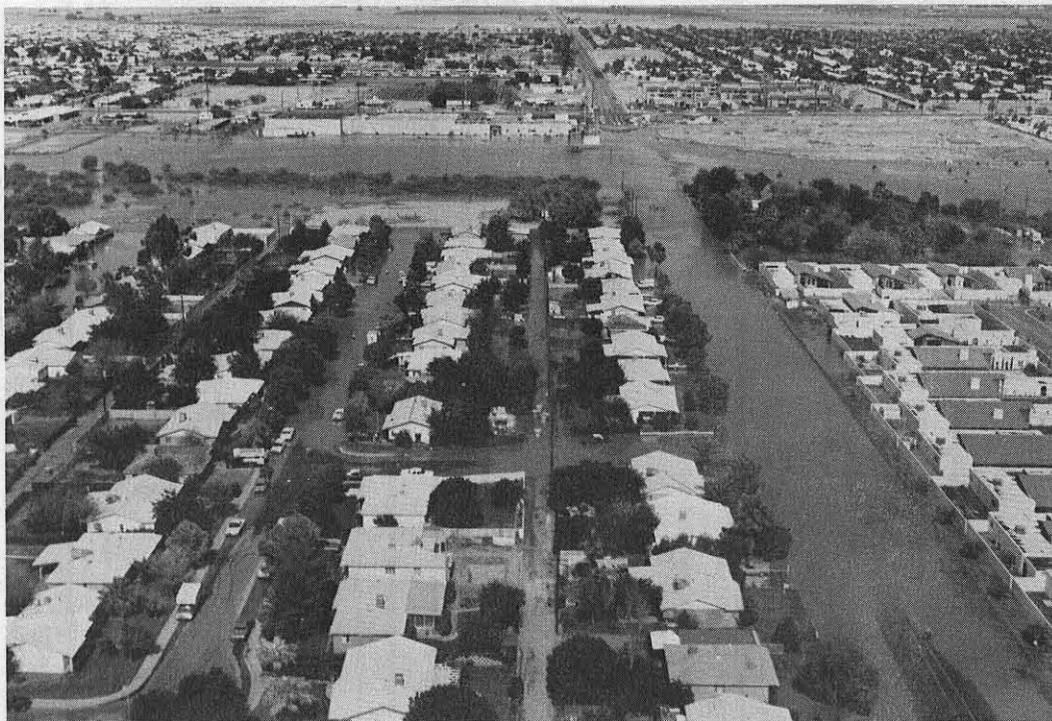
Floodwaters from Indian Bend Wash inundated homes, yards, and streets to the left of Thomas Road.

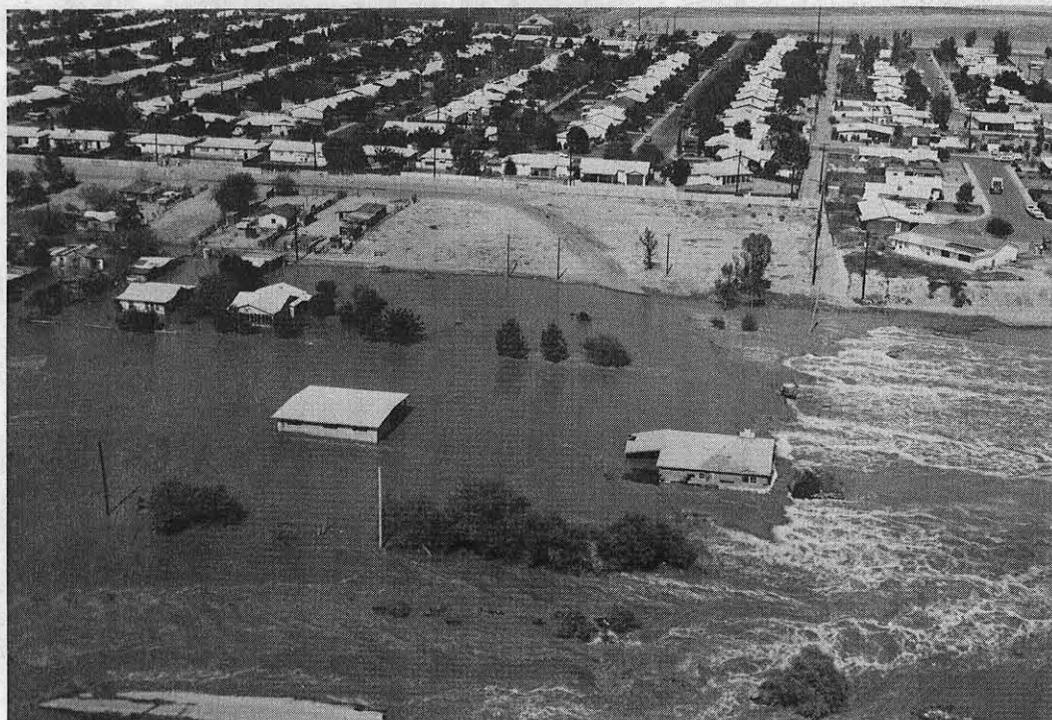
Roofs of these condemned homes became islands when Indian Bend Wash flooded west of McDowell Road.

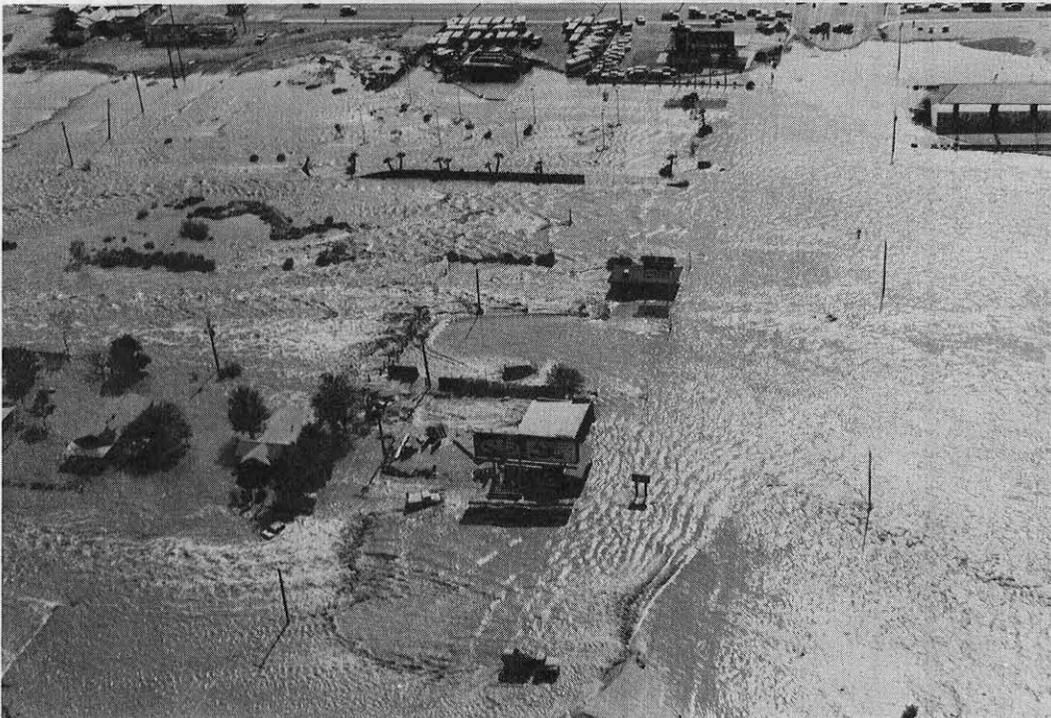
Commercial establishments on McDowell Road in Indian Bend Wash were flooded.

b. Damages to commercial property. Floodwaters exceeded the capacity of the wash and inundated and deposited debris and silt on the grounds of two gas stations, a pizza parlor, and a drive-in on the corner of Hayden Road and Indian School Road. Water depths at the above location ranged from 6 inches to 2 feet. Floodwaters also exceeded the capacity of the wash at McDowell Road, damaging landscaping and contents of a used car dealership, an electrical contractor shop, a cocktail bar, and a trailer sales establishment. Also a gas station on McDowell Road has silt deposited on the grounds. Water depths here ranged from 8 inches to 1-1/2 feet. Above McKellips Road at Pierce Street, a plating business was physically damaged and a restaurant suffered business losses. In summary, 11 commercial establishments were damaged in the amount of about \$186,000, of which \$169,000 were business losses and emergency costs.

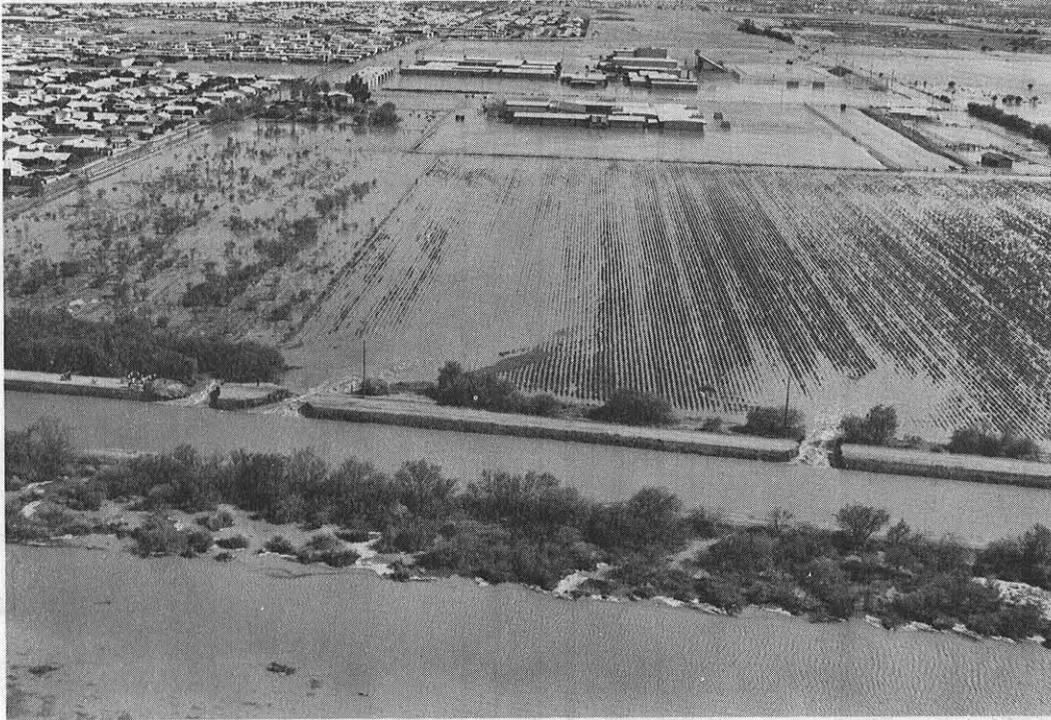
These breaks in the Arizona Canal enabled floodwaters to damage an elementary school, a high school, and some farmland.

i. Damages to irrigation works. The floodwaters overtopped the Arizona Canal where it intersects Indian Bend Wash, causing numerous breaks east of the wash on the south bank of the canal. The spillway at this intersection was also overtopped. Repairs to the Arizona Canal consisted of restoring the various washouts; rebuilding the roads and bank; and redigging and leveling the pump ditch. The total damages to the irrigation works were about \$35,000.

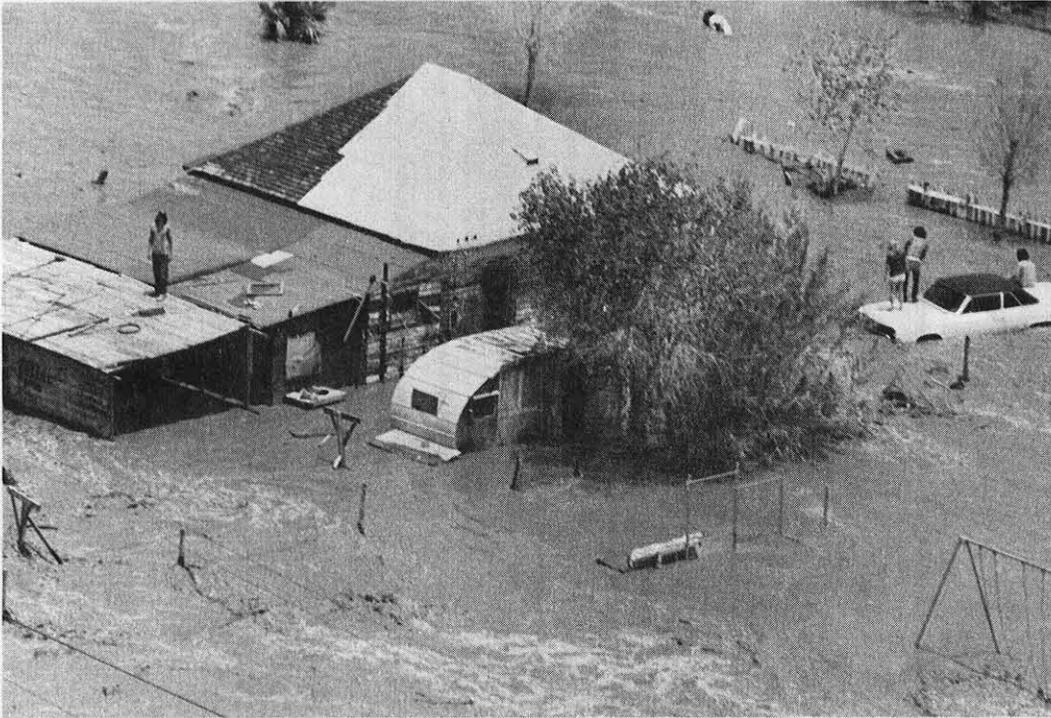
a. Damages to residential property. Damages to residential property occurred when the floodwaters exceeded the capacity of the wash at 78th Street and inundated areas north of Osborn Road and Thomas Road. Floodwaters in this area damaged 128 homes ranging in value from \$25,000 to \$35,000. The water depth in the homes ranged from a few inches to over 2 feet. About 30 homes south of McDowell Road were also inundated. Although these homes had been condemned and relocation was in progress, many of the homes were still occupied. When the flood occurred, these residents had to be rescued. A few other houses scattered along the wash sustained damages. In summary, about 160 homes sustained flood damages. Included under this category also are the funds expended by the American Red Cross and the Arizona National Guard for the care and rescue of the flood victims during the flood, particularly the flood victims south of McDowell Road. The total damages to residential property were about \$211,000.

Floodwaters in Indian Bend Wash forced these residents below McDowell Rd. to seek safety on the car and the roof of the house.

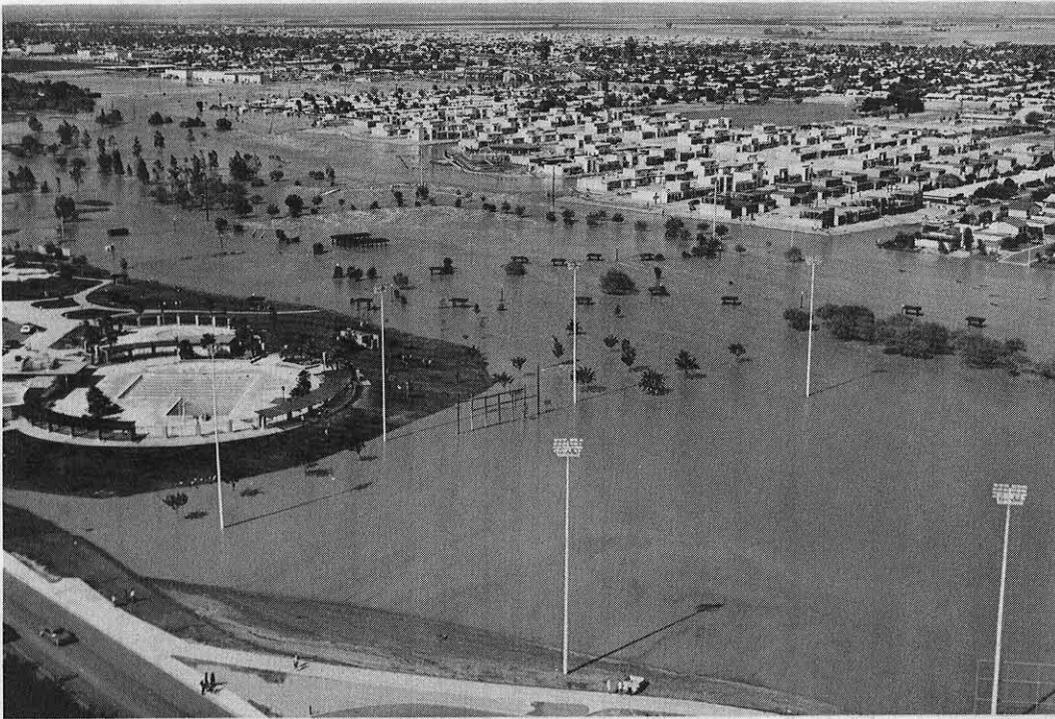
Floodwaters over 4 feet deep make the trees in El Dorado Park at Oak Street look like shrubs.

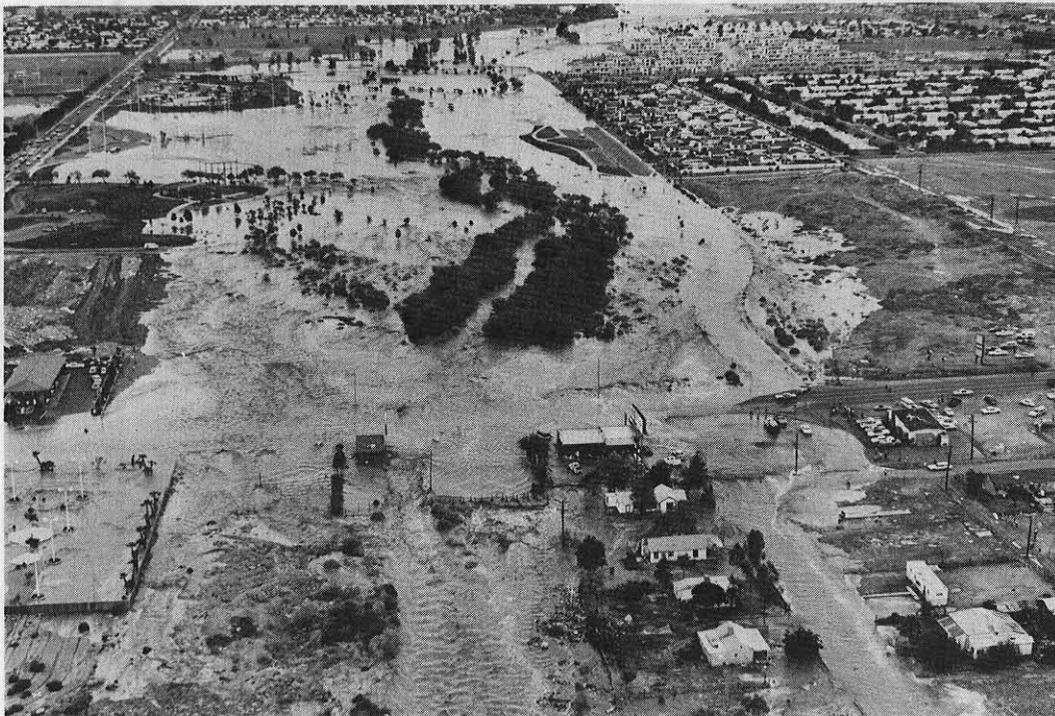
d. Damages to parks and recreation areas. A subdivision golf course on Indian School Road was inundated. In a greenbelt area, the flood damaged one golf course on Chaparral Road, two golf courses south of Thomas Road, a park on Oak Street, and another park on Roosevelt Road; damages consisted of silt deposition on the grounds and damages to the landscape. Water depth ranged from 3 to 5 feet with velocities ranging from 4 to 7 f.p.s. Total estimated damages to the greenbelt area were \$135,000.

Another view of El Dorado Park looking north from Mc Dowell Road.

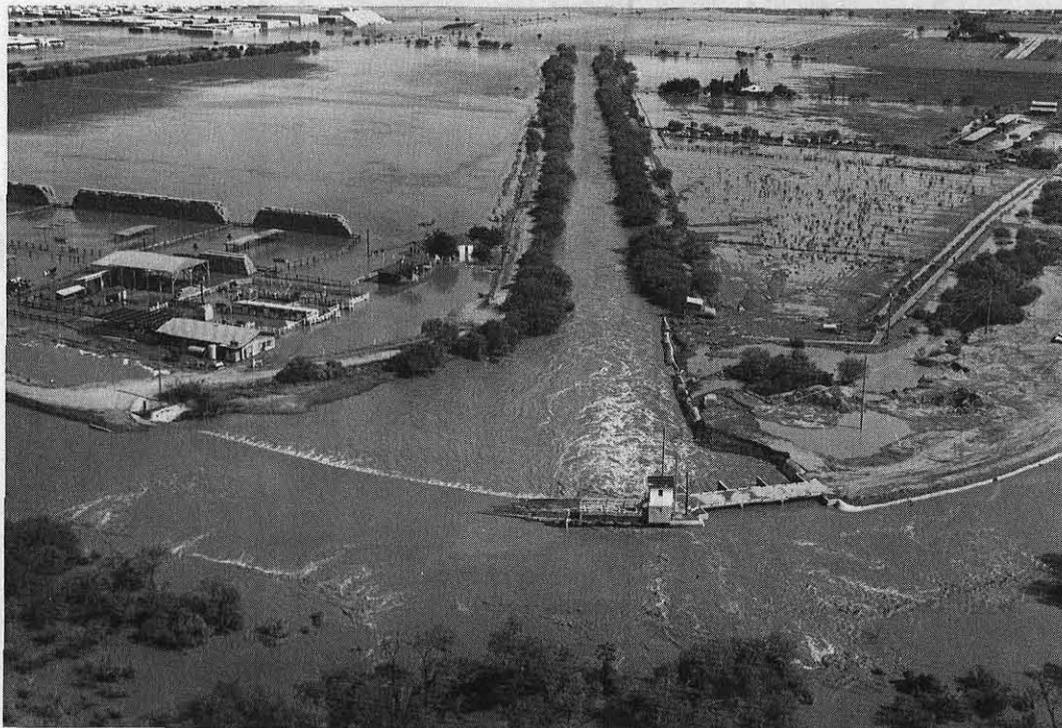
At the intersection of the Arizona Canal and Indian Bend Wash floodwaters damaged agricultural property and a dairy farm.

e. Damages to agricultural property. Several farms were flooded. At the intersection of the Arizona Canal and Indian Bend Wash, dairy farm equipment and contents downstream from the south bank of the canal were inundated to a depth of about 3-1/2 feet. Floodwaters ranging in depth from 2 to 4 feet also damaged the contents of two farms east of the Arizona Canal between Indian School Road and McDonald Road. Other flooded farms include three farms east of the canal near McDonald Road (cleanup of silt deposition); a farm south of the canal next to the Pueblo Elementary School (damage to contents); one at Camelback Road (cleanup of silt deposition); one at Indian School Road (damage to contents); and two farms near Thomas Road (cleanup of silt deposition). The estimated flood damages for these 11 farms amounted to \$87,000.

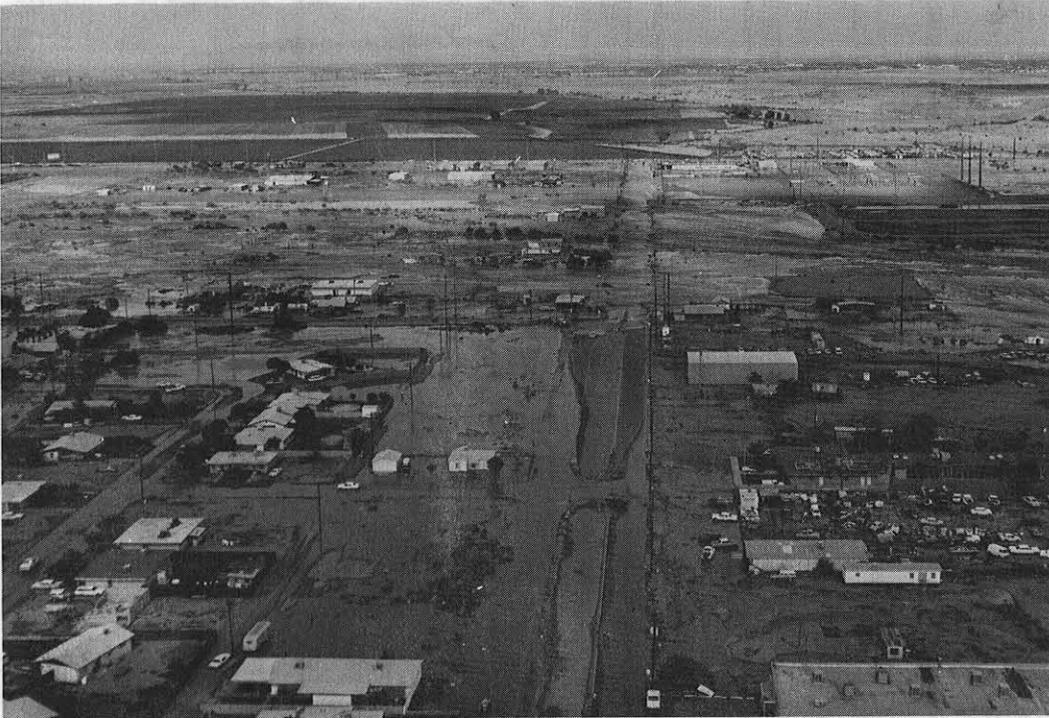
14 ✓

a. Damages to residential property. Residential property was damaged when floodwaters exceeded the capacity of the wash in the general area bounded on the north by McKellips Road, on the south by Princess Drive, on the west by Scottsdale Road, and on the east by Miller Road. Damages occurred to 52 homes when floodwaters ranging in depth from a few inches to 2 feet entered the homes and damaged carpets and contents. The depth of the floodwater inside the homes ranged from a few inches to a foot. Many houses whose foundations were about 1 foot above ground level suffered only yard damages. The value of the houses ranged from \$10,000 to \$20,000. Included in the damages in this category are the funds expended by the Arizona National Guard for the care and rescue of the flood victims during the flood. The total damages to residential property were about \$48,000.

These homes near Princess Drive in Tempe were inundated.

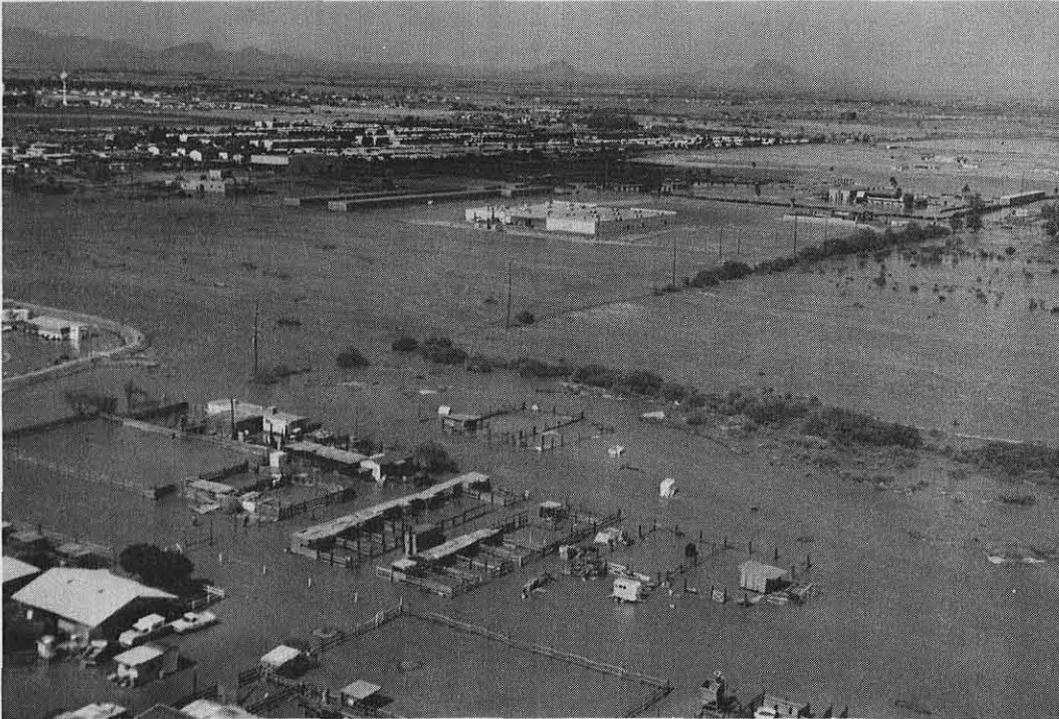
Indian Bend Wash was converted into a smooth plain of water damaging a farm near McKellips Road.

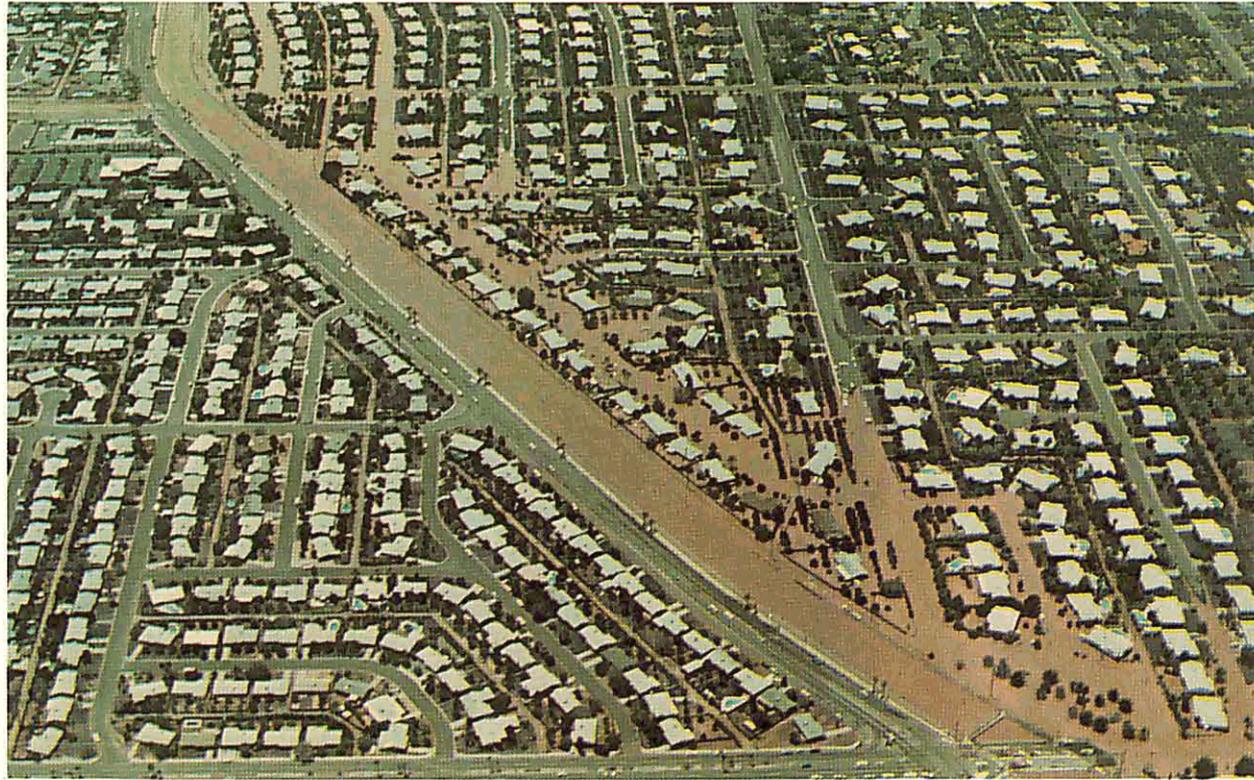
Residential property above the Arizona Canal in the vicinity of 68th Street in Scottsdale also was damaged by silt deposits.

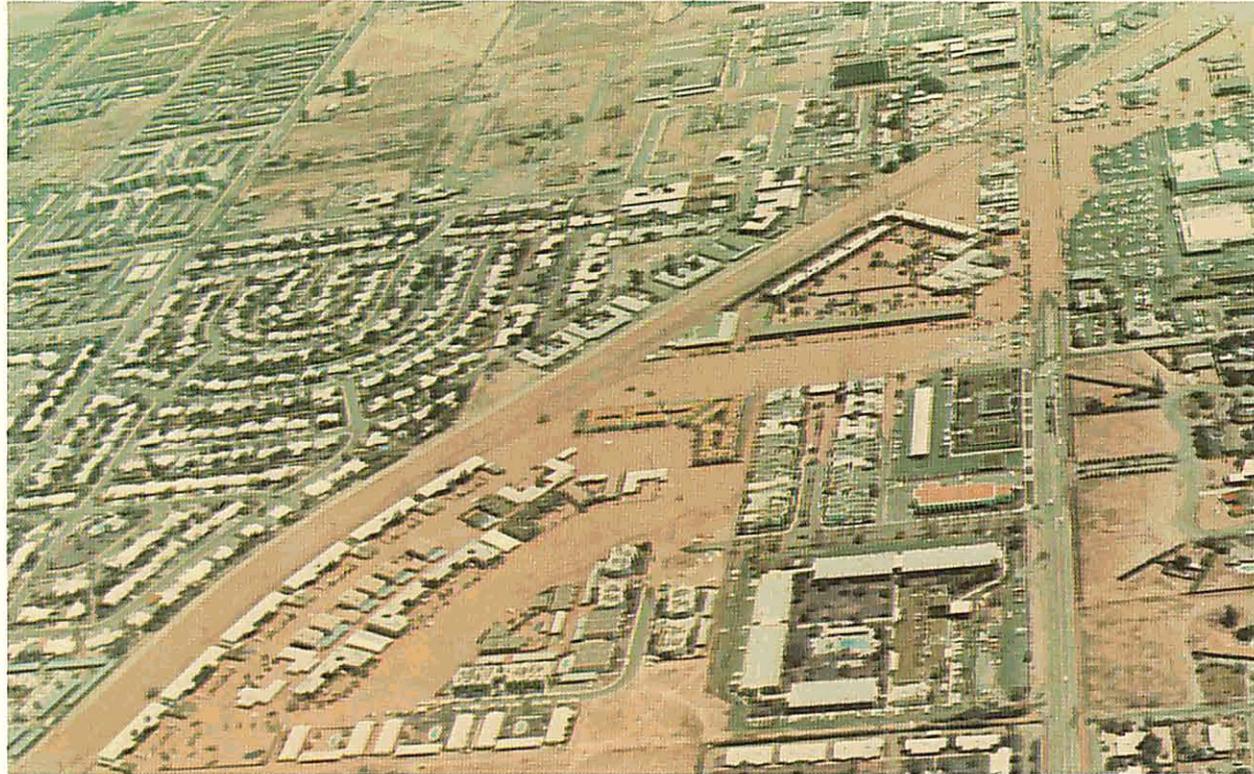
Commercial property above the Arizona Canal at Scottsdale and Camelback Roads in Scottsdale was inundated by floodwaters, silt, and debris.

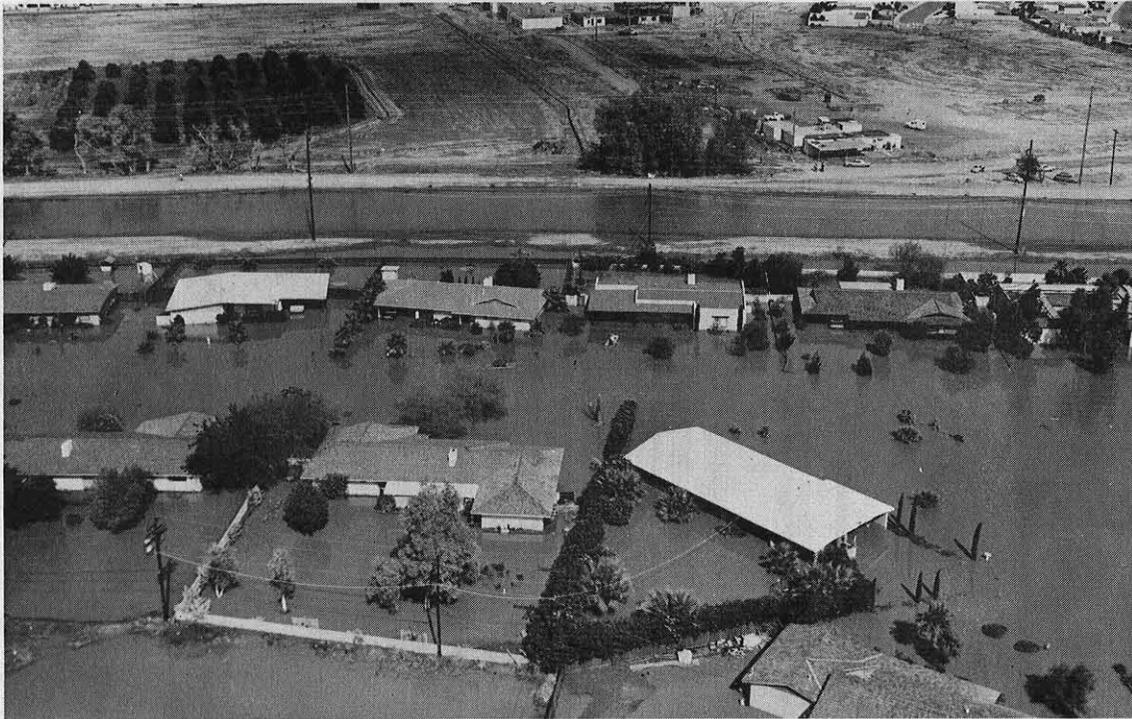
(17) ✓

a. Damages to residential property. Residential market values ranged from \$30,000 to \$60,000. Floodwaters from Indian Bend Wash, which carried large quantities of debris and silt, damaged carpets and furniture. Outside water depths ranged from 1-1/2 to 3-1/2 feet. The depths of floodwaters inside the damaged properties varied according to the efforts of the residents to keep the water out. Business losses of about \$96,000 consisted of time loss from work and the cost of temporary lodging. Total residential damages amounted to about \$804,000.

Rowboat navigates Woodmere Fairway when floodwaters 4-feet deep inundated a residential area above the Arizona Canal north of Camelback Road in Scottsdale.

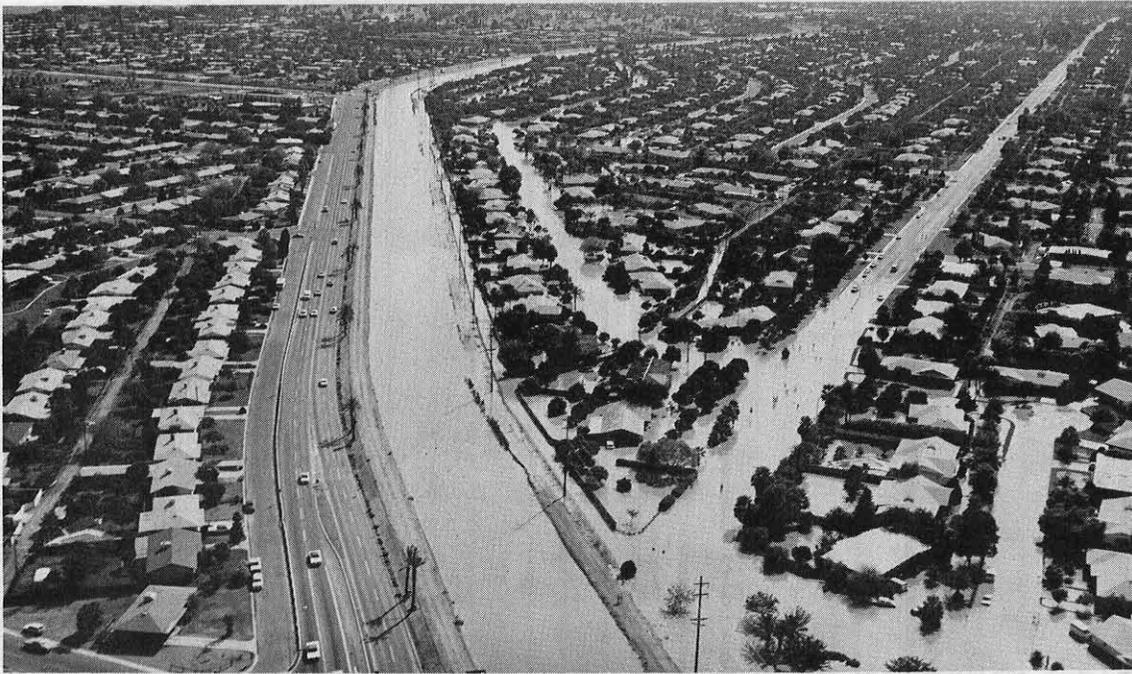
Muddy waters inundated these homes above the Arizona Canal along La Fayette Blvd. in Scottsdale.

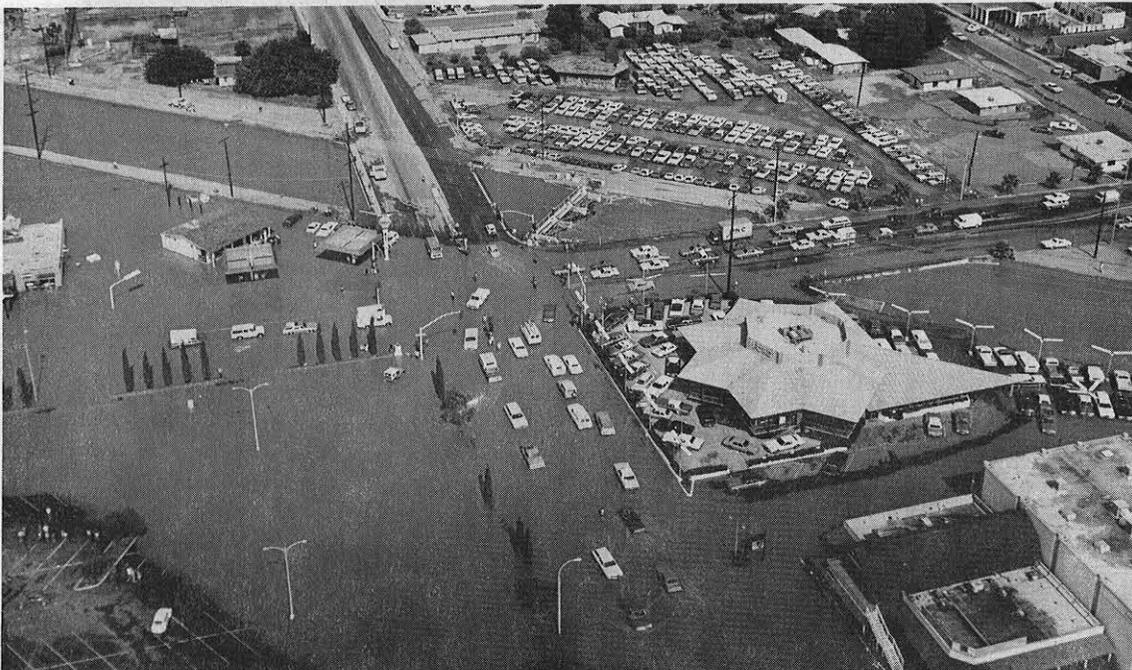
Car agency at Camelback and Scottsdale Roads in Scottsdale is surrounded by debris and silt-carrying waters that ponded above the Arizona Canal.

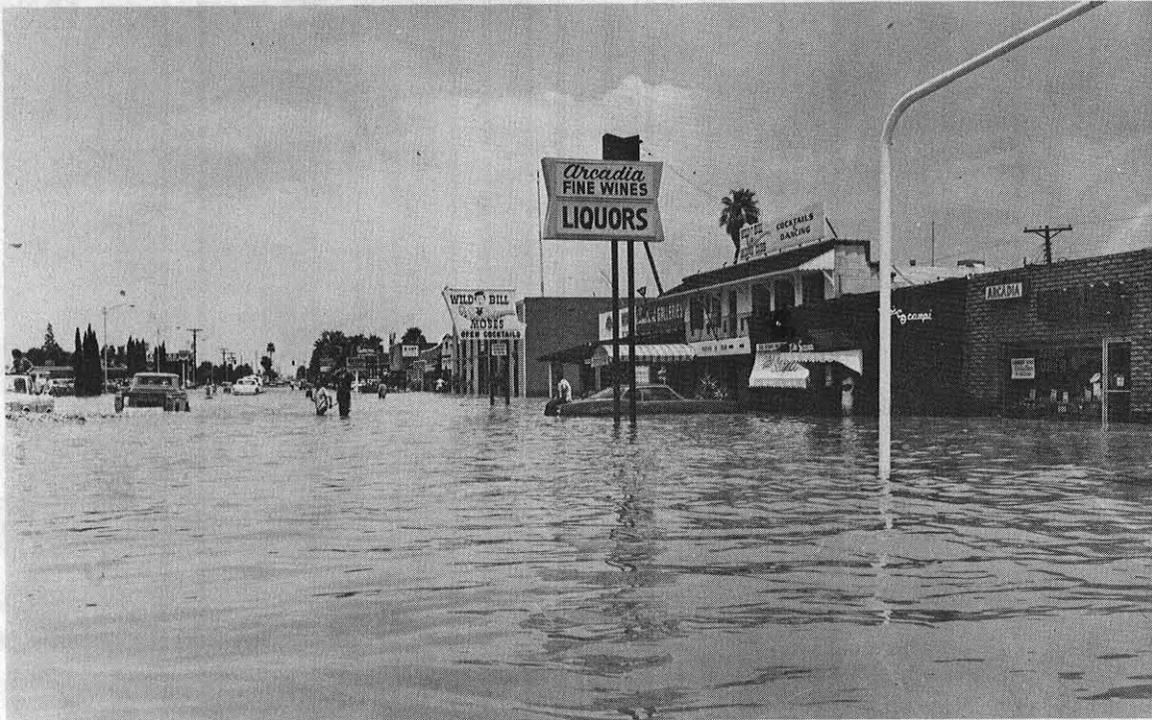
19✓

About 19 commercial establishments sustained flood damages east of Scottsdale Road and north of Camelback Road. The shopping center at Camelback and Scottsdale Roads also sustained flood damages.

Residents waded through hip-high floodwaters that swamped businesses on Scottsdale Road north of Camelback Road in Scottsdale.

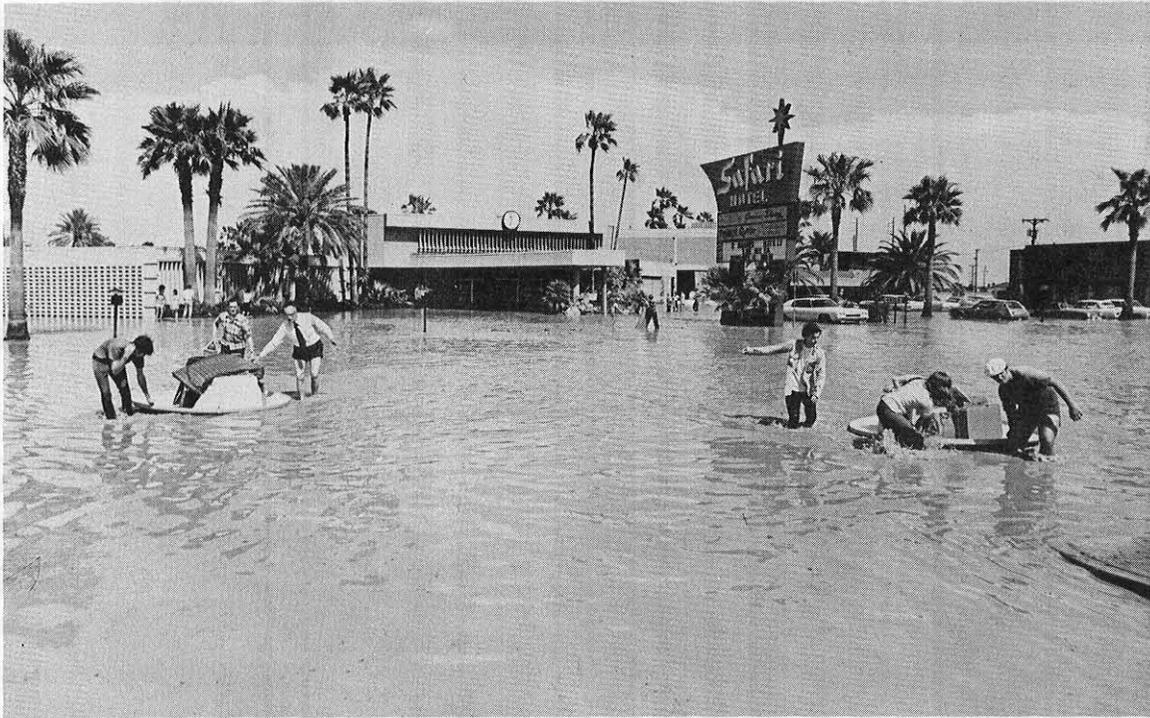
20

The largest commercial establishment damaged by floodwaters was the Safari Hotel complex, also at Scottsdale and Camelback Roads. Waters up to 3 feet were reported in the parking lots. Patrons in the hotel restaurant were in waters up to their knees. The estimated damages to commercial property totaled \$365,000.

Patrons resort to floating their luggage when floodwaters engulfed this hotel on Scottsdale Road north of Camelback Road in Scottsdale.
