U.S. ARMY CORPS OF ENGINEERS
LOS ANGELES DISTRICT

REPORT ON FLOOD OF 22 JUNE 1972
IN
PHOENIX METROPOLITAN AREA, ARIZONA

OCTOBER 1972

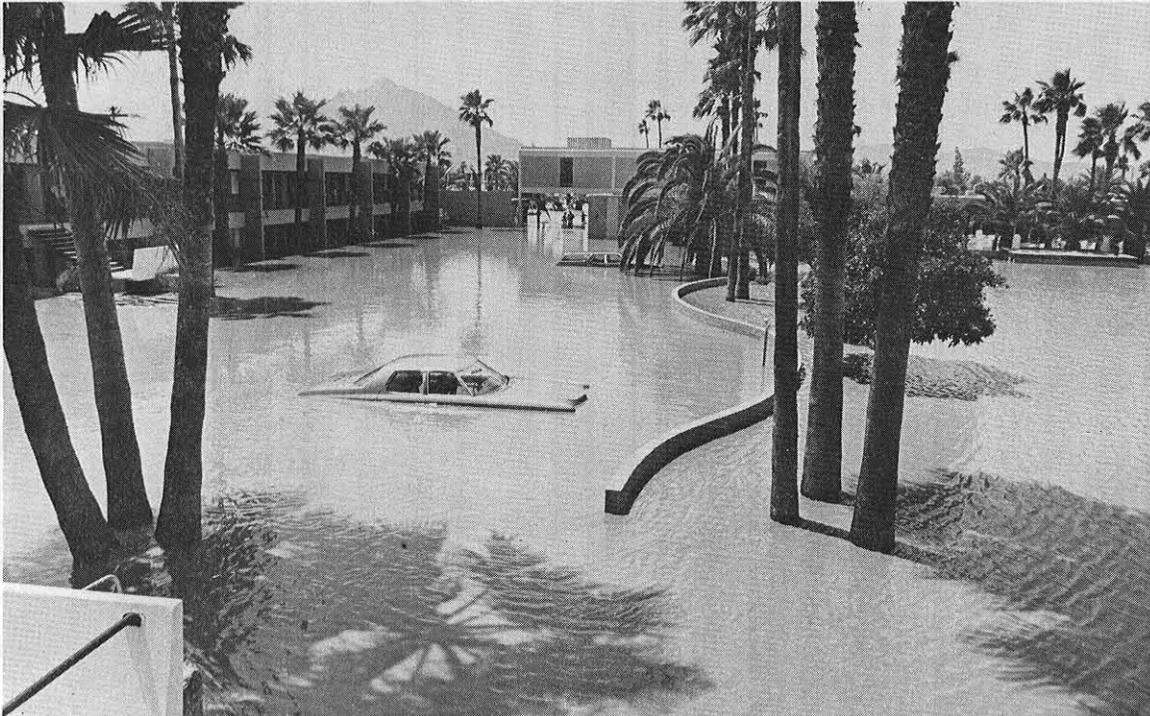
Automobiles are almost submerged in floodwaters that filled the interior patio of the same hotel in Scottsdale.

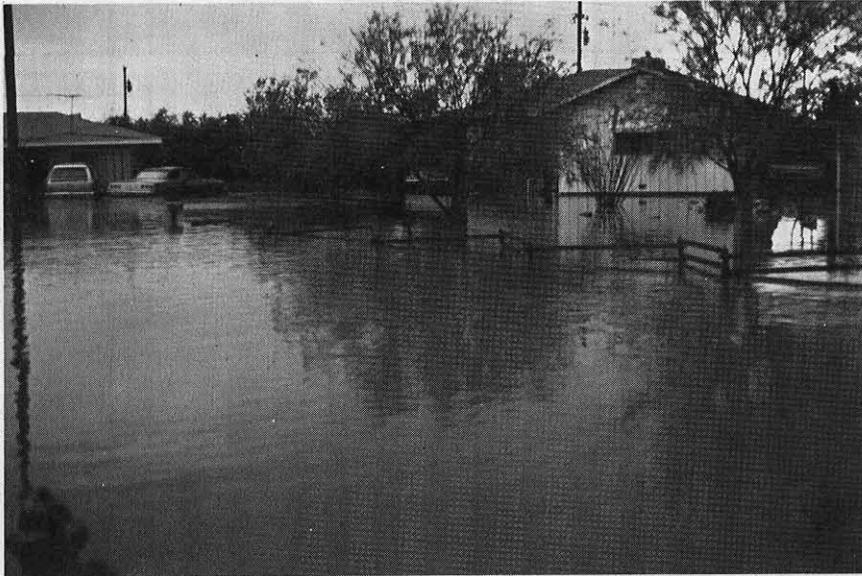
21

Another inundated home at 13th Street and Orangewood Avenue in Phoenix.

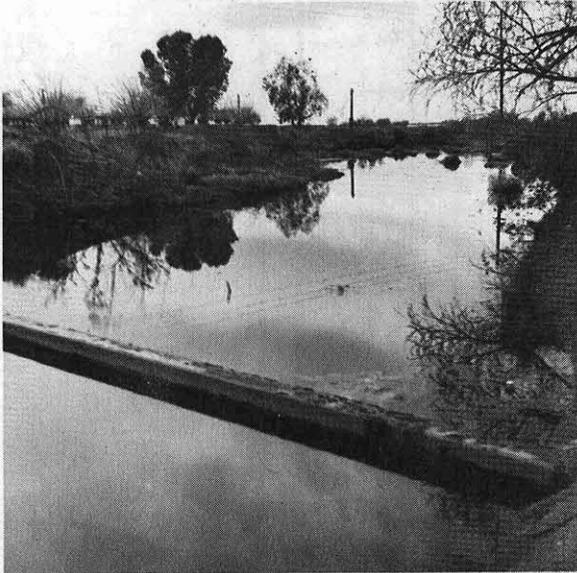
22

a. 23rd Avenue. At the junction of Cave Creek and the Arizona Canal near 23rd Avenue the floodwaters were confined in the creek. Floodwaters went over the spillway south of the canal, but caused no reported damage to a citrus grove below the spillway. The waters then flowed to Dunlap Avenue and were diverted into side streets and storm drains. Very little flooding occurred in this area because it was on the western fringe of the storm.

A view of the junction of Cave Creek and the Arizona Canal near 23rd Avenue in Phoenix.

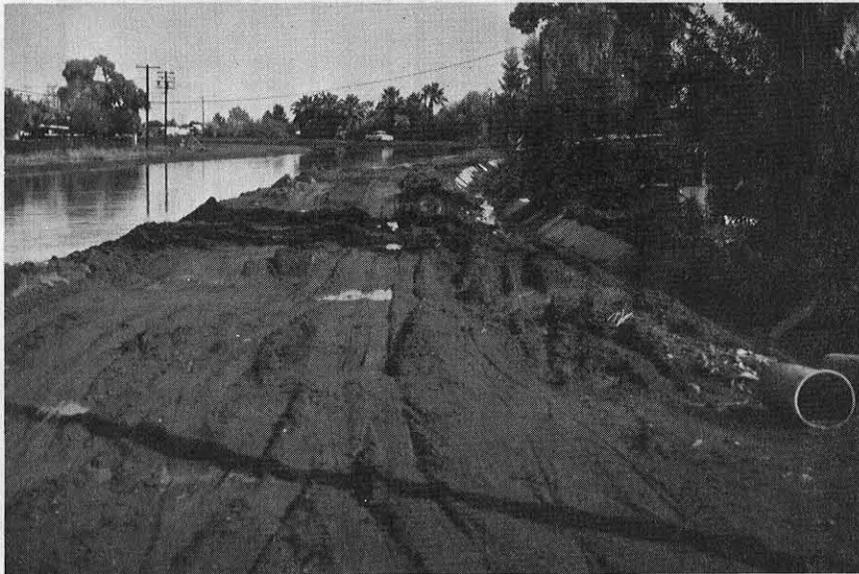
Repairs are started on the break in the Arizona Canal's south bank east of Central Avenue in Phoenix.

b. Central Avenue. The Arizona Canal was breached at the southeast corner of the Central Avenue crossing. (See pl. 15.) The water depth was about 4 feet immediately below the canal.

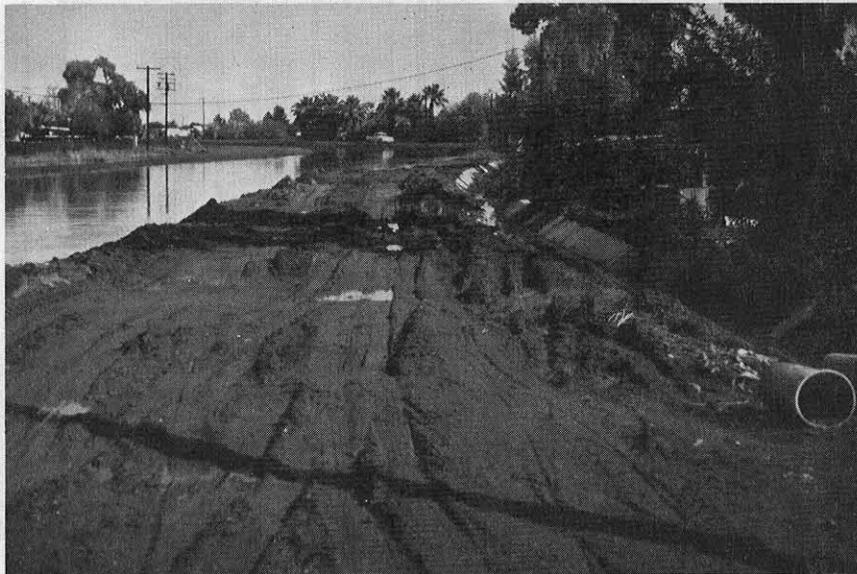
b. Central Avenue. The Arizona Canal was breached at the southeast corner of the Central Avenue crossing. (See pl. 15.) The water depth was about 4 feet immediately below the canal.

Repairs are started on the break in the Arizona Canal's south bank east of Central Avenue in Phoenix.

The total damages resulting from this break were estimated at \$315,000, the flooded area, amounting to 12 acres, is shown on pl. 15.

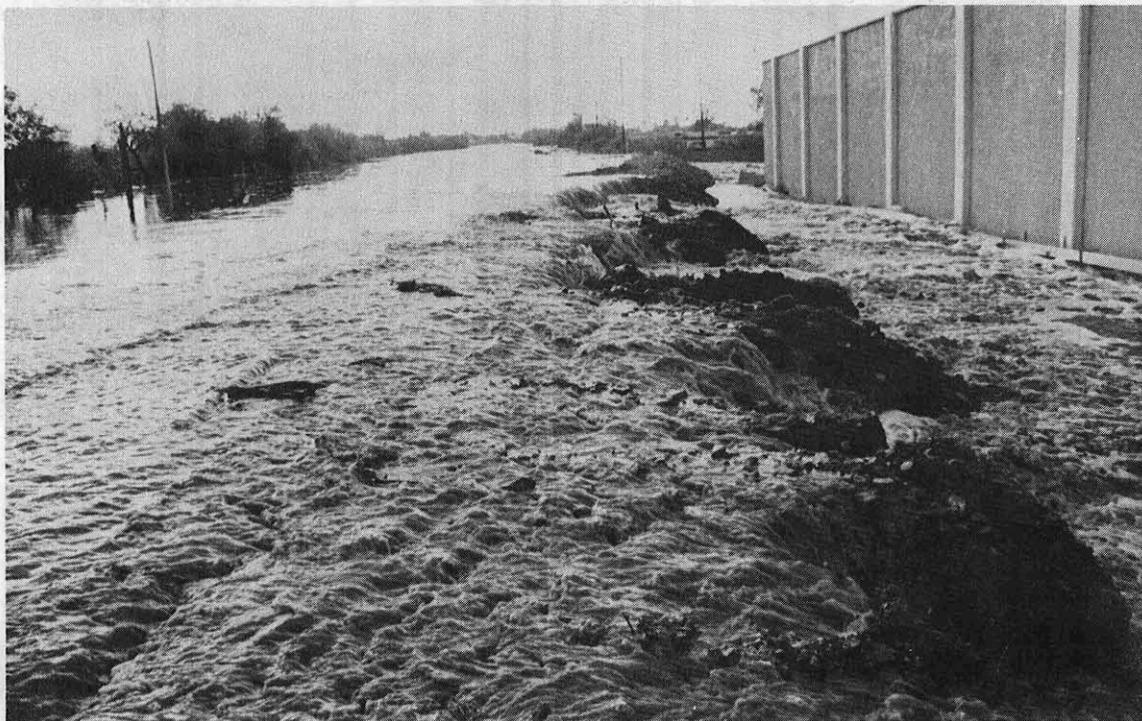
Floodwaters and debris gush over the top of the southern bank of the Arizona Canal east of 16th Street in Phoenix.

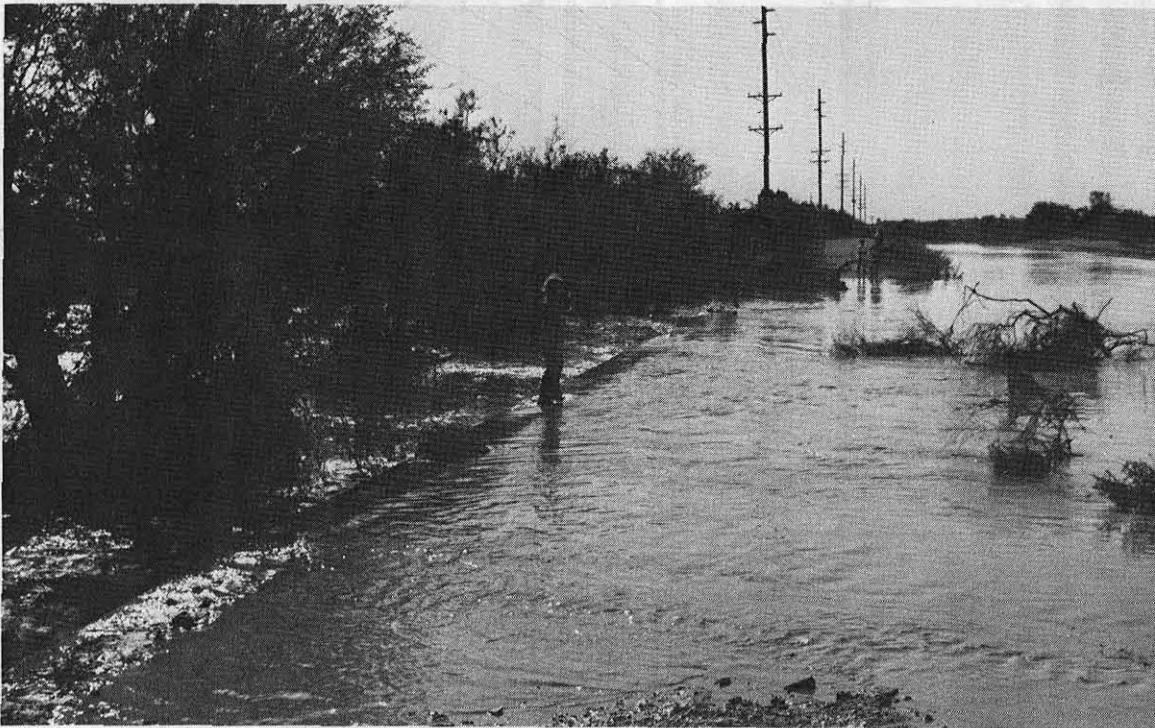
27

g. 32nd Street and 40th Street. The flooding in this area, amounting to 2,800 acres, resulted from local runoff caused by the thunderstorms centered at 24th Street and Camelback Road and from floodwaters gushing from spillways and breaks in the canal. Floodwaters caused breaks in the south bank of the canal at 30th Street and 40th Street and overtopped the spillways at 30th Street, 32nd Street, and 40th Street. (See pl. 19)

Children play in floodwaters that overtopped the Arizona Canal spillway on the south bank west of 40th Street in Phoenix.

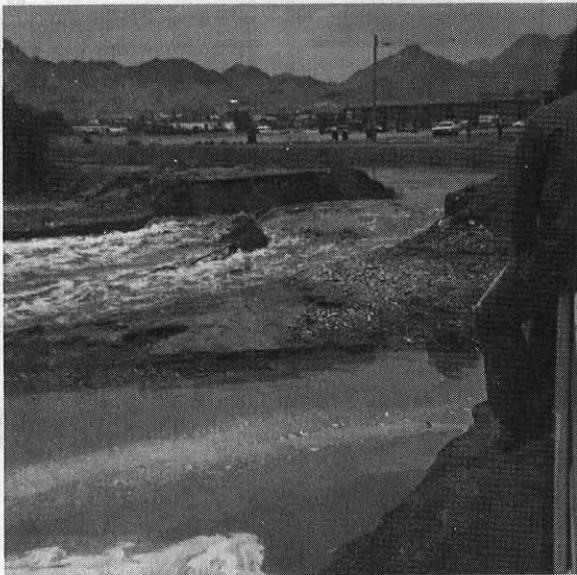
Floodwaters escape through a break in the Arizona Canal west of 40th Street in Phoenix.

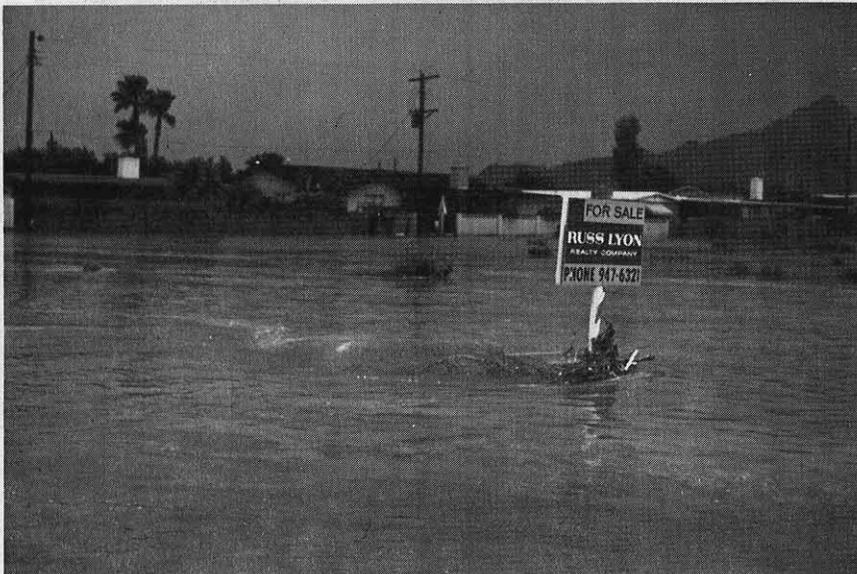
The floodwaters combined near 28th Street and Indian School Road, then spread out until the waters ponded along the Grand Canal. The overflow area of about 5 square miles, extended from the Arizona Canal on the north to the Grand Canal on the south, and from 40th Street on the east to 12th Street on the west. Camelback Road from 40th Street to 16th Street resembled a river. Outside water depths ranged from 4 feet near the breaks to 1-1/2 to 2 feet near the Grand Canal. The floodwaters wiped out block-wall fences and caused serious structural damages. Total damages in this area were estimated at \$3,768,000, 85 percent of which accrued to residential property.

Floodwaters inundate residences along 38th Place as shown in this view looking northwest from Camelback Road in Phoenix.

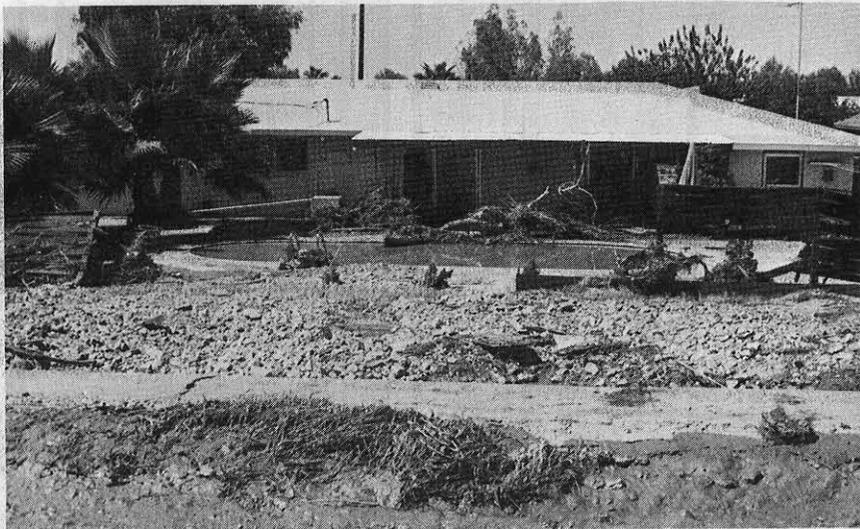
This house east of 32nd Street was severely damaged when floodwaters overtopped the spillway on the south bank of the Arizona Canal in Phoenix.

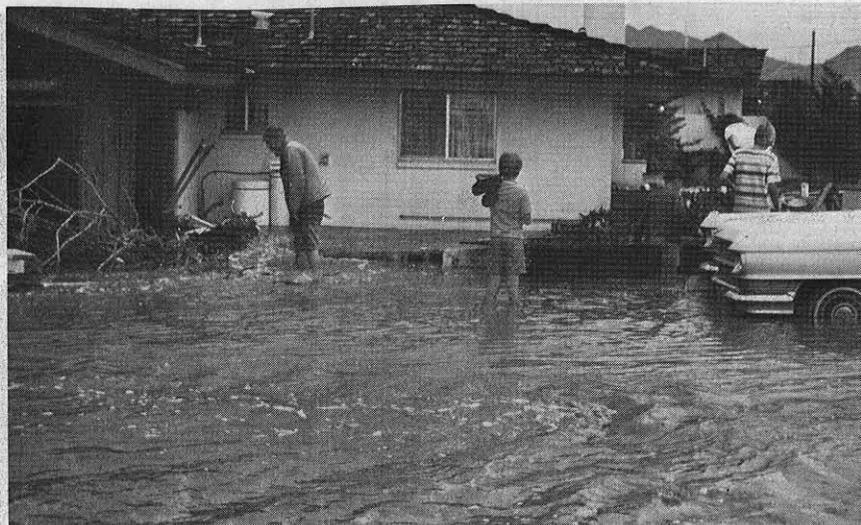
Homeowner on 38th Street and Camelback Road in Phoenix surveys damage from floodwaters and debris.

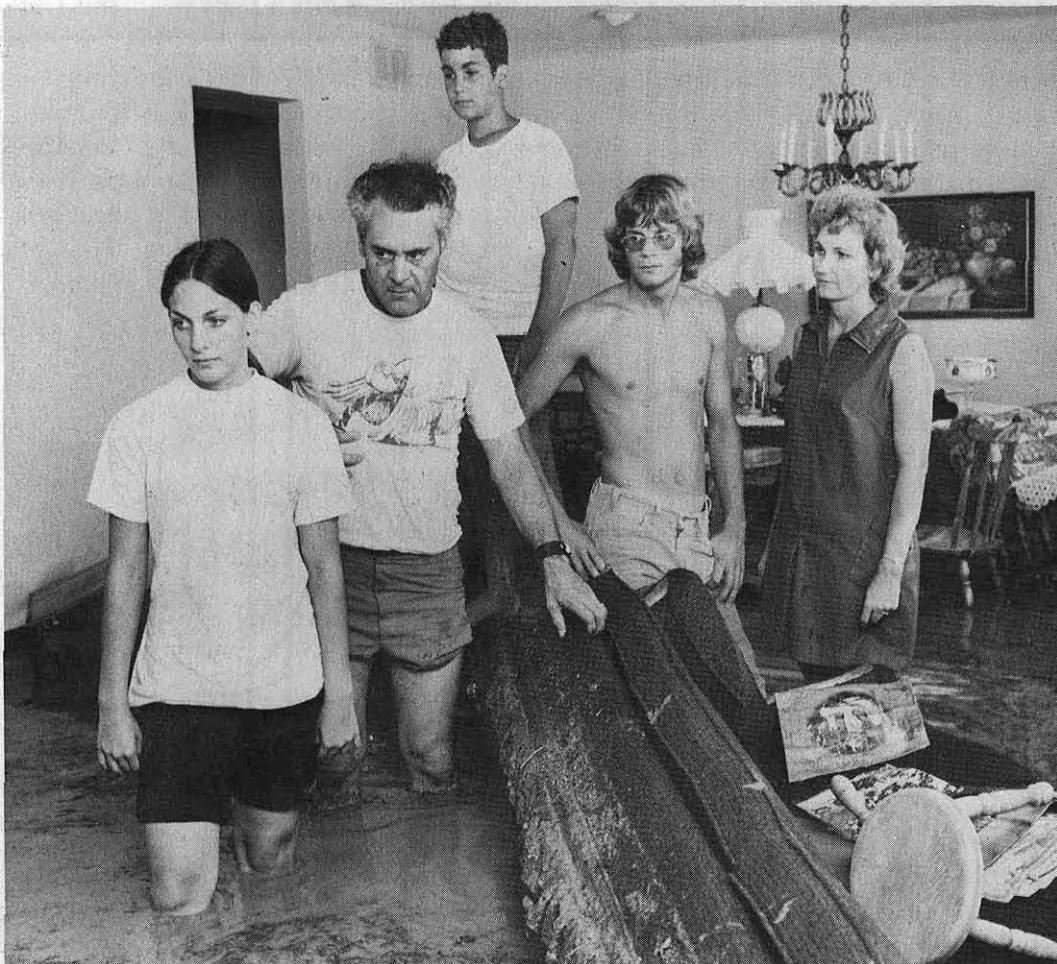
130

This family stands disconsolate in knee-deep floodwaters that entered their home at 38th Place and Camelback Road in Phoenix.

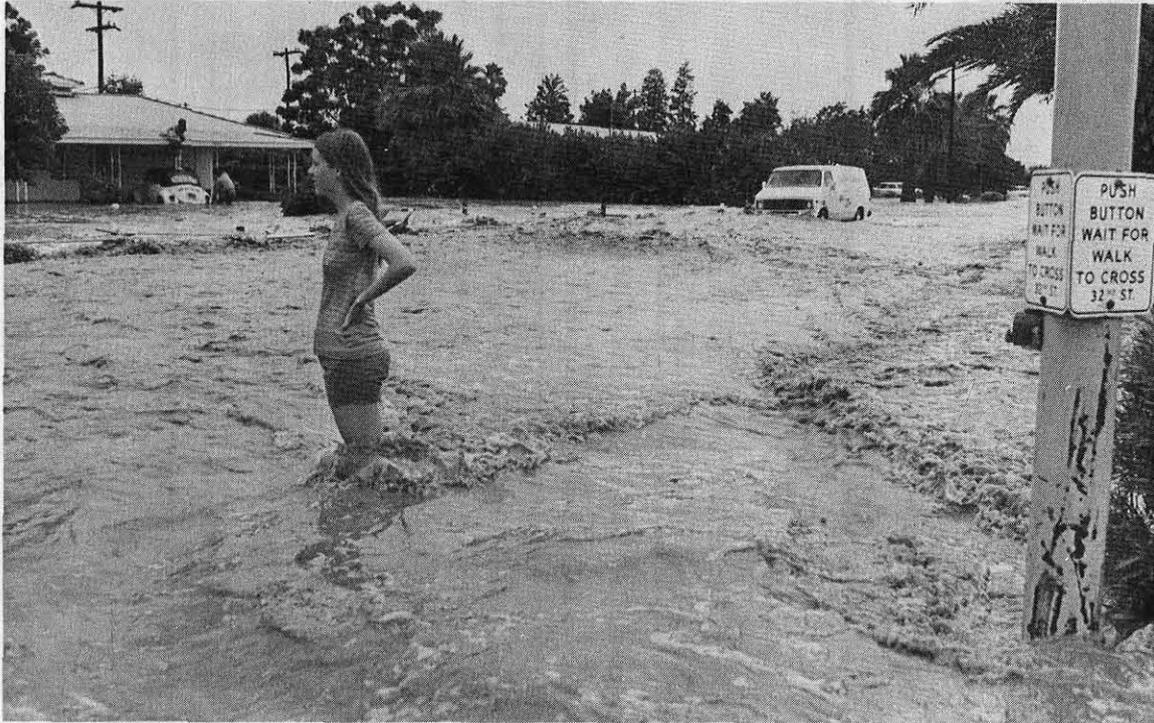
31

(5) Damages to streets, roads and bridges. Physical damages to streets and roads were negligible. Included in this category are damages for loss of time due to the additional traveling and delays experienced by residents. The total damages to streets and roads were about \$200,000.

Young girl experiences difficulty crossing the intersection of 32nd Street and Campbell Avenue in Phoenix.

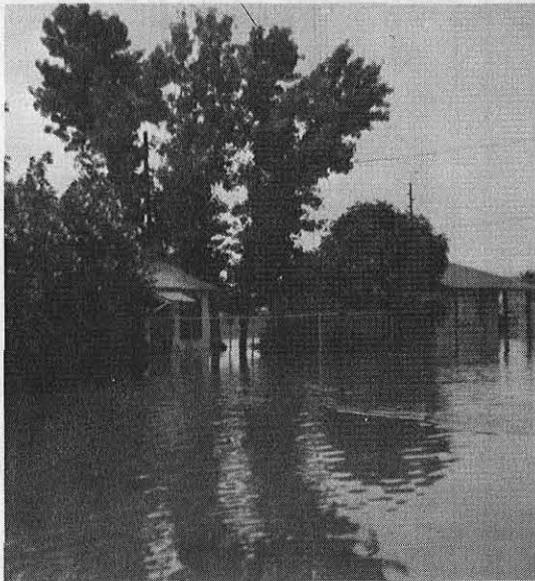
a. Damages to residential property. The flooded area is predominantly residential, characterized by single-family homes ranging in value from \$7,000 to \$25,000. Small 10- to 20-unit apartments are scattered throughout the flooded area, with two major apartment complexes on 12th Street. There were extensive flood damages to residential properties throughout the area. The damages ranged from \$500 to \$2,000 per home. The major items damaged were carpets, drapes, furniture, and the flooring. In two houses constructed with plaster-covered adobe bricks, the walls completely disintegrated. Damages to 510 residential units in the area extending from 15th Avenue to Indian School Road were about \$1,043,000. Damage to 90 units in the area extending from 24th to 44th Streets amounted to \$111,000. Also included in this category are the costs incurred by the American Red Cross. Flood damages to residential property, totaled about \$1,154,000.

Muddy waters almost reach the windows of homes above the Grand Canal east of 7th Street in Phoenix.

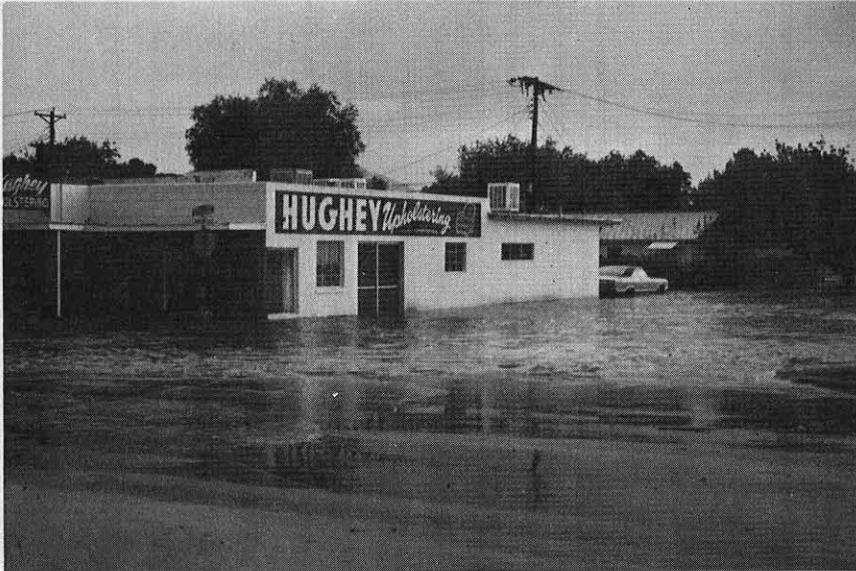
38

b. Damages to commercial property. Businesses, which predominate along 7th Avenue and Central Avenue, were subjected to flooding. Floodwaters inundated 30 commercial stores resulting in damages to contents and business losses totaling about \$441,000.

An upholstering business above the Grand Canal at Cambridge Avenue and 24th Street in Phoenix is flooded.

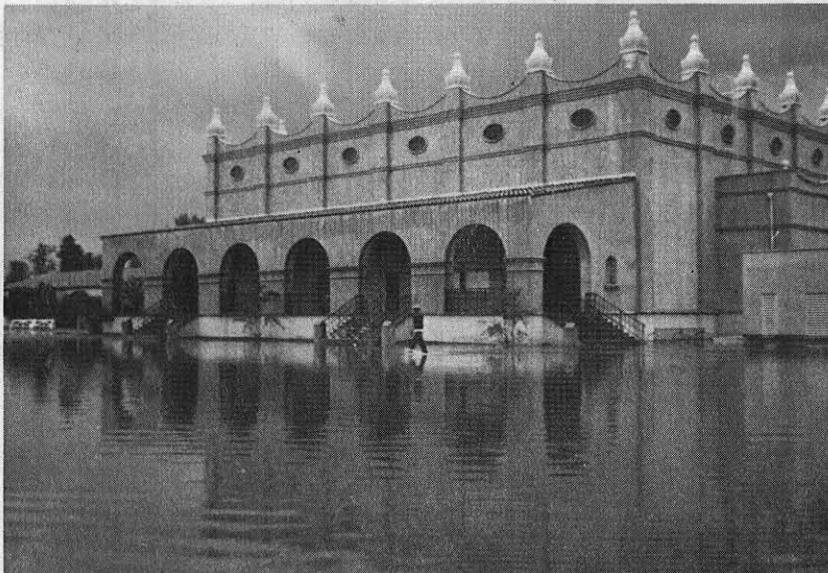
c. Damages to public property. Floodwaters, overtopping the north bank of the Grand Canal, caused extensive damages to the contents and landscape of two parochial schools on Central Avenue. Water depths of 2 feet occurred in the area.

The Brophy College gymnasium building above the Grand Canal east of Central Avenue in Phoenix is engulfed by floodwaters.

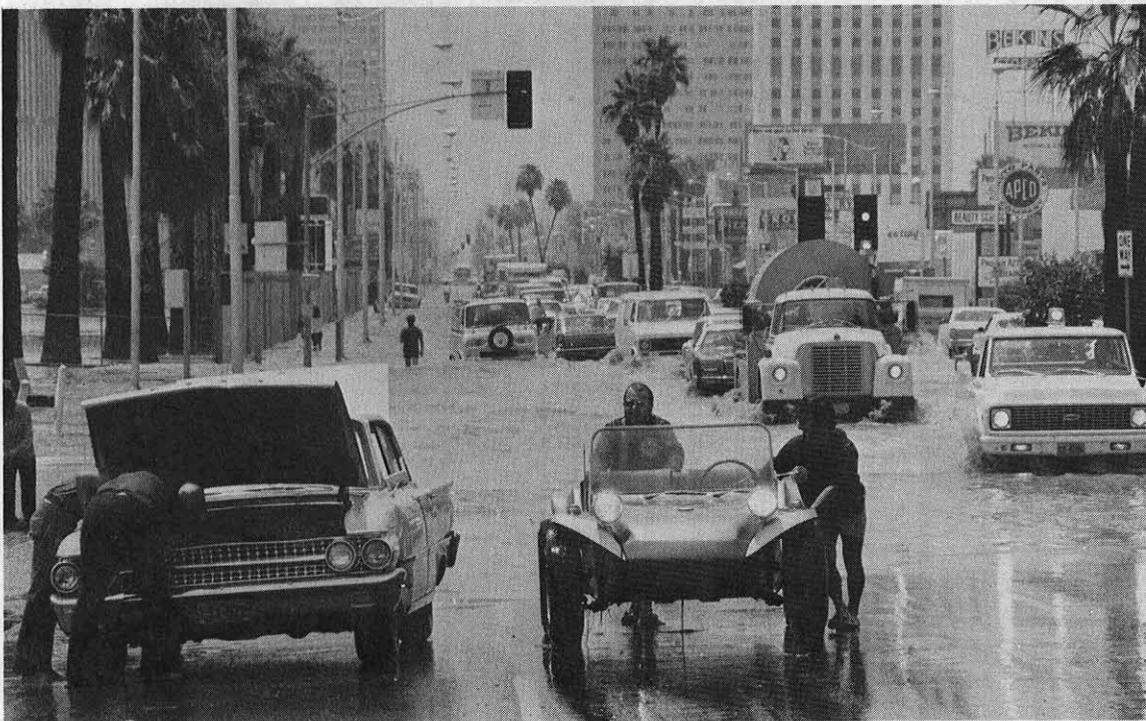
341

(4) Damages to streets, roads, and bridges. No major physical damage occurred to Central Avenue below the Grand Canal. Traffic control and delays to numerous motorists were problems in this heavily trafficked avenue. Included as emergency cost is the cost of the delays and the traffic control. The total damages to streets, roads, and bridges were about \$201,000.

Motorists endure stalled automobiles and traffic delays on Central Avenue near Indian School Road in Phoenix.

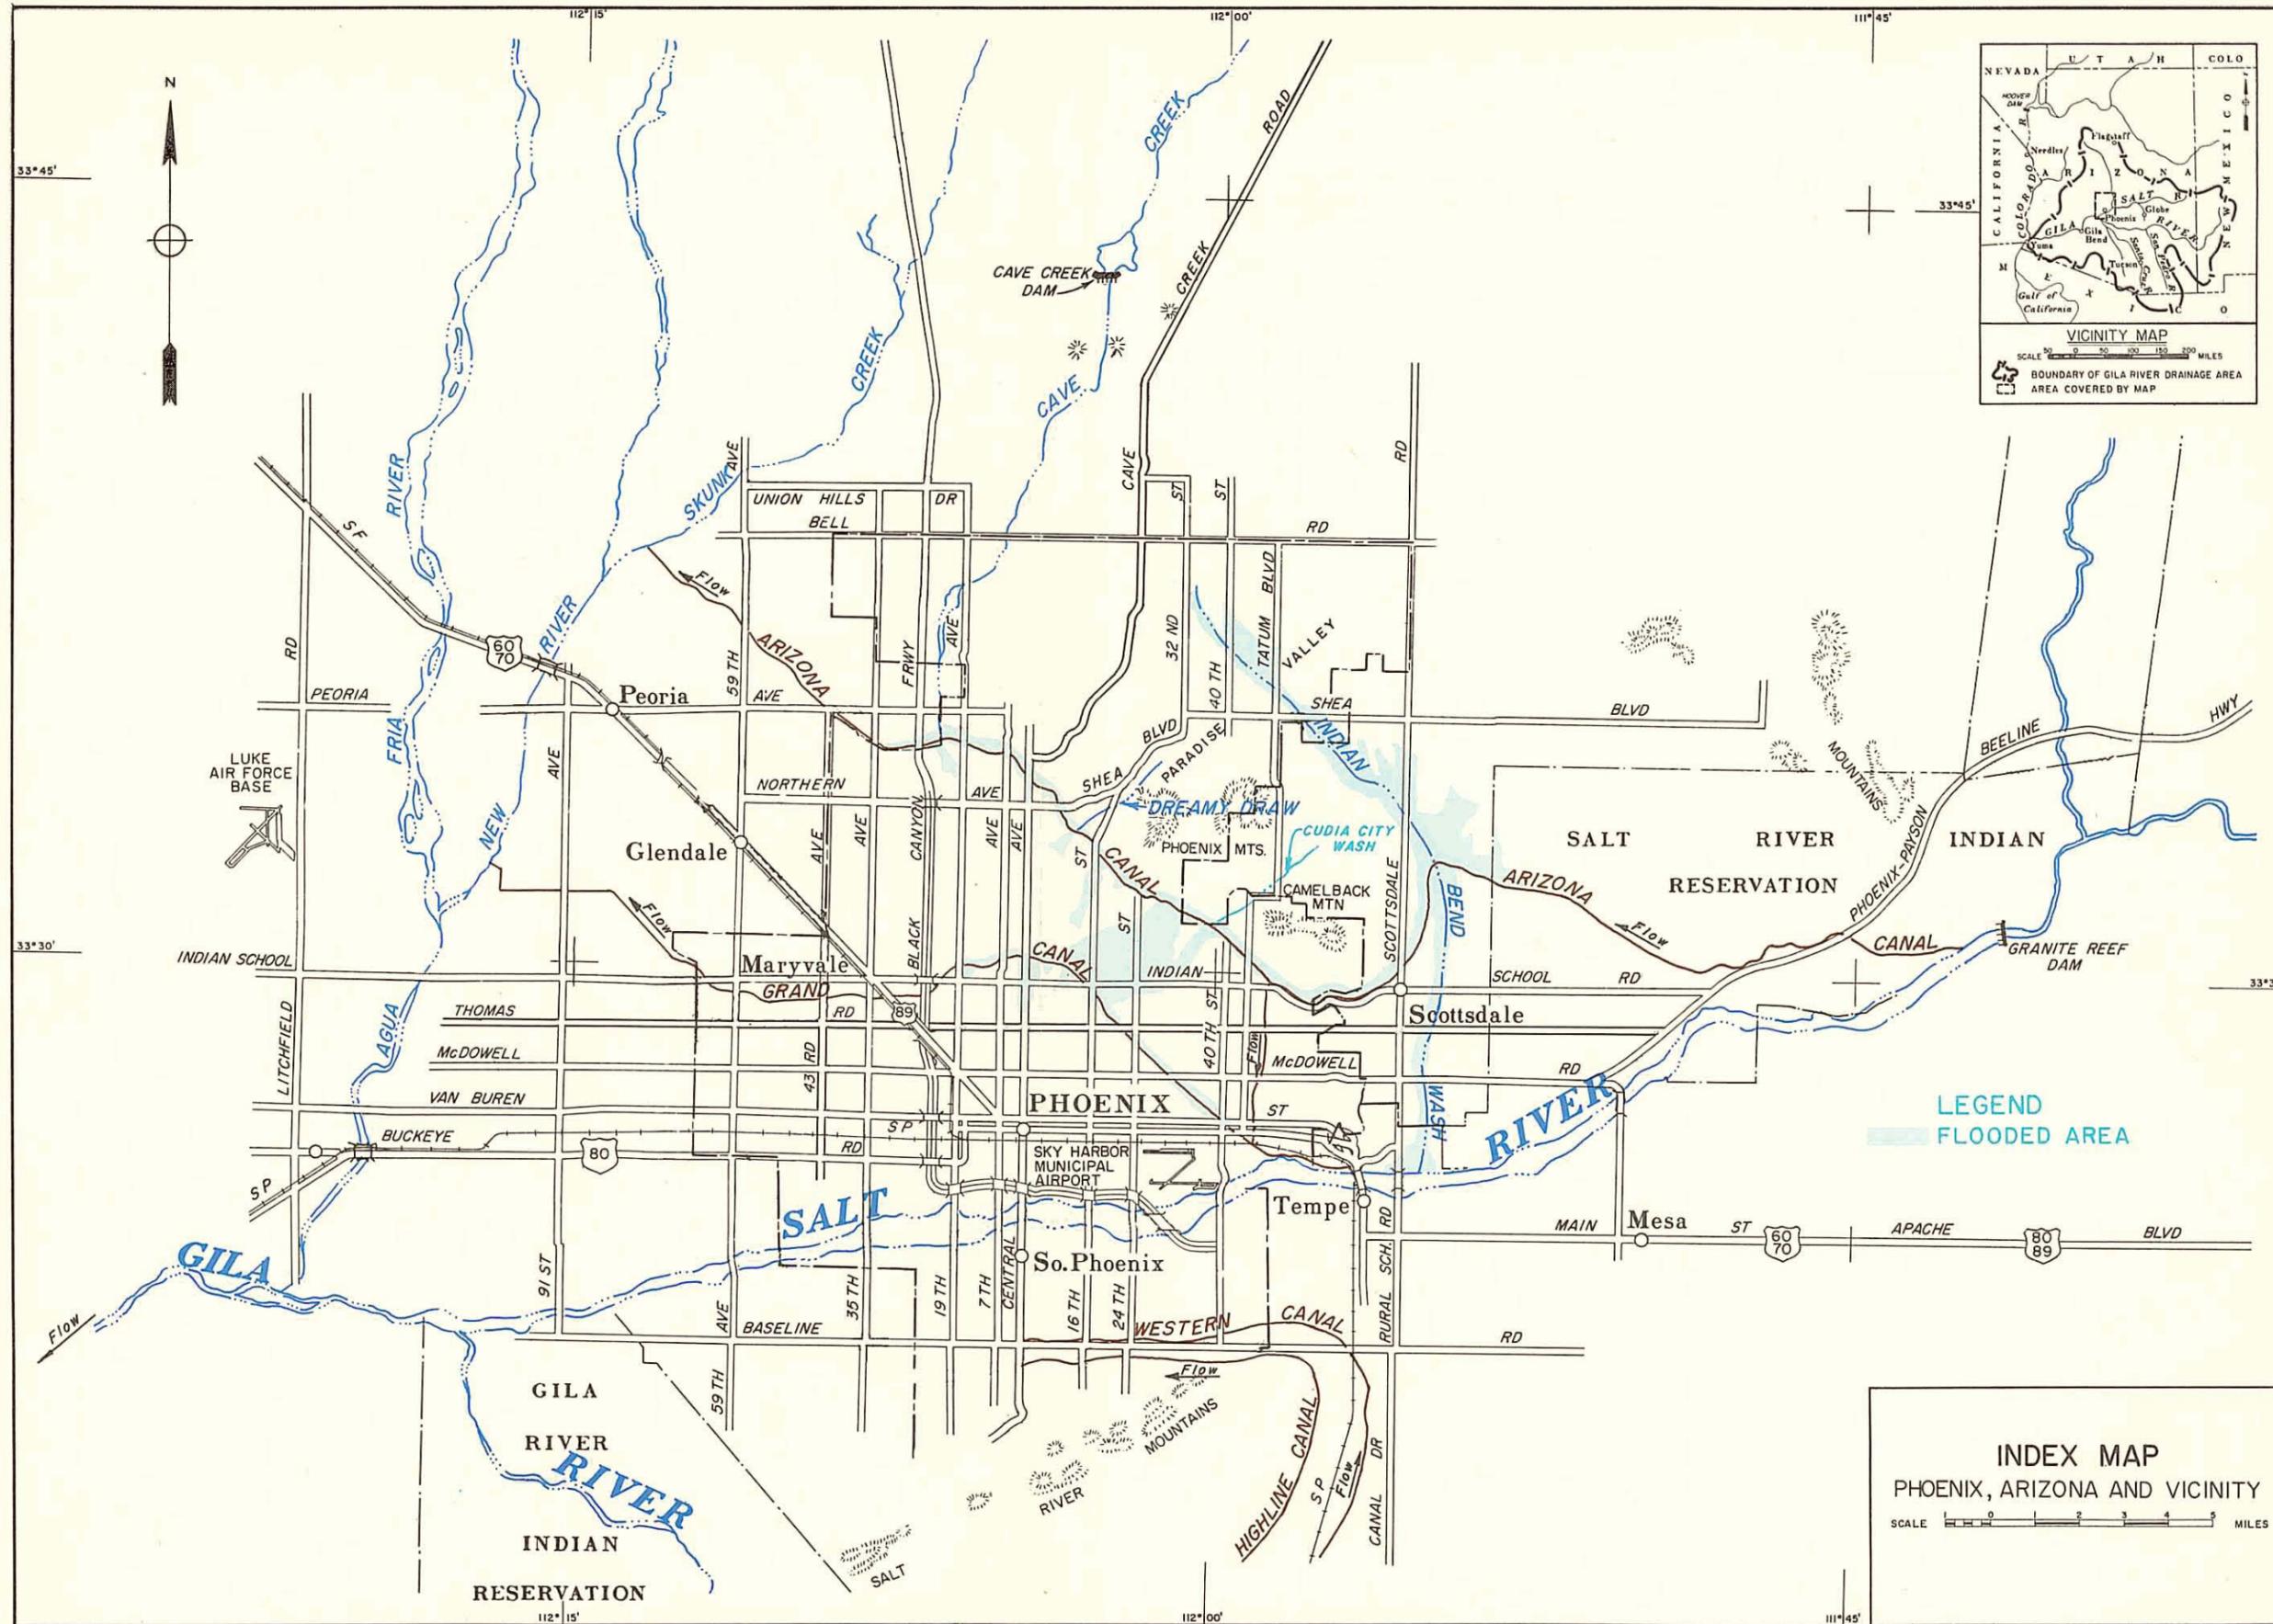
INDEX MAP
 PHOENIX, ARIZONA AND VICINITY
 SCALE 1 2 3 4 5 MILES

4. **LOCATION.** The flood-damaged cities of Phoenix, Scottsdale, Tempe, and Paradise Valley are in the south-central part of Arizona. (See pl. 1.) The flooded areas lie in the Gila River Basin, a drainage area of 58,200 square miles -- 5,600 in New Mexico, 51,500 in Arizona, and 1,100 in Sonora, Mexico.

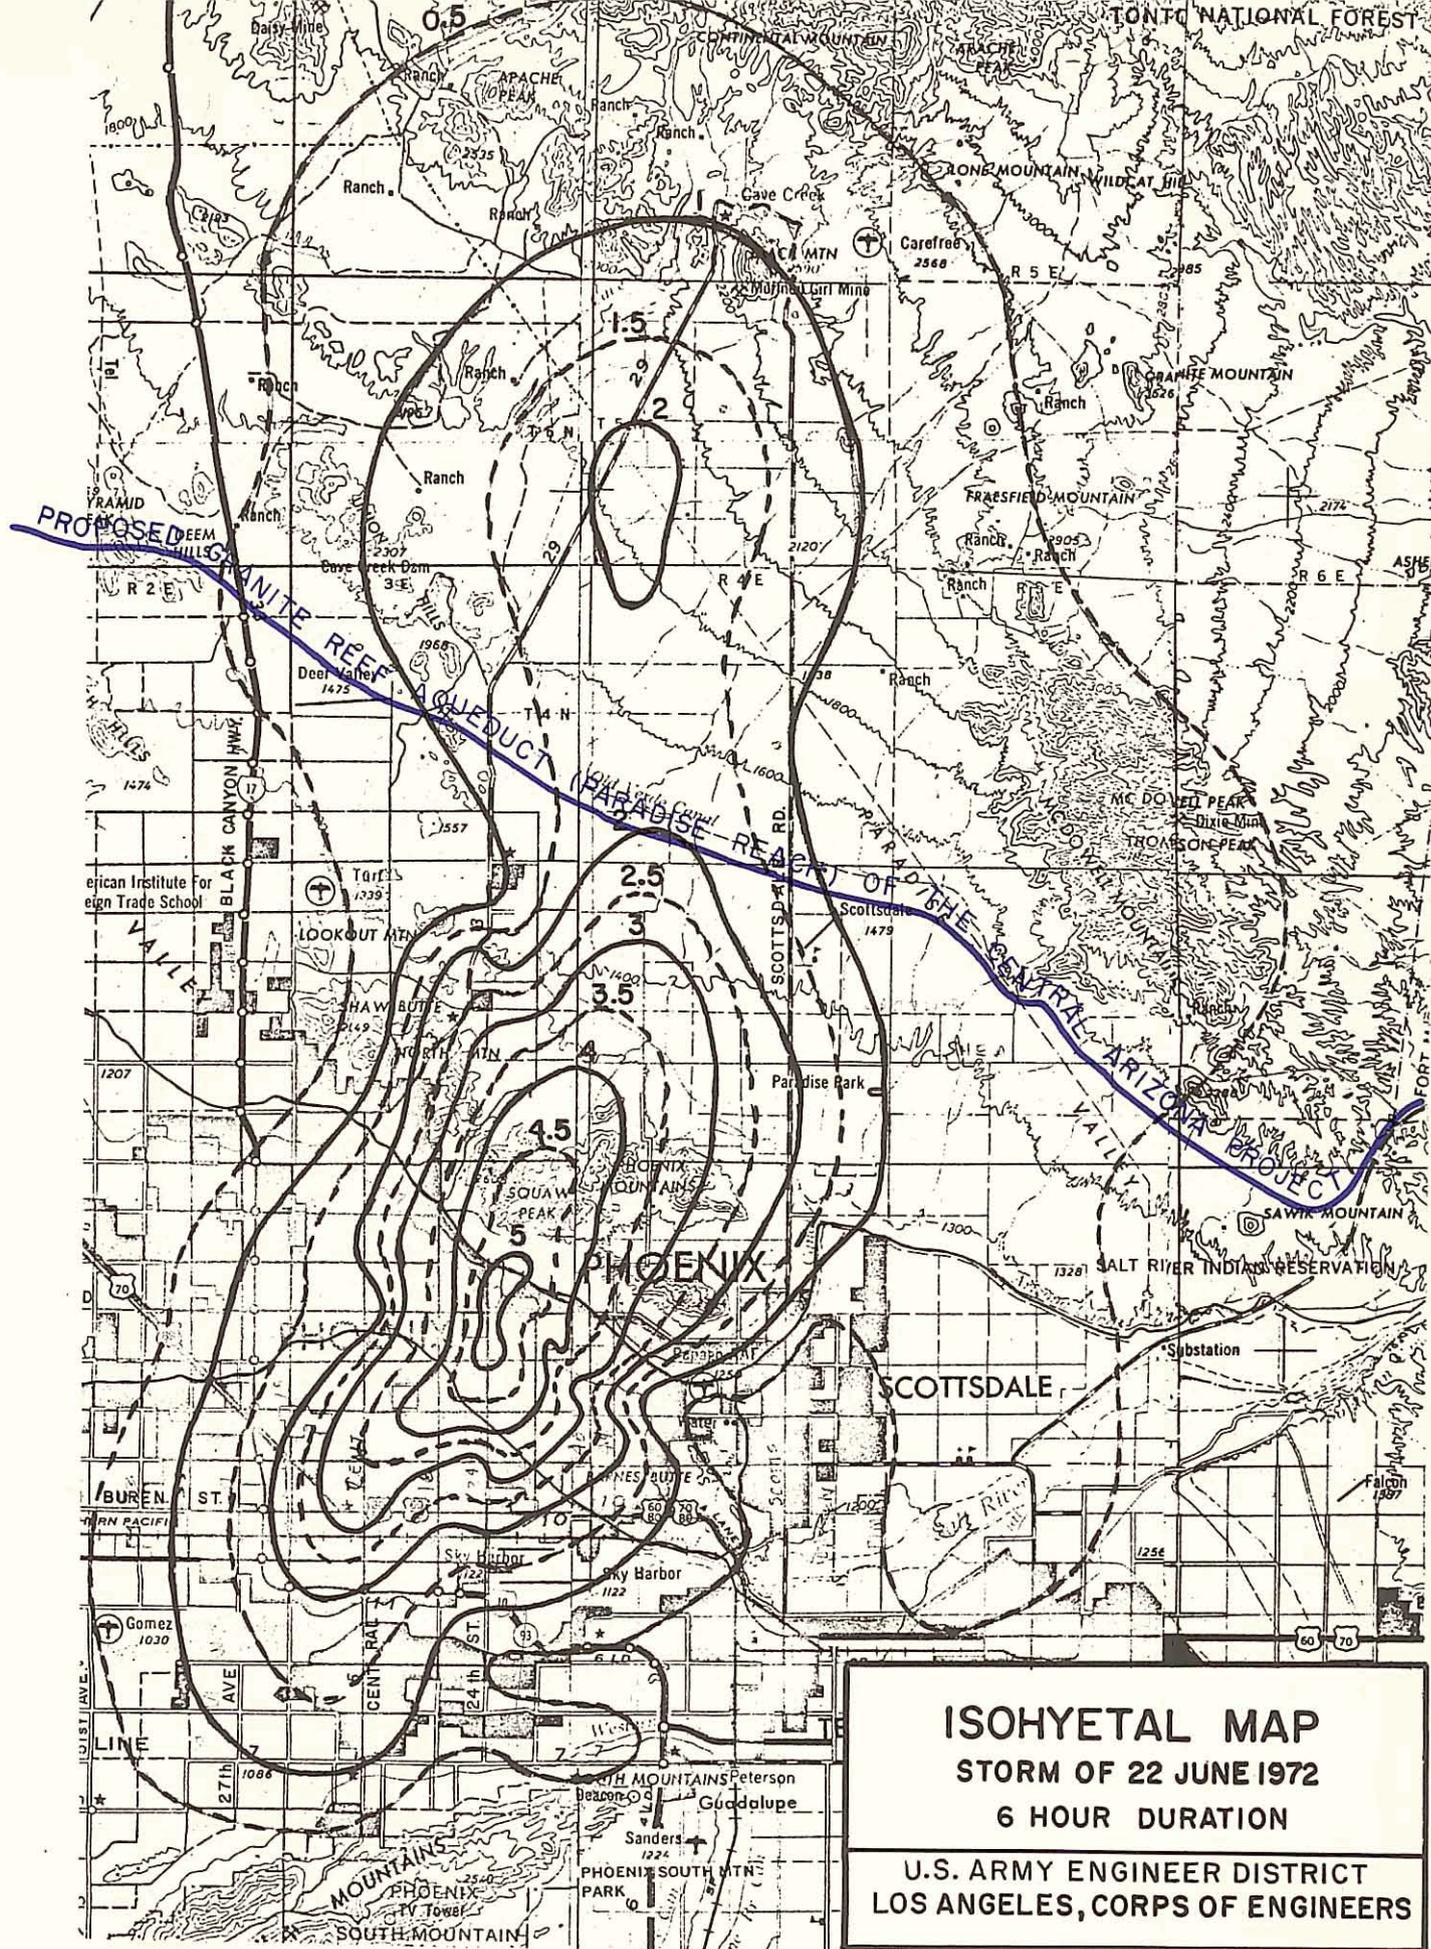
ISOHYETAL MAP
STORM OF 22 JUNE 1972
6 HOUR DURATION

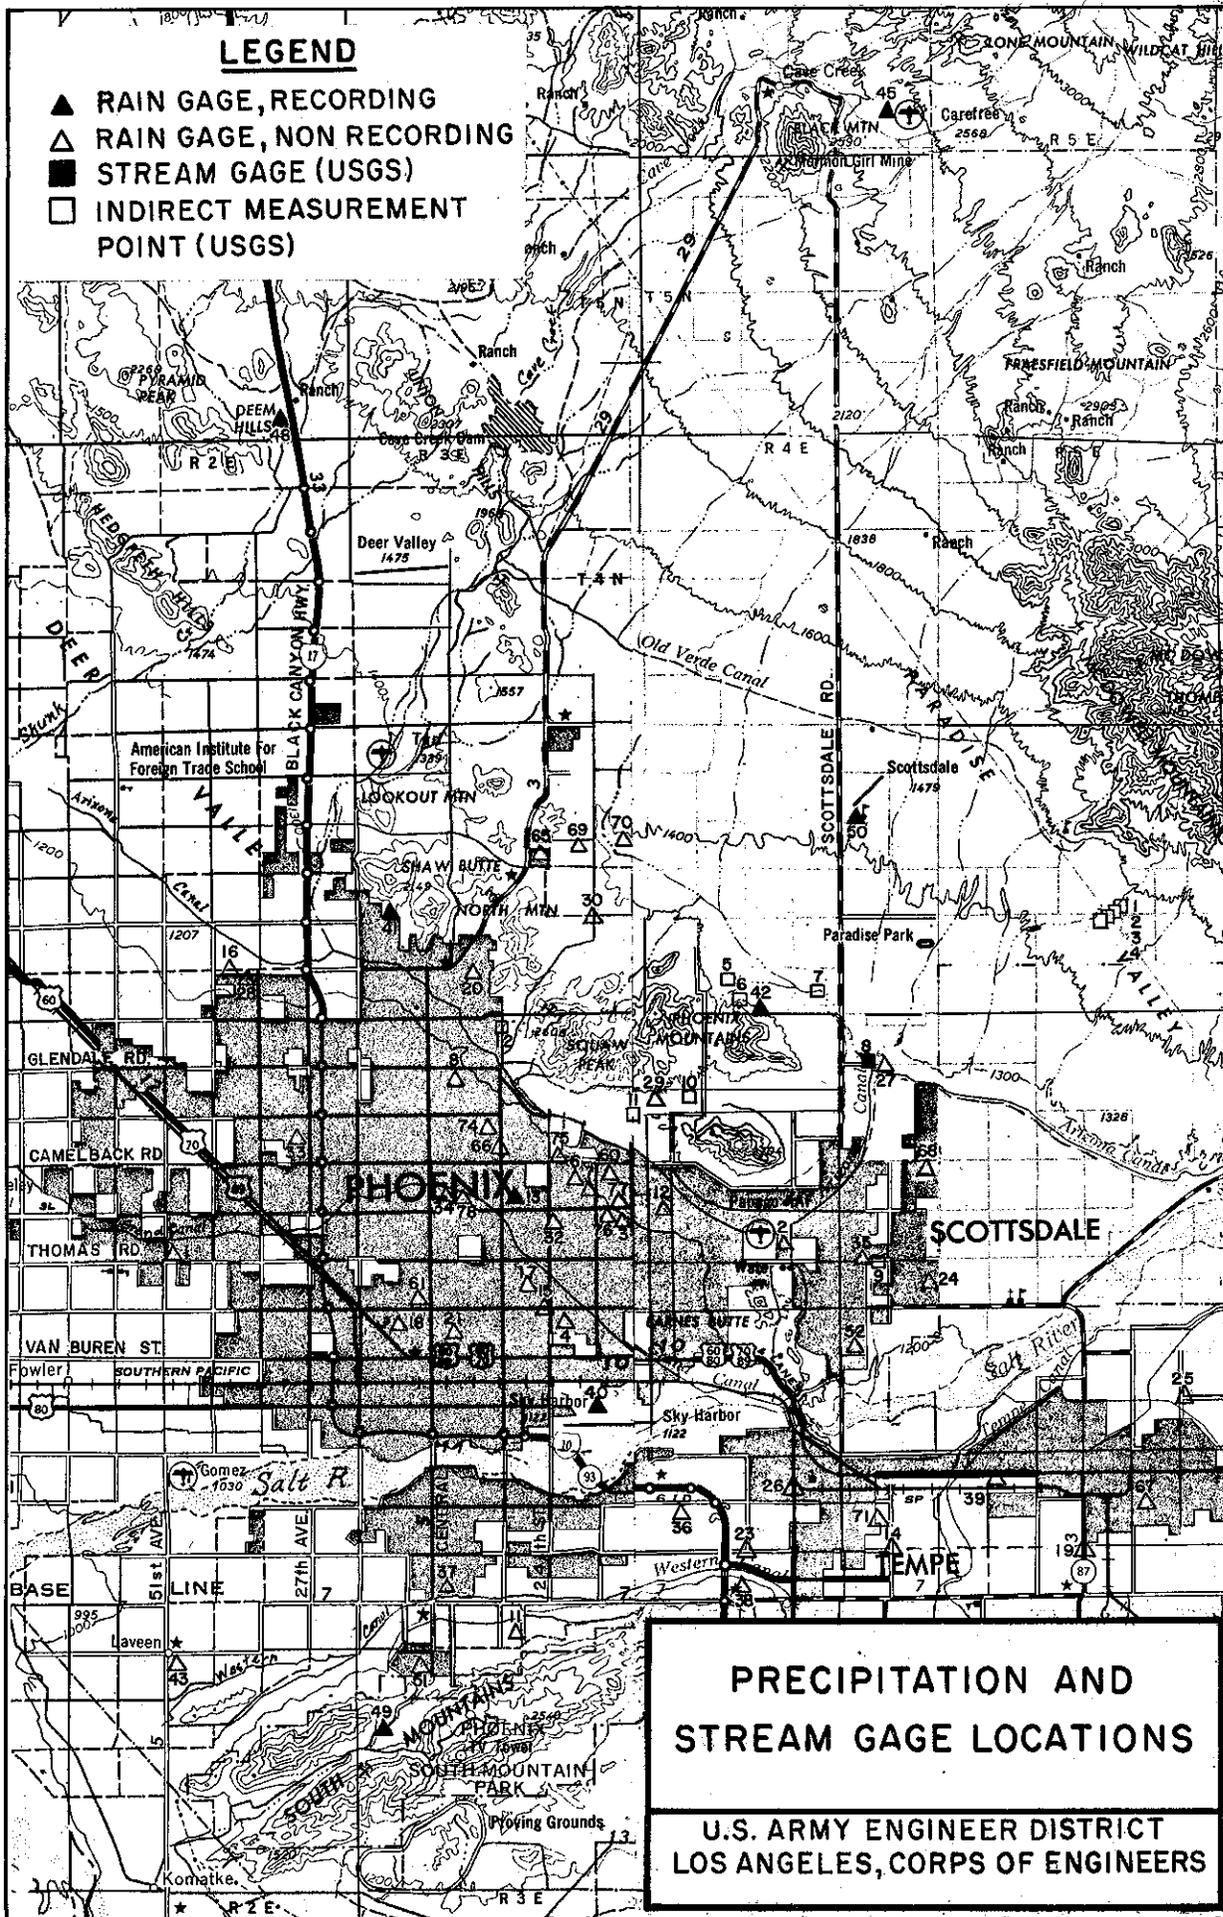
PRECIPITATION AND STREAM GAGE LOCATIONS
