U.S. ARMY CORPS OF ENGINEERS
LOS ANGELES DISTRICT

REPORT ON FLOOD OF 22 JUNE 1972
IN
PHOENIX METROPOLITAN AREA, ARIZONA

OCTOBER 1972

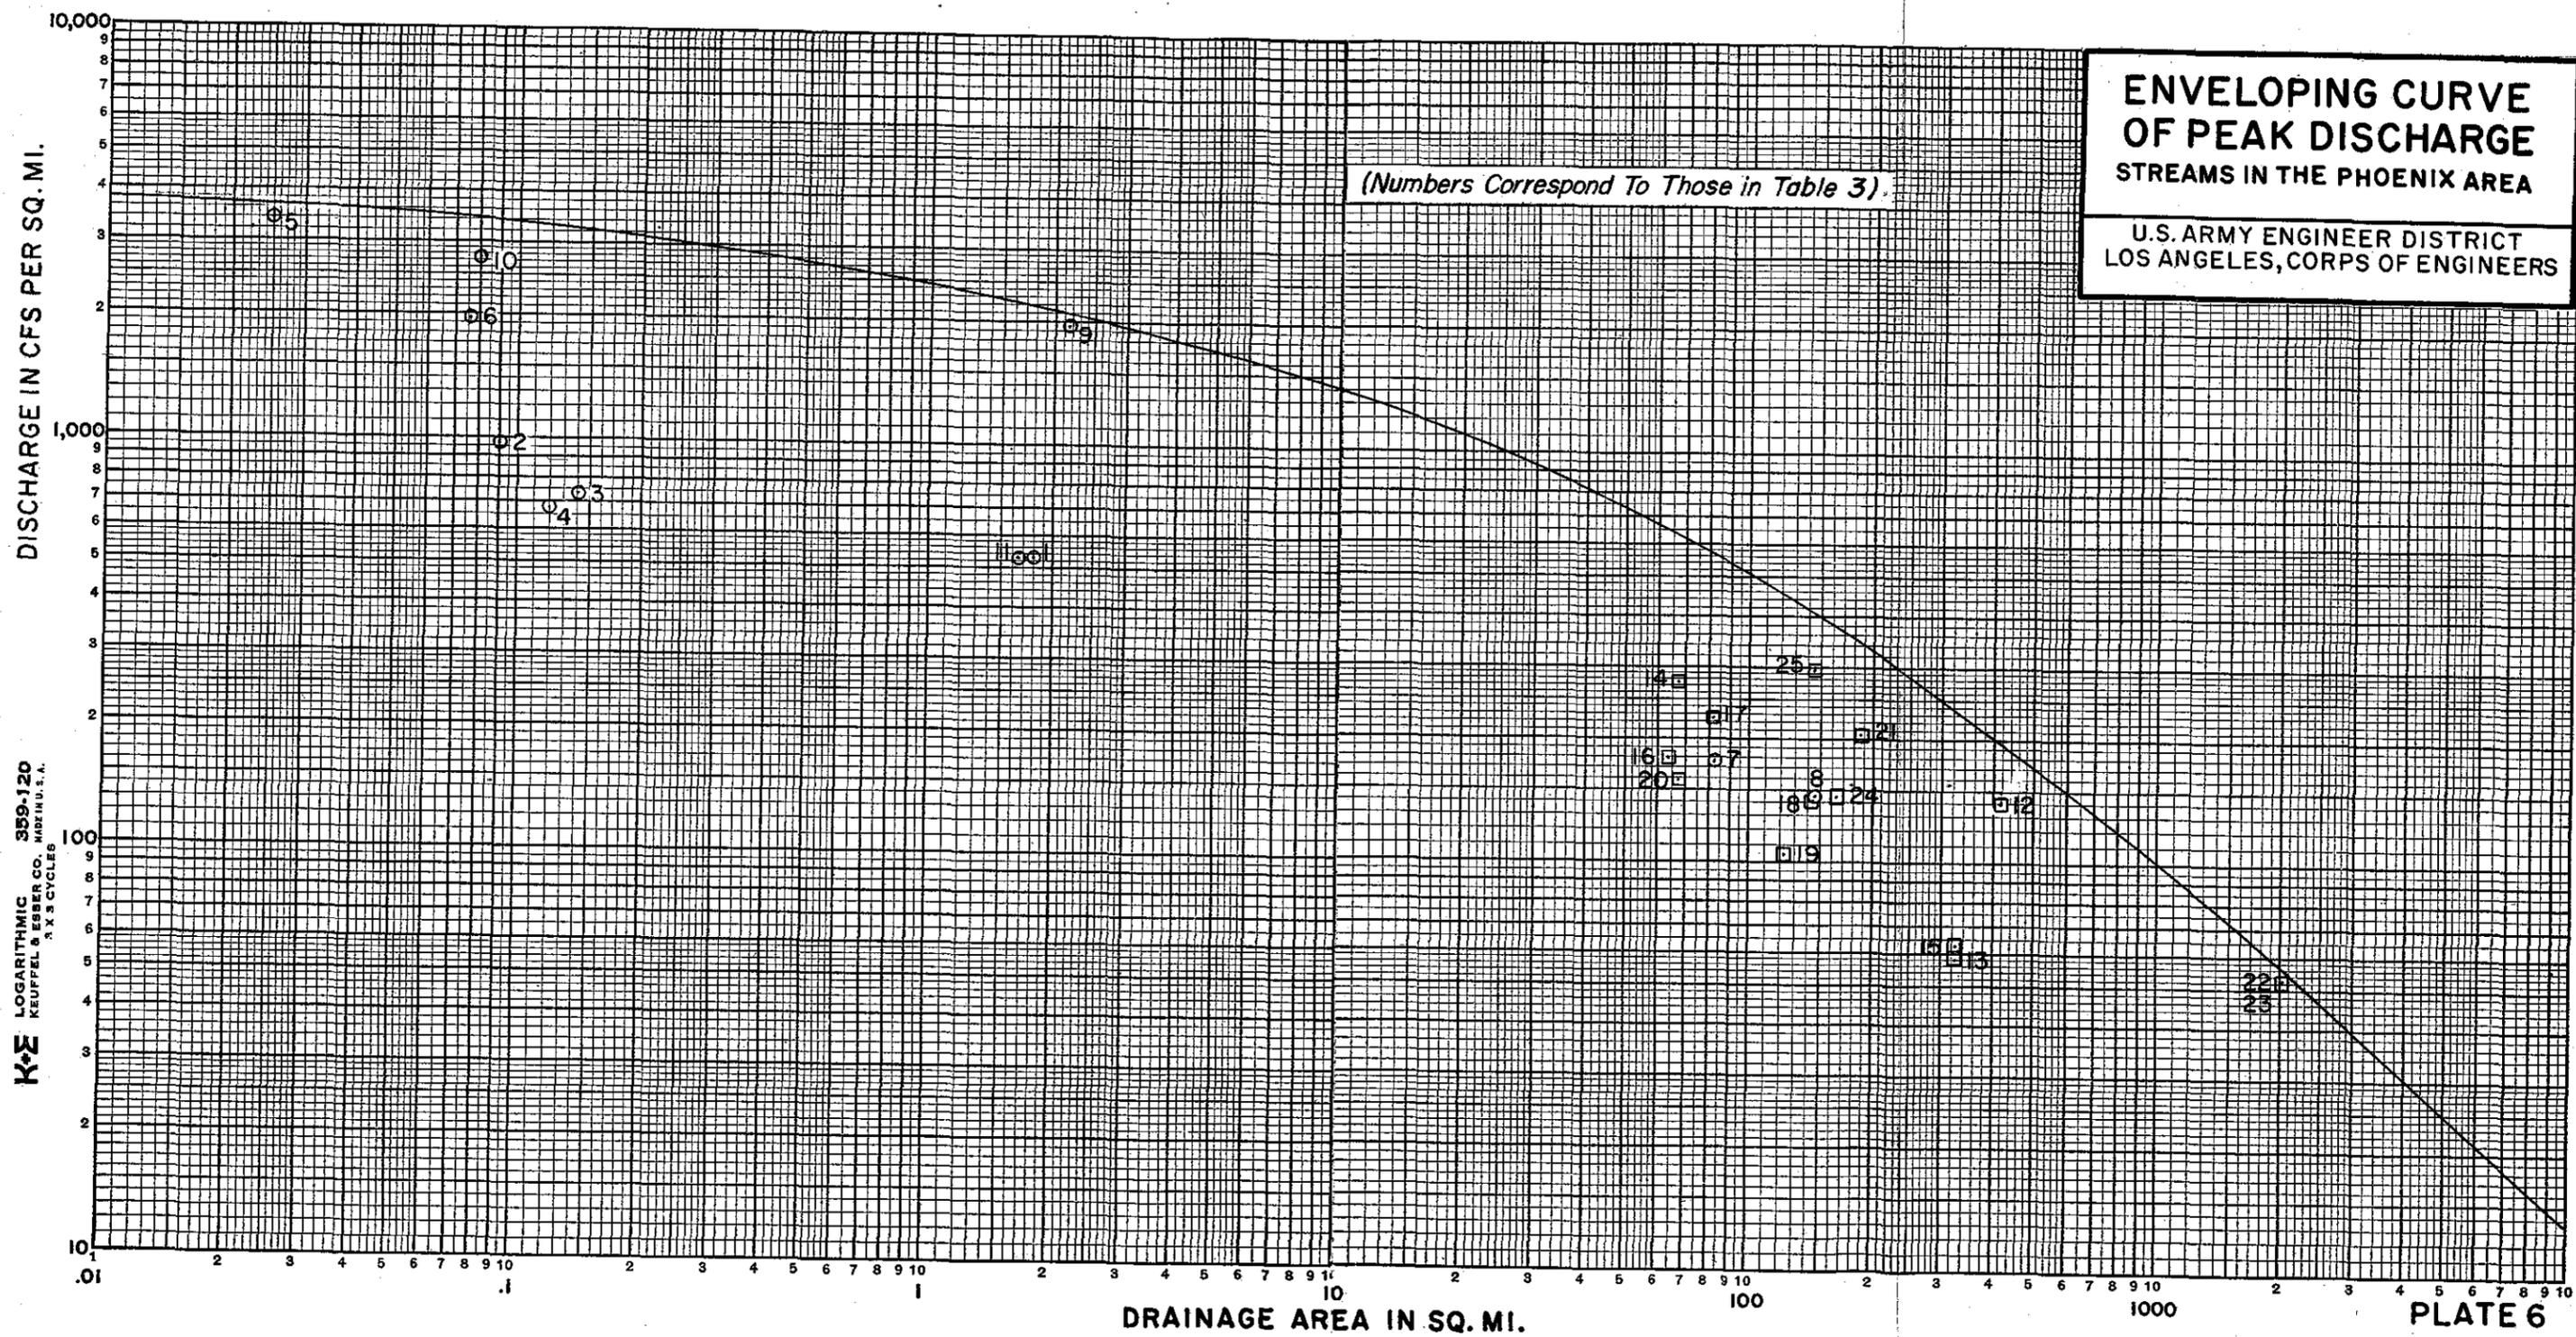
**ENVELOPING CURVE
OF PEAK DISCHARGE
STREAMS IN THE PHOENIX AREA**

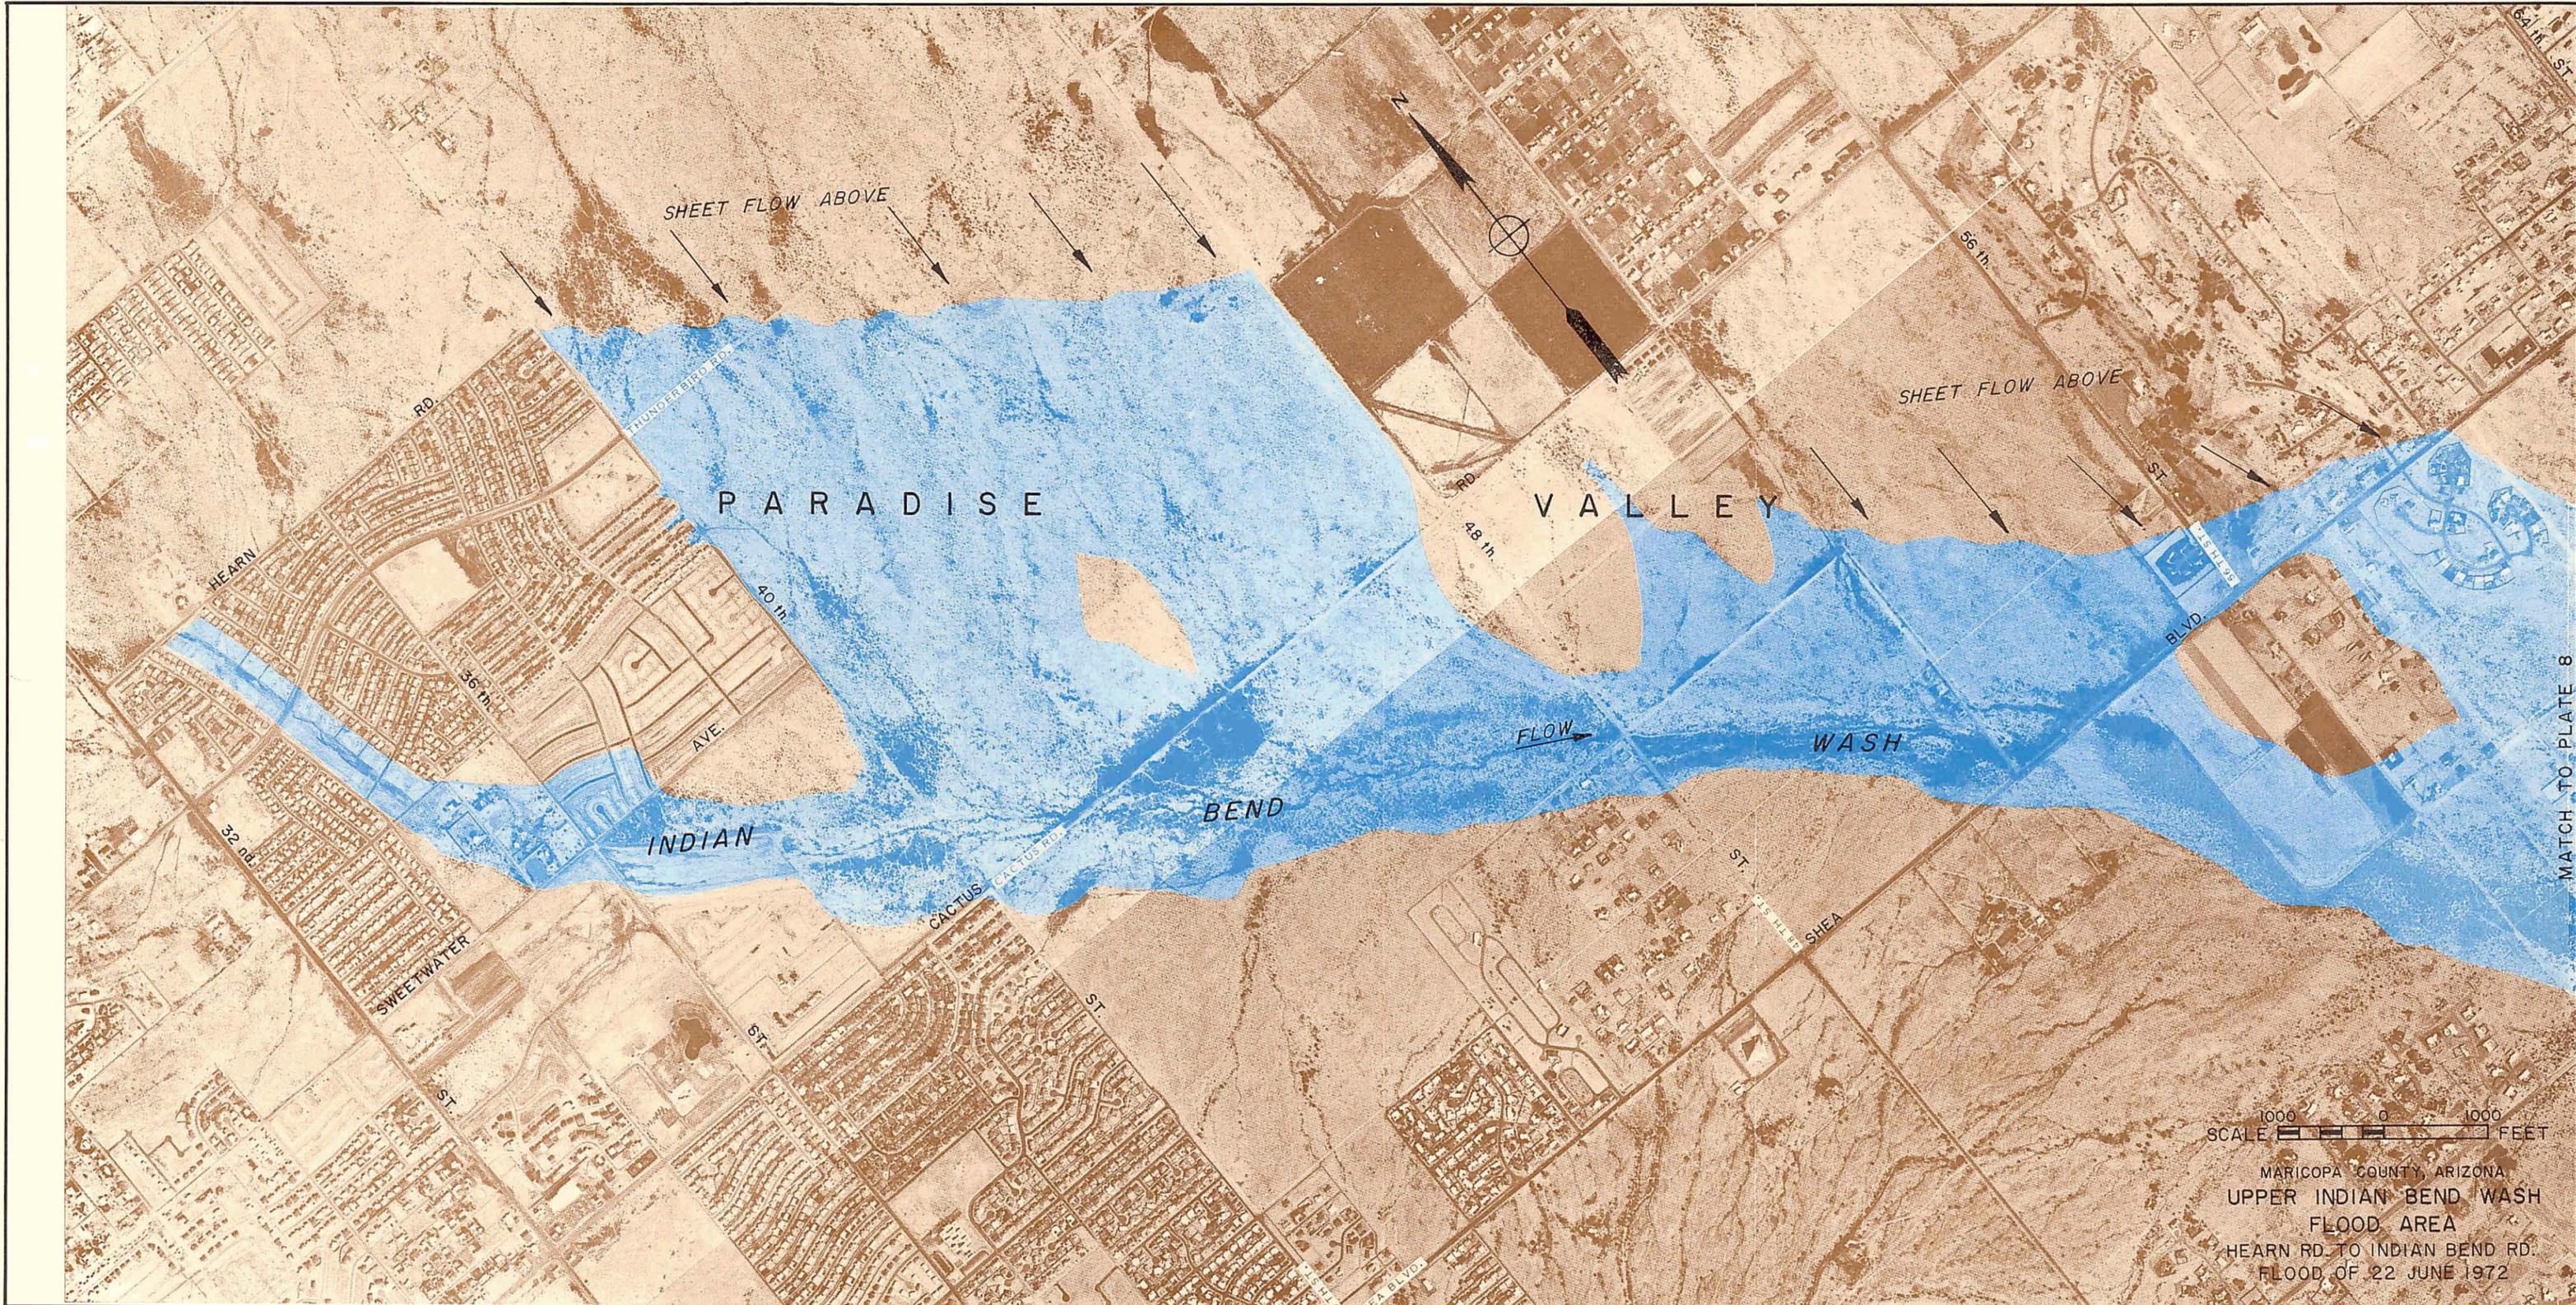
MATCH TO PLATE 8

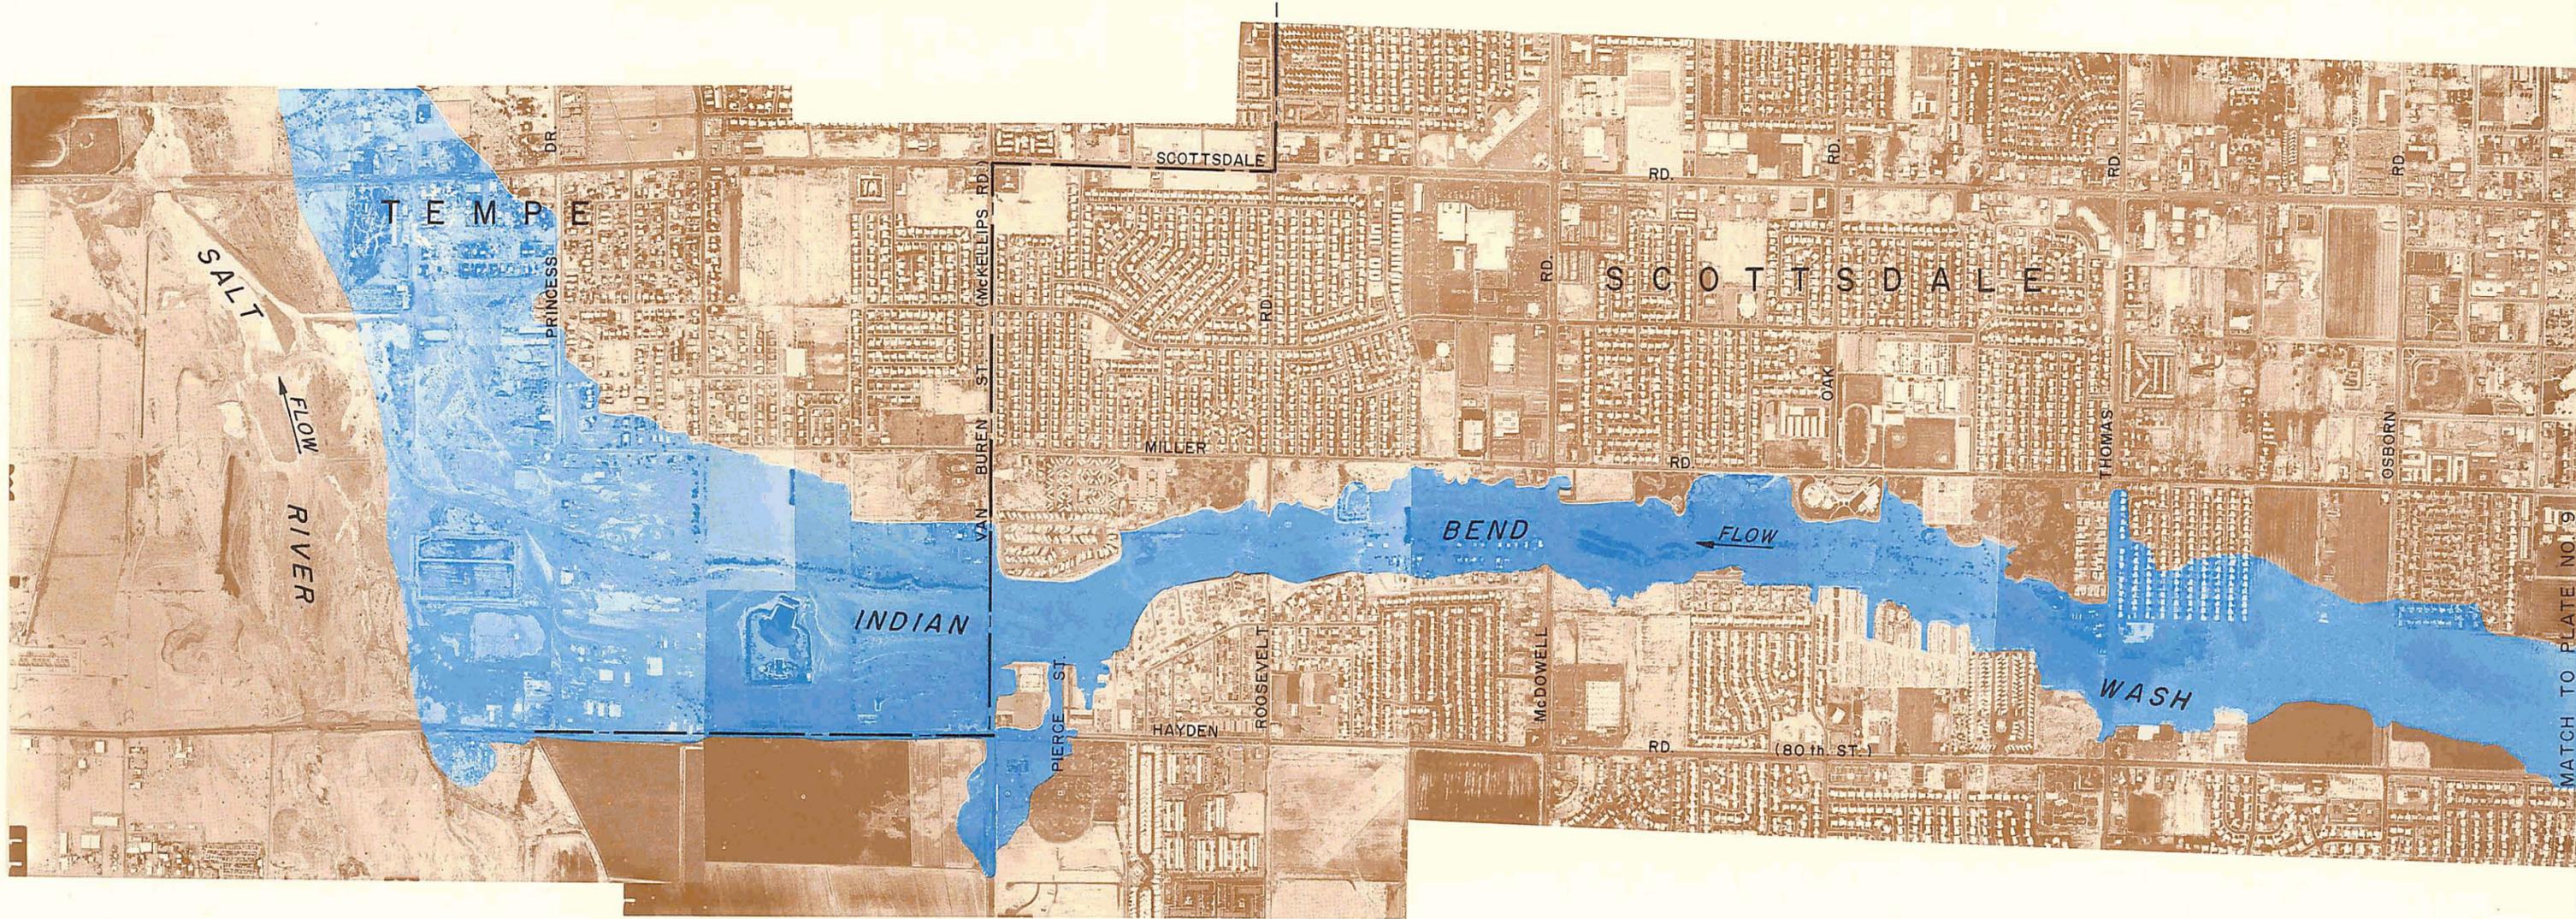
MARICOPA COUNTY, ARIZONA
 INDIAN BEND WASH
 FLOOD AREA
 INDIAN BEND RD. TO SALT RIVER
 FLOOD OF 22 JUNE 1972

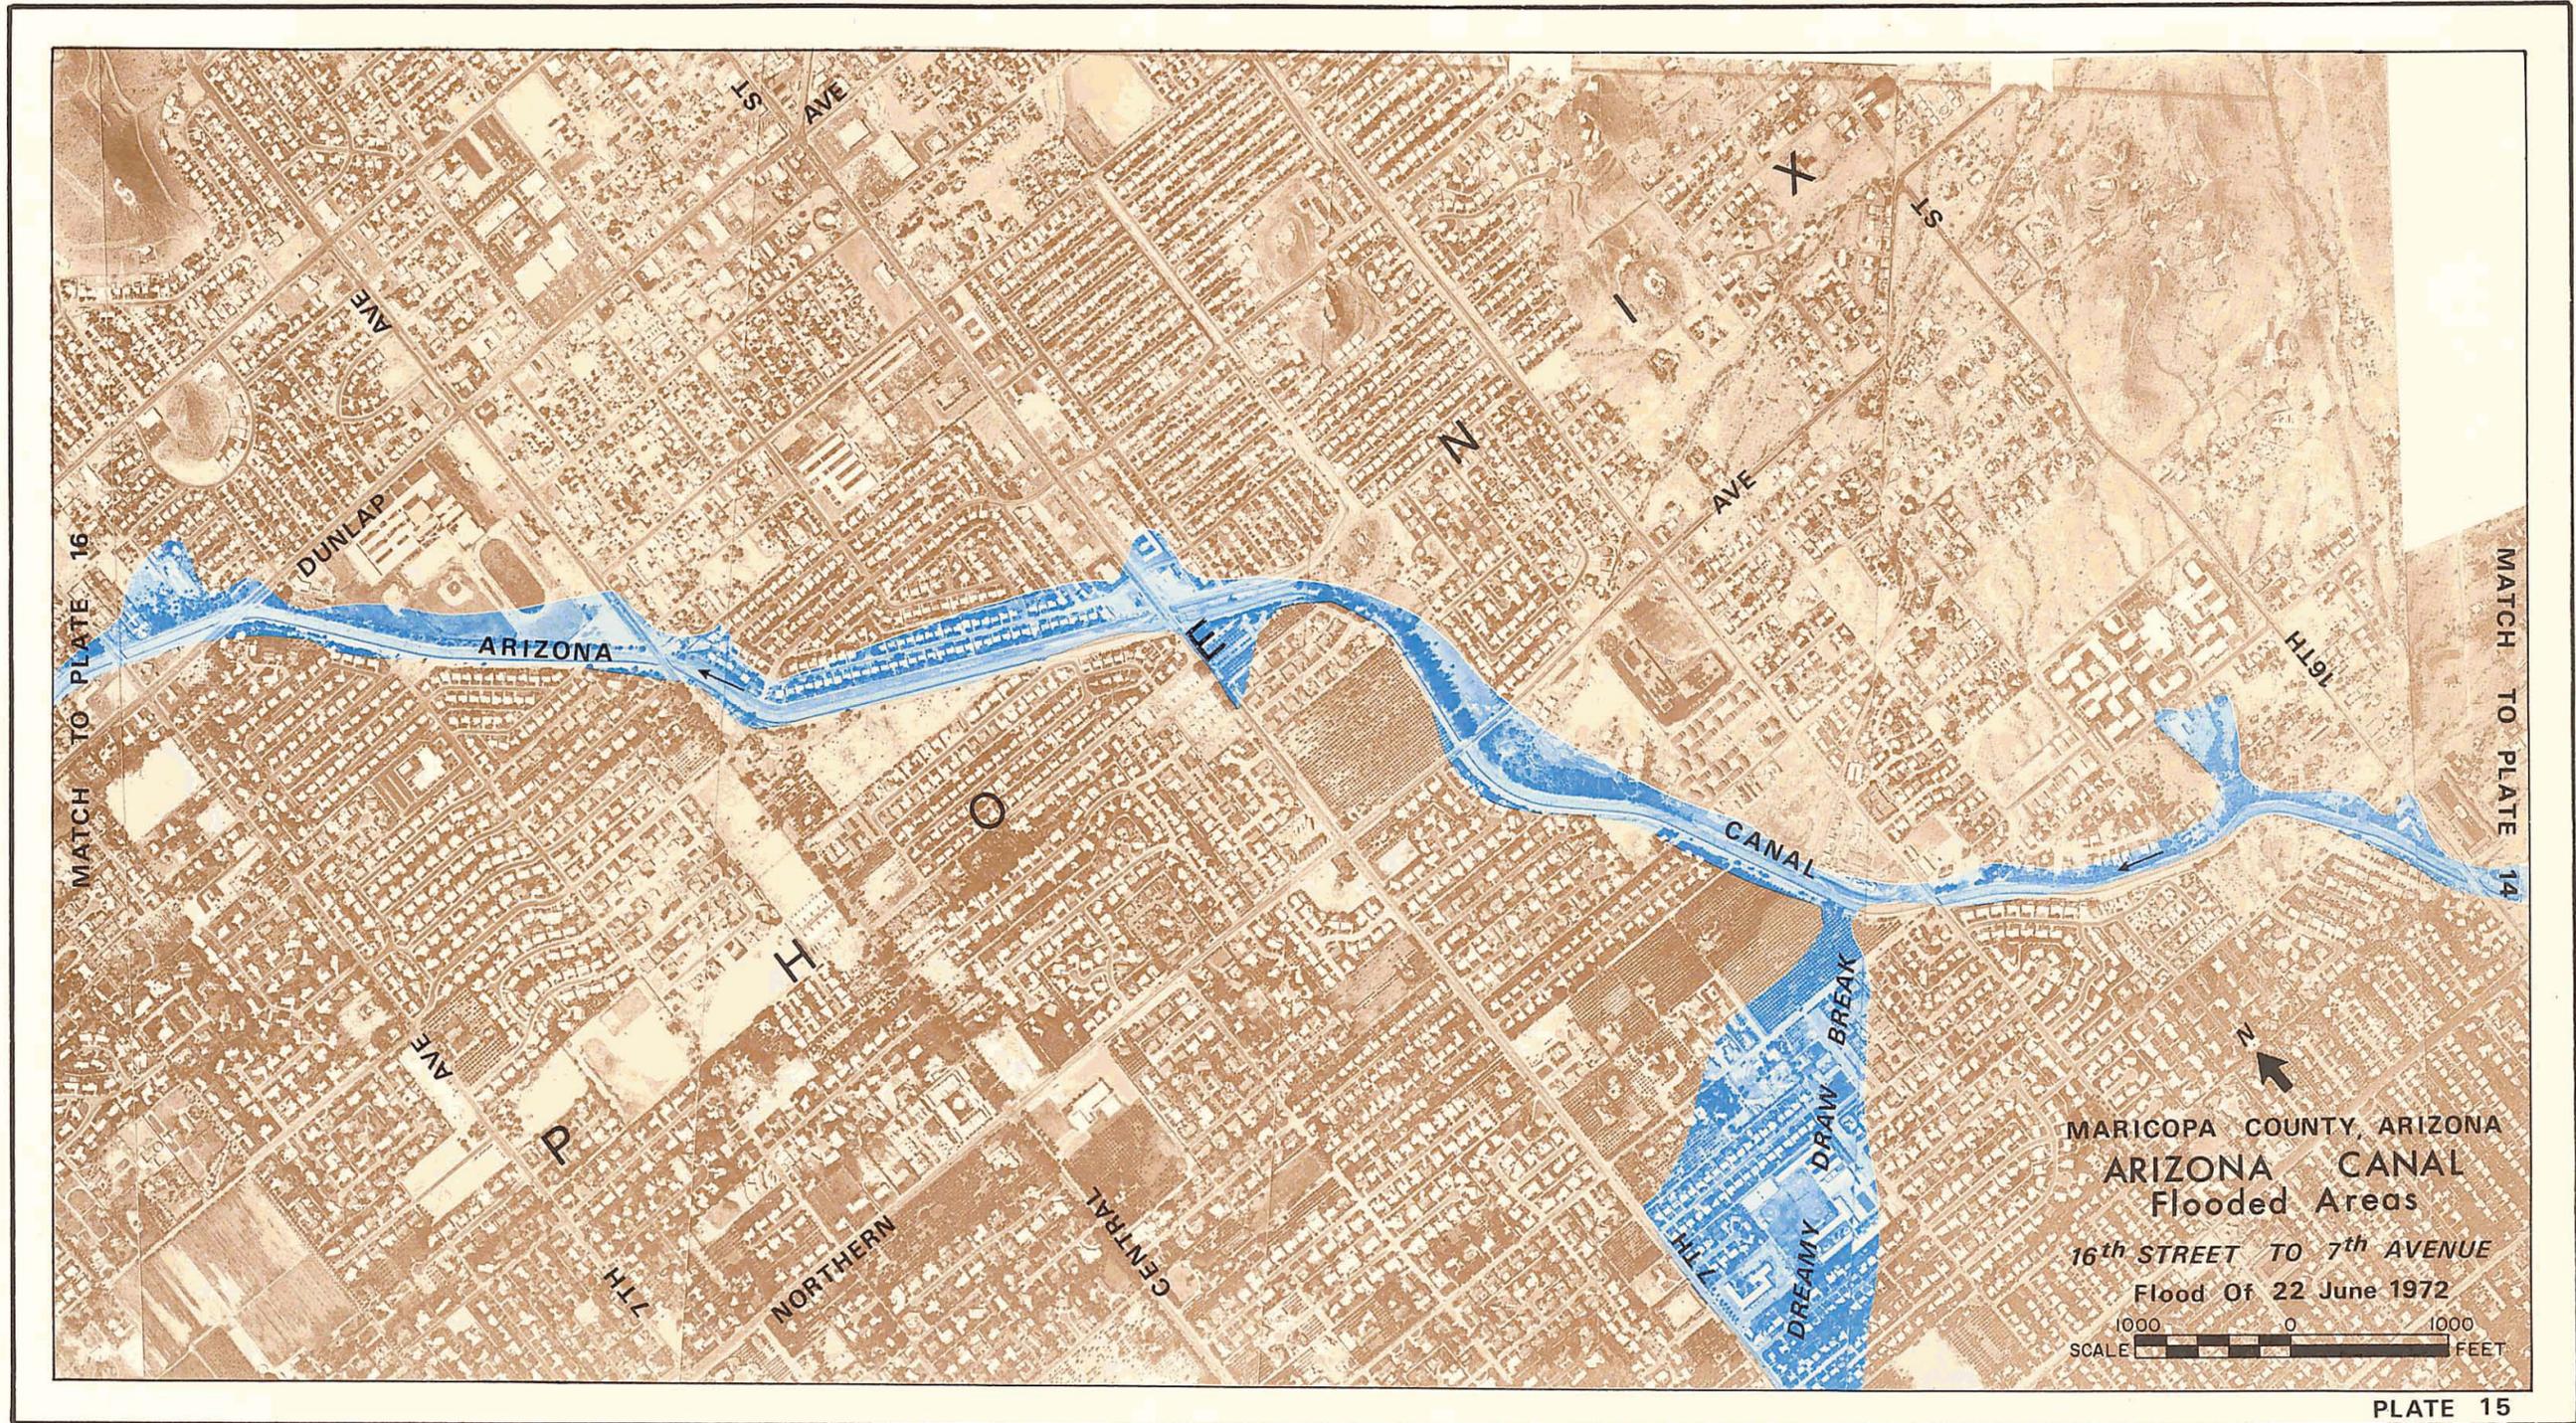
PLATE 14

MARICOPA COUNTY, ARIZONA
ARIZONA CANAL
Flooded Areas

16th STREET TO 7th AVENUE
Flood Of 22 June 1972

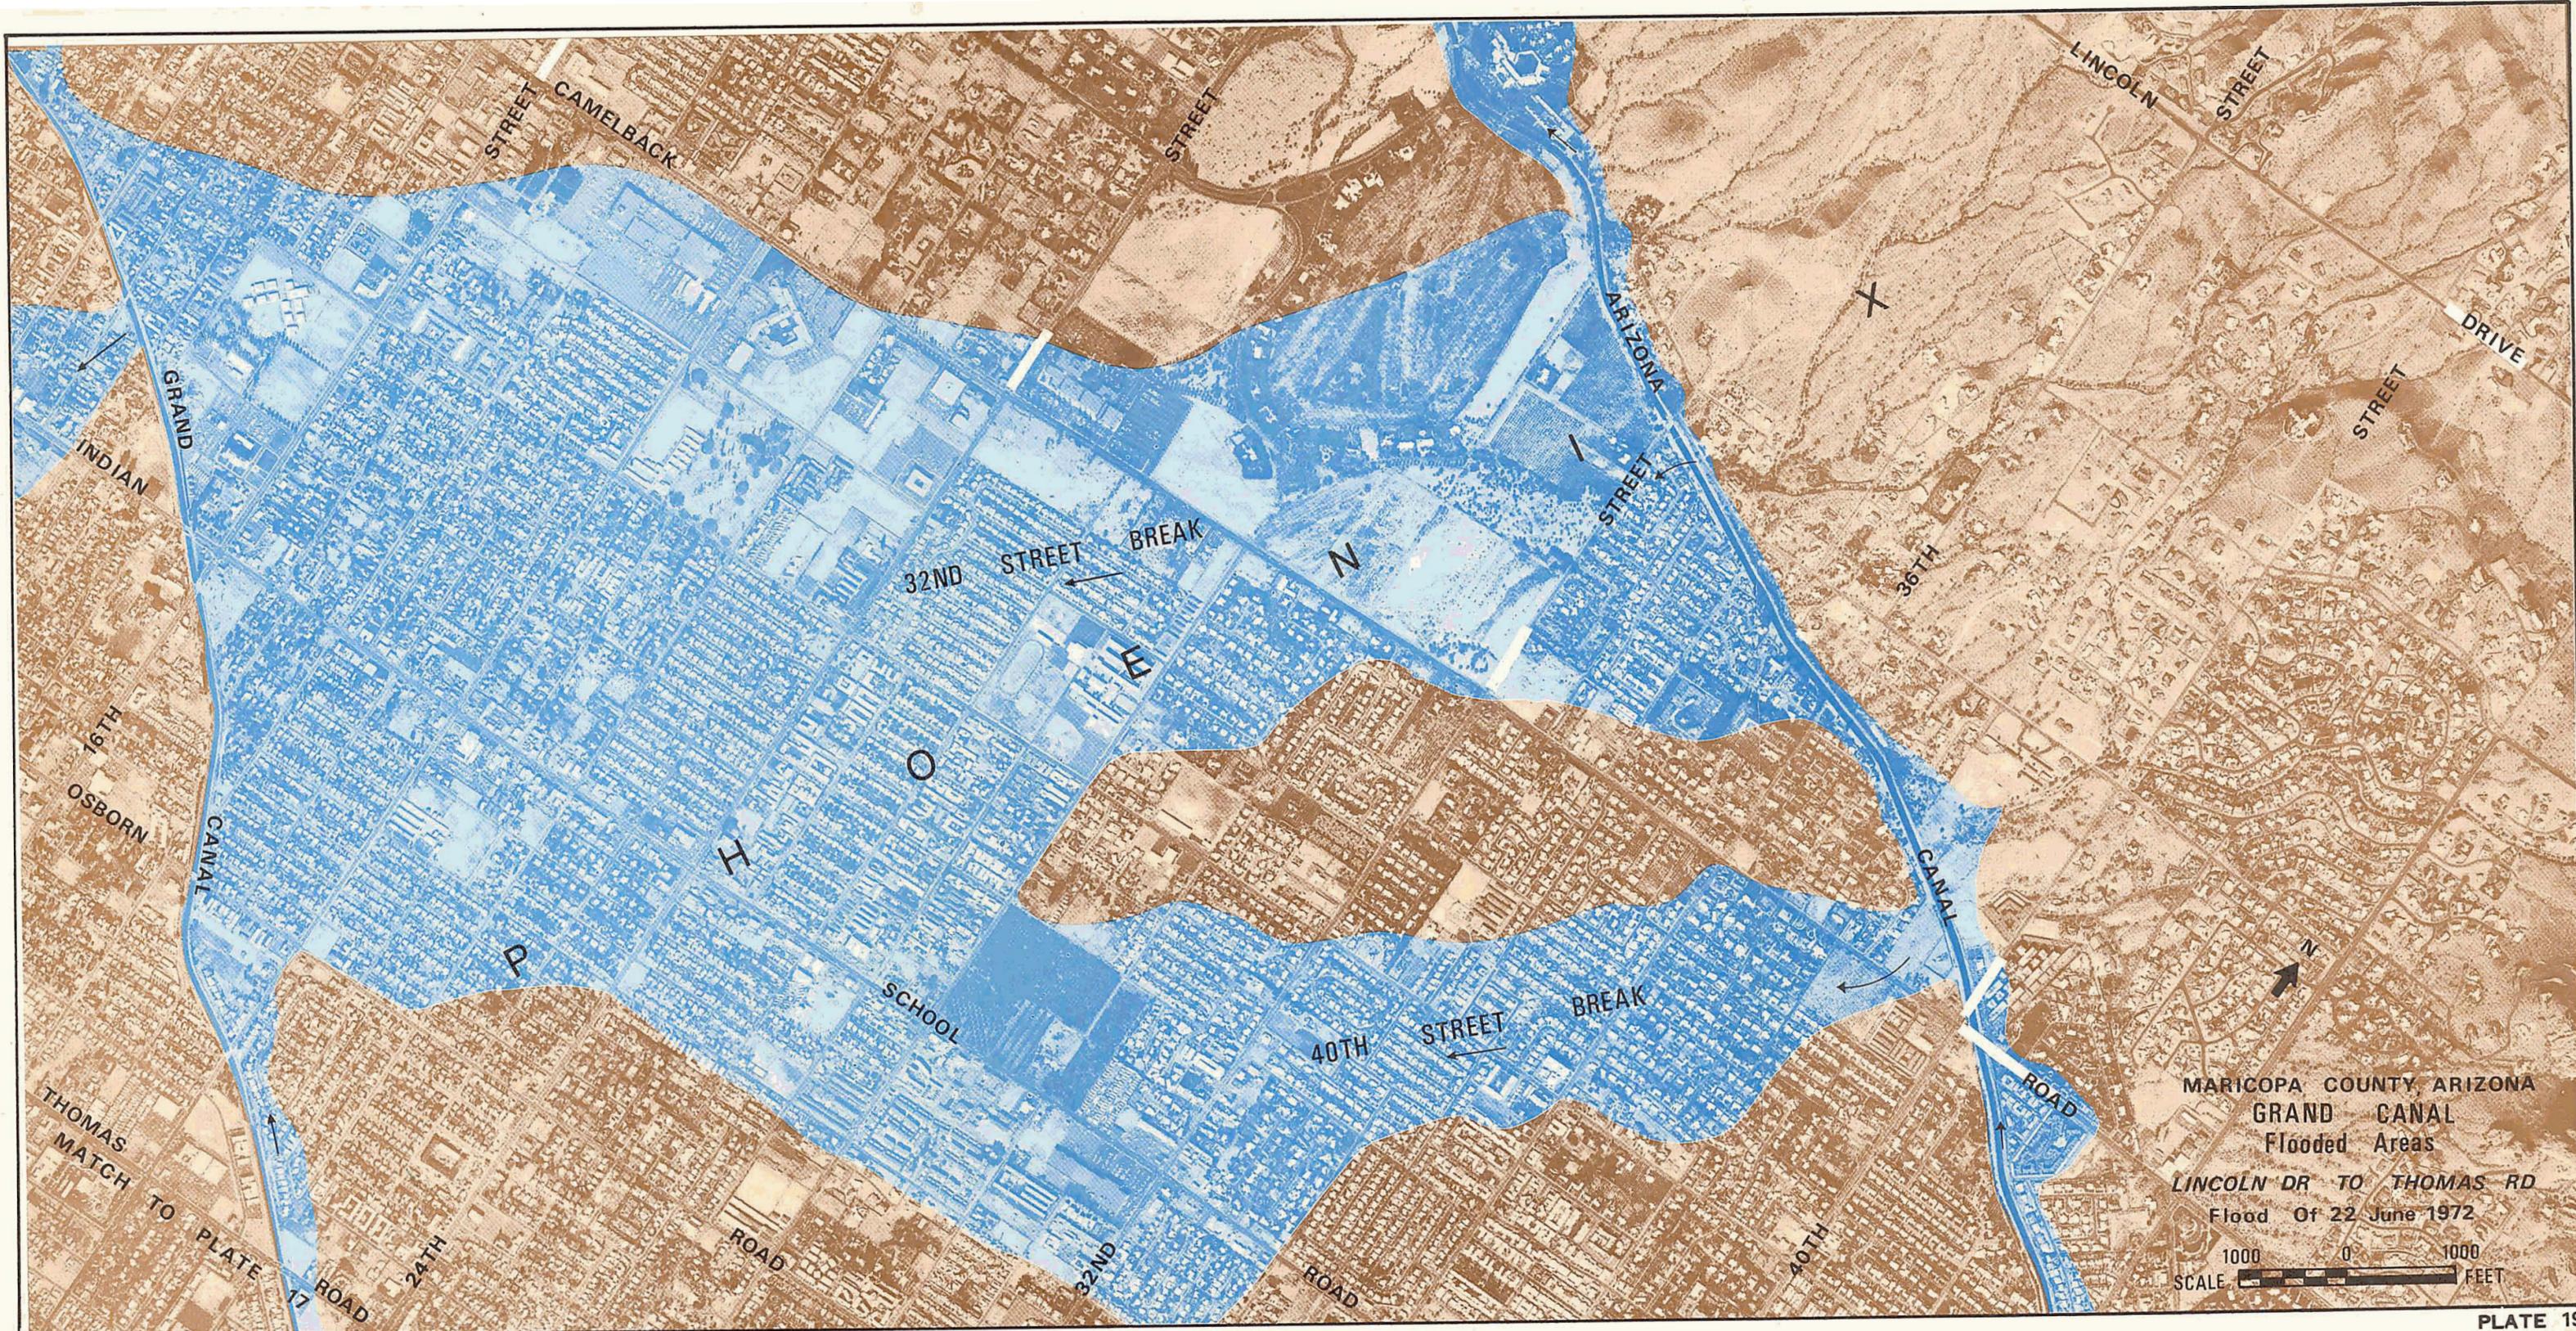
MARICOPA COUNTY ARIZONA
GRAND CANAL
Flooded Areas
LINCOLN DR TO THOMAS RD
Flood Of 22 June 1972
SCALE 1000 0 1000 FEET
