**FLOOD DAMAGE REPORT
STORM & FLOOD OF SEPT. 4-6, 1970
CITY OF PHOENIX, ARIZONA**

ENGINEERING DEPARTMENT

FEBRUARY 1971

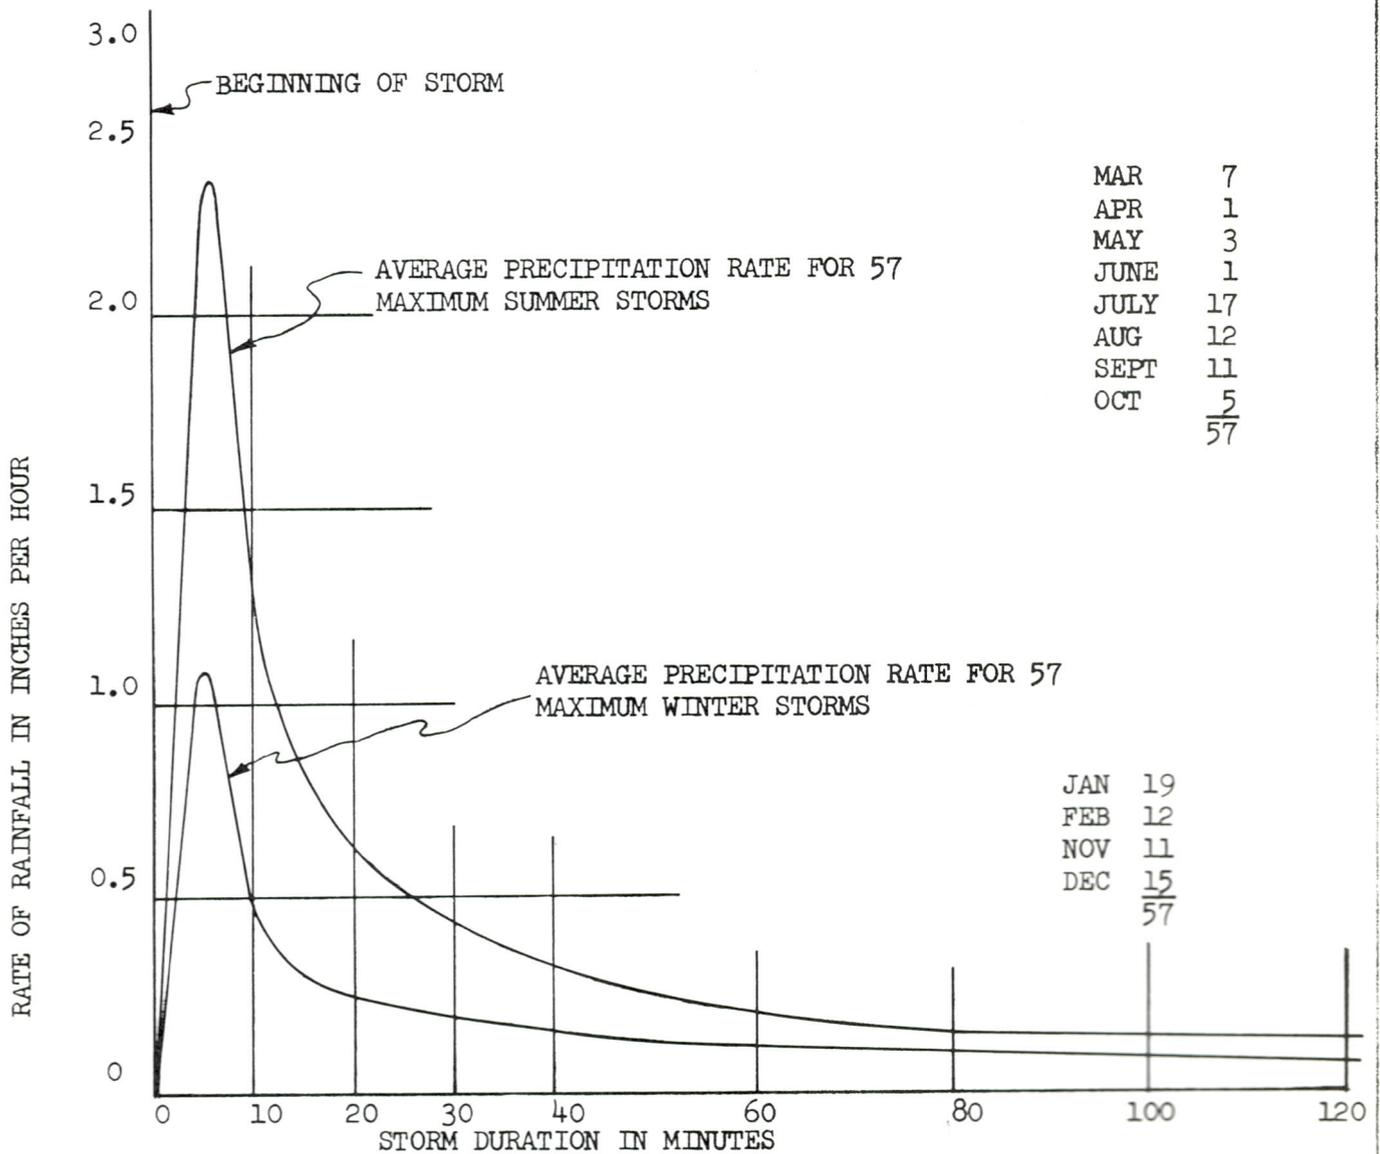
PHOENIX RAINFALL RATE PATTERN

Phoenix is an unusual city in several respects. It is a desert city, located on what can best be described as a desert flood plain. Local precipitation is generally very light; the average annual rainfall being about 8 inches. The manner in which this precipitation occurs is of some interest, since the majority of problems are caused by the short, intense, summer thunderstorms localized in a relatively small area. The chart on the following page illustrates the rainfall rate patterns in Phoenix.

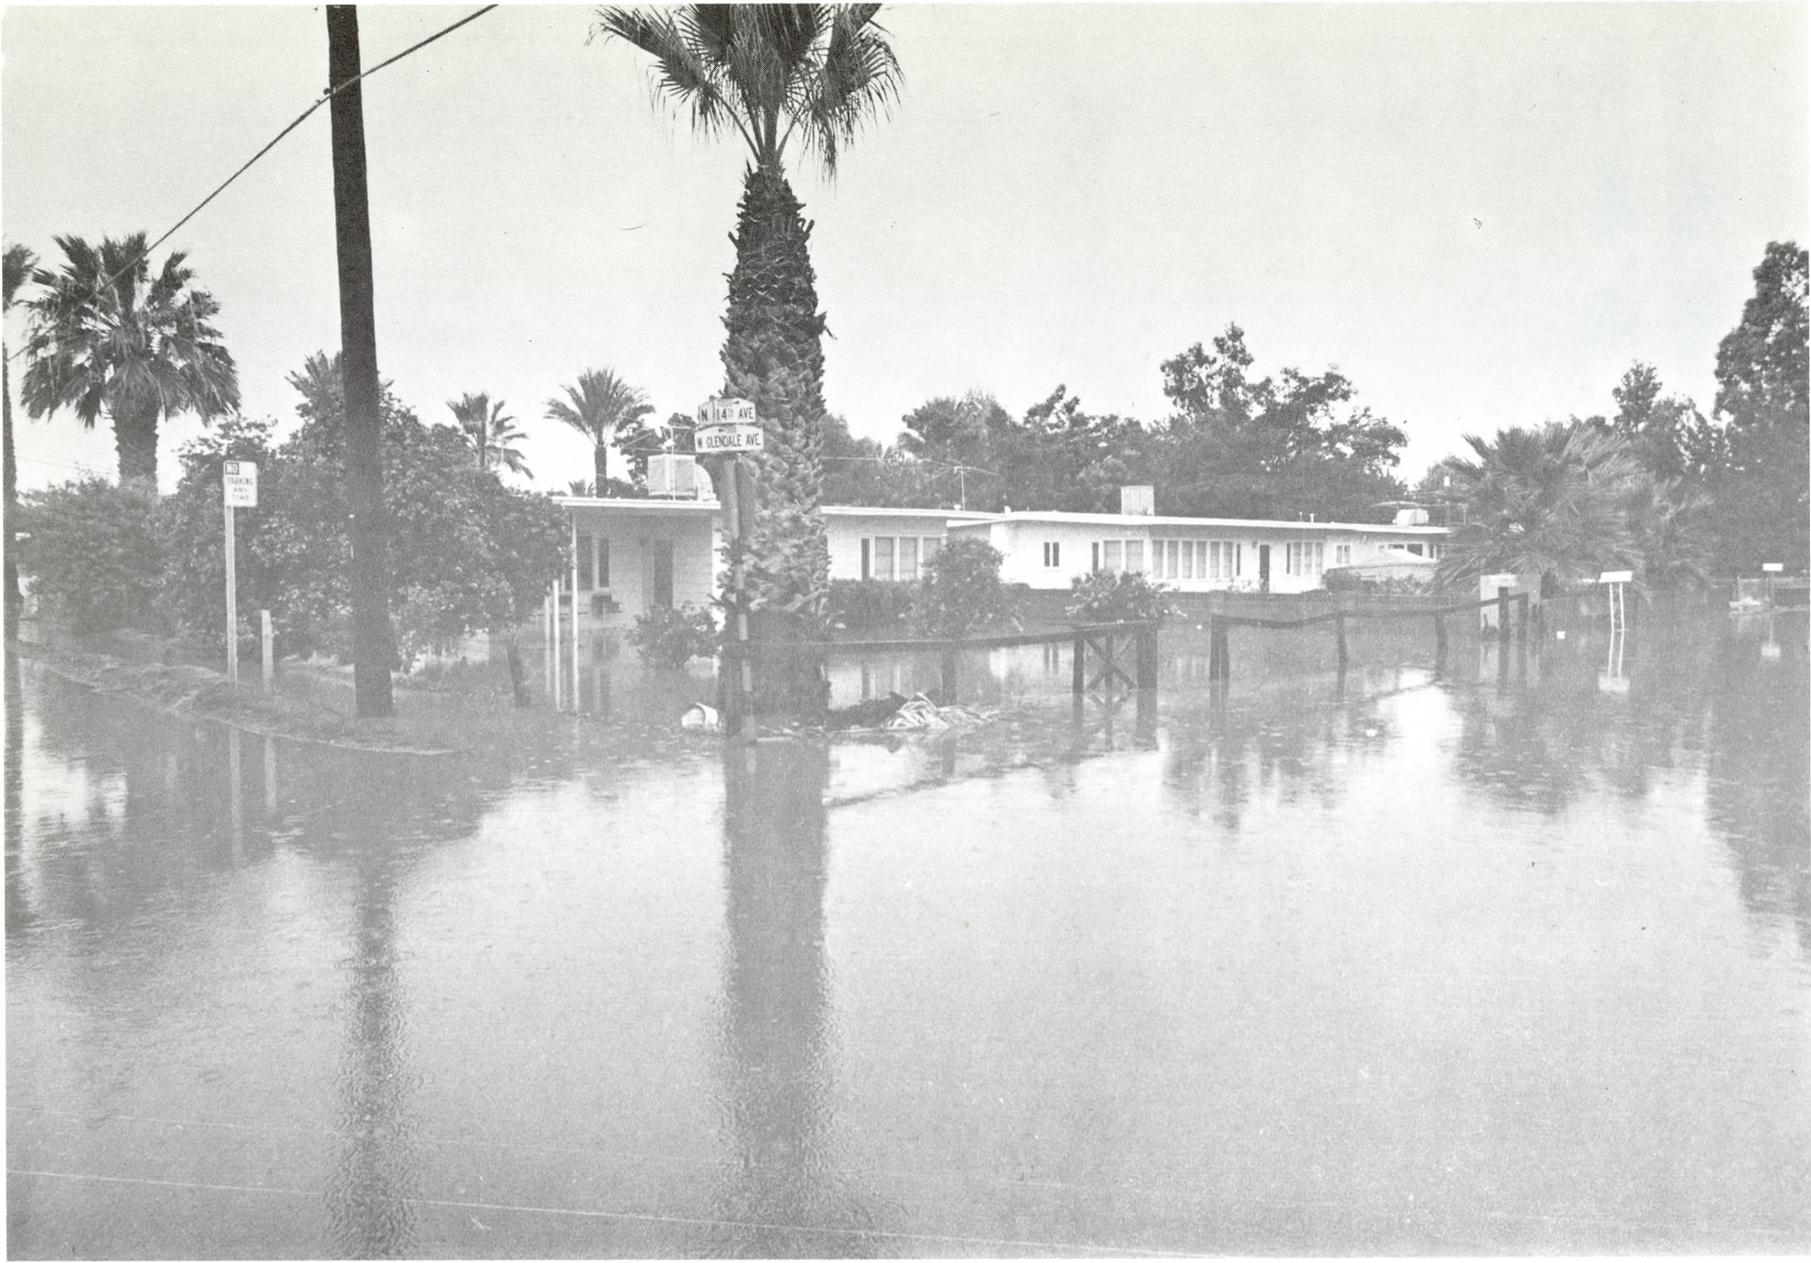
PHOTO # 2

INTERSECTION AT 14TH AVENUE AND GLENDALE ARIZONA REPUBLIC

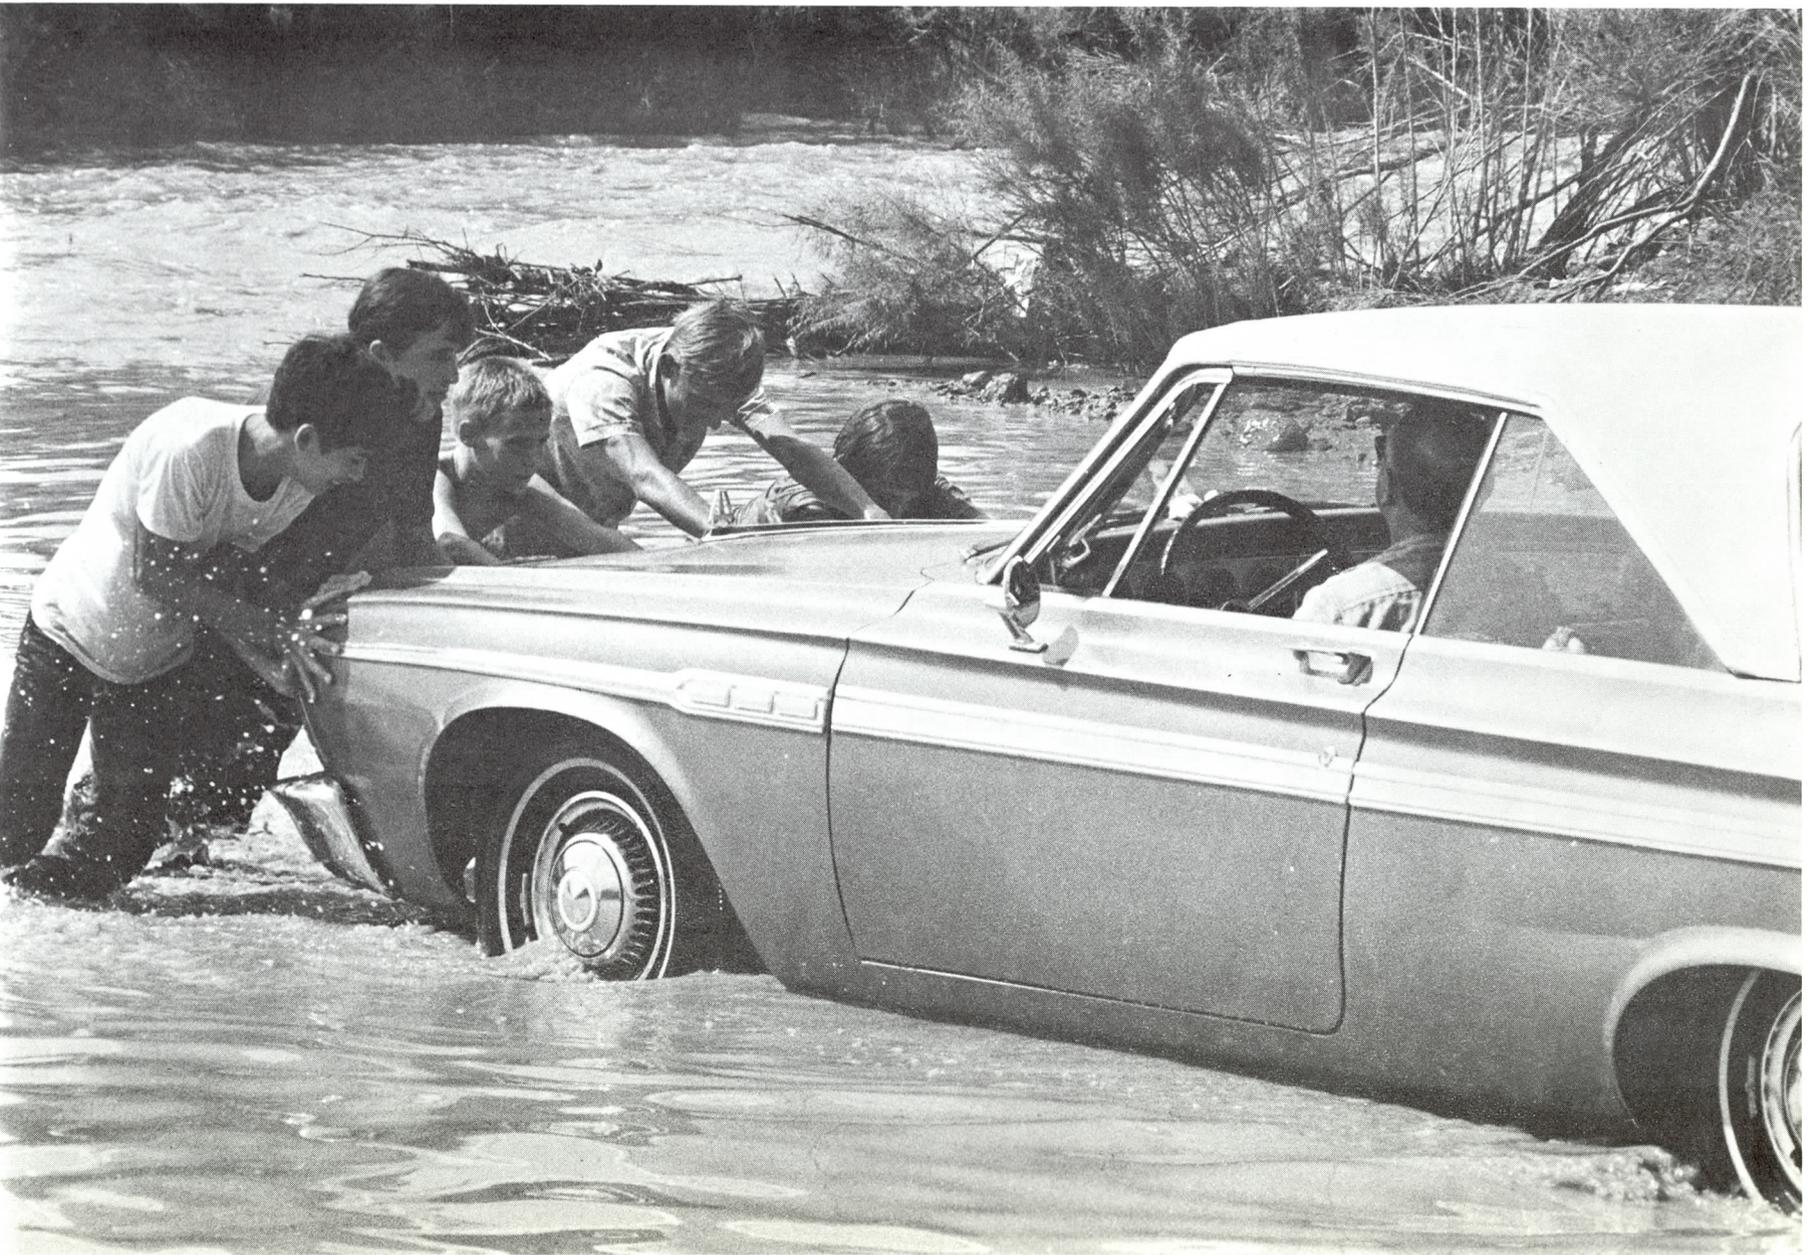
PHOTO # 3

BELL ROAD AT CAVE CREEK WASH

Cave Creek Wash at Bell Road (see photo on page 10) - 1500 cfs

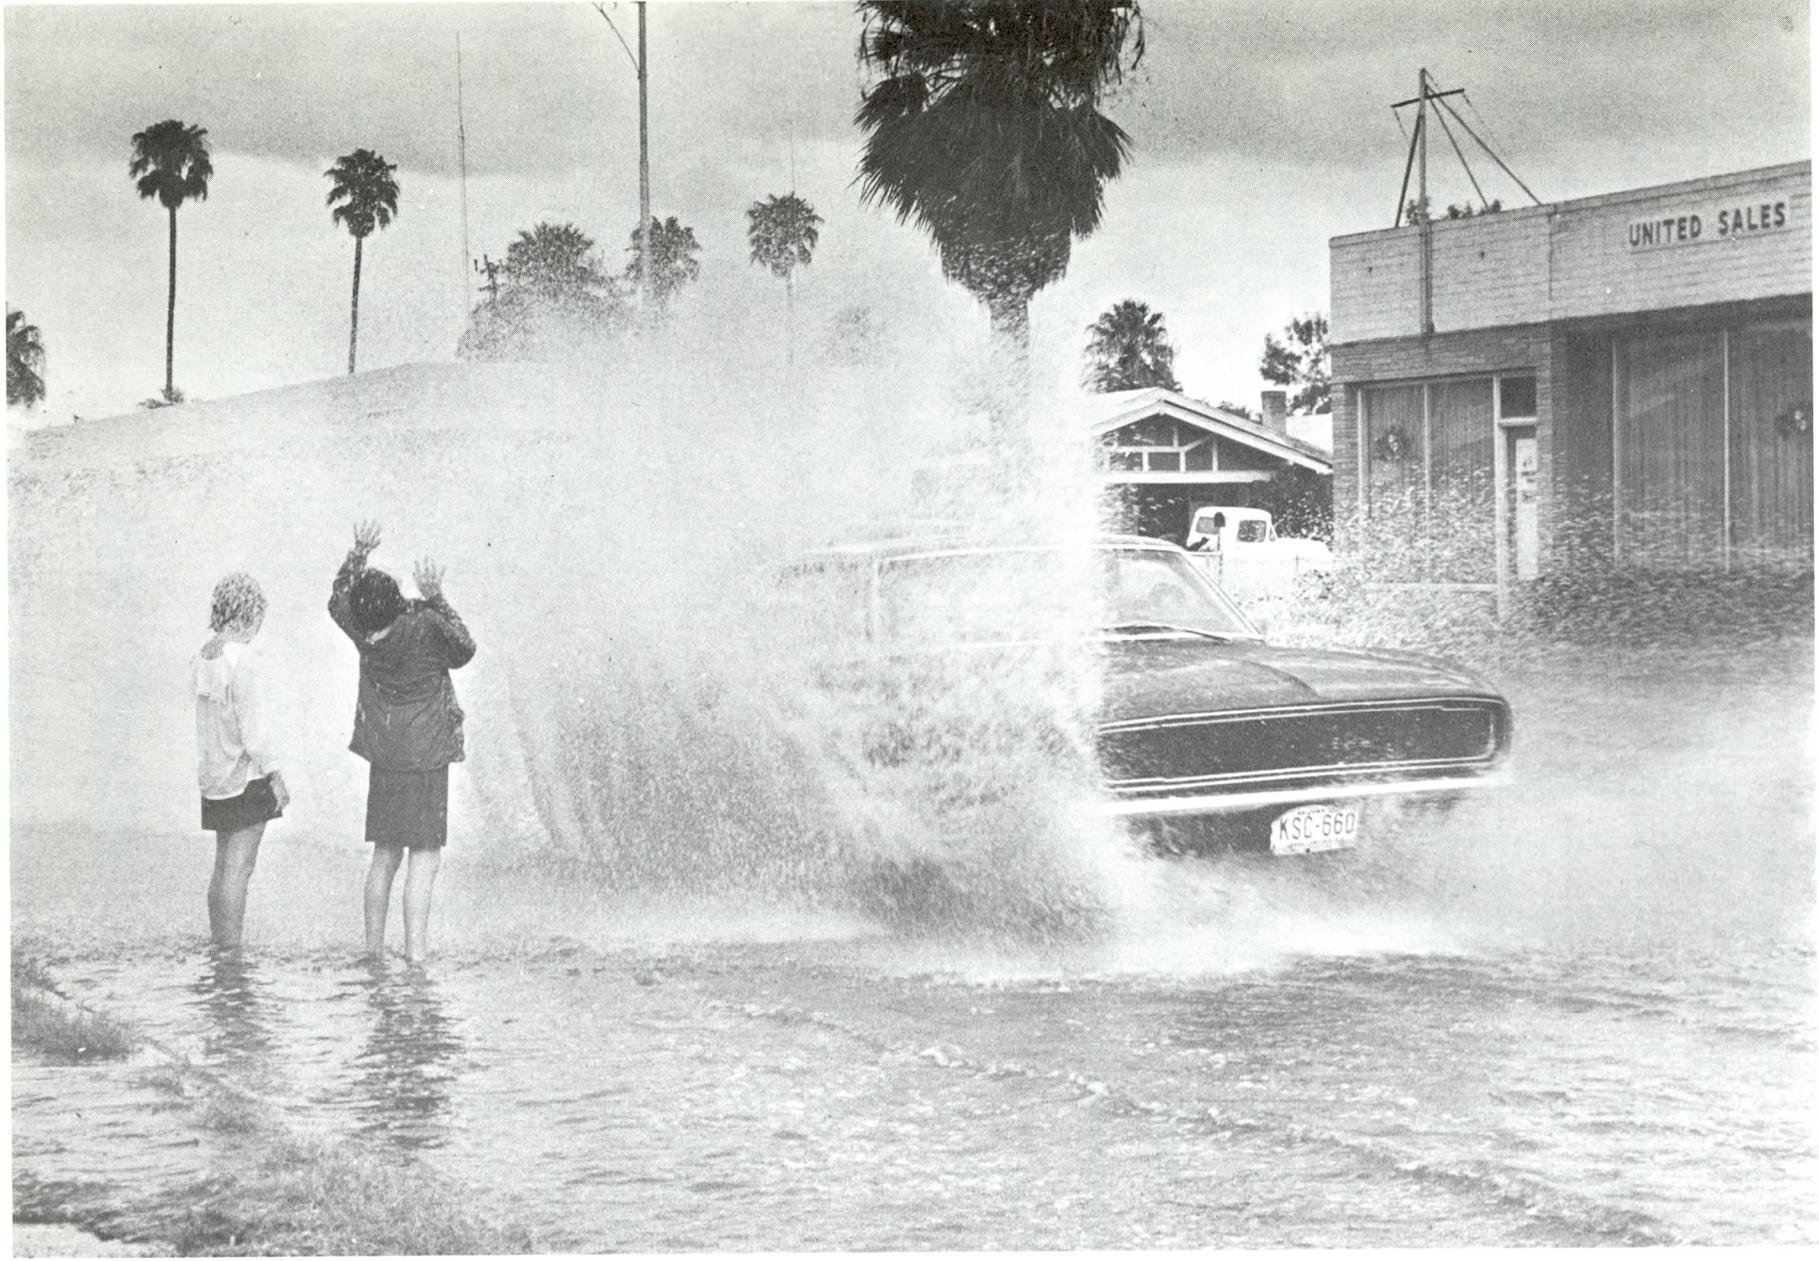
PHOTO # 4

3RD STREET AND ROOSEVELT

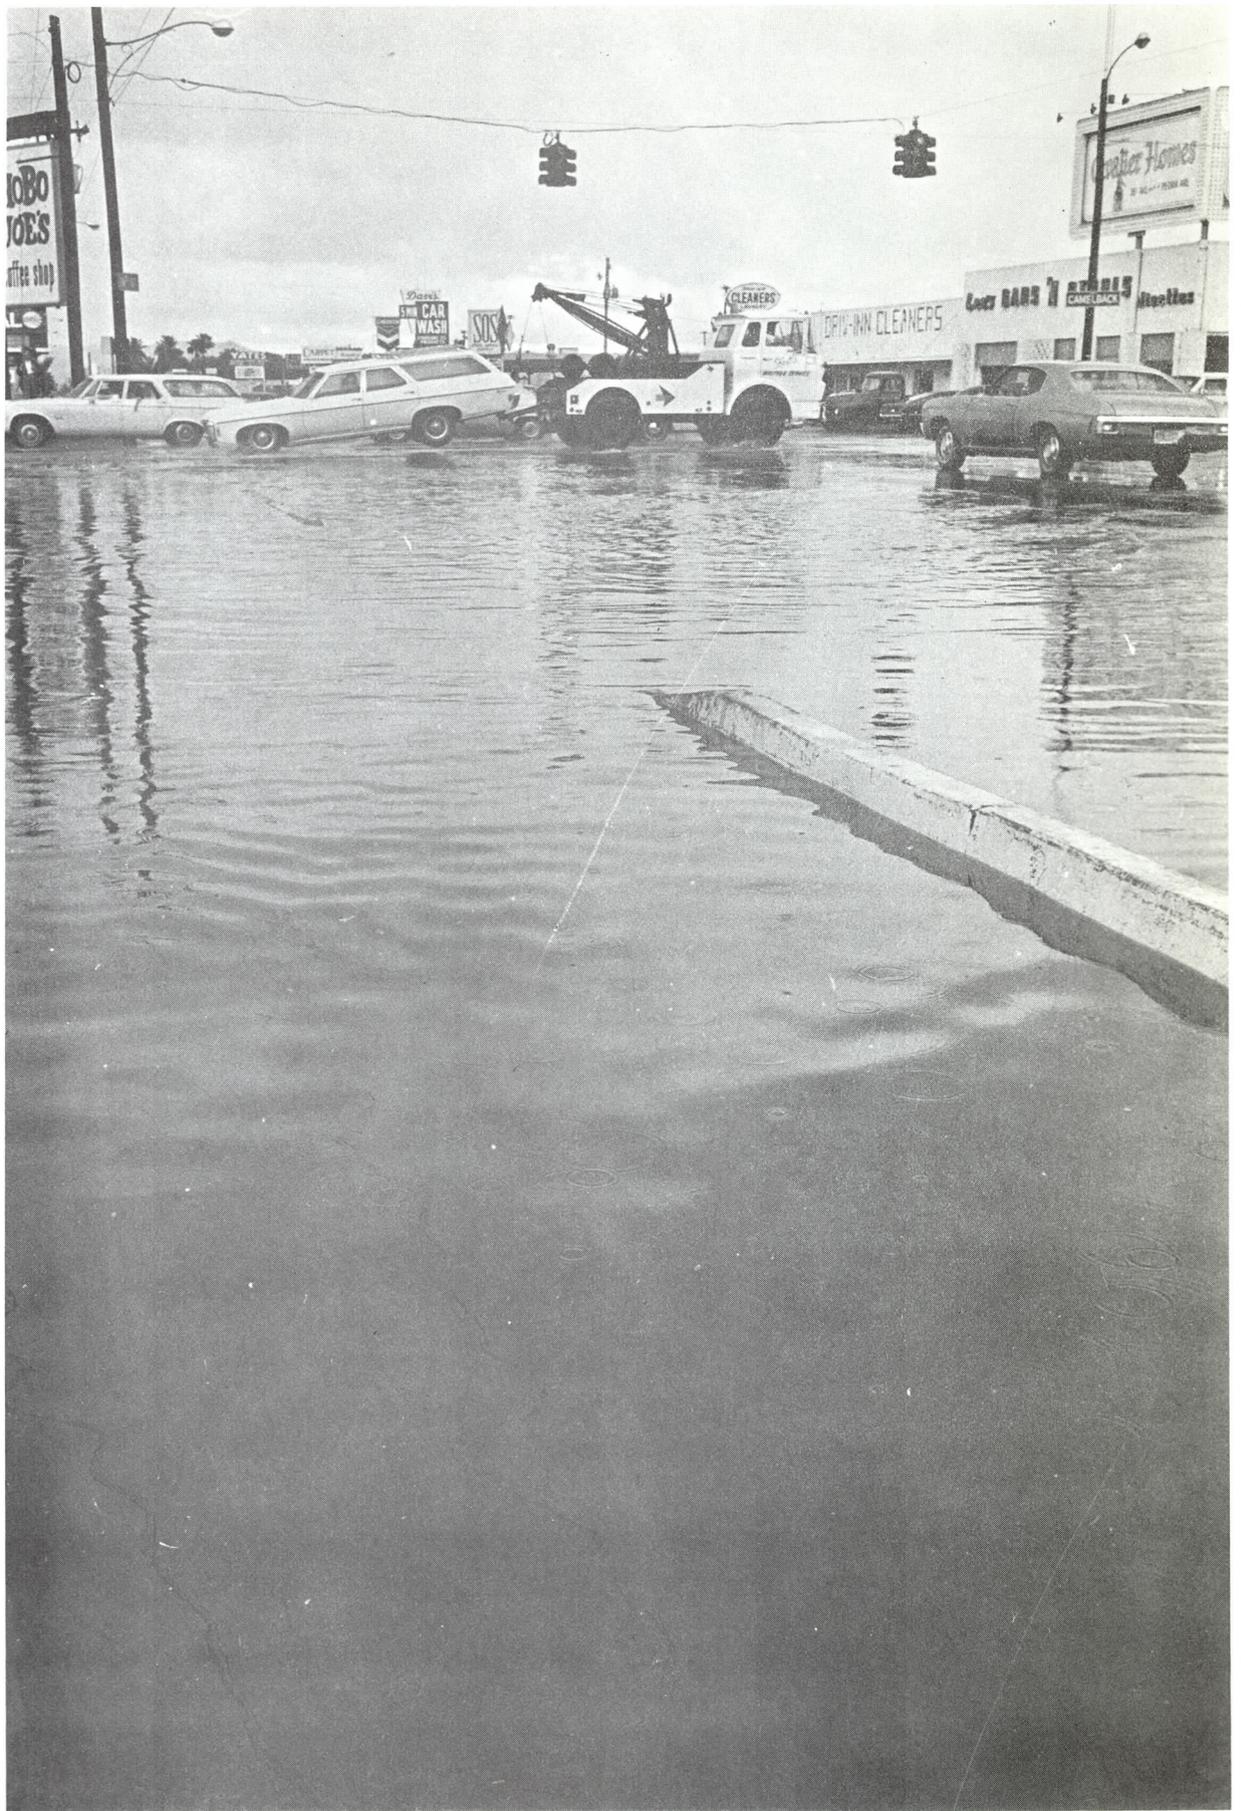
PHOTO # 5

16TH STREET AND CAMELBACK

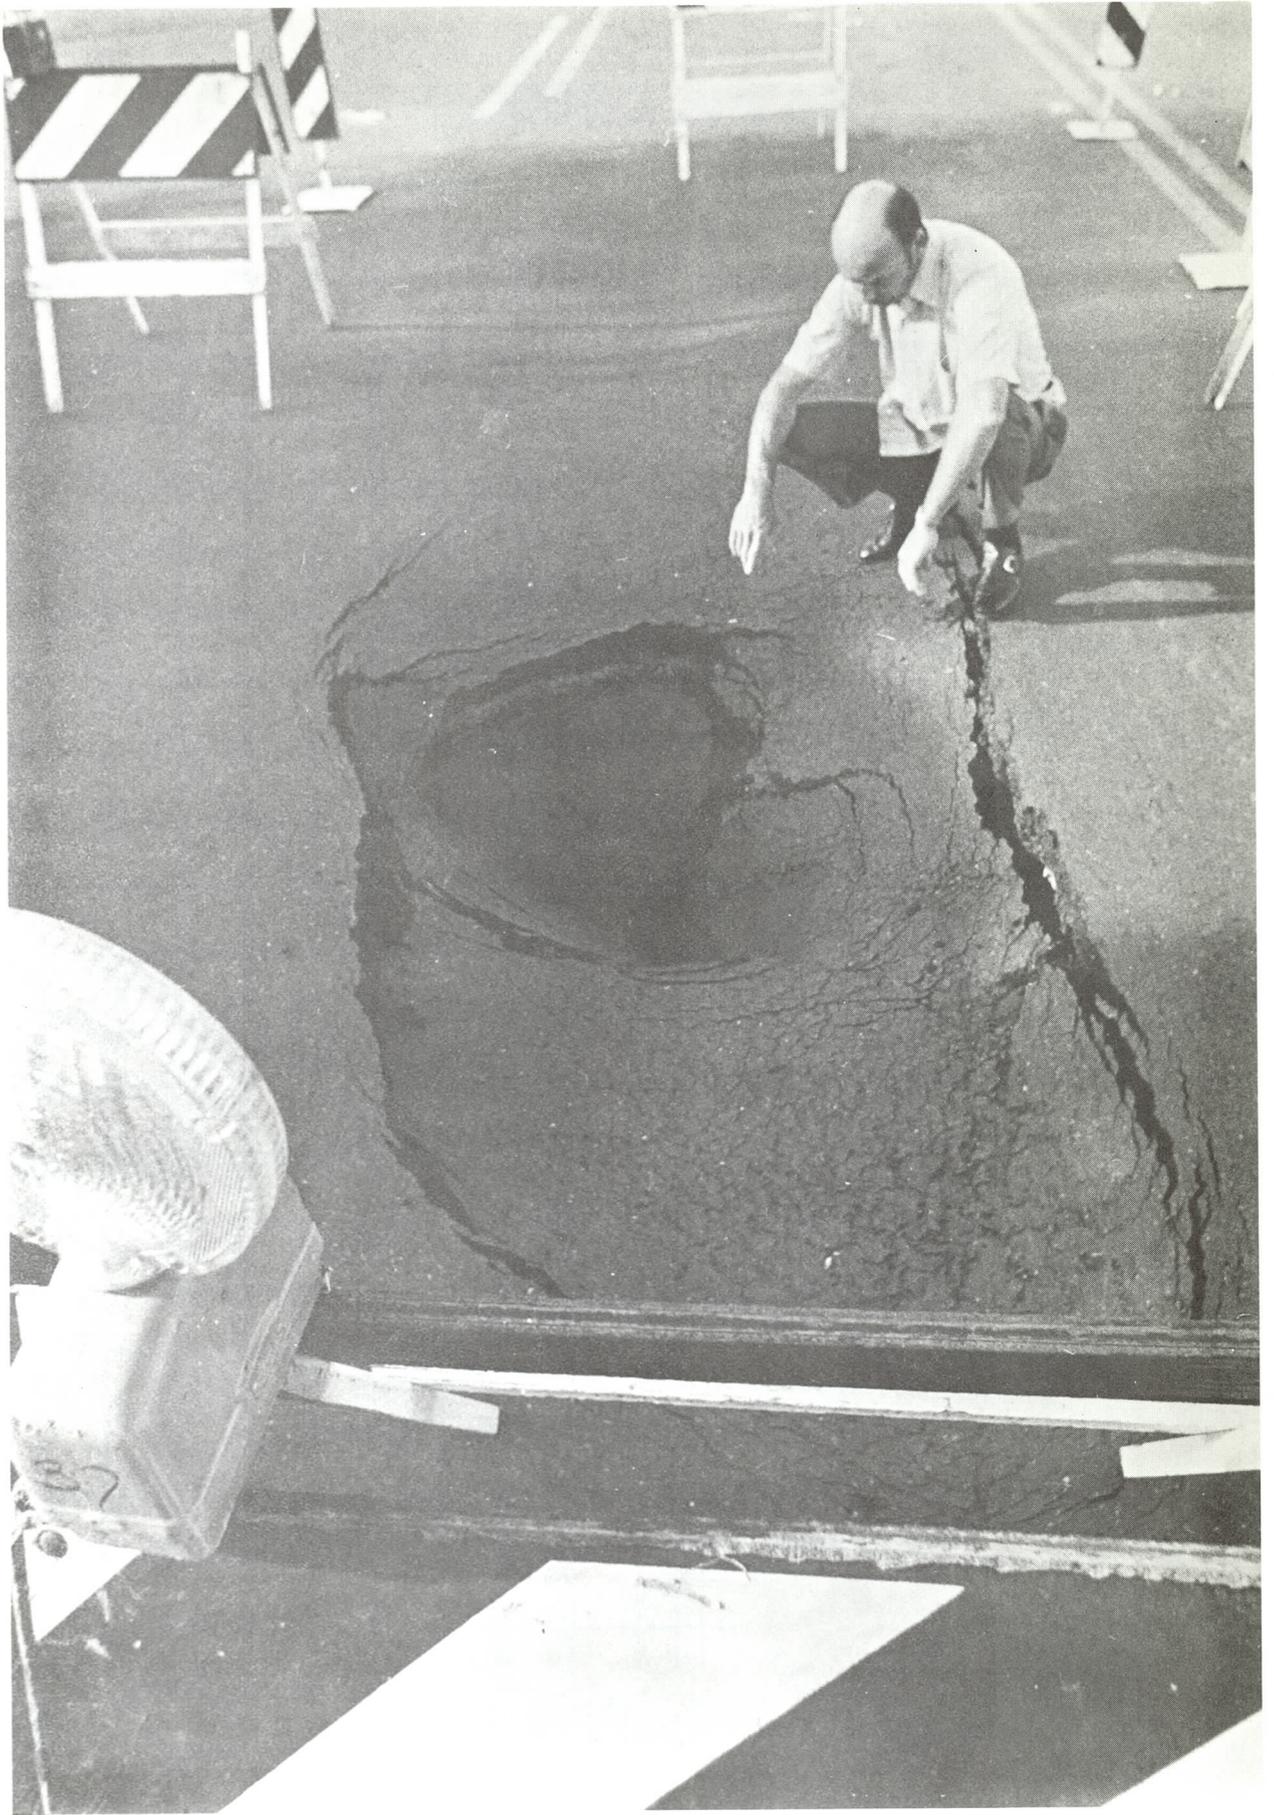
PHOTO # 6

7TH STREET AND WILLETTA

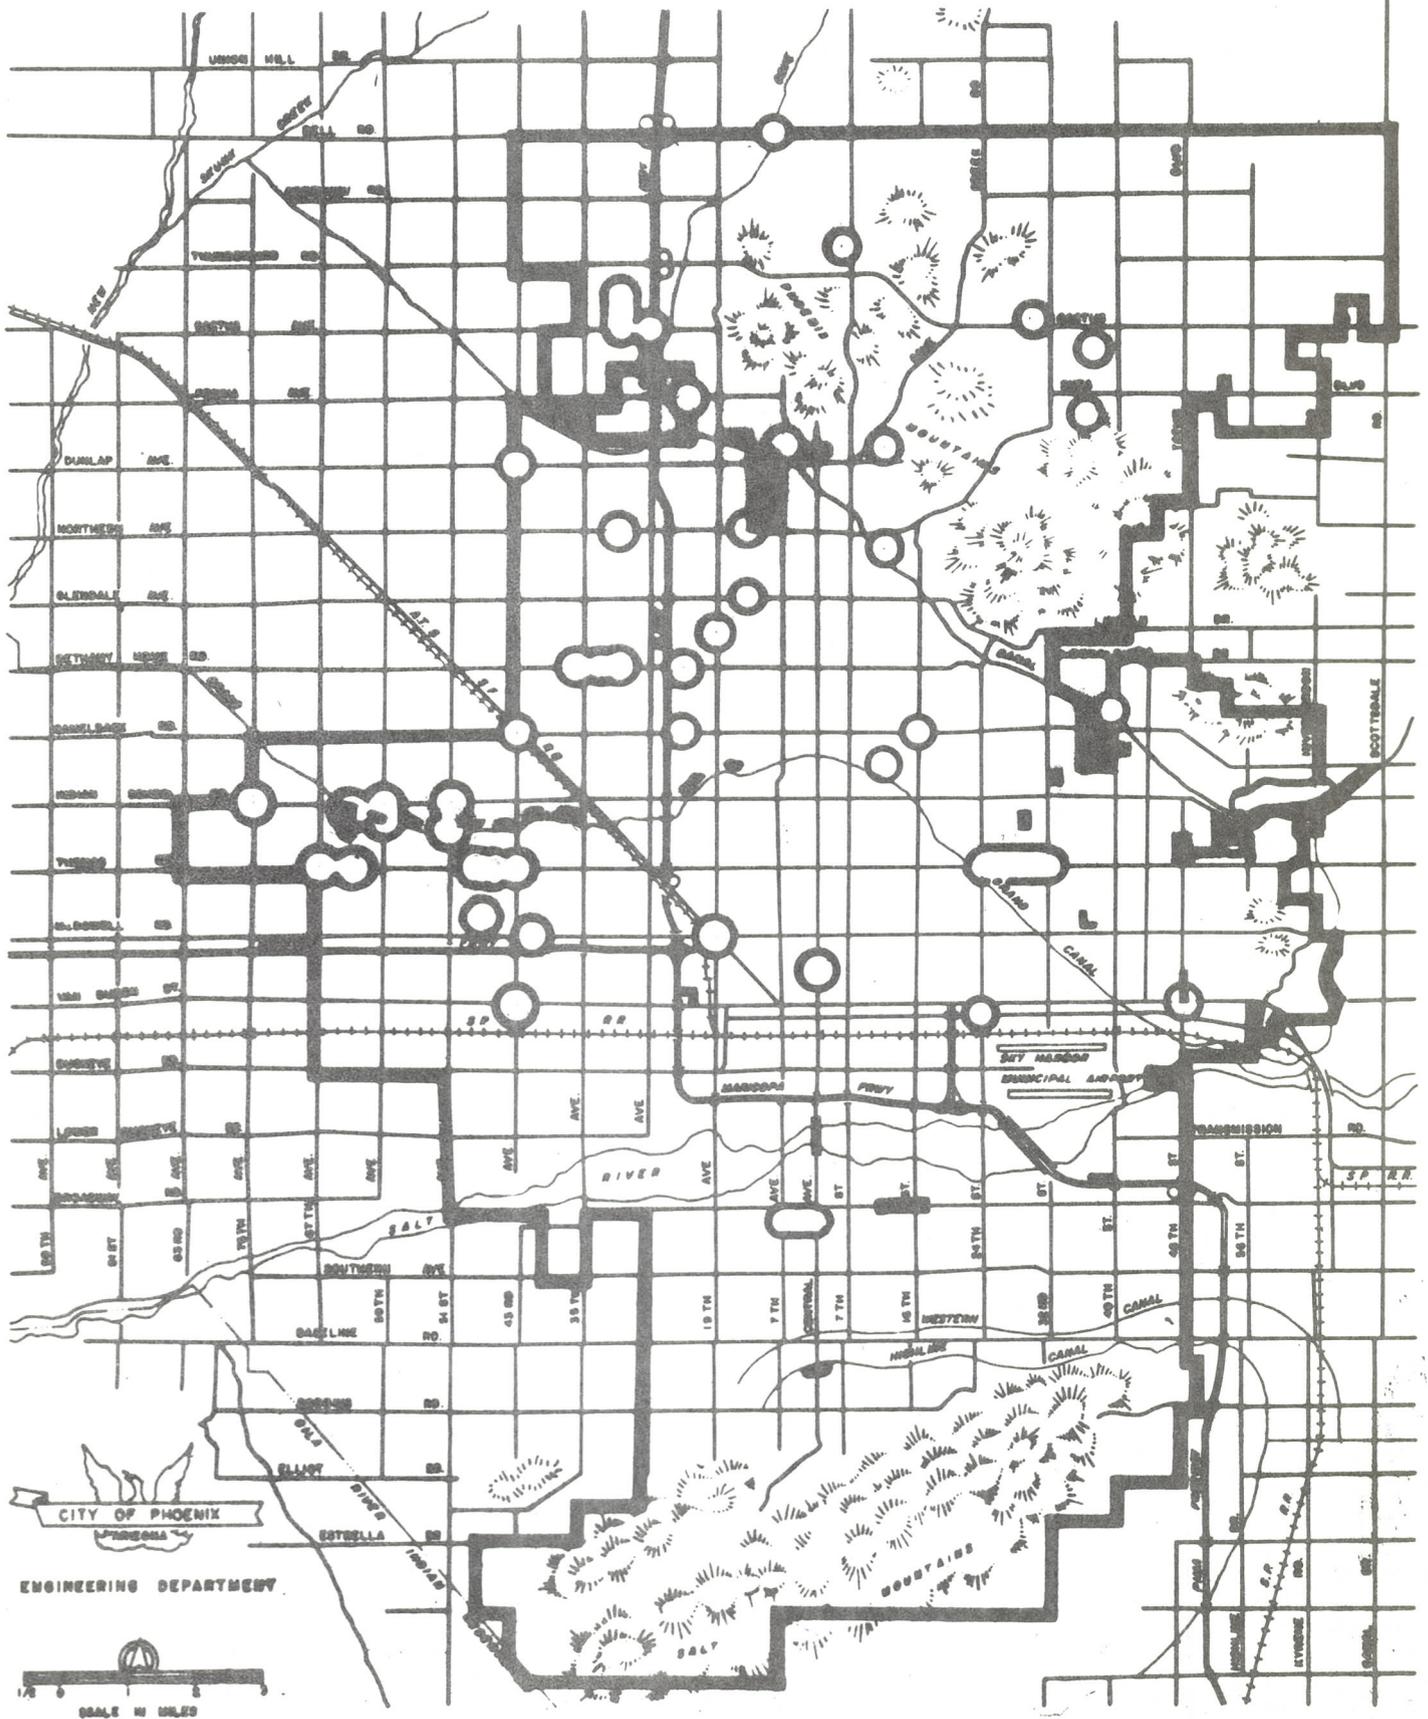
Figure 2

As can be seen from figure 2, portions of the City were sheet flooded, with the streets carrying the water. Fully improved streets, with storm drains handled the flow well, but some drainage problems occurred at intersections. A large number of intersections had deep water, with some overflow of curb and gutter, but little or no property damage. Generally, only in depressions and behind large obstructions did sufficient ponding occur to cause property damage.

FLOODED AREAS

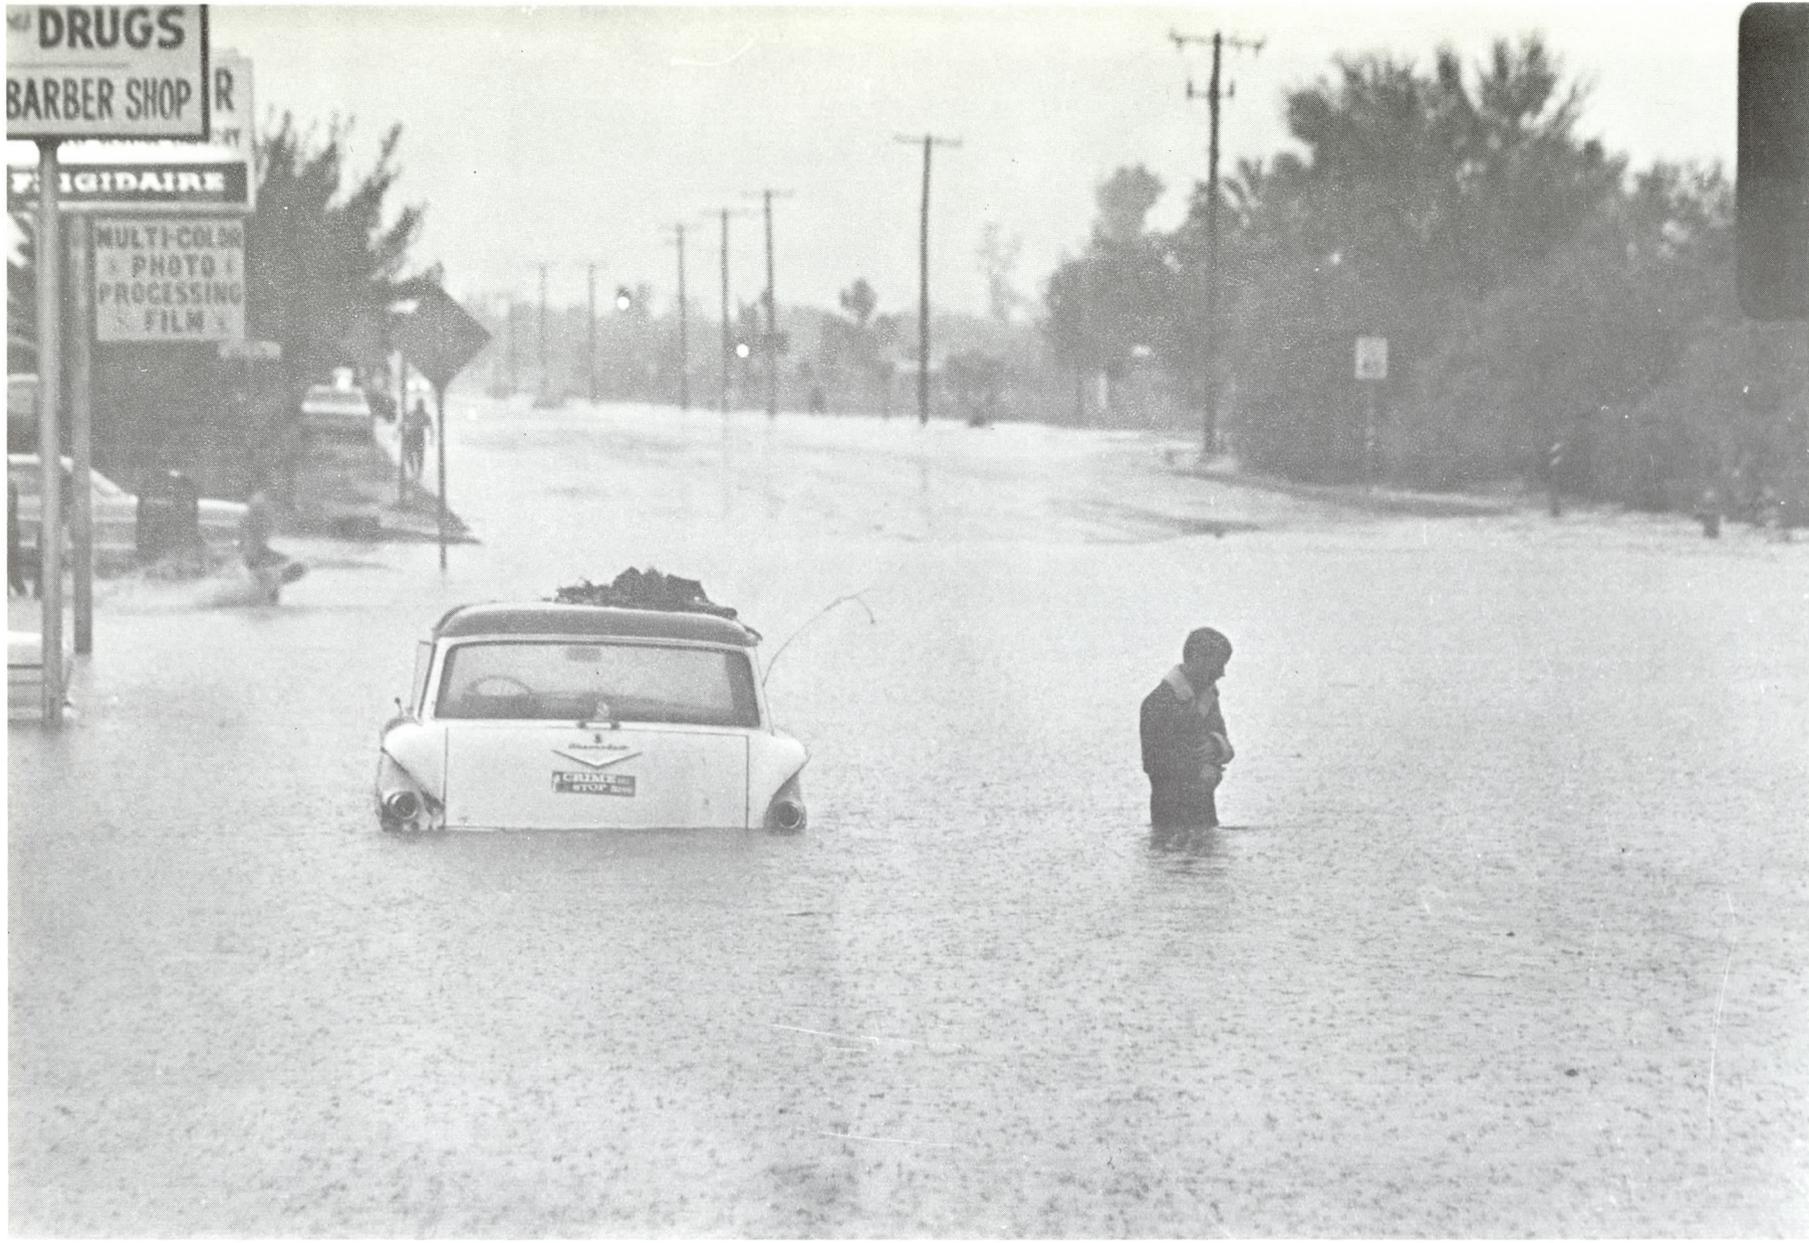
PHOTO # 7

Several businesses were flooded in the vicinity of 48th Street and Melvin as water flowed west from Papago Park; however, damage was slight.

48TH STREET, VAN BUREN TO MELVIN

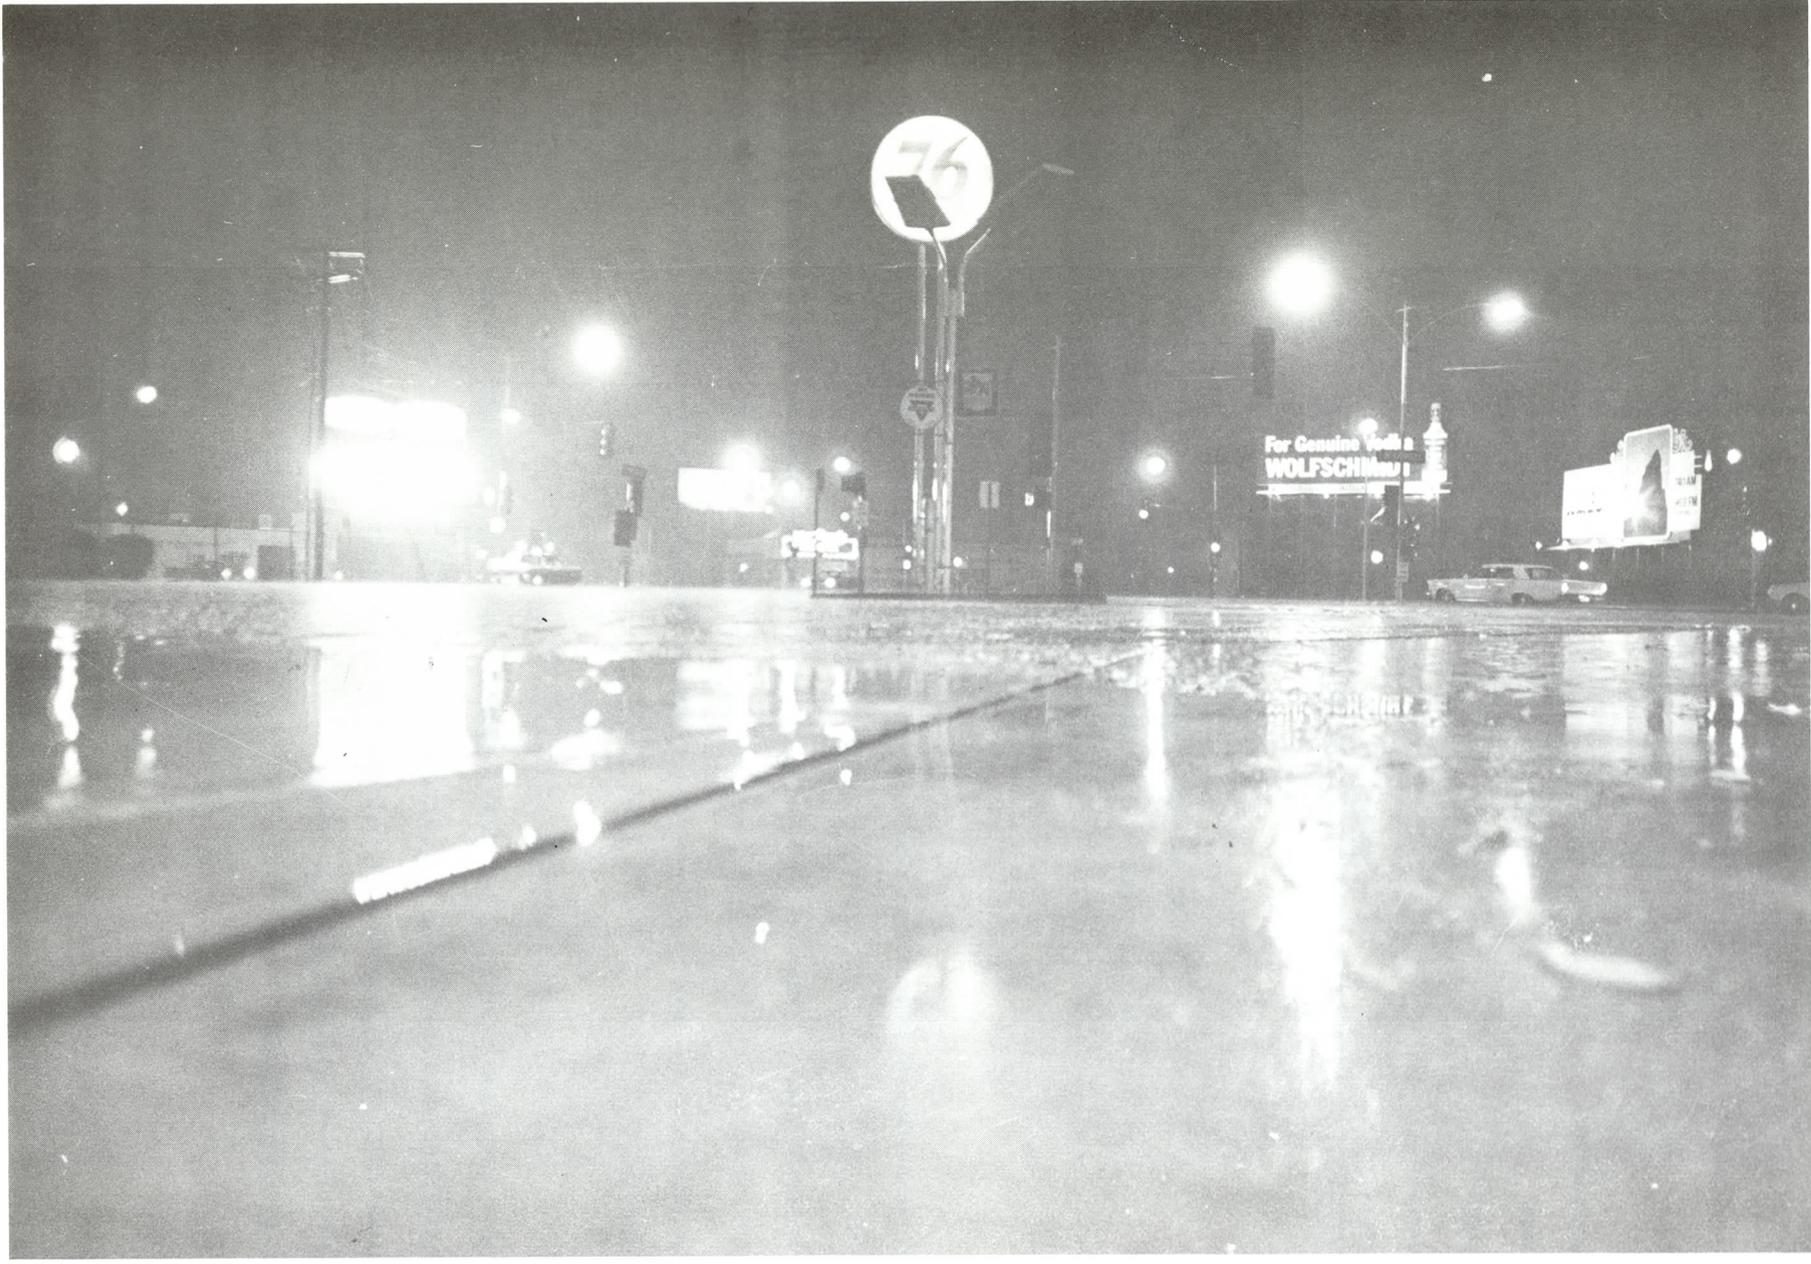
PHOTO # 8

Flooding and property damage occurred in numerous areas along the Grand Canal, from 19th Avenue west, due to ponding behind the embankment.

19TH AVENUE, MCDOWELL AND GRAND AVENUE
