AFTER ACTION REPORT

The Floods of January 1993

Flood Control District of Maricopa County April 1993

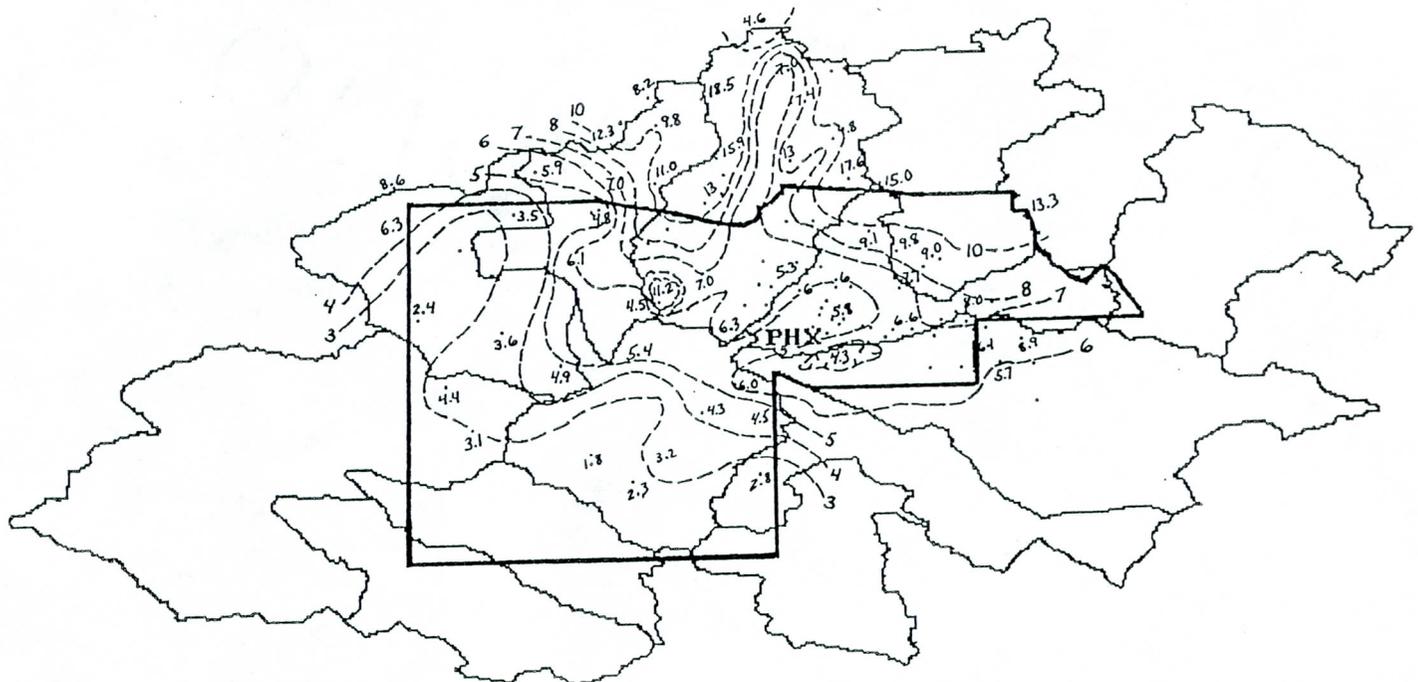
Isohyetal Map for Maricopa County
Storms of Dec. 27, 1992
thru Jan. 19, 1993

An Isohyetal map was produced showing some of the precipitation totals for the period December 27, 1992 through January 19, 1993.

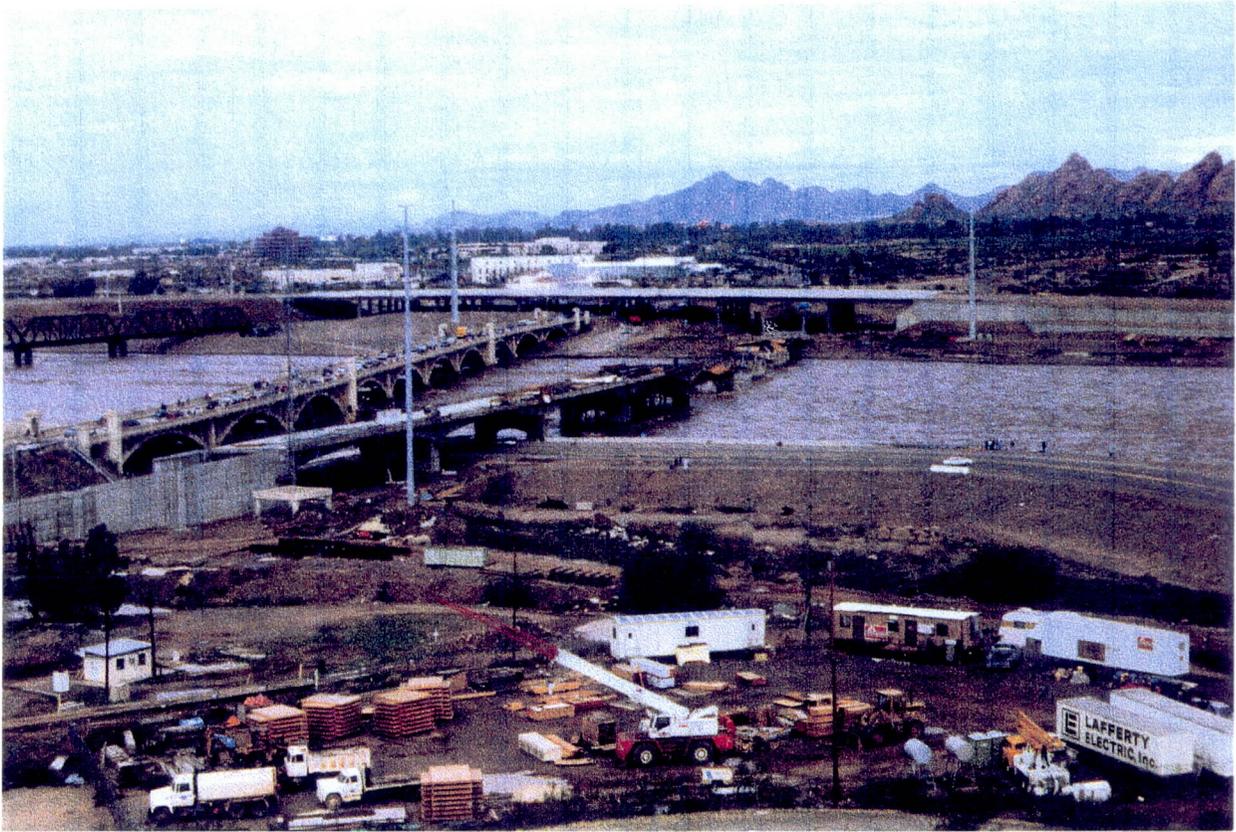
Channelization in the Salt River in Tempe successfully contains flows of 124,000 cubic feet per second on January 8-9, 1993.

Levees constructed along the Salt River in Tempe successfully contained flows of 124,000 cfs, although an analysis of levee erosion is underway. The diagram below shows the location of the levees relative to the areas inundated in February 1980 when 178,000 cfs flowed down the Salt River. The levees are designed for flows of up to 215,000 cfs. Minor damage caused by erosion was reported on several channels and floodways elsewhere in the County, including the East Maricopa Floodway, Skunk Creek Channel at 35th Avenue, Pass Mountain Diversion Channel, Spookhill Outlet Channel, Signal Butte Floodway and Bulldog Floodway.

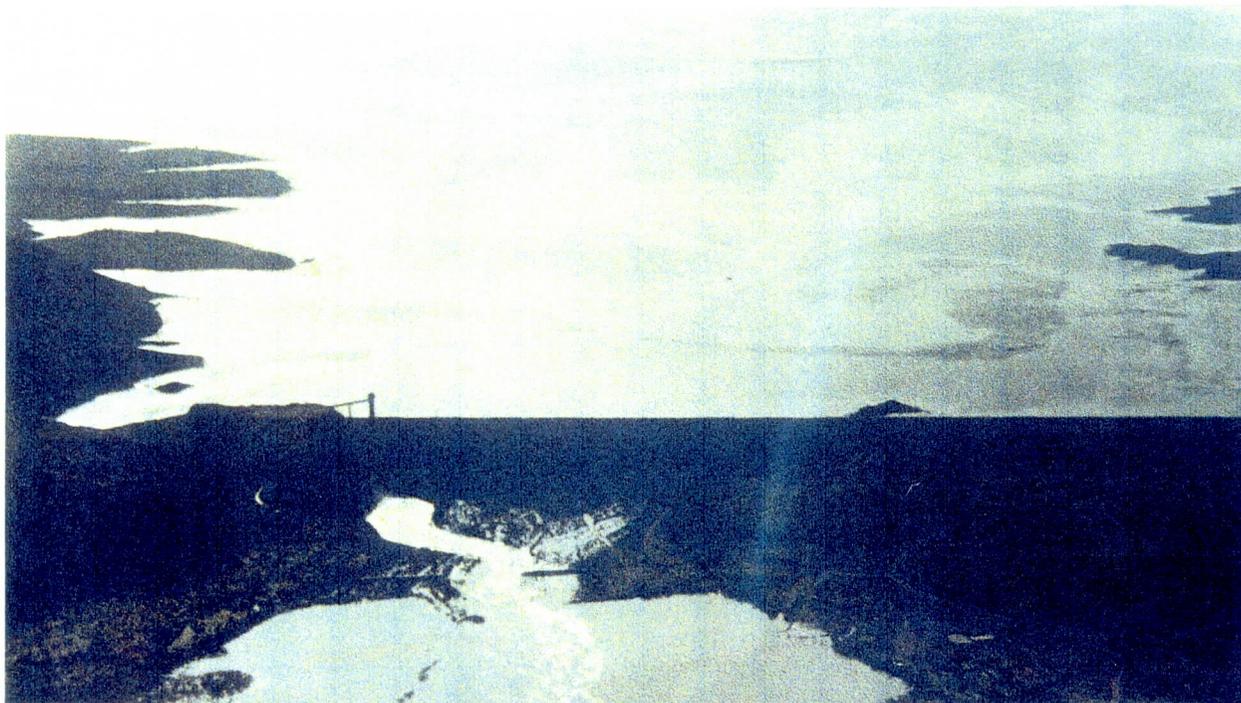
A large lake forms behind Painted Rock Dam on the Gila River as seen from the air on February 3, 1993.

Below its confluence with the Salt River, the Gila River attained an estimated peak discharge of 137,300 cfs on January 8 at 7:45 P.M. as recorded by a District stream gauge located at the Estrella Parkway crossing. Flows in the Gila River accumulated behind Painted Rock Dam west of Gila Bend, resulting in a record impoundment of 2.8 million acre-feet of water, which is 117% of capacity. The surface area was estimated at 150 square miles.¹⁰ Water eventually began flowing over the spillway of Painted Rock Dam on February 21 and peaked February 27 at 26,000 cfs.¹¹ This was the first time since the dam's construction in 1963 that releases occurred at the spillway.

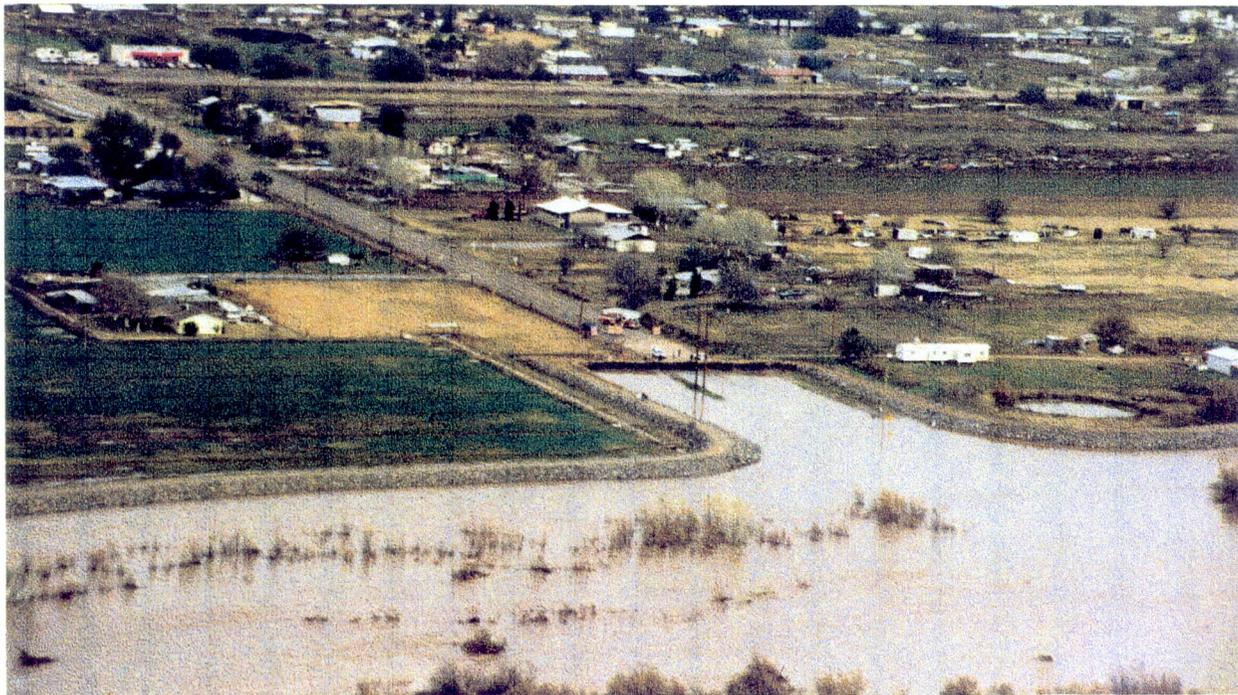
Flows in the Gila River are held back January 9, 1993 by a levee protecting homes and property in Holly Acres. Crews placed sand bags across 115th Avenue to keep water from surging northward.

Approximately 200 families in the community of Holly Acres were evacuated January 8 when rising waters threatened to overtop a levee constructed by the District in 1985 to protect the community. Holly Acres is located near the confluence of the Gila and Salt Rivers. The levee successfully protected the community and the evacuees were allowed to return to their homes late on January 9. (See section of this report on FCD structure performance for additional information regarding the performance of the Holly Acres Levee)

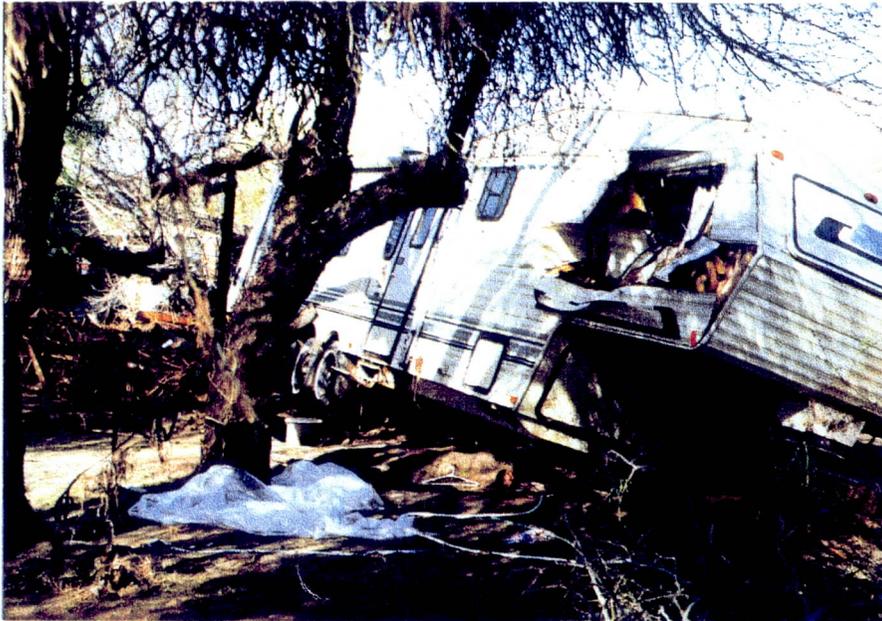
This trailer was among many damaged by Hassayampa floodwaters on January 8, 1993 downstream of Wickenburg below the Nature Conservancy

The Hydrology Division's Floodplain Management Branch responded to flooding complaints from residents living along the Hassayampa River south of Wickenburg and the Nature Conservancy. A Floodplain Representative and a District Public Involvement Coordinator met with about 30 residents on March 1 to hear their concerns and provide recommendations for floodproofing and other flood mitigation possibilities. A summary of the meeting is found in **Exhibit M**, along with a copy of a letter sent to the District requesting assistance.

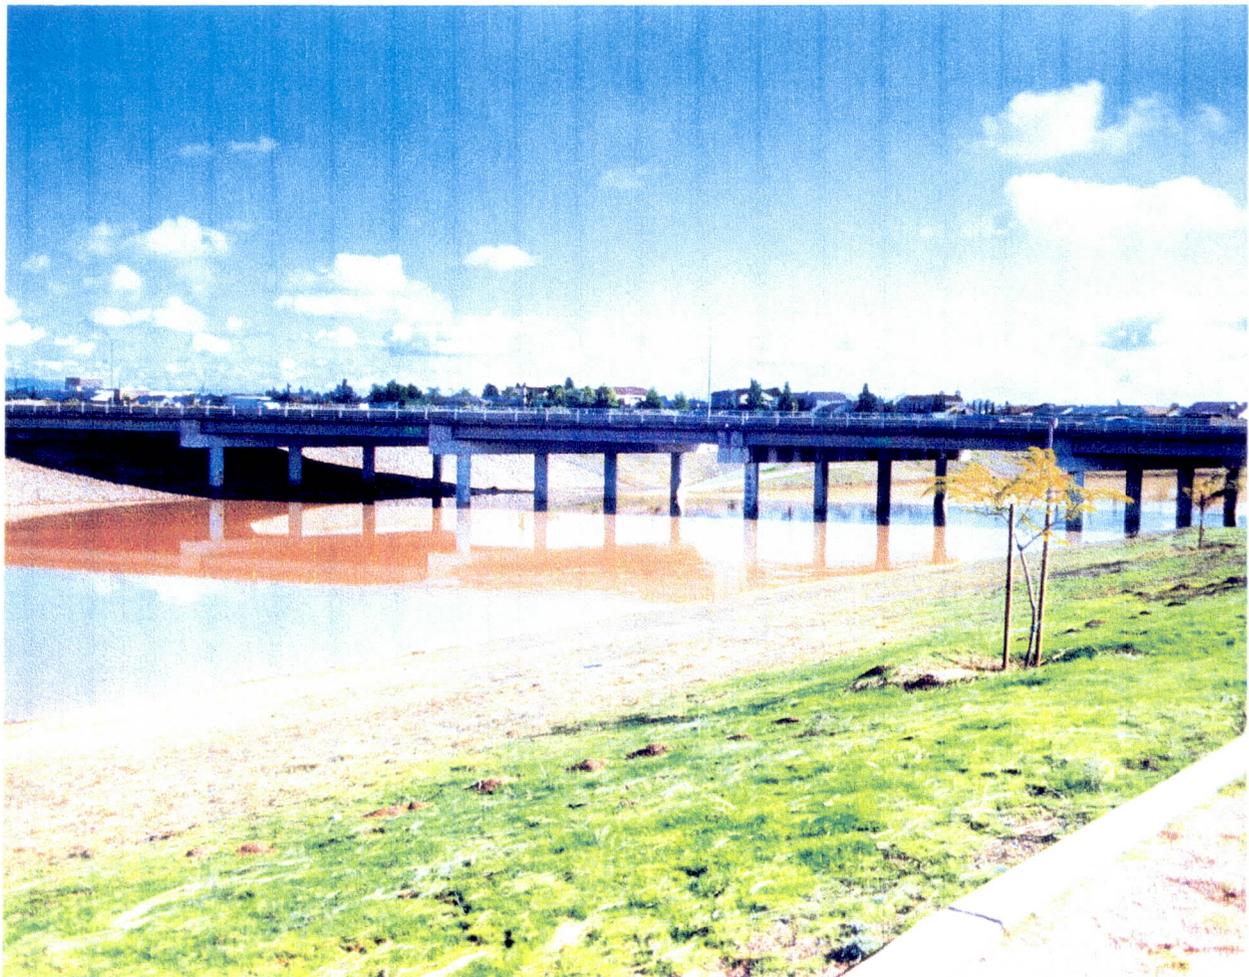
Stormwater from January rains flow in the Arizona Canal Diversion Channel at the 67th Avenue crossing as seen on January 11, 1993.

Flows in the Arizona Canal Diversion Channel began registering on District gauges the morning of January 7 and peaked on January 11 with a depth of 3.6 feet at 67th Avenue. The peak discharge at this location was 480 cfs.

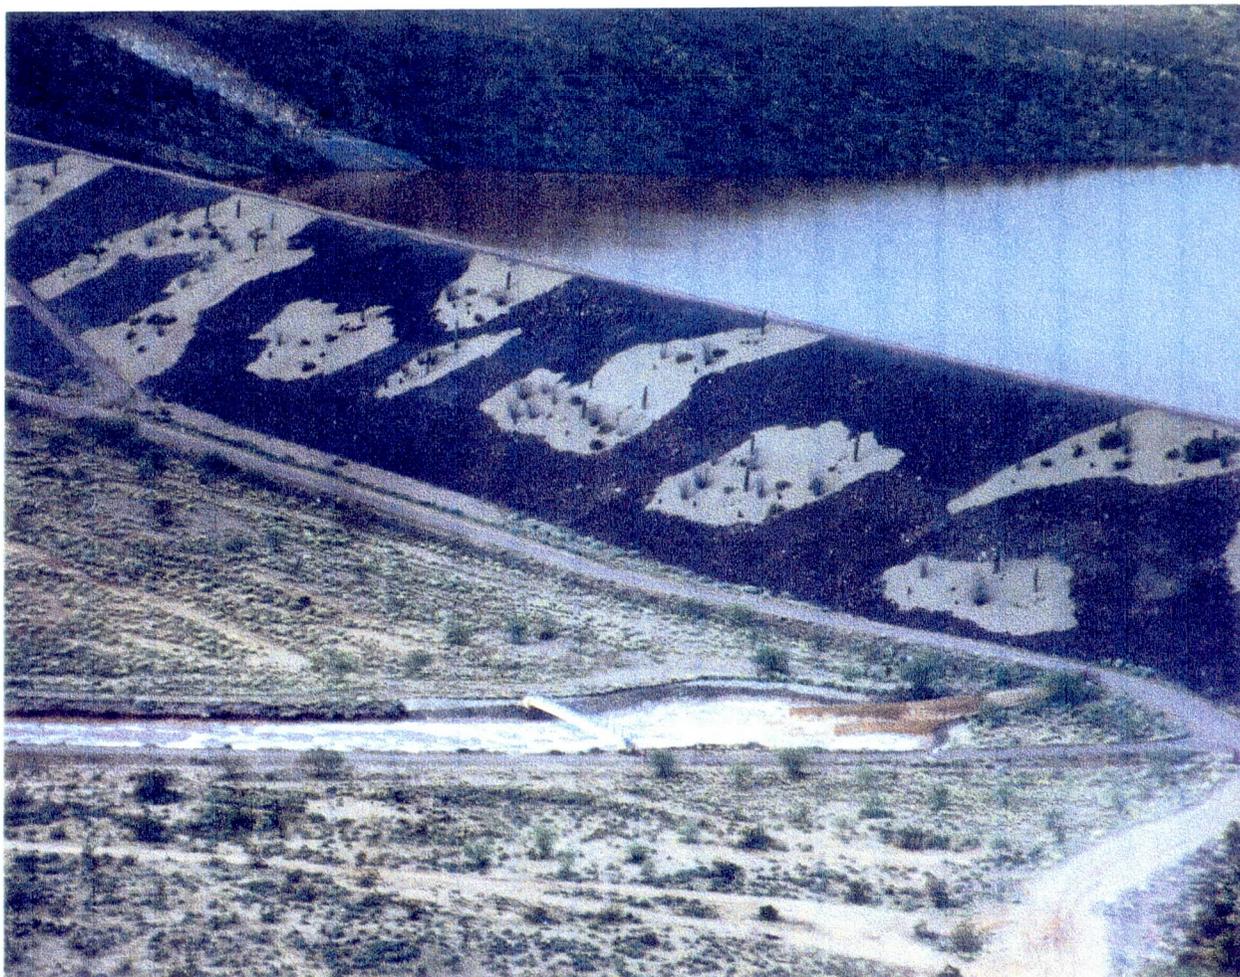
Stormwater runoff collects behind New River Dam on January 9, 1993 and is released slowly downstream.

Peak flows in New River at New River Road were estimated at over 28,000 cfs, causing significant impoundments of stormwater behind New River Dam which peaked January 8 at 4:13 p.m. with a depth of 44 feet and storage of 15,000 acre feet.

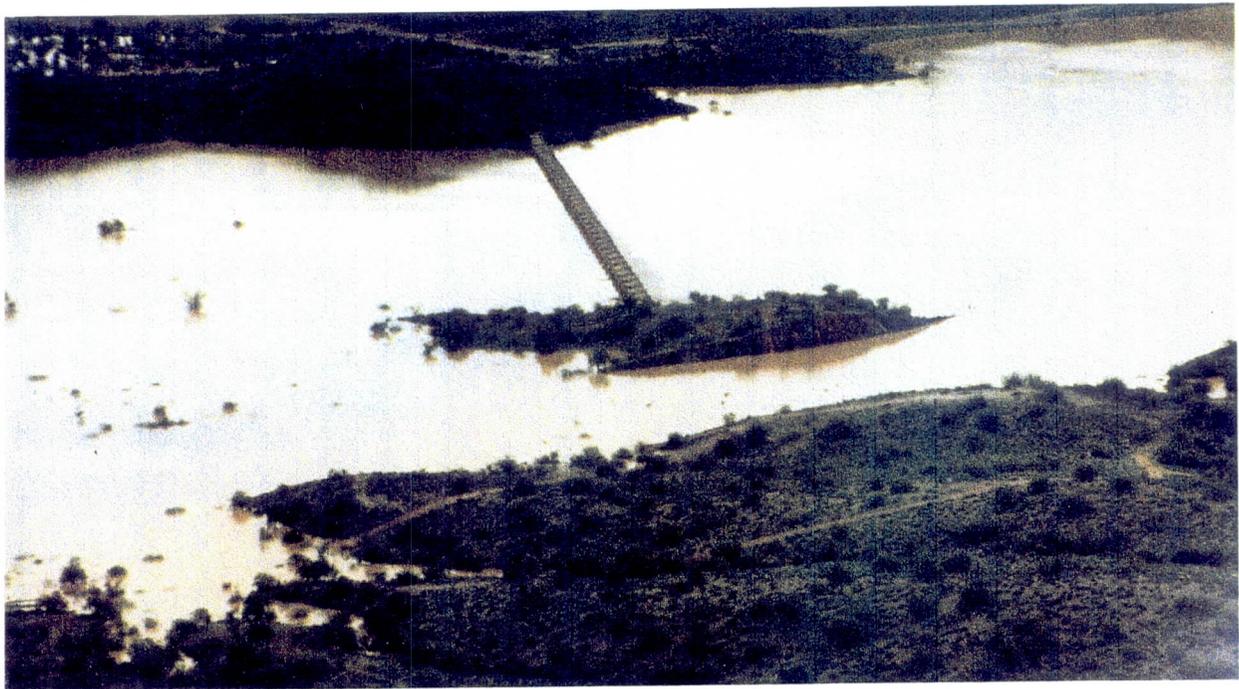
Cave Creek Dam, built in 1923, is shown nearly submerged within the Cave Buttes Dam Reservoir on January 9, 1993

The largest impoundment of stormwater ever recorded behind Cave Buttes Dam occurred during the flood event when 17,500 acre feet of stormwater impounded behind the structure to a depth of 75.8 feet. The peak occurred on January 11.

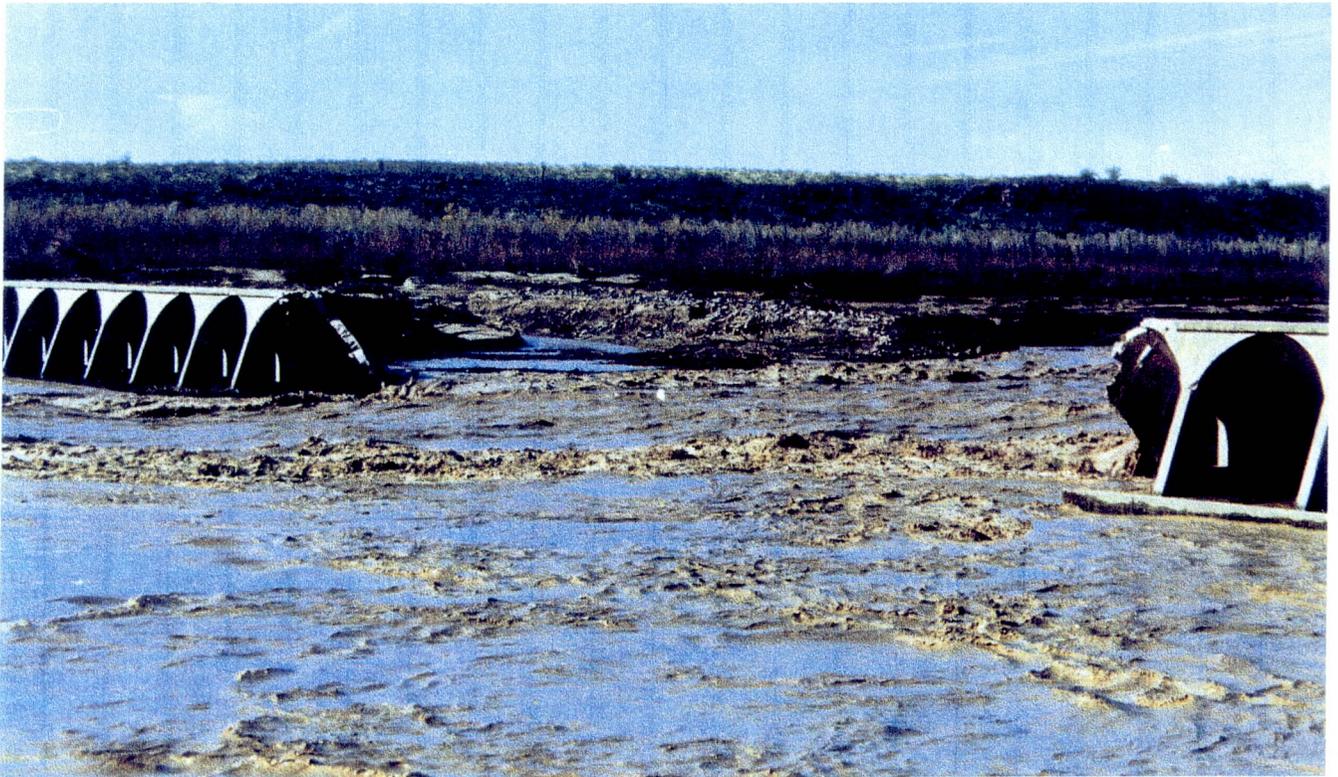
Breached section of Gillespie Dam as seen on January 24, 1993.

At the western end of the District's clearing project is Gillespie Dam, a privately-owned concrete dam constructed in 1921 as a diversion structure to divert surface water from the Gila River to irrigation canals supplying water to more than 50,000 acres of farmland in the Gila Bend area. On January 9, an approximately 100-foot section of the dam failed. As of the writing of this report, the breach is now approximately 230 feet. A report prepared by the District's planning branch outlines four alternative approaches to repair or replacement of the dam. This report is attached as **Exhibit P**.

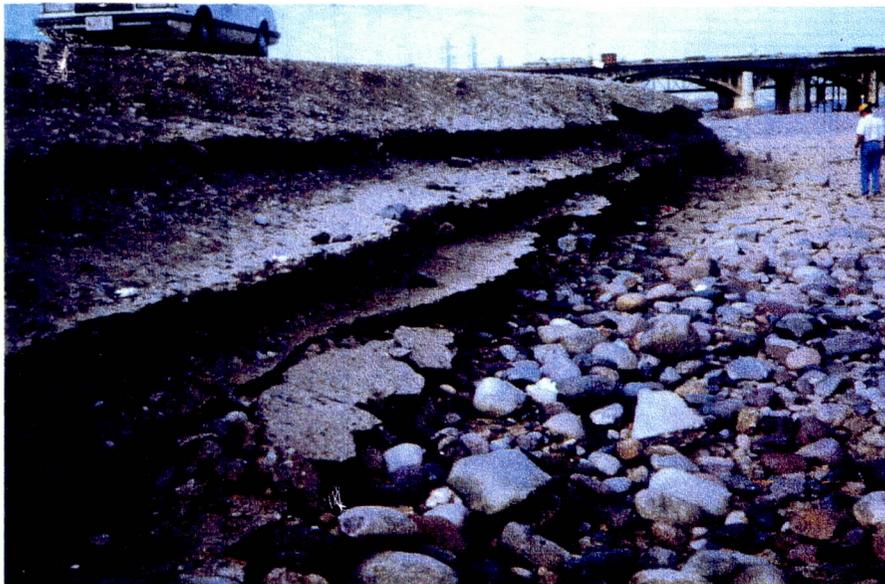
Erosion of soil cement levees along north bank of Salt River in Tempe

Phoenix reported the Verde Water Treatment Plant received considerable damage from high water and would probably have to be shut down for several months. Preliminary cost estimates for the City of Phoenix to repair flood damages, including mitigation efforts, is estimated at \$4.2 million. Half of the estimate is for funds to replace the embankment lost at Sky Harbor International Airport along the north bank of the Salt River below the southern runway as well as to improve the riverbank with reinforced barriers to prevent future erosion.
