**PHASE I ENVIRONMENTAL
SITE ASSESSMENT**

**GUADALUPE PROJECT
PASCUA YAQUI PROPERTY
GUADALUPE, ARIZONA**

JOB NO. 2181JH195

Flood Control District of
Maricopa County
2801 West Durango Street
Phoenix, Arizona

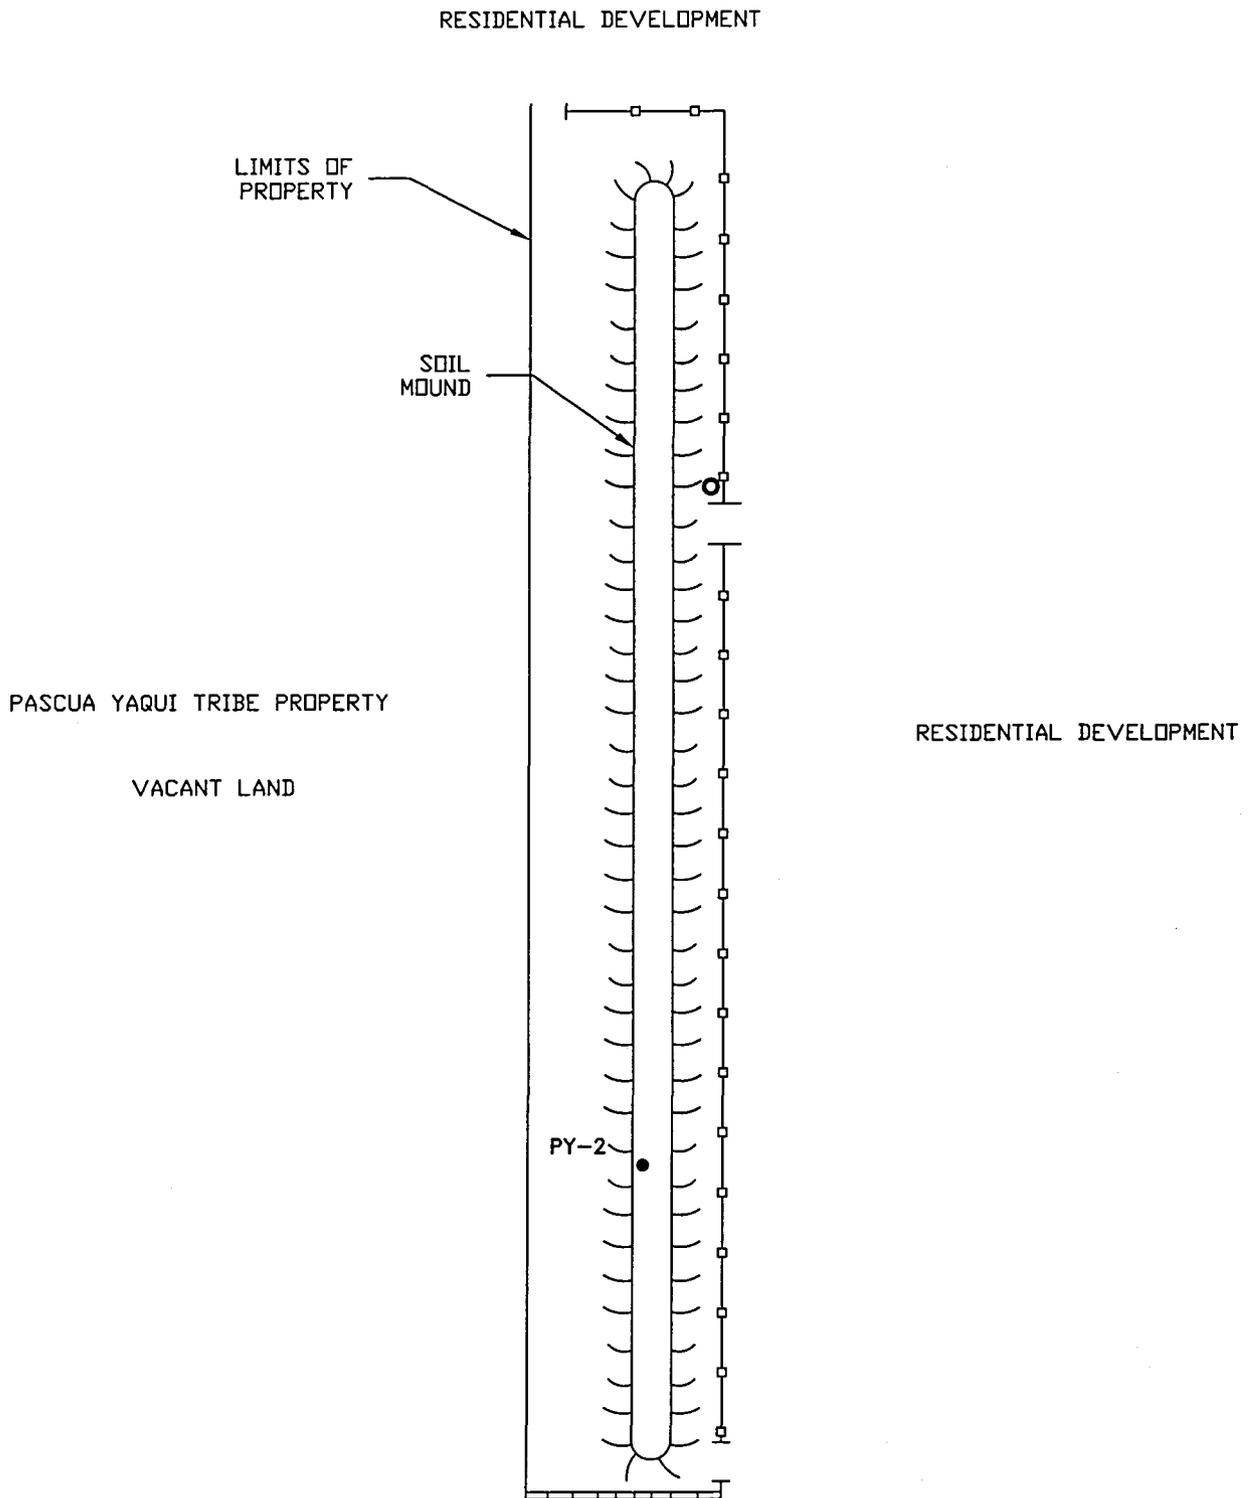
Figure 2 - Site Plan
 Pascua Yaqui Property - Guadalupe Project
 Phase I Environmental Assessment

One assessment point was selected for the soil mounds on the Property (see Appendix A, Figure 2). The soil sample was obtained with a manually operated stainless steel soil scoop. A pre-cleaned soil scoop was used to collect the surface soil sample from a randomly selected point on the soil mound. The collected soil was transferred to a 4-ounce glass jar.

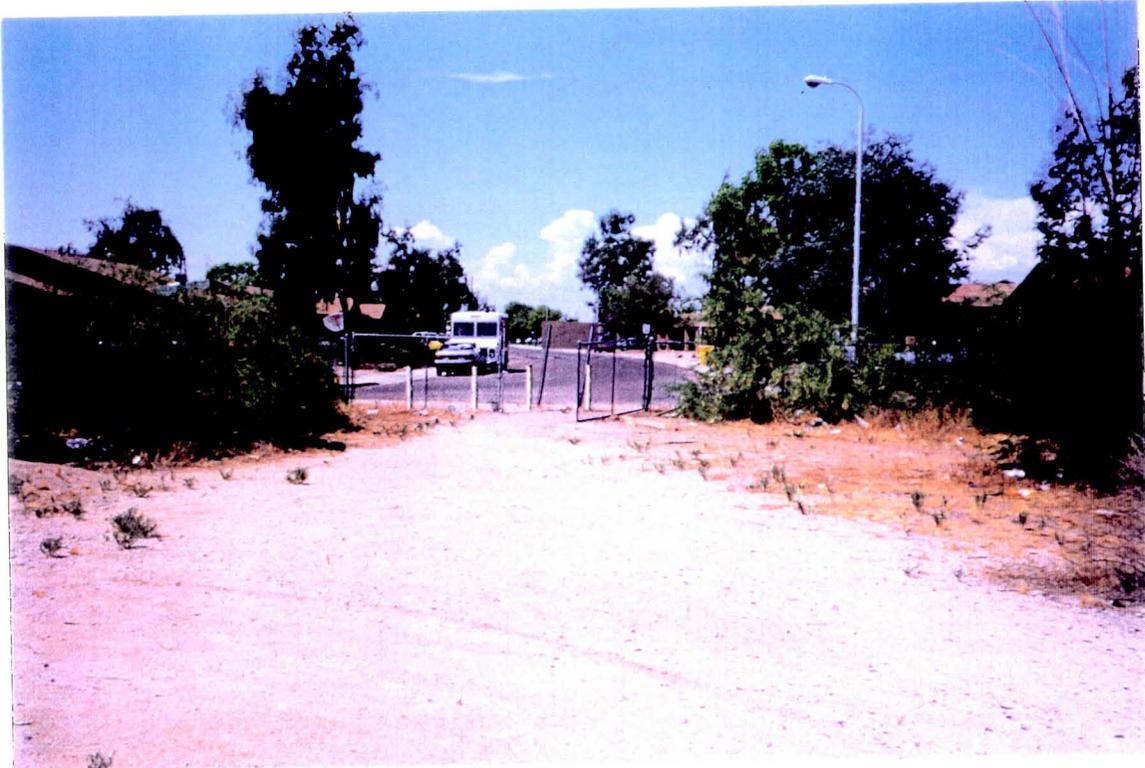
Foot paths transverse through the Property (Appendix B, Pictures 1 and 2). These paths appear to be used for pedestrian, bicycle, and motorcycle movement across the Property.

Picture No. 1 - Foot path access on the north side of the Property.

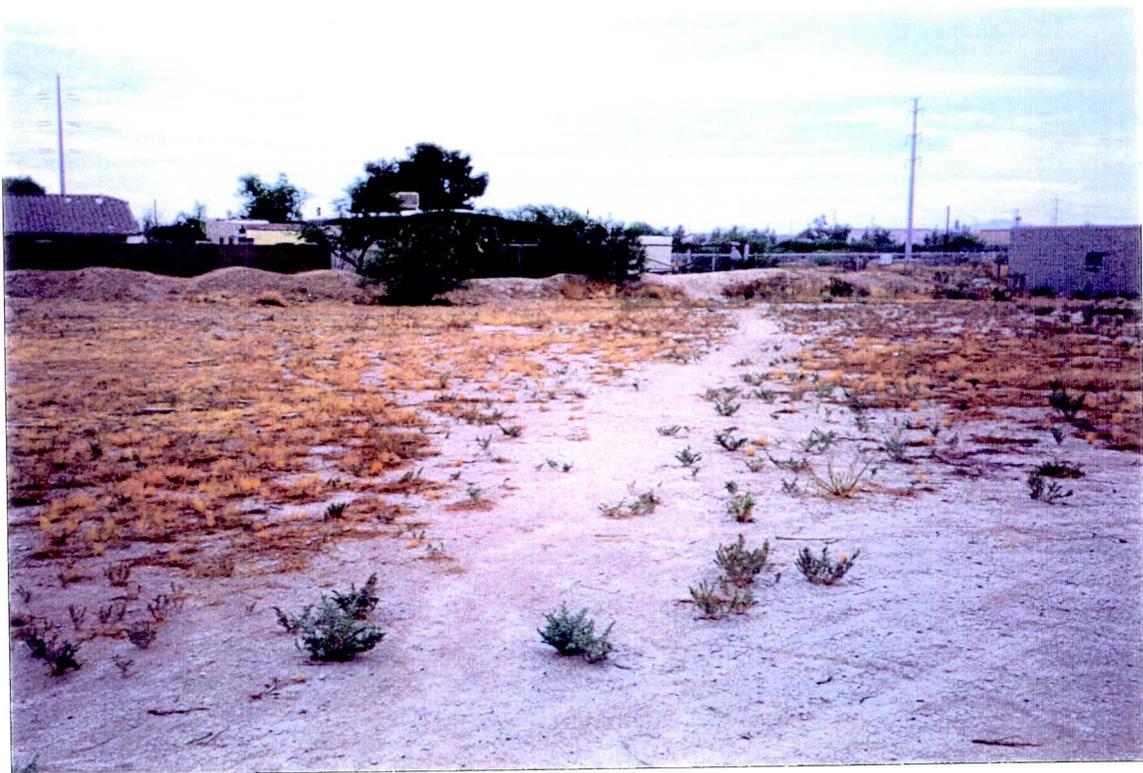
WT observed soil mounds transversing the center of the Property (Appendix B, Pictures 2 and 3). According to Ms. Martinez, these soil mounds possibly could be the result of ground leveling for mobile homes that existed east of the Property from 1997 to 2000. A soil sample was collected from the soil mounds and the results of the soil sampling can be found in Section 6.0.

Picture No. 2 - Foot path access on the south side of the Property. Note the soil mounding transversing the Property.

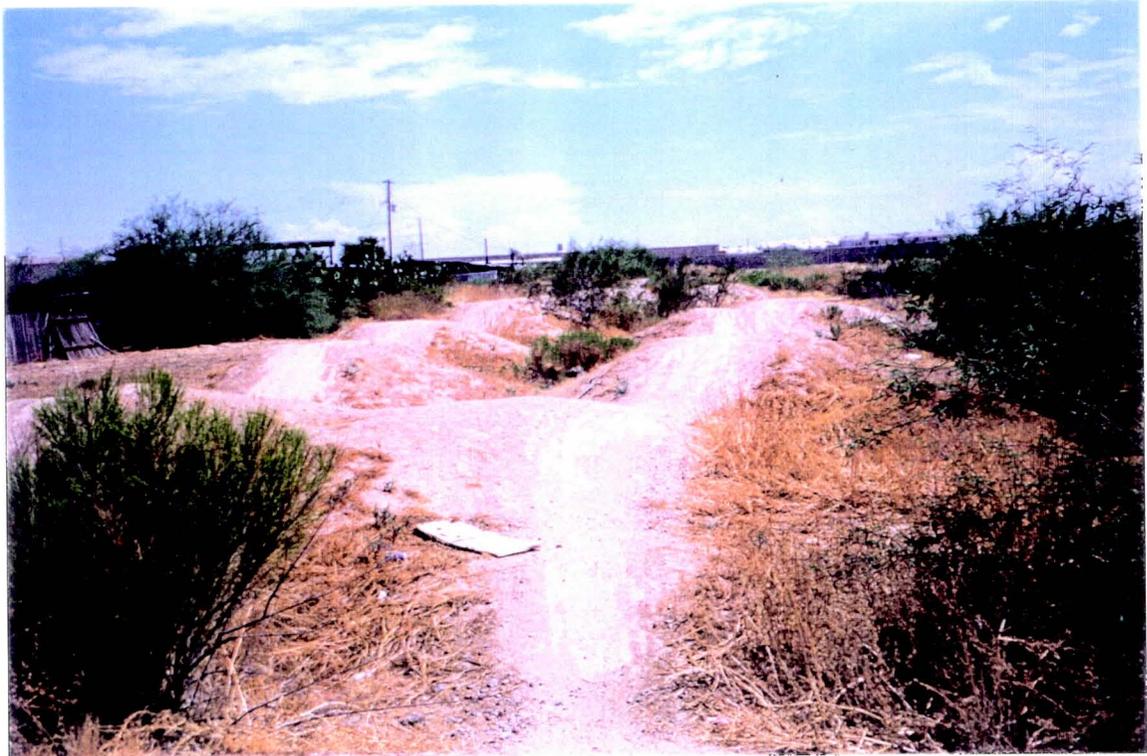
Picture No. 3 - Soil mounds transversing the center of the Property. Note tracks on soil mounds from bicycle use.

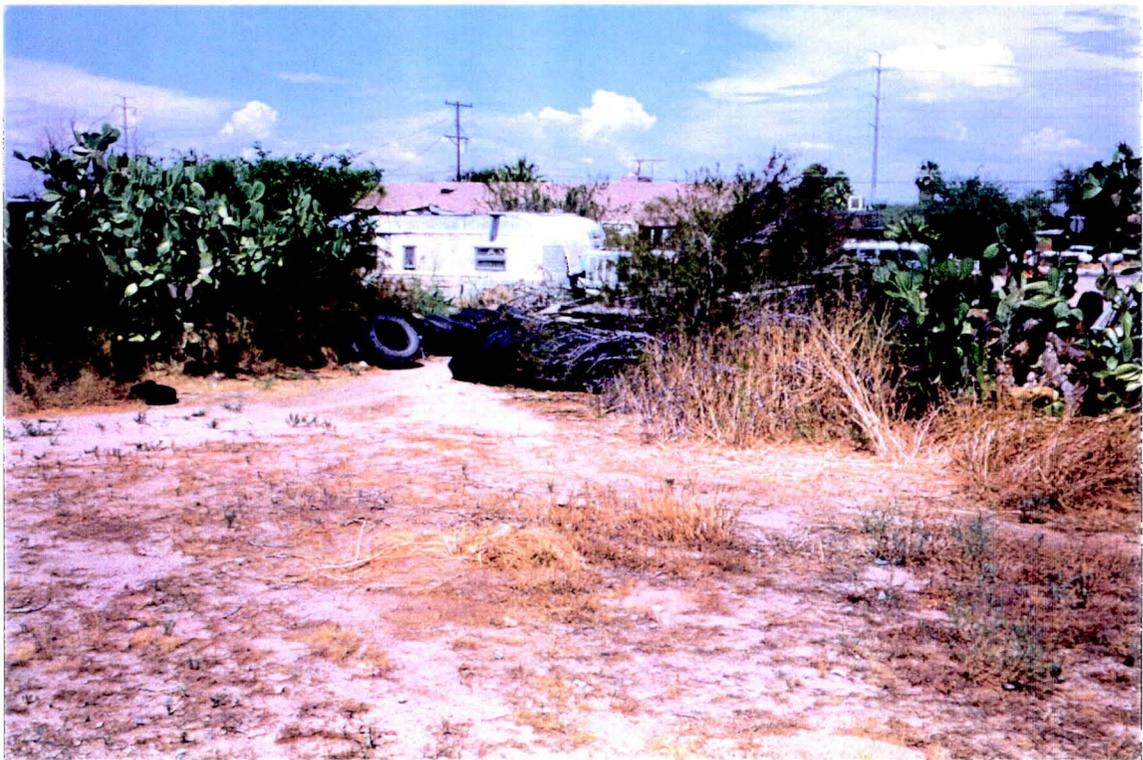
Old tires were observed on the east center boundary of the Property (Appendix B, Picture 4). Litter was present throughout the Property (Appendix B, Picture 5).

Picture No. 4 - Approximately 20 discarded used tires on the east boundary of the Property.

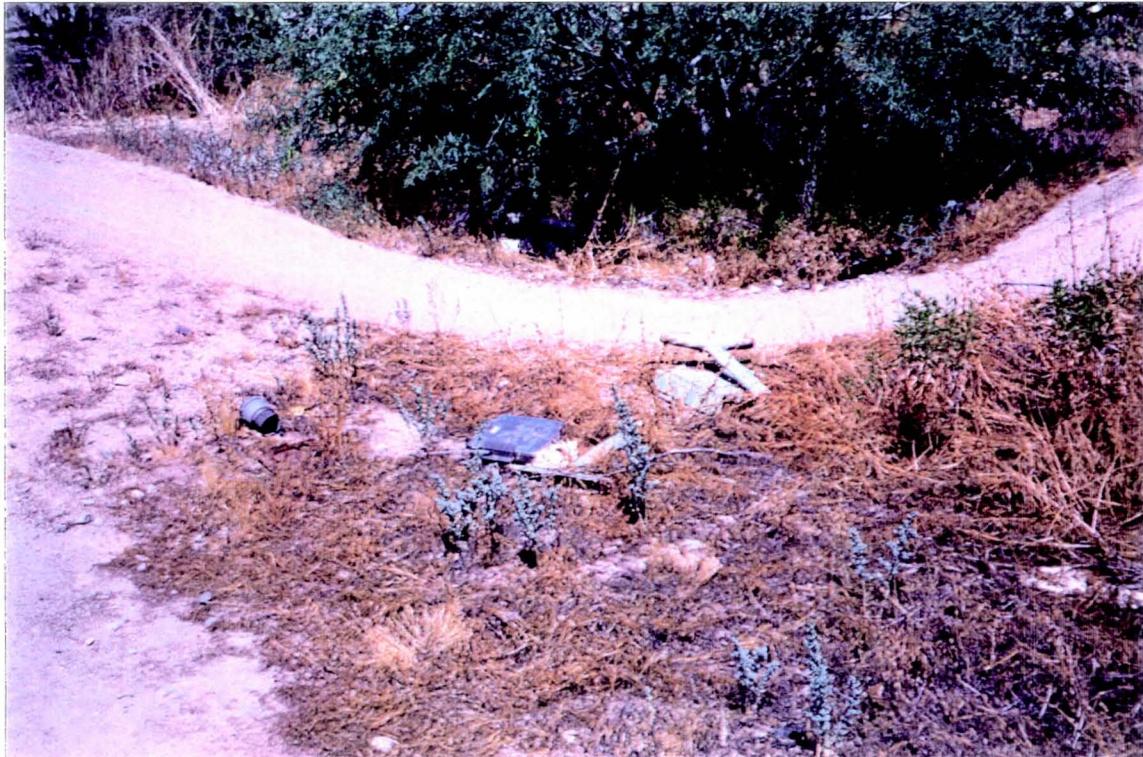
Figure No. 5 - Discarded surface litter on the north side of the Property.

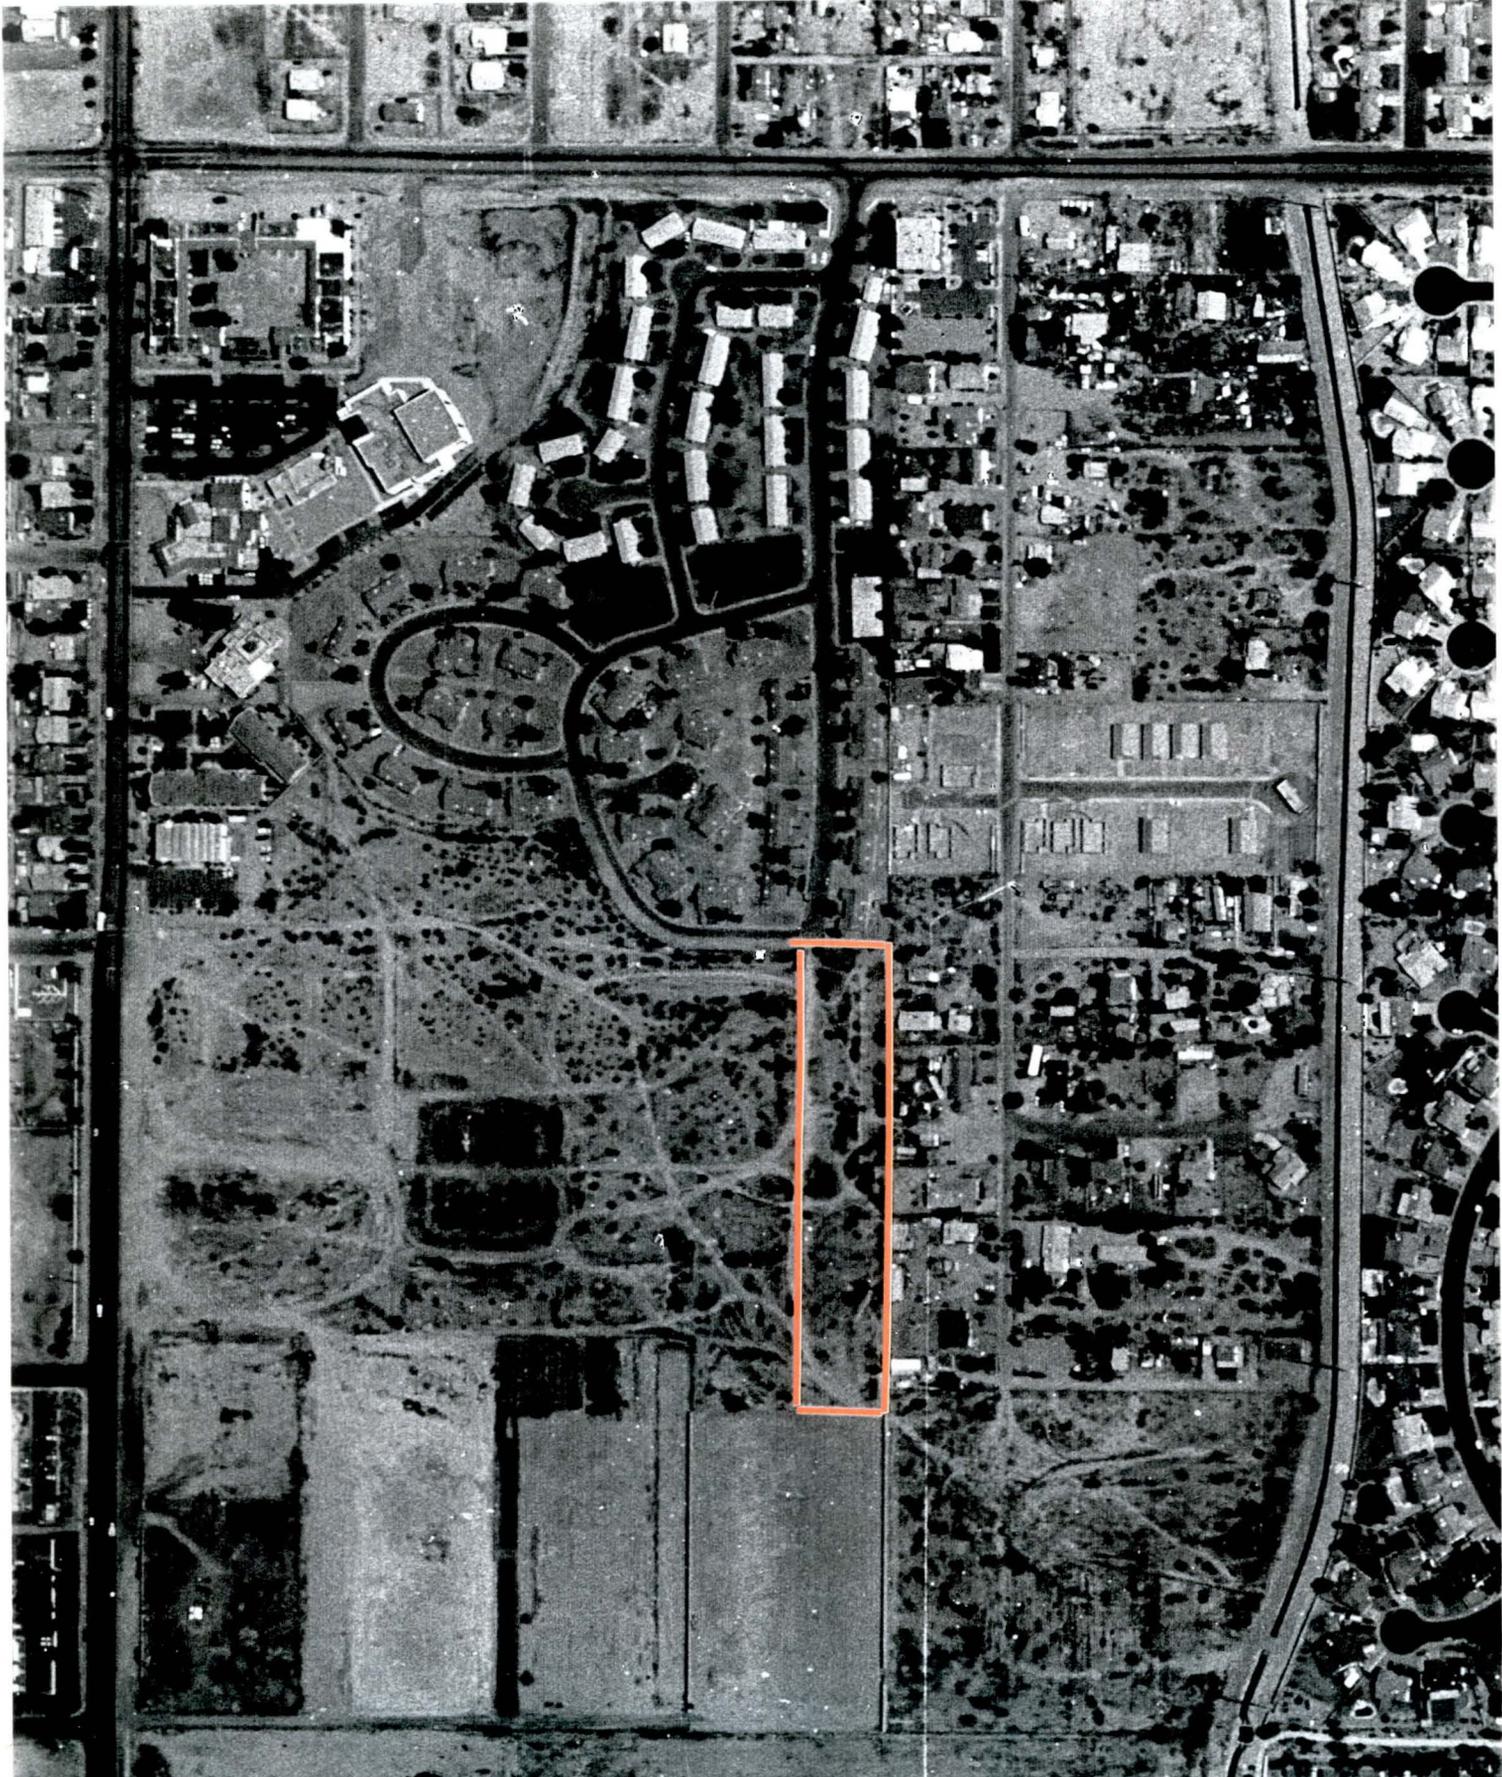
**APPENDIX C:
AERIAL PHOTOGRAPH**

1" = 325'	Reviewed: Aaron Stewart	Photo Date: 5-8-01
	Client: FCDMC	Photo Source: Rupp Aerial
	Western Technologies Inc.	
	Job No. 2181JH195	Figure: 3
